Investigations of Near-Edge Ballistic Impacts on Law Enforcement Body Armor

Kirk D. Rice, Amanda L. Forster, Michael A. Riley,
and Nicholas G. Paulter, Jr.

September 2014

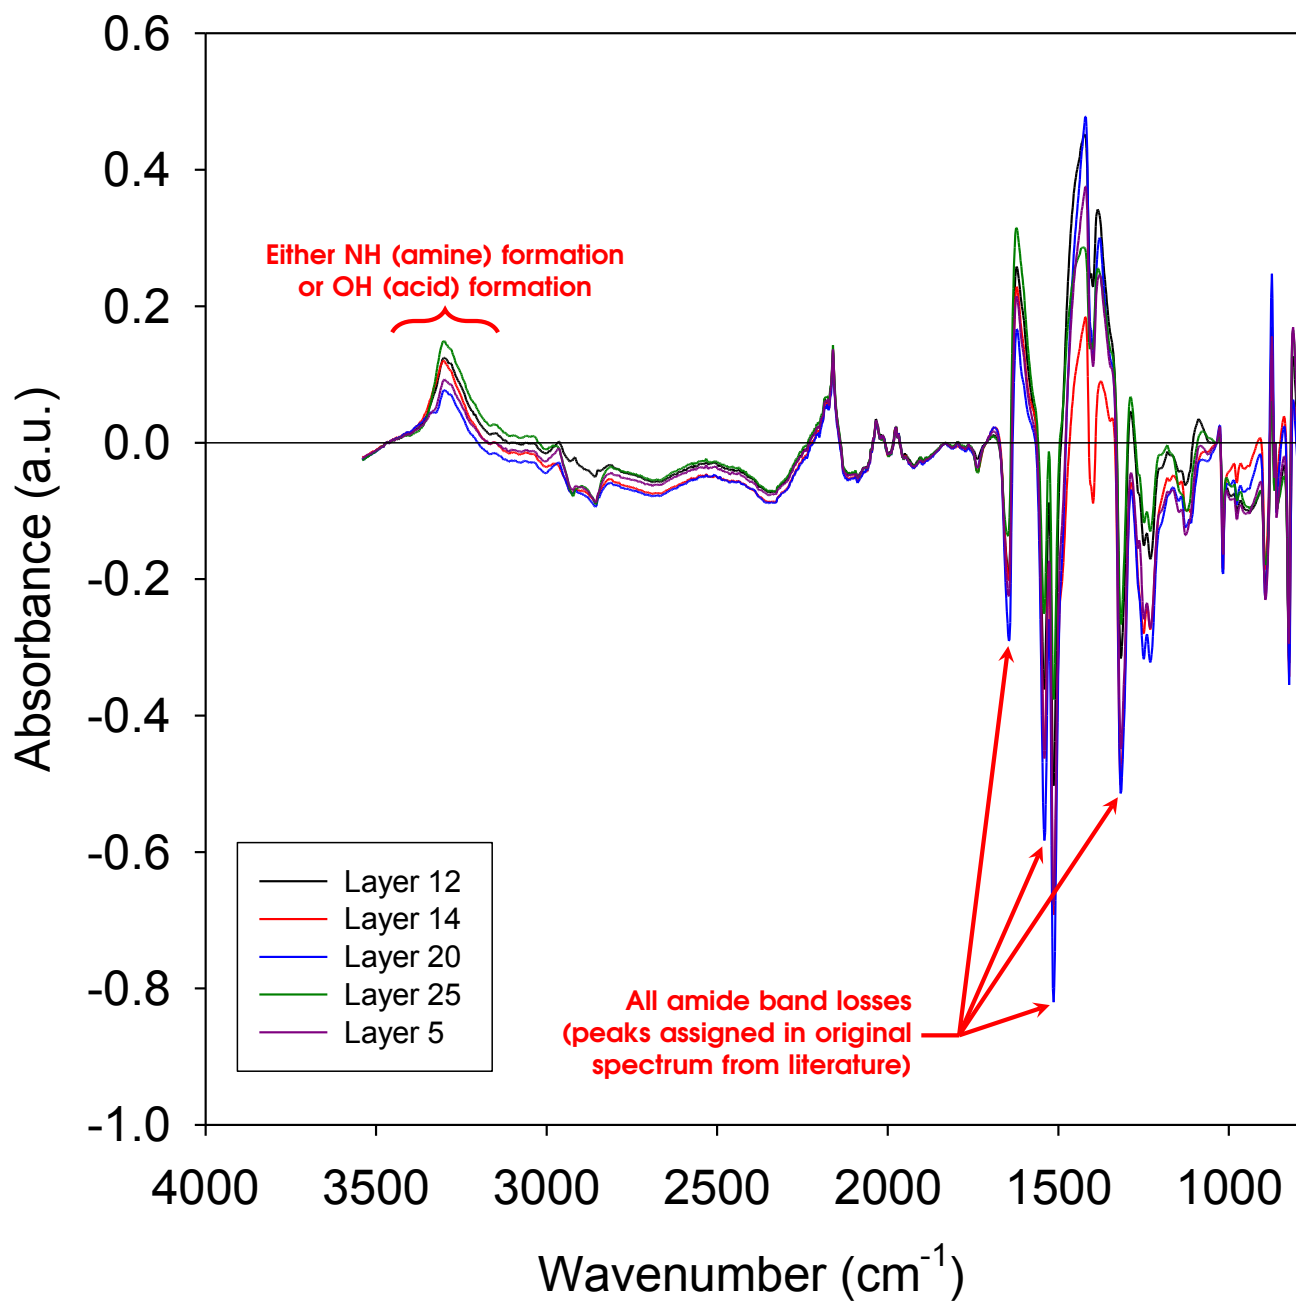
Figure 5.5: Difference Spectrum: Tampa Incident Vest minus Control Vest.

The peaks that are missing from the incident armor correspond to a breakdown of part of the material's chemical structure called an amide linkage. These peaks may be indicative of degradation in the incident armor. The positive peaks, however, do not correspond to the breakdown products expected when amide linkages disappear. The missing amide peaks may be attributed to slight batch to batch differences in the material for the two armors, or may be due to changes or rearrangement of impurities in the chemical structure of the material. While these results are interesting from a scientific perspective, there is no clear evidence to support chemical degradation of the incident armor.
