# **1994 Northridge Earthquake Performance of Structures, Lifelines, and Fire Protection Systems**

Diana Todd  
Nicholas Carino  
Riley M. Chung  
H. S. Lew  
Andrew W. Taylor  
William D. Walton  
James D. Cooper  
Roland Nimis

Building and Fire Research Laboratory  
National Institute of Standards and Technology  
Gaithersburg, MD 20899-0001

May 1994

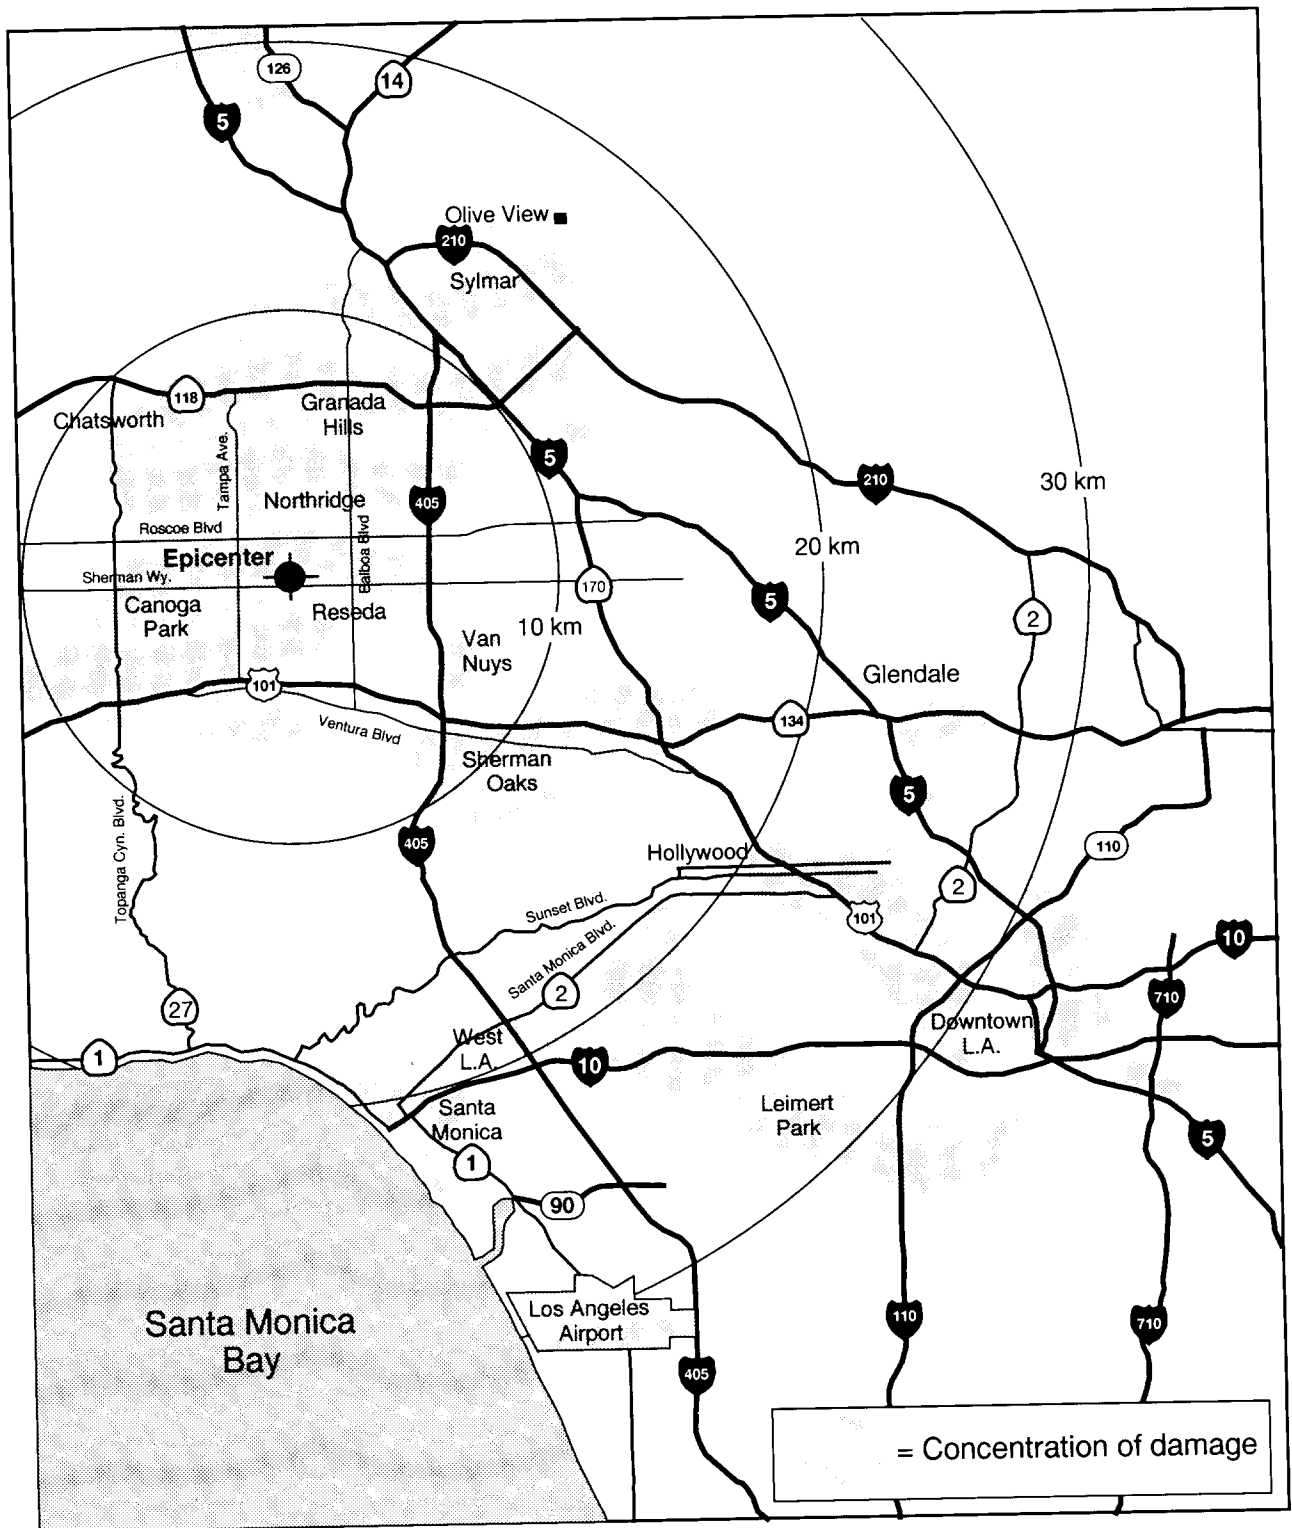
Figure 3.1. Serious damage to buildings caused by the magnitude 6.8 Northridge earthquake was widespread, but, outside of the epicentral area, seriously damaged buildings tended to occur in pockets.

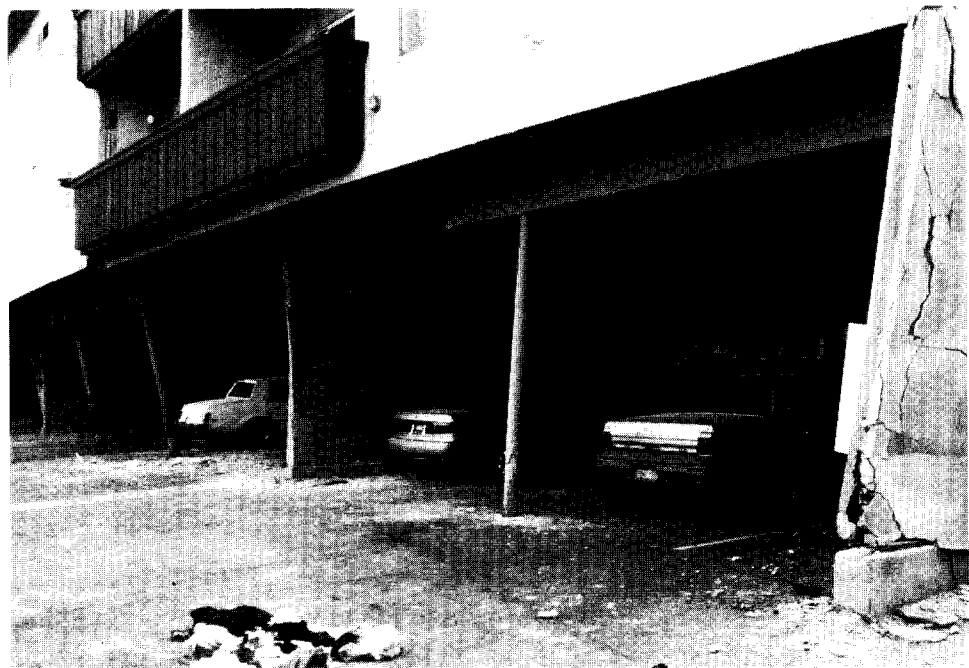
Figure 3.7. Racking, or leaning, of open first story parking areas was a common feature of damaged two and three-story apartment buildings.

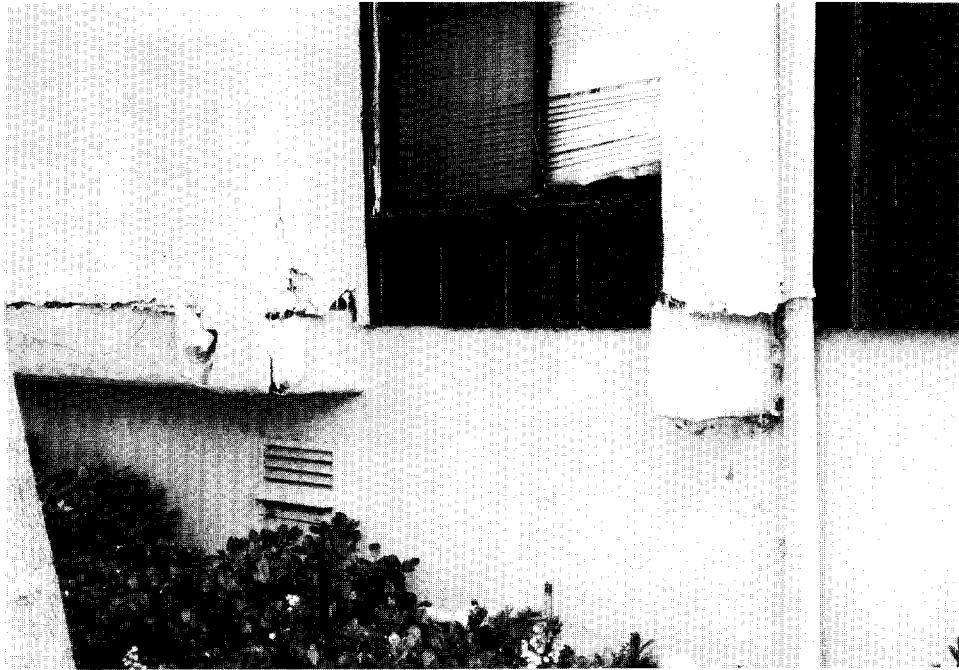
Figure 3.8. Horizontal cracks at the interface of the foundation wall (usually concrete) and the first story (typically wood-framed with stucco facade) were often seen in damaged low-rise apartment buildings.

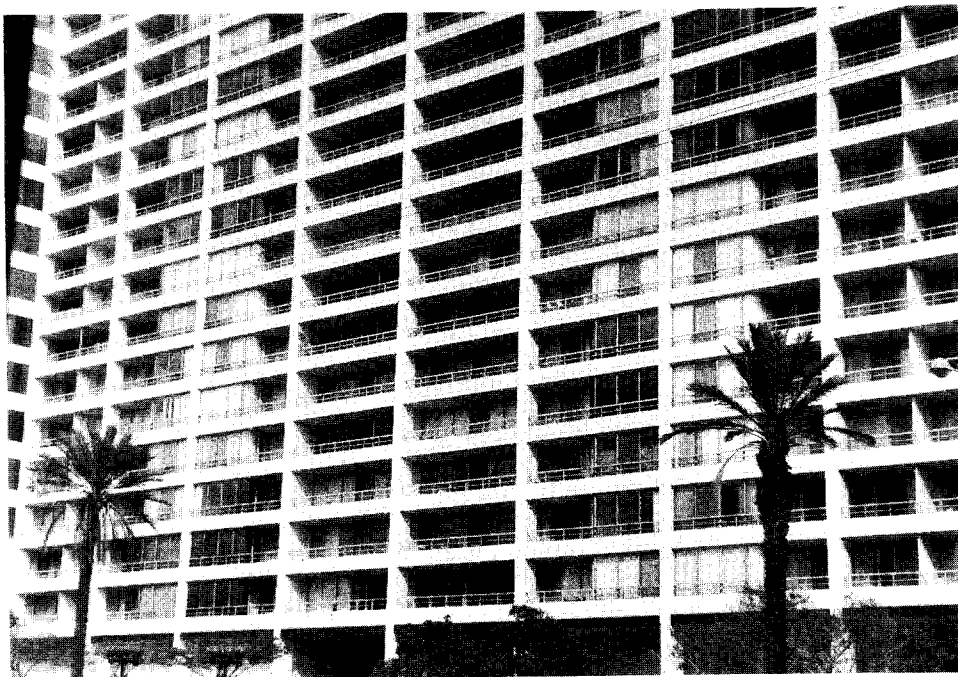
Figure 3.13. The front of the 16-story Champagne Towers building had no apparent damage. Note the steel pipe railings at the balconies.

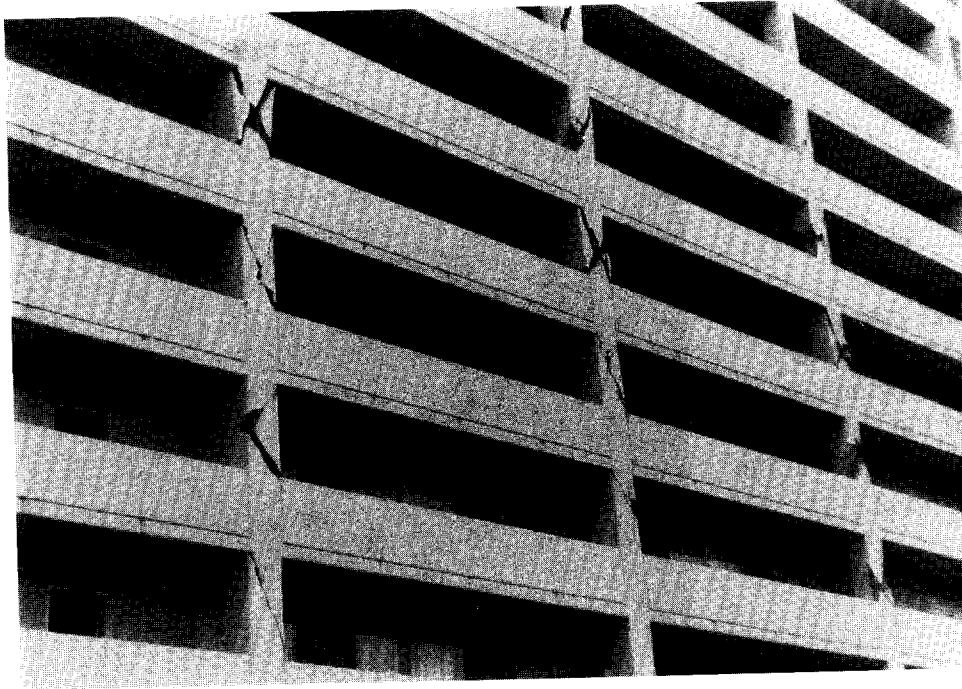
Figure 3.14. The back of the Champagne Towers building was badly damaged. The railings here are solid infill, which effectively stiffen the lower half of the columns. The shortened upper half of the columns were forced to accommodate all the displacement, and they failed in shear.

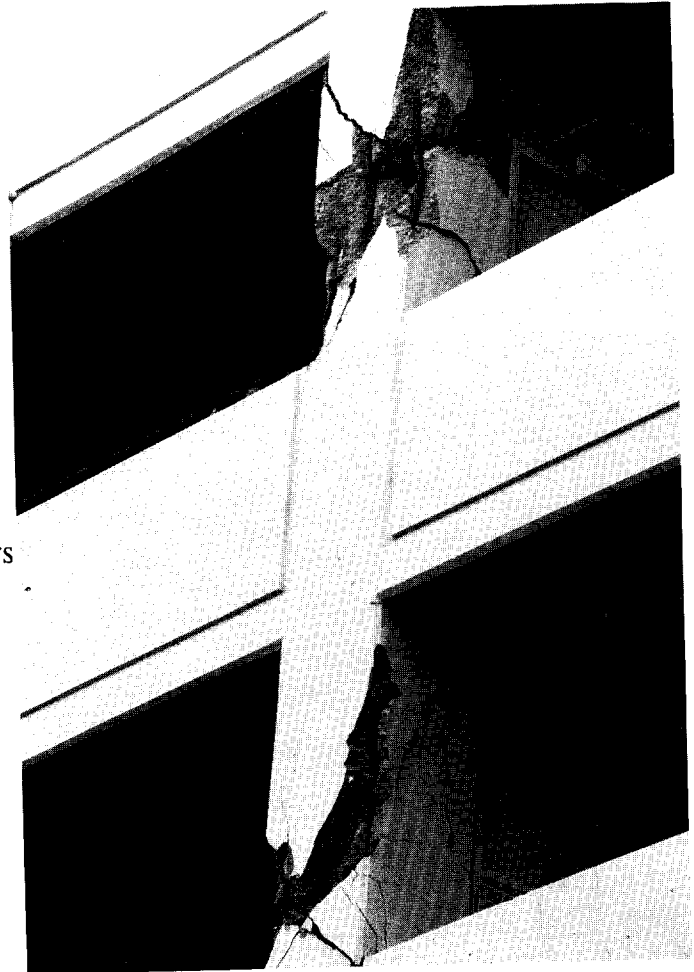
Figure 3.15. A closer view of the failed columns at the back of Champagne Towers shows minimal transverse reinforcement.

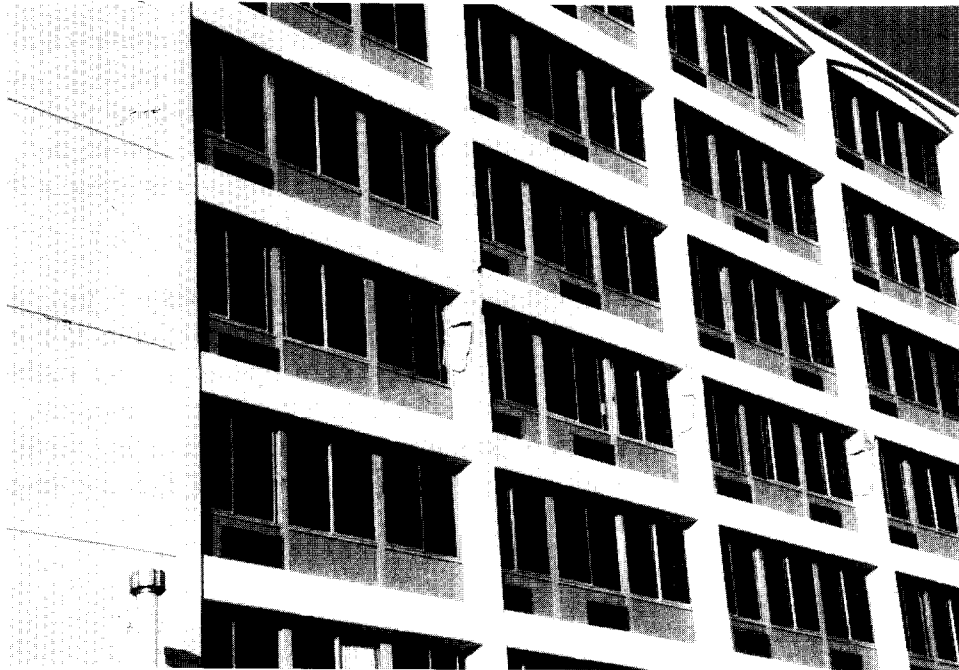
Figure 3.16. The bottom two stories of the concrete frame Holiday Inn in Van Nuys were damaged in the 1971 San Fernando quake and subsequently repaired. In the 1994 Northridge quake, damage was concentrated at the top of the fourth floor columns.

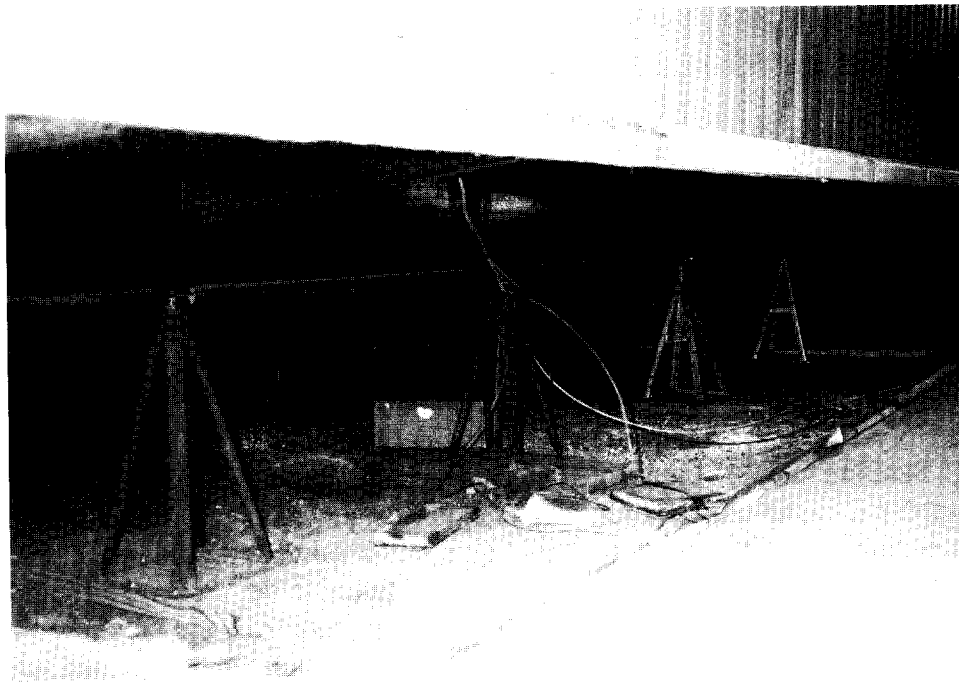
Figure 3.21. Another foundation system used for manufactured housing consists of supports constructed of small metal angles.

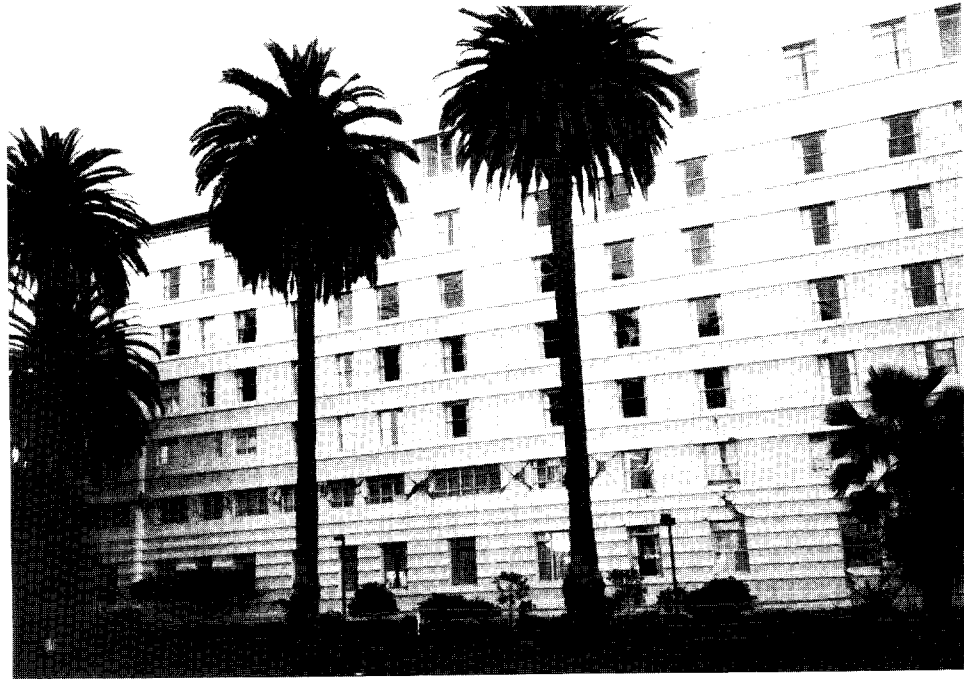
Figure 3.23. The seven-story northwest wing of St. John's hospital in Santa Monica experienced severe X-cracking in the piers between the second story windows.

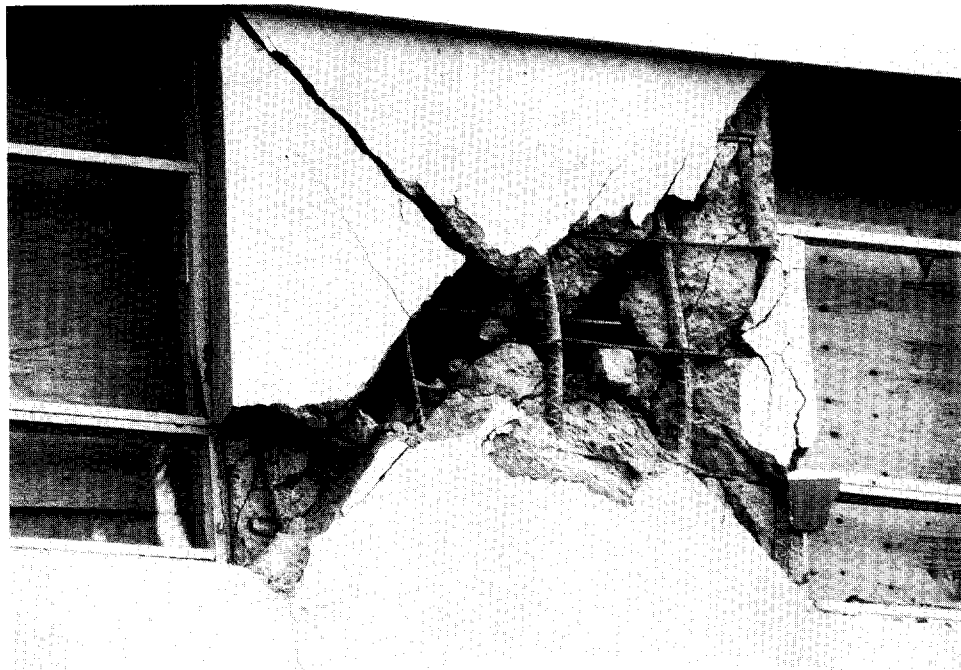
Figure 3.24. The transverse reinforcement in the St. John's hospital window piers was spaced at about 150-200 mm on center with 90° hooks at the ends, typical for construction of its age (about 50 years old).

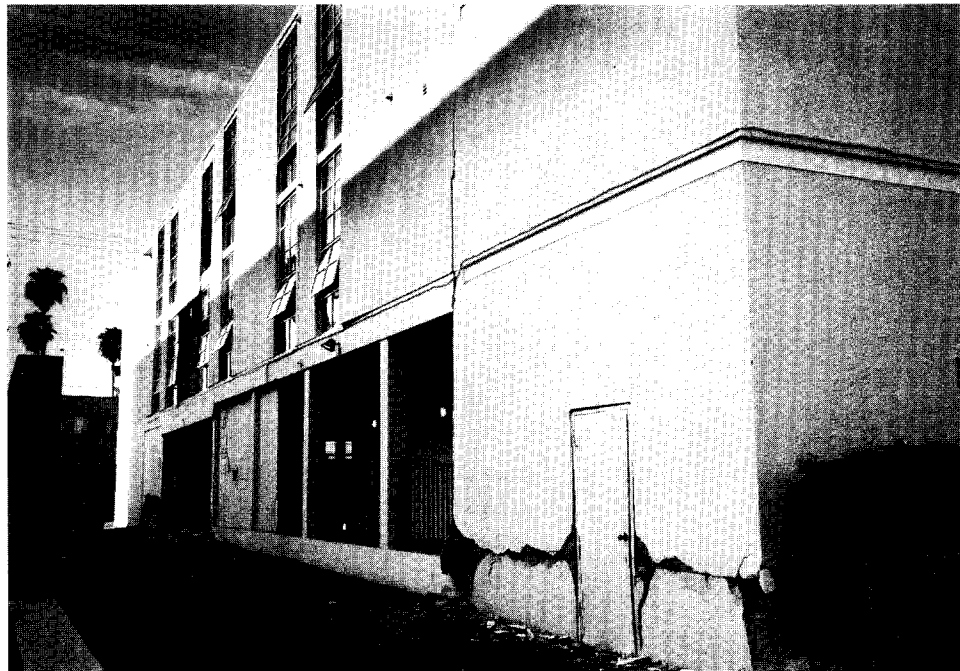
Figure 3.27. The facade of the five-story Berkley Convalescent Hospital directly adjacent to the St. John's Hospital complex consisted of two wythes of brick masonry with a reinforced and grouted space between. In some places, all three layers of this facade were destroyed along lines of diagonal cracking. The facility was evacuated.

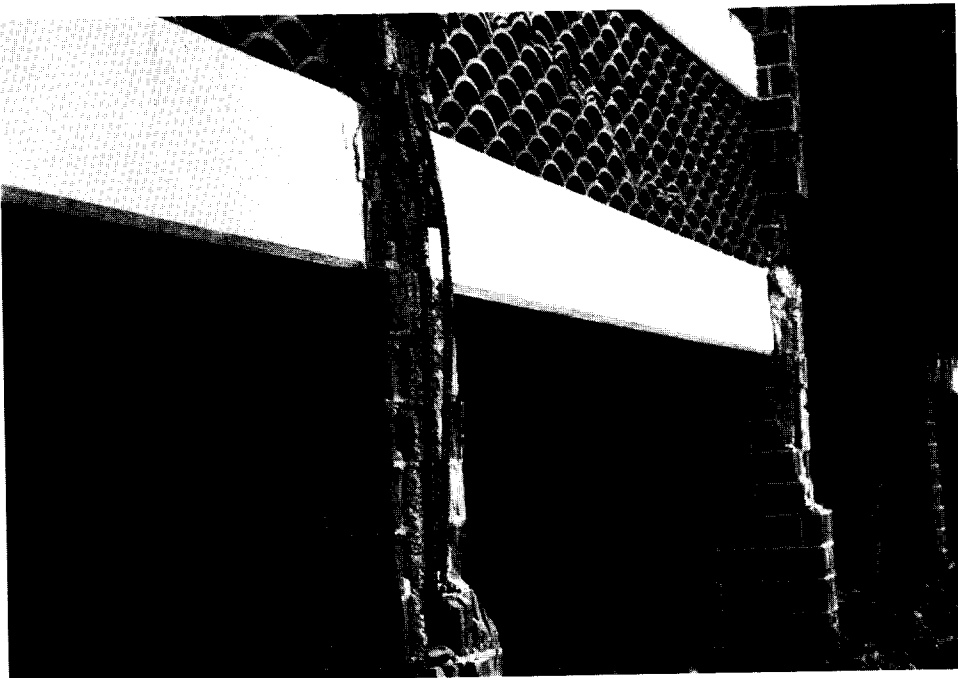
Figure 3.28. Two faces of the Berkley Convalescent Hospital had wing walls separating balconies. The ends of these wing walls spalled at the lower stories.

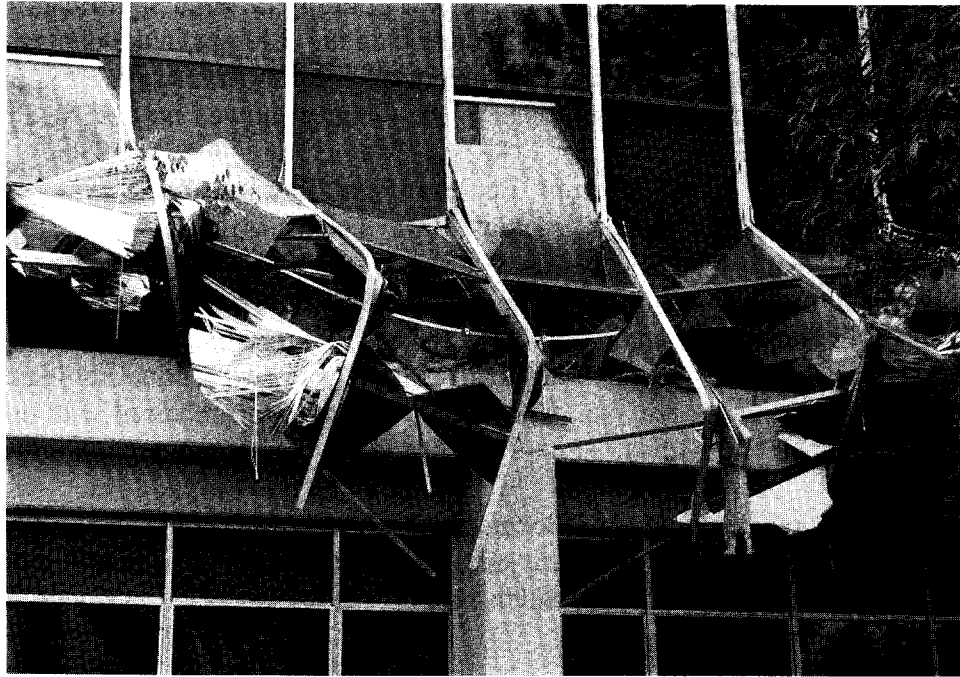
Figure 3.41. The second story of the concrete frame Kaiser Permanente office building on Balboa Avenue in Granada Hills completely collapsed. The first story was relatively undamaged, suggesting it was far stiffer than the story above.

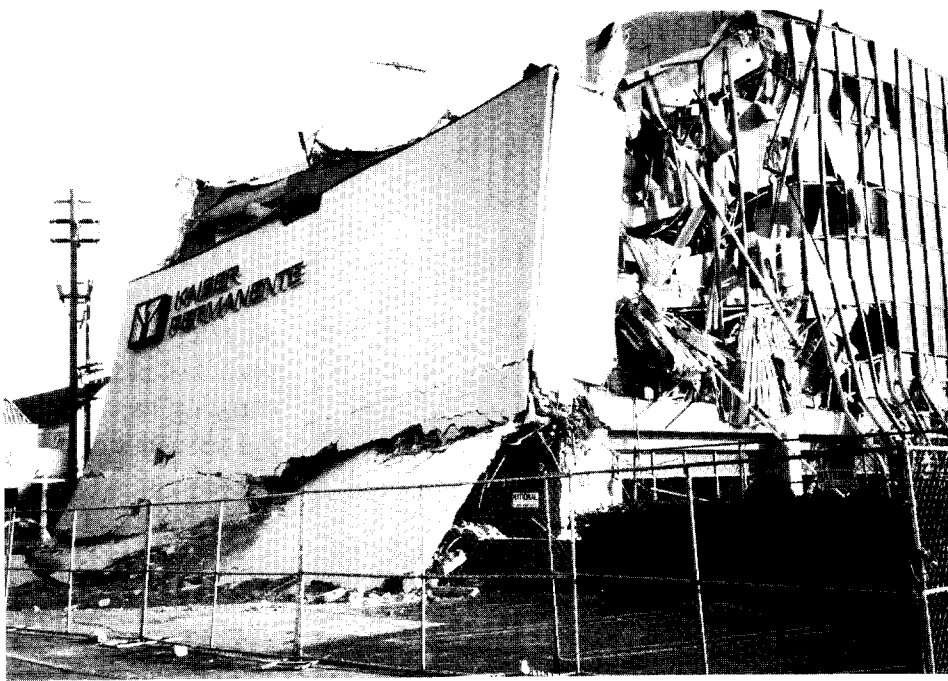
Figure 3.43. Damage at the north end of the building was similar to damage at the south.

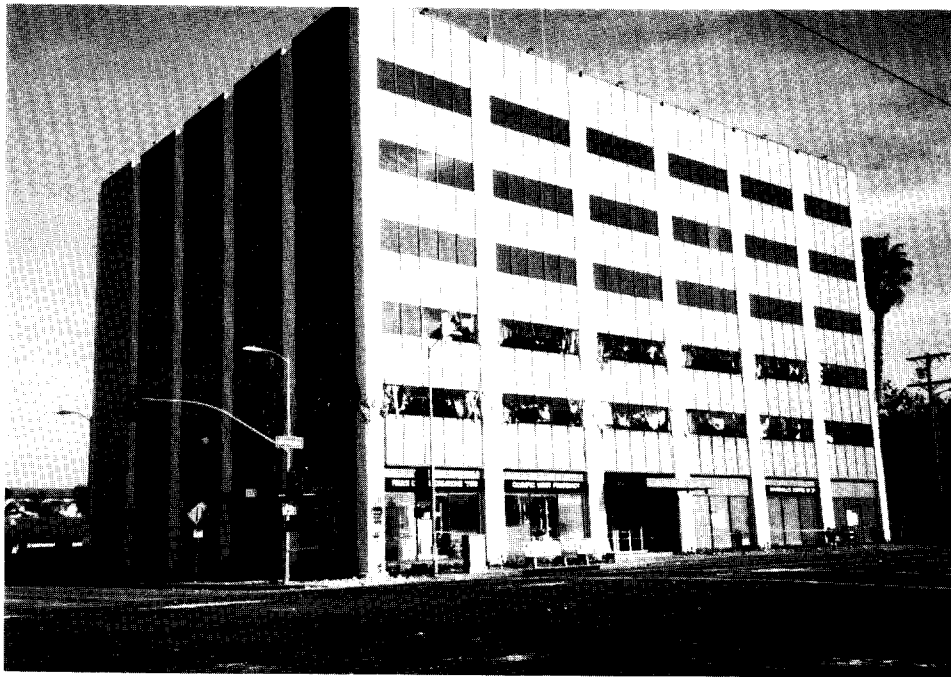
Figure 3.45. The six-story L-shaped concrete-frame Barrington Building on Olympic Boulevard in West Los Angeles lost its vertical-load carrying capacity at the second story.

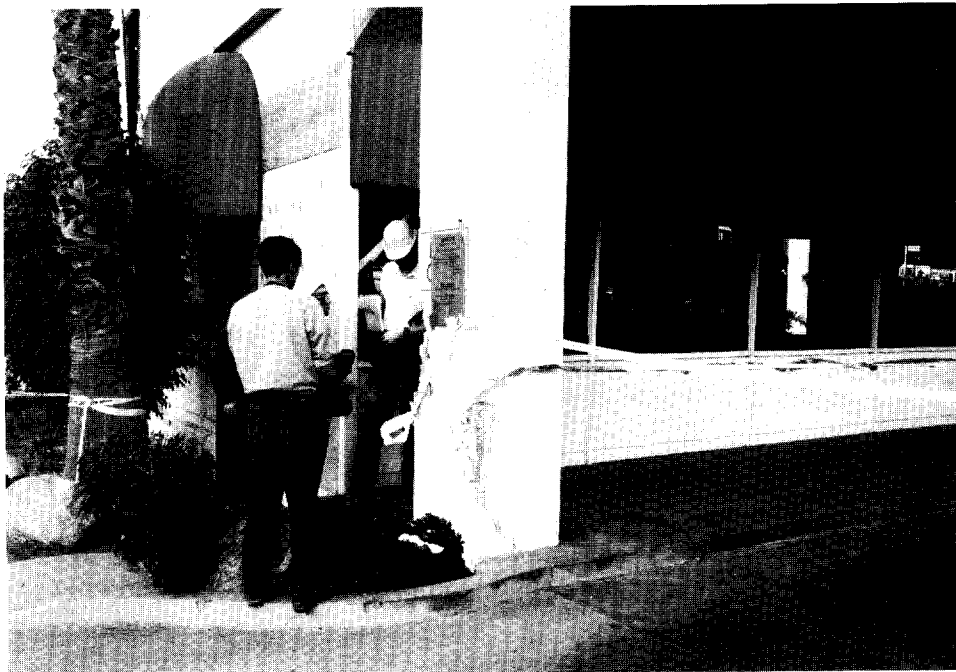
Figure 3.56. The columns supporting the three-story appendage at the front of the Radisson Hotel had serious shear cracks and related spalling.

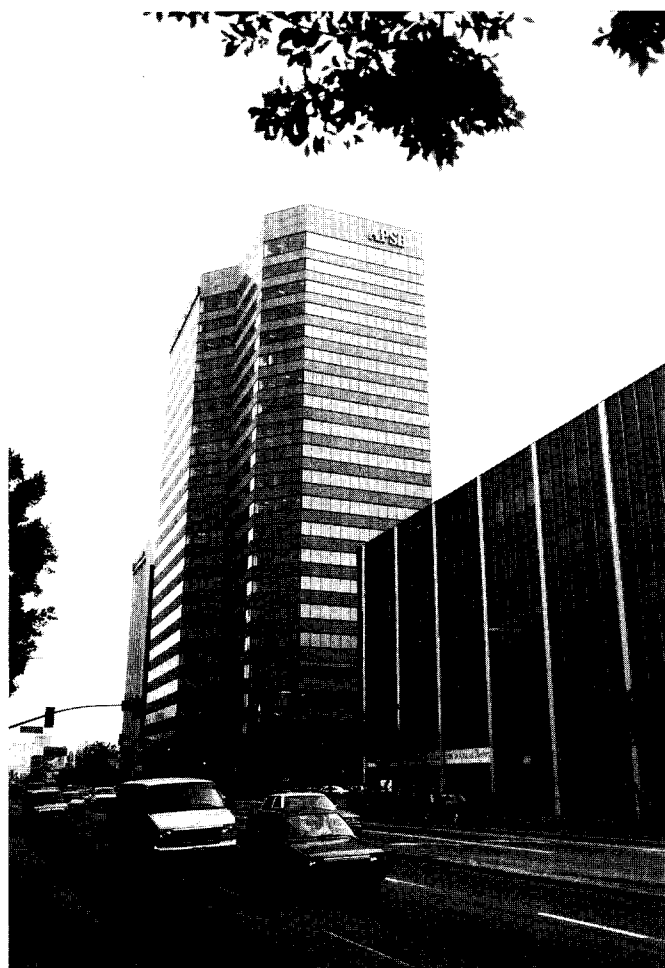
Figure 3.58. The reinforced masonry facade of this steel-framed building in Sherman Oaks was badly damaged.

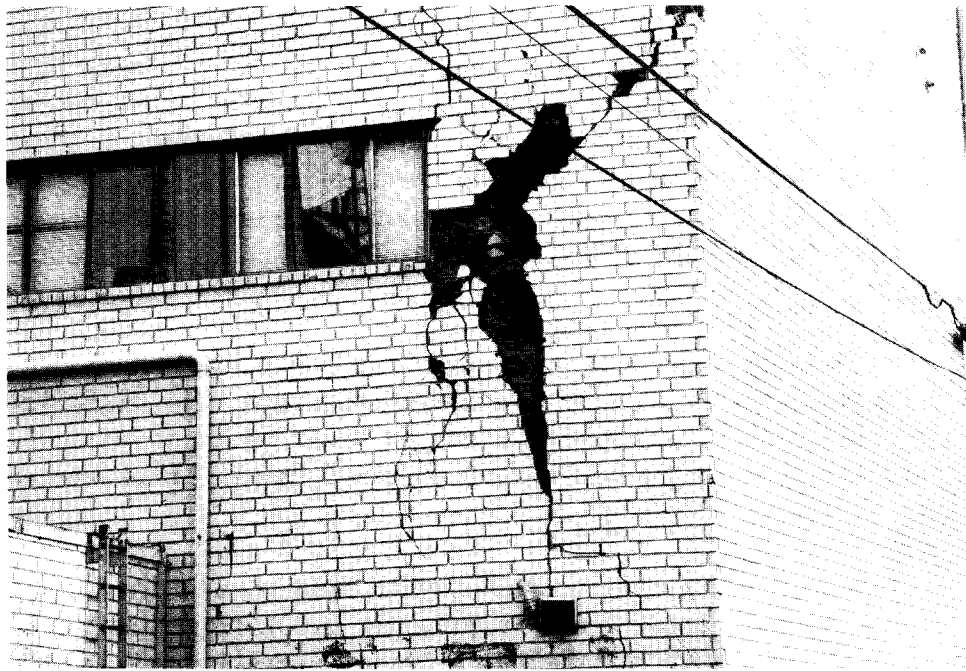
Figure 3.59. A close-up view of the damage shows the pattern of reinforcing used in the masonry facade.

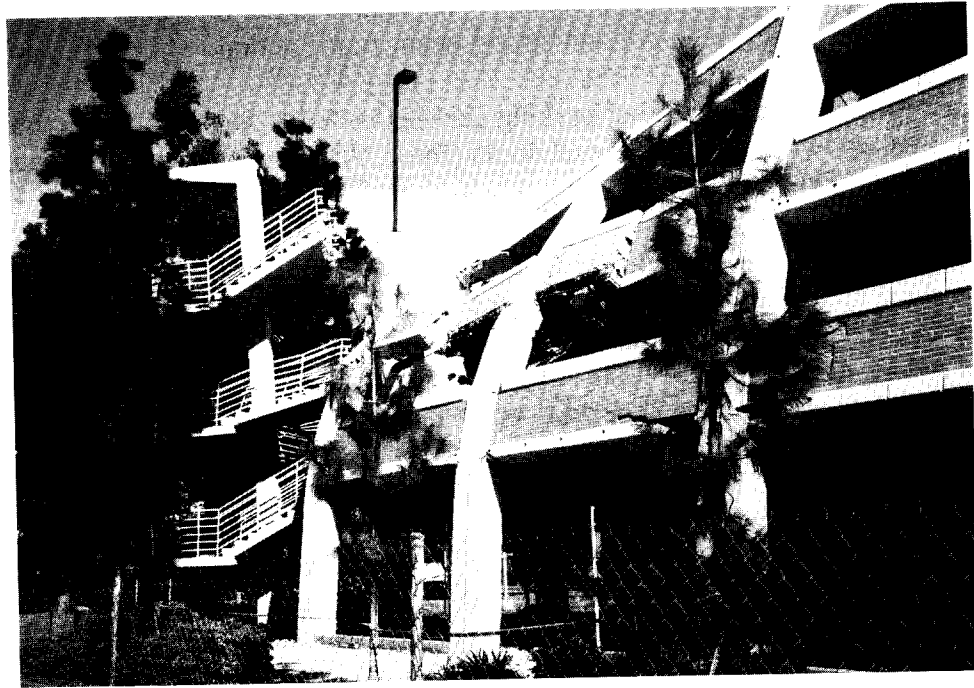
Figure 3.60. The three-year old four-level parking garage at the Northridge campus of California State University partially collapsed in the earthquake. The collapse apparently started at the interior, causing the exterior frame to be pulled in to the middle of the structure. Precast concrete "trees" were connected to form a moment-resisting frame at the exterior of the structure.

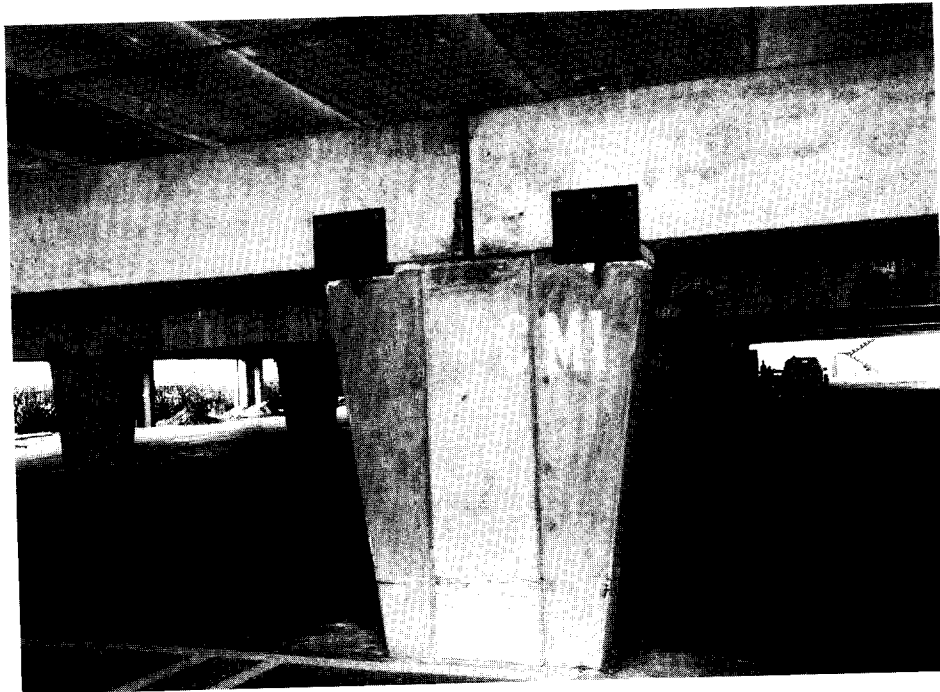
Figure 3.64. The interior columns of the two-level parking garage at the Trans World Bank in Sherman Oaks had been seismically strengthened after it suffered damage in the 1971 San Fernando quake. The interior columns fared well in the 1994 Northridge quake.

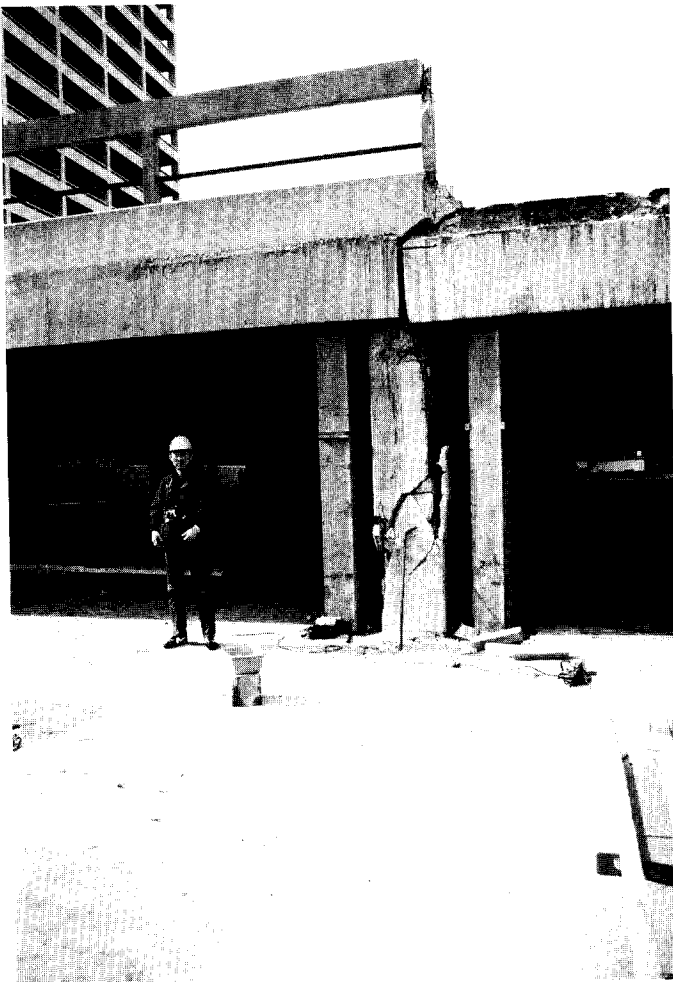
Figure 3.65. The exterior columns of the Trans World Bank parking garage, which had not been strengthened, were badly damaged.

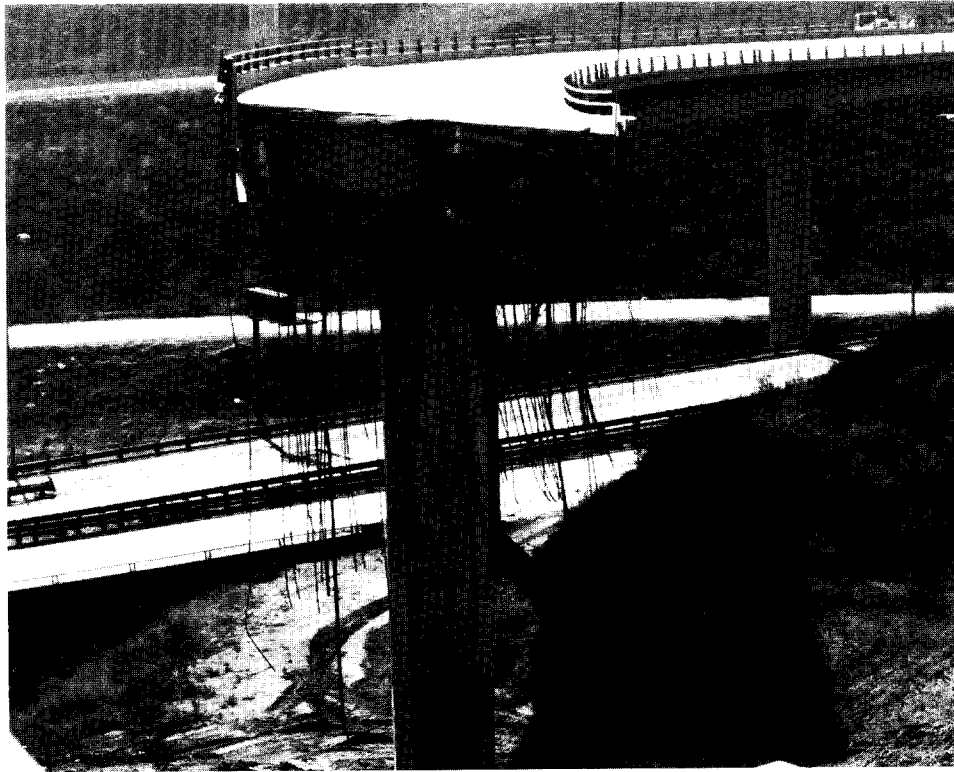
Figure 4.15. View of the flexural failure at Pier 3 of the SR14/I5 North Connector Overcrossing, looking to the south.

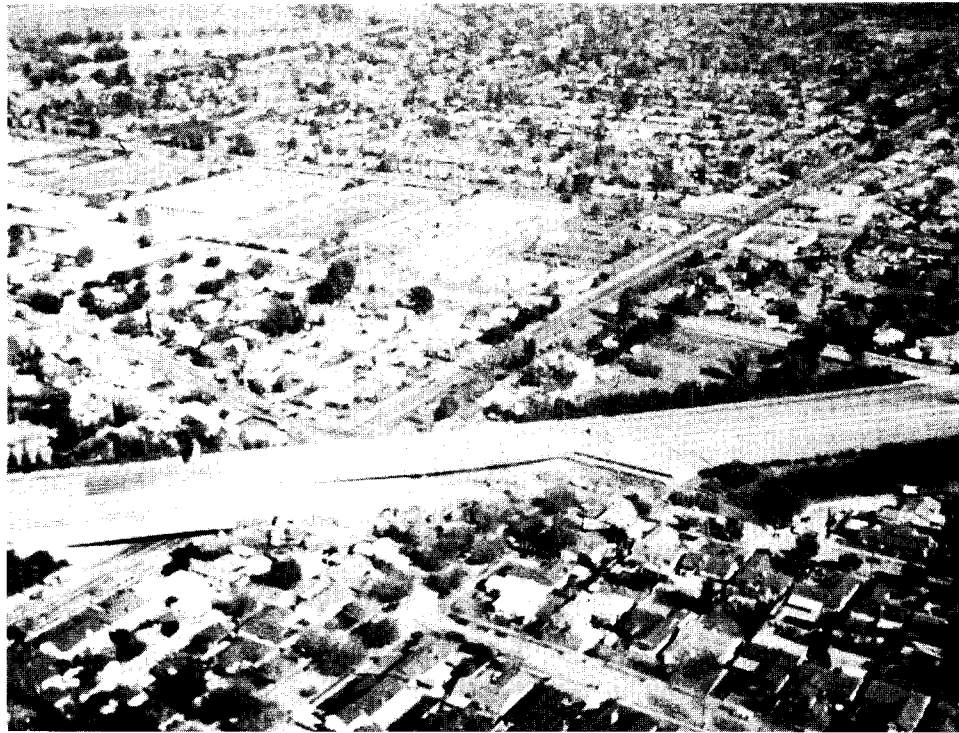
Figure 4.19. Aerial view of the SR118 Mission-Gothic Undercrossing, looking to the north showing collapsed eastbound bridge (Photo courtesy of FHWA).

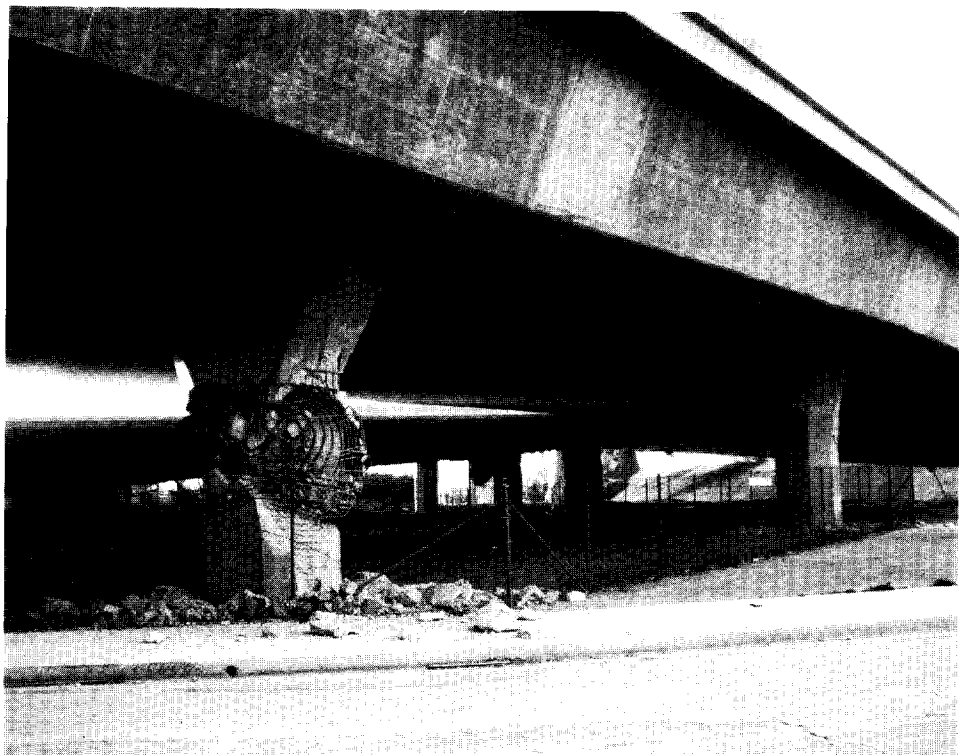
Figure 4.20. Damage to piers of the SR118 Mission-Gothic Undercrossing, looking to the northwest at the north face of the westbound bridge, Bents 3 (foreground) and 2.

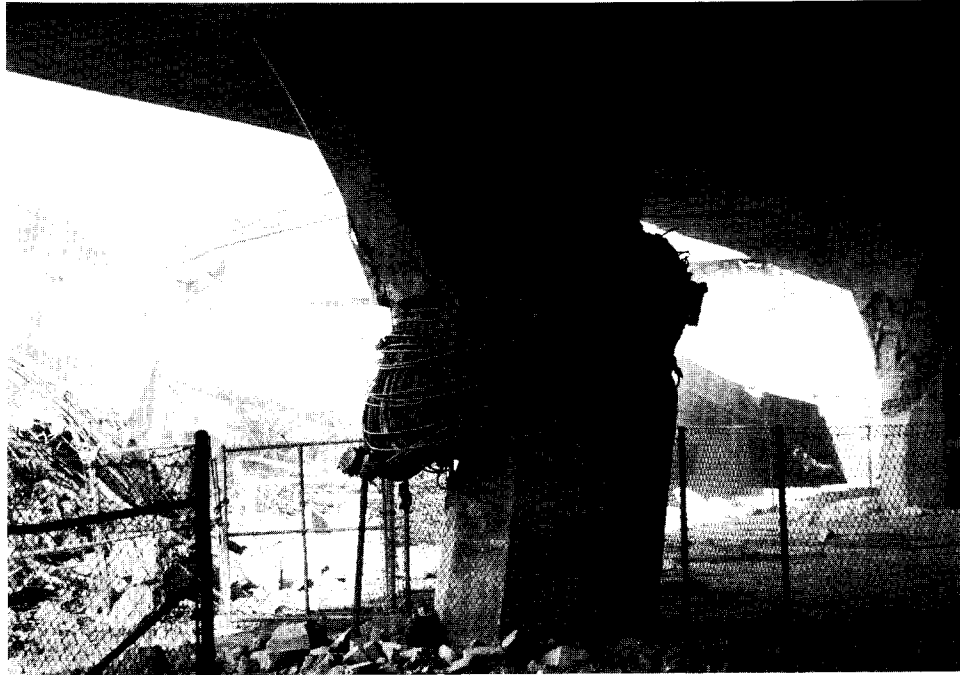
Figure 4.21. Damage to a pier of the SR118 Mission-Gothic Undercrossing, looking to the northwest at the southernmost pier of Bent 3 of the westbound bridge.

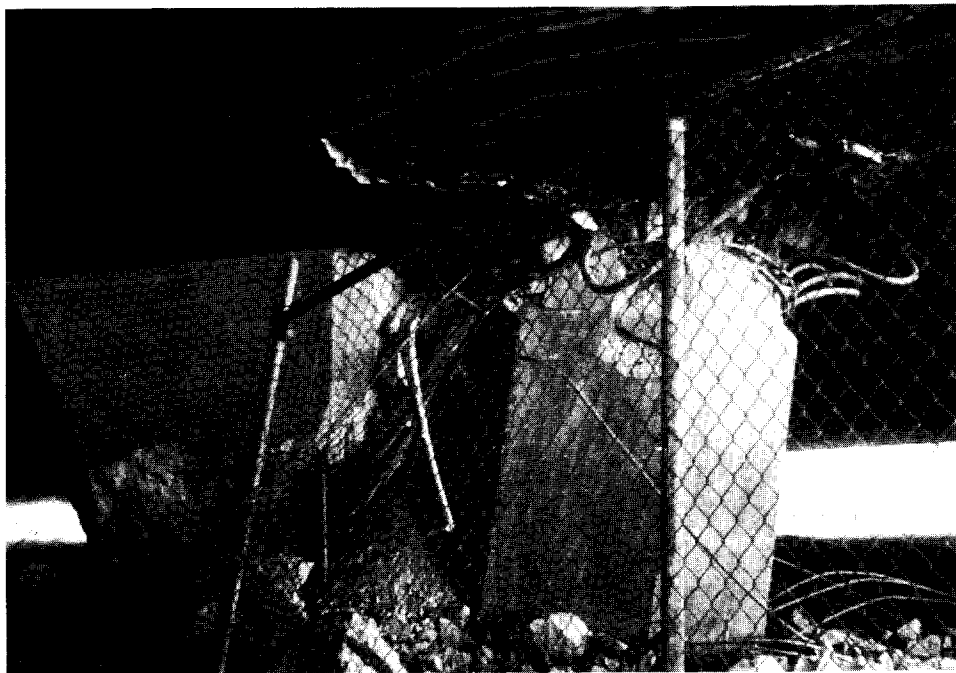
Figure 4.22. Damage to a pier of the SR118 Mission-gothic Undercrossing, looking to the west at Bent 4 of the eastbound bridge, which collapsed (Photo courtesy of EERC).

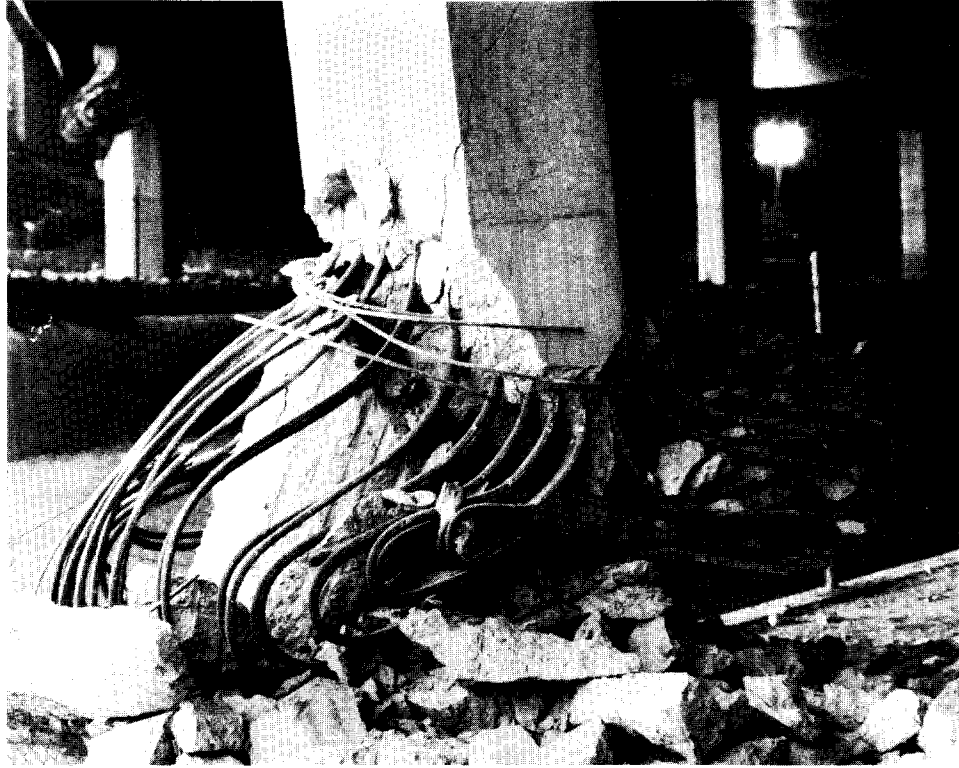
Figure 4.27. Damage to pier 3S-1 of State Route 118 at Bull Creek Canyon Channel, looking to the northwest.

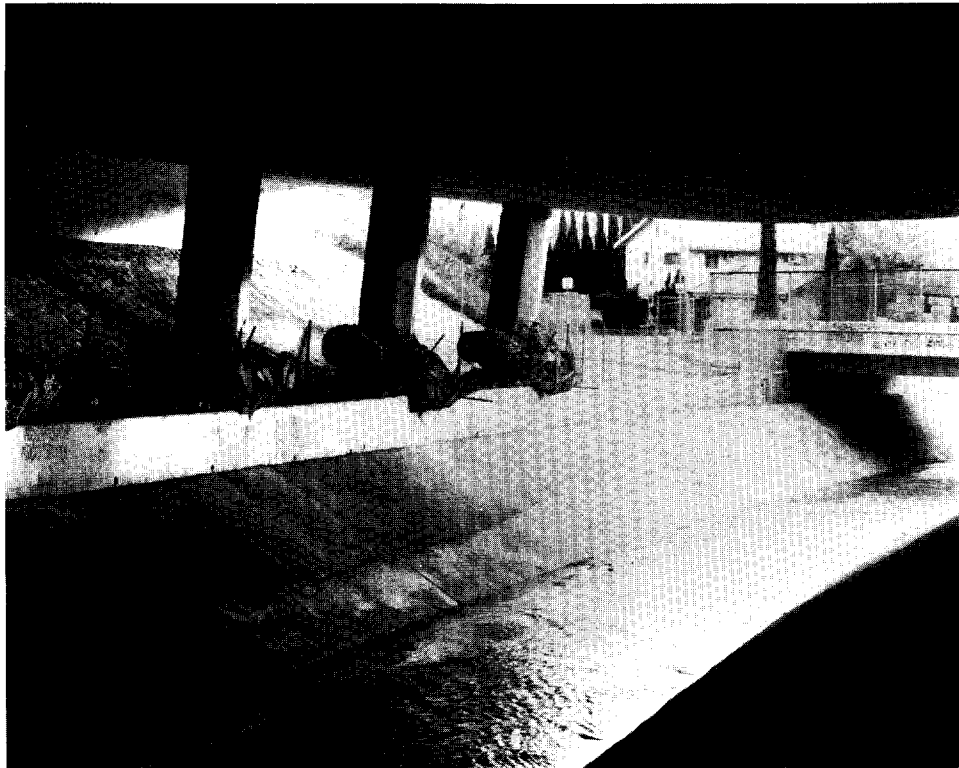
Figure 4.28. Damage to piers of Bent 3S of State Route 118 at Bull Creek Canyon Channel, looking to the southeast.

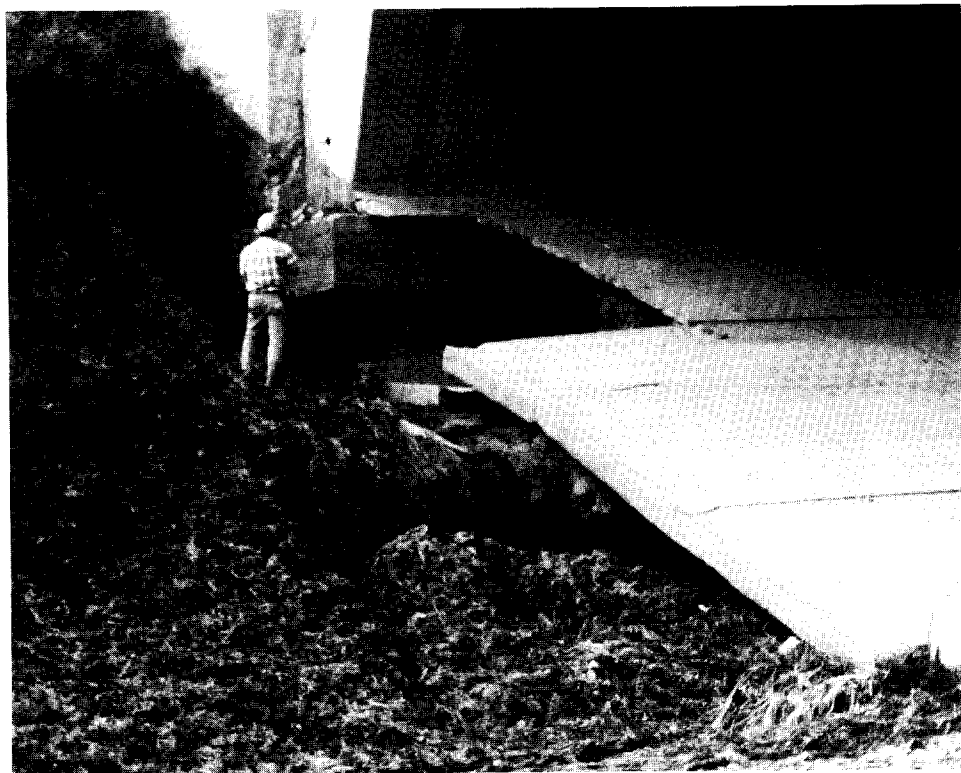
Figure 4.32. SR118 Balboa Avenue Overcrossing, view of the washout on the east side of the south abutment, caused by a ruptured water main.

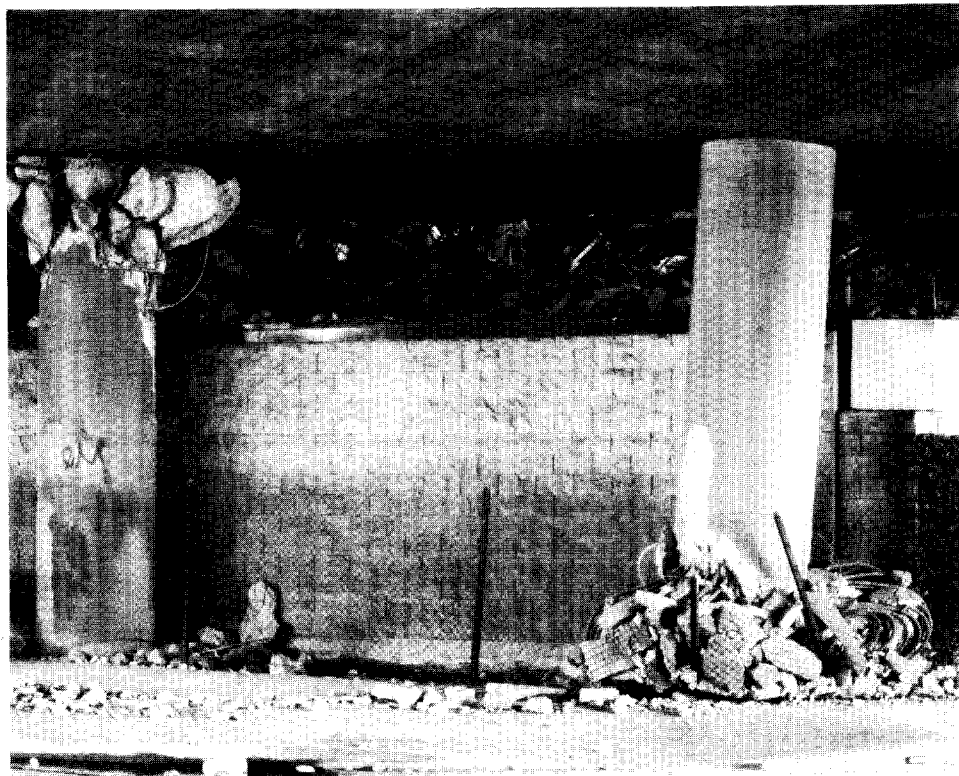
Figure 4.39. Failed piers in Bent 7 supporting westbound lane of I10 at Venice Blvd.
