# **1994 Northridge Earthquake Performance of Structures, Lifelines, and Fire Protection Systems**

Diana Todd  
Nicholas Carino  
Riley M. Chung  
H. S. Lew  
Andrew W. Taylor  
William D. Walton  
James D. Cooper  
Roland Nimis

Building and Fire Research Laboratory  
National Institute of Standards and Technology  
Gaithersburg, MD 20899-0001

May 1994

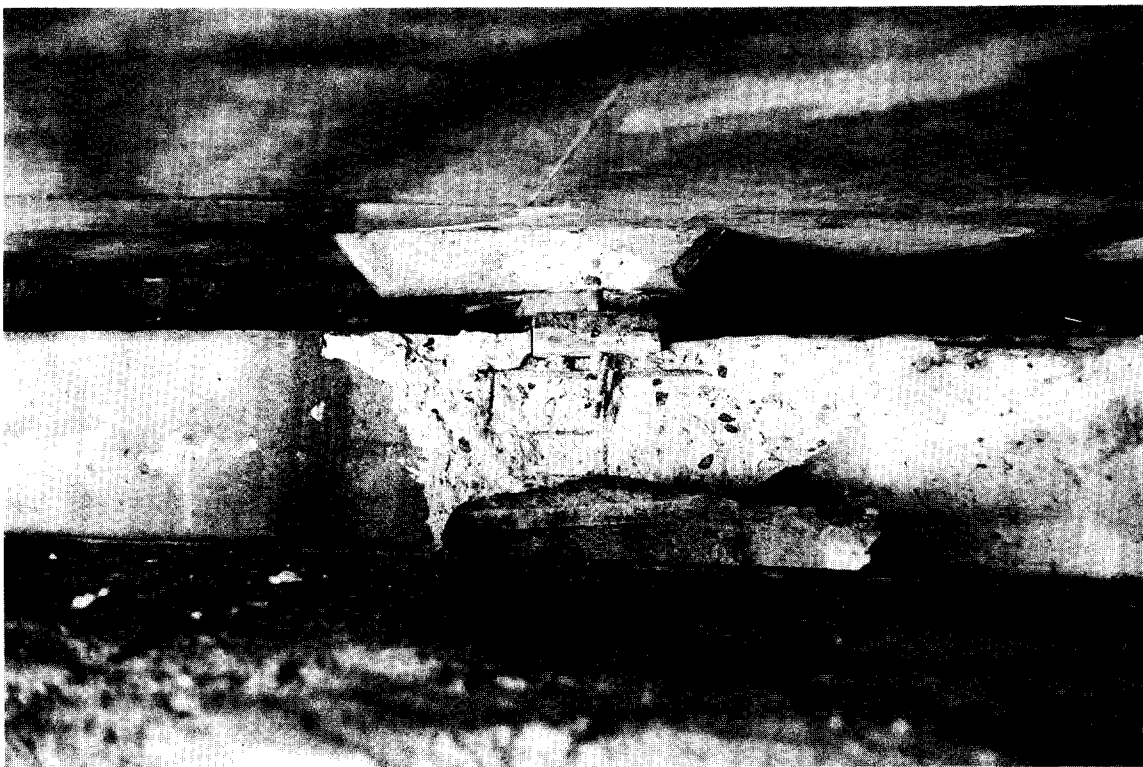
Figure 4.48. Abutment damage at sliding-type bearing.

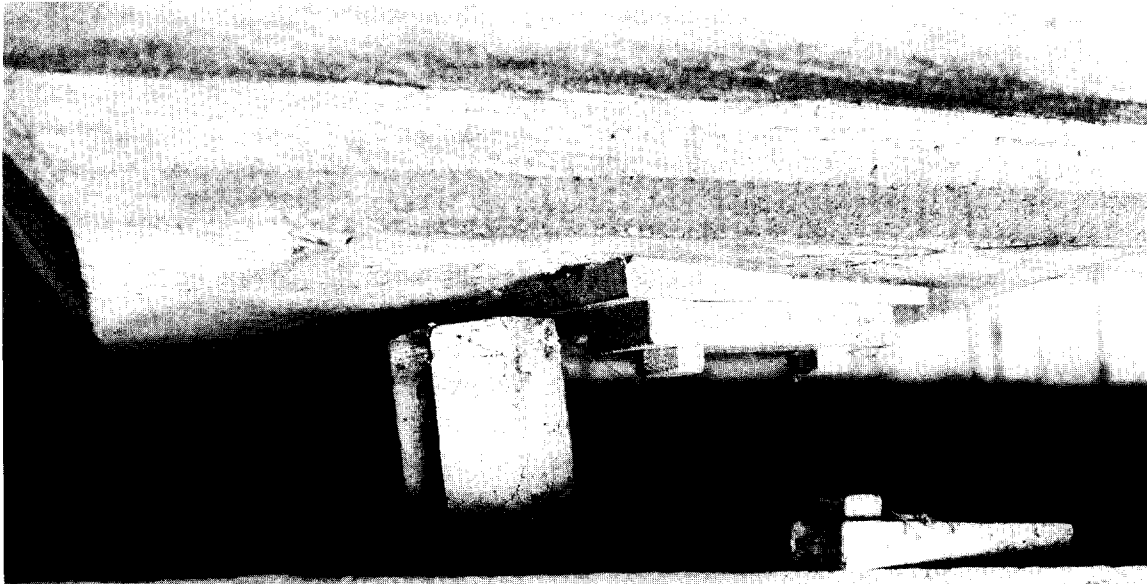
Figure 4.49. Displaced bearing block in rocker-type bearing.

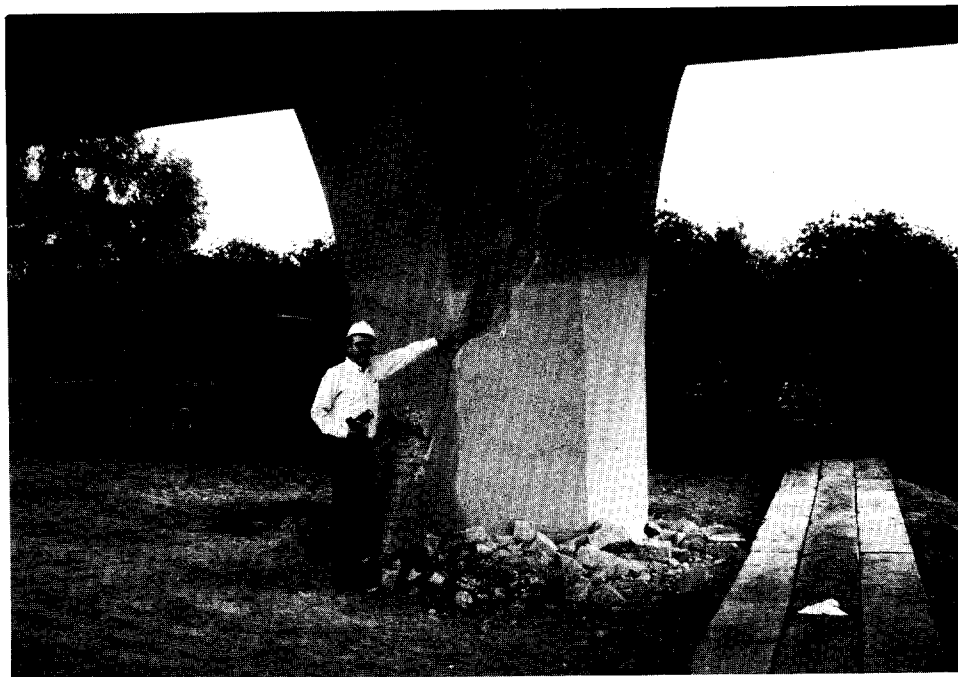
Figure 4.51. View of the westernmost pier at the Interstate 5, State Route 118, Southwest Connector, looking to the southeast. Loose cover concrete has been removed by Caltrans.

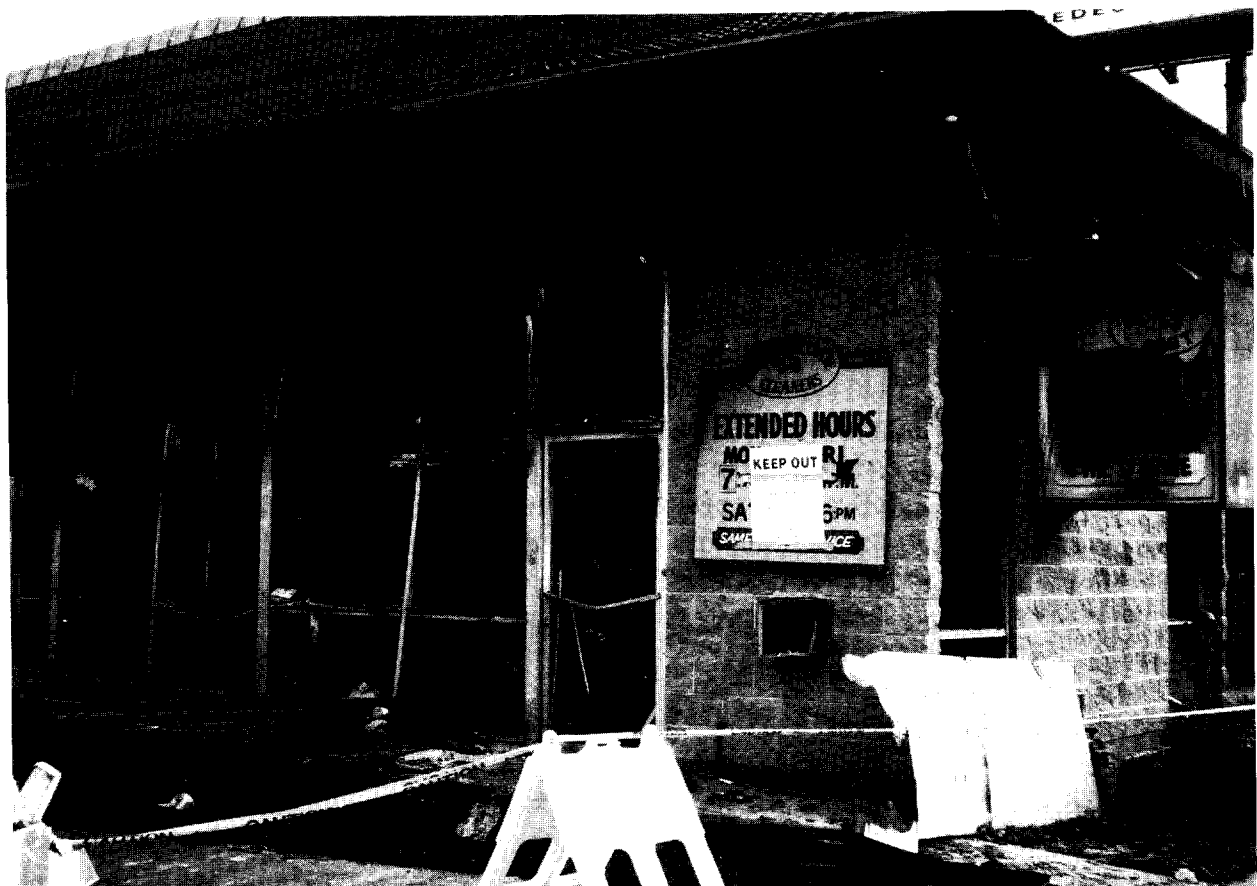
Figure 6.1. Fire damage in a single story commercial building.

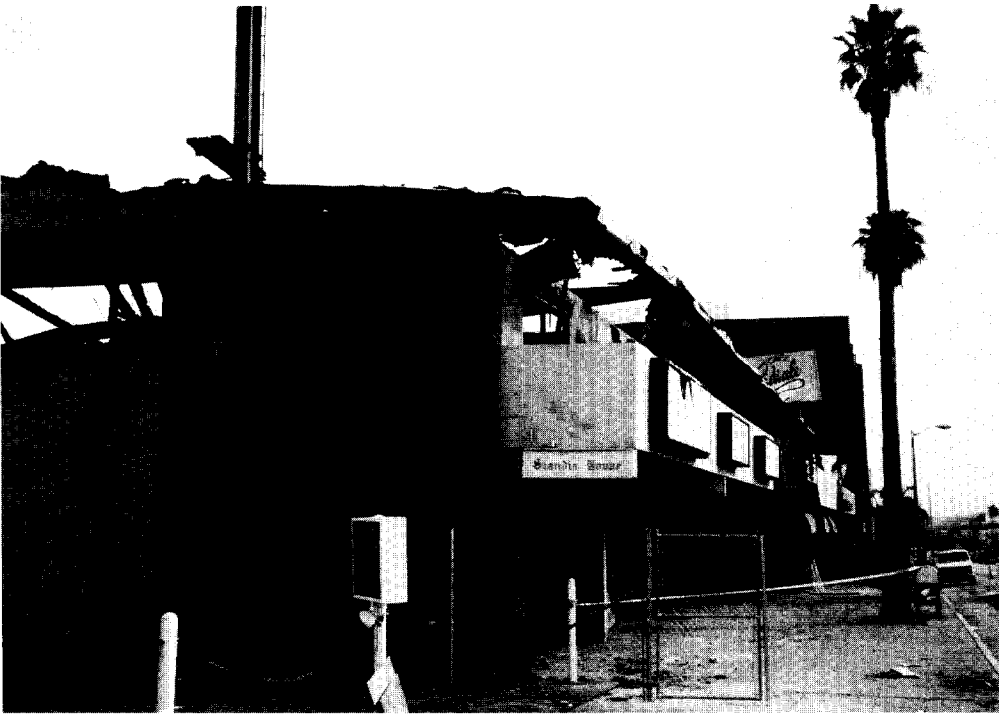
Figure 6.2. Fire damage in a two story commercial building.

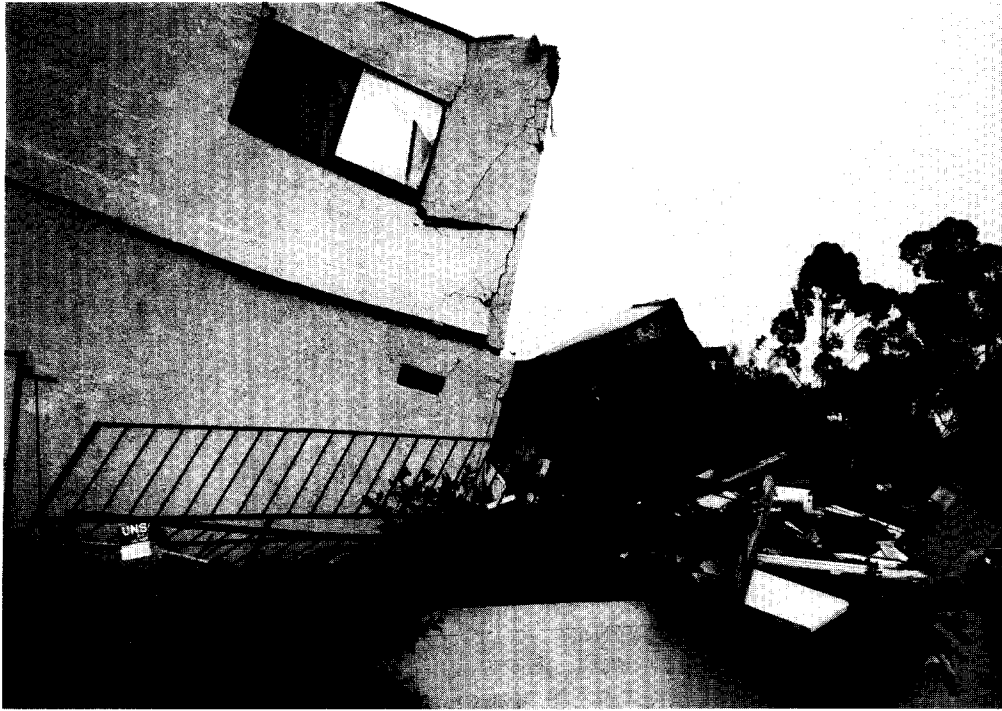
Figure 6.4. Partially collapsed apartment building with fire damage in the rear.

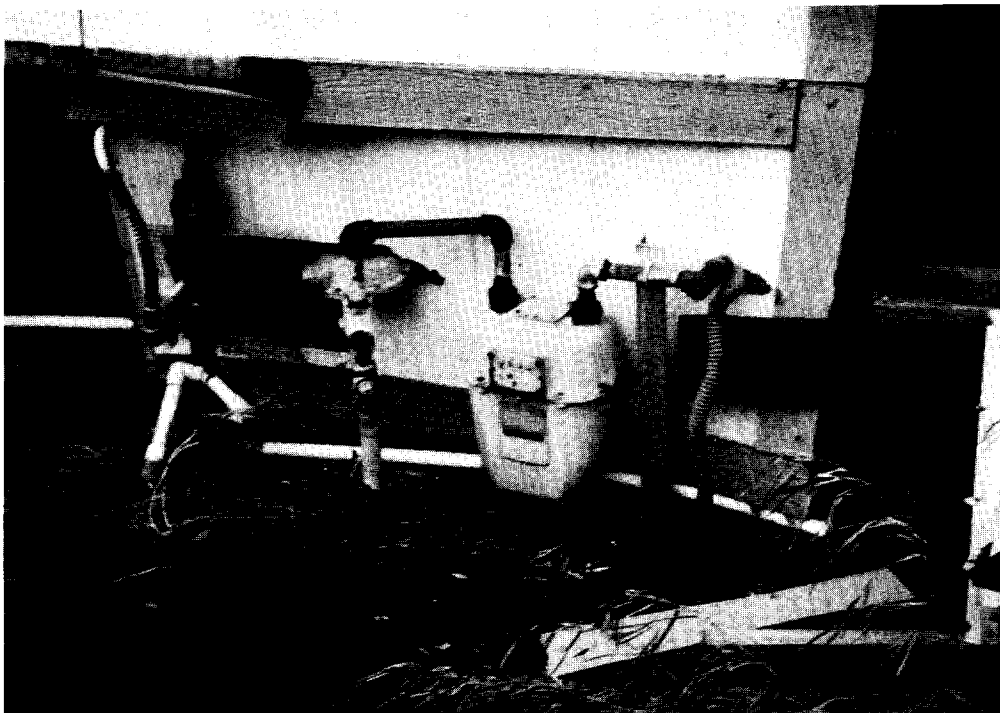
Figure 6.5. Damaged gas service in a manufactured housing development.

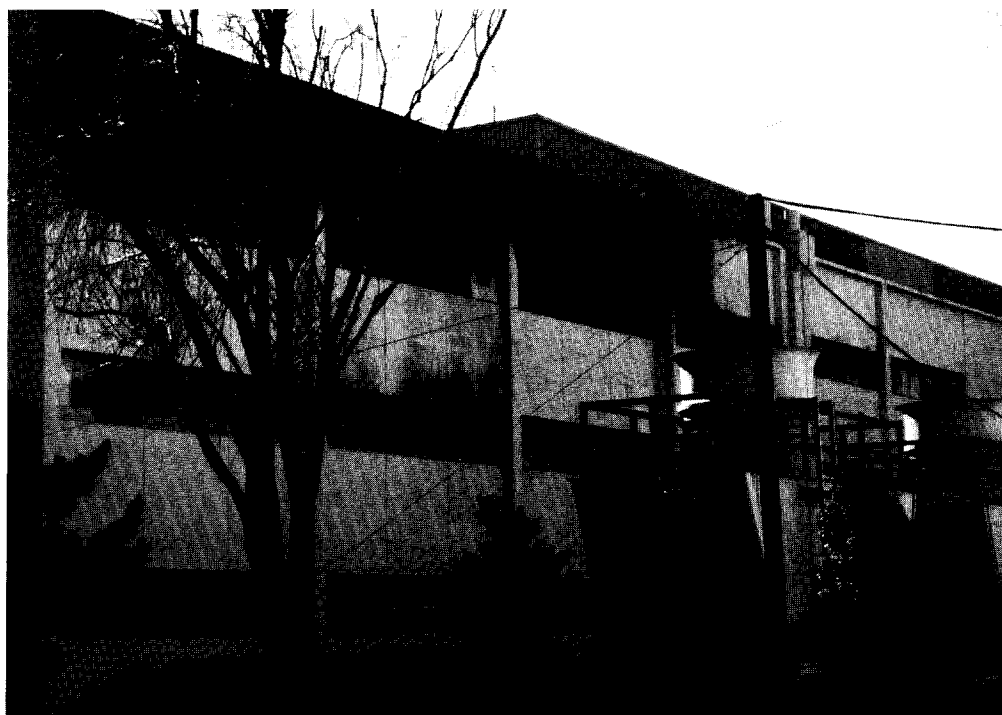
Figure 6.7. University science building damaged by fire.
