NIST NCSTAR 2: Vol. I

# Report of the Technical Investigation of The Station Nightclub Fire

June 2005

A fire occurred on the night of Feb. 20, 2003, in The Station nightclub at 211 Cowesett Avenue, West Warwick, Rhode Island. A band that was on the platform that night, during its performance, used pyrotechnics that ignited polyurethane foam insulation lining the walls and ceiling of the platform. The fire spread quickly along the walls and ceiling area over the dance floor. Smoke was visible in the exit doorways in a little more than one minute, and flames were observed breaking through a portion of the roof in less than five minutes. Egress from the nightclub, which was not equipped with sprinklers, was hampered by crowding at the main entrance to the building. One hundred people lost their lives in the fire. On Feb. 27, 2003, under the authority of the National Construction Safety Team (NCST) Act, the National Institute of Standards and Technology (NIST) established a National Construction Safety Team to determine the likely technical cause or causes of the building failure that led to the high number of casualties in that fire. This report documents the procedures, findings,

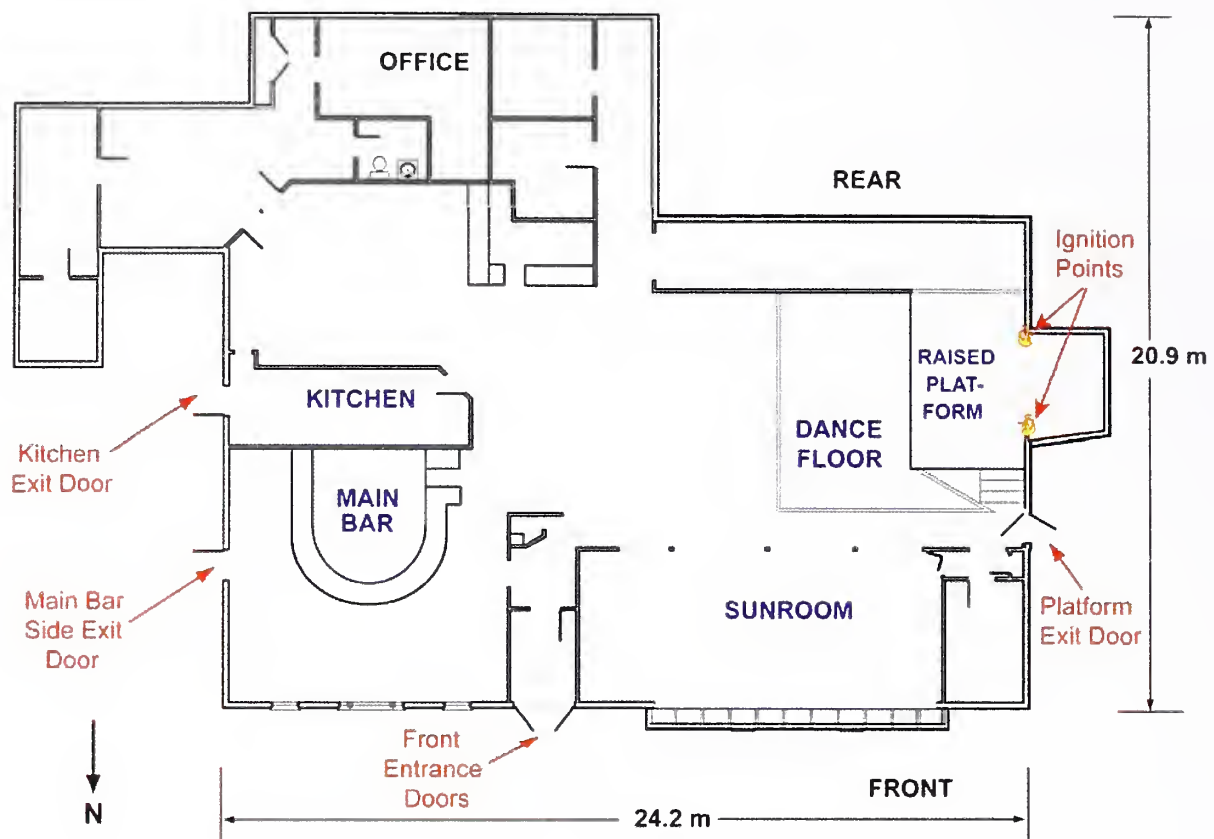
**Floor plan of The Station nightclub**

The Station nightclub was a single-story wood frame building with a footprint of about 412 m<sup>2</sup> (4484 ft<sup>2</sup>). A floor plan of the building is shown in the figure below. The main entrance on the north side, with double doors, led to a short hallway with a single interior door. In addition to the main entrance, there were doors leading directly to the outside adjacent to the platform (commonly, but less precisely, referred to as the stage) on the west end of the building, and at the side of the main bar at the east end of the building. The kitchen also had an exit door. There were windows along the north side of the building on

both sides of the main entrance. The fire began when pyrotechnics used during the performance of a band ignited polyurethane foam lining portions of the walls and ceiling of the platform, and spread quickly along the ceiling area over the dance floor. Smoke was visible in the exit doorways in a little more than one minute and flames were observed breaking through a portion of the roof in less than five minutes. Escape from the nightclub was hampered by the crowding at the main entrance to the building. One hundred people lost their lives in the fire.

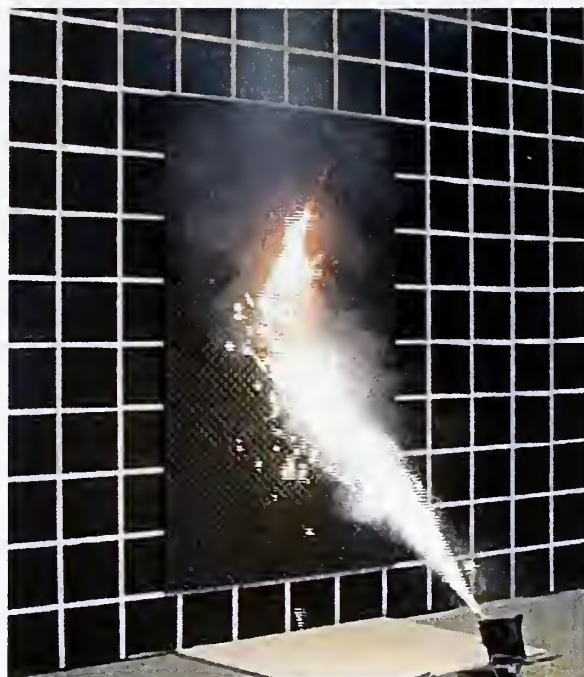
The hazard associated with the building contents was created by the close proximity of a high temperature source (a pyrotechnic device) and a substantial amount of material with a relatively low ignition energy and high flame spread rate (polyurethane foam). As could be seen in the WPRI video, flames spread rapidly over the foam, generating smoke and enough heat to ignite the wood paneling underneath and adjacent to the foam. The wood structure and paneling in the nightclub was estimated to contain over 95 percent of the fuel load, so that once most of the foam was consumed, the fire transitioned to a wood frame building fire.

**Pyrotechnic device impinging on non-fire retarded polyurethane foam panel**

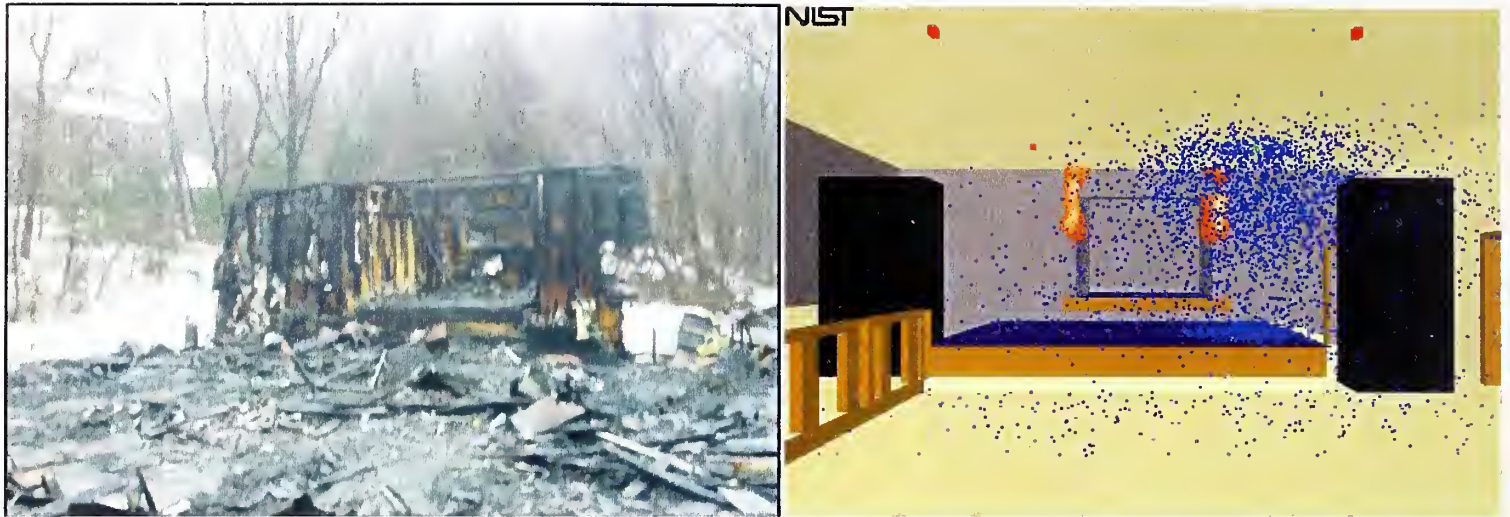
The capability to suppress this fire during its early stage of growth was insufficient primarily because automatic fire sprinklers were not installed in The Station. (Note that while the 2003 editions of the model codes would have required sprinklers to be installed for new construction, sprinklers would not have been required for an existing structure like The Station.) The building was equipped with hand-held fire extinguishers, although they were not located convenient to where the fire started; NIST found no indication that the employees of The Station were trained to use the hand-held extinguishers, and it is unclear if the extinguishers would have been effective in controlling this fire.

Experiments conducted at NIST in a reconstruction of the platform area fire demonstrated that a water sprinkler system installed in the test room in accordance with NFPA 13 (*Standard for the Installation of Sprinkler Systems*) was able to control the fire initiated in non-fire retarded polyurethane foam panels and to maintain survivable conditions at head height in the test room for the duration (over five minutes) of the experiment. A computer simulation of the full nightclub with and without sprinklers led to a similar positive result for the sprinklered scenario.

**Remains of the platform area after the fire (left) and an image from the simulation of The Station fire had sprinklers been installed (right)**

2. **Sprinklers:** NIST recommends that model codes require sprinkler systems according to NFPA 13 (*Standard for the Installation of Sprinkler Systems*), and that state and local authorities adopt and aggressively enforce this provision,

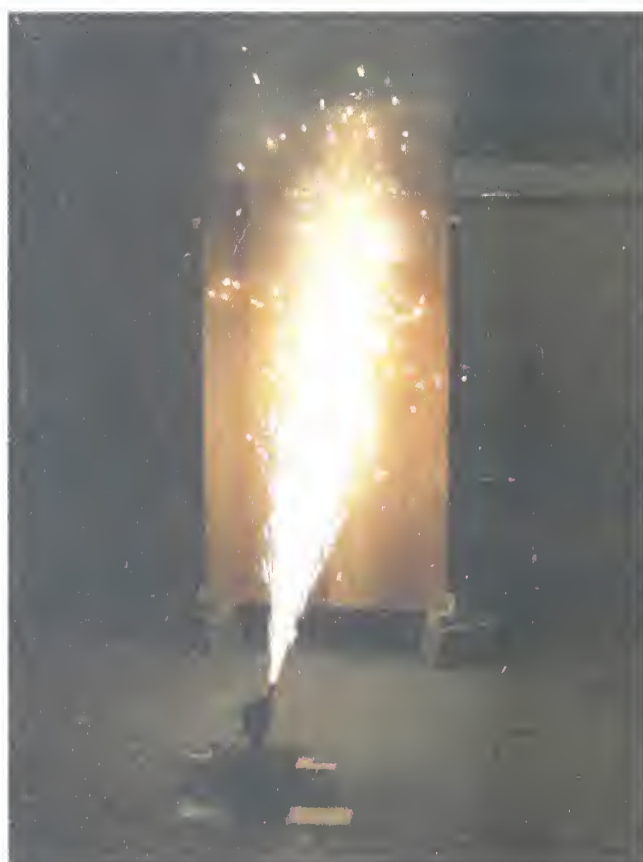
Figure 4-14a shows the sparks from the gerb impinging on the wood panel about half way through the test. No ignition was observed. The hot sparks did create small black marks and craters in the finish of the panel, as can be seen in Figure 4-14b.

Figure 4-14a. Gerb impinging on wood panel.

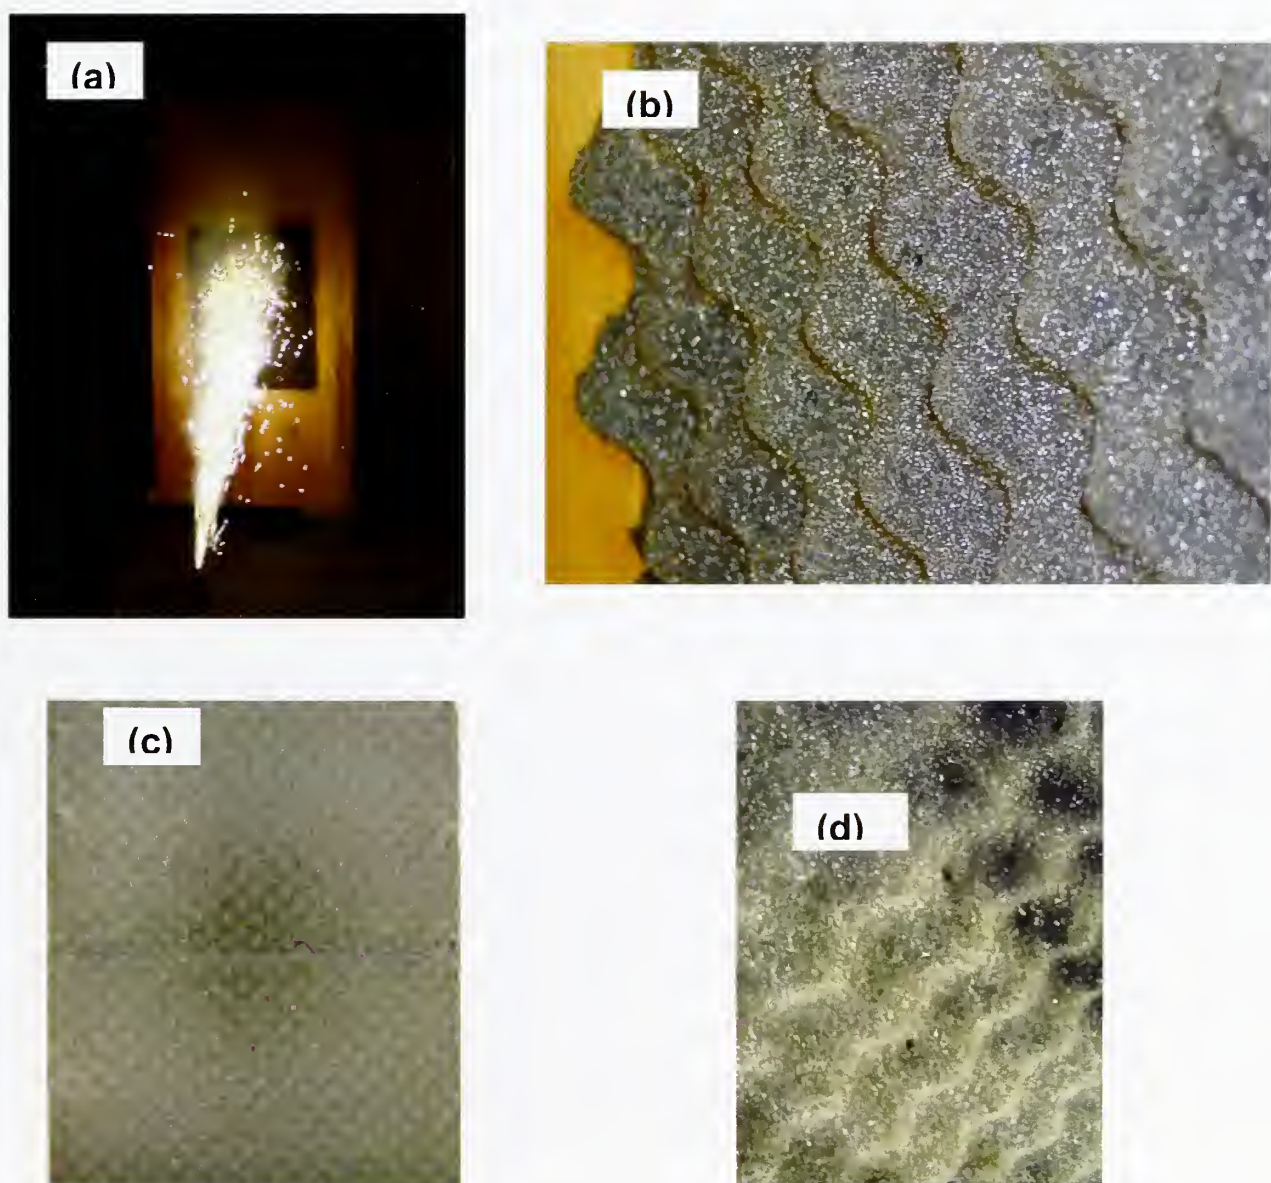
The experiment was repeated with a new piece of foam. The lower piece of foam overlapped the upper piece of foam, creating a small ledge as shown in Figure 4-15c. The positioning of the gerb was the same. The results were similar to the previous experiment; i.e., no ignition, just minor scorching and small holes in the foam from some of the sparks (see Figures 4-15c and 4-15d). The temperatures in the plume as a function of time are plotted in Appendix F, Figs. F-24 and F-25.

**Figure 4-15. Gerb impinging fire retardant polyurethane foam (a); evidence of pitting (b); horizontal ledge at mid-plane to catch sparks, and evidence of scorching in second sample (c); and close-up of scorched area (d).**

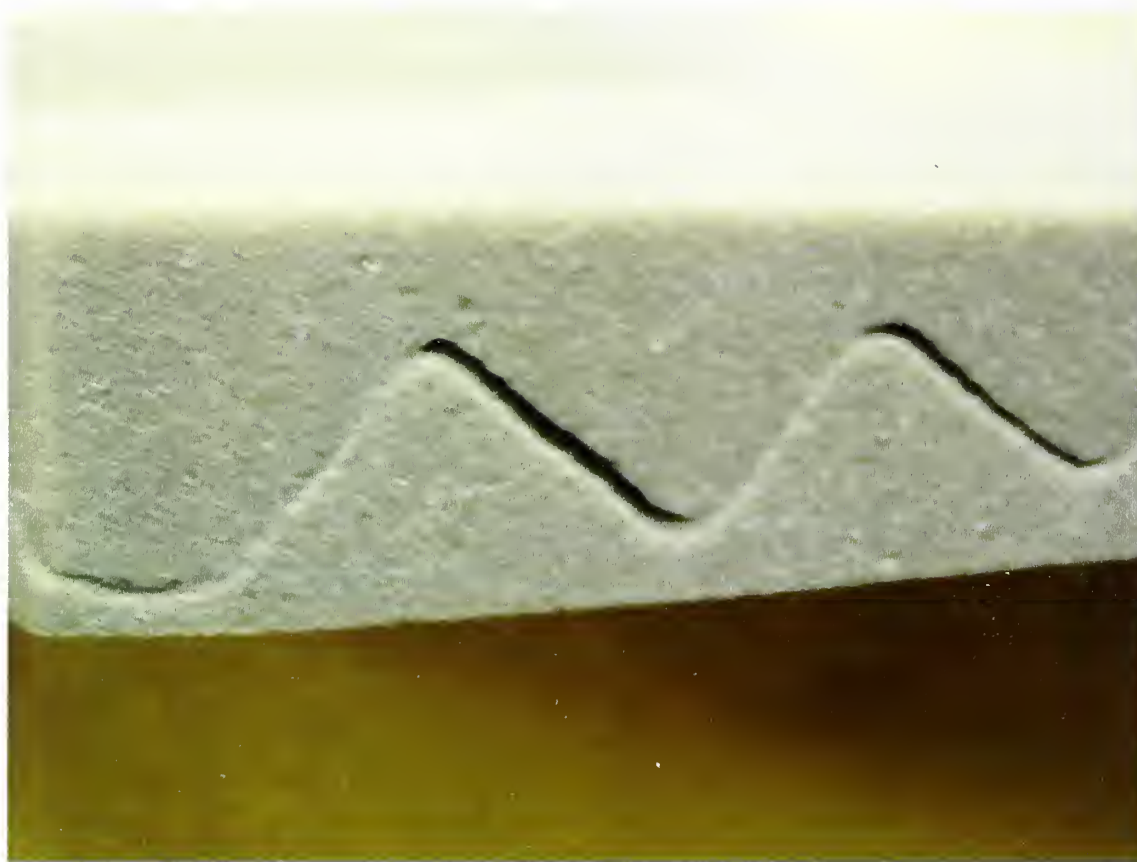
**Figure 5-1b. Photograph of the edge of two sheets of convoluted polyurethane foam.**

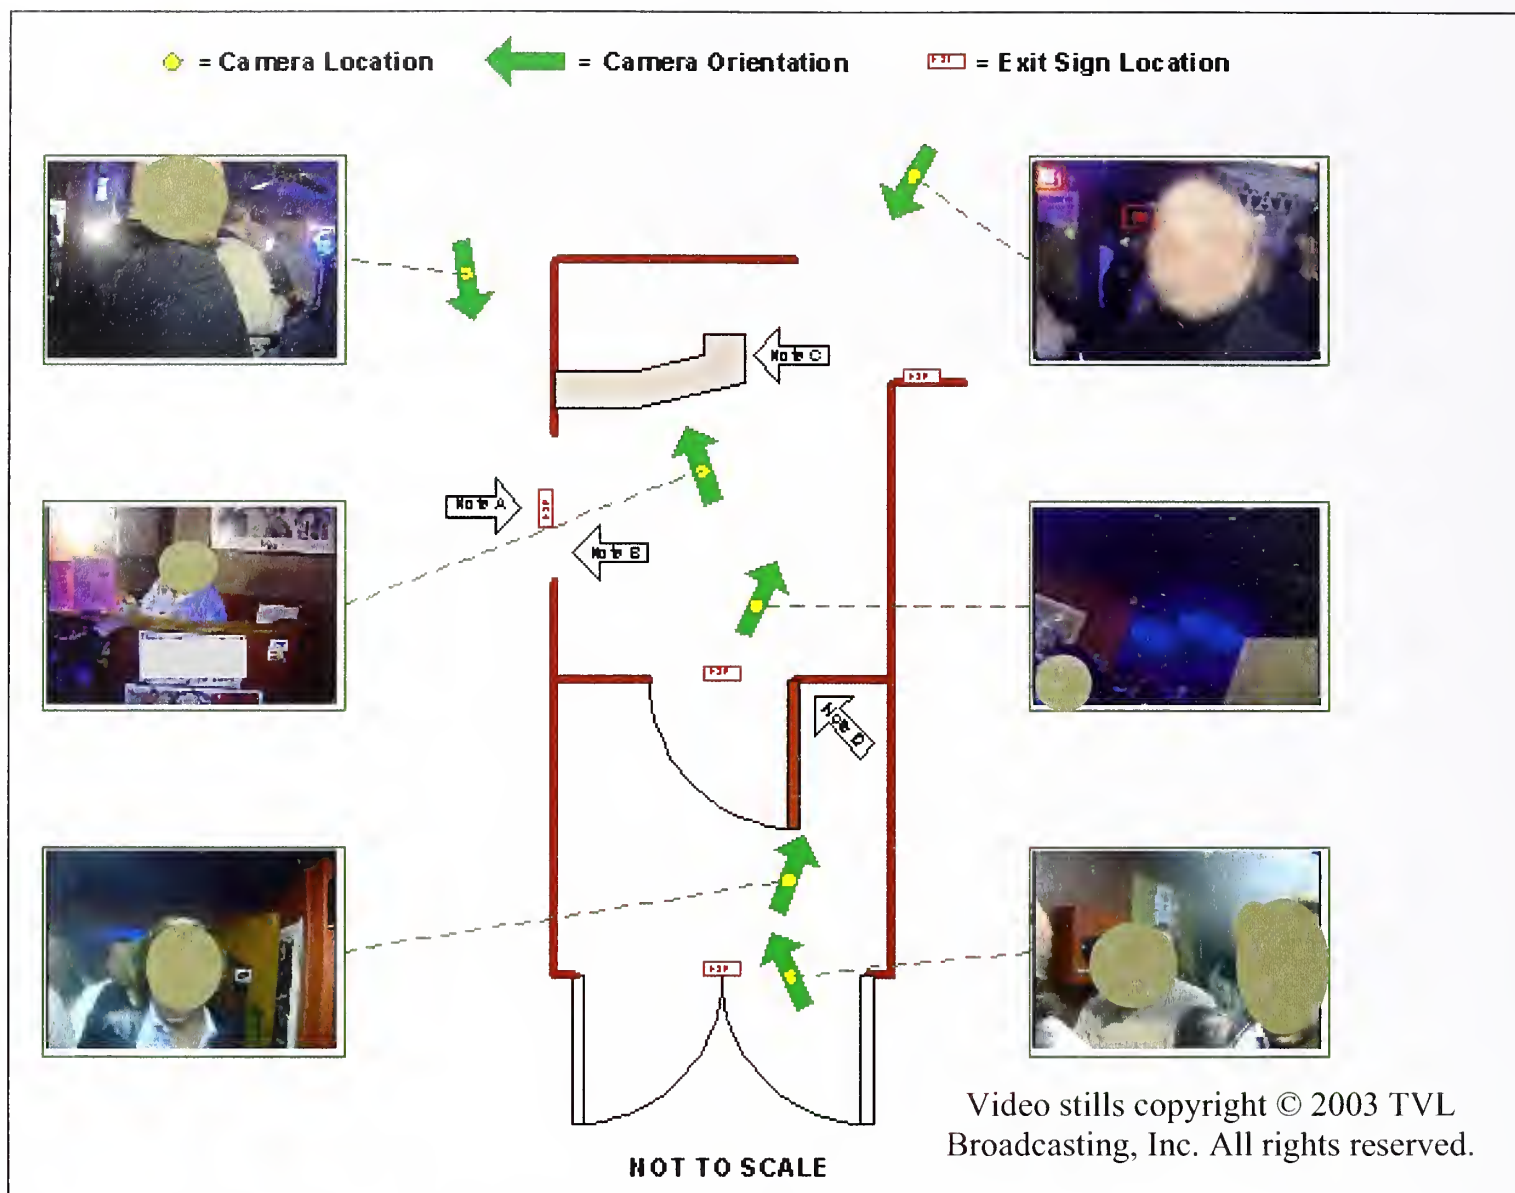
The precise event which led to the crowd-crush likely was related to the arrangement of the single interior door with merging streams of traffic and the pressure to escape the rapidly deteriorating conditions in the main area of the nightclub. Measurements of temperature, heat flux and gas species in a reconstruction of the platform area fire at NIST and computer models of the NIST experiment and the full nightclub suggest that the conditions around the platform, dance floor, sunroom, and dart room would have led to severe incapacitation or death within about 1-1/2 minutes after ignition of the foam for anyone remaining standing, and for not much longer even for those occupants close to the floor.

**Figure 6-12. Detail of Main Exit Vestibule Area (Video frames copyright © 2003 TVL Broadcasting, Inc. All rights reserved)**

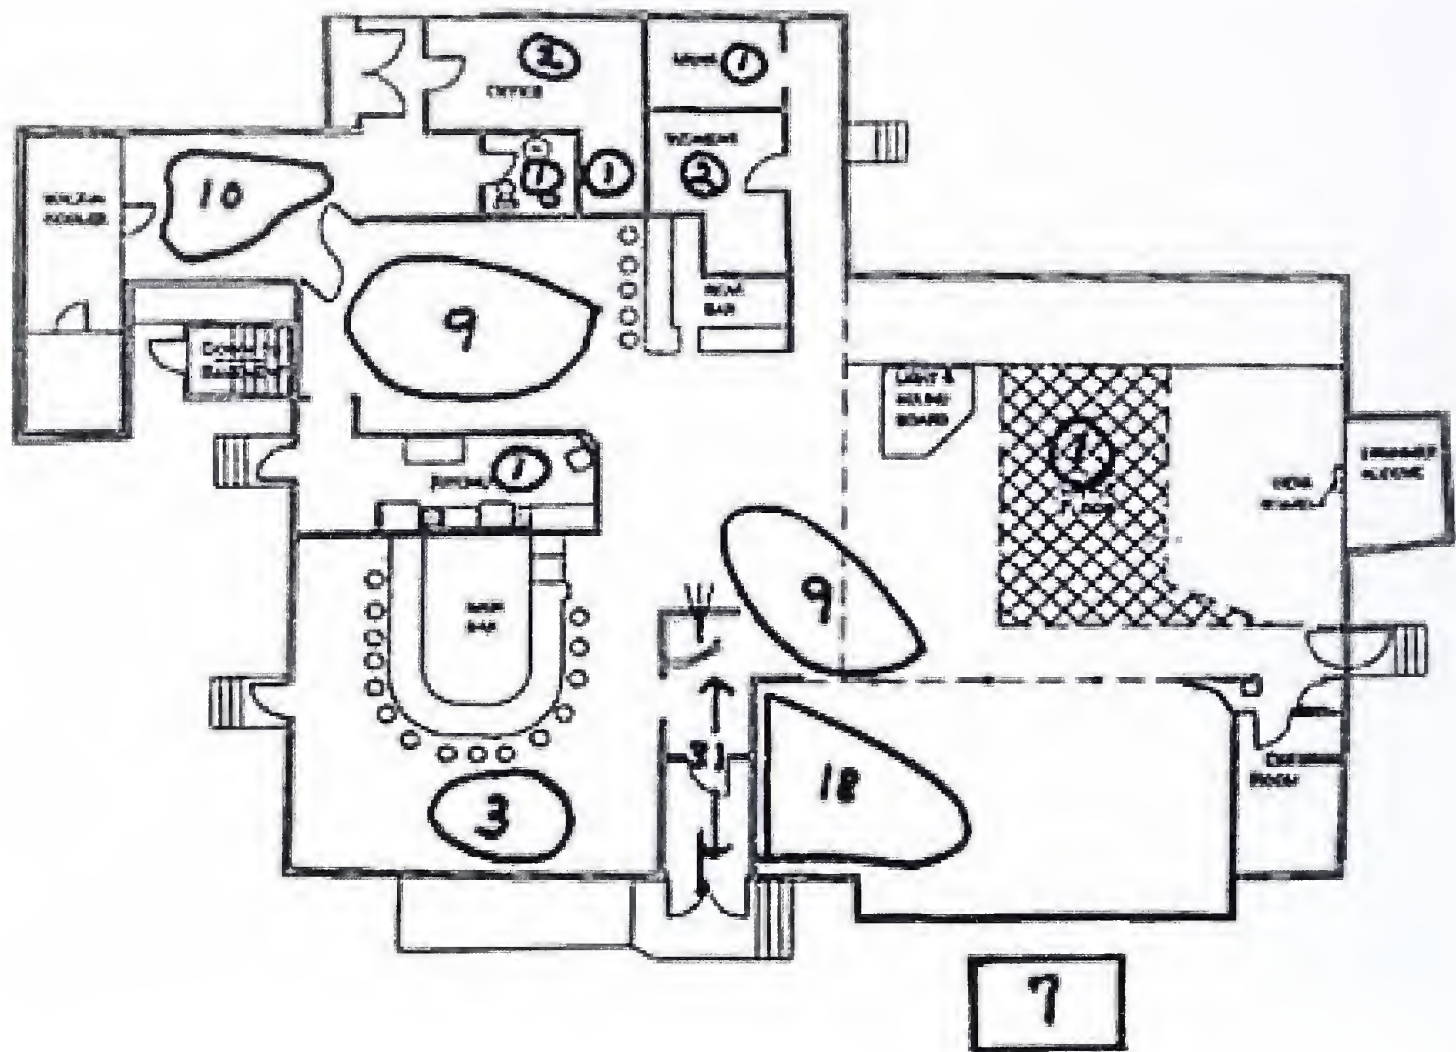
**Figure 6-14. Location of Recovered People Who Died at Scene [36]**
