NIST Special Publication 1000-5

June 2004
Progress Report on the
Federal Building and Fire Safety
Investigation of the
World Trade Center Disaster

Volume 4
Contains Appendices G, H, and I

Appendix H
Interim Report on Evolution of WTC Fires, Smoke, and Damage based on Image Analysis

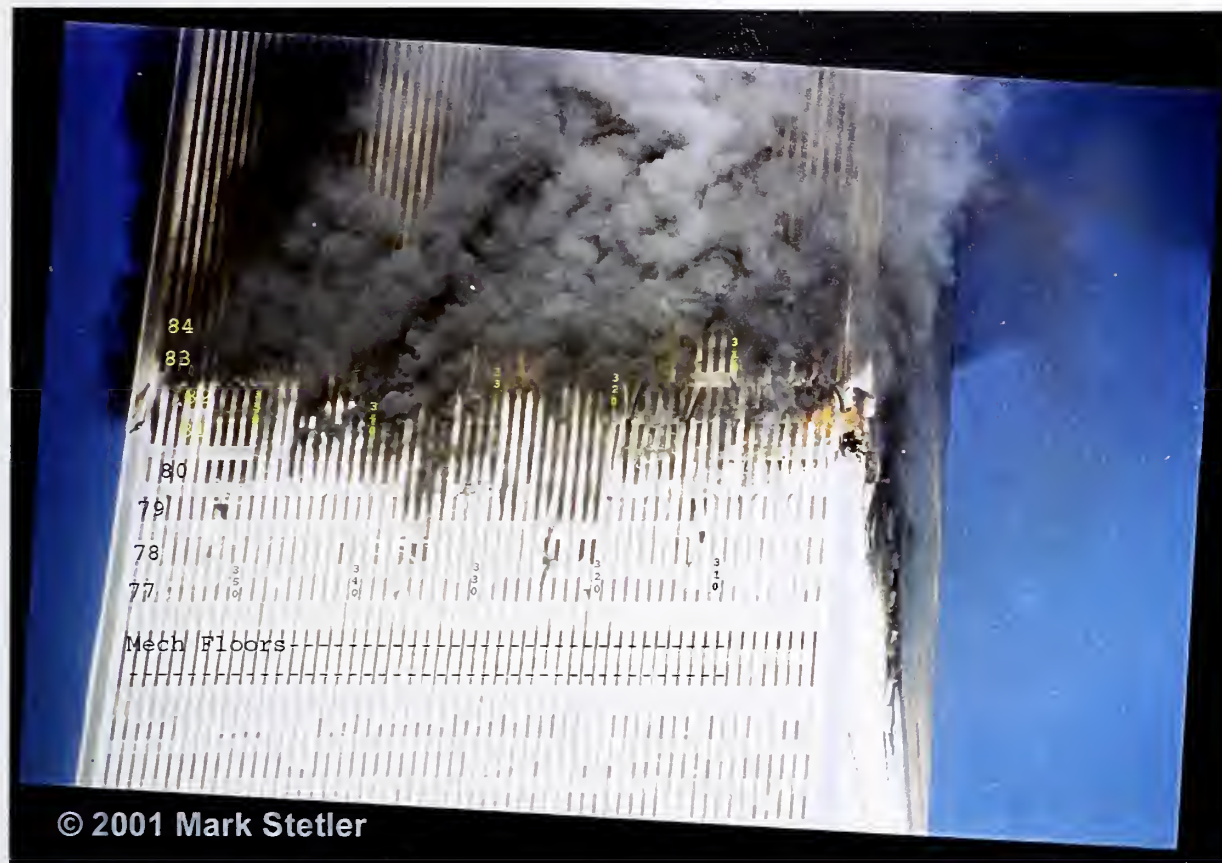
Figure H-6. Photograph taken at 9:26:20 a.m. on September 11, 2001, showing the east face of WTC 2. It has been enhanced, and lettering indicating floors and columns has been added.

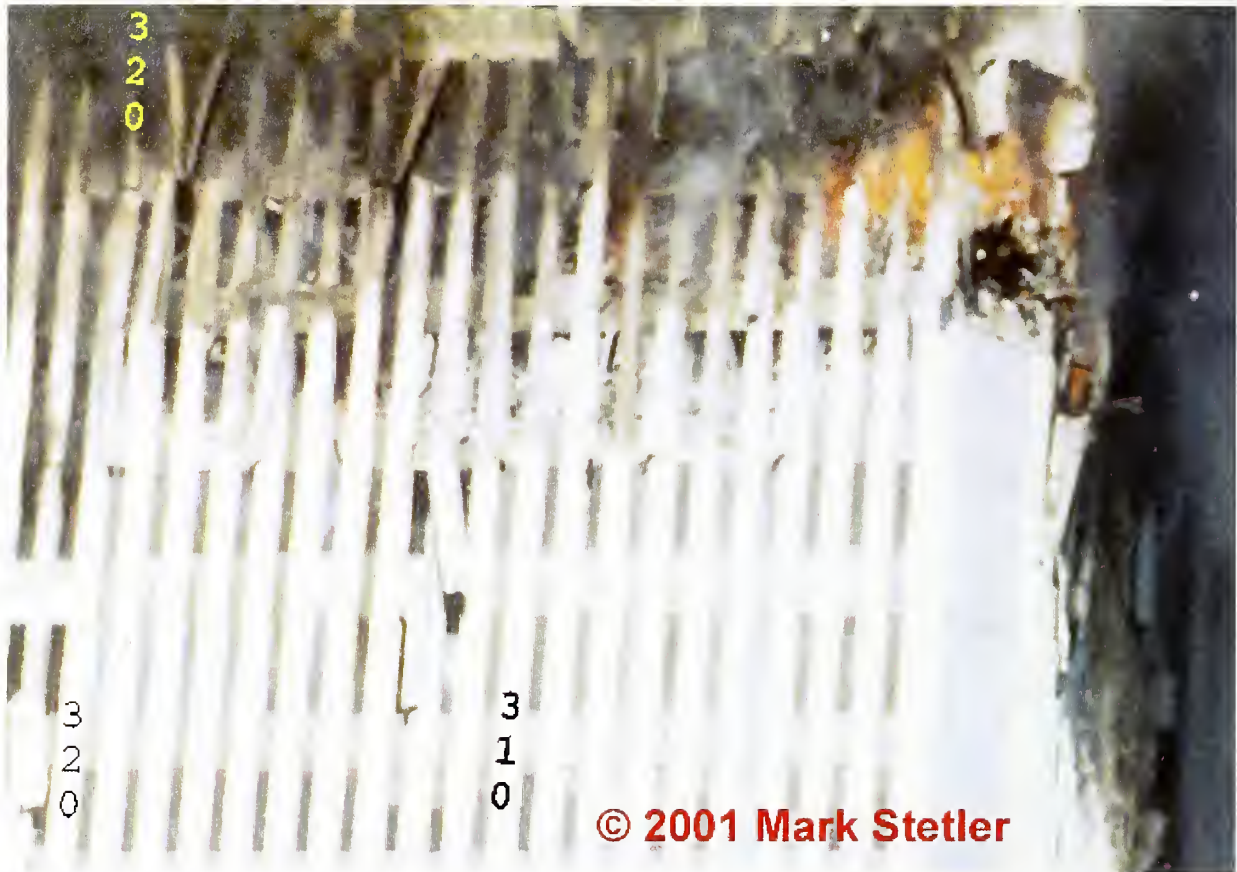
Figure H-7. This photograph is cropped from the image shown in Figure H-6. It was taken on September 11 and shows the east face of WTC 2 at the northeast corner from floor 77 to floor 82. Note the large piles of debris evident on floor 80 and floor 81.

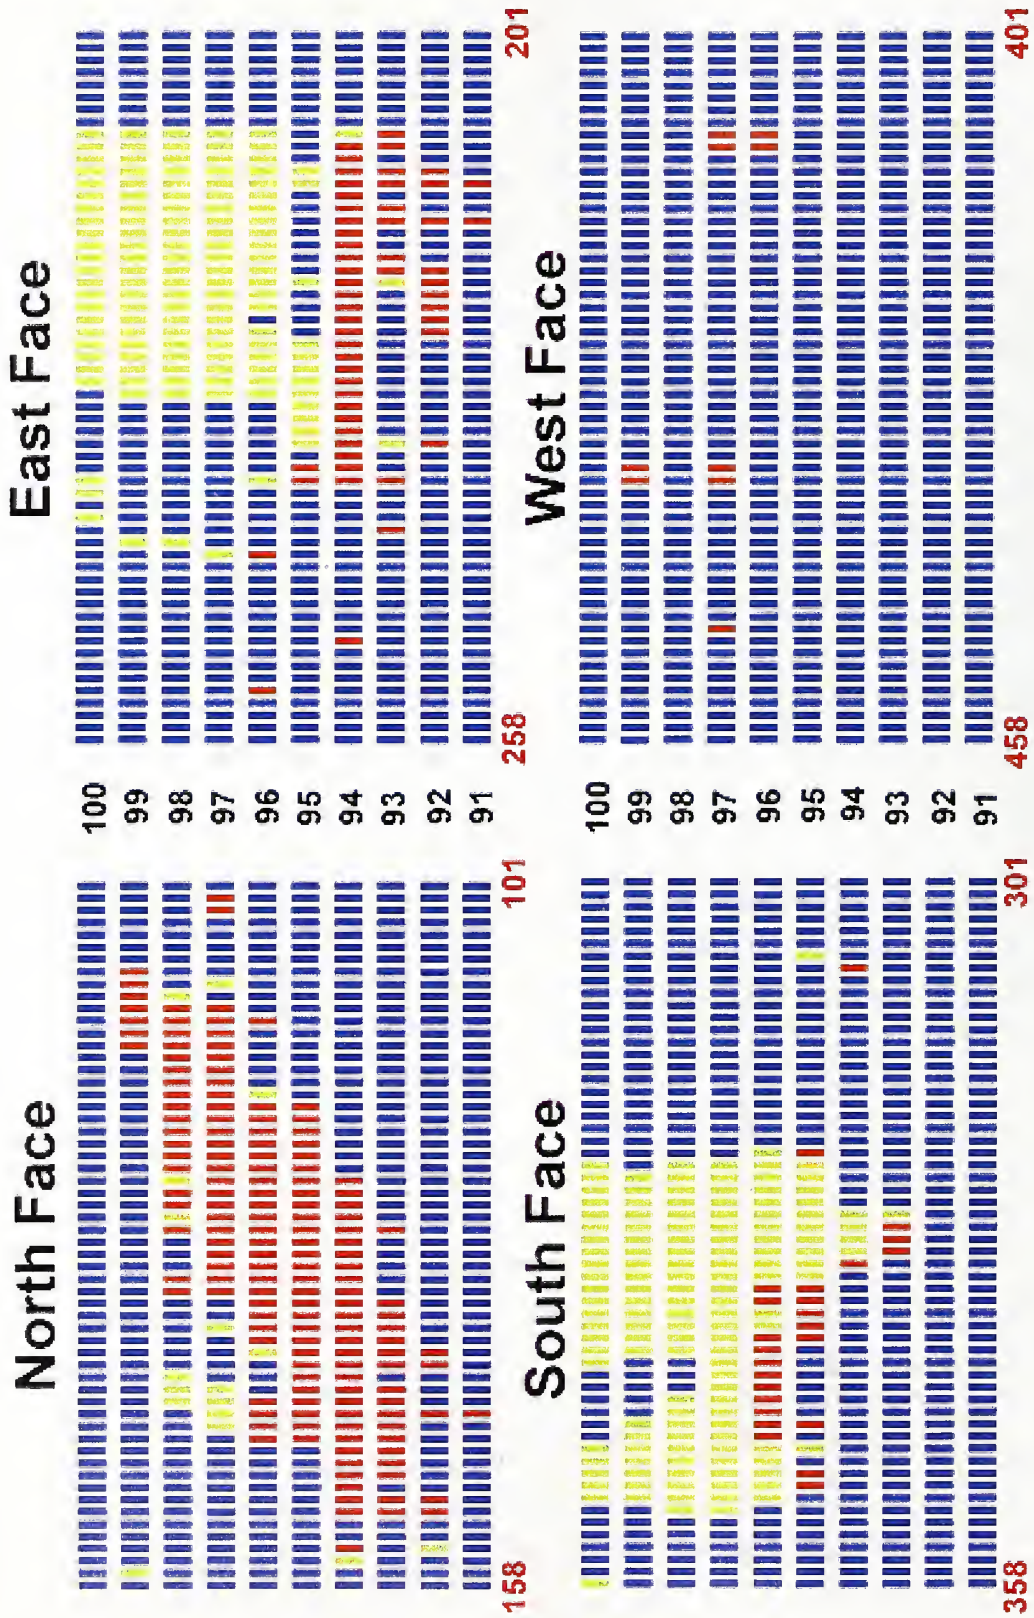
Figure H-13. The condition of windows is shown for the four faces of WTC 1 around 8:47 a.m. shortly after it was struck by American Airlines Flight 11. The colors represent ■ - window open, ■ - window in place, and ■ - not visible.

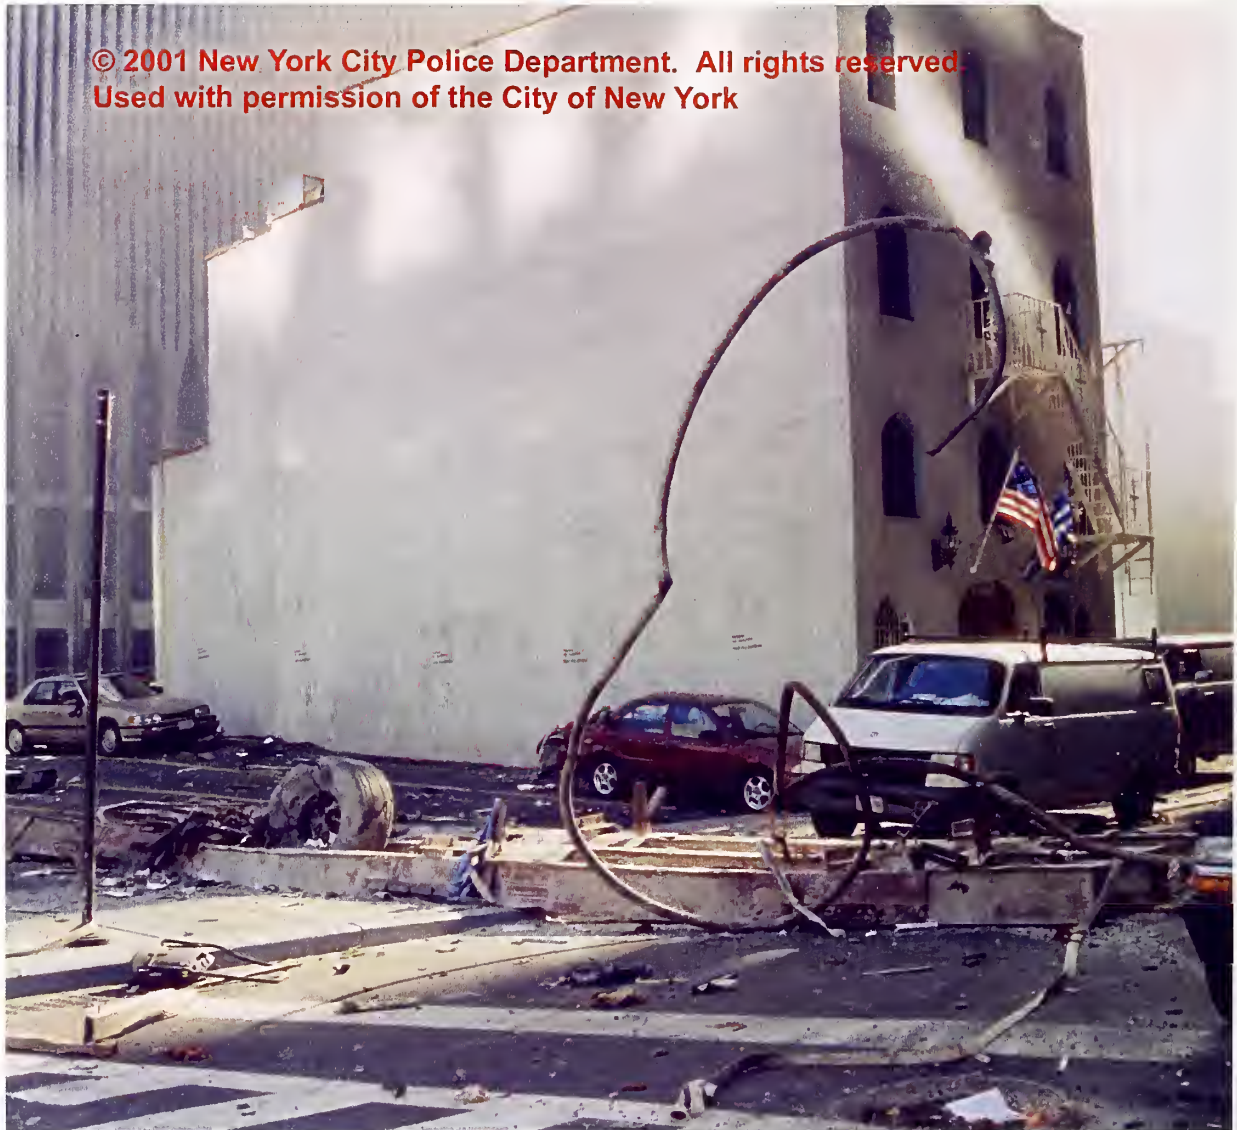
Figure H-14. Photograph showing a full panel section lying in Cedar Street near its intersection with West Street. An aircraft wheel can be seen imbedded in one of the windows. The building behind the panel is Saint Nicholas Greek Orthodox Church and the lower section of WTC 2 can be seen across Liberty Street.

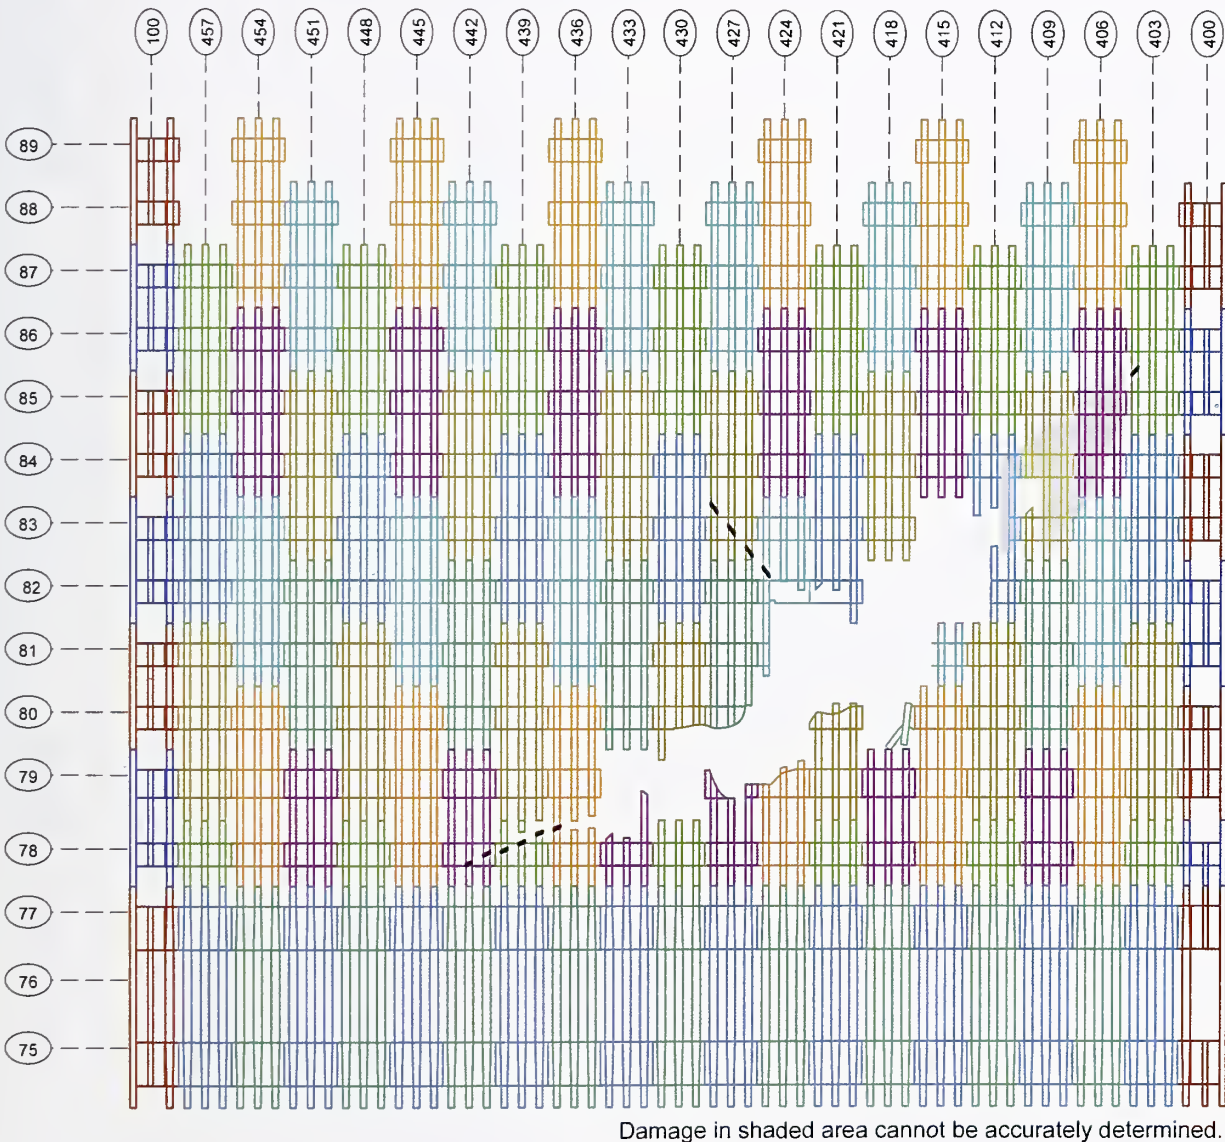
The results of an analysis of the damage to the steel façade of the south face of WTC 2 are provided in Fig. H-19. Much of the steel damage pattern is revealed, but it should be noted, as indicated, that a portion of this face on the east side of the plane strike location was constantly obscured by smoke, and the detailed pattern could not be discerned. The FEMA report (McAllister 2002) also includes a figure describing the damage to the steel façade inflicted by United Airlines Flight 175. The pattern in Fig. H-19 differs somewhat from that provided in this earlier study. Some inconsistencies in façade dimensions have also been corrected in the current version.

Figure H-19. A drawing of the damage to the steel facade of WTC 2. The dark dotted lines show locations where the airplane wings and tail marked the aluminum cladding on the columns. The area shaded in gray was hidden by smoke and could not be observed.

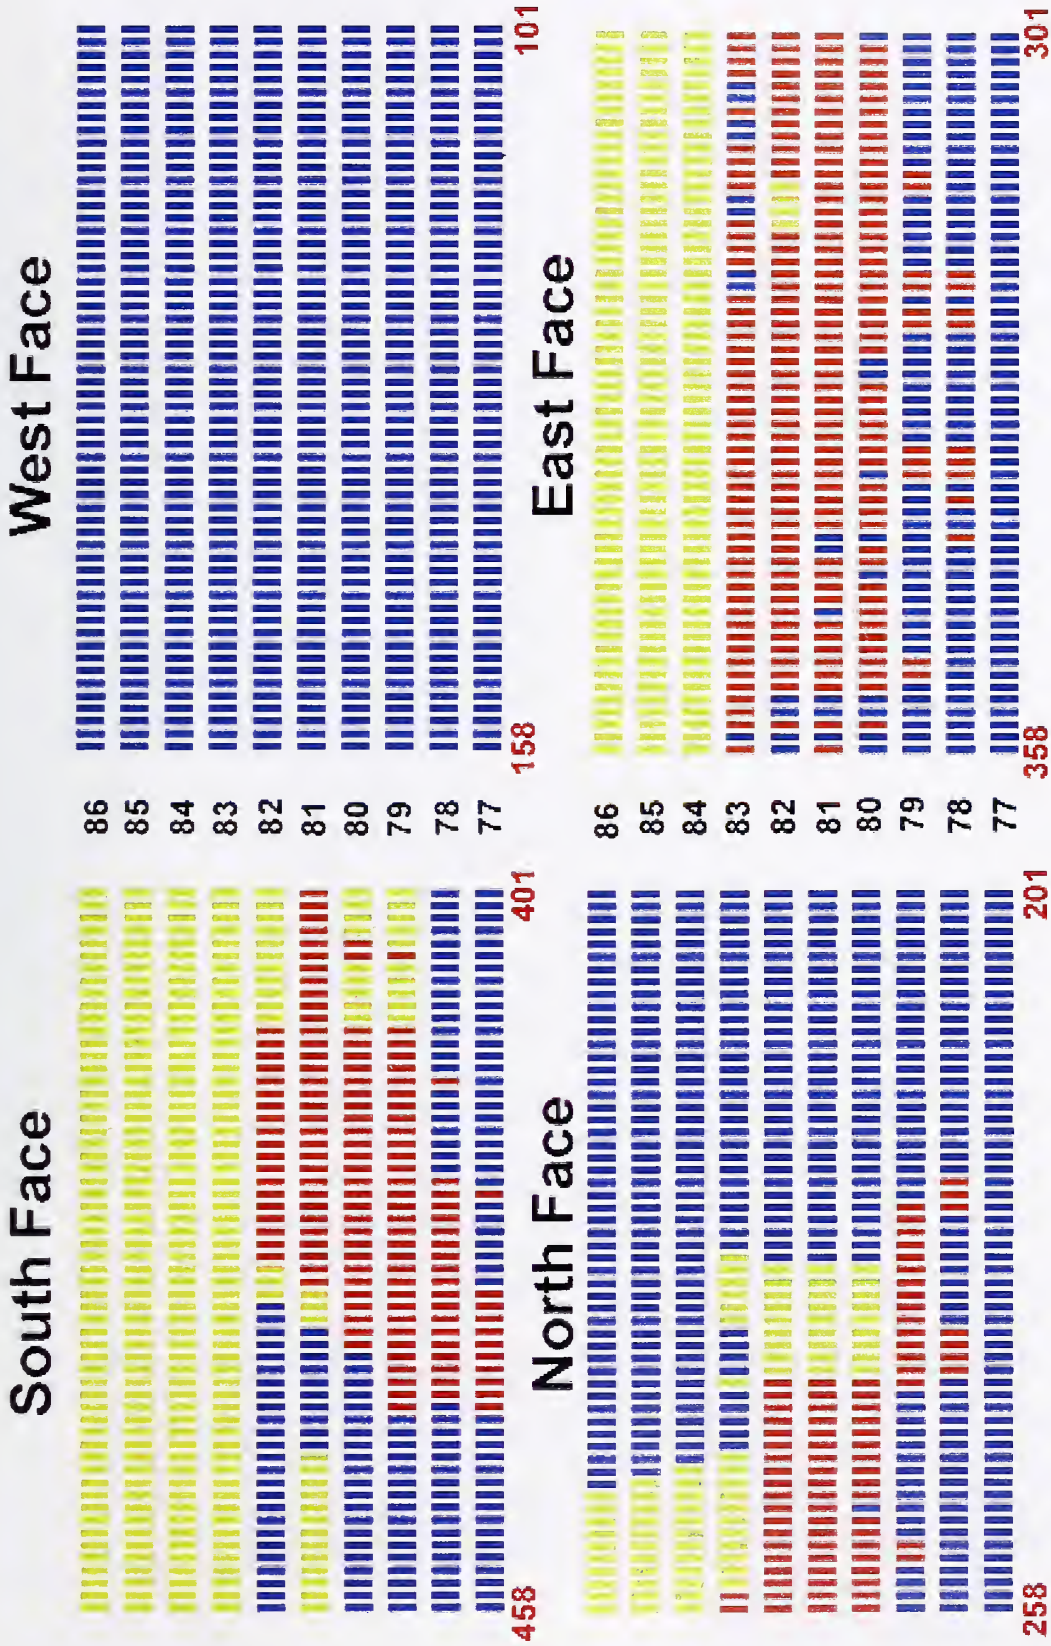
Figure H-20. The condition of windows is shown for the four faces of WTC 2 around 9:03 a.m. shortly after it was struck by United Airlines Flight 175. The colors represent ■ - window in place, ■ - window open, and ■ - not visible.

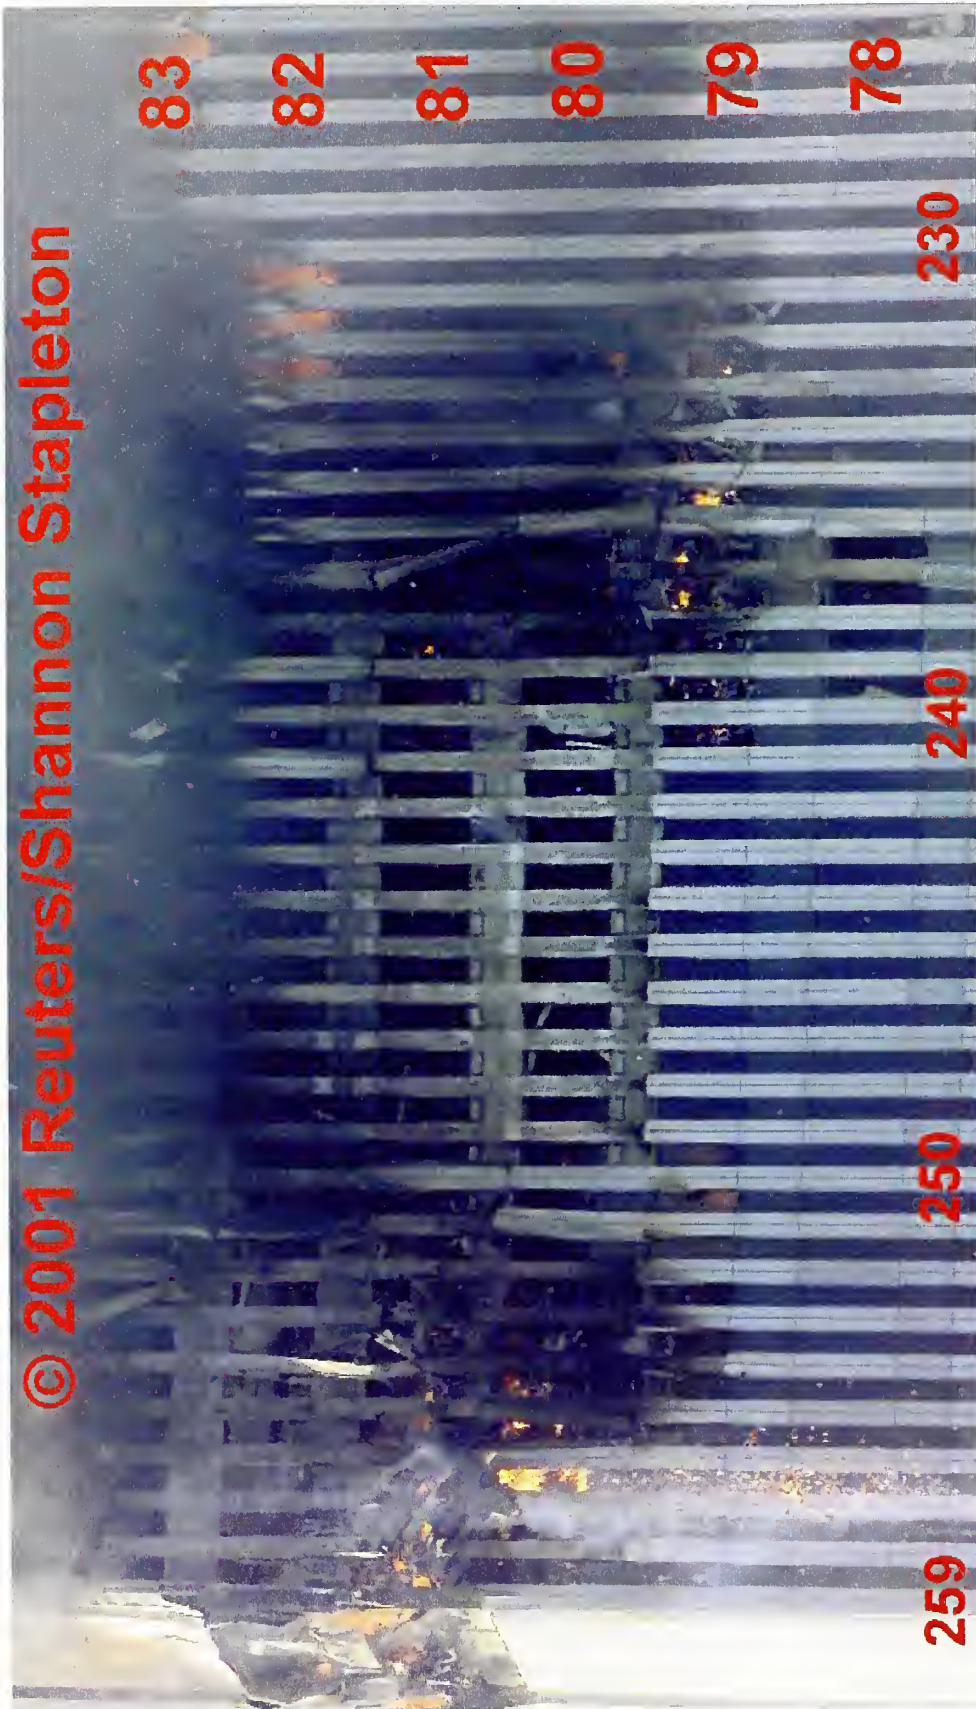
Figure H-21. An enhanced photograph of the north face of WTC 2 taken at 9:58 a.m. shows the east side of the north face. Piles of debris are evident on floor 80 and floor 81 on the northeast corner and on floor 79 to the right of column 230. The “cold” area extends over floor 80 to floor 82 from roughly column 229 to 240. There is a break in column 253 on floor 81, and the adjacent column, 254, is bent. Floors 80, 81, and 82 appear to be partially collapsed. It appears as if the collapsed floor 83 in the northeast corner has broken into sections.

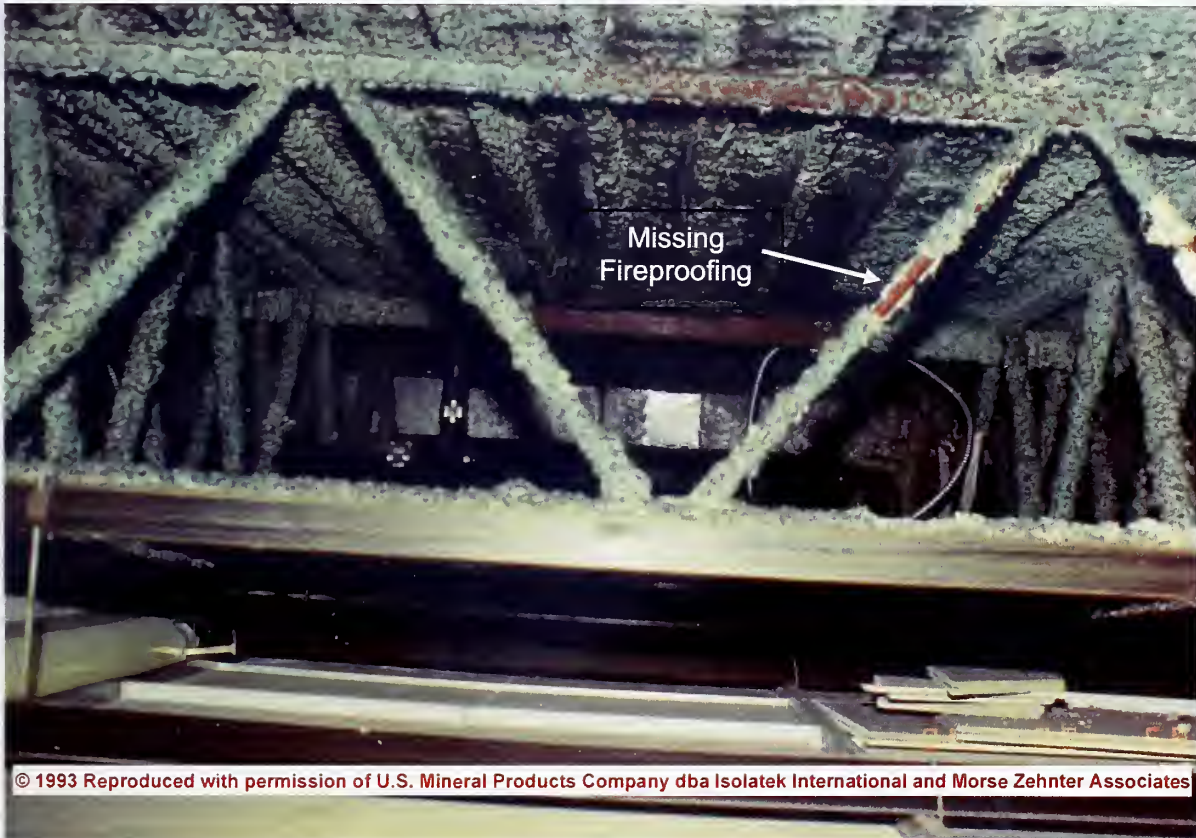
In addition to the effect of variation in thickness, it is important to understand the effect of missing fireproofing over a portion of a member. As an example, Fig. I-4 shows missing fireproofing from a diagonal of a bridging truss of the WTC towers floor system. Figure I-5 (a) shows an example of a numerical model with missing fireproofing. In this case, there is 12 in. of missing fireproofing on the steel plate, which is otherwise protected by 2 in. of uniform thickness fireproofing. Figure I-5 (b) shows the temperature contours (isotherms) at time 50 min. For comparison, Fig. I-5 (c) shows isotherms at the same time in a plate with no gap in the fireproofing. As expected, the bare steel at the missing fireproofing is at the gas temperature, but more importantly the “gap” in fireproofing leads to a “leakage” of heat into the interior steel.

Figure I-4. Example of “gap” in fireproofing on diagonal member of a bridging floor truss.
