# NATIONAL BUREAU OF STANDARDS REPORT

by  
J. W. Ryan and W. W. Sander

Fire Endurance Tests of Prefabricated Exterior Wall Panels

Test Report No. T010219-53; 673286

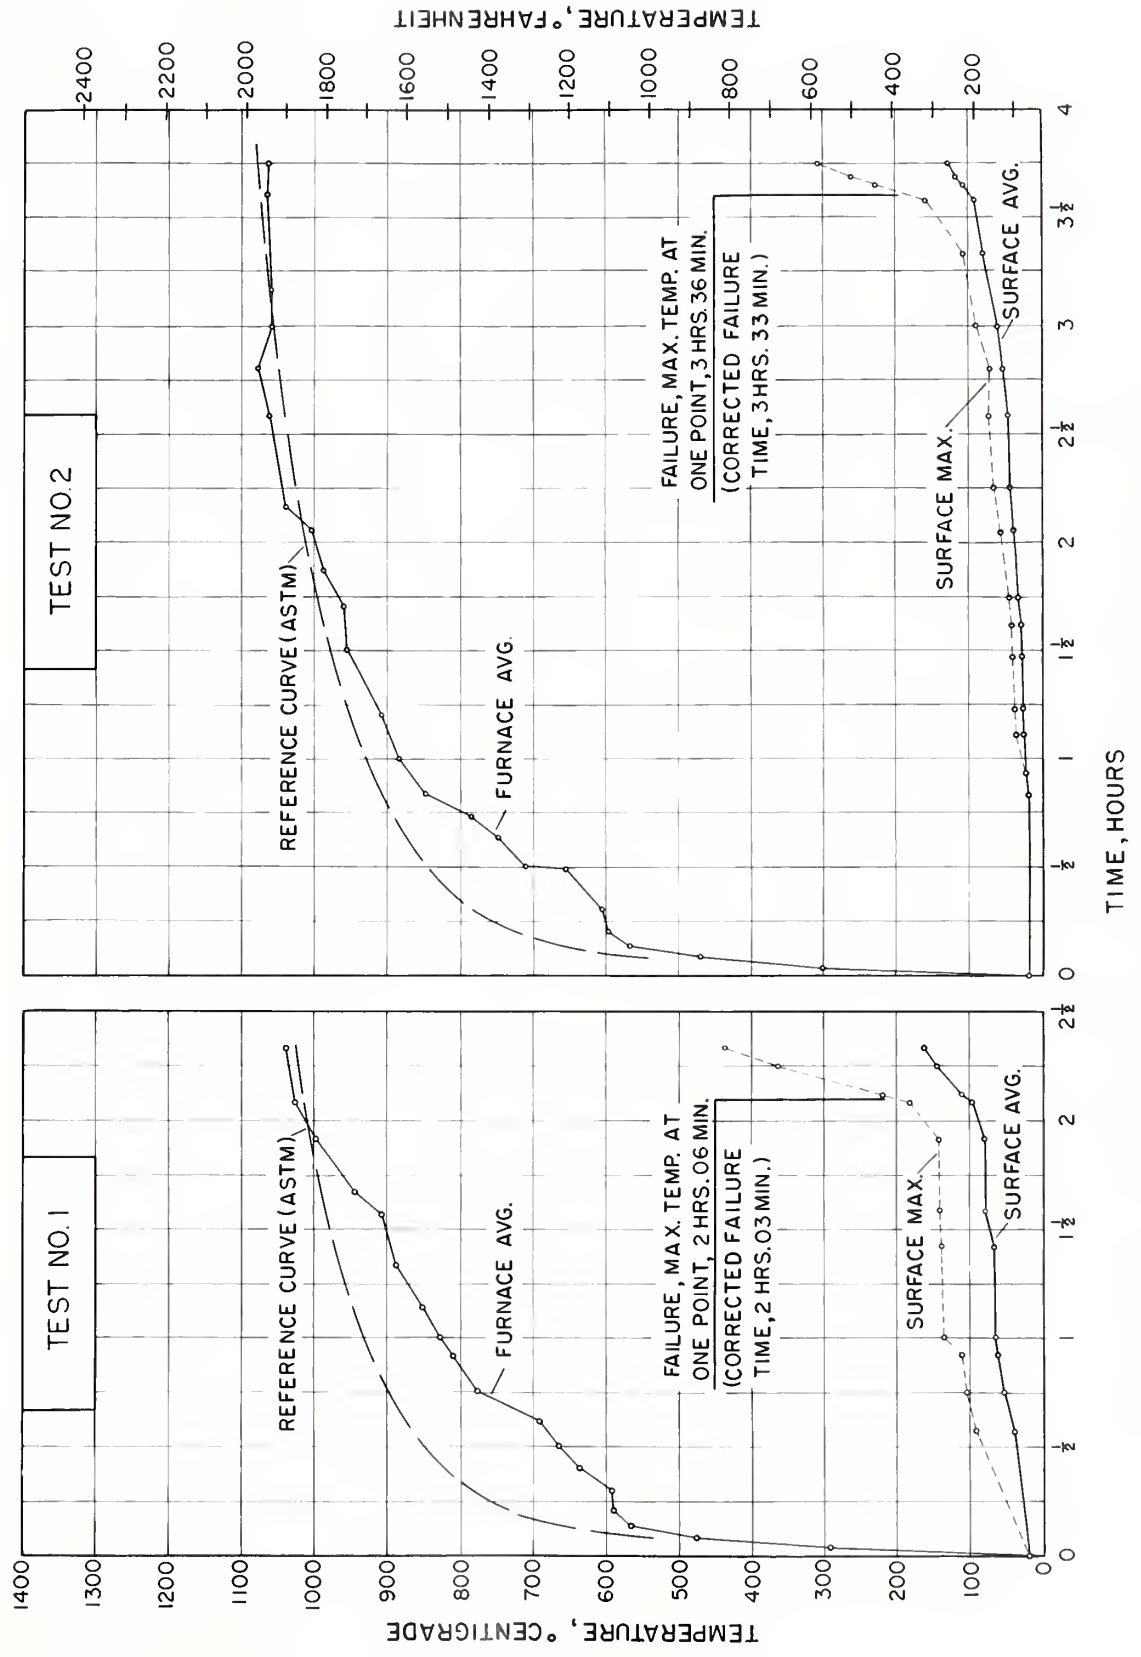
FIG. 6 TIME-TEMPERATURE CURVES FOR TESTS NO.1 AND 2

The control of the furnace temperature was such that the exposure severity was 69 percent of standard. The fire endurance limit was determined by temperature rise of 325 degrees F at one thermocouple on the unexposed surface at 2 hr. 6 min. The thermocouple was on the face of the center panel. If the correction formula in E119 is applied to the temperatures indicated by the bare thermocouples, the correction is minus 3 min. Therefore, the corrected fire endurance is 2 hr. 3 min. The temperatures measured during the test are shown in figure 6.

The control of the furnace was such that the fire exposure severity was 96 percent of standard. The fire endurance limit was determined at 3 hr. 36 min. by temperature rise of 325 degrees F at one thermocouple located on the unexposed face of the center panel in the upper half. If the correction formula in E119 is applied to the temperatures as indicated by the bare furnace thermocouples, the correction is minus 3 min. Therefore, the corrected fire endurance is 3 hr. 33 min. The temperatures measured during the test are shown in figure 6.

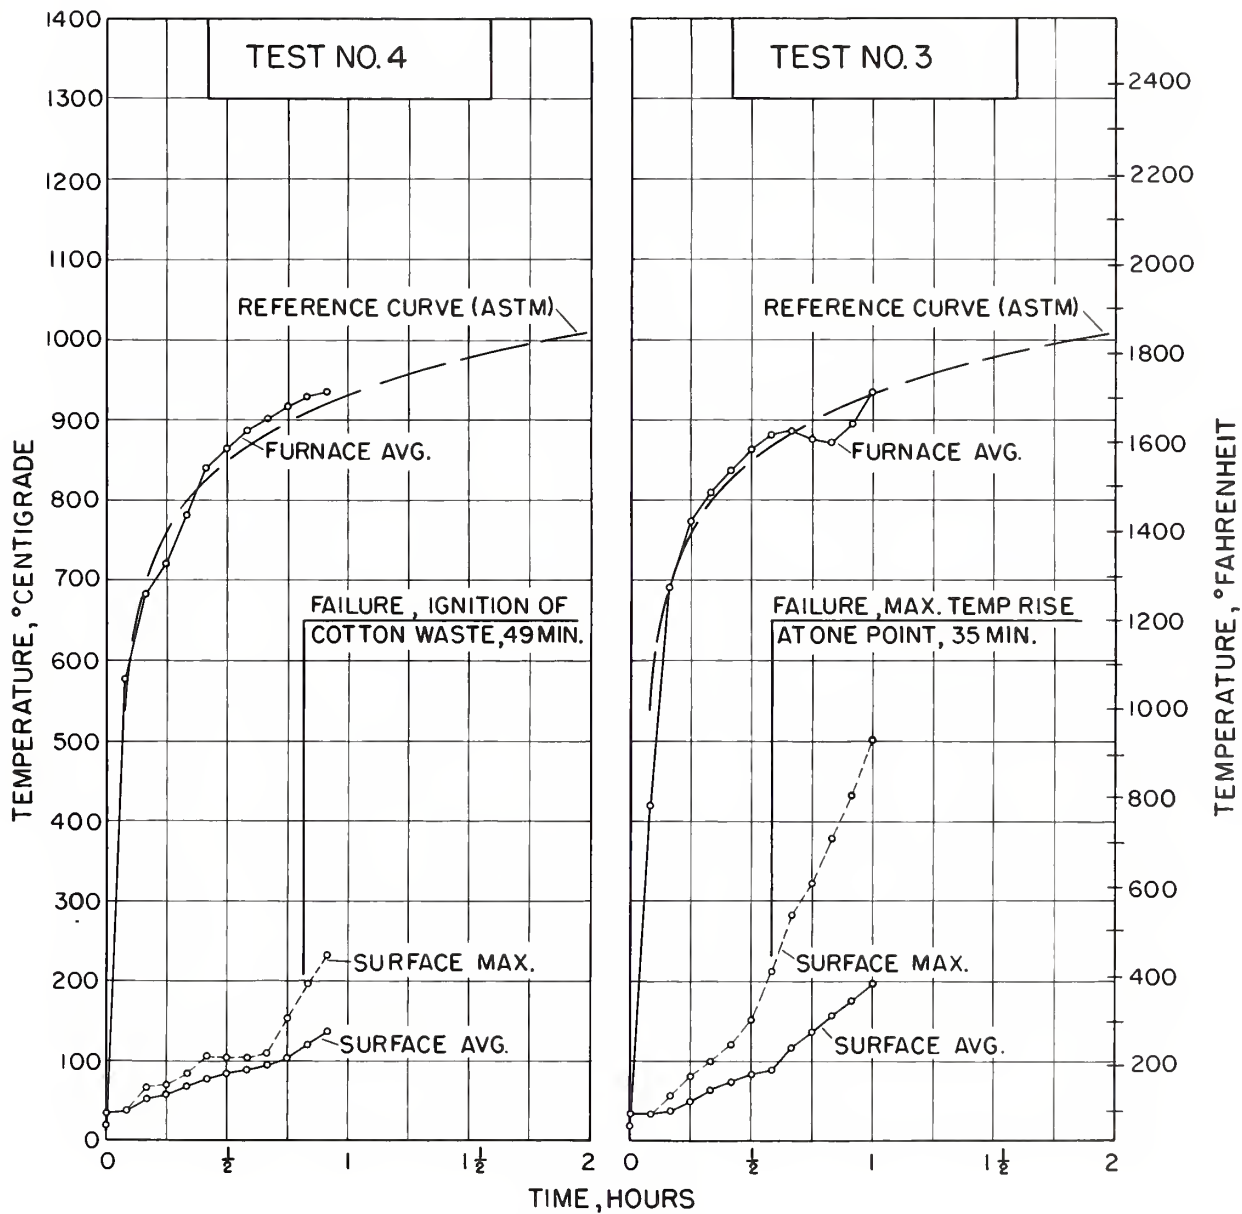
FIG. 7 TIME-TEMPERATURE CURVES FOR TESTS NO. 3 AND 4

The furnace control was such that the fire exposure severity was 98.8 percent of standard. The fire endurance was limited to 35 min by 325 degree F temperature rise at one thermocouple on the unexposed surface. This thermocouple was located on the cover strip of one of the joints between panels. The applicable correction was minus 1 min. making the corrected fire endurance 34 min. The temperatures measured during the test are shown in figure 7.

The furnace control was such that the fire exposure severity was 101.2 percent of standard but an correction was applicable to the fire exposure which was limited to 49 min. by the ignition of cotton waste on the exposed surface over the joint exposed panels. The temperatures measured during the test are shown in Figure 7.

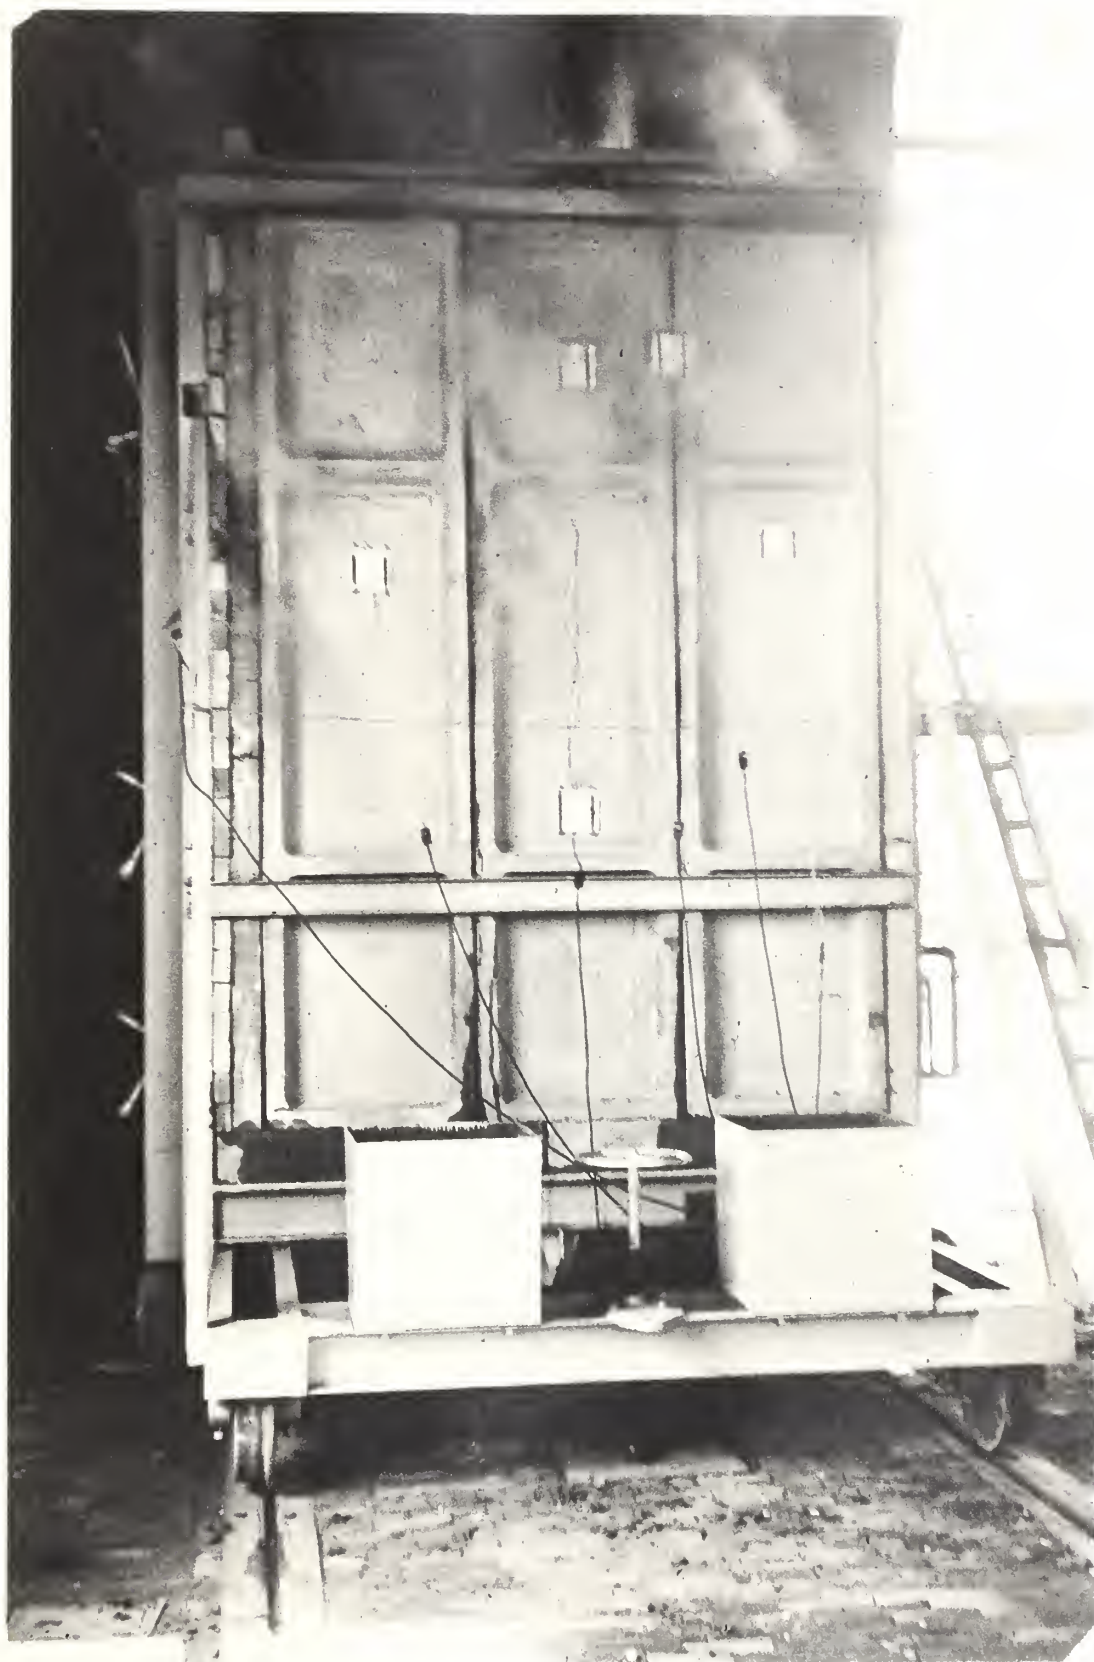
Test of precast shocked concrete outer face and cement coated fiber board inner face with 2 in. air space between. During the first 40 min., slight amounts of smoke and steam issued from joints; at 45 min., 2 explosions, cement coating of inner face fell off from core and covered observation ports; 50 min, another explosion; 53 min., fourth explosion; 2 hrs., fifth explosion; 2 hr. 10 min., hairline cracks in unexposed surface of center panel, upper section; 2 hr 20 min., gas off.

Fig. 5 Exposed surface of specimen during test 1.

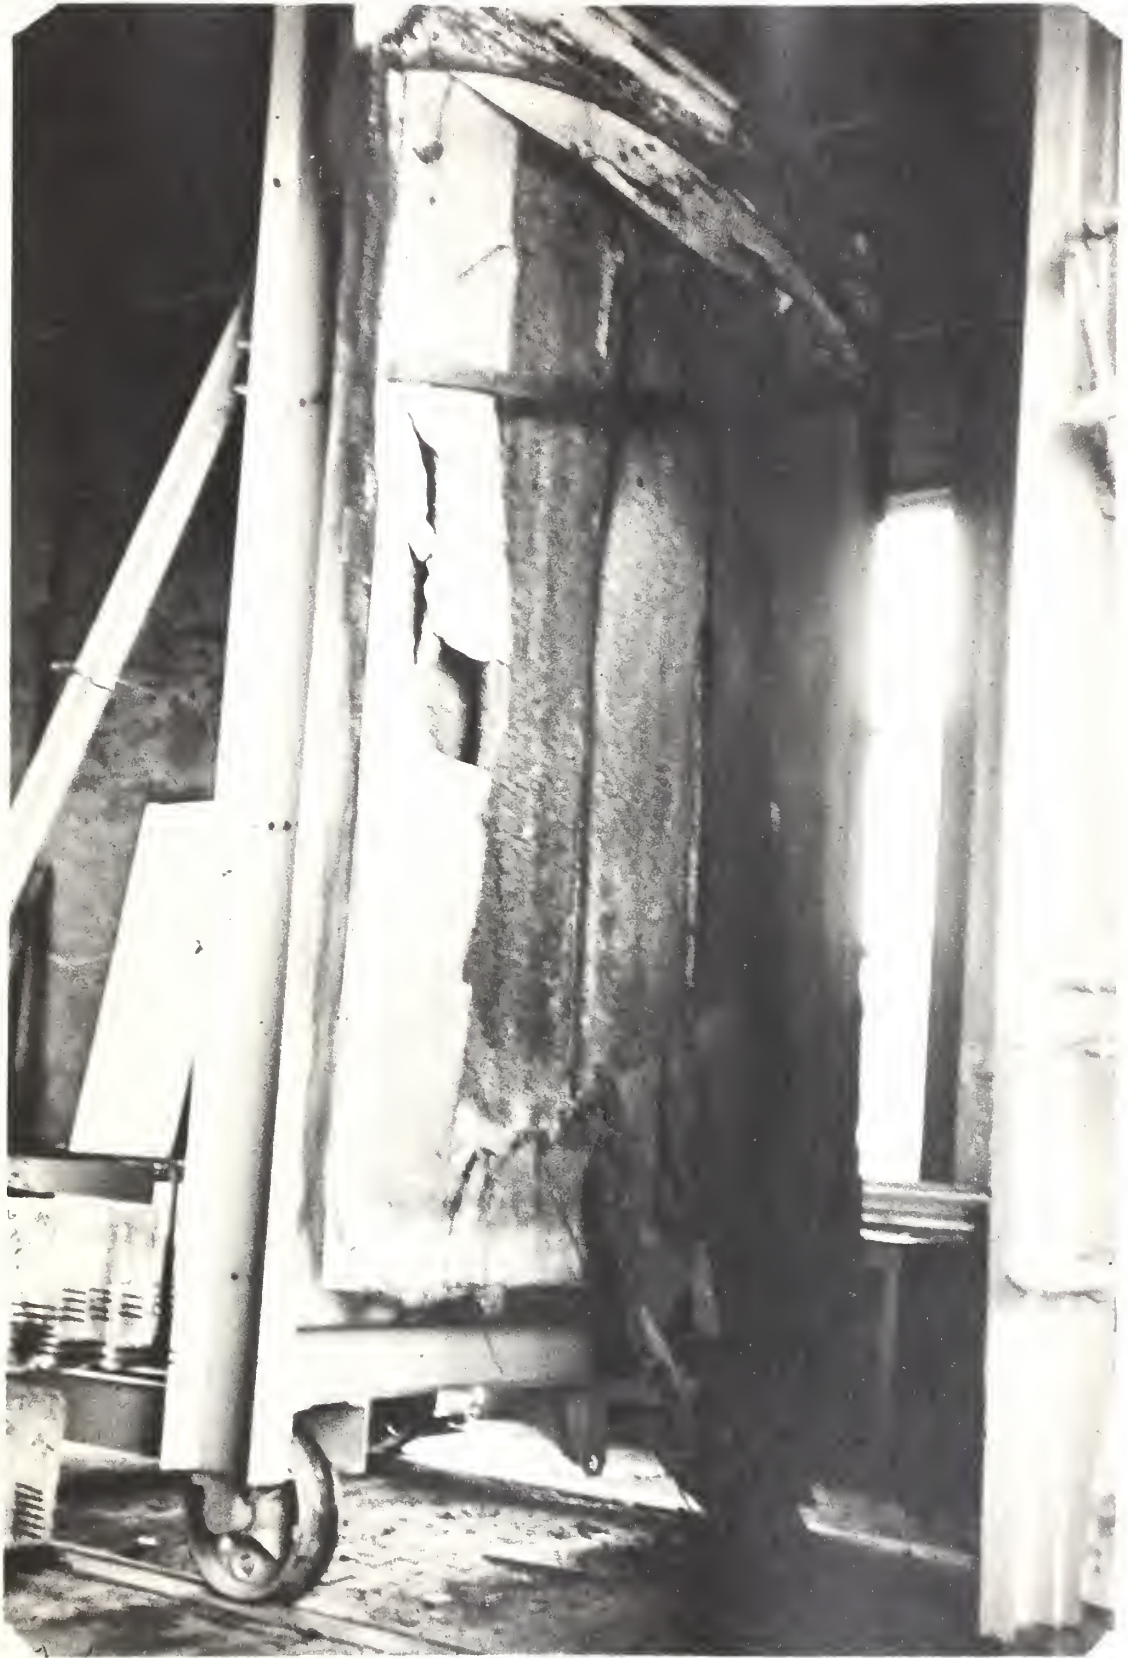
Immediately after the gas was turned off, the test specimen and frame were removed from the furnace. The insulating inner face panel in the center and portions of those on either side had fallen into the furnace chamber. The only damage to the concrete outer face was a spalled spot about  $\frac{1}{2}$  in. deep and 6 in. diameter in the center of the upper section of each panel. Collections of the outer face were negligible.

Fig. 9. Exposed surface of specimen immediately after  
end of test 1.

Test 1. The inner face would have to be replaced after a standard 2 hr. fire exposure or equivalent and the outer face panels should be patched but could be used as is.

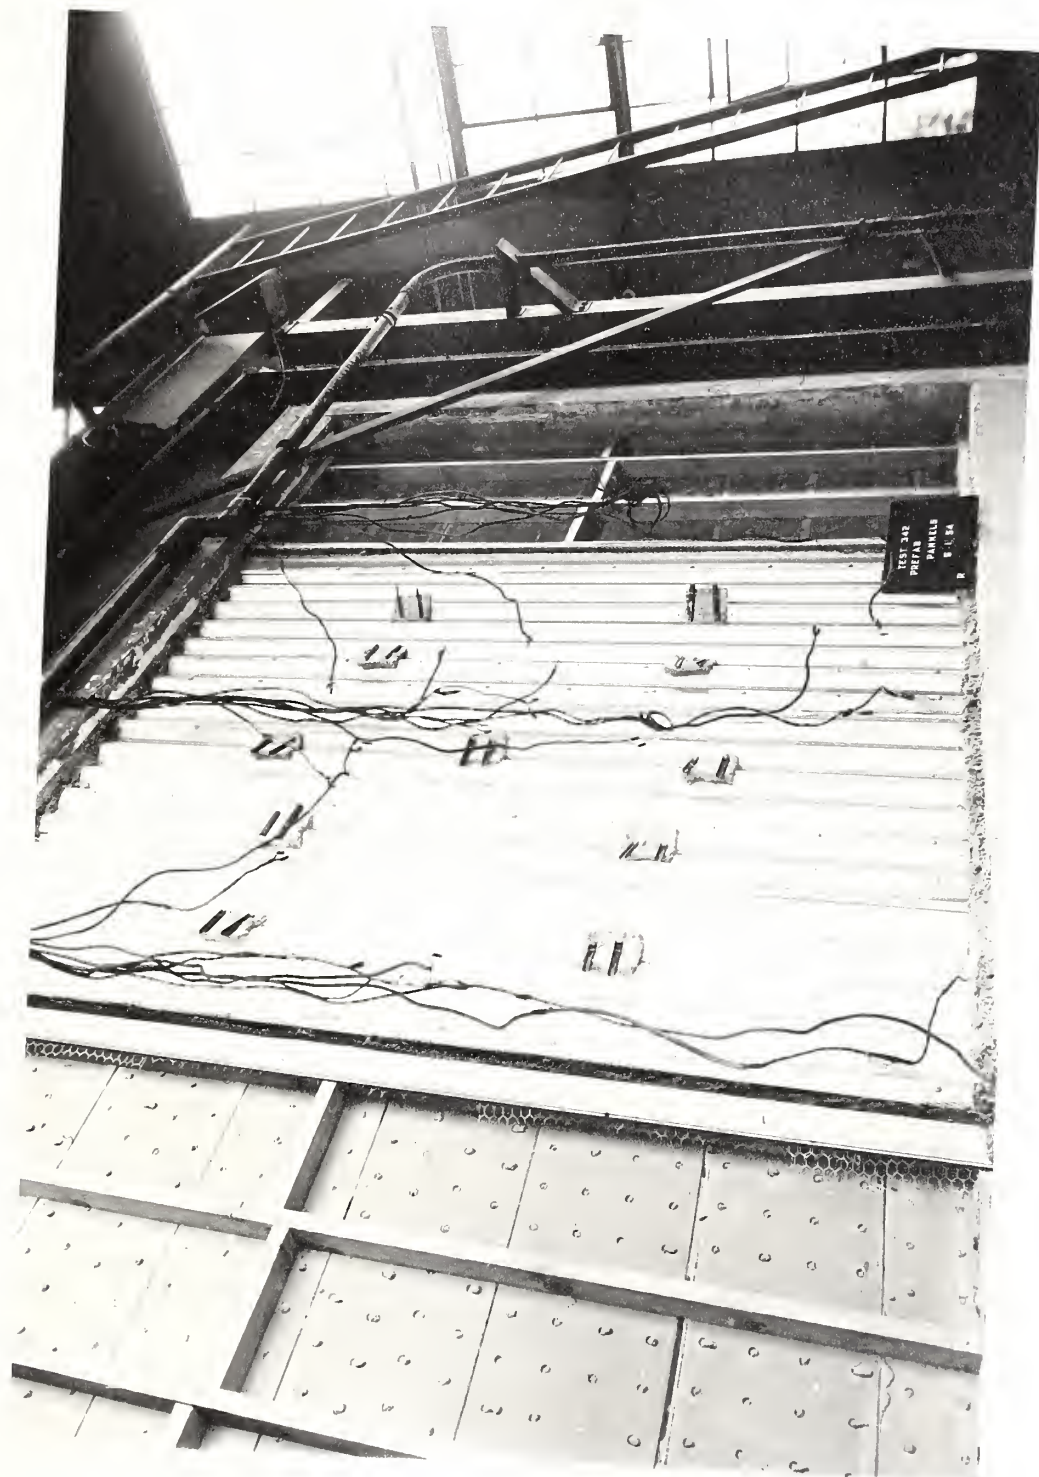
Fig 10. Unexposed surface of specimen at start of  
test 3.

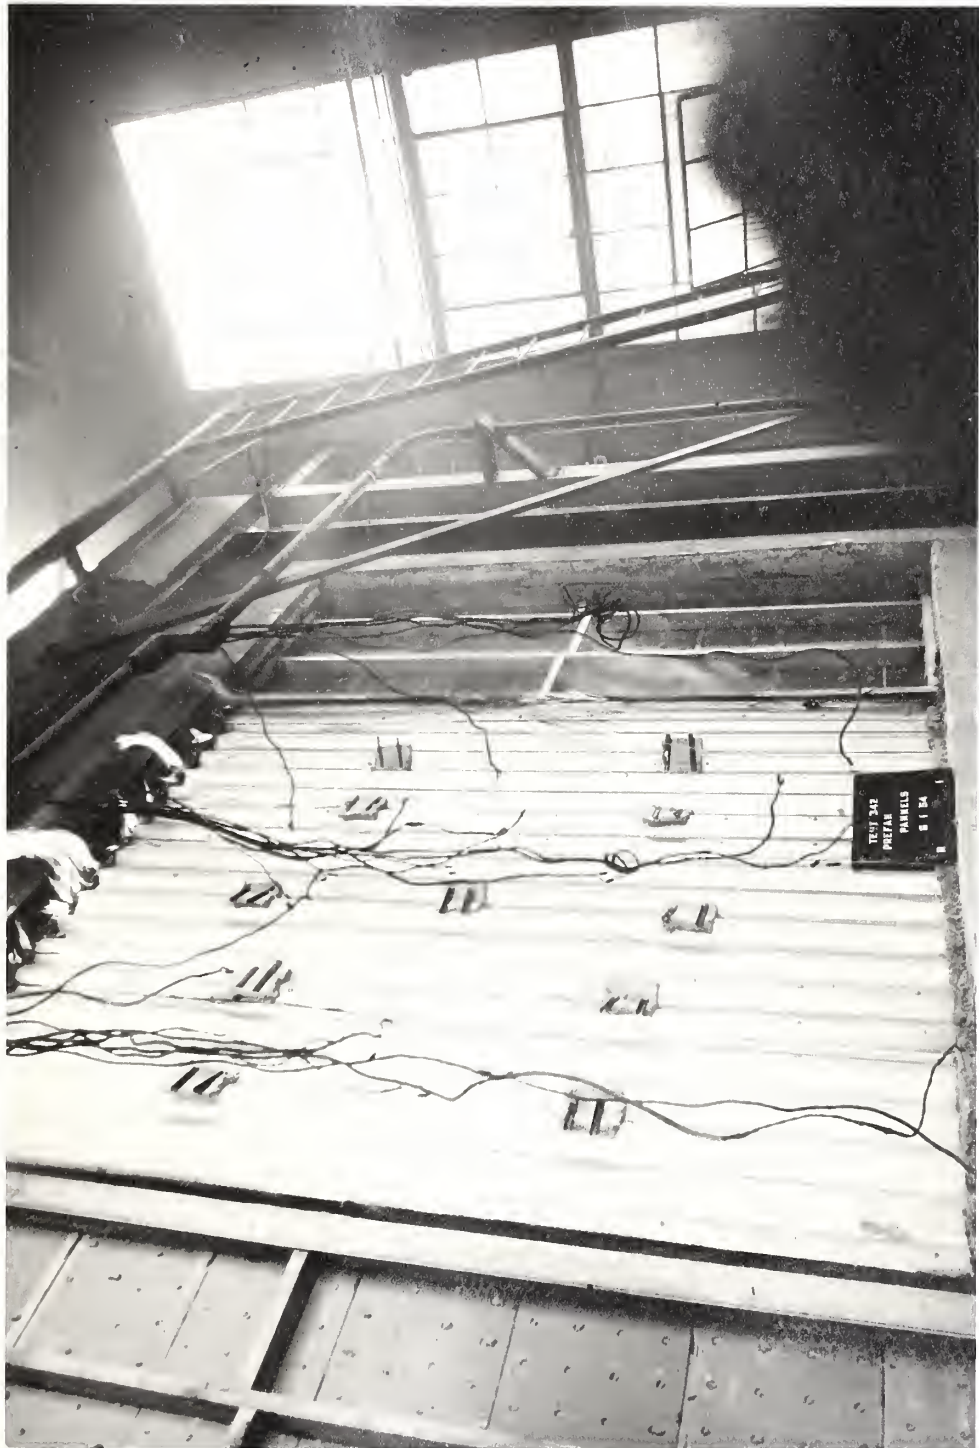
Test of mineral wool filled metal faced prefabricated wall. At 5½ min., flames into furnace from one joint between panels, on exposed side; 6½ min., flames into furnace from other joint, exposed metal faces of all panels bowed toward flames; 10 min., yellow smoke from joints in unexposed surface; 13 min., flames into furnace from joints in exposed face almost out; 15 min., and after, repeated popping sounds; 31 min., flames out of furnace along top edge of specimen; 45 min., paint and/or bituminous coating on upper 1/3 of unexposed face blistered; 1 hr. 1 min., gas off.

Fig. 11. Unexposed surface of specimen at 43 min in test 3.

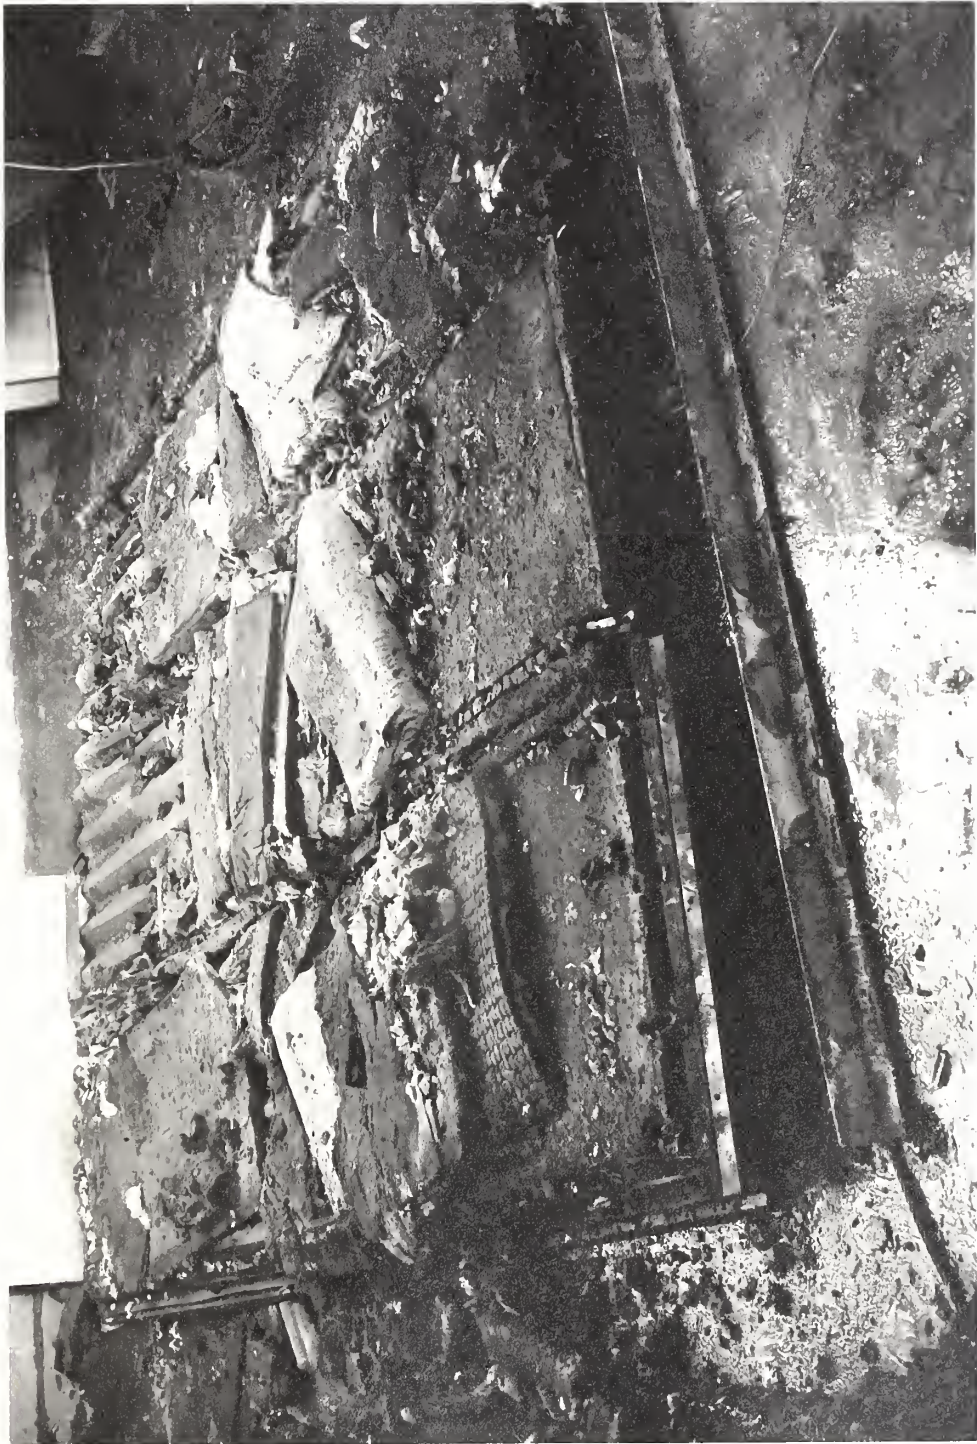
Immediately after the gas was turned off, the test frame was removed from the furnace. The exposed face of the specimen was badly warped and a bright glow or flames in the interior were visible through the joints. The specimen was removed from the frame, the exposed faces removed from the panels and the fires in the interior extinguished with water. The insulation in the upper 3 to 4 ft. had slipped down, into the space resulting from the bowing or puffing out of the exposed face. The wood frame and insulation were badly charred.

Fig. 14. Remains of specimen from test 3, after removal from test frame.

Test 3. The complete wall panels would have to be replaced after a 1 hr. standard fire exposure, or equivalent.

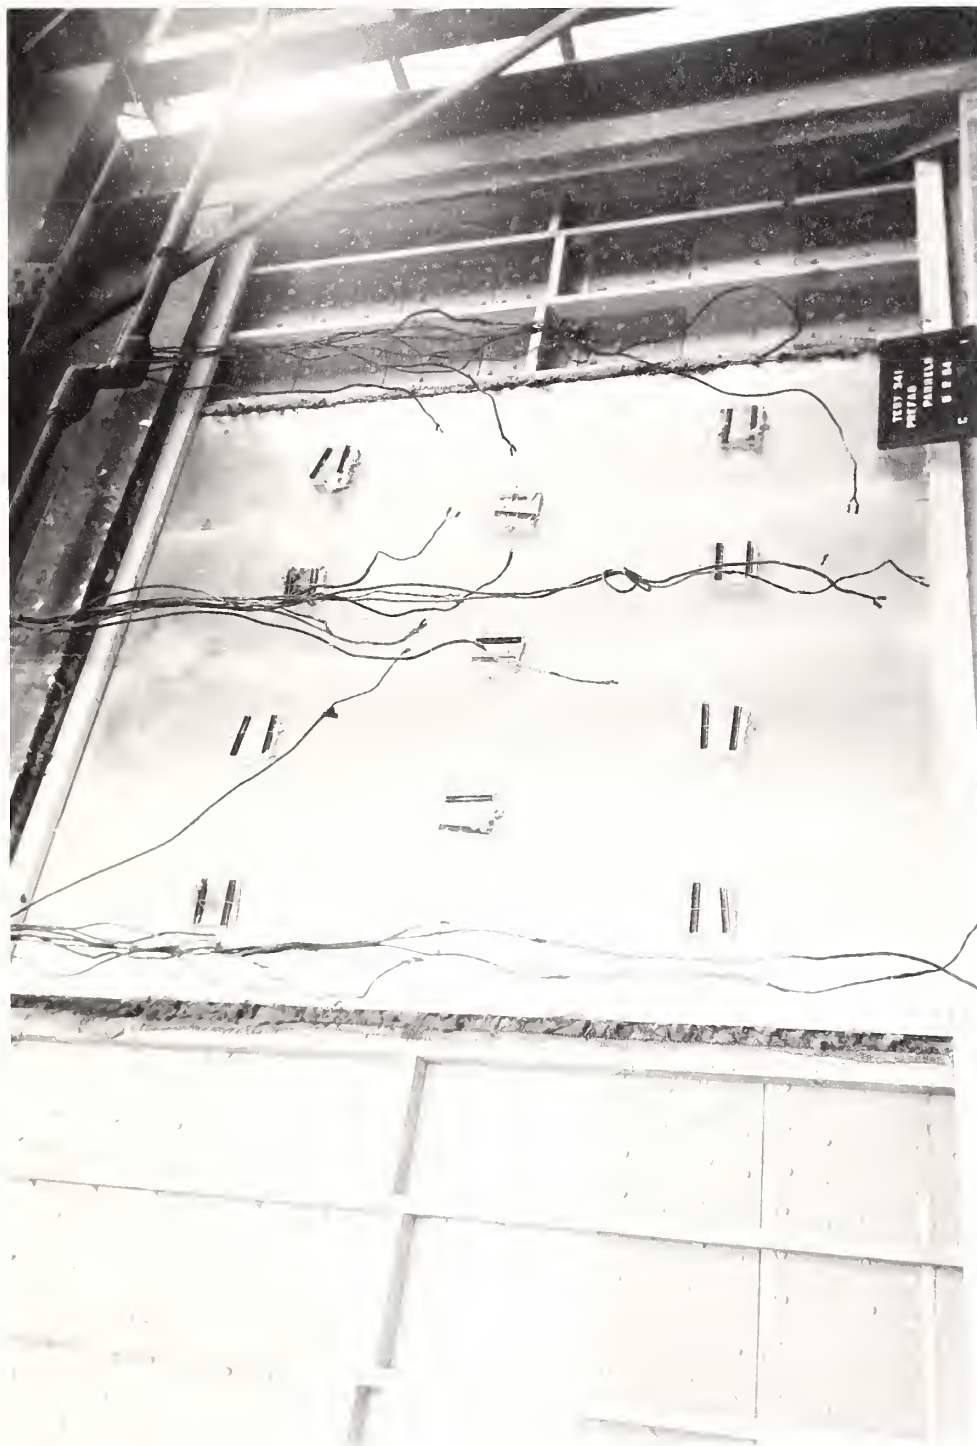
Fig. 13. Exposed surface of specimen at start of test 4.

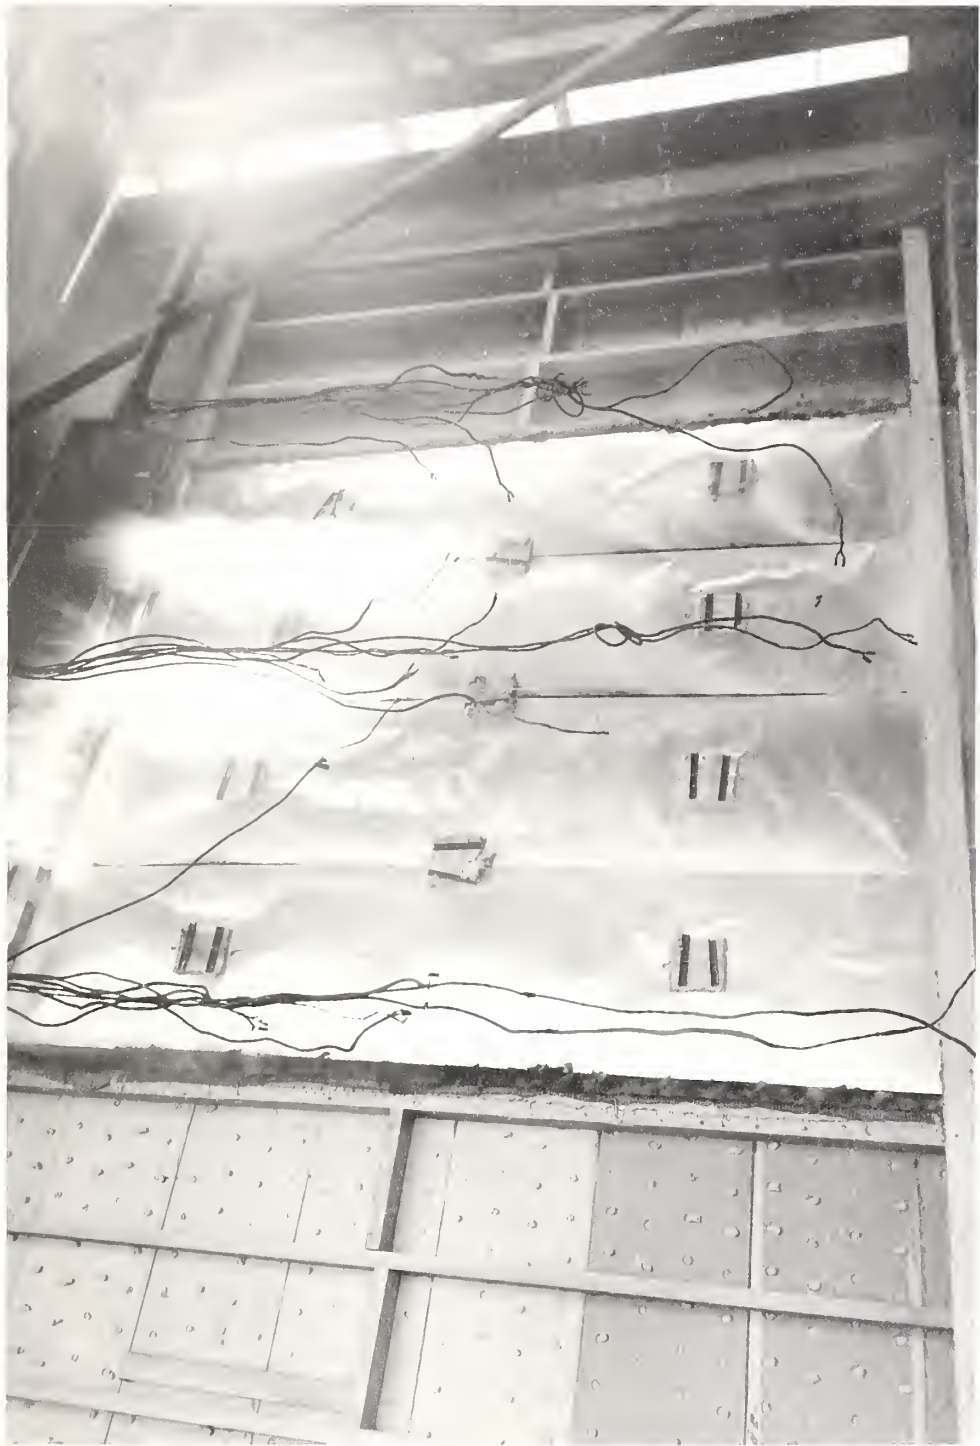
north joint; 49 min., cotton waste over north joint ignited; 73 min., flames through north joint; 94 min., flames from all joints, gas off.

Fig. 14. Unexposed surface of specimen at 95 min in test 4, showing wrinkled condition of aluminum surface and flames through joints.

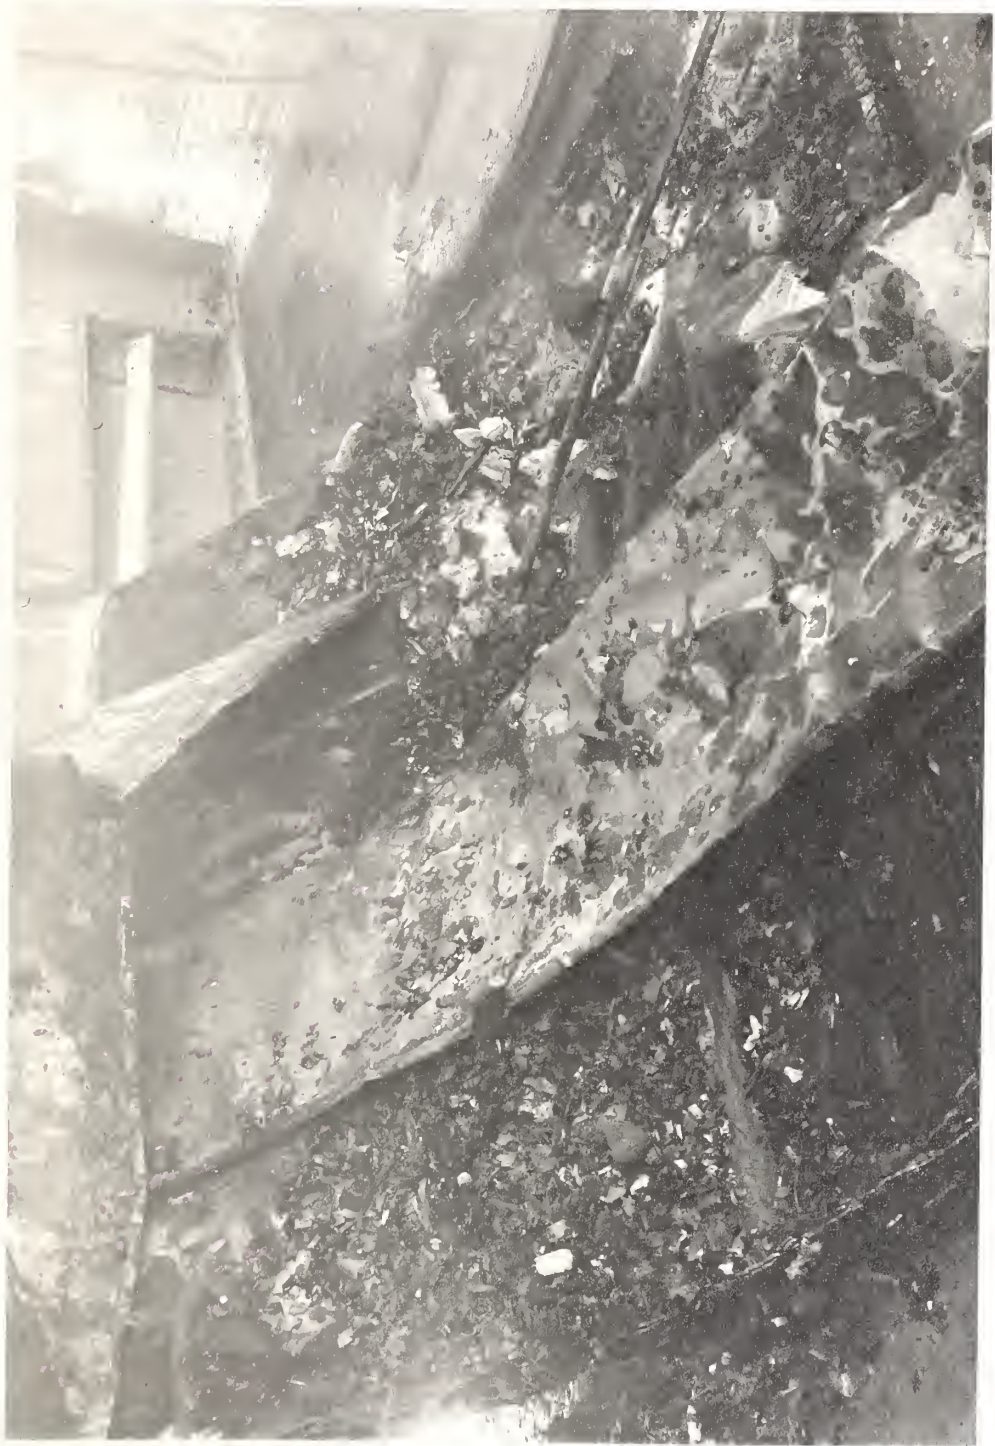
Immediately after the gas was turned off, the test frame was isolated from the furnace. Some flames still issued from the joint to the exposed surface and interior also was visible through others. The specimen was removed from the test frame, the exposed face removed and the interior fires extinguished. The wood and insulation were checked but the latter had not moved from its original position.

Fig. 15. Remains of specimen from test 4, after removal from test frame.

Test 4. The complete wall panels would have to be replaced after a 3/4 hr. standard fire exposure, or equivalent.
