NISTIR 7661

Final Report on the Collapse of the Dallas Cowboys Indoor Practice Facility, May 2, 2009

January 2010

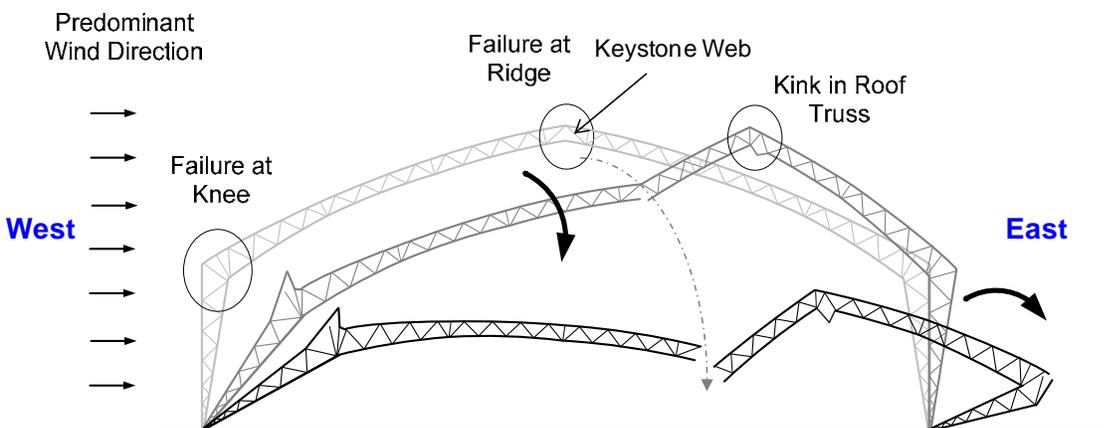
Based upon the observations made during the field reconnaissance and the results of the analysis in which the demand-capacity ratios were ranked in descending order to identify a sequence of member failures, NIST identified the likely collapse sequence for the structure as follows (see Figure ES-2):

1. Buckling of the inner chord in the straight section of the roof on the east side, resulting in formation of a kink in the frame at this location
2. Failures at the east and west knees, allowing the frame to sway eastward (in the direction of the wind)
3. Compressive failure of the east keystone web, leading to tensile fracture of the inner and outer keystone chords at the ridge
4. Spread of individual frame failures in similar patterns, through load redistribution and loss of lateral bracing, resulting in total collapse of the practice facility

Figure ES-2 Pattern of overall collapse of the north portion of the structure

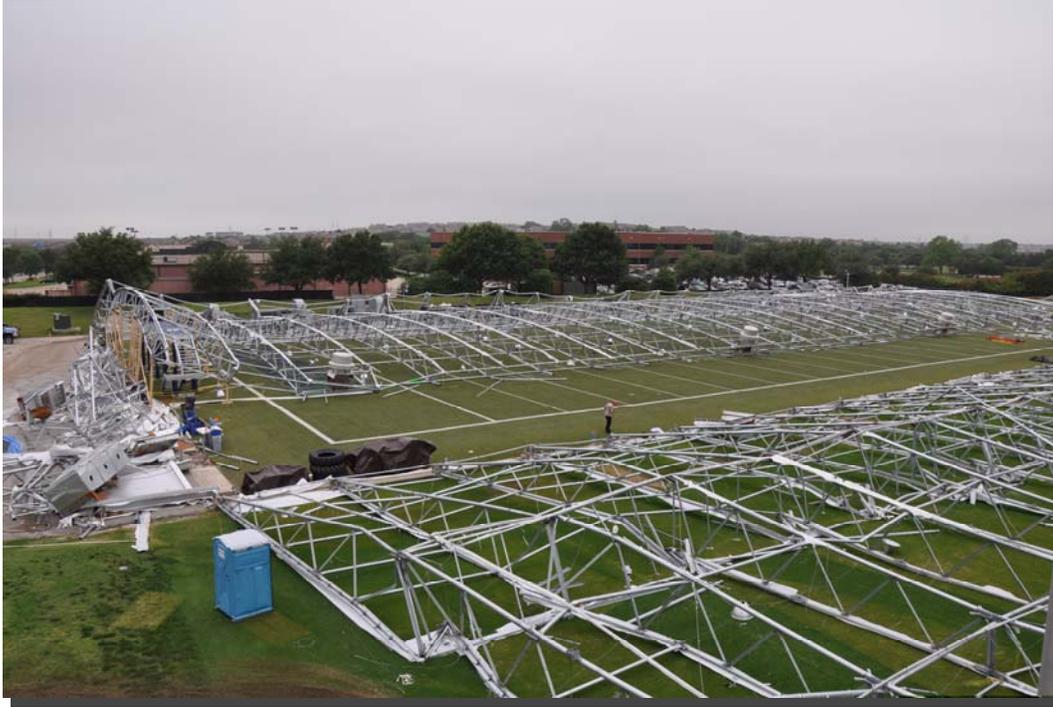
**Figure 1–7 Overall view of collapsed structure after fabric had been removed
(Photo credit: NIST)**

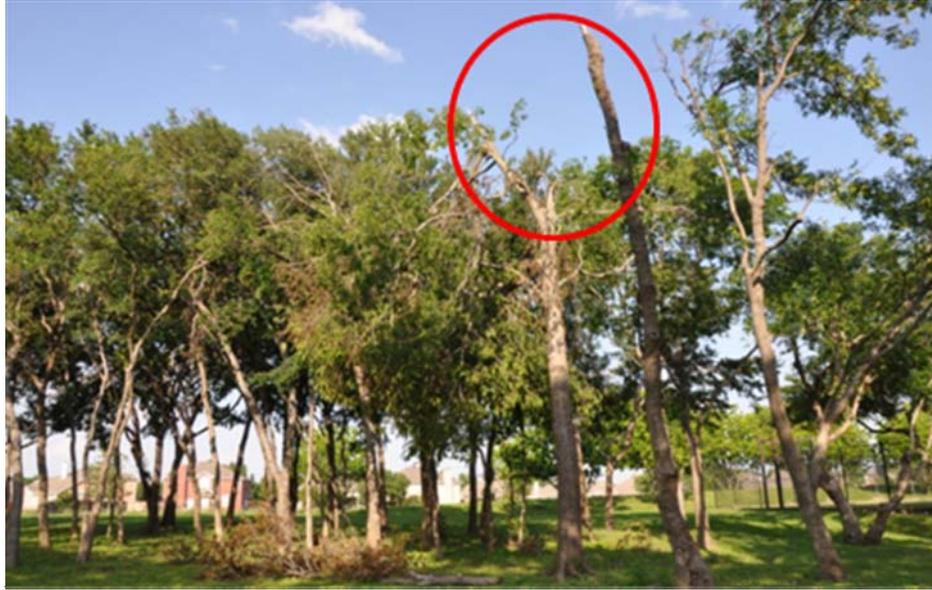
**Figure 2–1 Wind damage to tree limbs east of the collapsed structure
(Photo credit: NIST)**

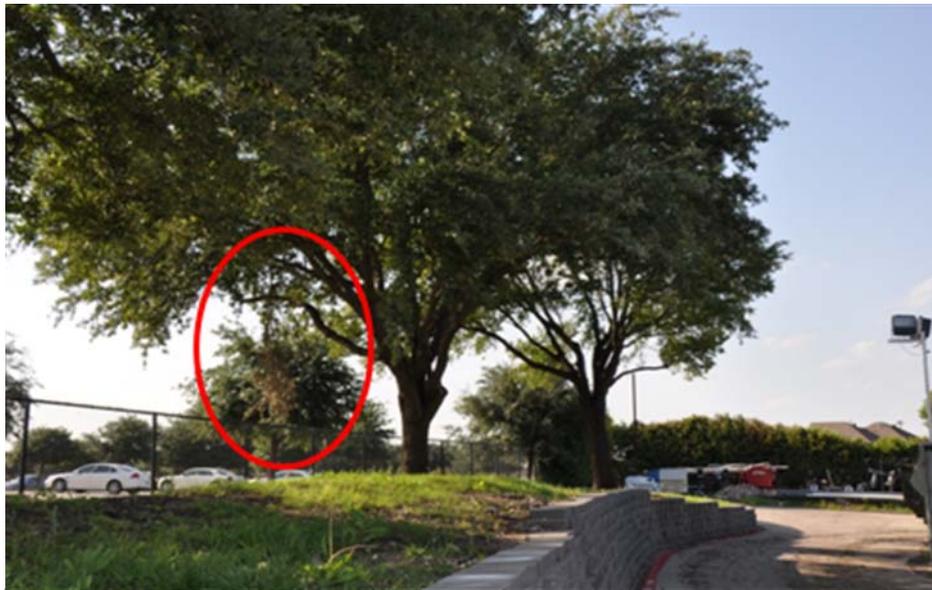
**Figure 2–2 Wind damage to tree limb west of the collapsed structure
(Photo credit: NIST)**

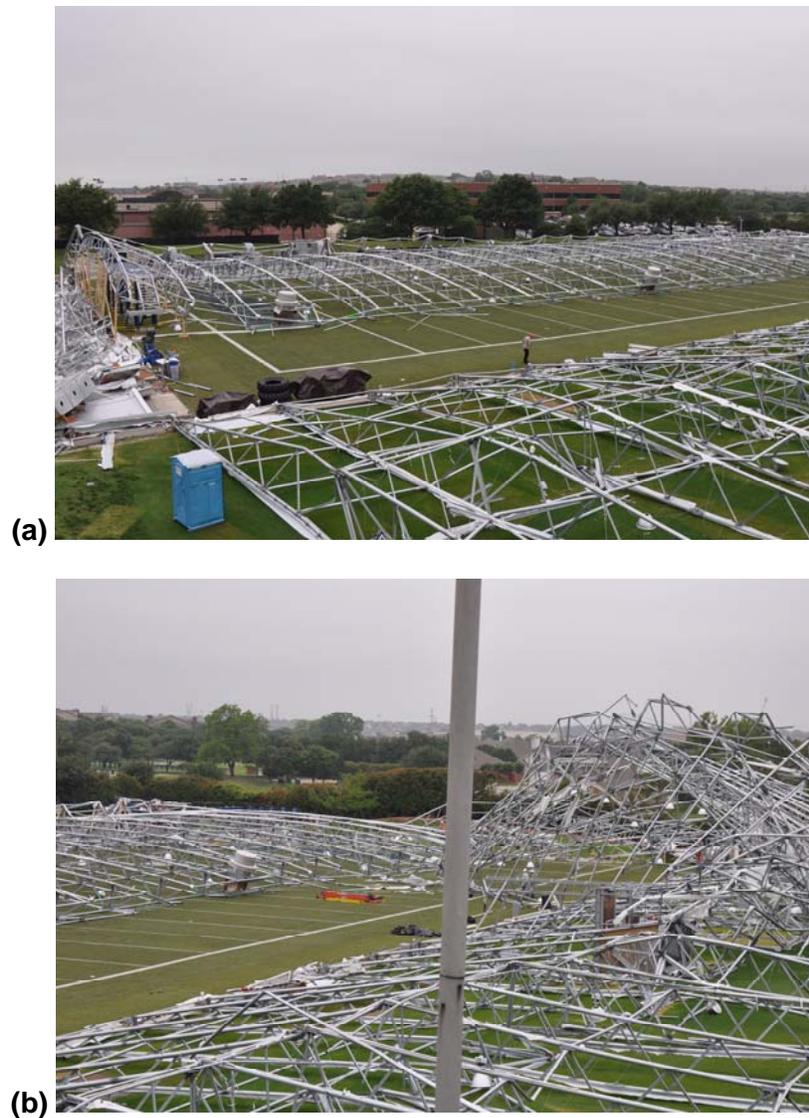
The wind direction on May 2, 2009, was predominantly from the west (see Chapter 2), and the collapse of the entire practice facility was toward the east. The pattern of collapse differed between the south and the north ends of the structure, as shown in Figure 3–4.

**Figure 3–4 View of (a) southern and (b) northern portions of the collapsed structure
(Photo credit: NIST)**

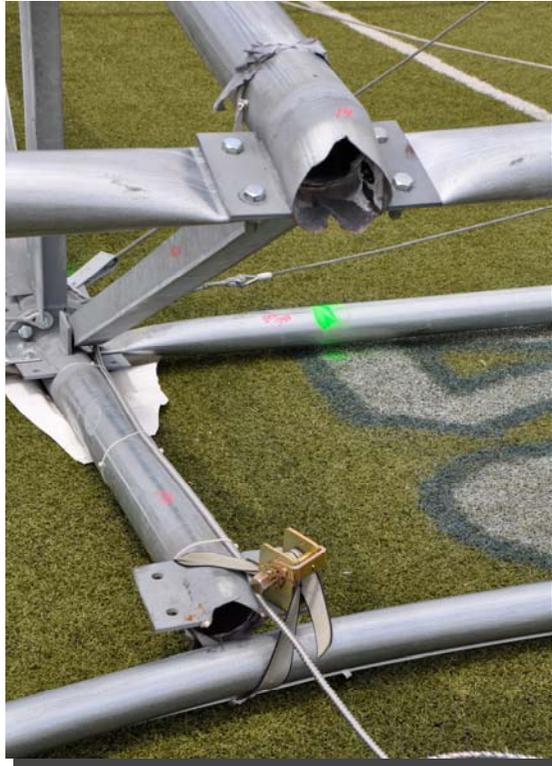
**Figure 3–7 Fracture of inner and outer chords at the keystone
(Photo credit: NIST)**

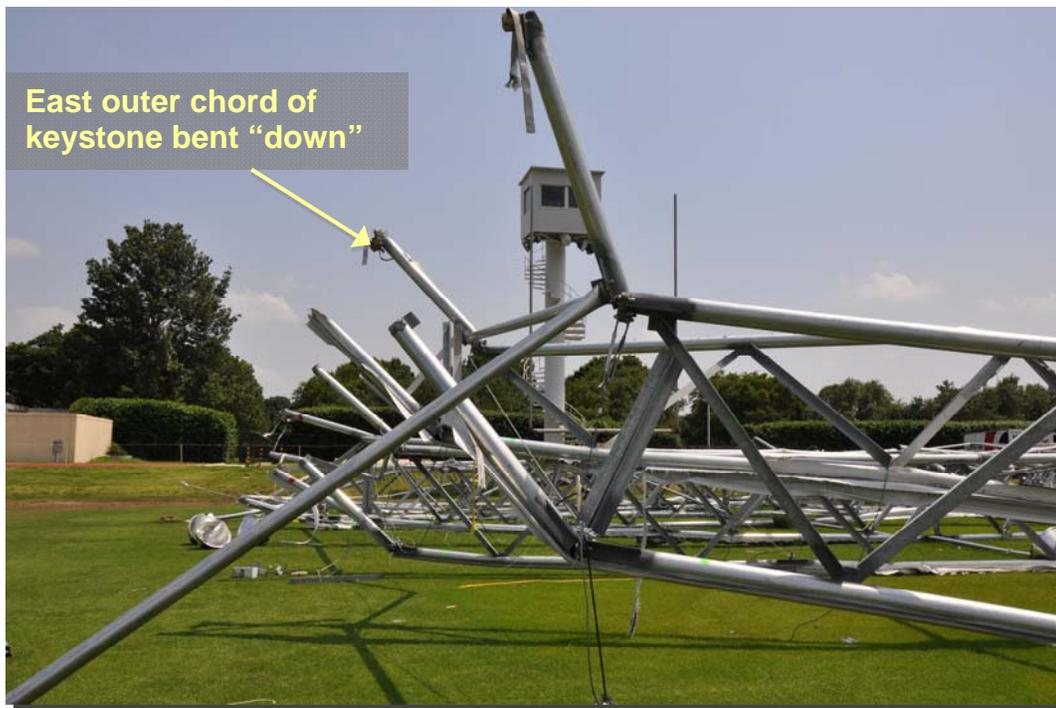
**Figure 3–8 Keystone chords bent down (note roof is upside down)
(Photo credit: NIST)**

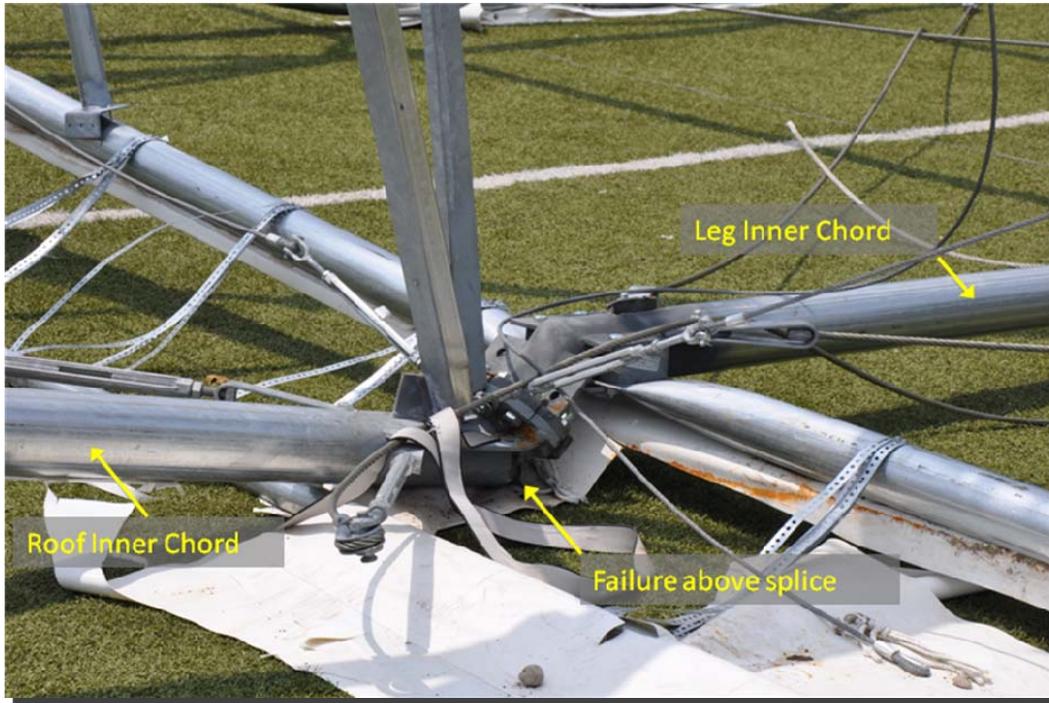
**Figure 3–9 Failure of inner chord near the splice at the west knees
(Photo credit: NIST)**

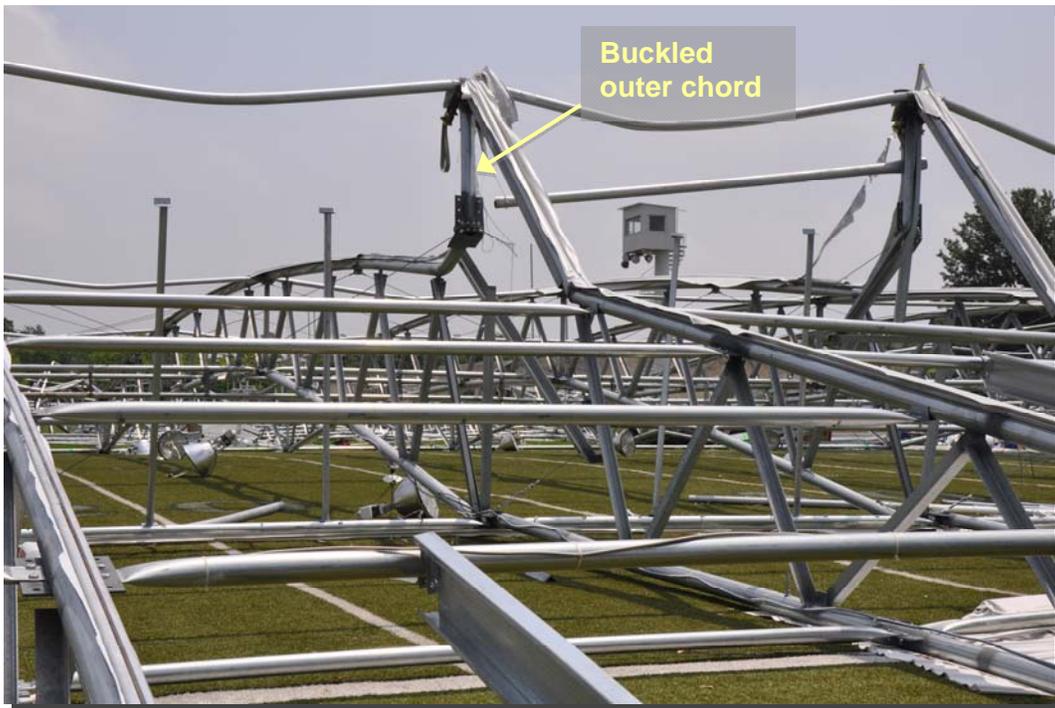
**Figure 3–10 Failure of both outer leg chord and eaves chord
(Photo credit: NIST)**

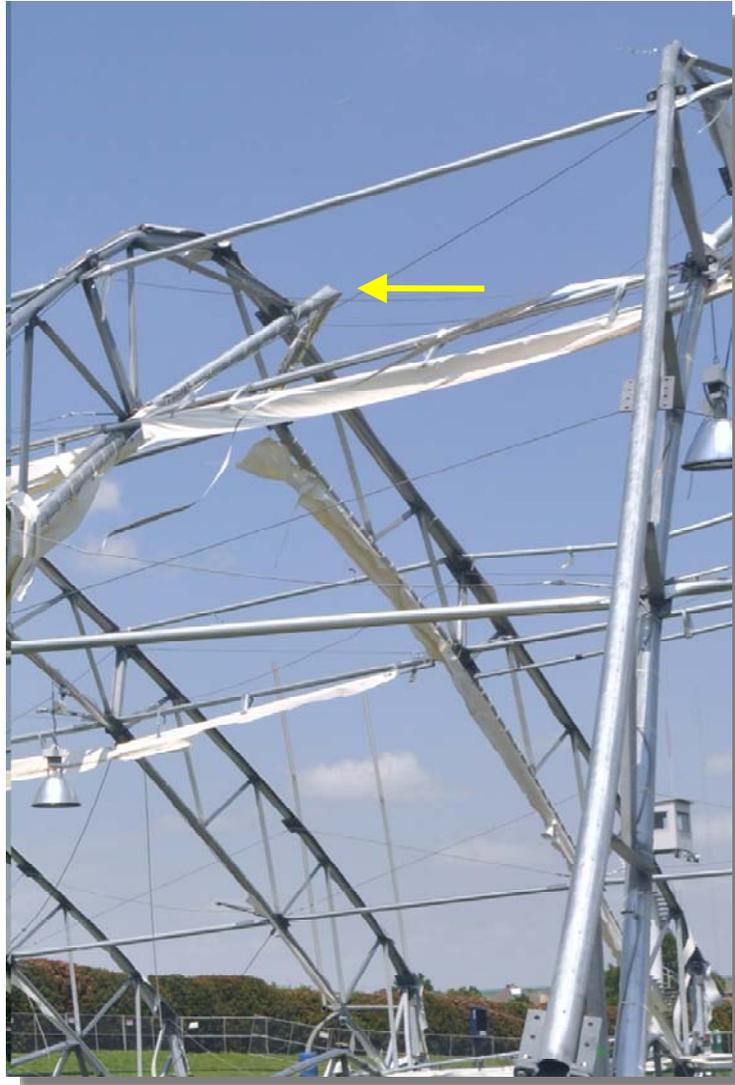
**Figure 3–11 Out-of-plane buckling of inner chord in north portion of collapsed structure
(Photo credit: NIST)**

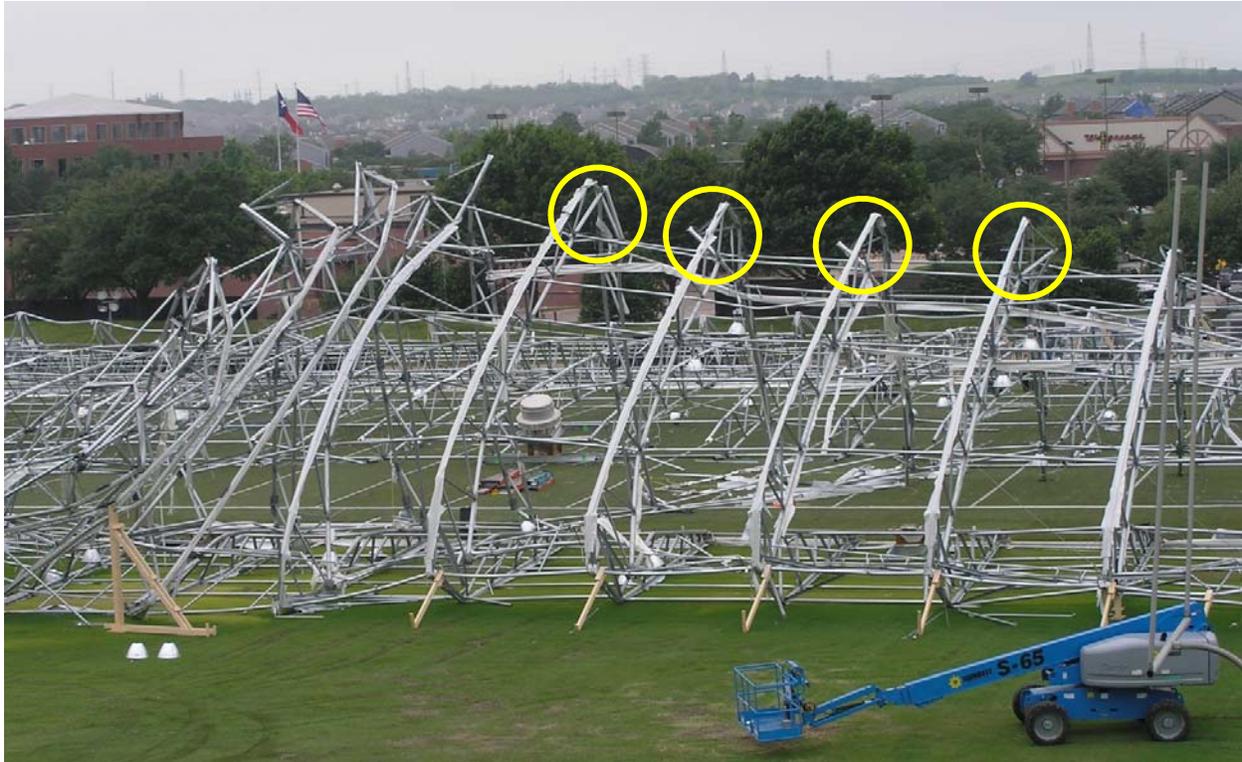
Figure 3–12 Out-of-plane buckling of inner chords in north portion of collapsed structure (Photo credit: NIST)

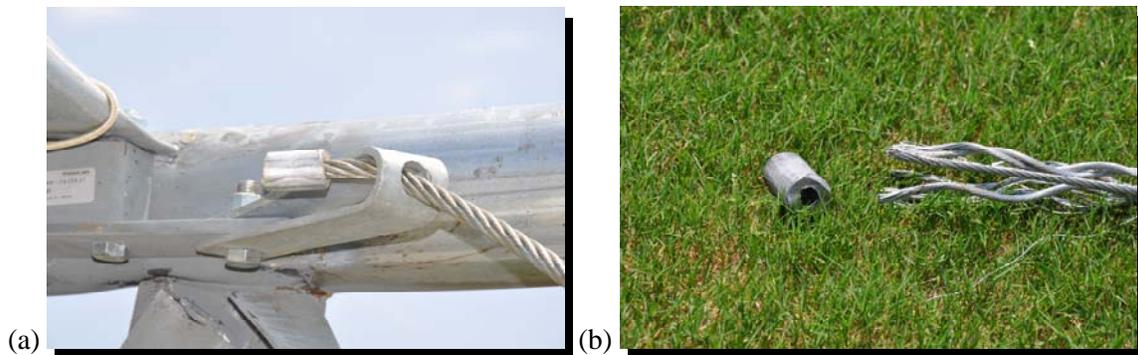
Figure 3–13 Failure of bracing cable connections: (a) intact, (b) failed (Photo credit: NIST)

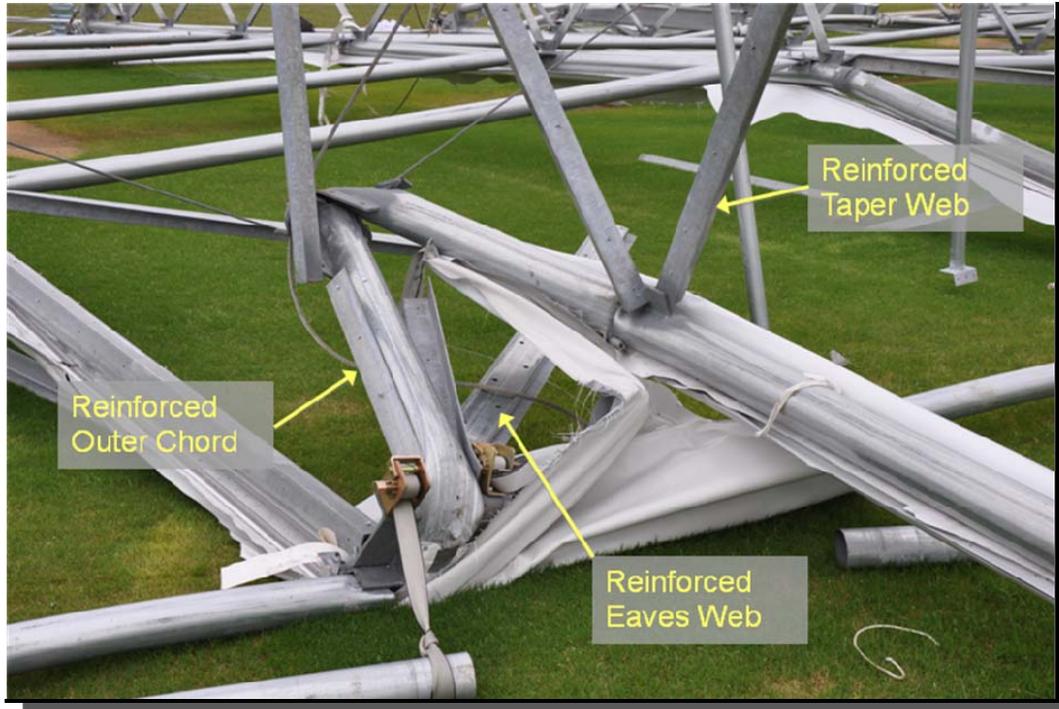
The structural frames supporting the fabric cover were designed and constructed in 2003. In 2008, the frames were reinforced by adding structural angles to selected chord members, rectangular structural tubes to the web members at the knees, and square structural tubes to two webs in the taper section. Figure 4–10 shows the locations of the reinforcement. All three reinforcing schemes can be seen in the photograph of one of the collapsed knees shown in Figure 4–11. Note that in many cases, the reinforcing detached from the original member during the collapse of the facility due to the failure of the screws used to attach the reinforcing.

**Figure 4–11 Collapsed structure showing reinforcement added in the knee region
(Photo credit: NIST)**
