# Examination of Failed Pylon Components

T. Robert Shives

Failure Analysis Report

Prepared for  
**Naval Air Test Center**  
**Patuxent River, Maryland 20670**

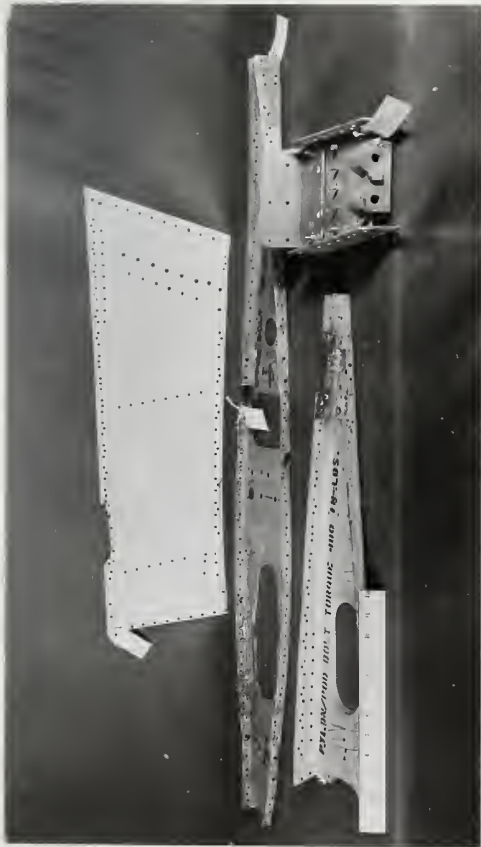
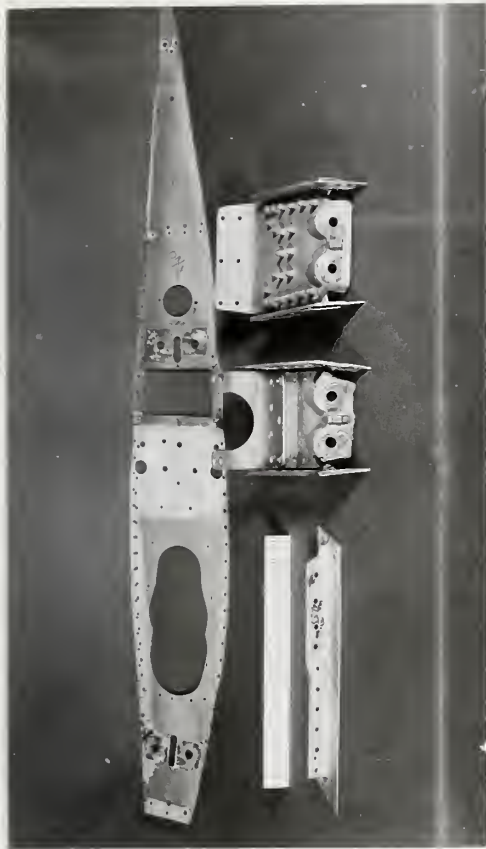
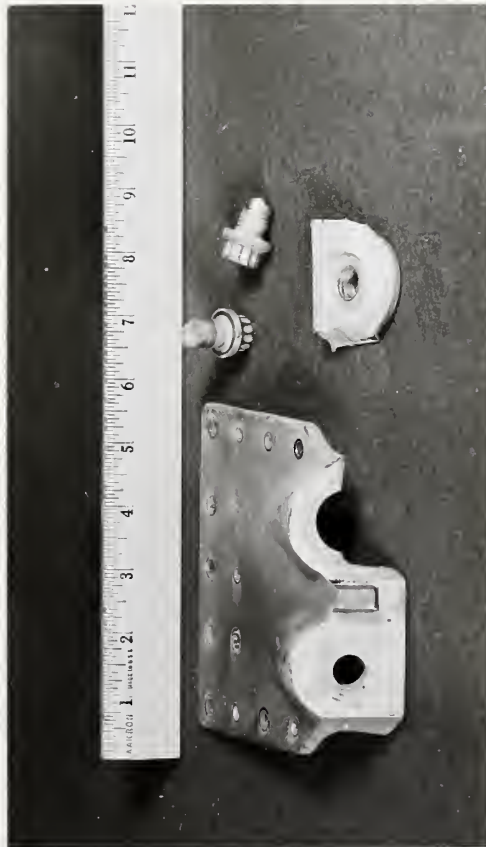
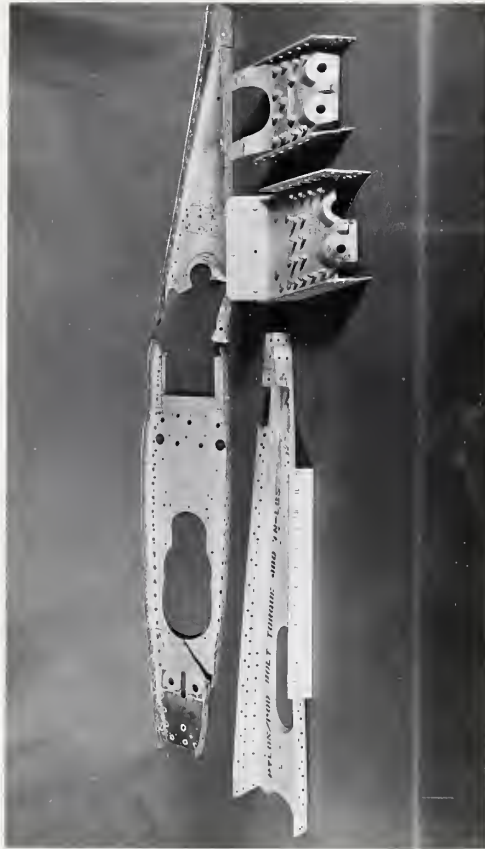
Figure 1. Significant pylon parts as received

- a. Pylon no. 1, X 1/10
- b. Pylon no. 2, X 1/10
- c. Pylon no. 3, X 1/3
- d. Pylon no. 4, X 1/10

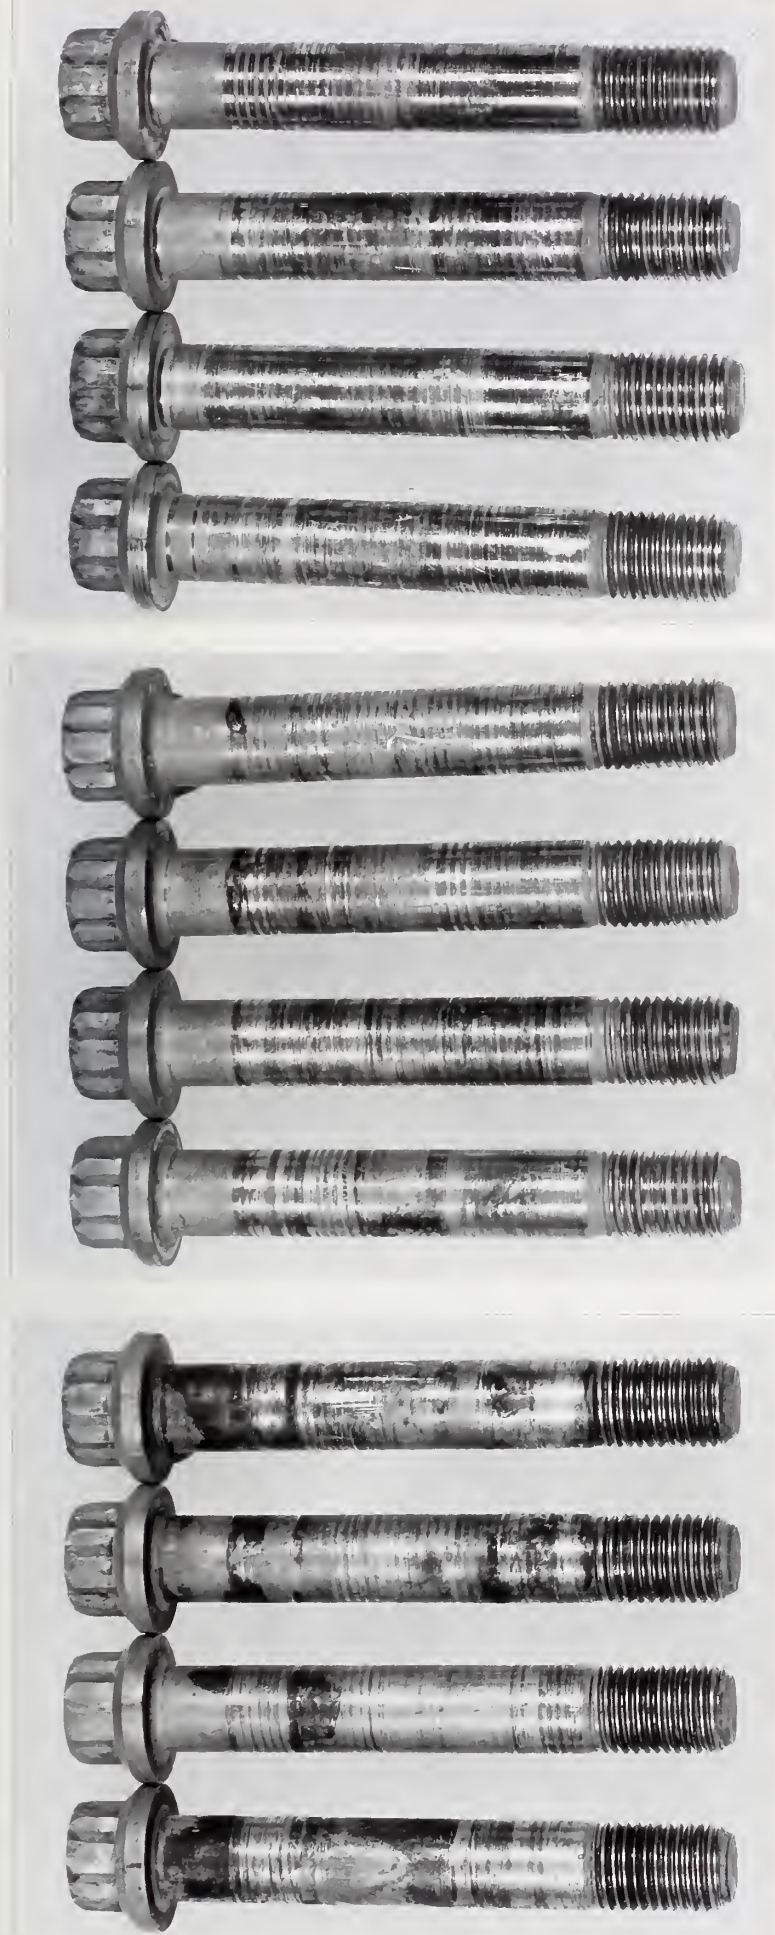
The twelve unbroken bolts that had been used in the normal torque condition are shown as received at NBS in figures 2a, b, and c. They were in three groups of four each labeled as indicated in the legend of figure 2.

Each of the bolts had suffered mechanical damage and apparent fretting corrosion damage. Some of this damage can be seen in figure 2. The damage to the LQ-6 bolts and to two of the LQ-9 bolts was concentrated in a 1.9 inch length along the shank, starting at about 0.4 inch from the underside of the bolt head and extending to a location just short of the threaded region. For the other two LQ-9 bolts and the LQ-2 bolts, the damage extended essentially from the underside of the bolt head to just short of the threaded region. The damage adjacent to the bolt heads was primarily fretting corrosion. Most of the mechanical damage was circumferential in nature. In many cases there were areas where the cadmium plating was ruptured due to abrasion - and consequently was either missing or peeling away from the bolt. One example showing the absence of cadmium plating appears in figure 13, which is higher in magnification than figure 2.

Figure 2. Intact bolts used at the normal torque as received. X 1

- a. Bolts labeled LQ-2
- b. Bolts labeled LQ-6
- c. Bolts labeled LQ-9

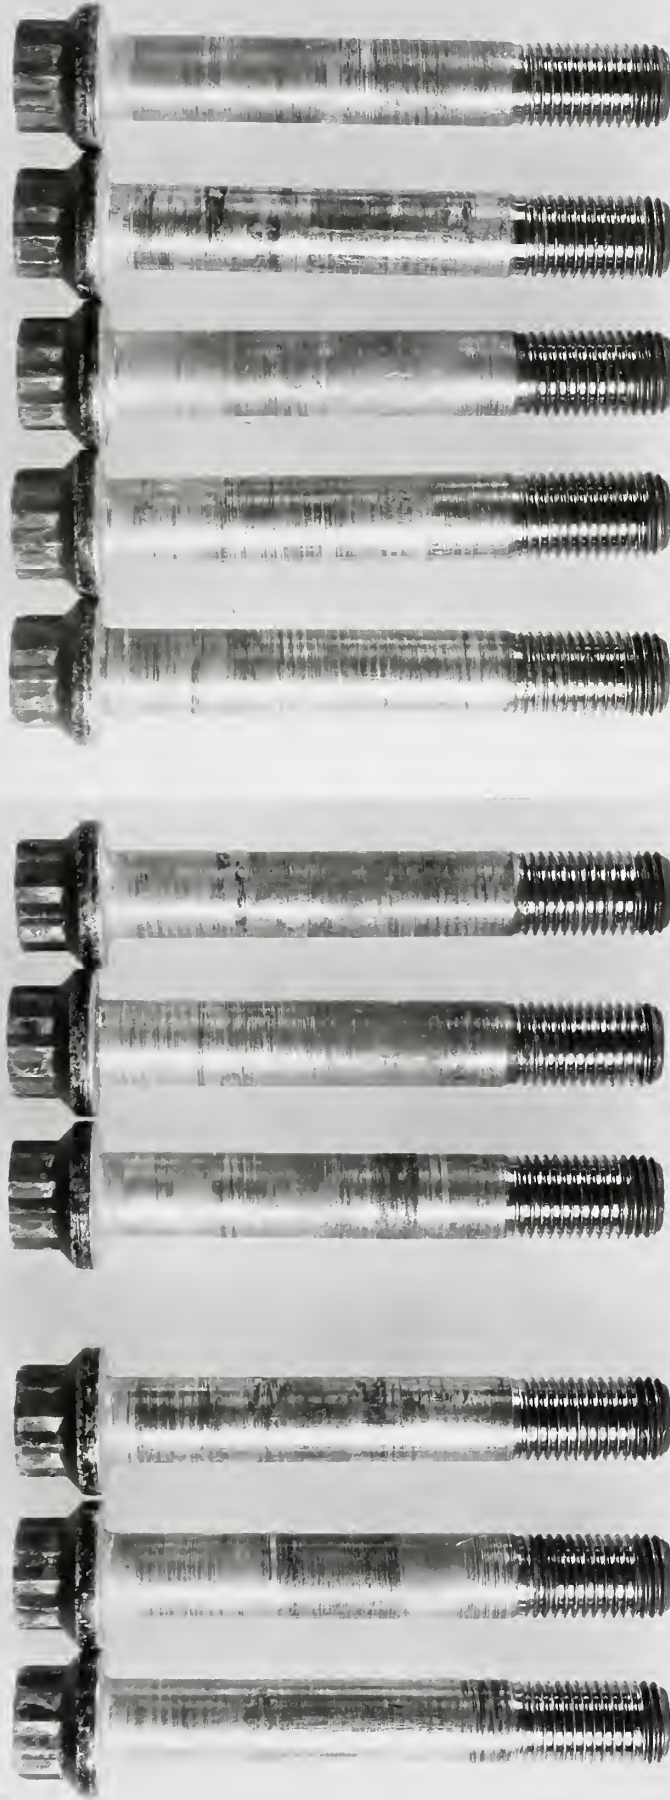
The eleven unbroken bolts that had been used in the higher torque condition are shown as received at NBS in figure 3. These bolts had suffered some circumferential mechanical damage, but in general, this damage was much less severe than that sustained by the unbroken bolts used in the normal torque condition.

Figure 3. Intact bolts used at the new higher torque as received.  
The bolts were in three groups, but neither the bolts  
nor the groups were identified. X 1

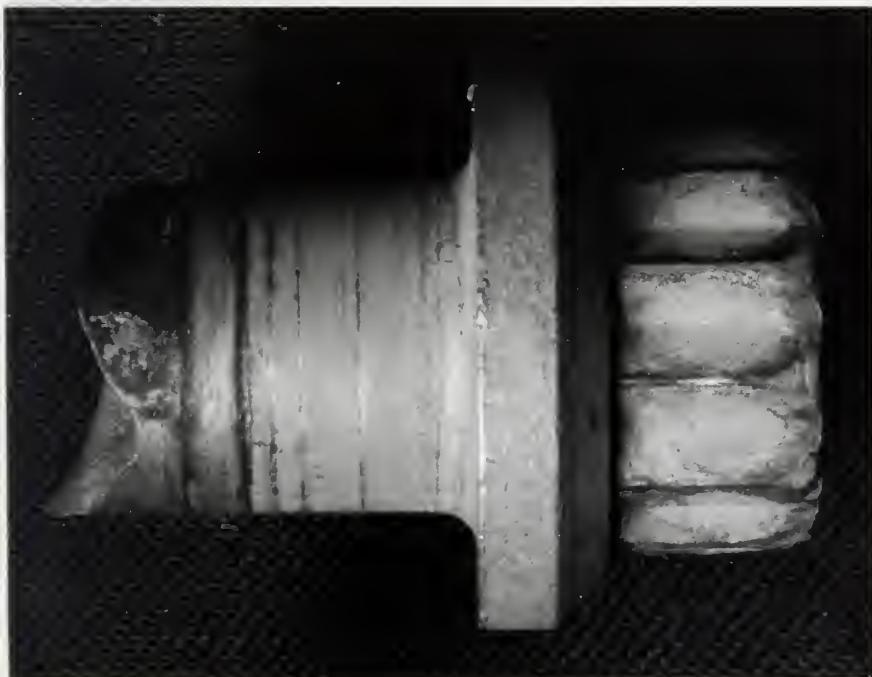
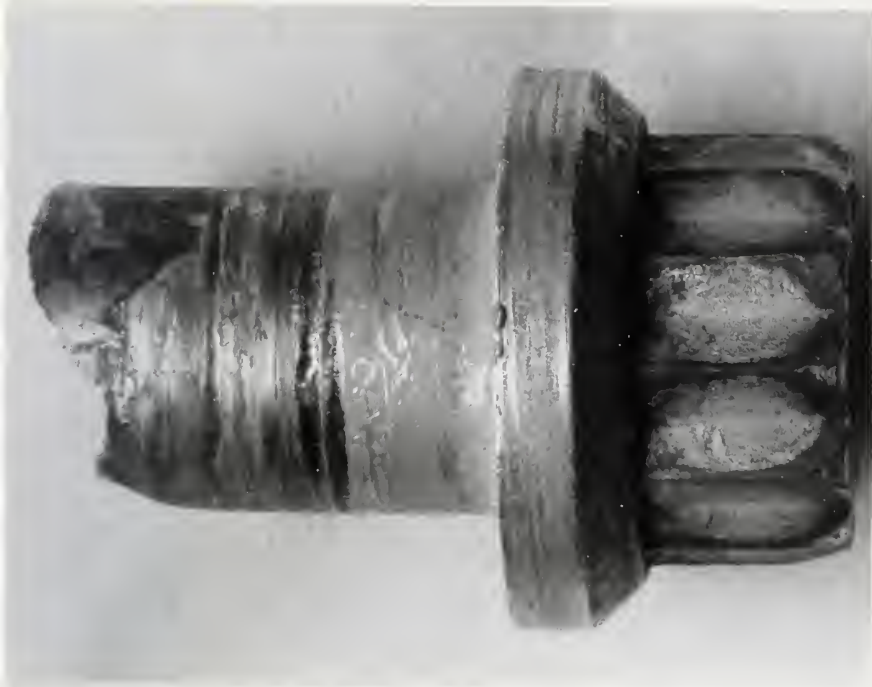
Fracture of the two failed cadmium plated steel bolts from pylon no. 3 occurred in the shank in each case and not in the threaded area. There was considerable mechanical damage - largely in the form of circumferential grooves - and what appeared to be fretting corrosion damage on the bolt shanks. The fracture cracks initiated in or adjacent to damaged areas. One view of each bolt shank is shown in figure 4. (The parts of the bolts not shown were lost at the time of failure and therefore were not available for examination.)

There was some deformation in the form of necking and bending near the fracture of the bolt shown in figure 4b. The change in the diameter of the bolt shank from 0.436 inch in the undeformed regions away from the fracture to 0.430 inch adjacent to the fracture gives an indication of the amount of necking.

Figure 4. Parts of the two fractured bolts from pylon no. 3. The circumferential mechanical and fretting damage can be seen. Deformation can be seen in the shank of the bolt shown in 4b. X 4

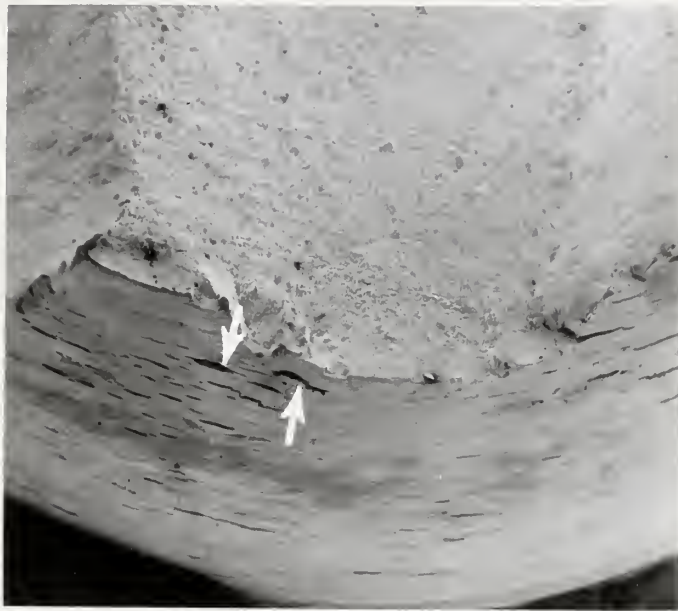
There were also a number of secondary cracks in this same bolt in the vicinity of, and essentially parallel to, the fracture. Two of these cracks are indicated by the arrows on the scanning electron photomicrograph shown in figure 5, and others can be seen in this same figure.

Figure 5. Scanning electron photomicrograph of bolt appearing in figure 4b. Several secondary cracks (arrows) appear in the shank surface, which is in the lower portion of the figure. Part of the fracture surface is shown in the upper portion of the figure. X 19

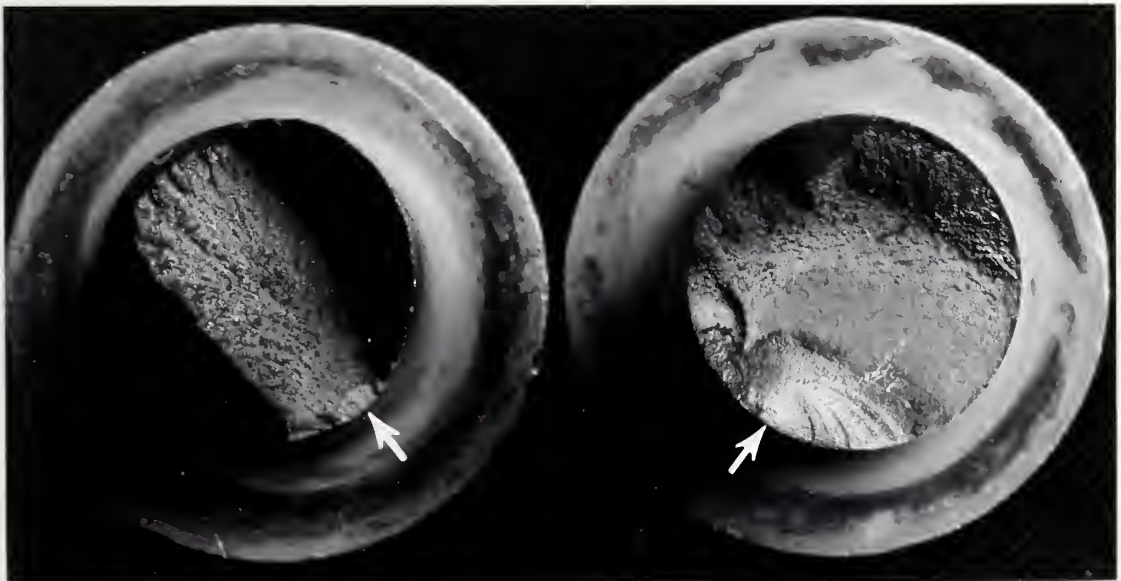
The fracture surfaces of the bolts shown in figure 4 appear in figure 6 - on the left is the bolt in figure 4a, and on the right is the bolt in figure 4b. Approximate locations of the crack origins are indicated by arrows in figure 6. These fracture surfaces were examined with the scanning electron microscope. The fracture cracks in both bolts appear to have propagated initially in fatigue. When the cross sections of the bolts had been reduced by the advancing fatigue cracks so that the applied load could no longer be sustained, the cracks propagated to fracture in ductile overload.

Figure 6. Fracture surfaces of the bolts shown in figure 4. The fracture surface on the left corresponds to the bolt shown in figure 4a. Arrows indicate the approximate locations of the crack origins. X 4

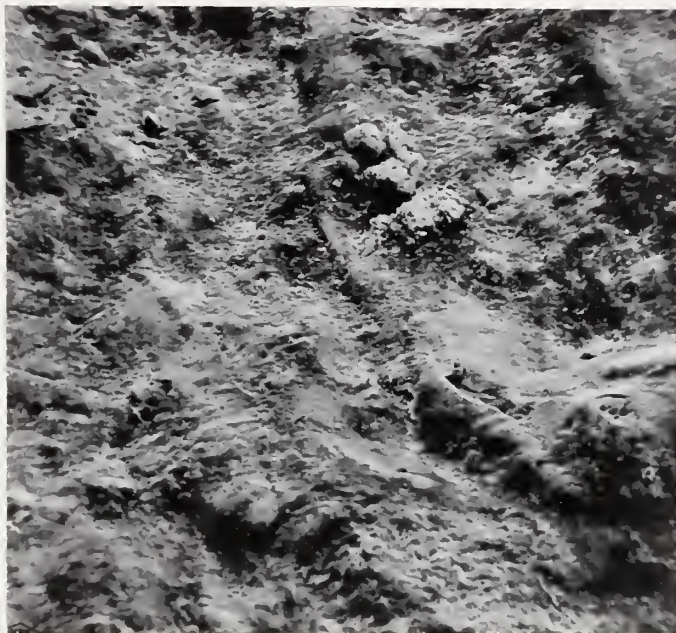
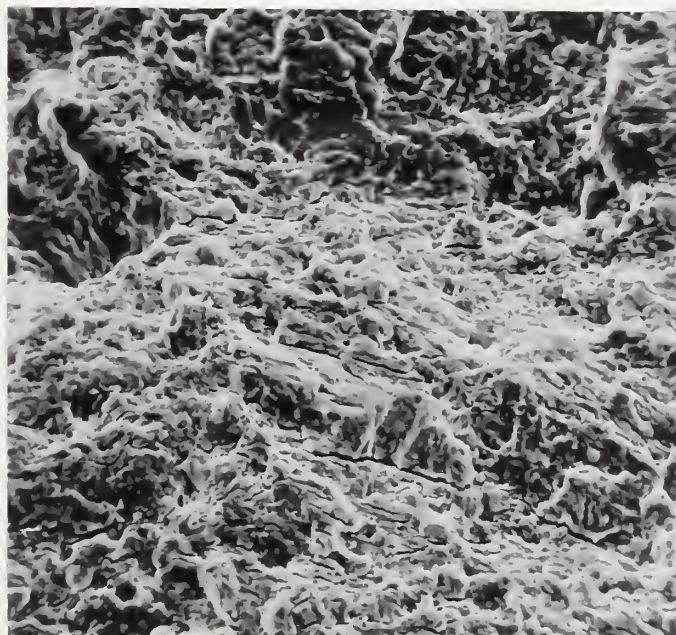
Representative scanning electron fractographs exhibiting fracture modes typical of the apparent fatigue portion of the fracture of the bolt shown in figure 4b appear in figure 7. A suggestion of fatigue striations appears in figure 7a. An area representative of the overload portions of the bolt fractures is shown in figure 8, where the primary fracture mode is dimpled rupture.

Figure 7. Scanning electron fractographs from the apparent fatigue portion of the fracture surface of the bolt shown in figure 4b. A suggestion of fatigue striations running from 1 o'clock to 7 o'clock appears in figure 7a.

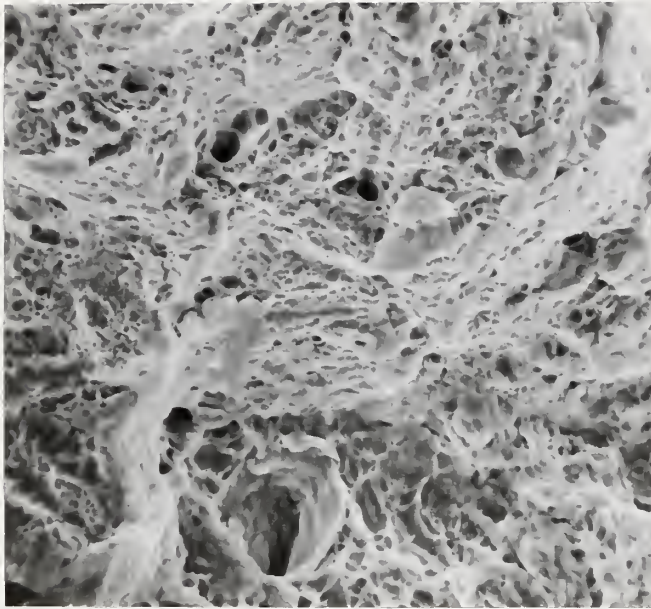
Figure 8. Scanning electron fractograph from the overload portion of the fracture of the bolt shown in figure 4b. The primary fracture mode is dimpled rupture.  
X 2000

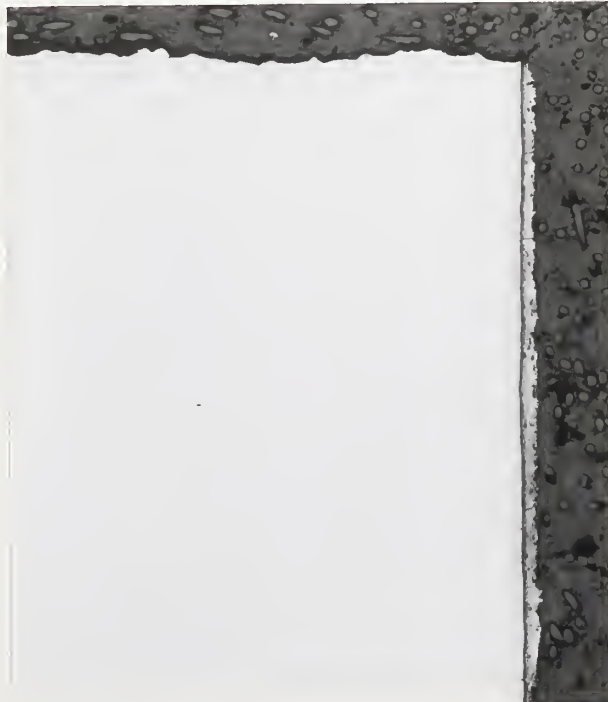
A longitudinal section intersecting the fracture was prepared for metallographic examination from the bolt exhibiting secondary cracks (bolt shown in figures 4b and 5). An as-polished field showing the fracture profile in the fatigue portion of the fracture appears in figure 9. The fracture profile is relatively smooth. The material appears to be quite clean and relatively free of inclusions.

Figure 9. As-polished longitudinal section from the bolt shown in figure 4b. The fracture profile in the fatigue portion of the fracture is horizontal at the top. The cadmium plating can be seen along the surface of the bolt shank vertically at the right.  
X 100

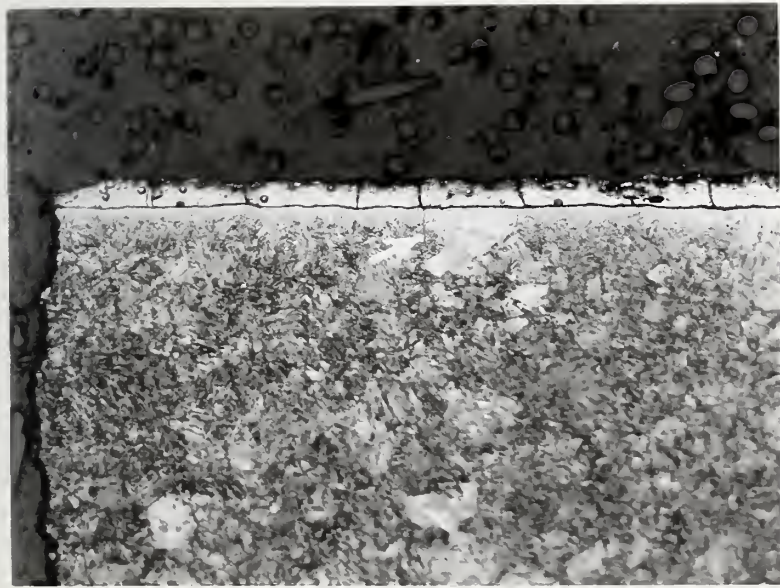
Part of the area shown in figure 9 appears at higher magnification in the etched condition in figure 10. (The specimen orientation is the same in both figures 9 and 10.) The microstructure consists primarily of tempered martensite. Several transverse cracks can be seen in the cadmium plating, and one crack (arrow) can be seen in the basis steel material. In figure 11, two more cracks in the basis steel are shown where there are no cracks in the cadmium plating. Indeed, the cadmium plating had substantially filled the cracks. The cracks shown in figure 11 are about 2 mm from the fracture.

Figure 10. Part of the area shown in figure 9. The microstructure consists primarily of tempered martensite. The crack in the steel (arrow) is thought not to be associated with the crack in the cadmium plating. Several other cracks can be seen in the plating.  
Etchant: 4% picral X 200

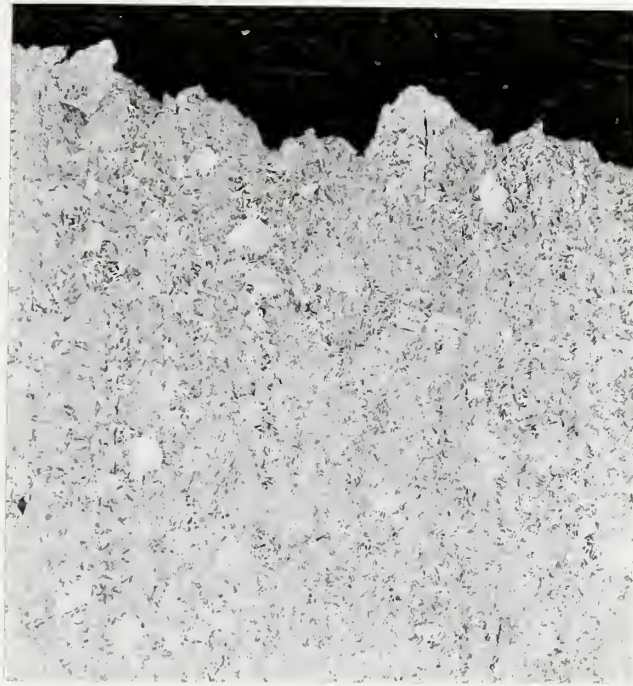
The fracture profile in the overload portion of the fracture from the same bolt is shown in figure 12. The fracture is horizontal at the top of the figure. The rougher, more jagged appearance of the overload fracture profile - where the fracture mode is dimpled rupture - is contrasted with the relatively smooth appearance of the fracture profile in the fatigue portion of the fracture as shown in figures 9 and 10.

Figure 12. Etched longitudinal section from the bolt shown in figure 4b. The fracture profile in the overload portion of the fracture is horizontal at the top.  
Etchant: 4% picral X 100

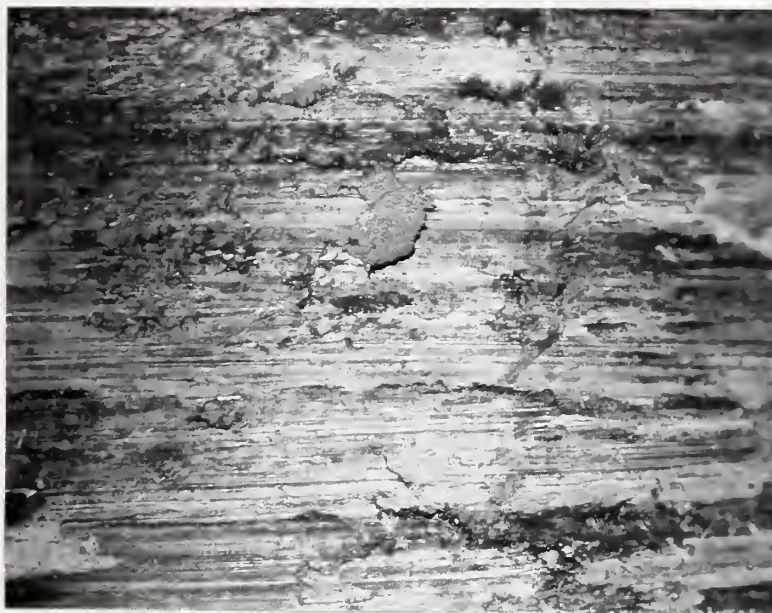
Figure 13. Part of the shank of one of the unbroken bolts from the LQ-2 group showing the mechanical damage and an area where the cadmium plating is missing. X 16

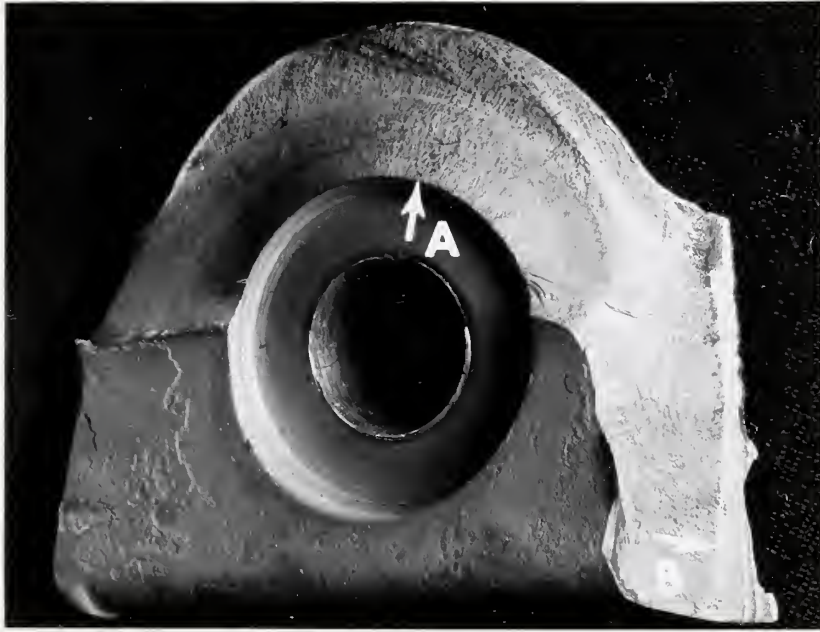
Both the forward and aft lugs from pylons number 2 and 4 were received and examined. Only the aft lugs from pylons 1 and 3 were received. There were complete fractures in the aft lugs from pylons 3 and 4. These fracture surfaces are shown in figures 14 and 15, respectively. In both cases, the fracture cracks appear to have started (arrows A) at the edge of the flat area where the bolt head would seat. A secondary fatigue crack (arrow B) can also be seen in figure 14.

Figure 14. Separated piece from the aft spar subassembly lug from pylon no. 3 showing the fracture surface. Arrow A indicates the approximate location of the crack origin. Arrow B indicates a secondary fatigue crack. X 2

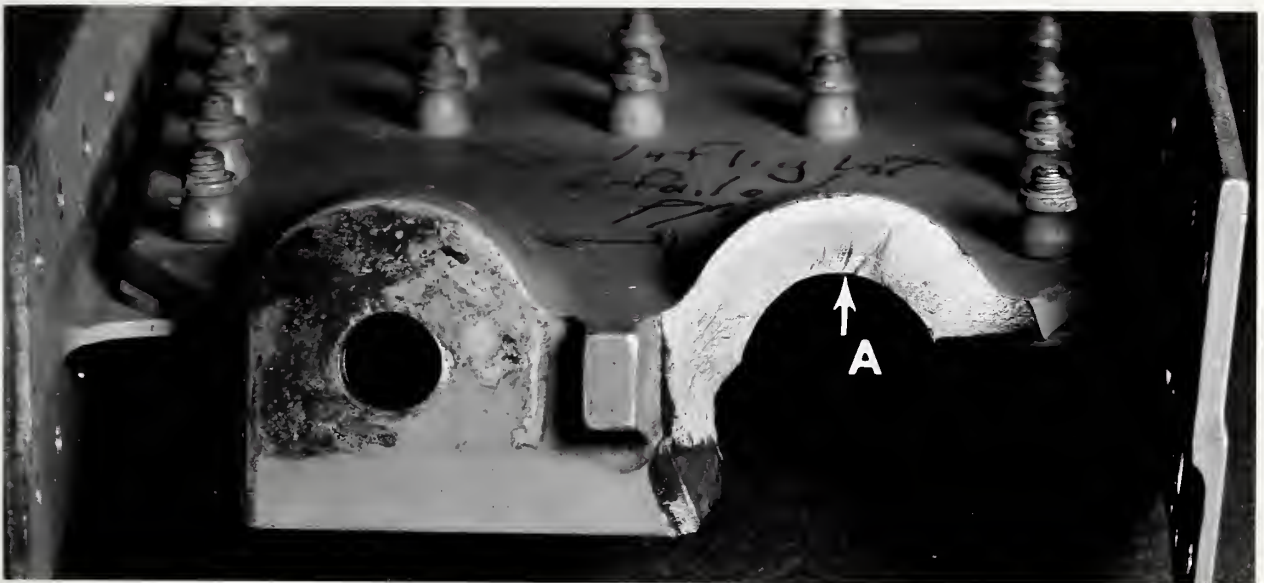
Figure 15. Aft spar subassembly lug from pylon no. 4 showing the fracture surface. Arrow A indicates the approximate location of the crack origin. X 1

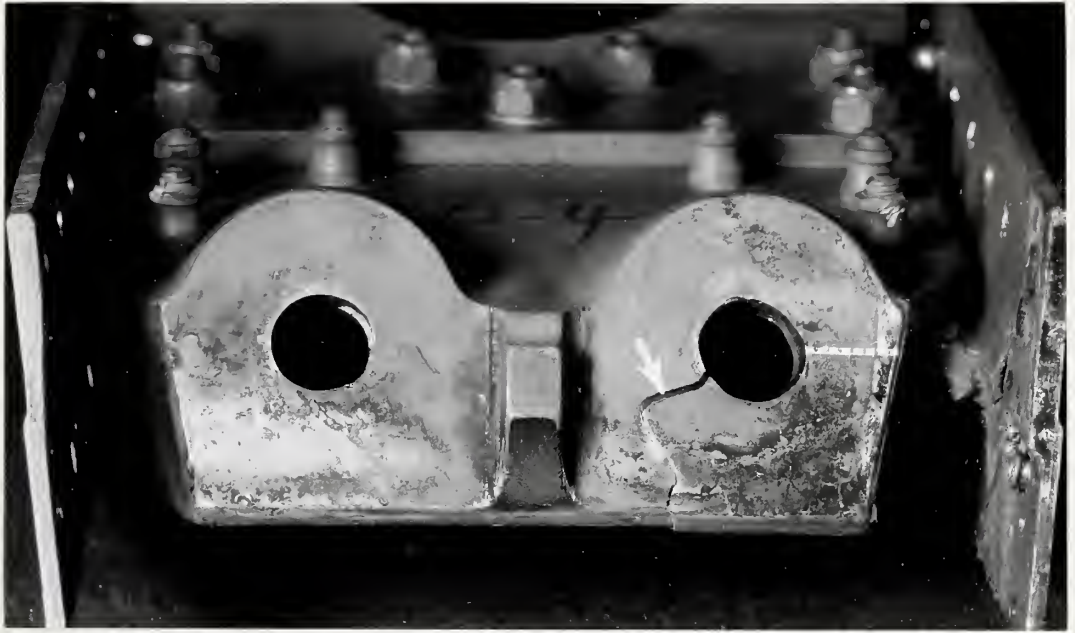
A large crack was also found in the forward lug from pylon no. 4 as shown in figure 16. This crack had traversed the entire distance between the hole and the outside of the lug on one side. This crack was opened by a saw-cut in the approximate location of the dotted line in figure 16. The exposed fracture surface is shown in figure 17. This crack initiated at the edge of the bolt hole at the bottom

Figure 16. Forward spar subassembly lug from pylon no. 4. Arrow indicates crack. A saw-cut was made at the approximate location of the dotted line in order to expose the fracture surface. X 1

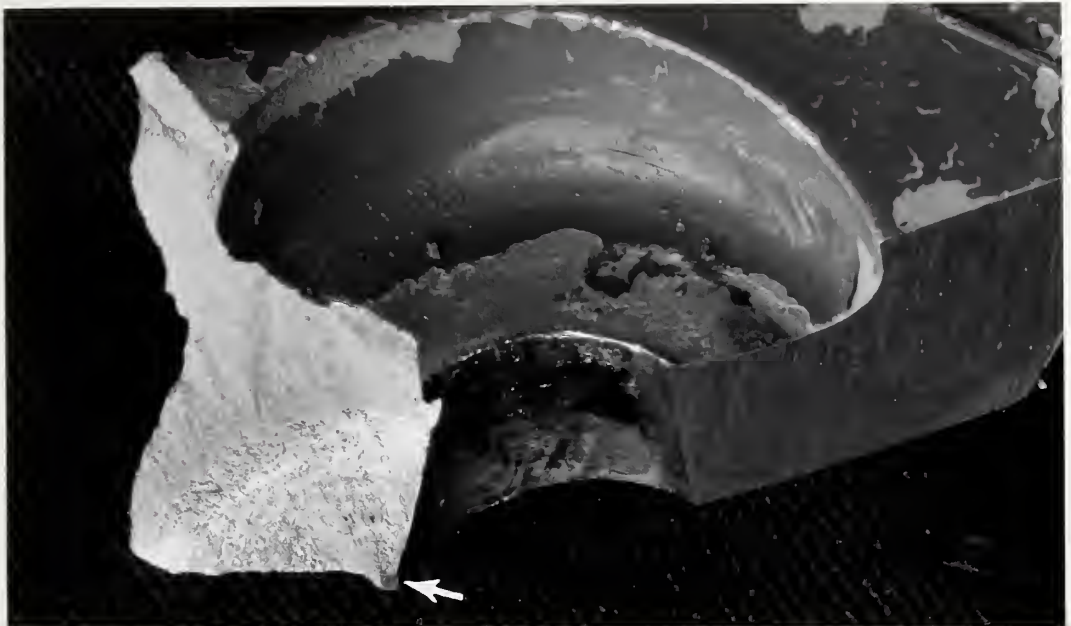
of the lug as indicated by the arrow in figure 17. The other spar subassembly lugs were examined macroscopically for cracks and none were found. The surfaces of many of the holes in the lugs exhibited evidence of mechanical and fretting corrosion damage. The surfaces of the two bolt holes in the forward lug from pylon no. 4 appeared to have suffered more damage than the surfaces of the holes in the other submitted lugs. Part of the surface of the bolt hole intersected by the fracture (hole on the right in figure 16) is shown in figure 18. This same lug was sectioned through the other bolt hole, and part of the surface of that hole is shown in figure 19. There appeared to be cracks in the surface (arrows, figure 19).

Figure 17. Part of the lug shown in figure 16 after being cut out. The fracture surface is at the left. The arrow indicates the approximate location of the point of crack initiation. X 4

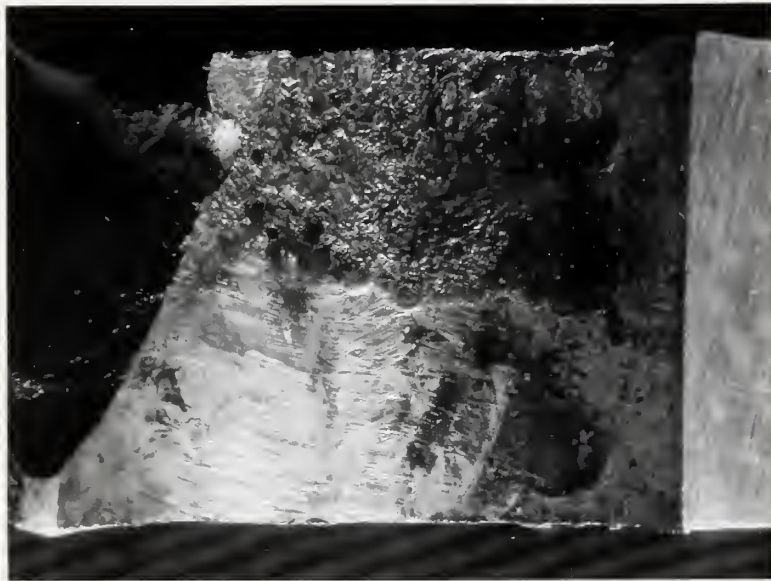
Figure 18. The bolt hole surface of the part of the lug shown in figure 17 is in the center of the photograph. The fretted and mechanically damaged surface can be seen. Part of the fracture surface is at the far left. A saw-cut surface is at the right. X 8

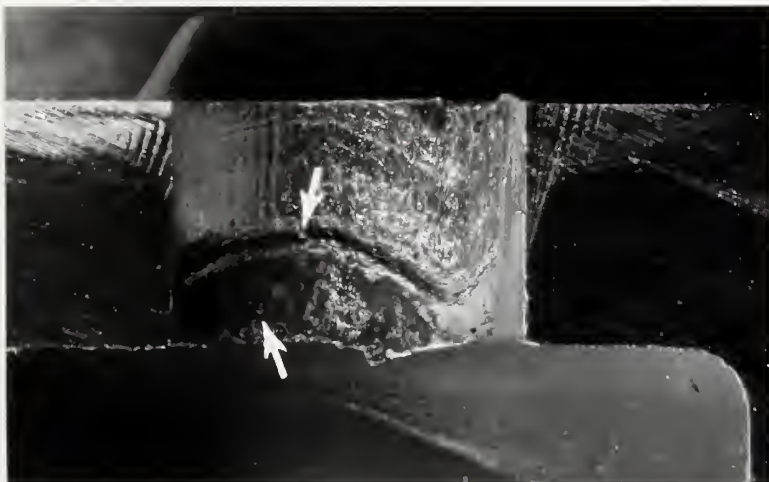
Figure 19. Part of the surface of the other bolt hole from the forward lug from pylon no. 4. This is the left bolt hole in figure 16. The damaged surface can be seen. Arrows indicate two apparent cracks. X 4

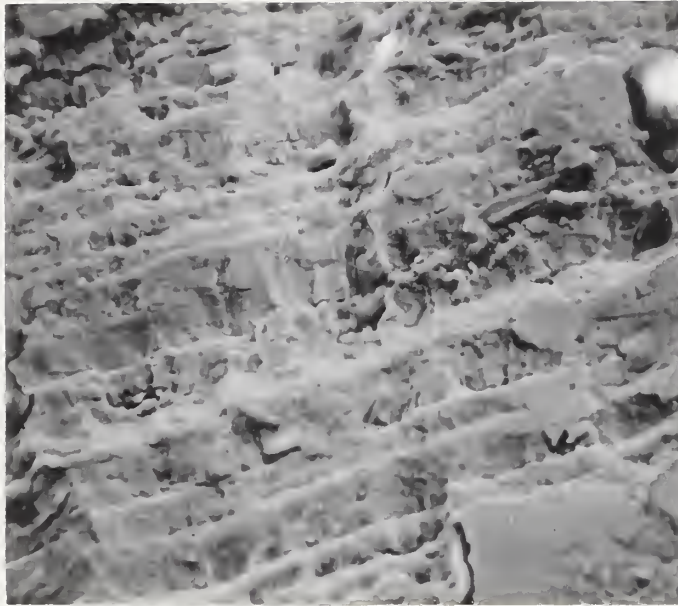
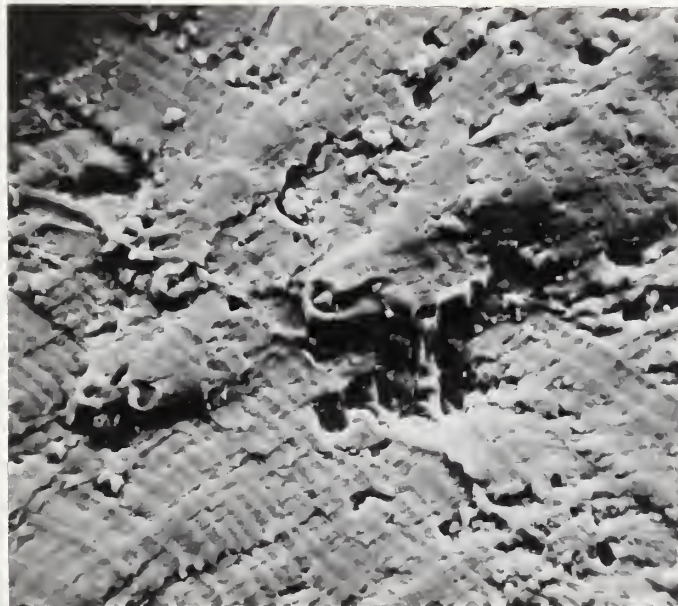
fracture in the lug from pylon no. 3 are shown in figures 20 and 21. There is evidence of fatigue striations in each of these figures. A representative fractograph from the overload portion of one of the lug fractures from pylon no. 4 is shown in figure 22. The mode of fracture in the overload portion of the fractures appears to be dimpled rupture.

Figure 20. Scanning electron fractograph from the fatigue portion of the fracture through the aft spar subassembly lug from pylon no. 3. Fatigue striations are evident. X 470

Figure 21. Scanning electron fractograph from the fatigue portion of the fracture through the aft spar subassembly lug from pylon no. 3. Fatigue striations are evident. This fractograph was taken in a different area than that shown in figure 20. X 540

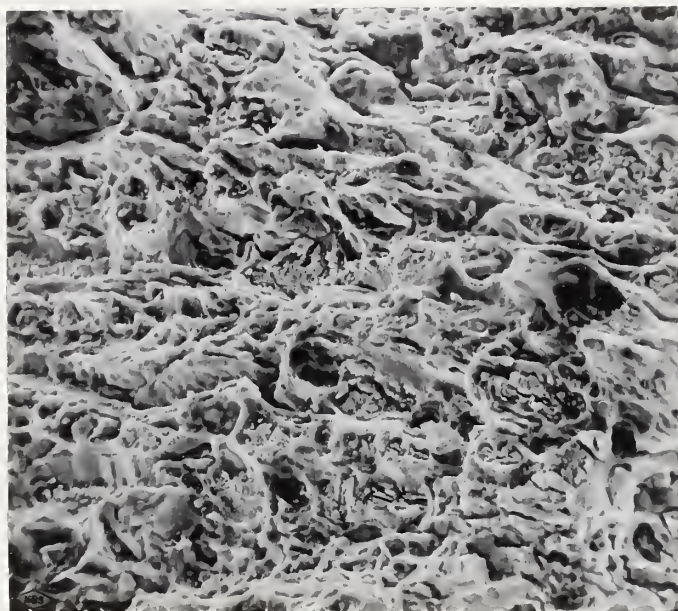
Figure 22. Scanning electron fractograph from the overload portion of the fracture through the forward spar subassembly lug from pylon no. 4. X 440

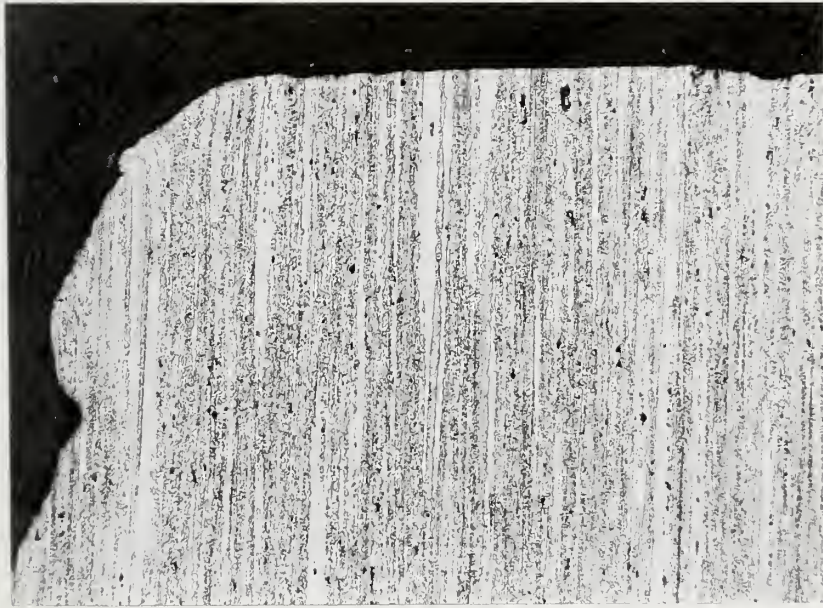
Figure 24. Etched section through the aft spar subassembly lug from pylon no. 3 showing the fatigue portion of the fracture. The fracture profile is vertical at the right.  
Etchant: 10% NaOH X 100

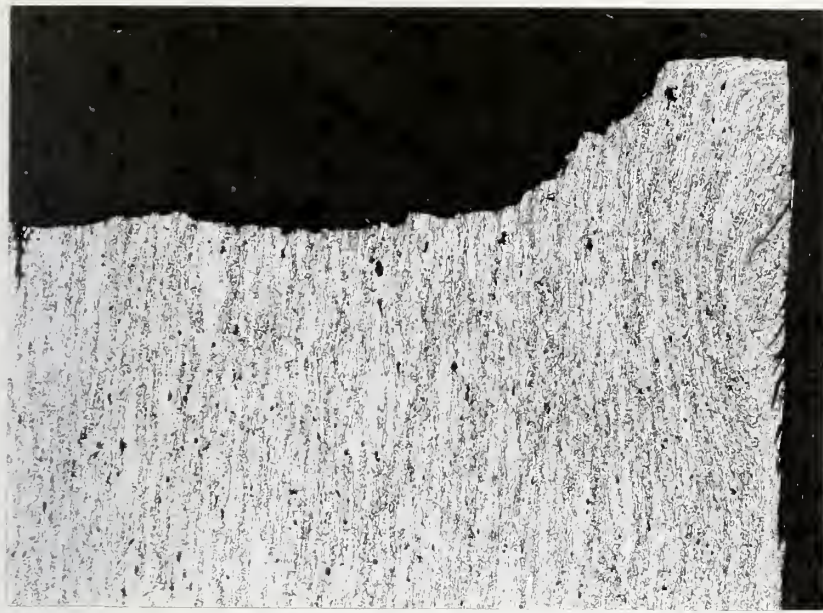
Figure 25. Etched section through the aft spar subassembly lug from pylon no. 3 showing the fracture profile in the overload portion of the fracture. The fracture profile is vertical at the right.  
Etchant: 10% NaOH X 100

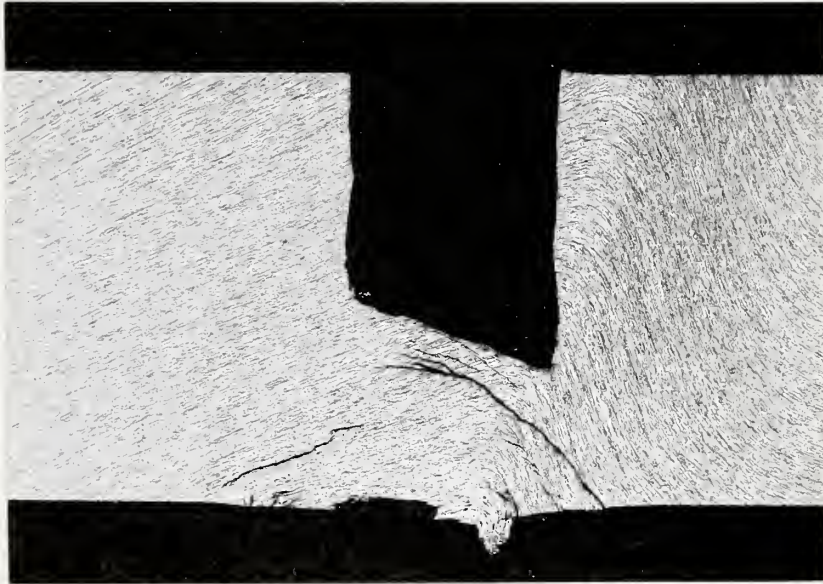
A section was taken through the intact hole in the forward lug from pylon no. 4 parallel to the longitudinal axis of the hole. This is the hole where apparent cracks could be seen in the hole surface (figure 19). When this section was polished, several cracks were revealed (figure 26). In some areas, they tend to follow forging flow lines.

In addition to the partial fatigue fracture at one bolt hole in the forward lug from pylon no. 4, there were a number of cracks in the vicinity of the other bolt hole. These cracks looked similar to those that can form from cavities that develop at the time of solidification (2). Such cracks can remain in the material through the forging process.

Figure 26. Etched section through the intact hole in the forward spar subassembly lug from pylon no. 4 revealing several cracks.  
Etchant: 10% NaOH
