# Investigation of Construction Failure of Harbour Cay Condominium in Cocoa Beach, Florida

September 1981

H. W. Lew  
N. J. Carino  
S. G. Fattal  
M. E. Batts

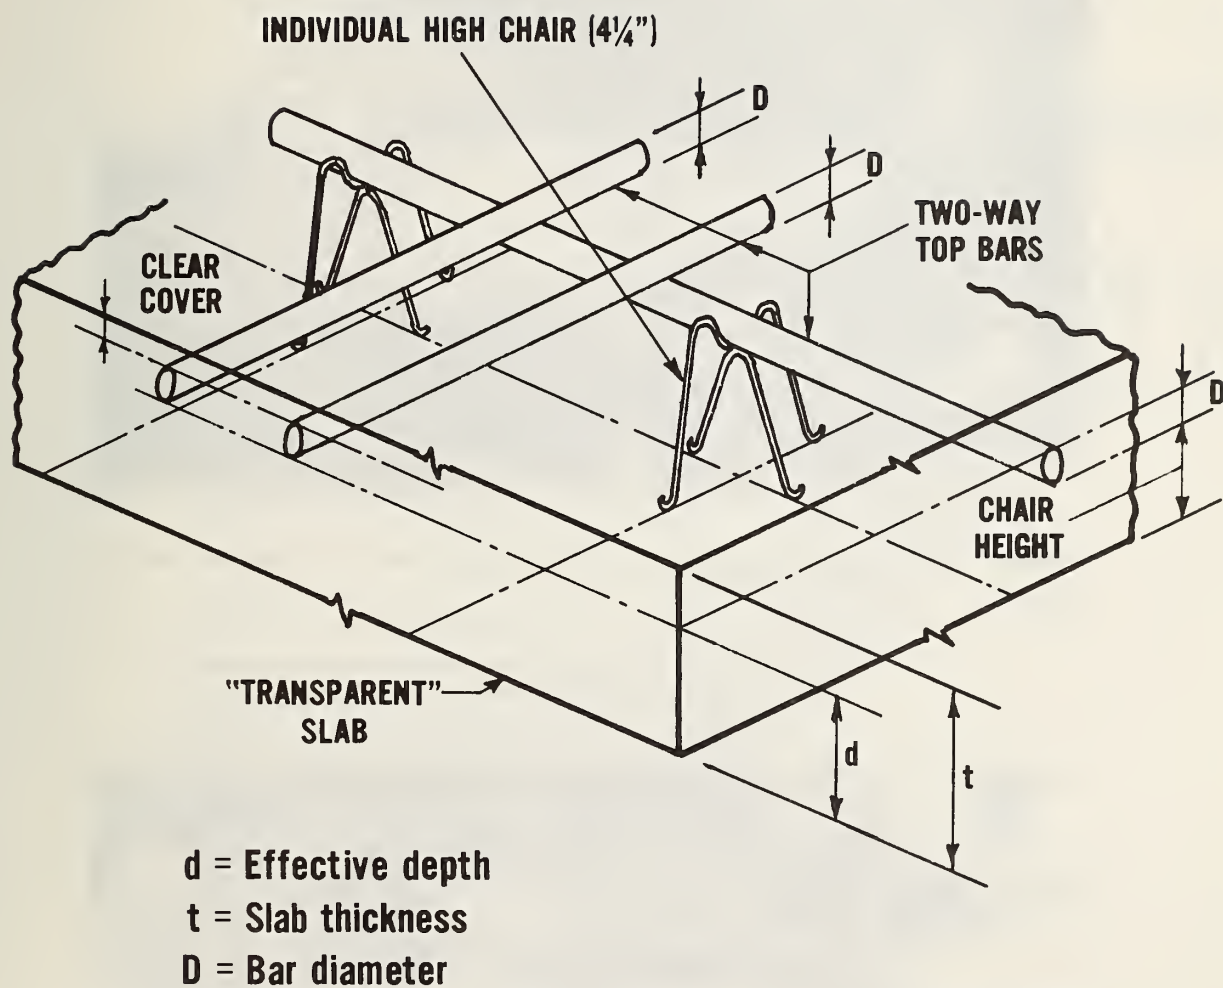
The calculated effective depth at a column where the top reinforcement in the slab consists of #8 and #9 bars is 5.3 in (135 mm). This is obtained by adding to the 4-1/4-in (108-mm) chair height the average diameter of the two bars. If the effective depth is taken to the centroid of the bars, as defined in section 2.1 of the ACI Code [2.1], its value would be 5.28 in (134 mm) or 5.35 in (136 mm) depending on which size bar is assumed to be at the top. Considering all the columns and using both methods of calculation, the effective depth is found to fall in the range of 4.97 to 5.35 in (126 to 136 mm). These figures will be somewhat less along the sides of columns at the edges of balcony and walkway

Figure 2.3 Configuration of chairs and top reinforcement in column strip

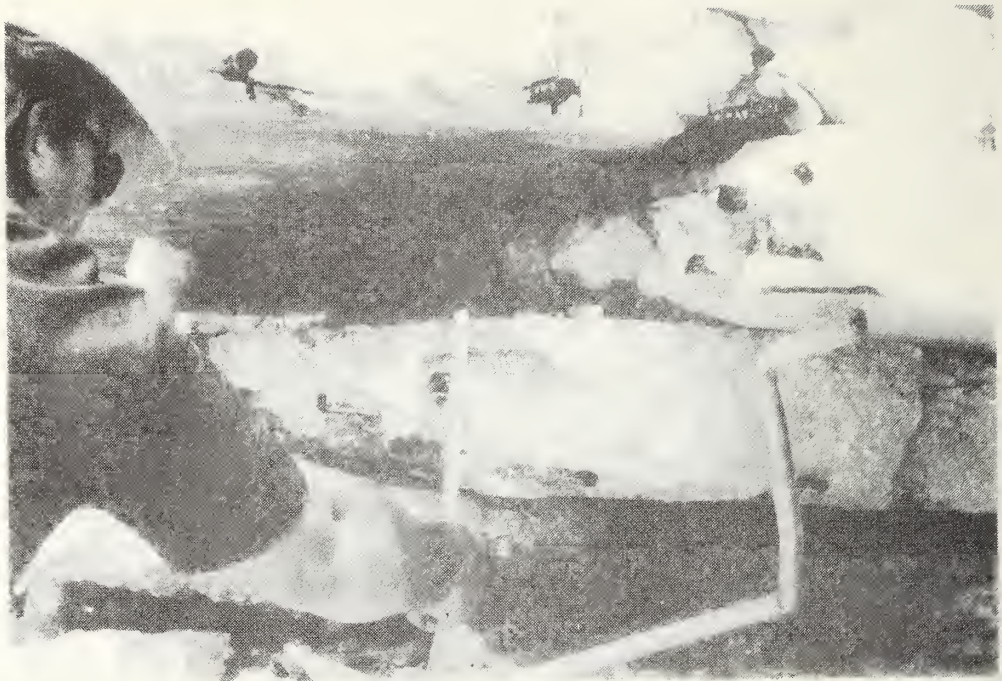
There is, therefore, an inconsistency in the construction documents. The structural drawings indicated a 3/4-in (19-mm) cover for the top slab bars, whereas the chair height indicated on the steel supplier's shop drawings would result in more than 3/4-in cover for the top bars in the column strips of the slabs. The record copies of the shop drawings contained numerous check marks. One of the six pages bore the handwritten words "approved as noted" and the signature of the design engineer of record.

Figure 2.4 Field measurement of top bar cover in column strip

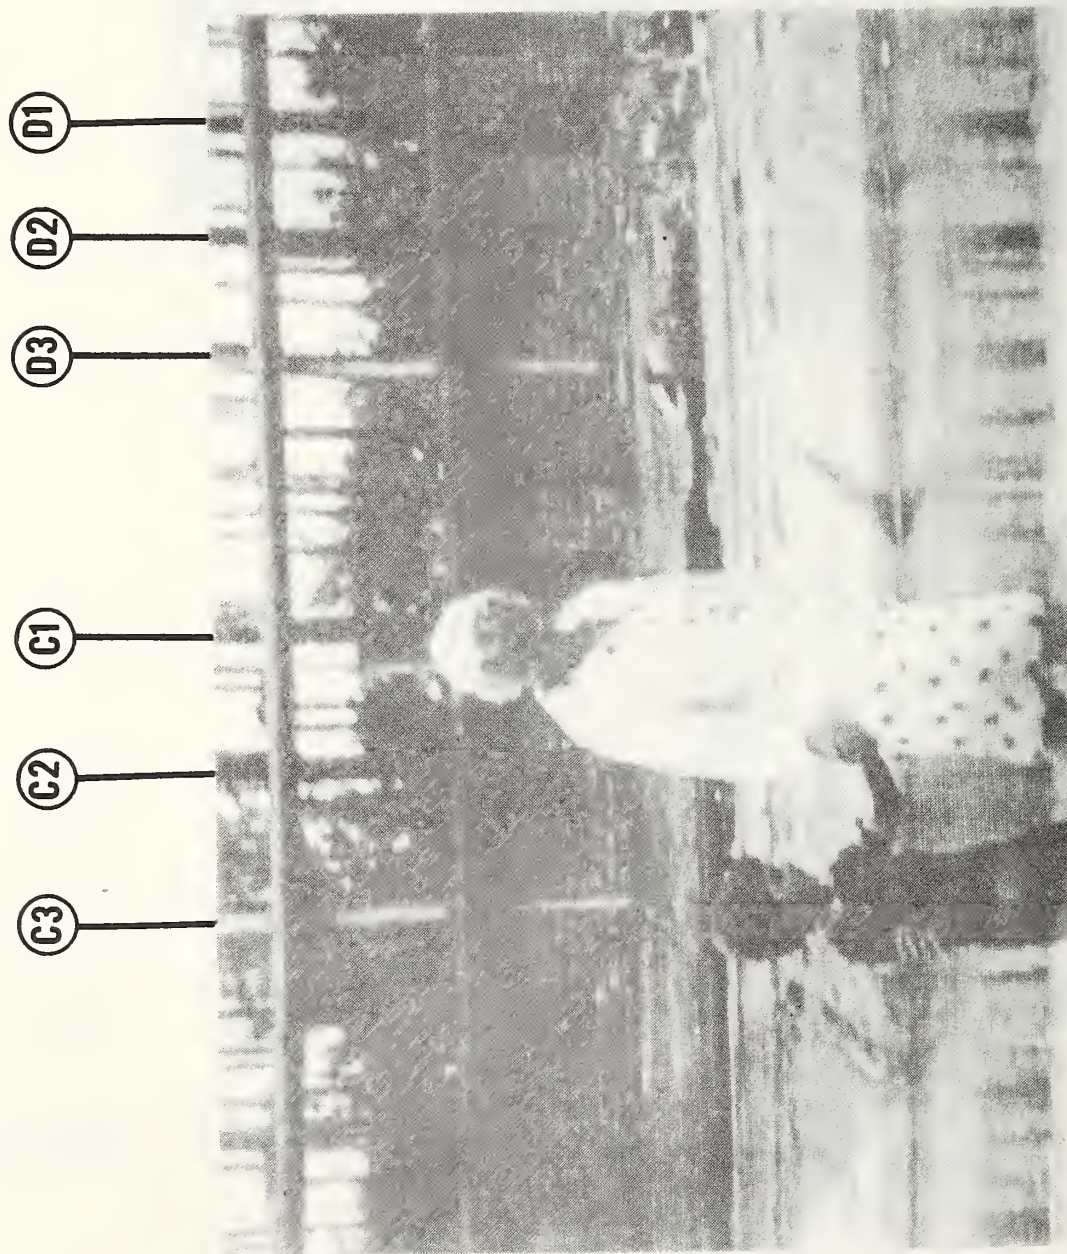
Figure 2.13 Partial view of bay CD from east side of building

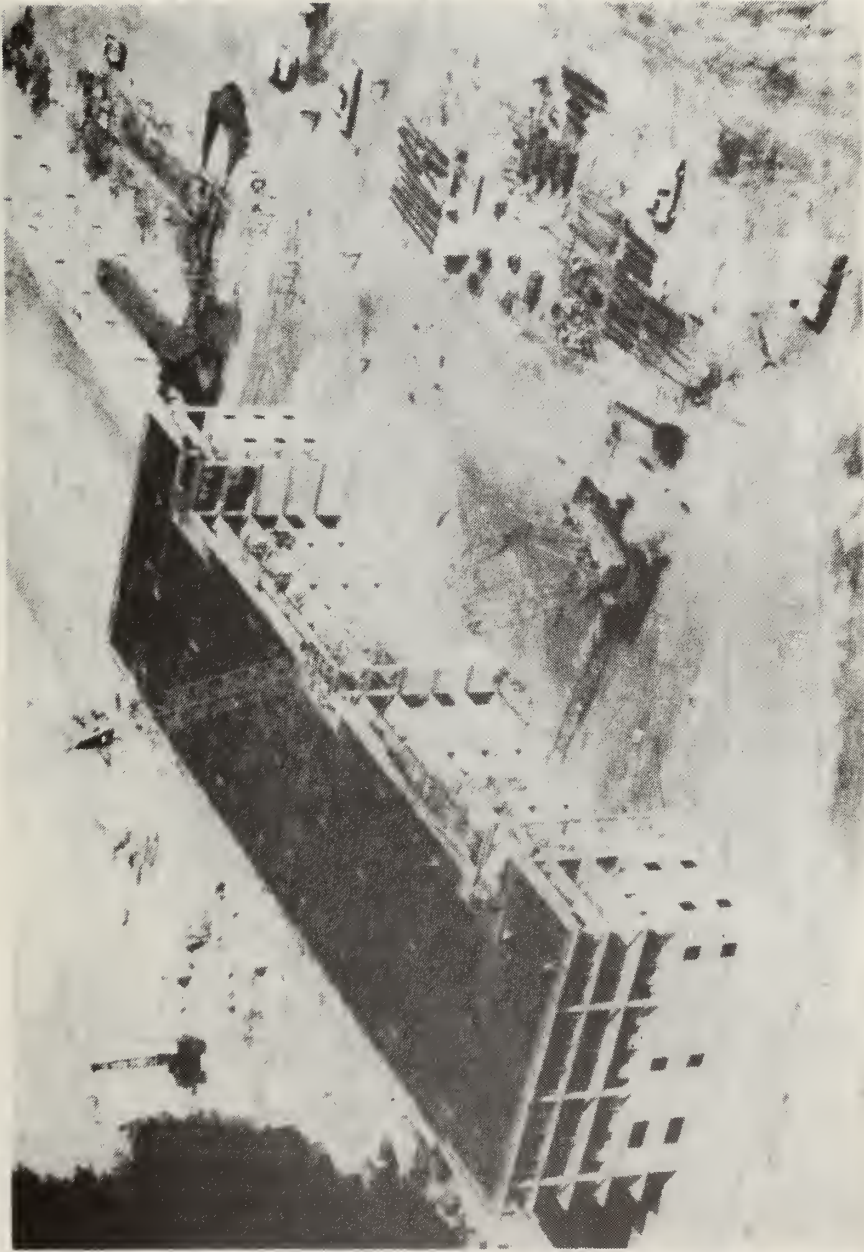
Figure 2.14 is an aerial photograph of the building viewed from the southeast side. The direction of the shadows and the presence of the steel reinforcement for the roof slab indicate the photograph to have been taken on the morning of March 26, or the day before the collapse. The steep angle of the photograph conceals the view of interior reshores in the fourth story and below. It is noted that at the south end only one exterior reshore is in place in each bay of the fourth story while no reshores are in place at the same location in the third story. This contradicts the reshoring plans supplied by the general contractor where two reshores are shown in each bay along the exterior edges of the slabs. It is possible that some of the original reshores were removed to place masonry units in the third floor, as indicated by worker statements.

Figure 2.14 Aerial view of building taken from southeast

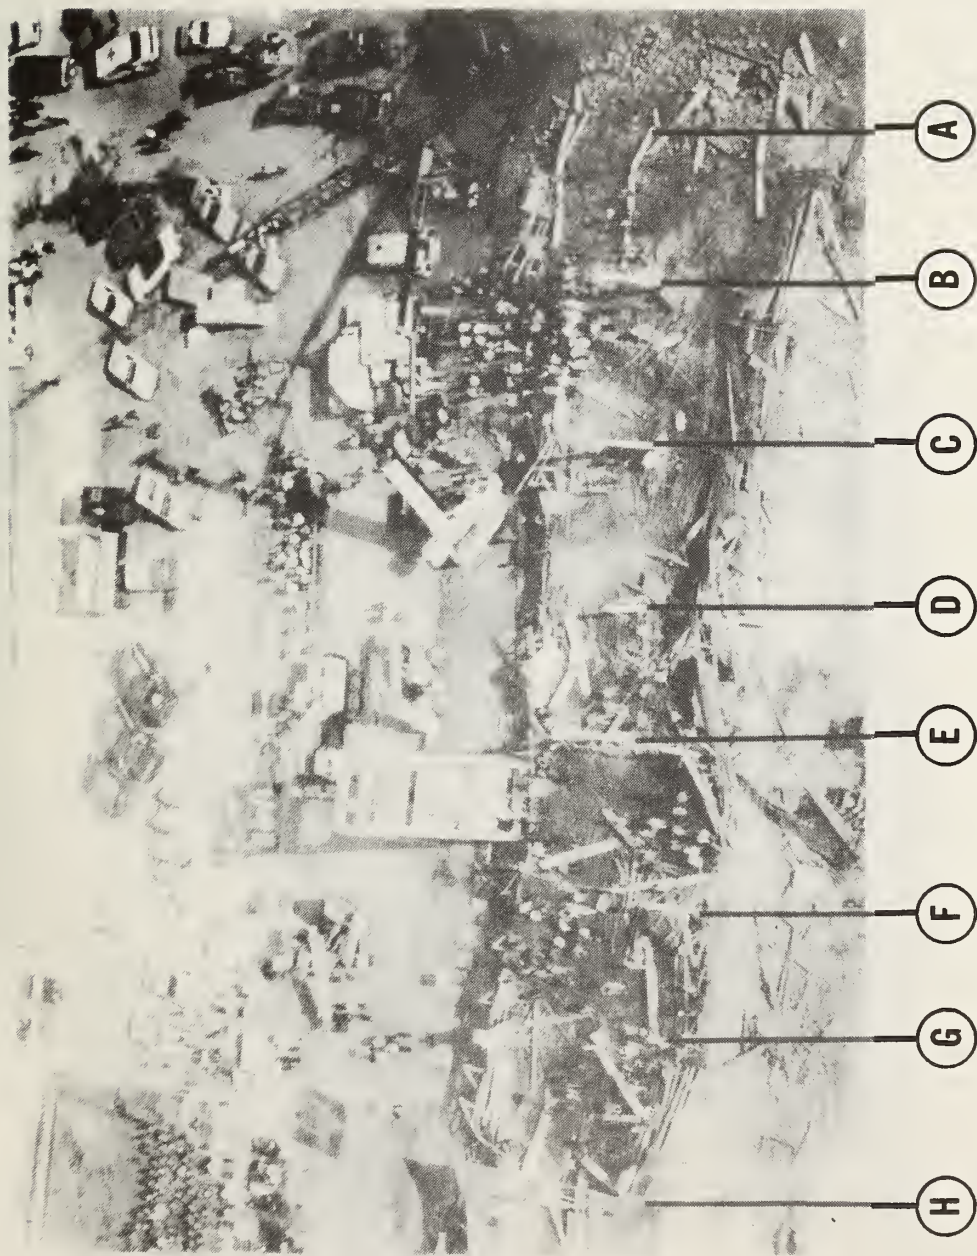
Figure 2.16 General view of wreckage after the collapse

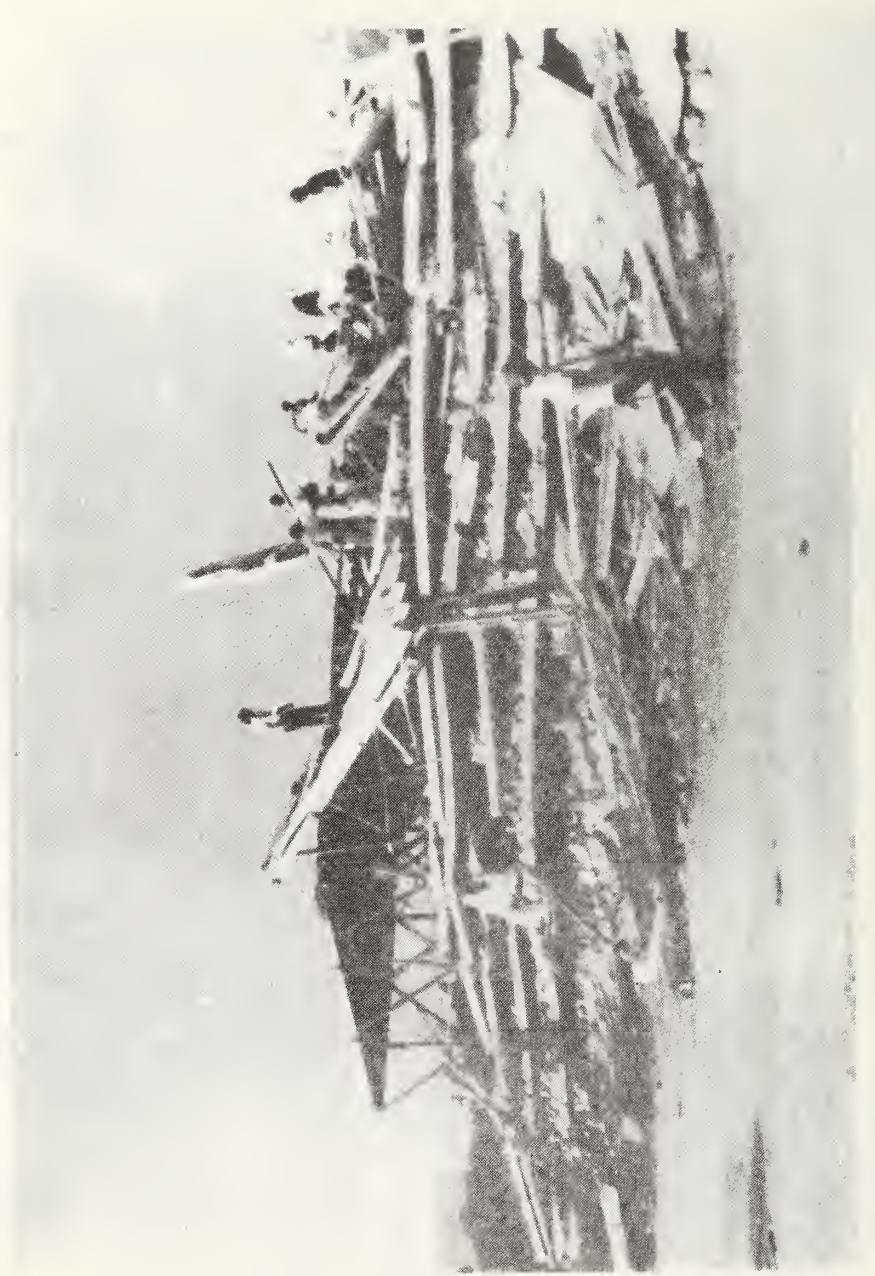
Figure 2.17 View of debris at north end of building after the collapse

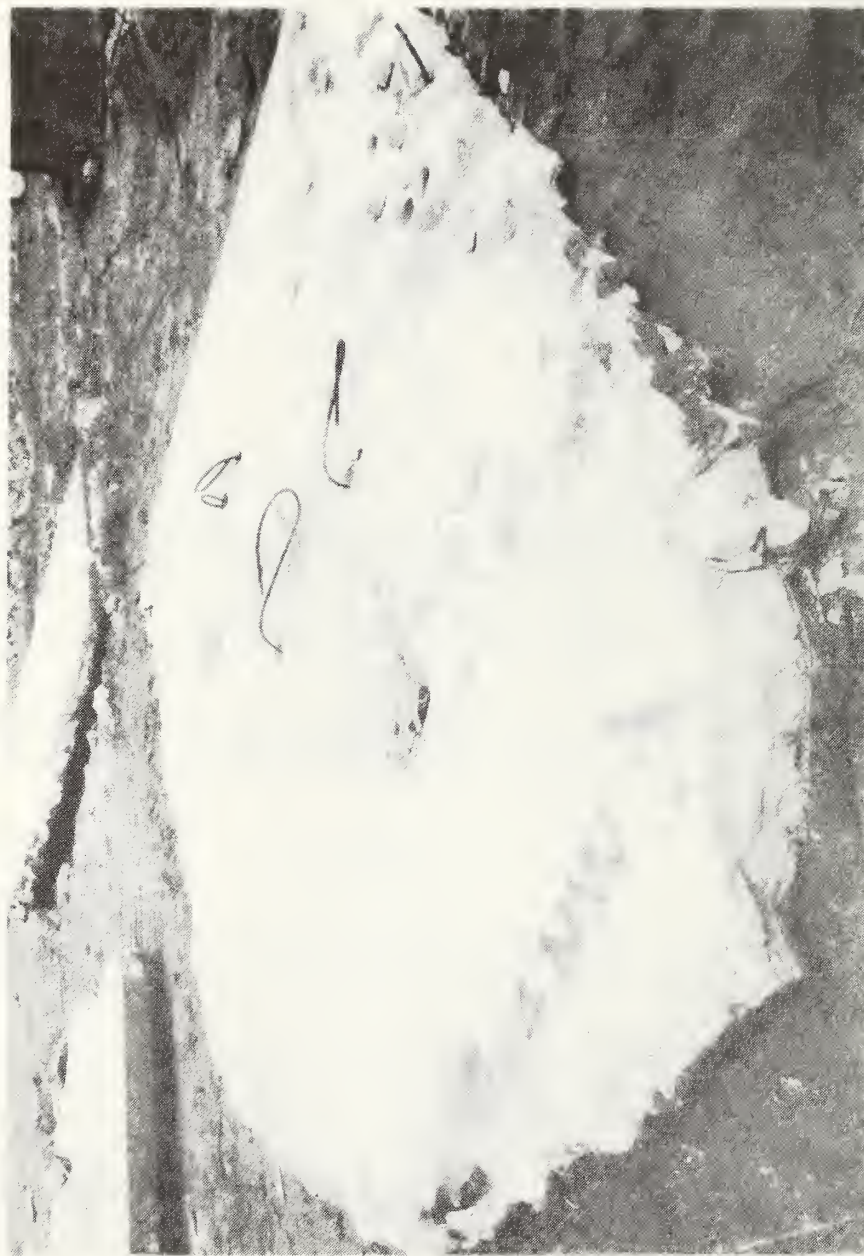
Figure 3.1 An identified portion of slab removed from the north-west section of the fourth floor

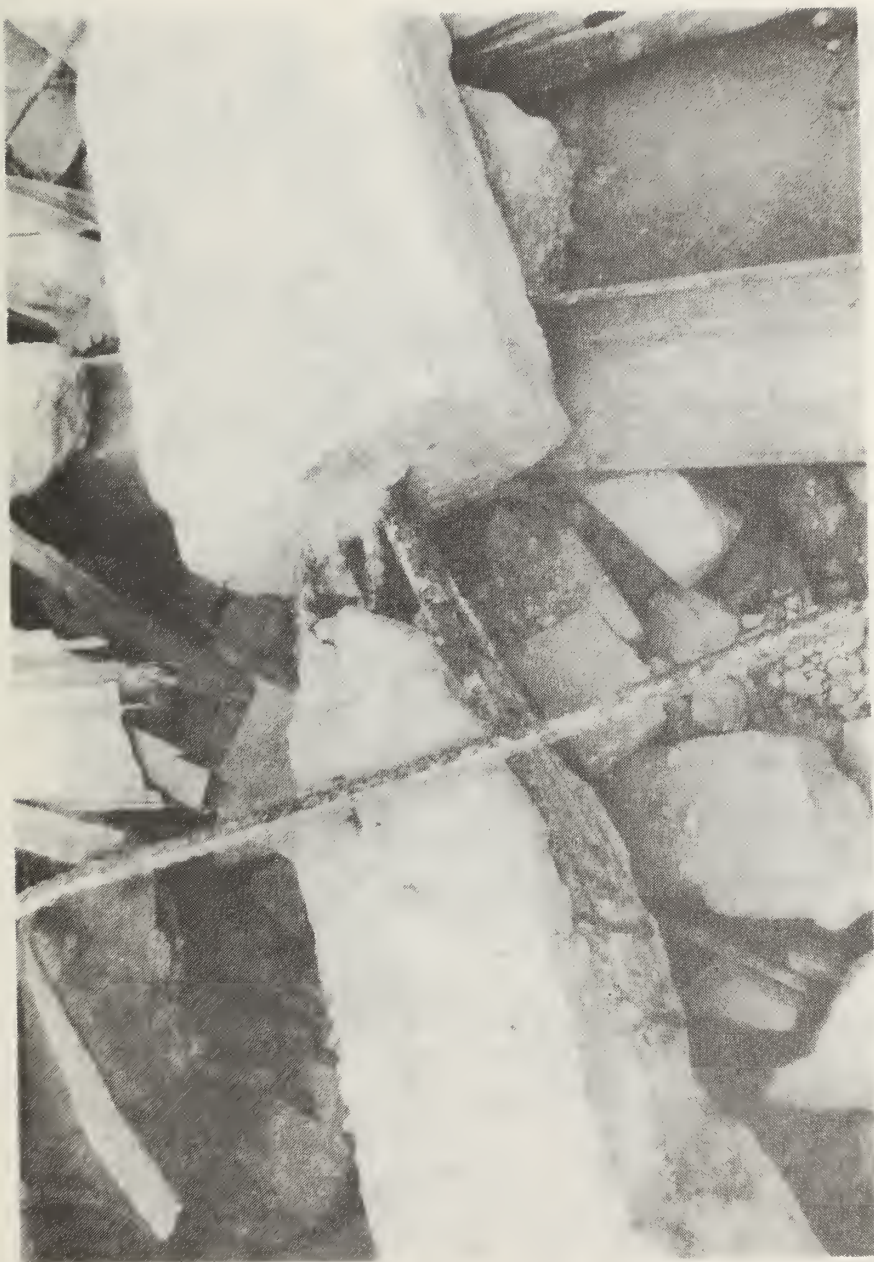
1. The slabs broke away from the columns at the slab-column interface (figure 3.2).
2. One or two bottom slab bars were placed through some columns. In many other columns no such evidence was noted.
3. In some cases, the vertical reinforcement above the floor level was bent severely during fabrication (figure 3.2).
4. Column size measurements agreed with the structural drawings.

Three workers (#40, #45, #73) mentioned that the construction joints at the middle of the building were not of good quality. They were described as "ragged", "cracked", and "honeycombed". Two workers (#45, #14) mentioned that they saw rebars showing on the faces of some columns. The incomplete filling of the column forms was probably due to congestion of steel (see figure 3.3), which, according to a supervisor (#72) was so severe in some of the second and third floor columns that the top reinforcing steel in the slabs could not pass through. In order to pass slab bars through some columns, the protruding column reinforcement was "bunched together" and the slab bars were placed alongside the column bars (figure 3.2).

Figure 3.2 Severely bent column reinforcement

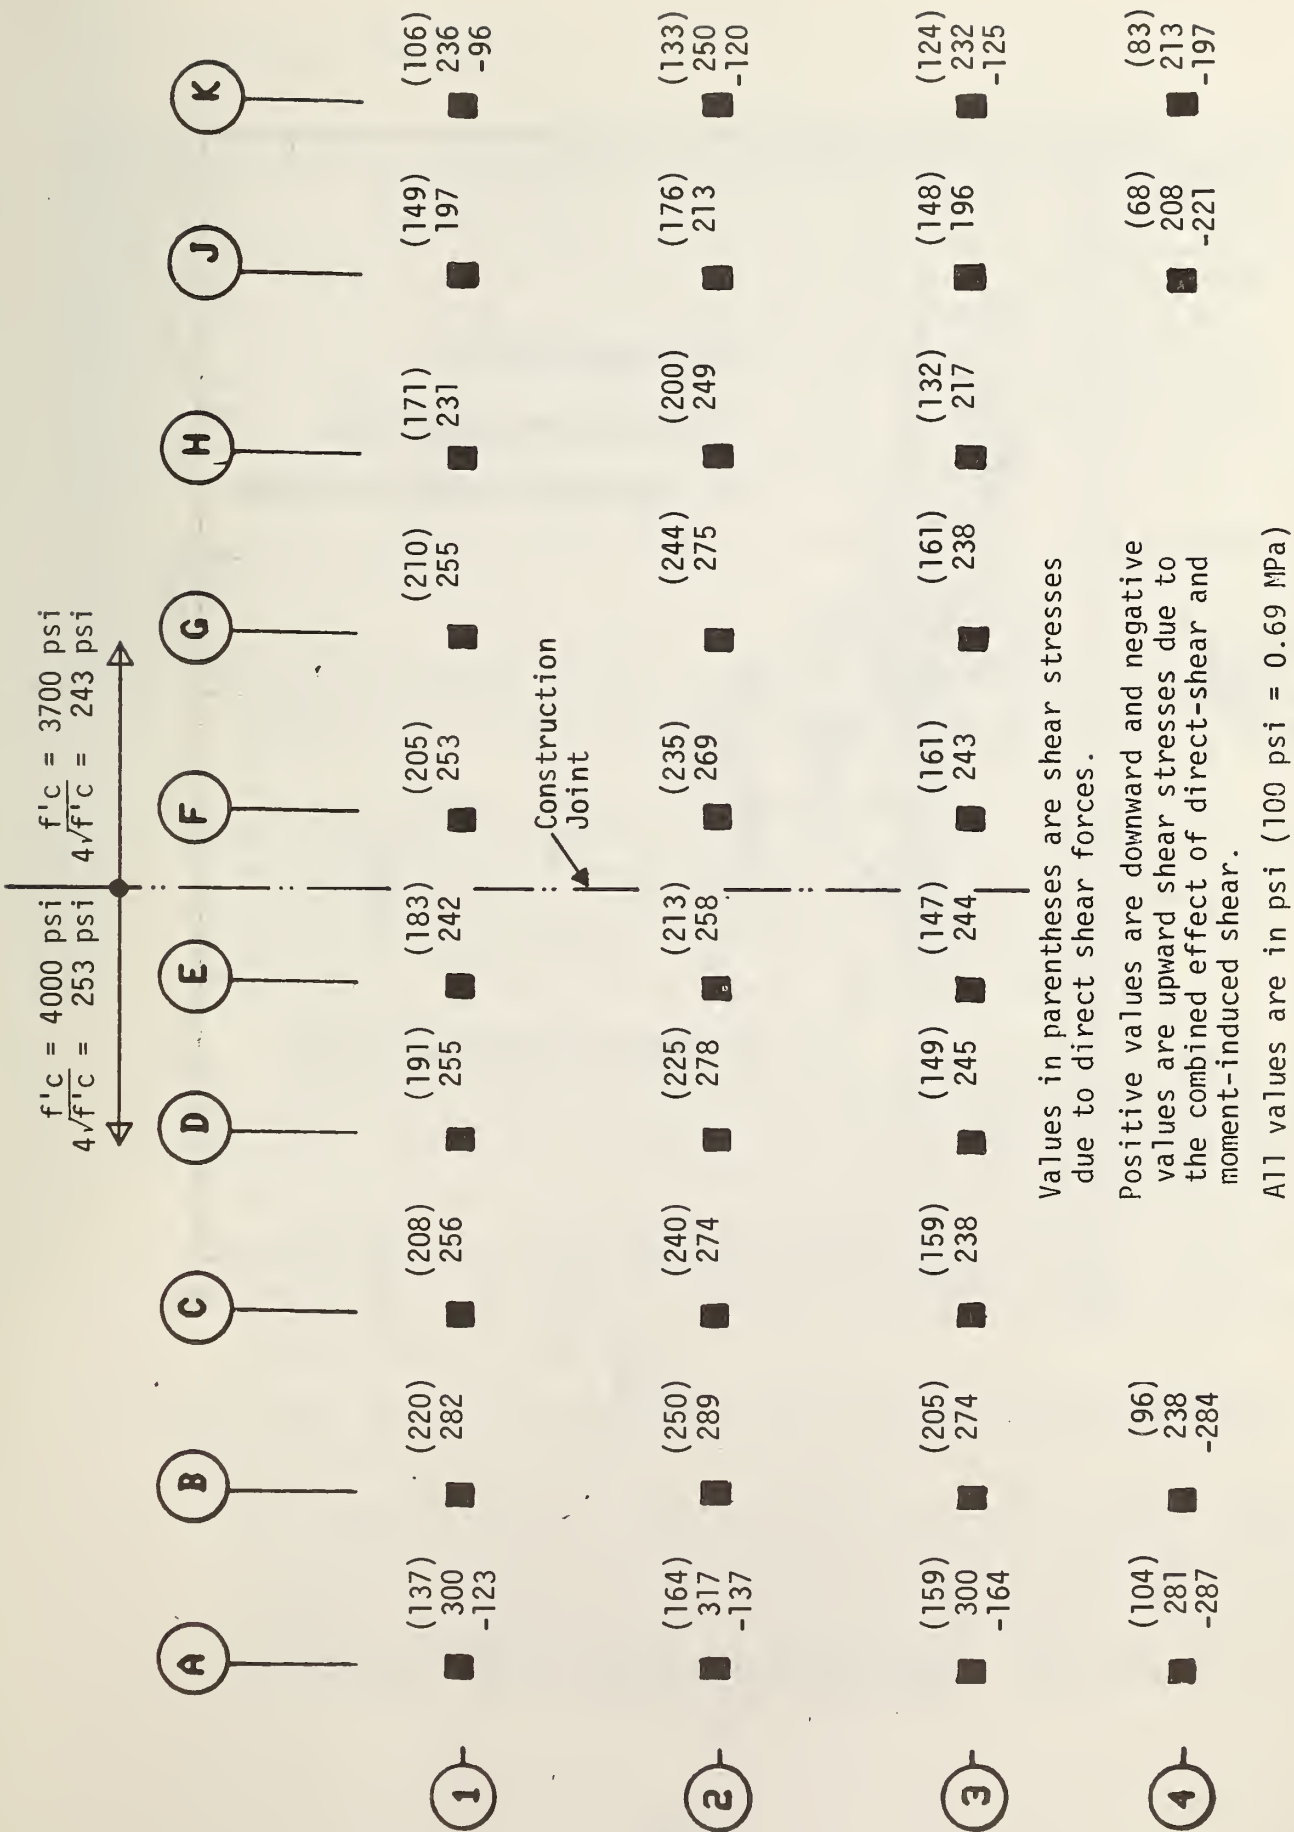
It is concluded that the most probable cause of the failure was the lack of adequate punching shear capacity in the fifth-floor slab at several of the columns to resist the applied construction loads. This deficiency was brought about by the design inadequacy which resulted in the slab thickness of 8 in instead of 11-in and by the placement of the top reinforcement at the column strips with significantly greater cover than that which would have met the cover requirement specified by the structural drawings. This resulted in an insufficient effective depth of the fifth floor slab to resist punching shear under construction loads.

Figure 6.4 Punching shear stresses in fifth floor slab
