BUILDING SCIENCE SERIES 40

Engineering Aspects of the 1971 San Fernando Earthquake

This report presents the observations of the NBS on-site inspection team (most photographs in this report were taken by the team). The material presented herein is intended to serve as (1) a documentation of damage resulting from the earthquake and (2) as a source document for further studies, research, and recommendations. This is particularly important as necessary remedial work and restoration have resulted in the removal of evidence that is essential for studies and evaluations.

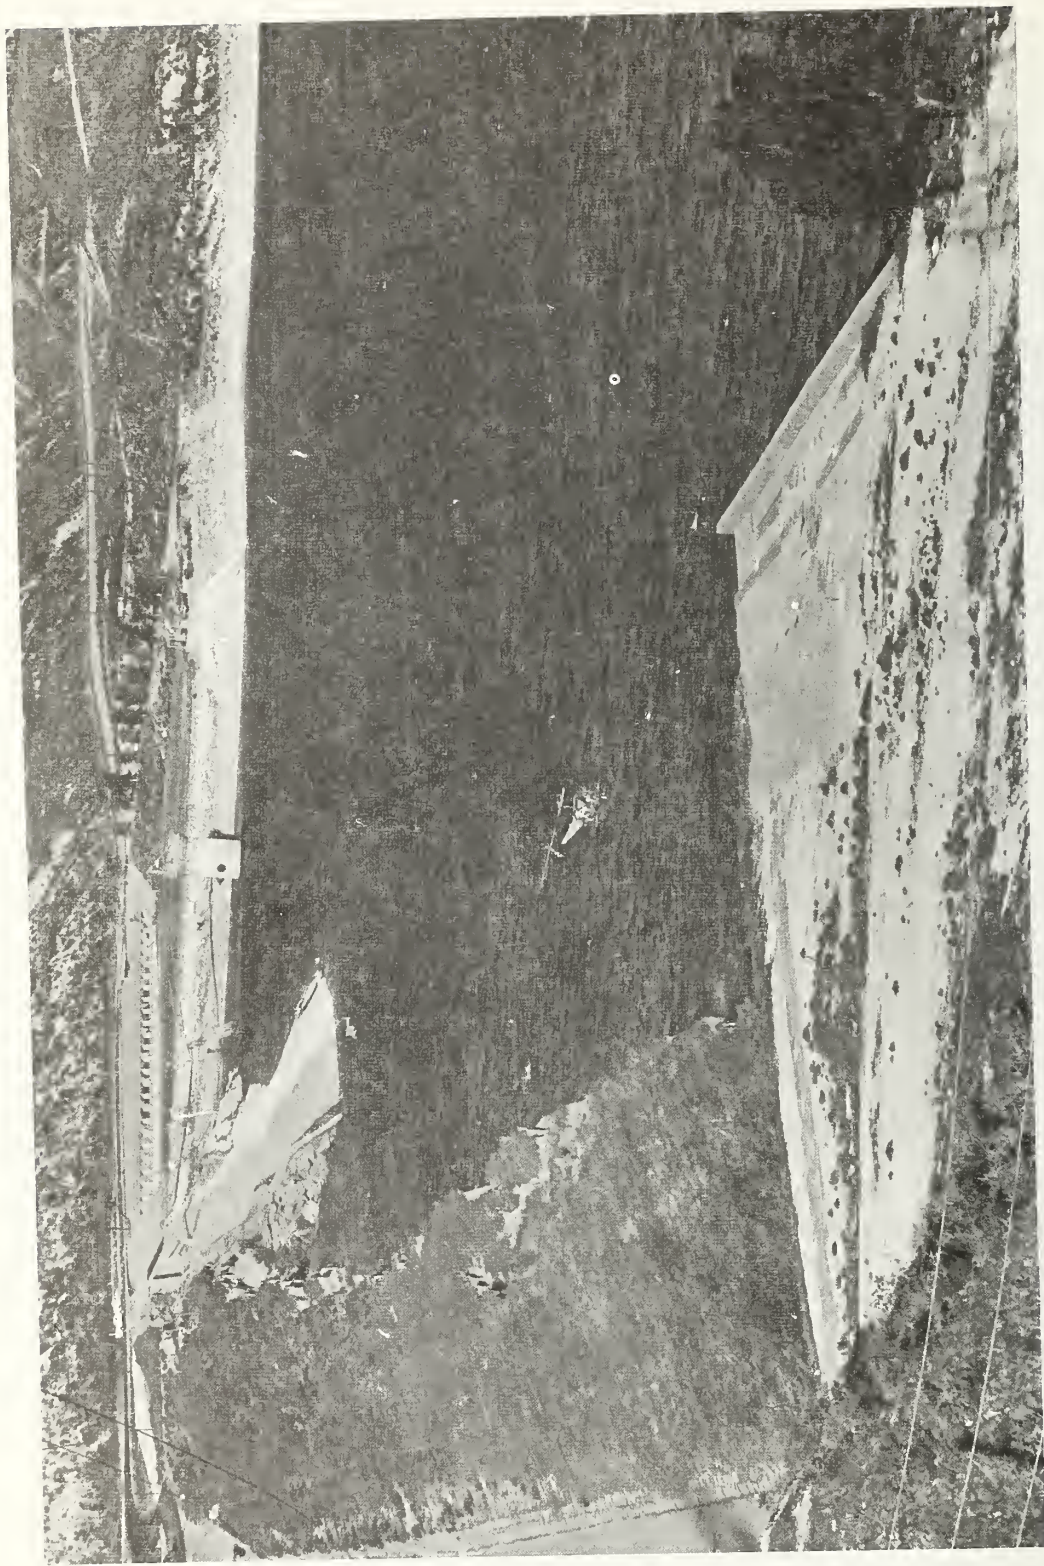
Figure 4.3 Lower San Fernando Dam immediately after quake.

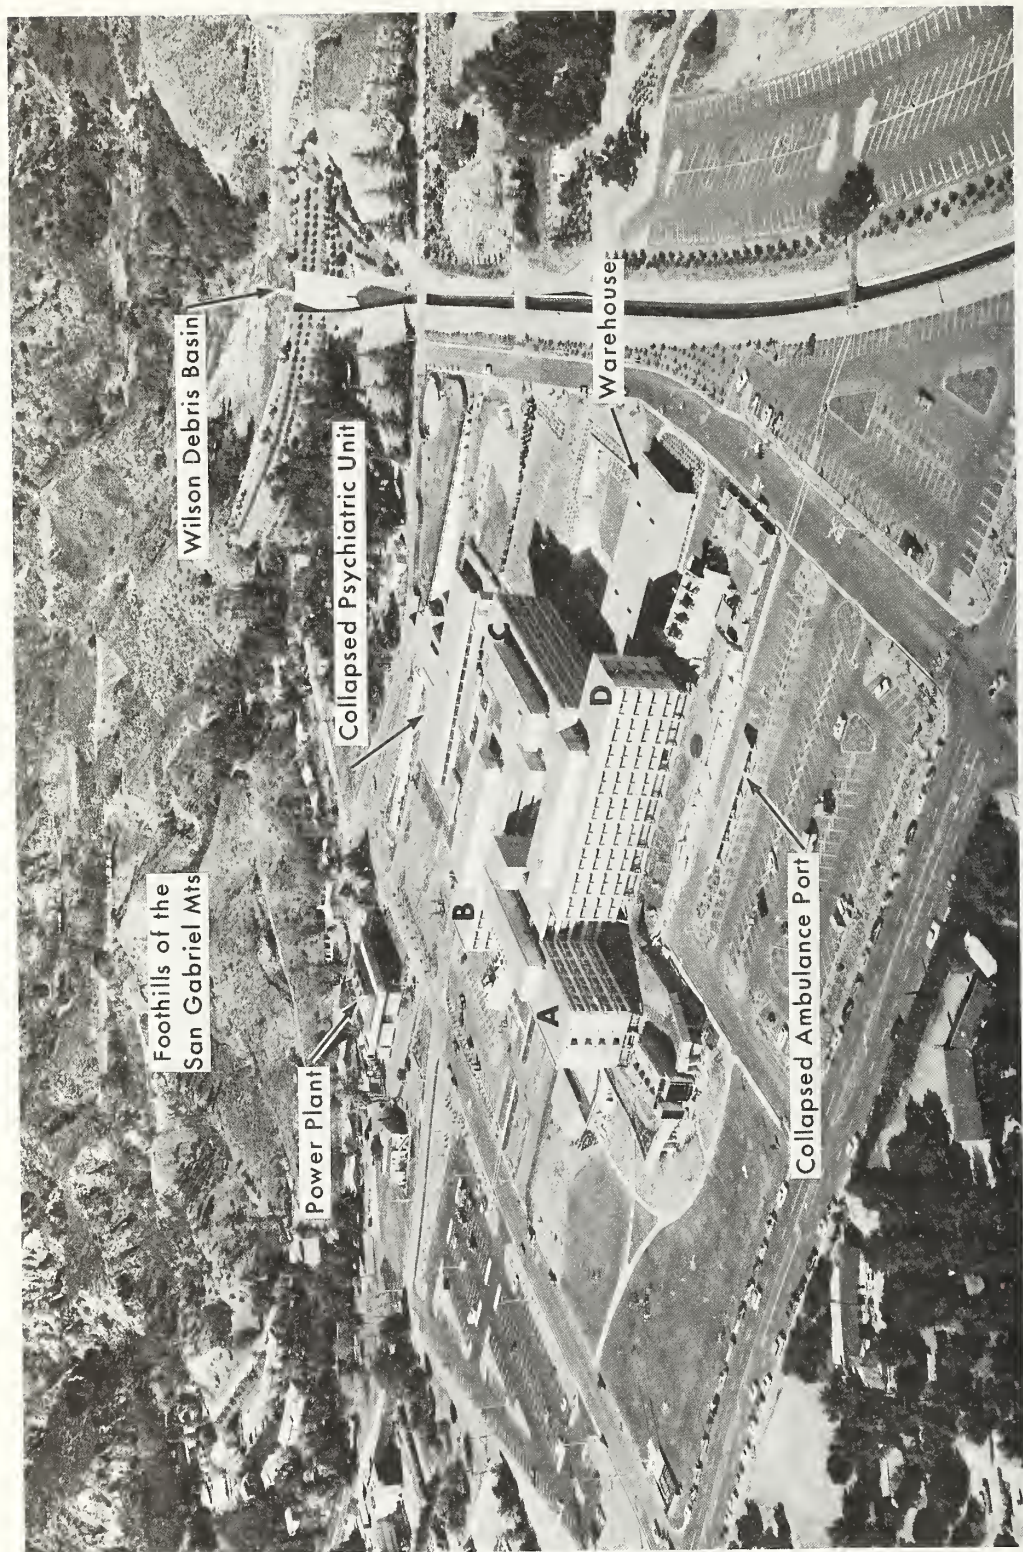
Figure 5.6 Olive View Medical Center after the earthquake, as viewed from the southeast (Los Angeles County Engineer Photo).

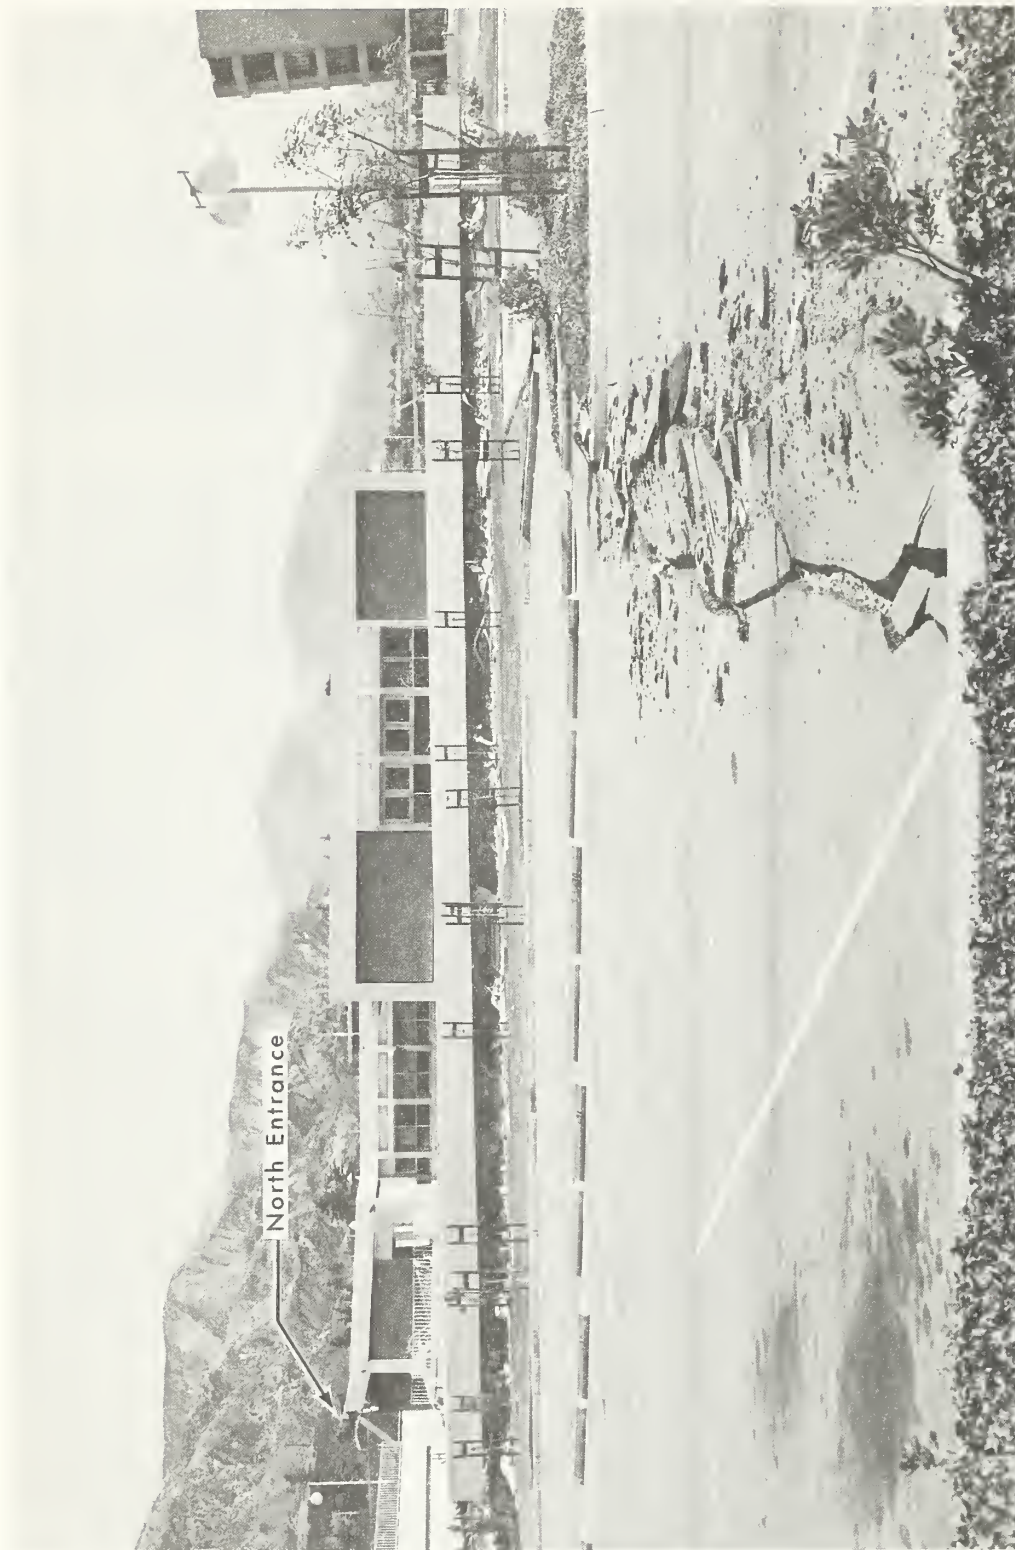
Figure 5.12 West elevation of the Psychiatric Unit.
Damage to the surface of the parking lot,
just west of this building, indicates
severe ground movement.

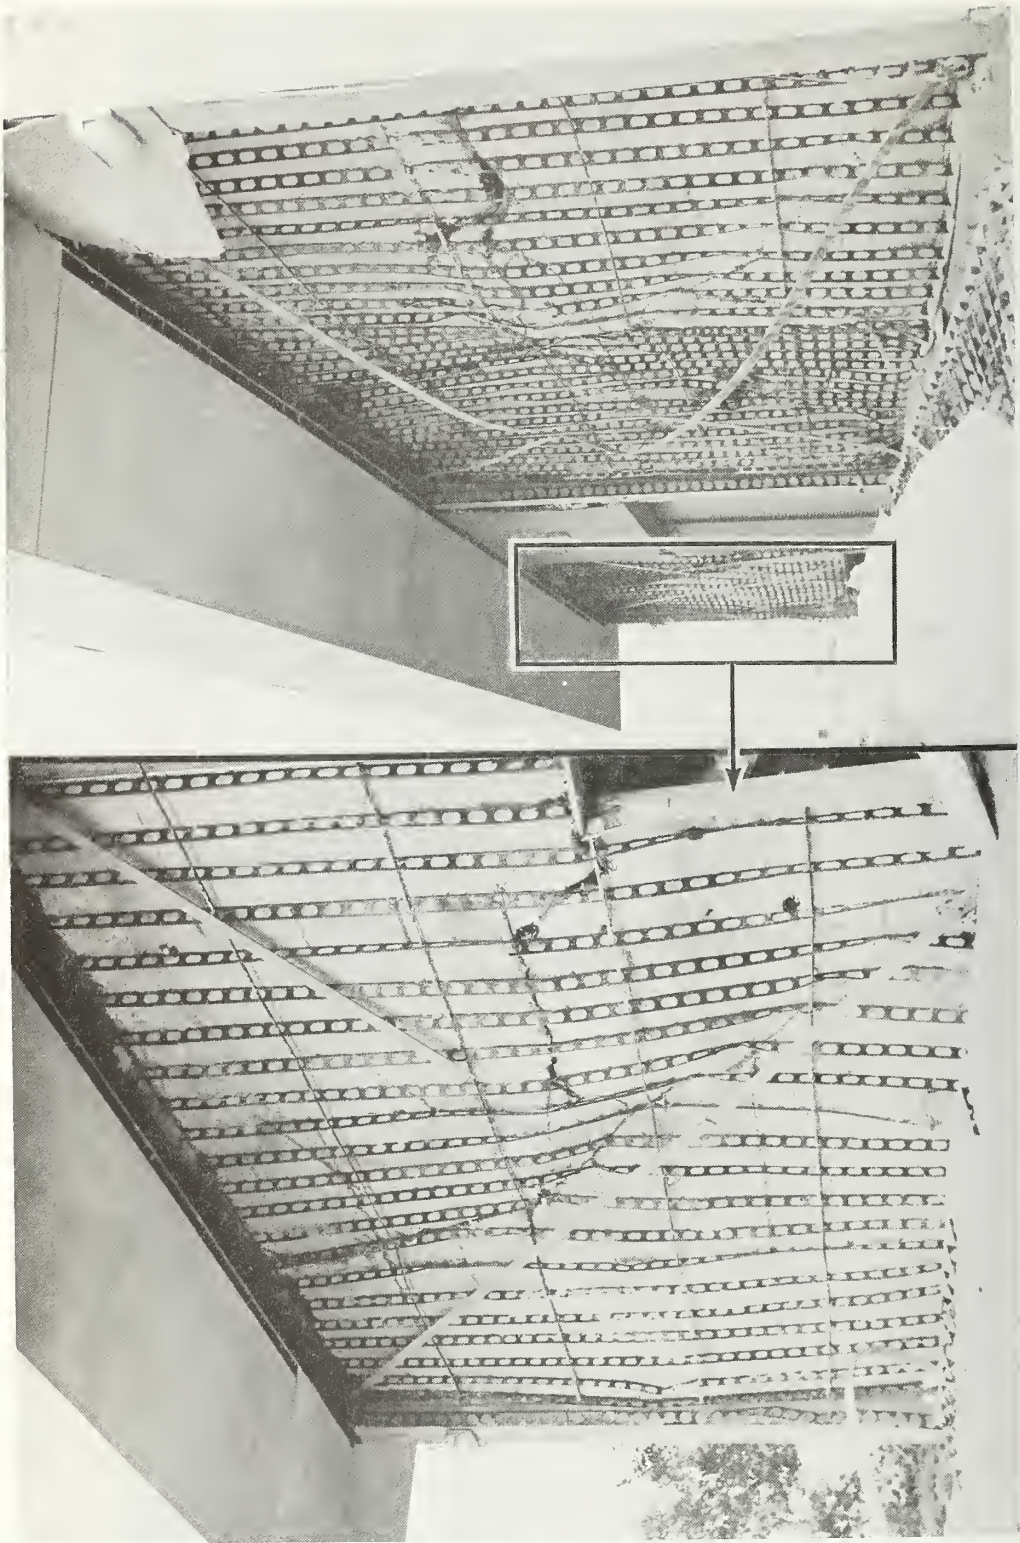
Figure 5.38 Damaged diagonal bracing in the north wall of the power plant.

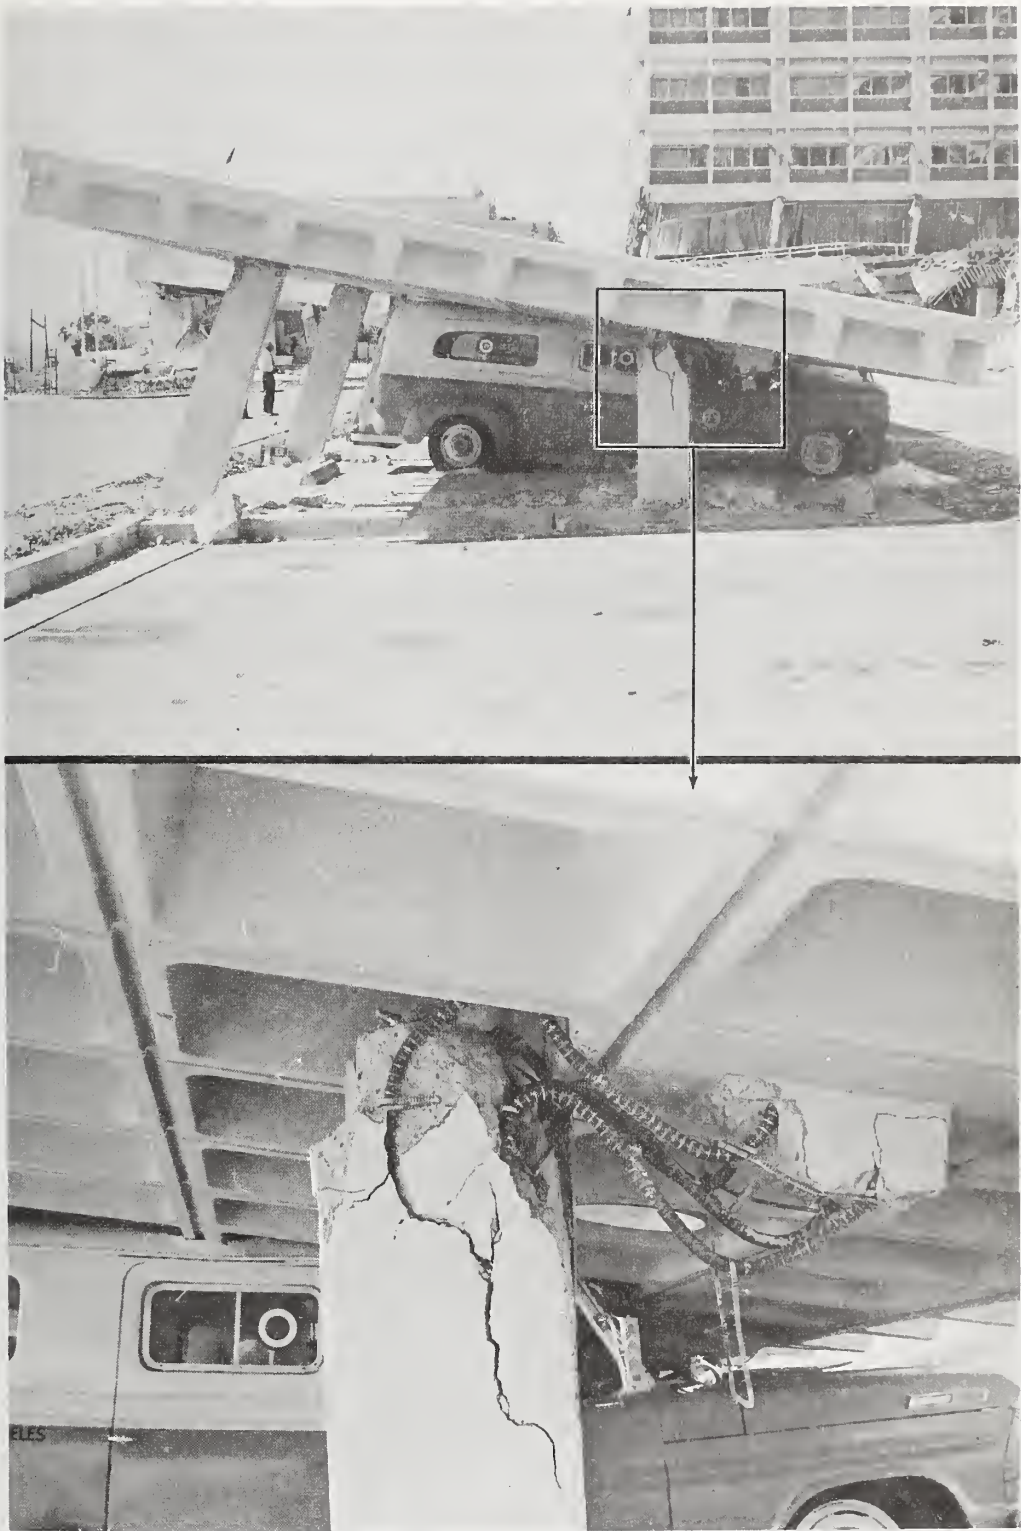
Figure 5.39 Damaged reinforced concrete ambulance port south of Wing D.

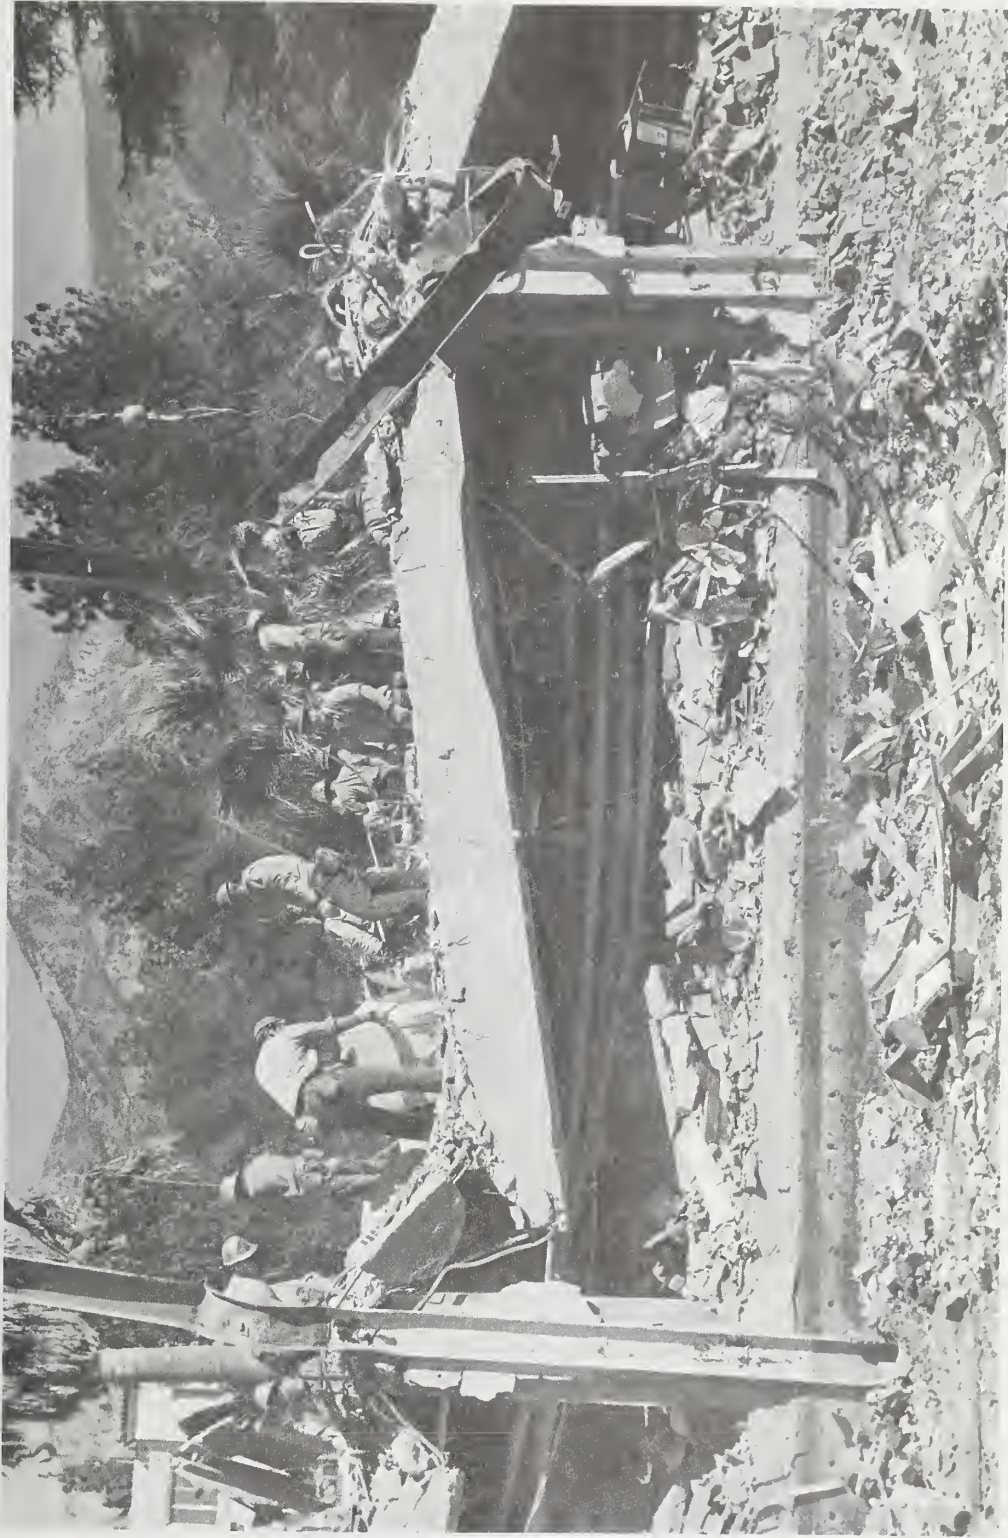
Figure 5.42 Rescue and clean-up operations. This collapsed building was constructed in 1925 and is a reinforced concrete frame structure infilled with unreinforced clay tile walls. (Los Angeles Times Photo).

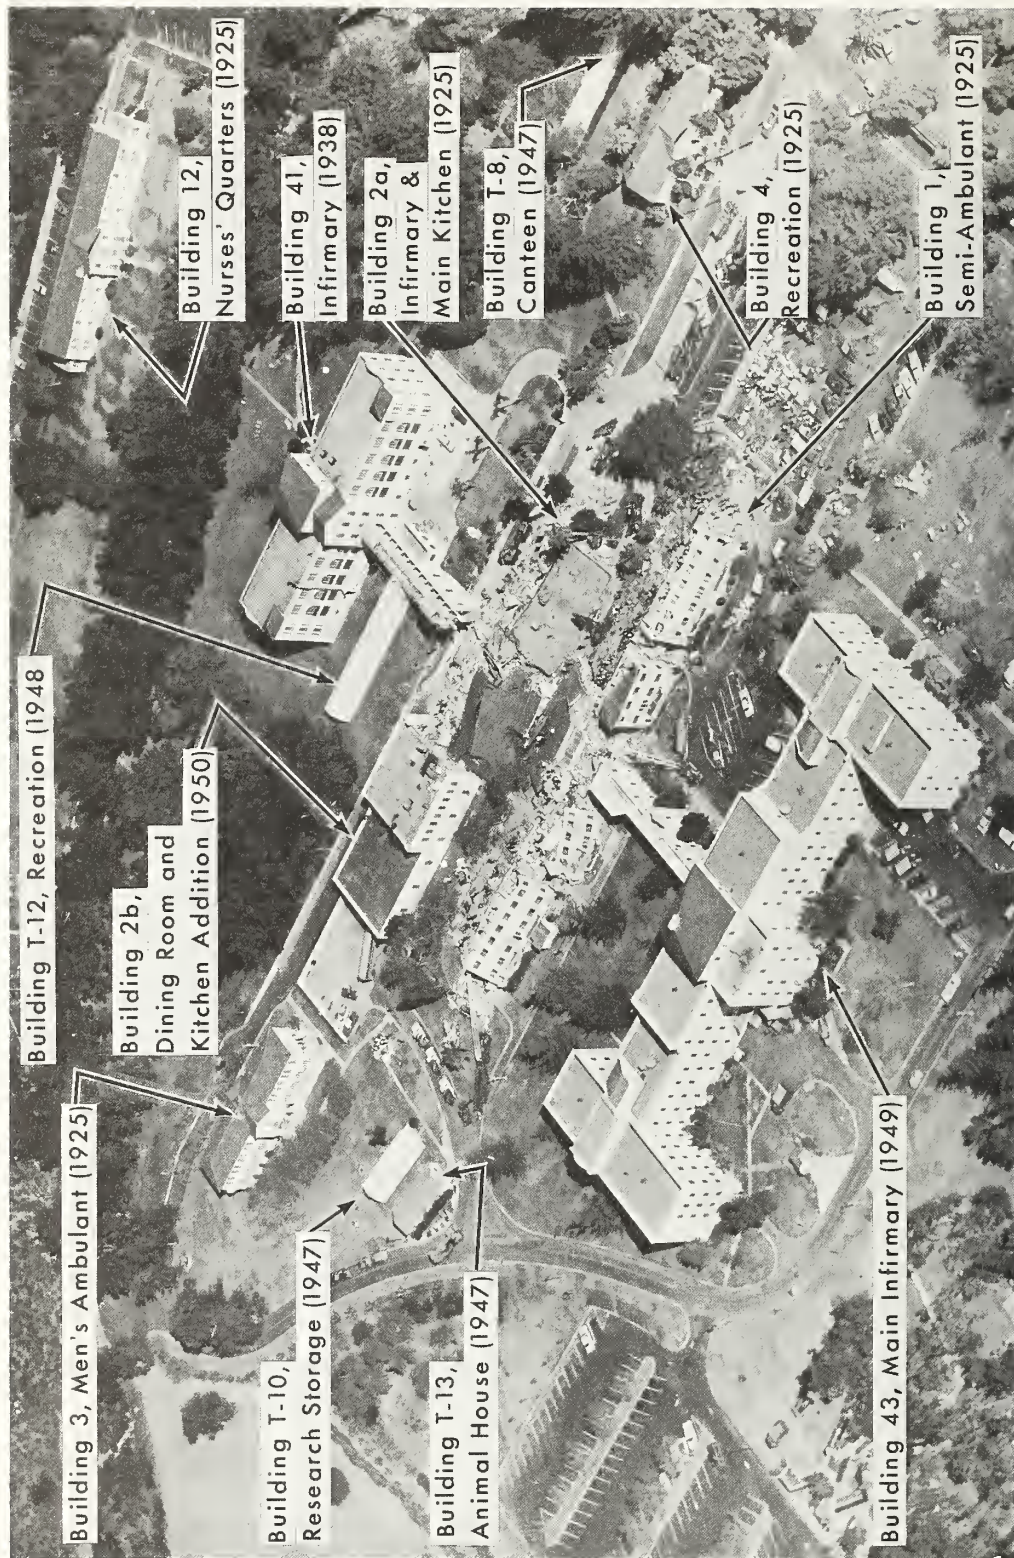
Figure 5.44 Collapsed buildings (No. 1 and 2a) constructed in 1925 where 46 patients and hospital workers were killed. Many of the buildings, also constructed in 1925 (Buildings 3, 4, and 12), although still standing, were severely damaged. (Los Angeles Times Photo).

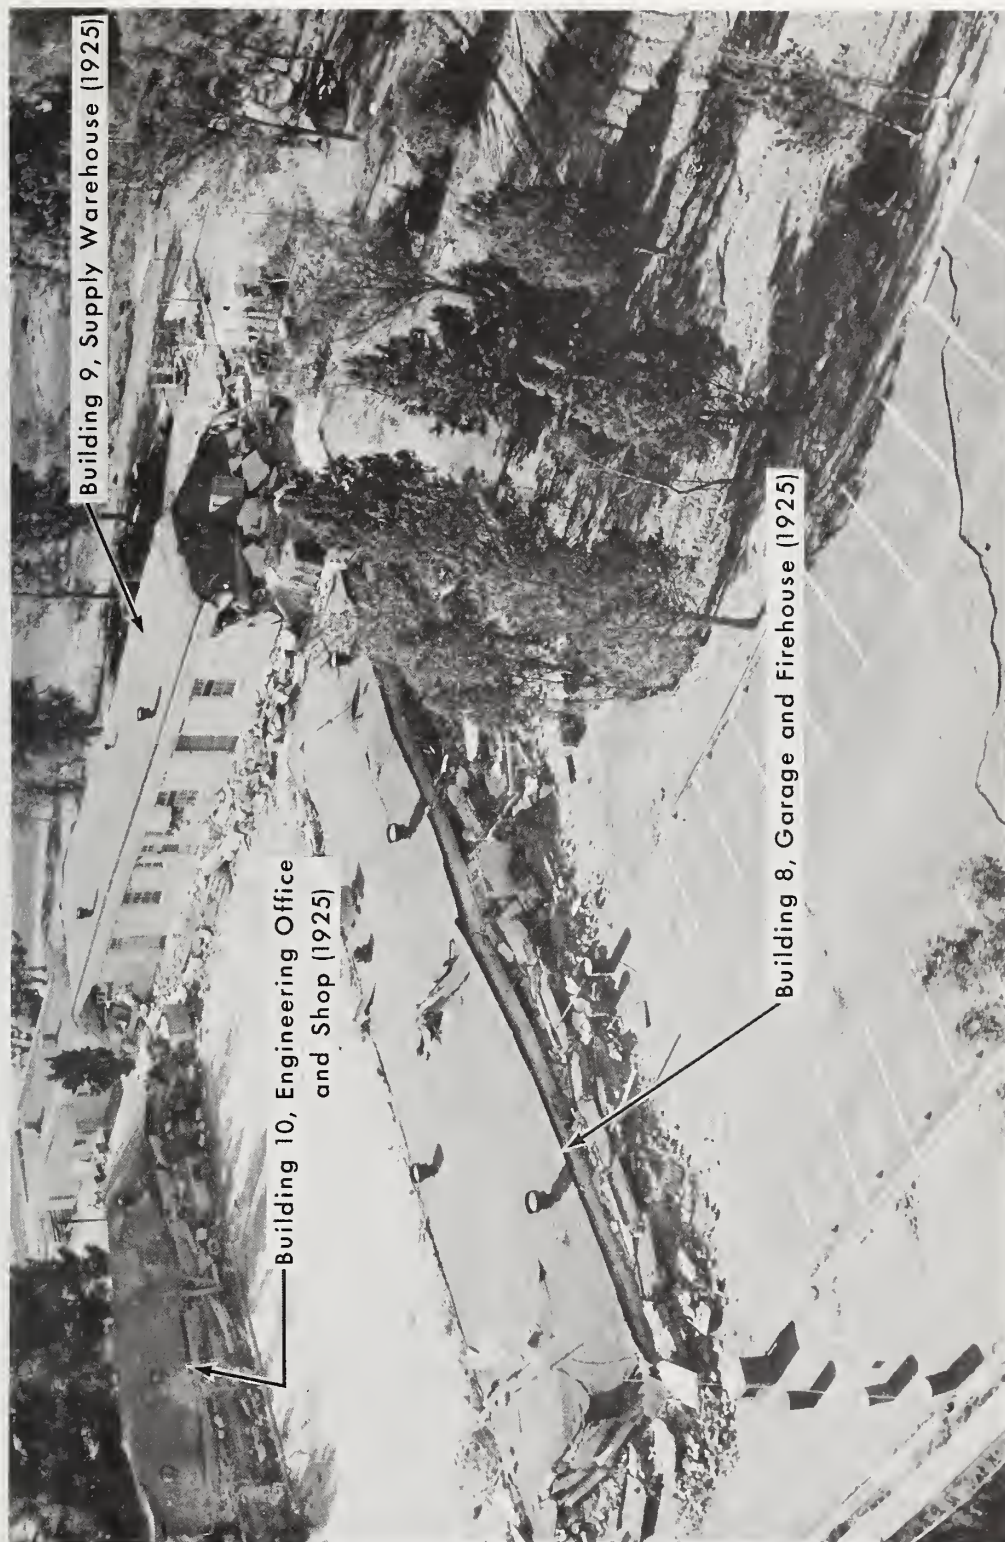
Figure 5.45 Collapsed one-story buildings (No. 8 and 10) located at the east end of the hospital complex. Note that two structures oriented in one direction collapsed; whereas, the building (No. 9) oriented 90 degrees to them is damaged but still standing.

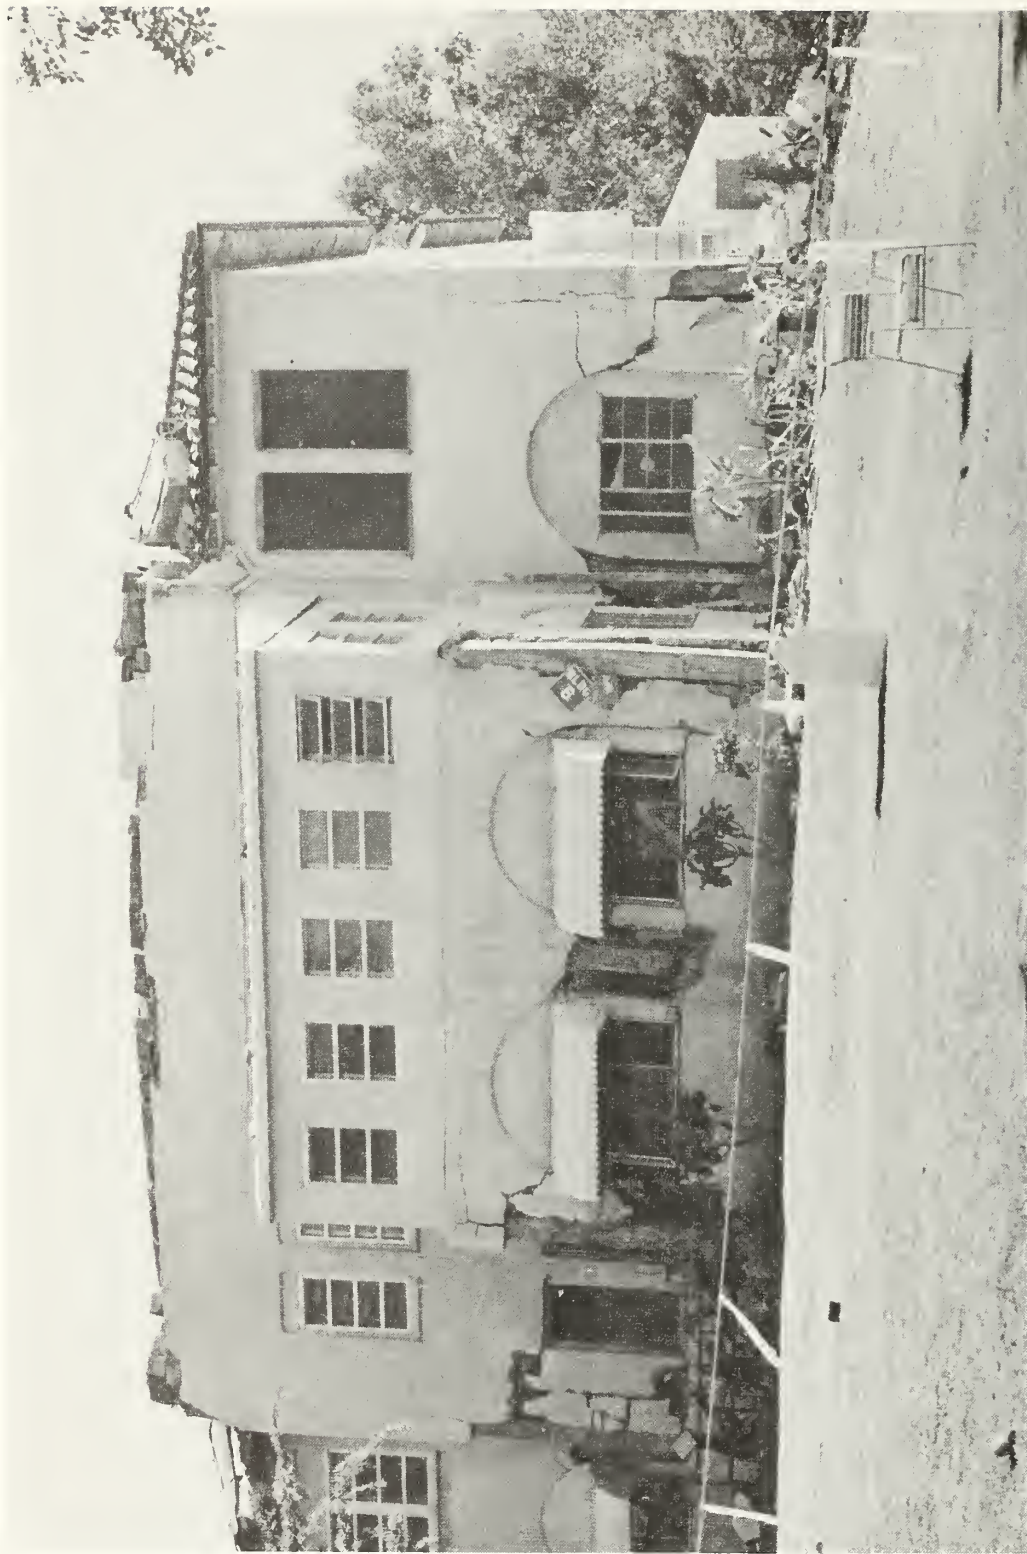
Building No. 6, a two-story building approximately 50 ft by 100 ft in plan, was one of the original 1925 buildings which was severely damaged (figs. 5.48, 5.49 and 5.50). A small one-story wood frame building (Building No. T-7) constructed in 1947 adjacent to Building No. 6 suffered no apparent damage.

Figure 5.48 Building 6, located east of the main buildings.
This building which was constructed in 1925 was
severely damaged.

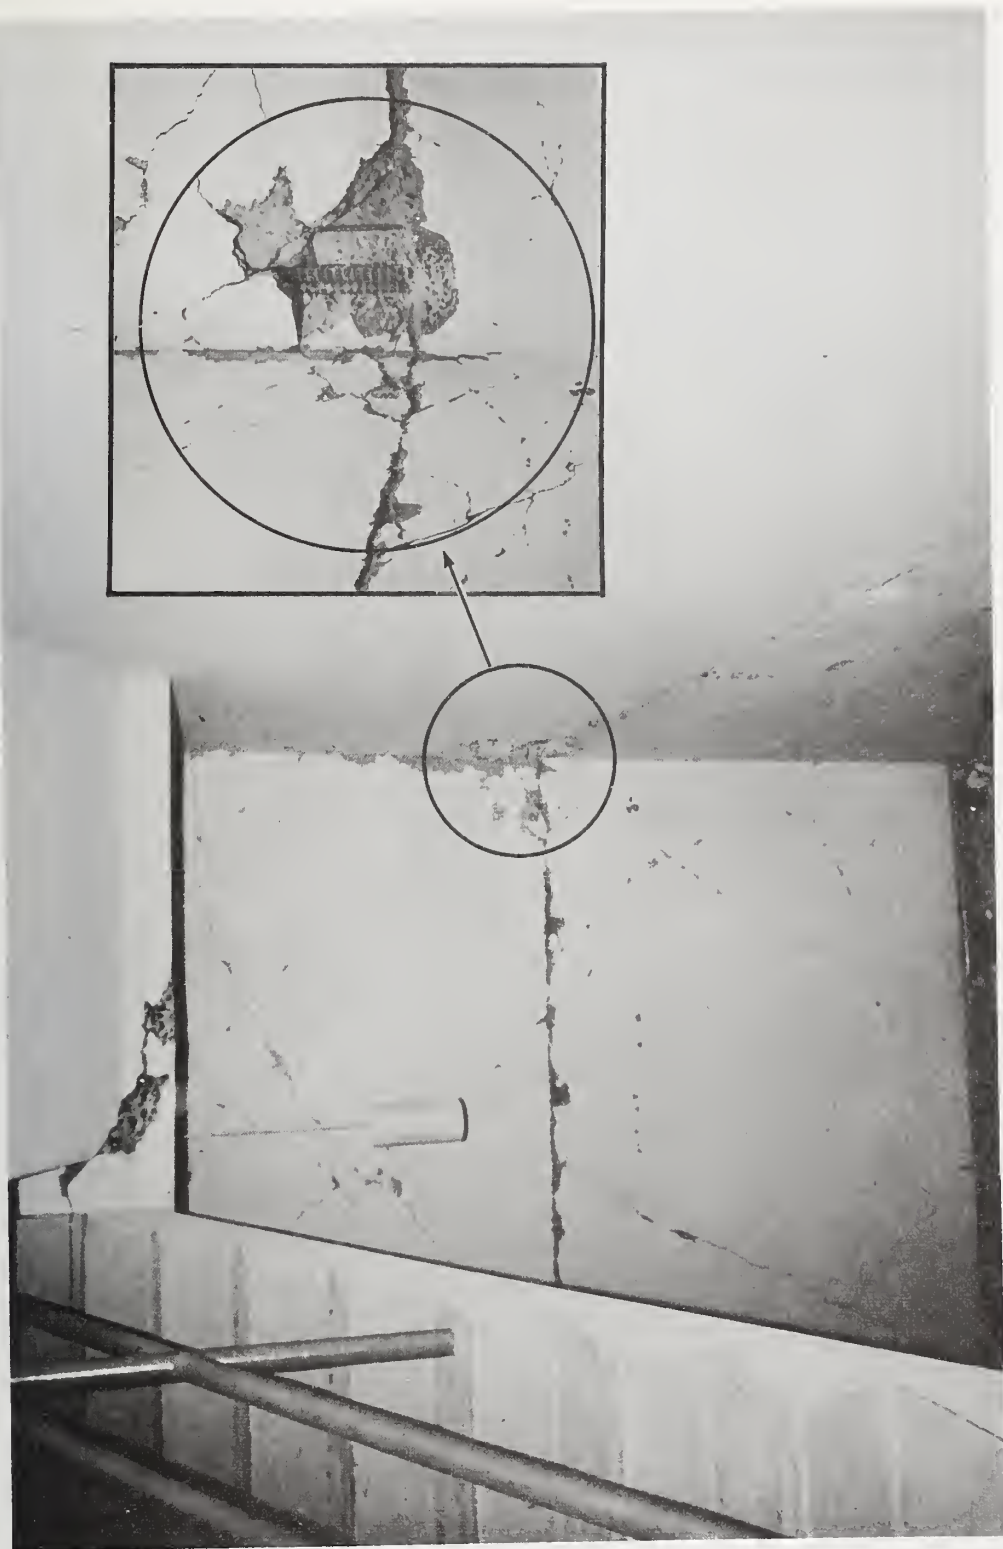
Figure 5.69 Diagonal and horizontal cracking in stairwell near the west end of the building. The horizontal crack is at the third floor.

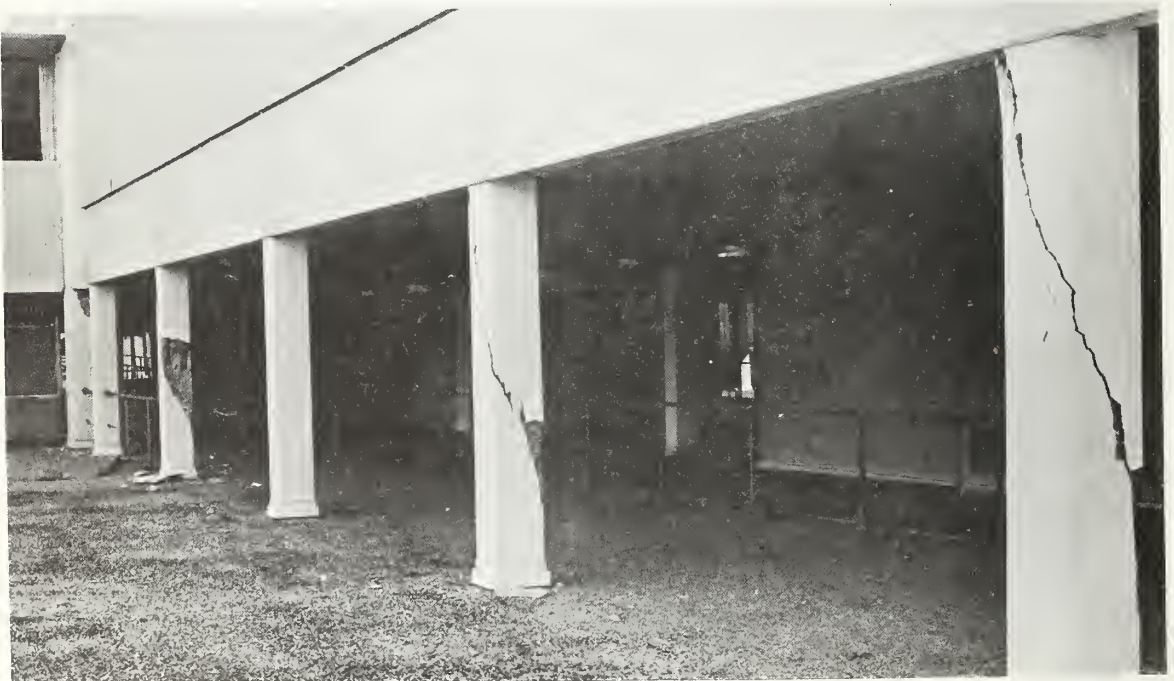
Figure 5.74 *Torsional cracking of second-story columns in the north wing.*

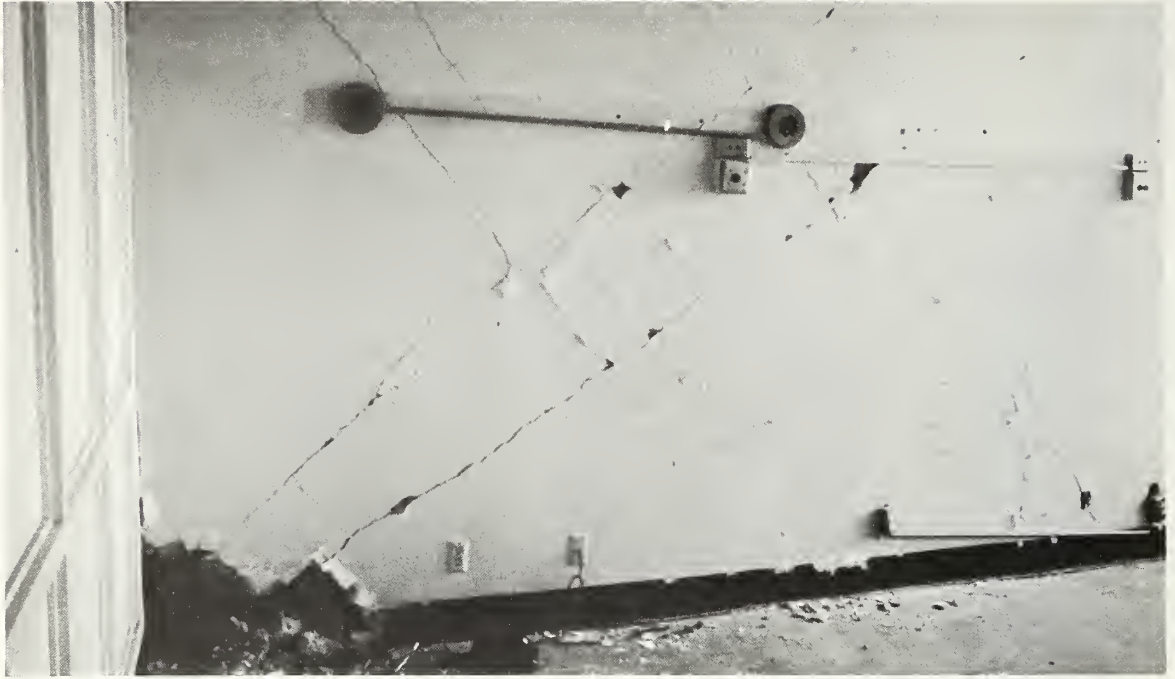
Figure 5.82 Interior view of damaged reinforced concrete shear wall at the east end of the center section of Pacoima Hospital.

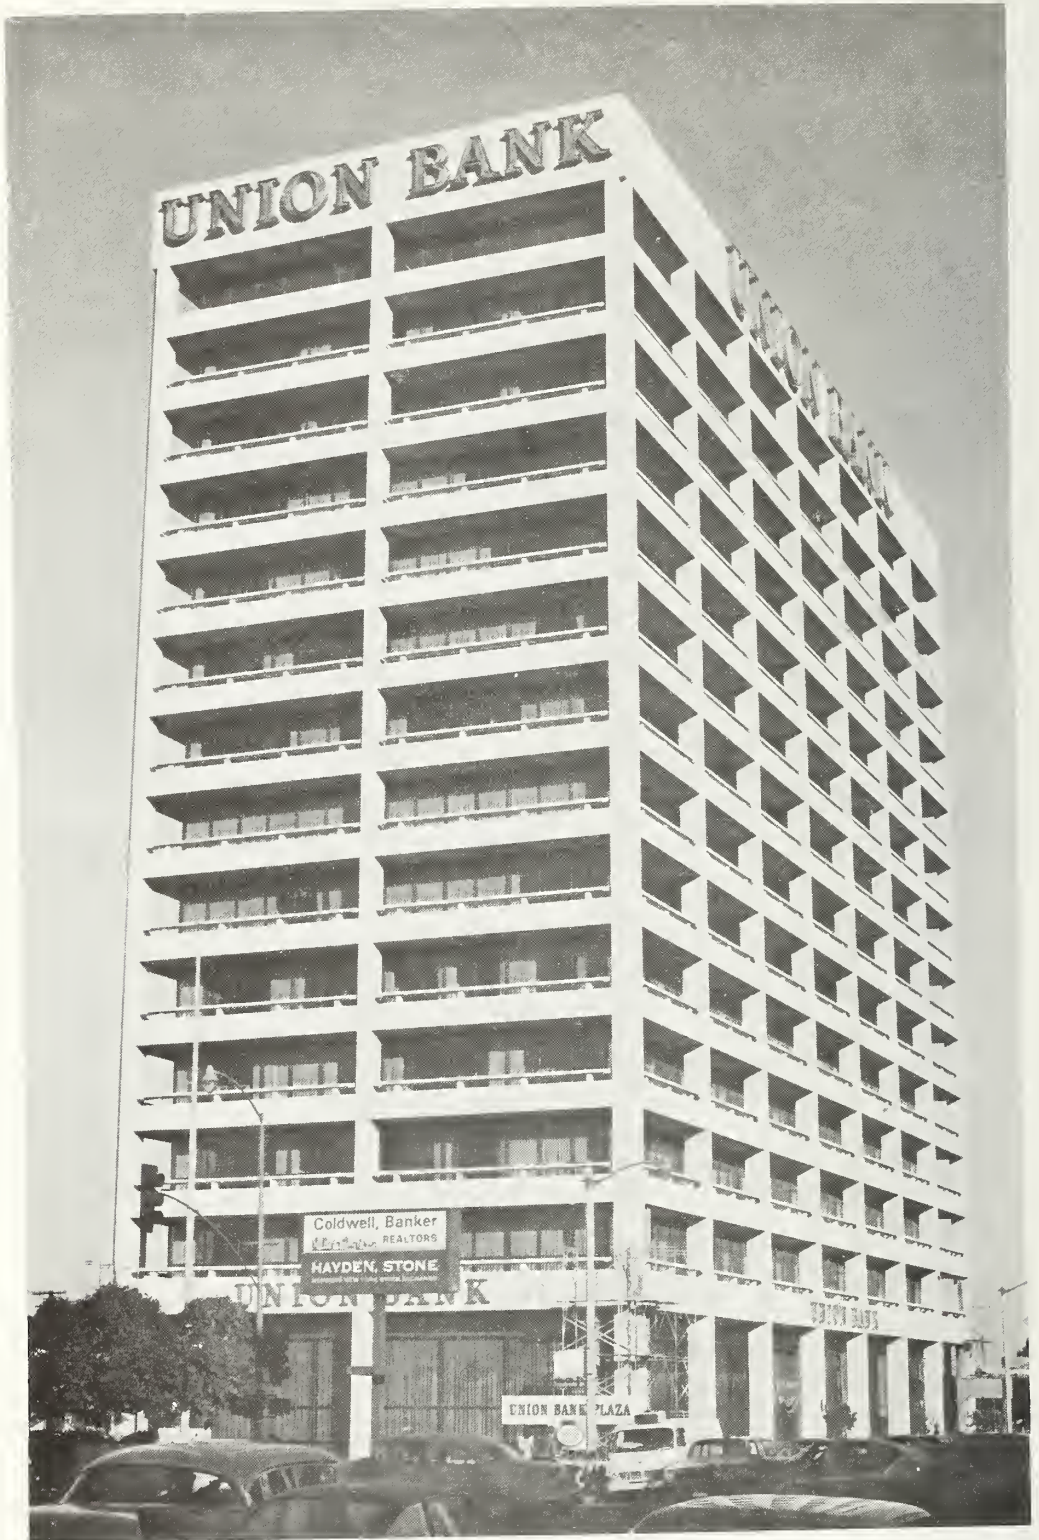
Figure 5.113 The south and west elevations of the thirteen-story Union Bank building. All four exterior corner columns in this reinforced concrete structure were cracked at the second floor level.

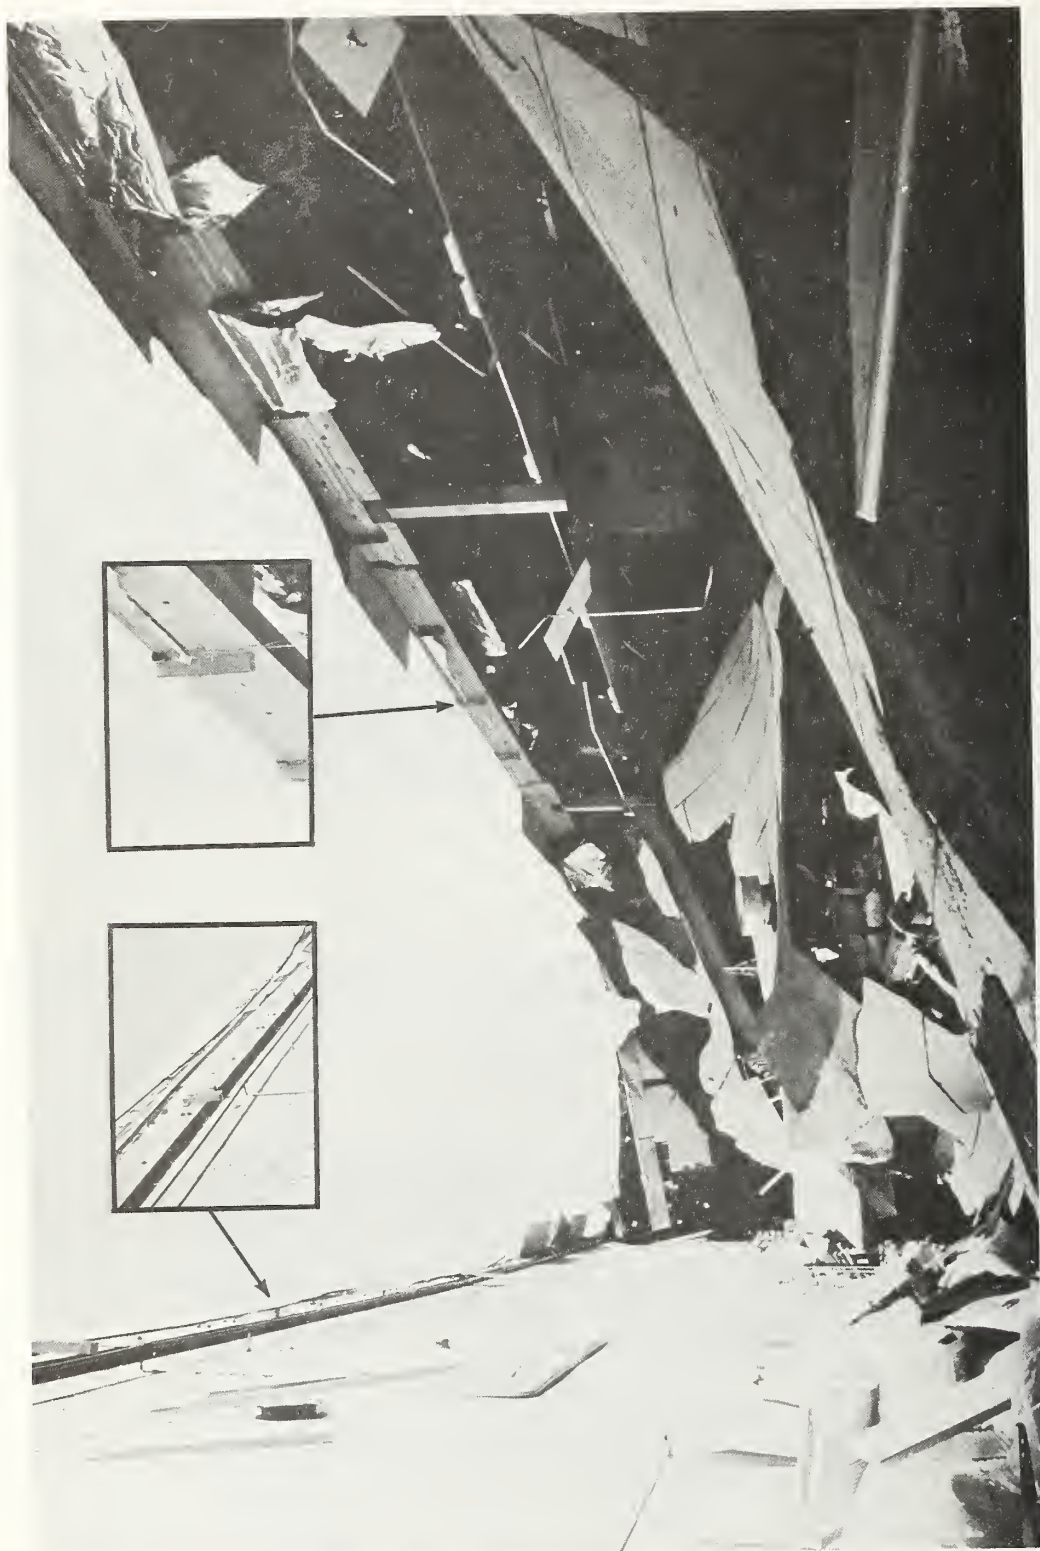
Figure 5.129 Collapsed roof structure at rear of Grants Department Store. Arrows indicate a wooden ledger fastened to the masonry wall (on the left) and metal beam hangers on the laminated wood girder (on the right).

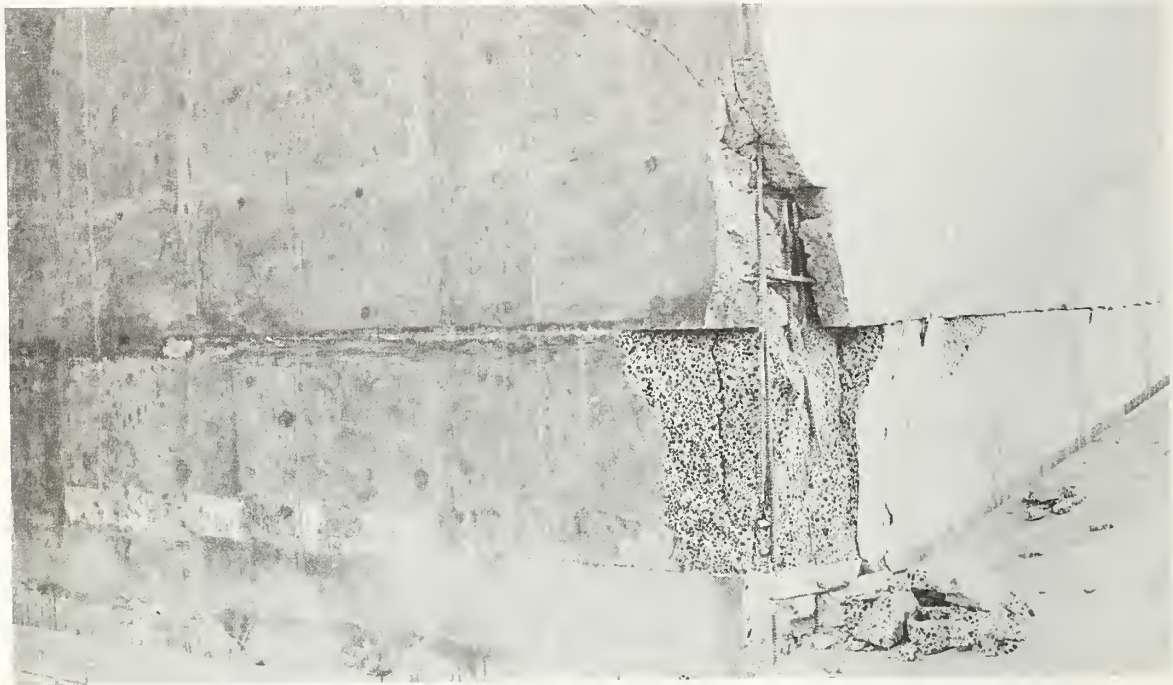
*Figure 5.178 Cracking and spalling at first floor
Corner of the Nethercutt Museum.*

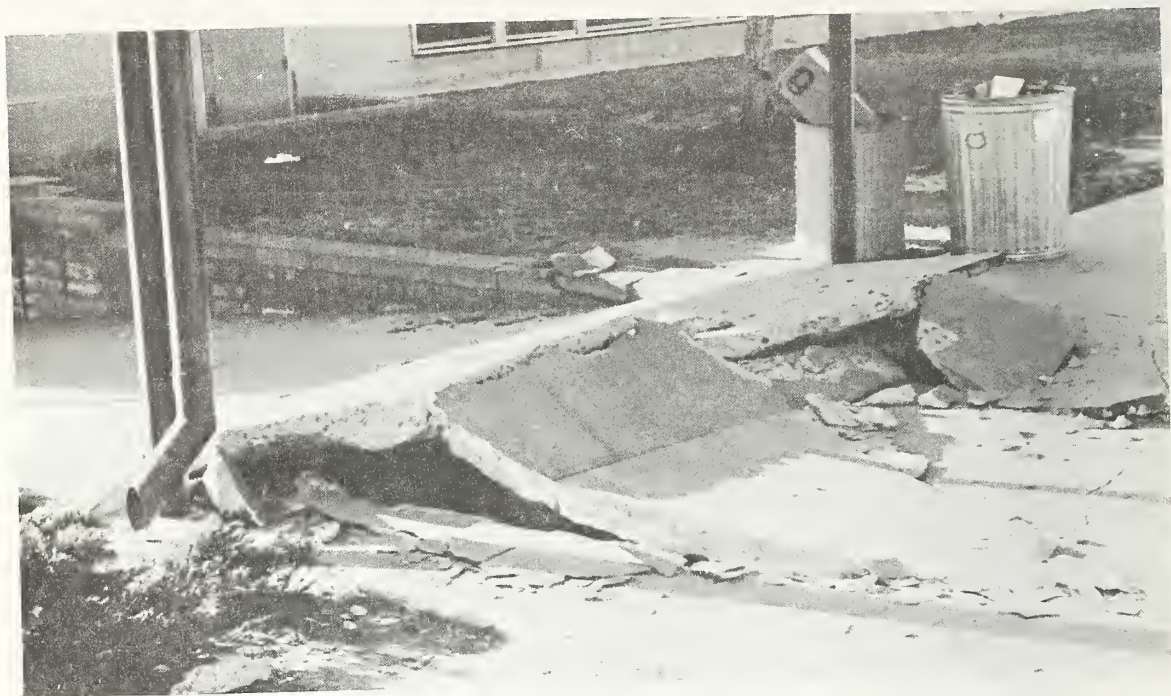
Figure 6.18 Slabs on grade were extensively cracked and buckled, Sylmar High School.
