BUILDING SCIENCE SERIES 40

Engineering Aspects of the 1971 San Fernando Earthquake

This report presents the observations of the NBS on-site inspection team (most photographs in this report were taken by the team). The material presented herein is intended to serve as (1) a documentation of damage resulting from the earthquake and (2) as a source document for further studies, research, and recommendations. This is particularly important as necessary remedial work and restoration have resulted in the removal of evidence that is essential for studies and evaluations.

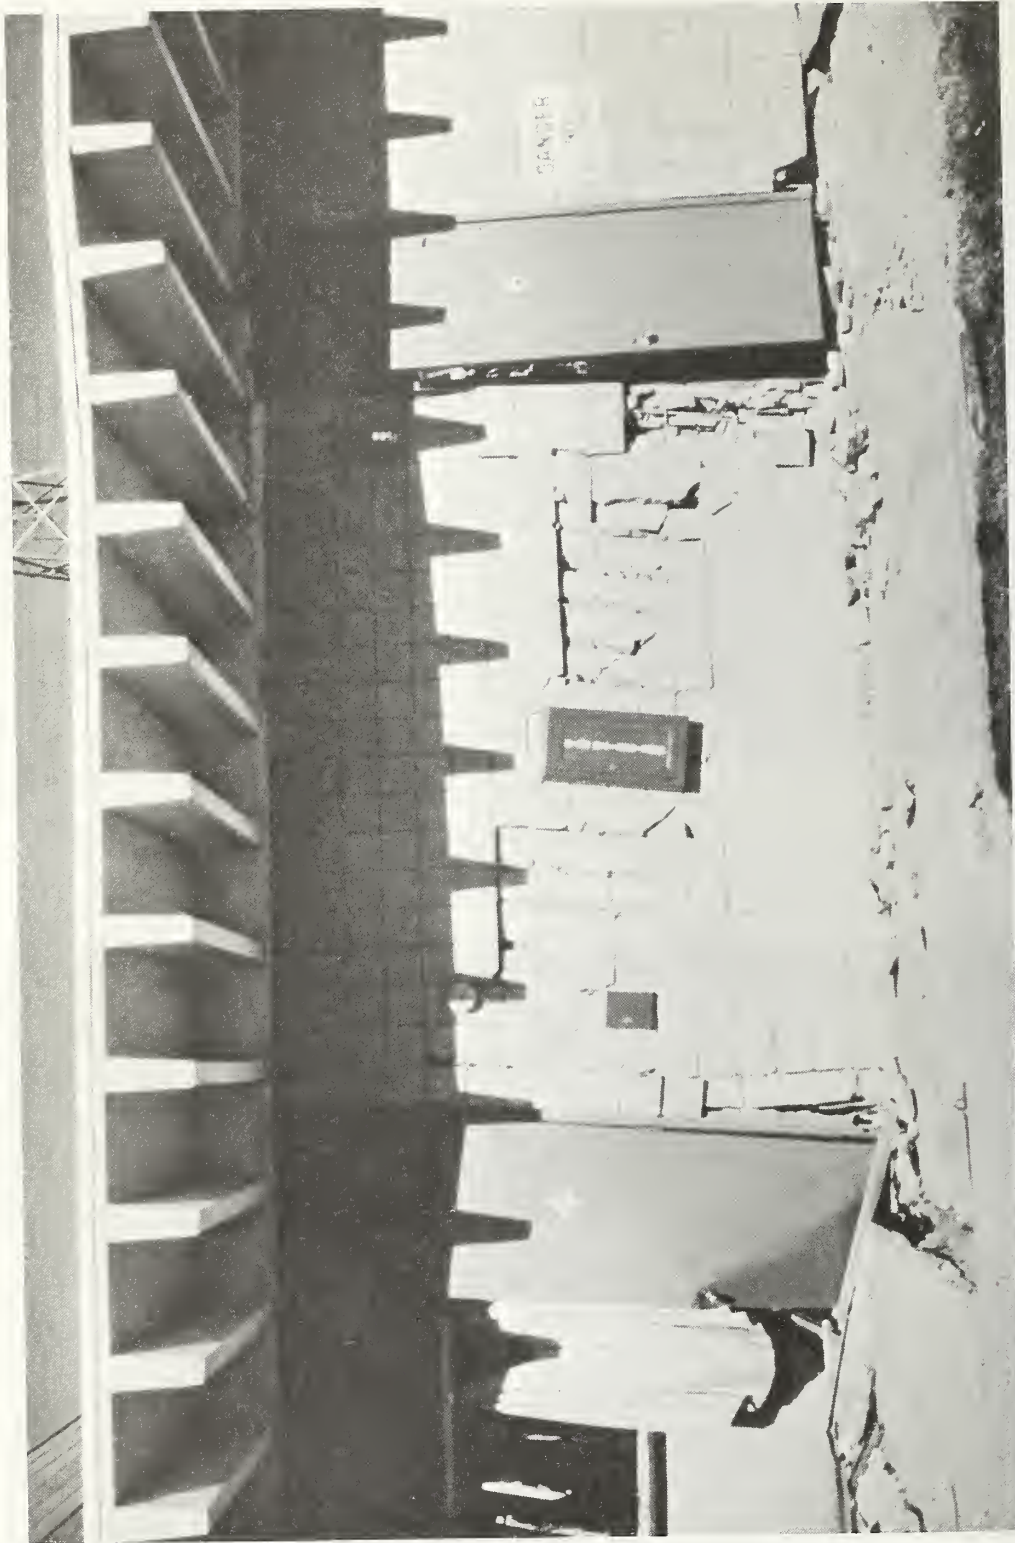
Figure 6.48 Damage to girls' school adjacent to cafeteria, Los Angeles County Juvenile Facility. The solidly grouted concrete block wall resisted the distortion.

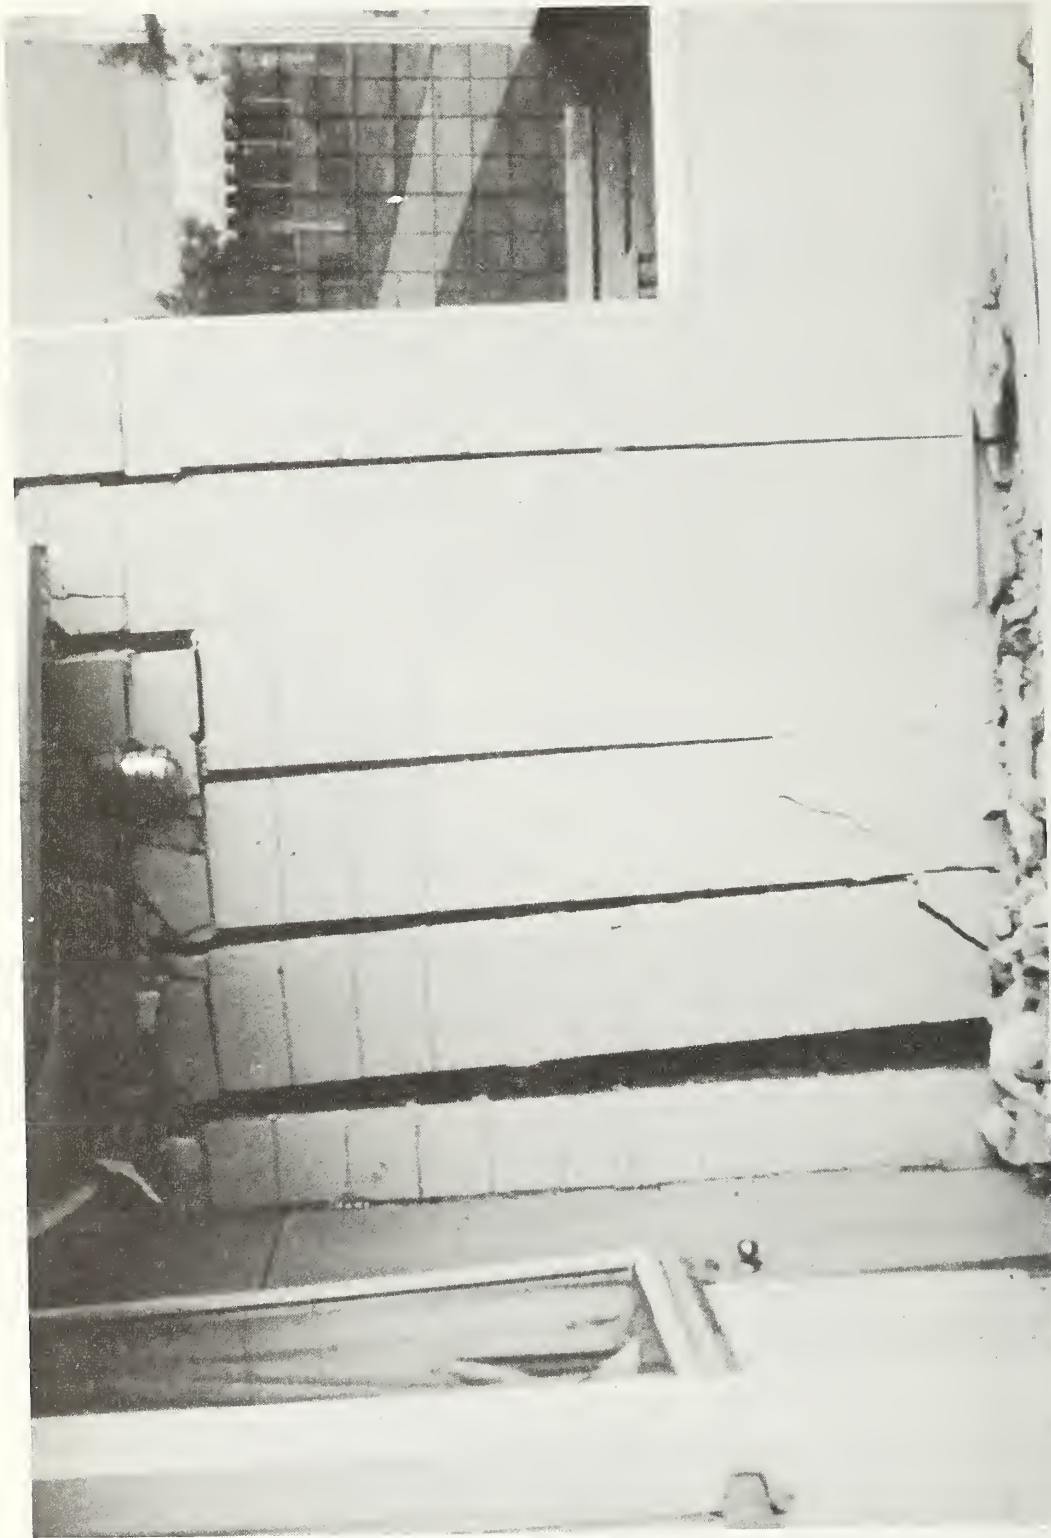
Figure 6.51 Damage to concrete block wall, Los Angeles County Juvenile Facility. Note absence of horizontal reinforcement. Only reinforced vertical cells are filled with grout.

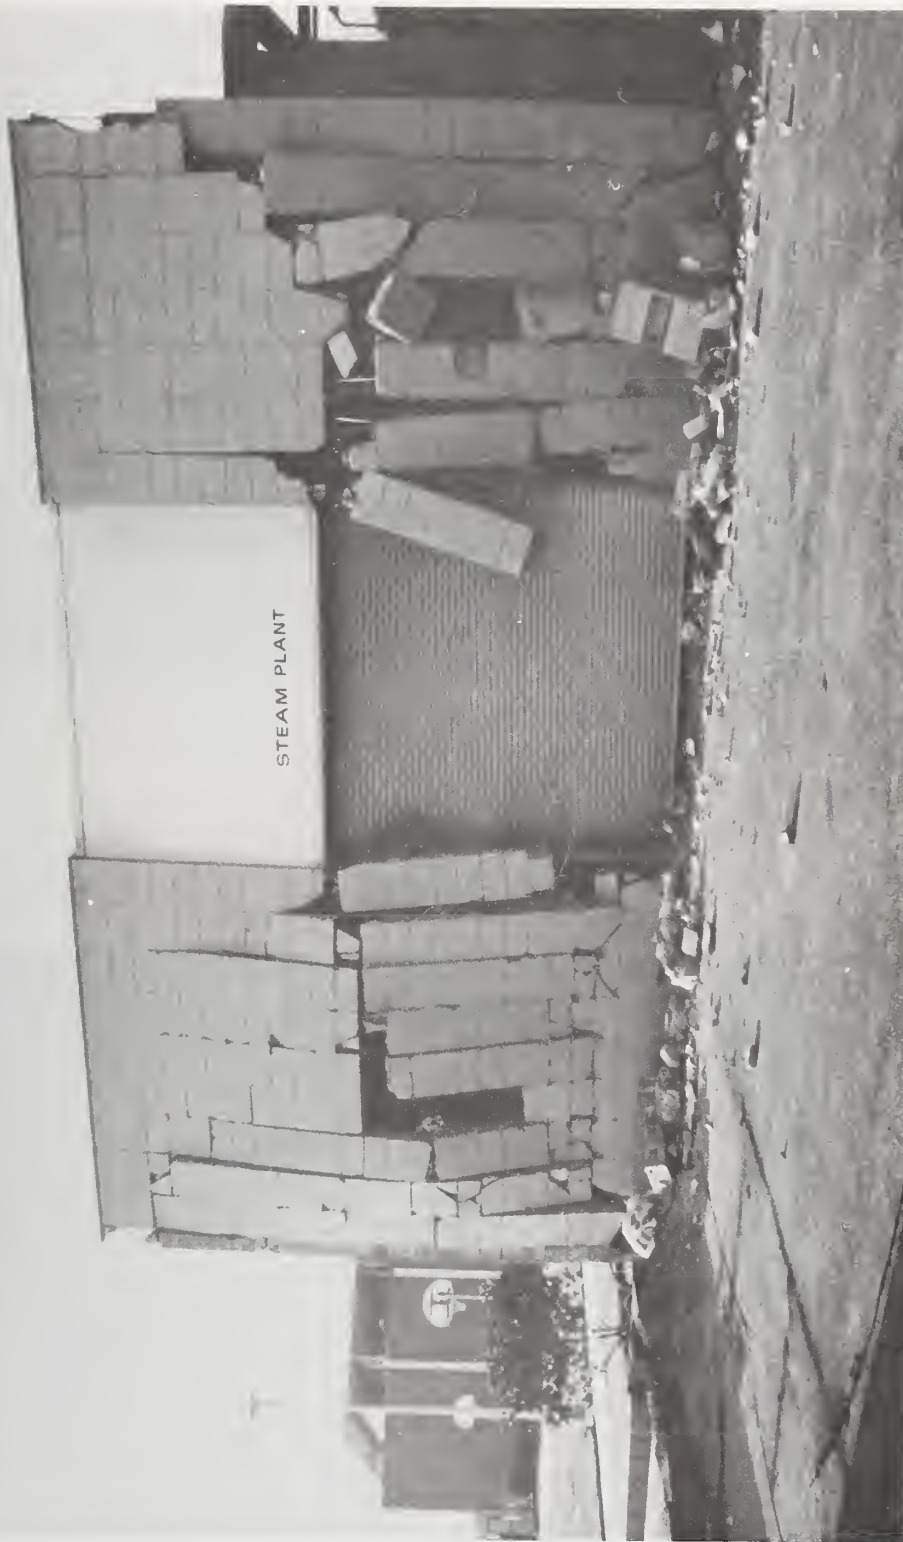
Figure 6.52 Damage to concrete block wall, Los Angeles County Juvenile Facility. Note absence of horizontal reinforcement. Only reinforced vertical cells are filled with grout.

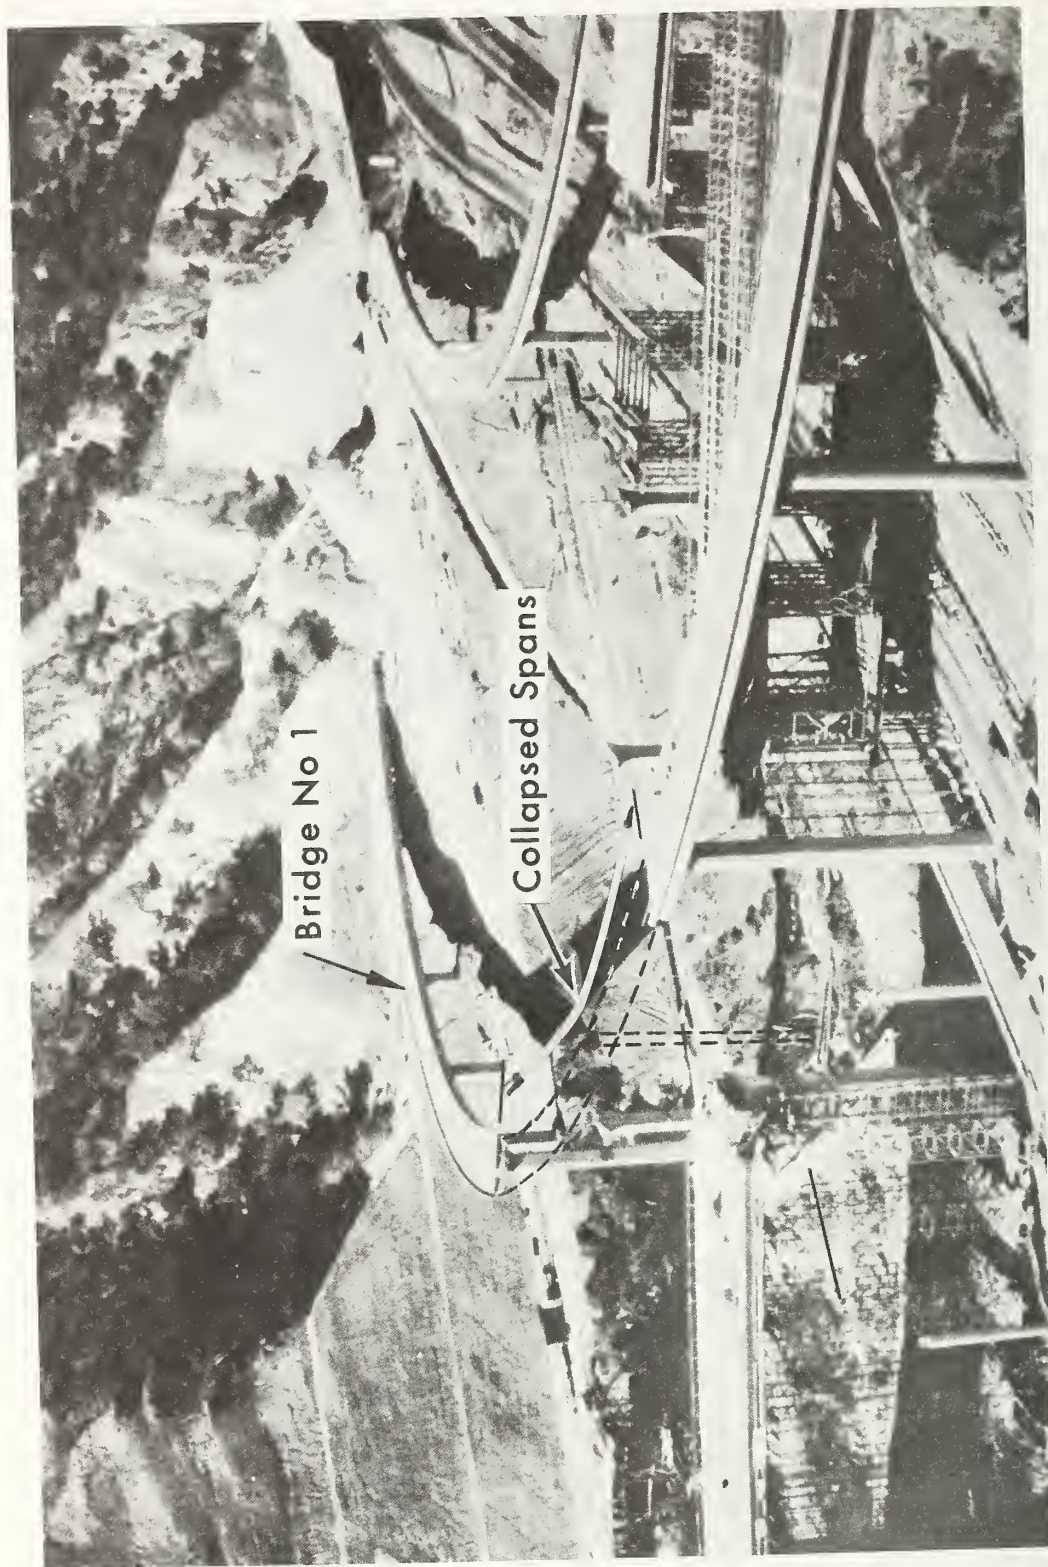
Figure 7.2 Collapse of the South Connector Overcrossing at Palmdale interchange.

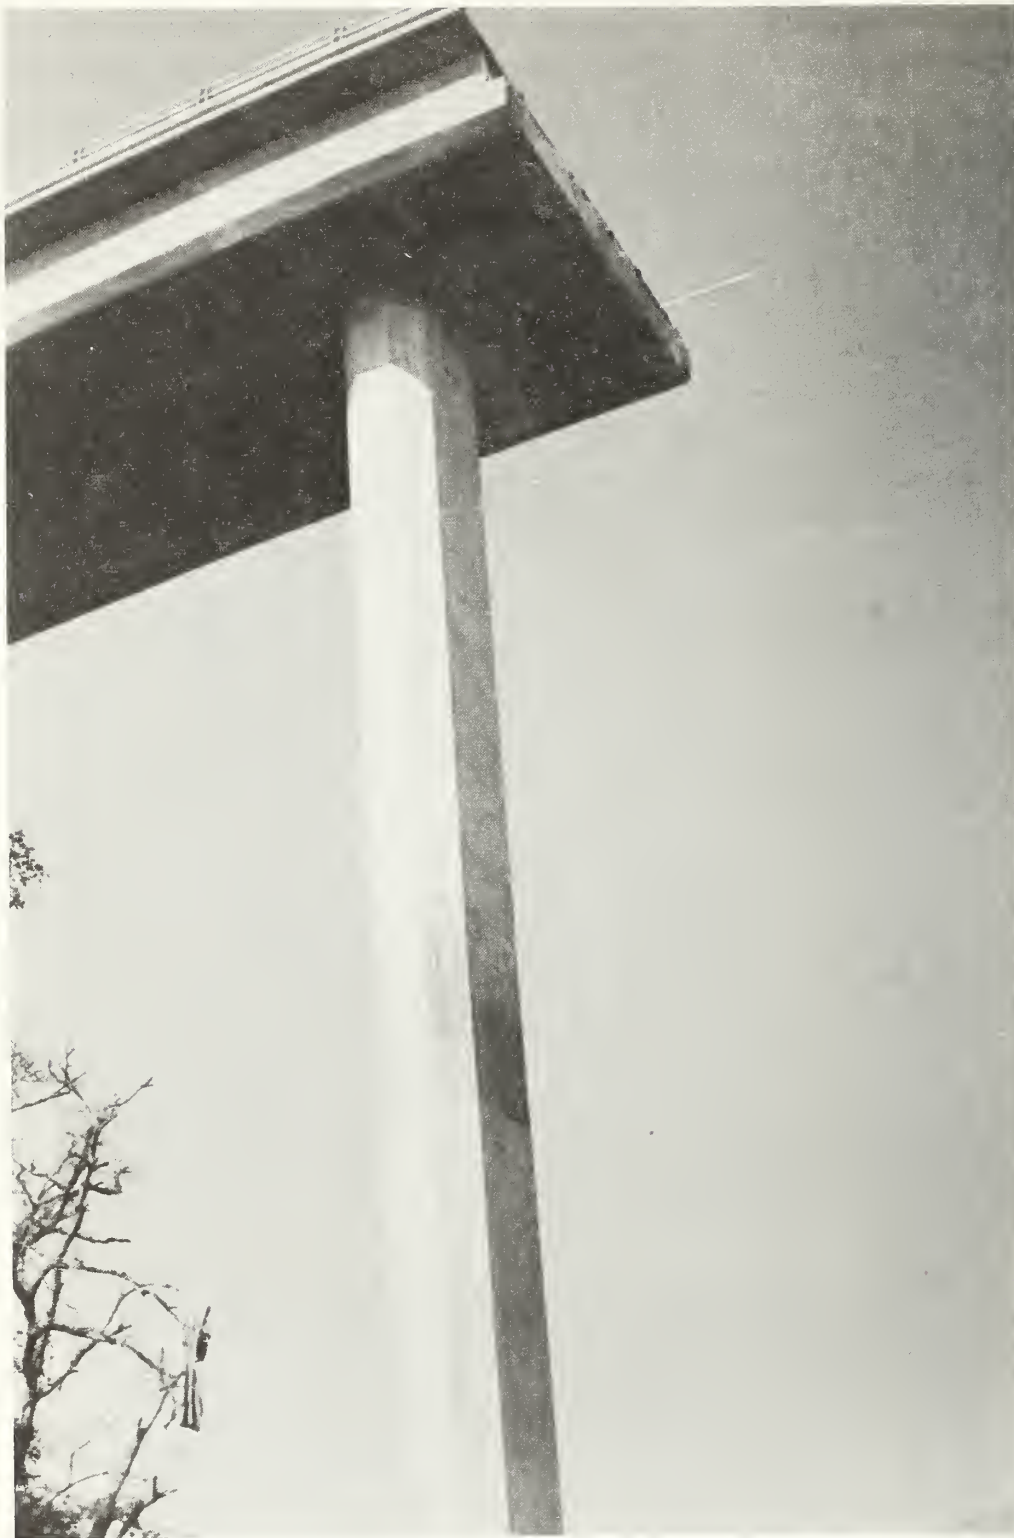
Figure 7.5 Post-failure view of Pier 5 and hinge seat.

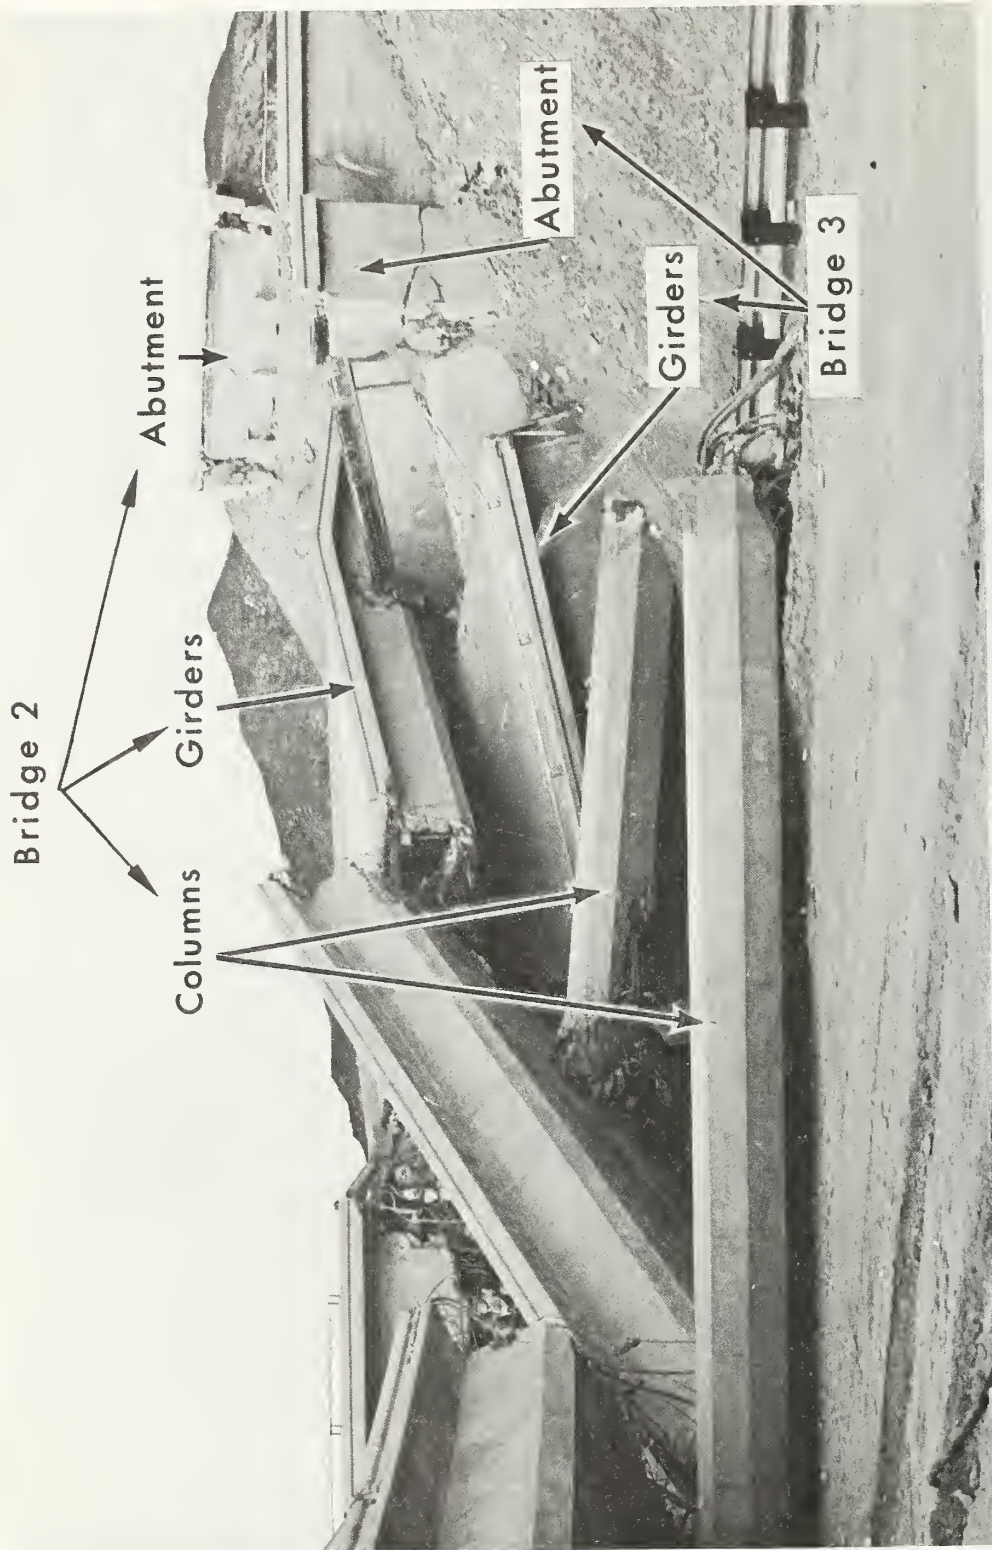
Figure 7.18 Collapsed girders and columns of the IS 210/5 Separation and Overhead structure (Bridge 2) on top of the collapsed Northwest Connector Overcrossing bridge (Bridge 3).

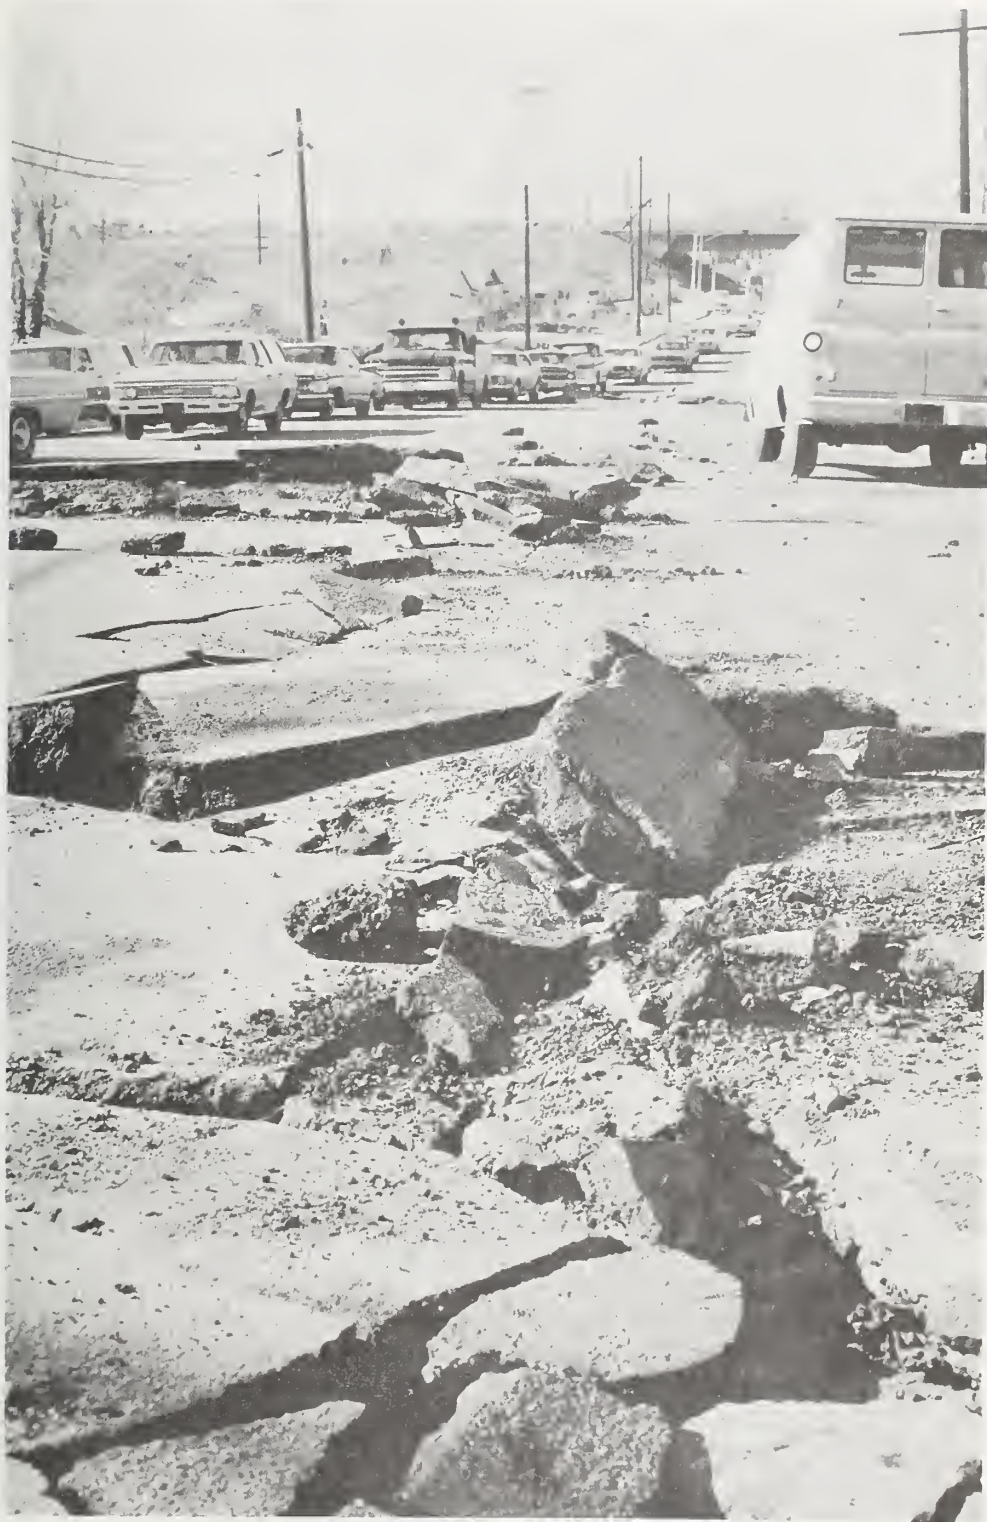
Figure 7.43 Buckled street in Sylmar near Harding Elementary School. (Los Angeles Times Photo.)

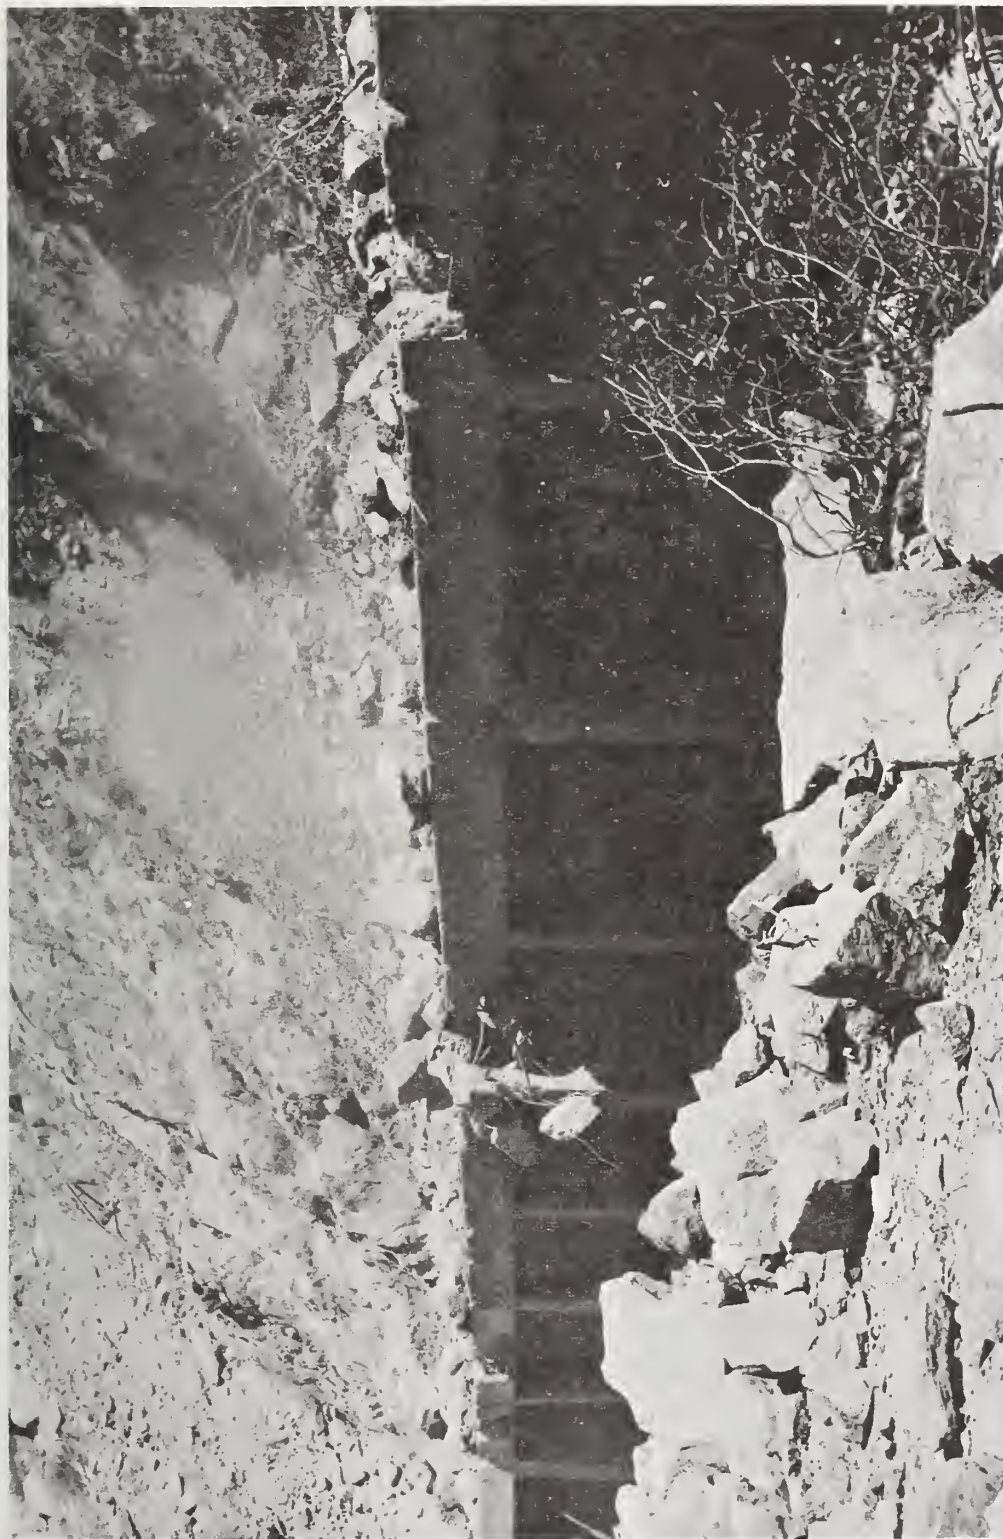
Figure 8.29 Slides on access road along covered walkway,
Pacoima Dam.
