NIST NCSTAR 1-1C

**Federal Building and Fire Safety Investigation of the
World Trade Center Disaster**

Maintenance and Modifications to Structural Systems

September 2005

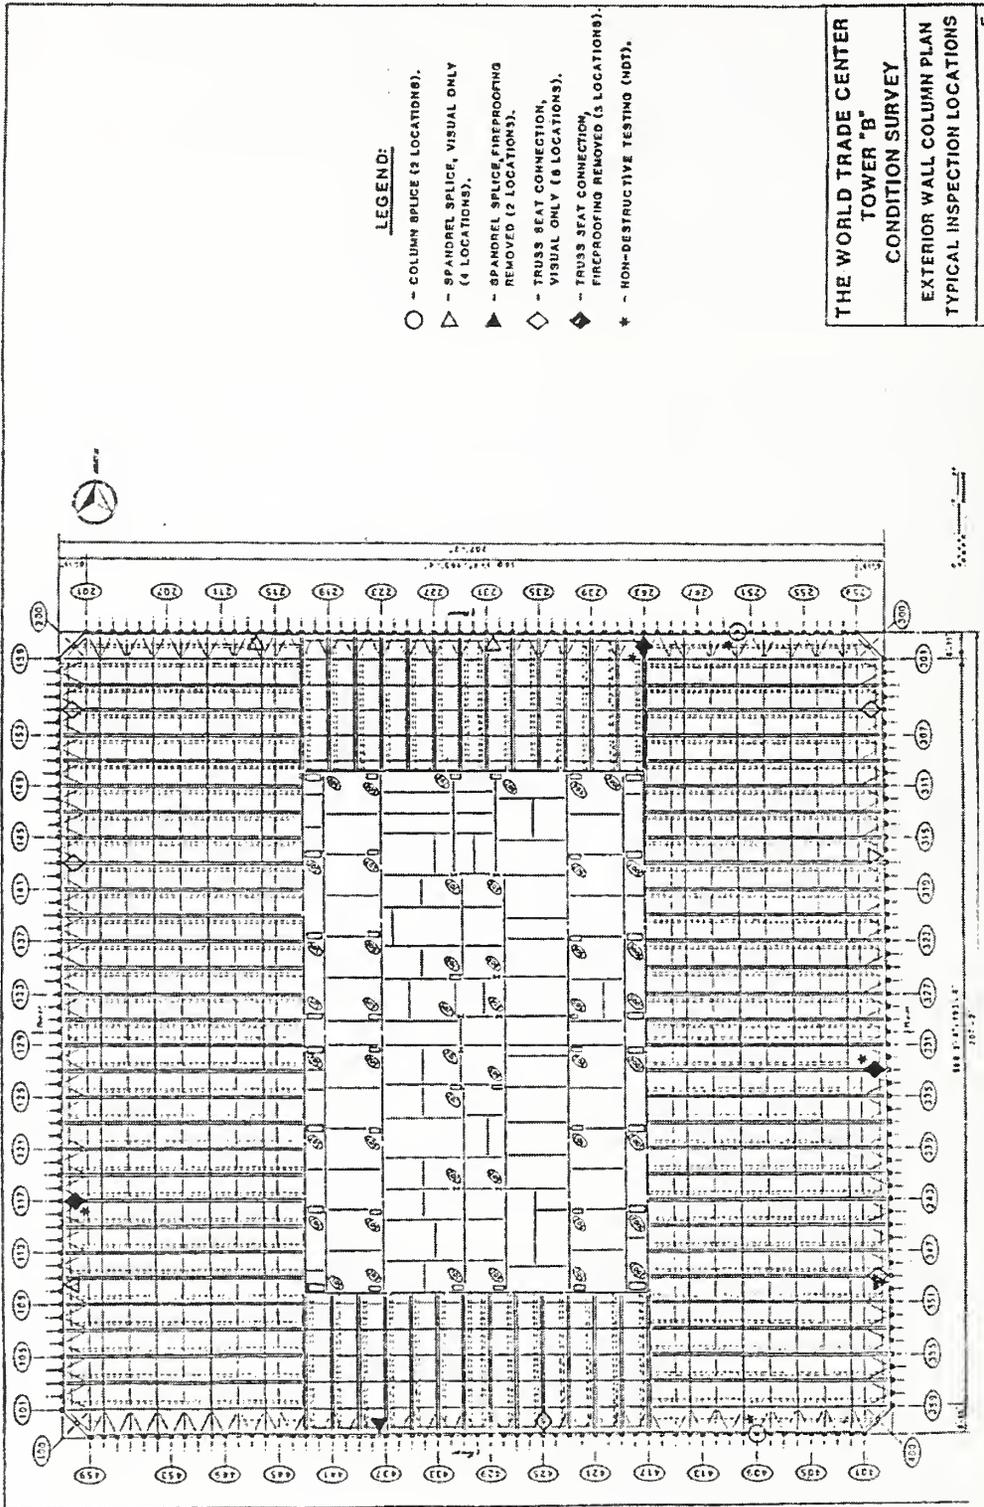
Figure 3-1. Typical inspection locations of exterior wall per 1990 Condition Survey Report of WTC 2.

Inspection of the exterior walls was made from inside the building. Inspection locations are indicated in Fig. 3–1, which is Drawing 5 from the report (PANYNJ 1990).

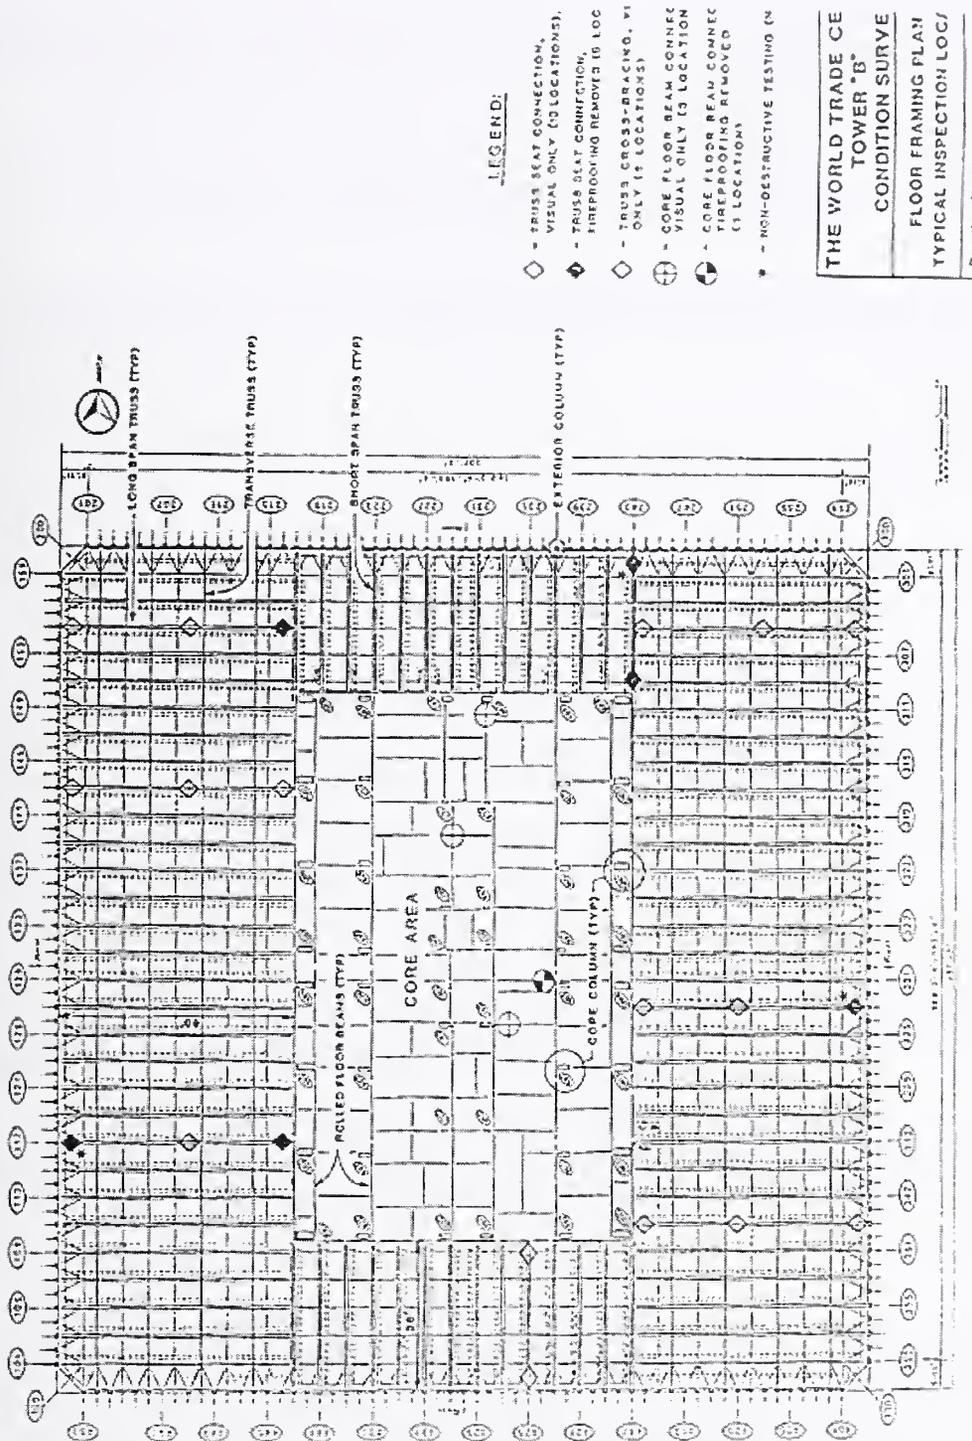
Source: PANYNJ 1990. Reproduced with permission of The Port Authority of New York and New Jersey.
Figure 3-3. Typical inspection locations of floor framing per the 1990 Condition Survey Report of WTC 2.

Floors 9 through 41—Floor framing inspected in this zone was found to be in good condition. Light corrosion was observed on all core beams and beam connections, and on main truss connections on floors 28 and 37.

According to the report, the most significant deficiencies in this zone were found at the damping units (see Table C-1 in the survey report). Damping units on floors 18 and 37 were observed to be missing one fastener at each unit. Two fasteners were found to be missing in one damping unit on floor 29, as well as on floor 38. Also, at floor 38, a damping unit was observed to be missing four fasteners. According to the structural drawings (WSHJ 1967a), four fasteners were required to connect the damping unit to the member attached to the bottom chord of the floor truss, and two fasteners were required to connect the damping unit to the exterior column.

Floors 43 through 75—The floor framing in this zone was also found to be in good condition. Light corrosion was observed on the same members as in the previous zone.

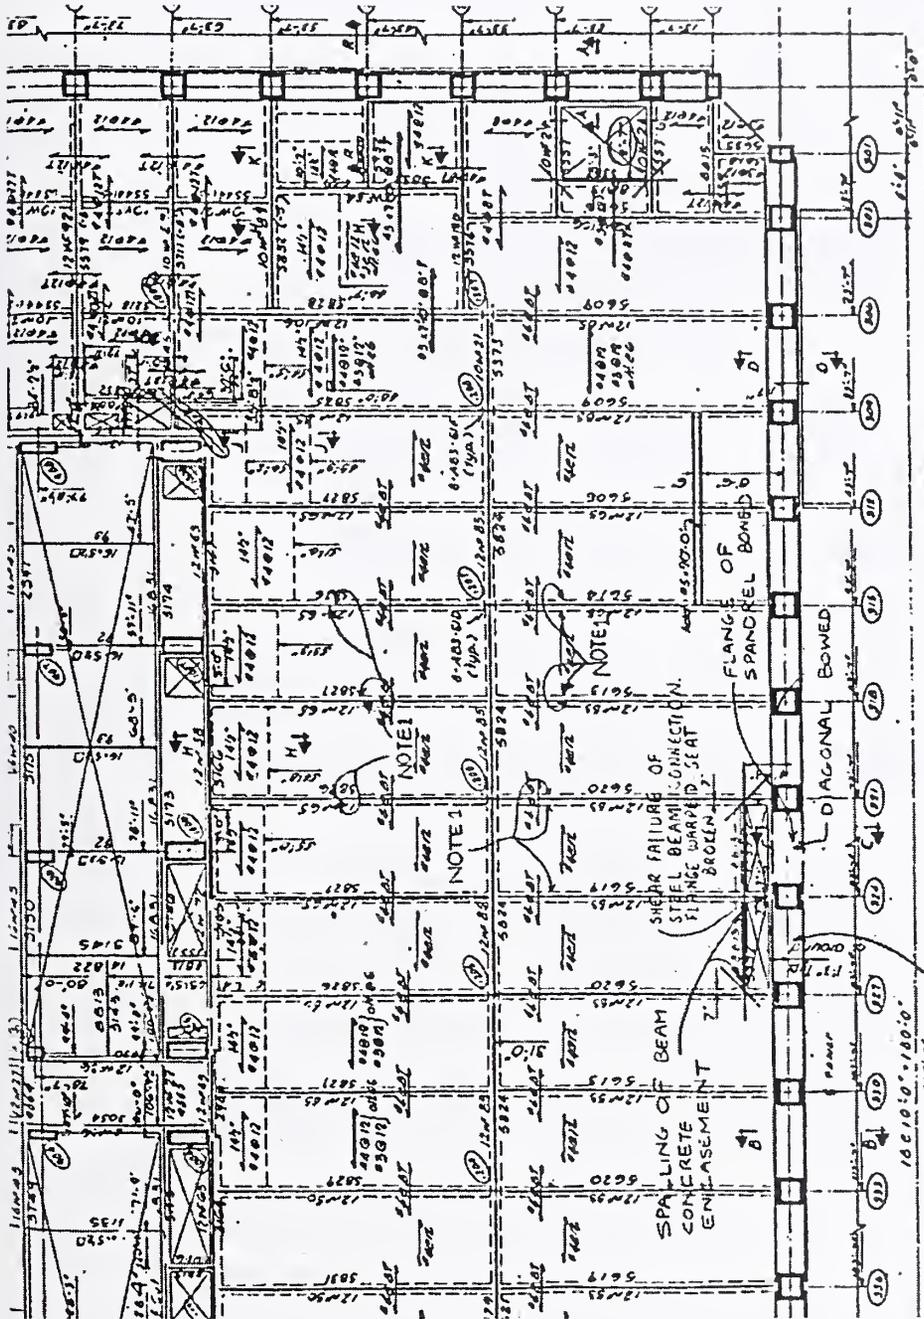
Figure 4-1. Damage assessment for WTC 1 at Level B1.

DIAGONAL MISSING

NOTE 1 -> SEPARATION OF SLAB FROM BEAM
CONCRETE ENCASEMENT
