**NBSIR 87-3667**

# The Whittier Narrows Earthquake of October 1, 1987

## A Reconnaissance Report

By H. S. Lew

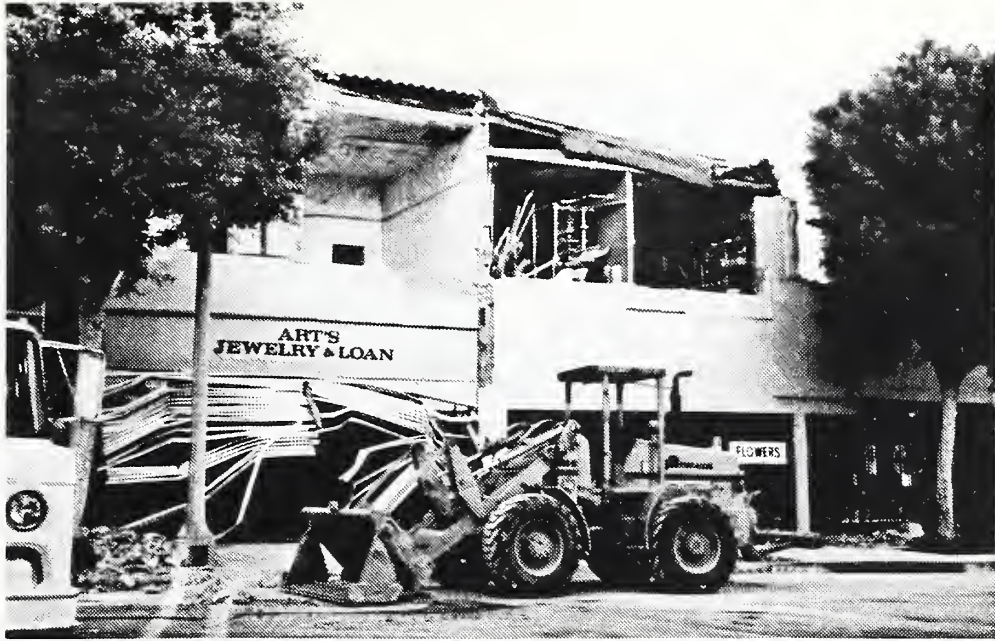
Photo 1 Total collapse of brick masonry wall of 2-story unreinforced masonry building in Uptown, Whittier.

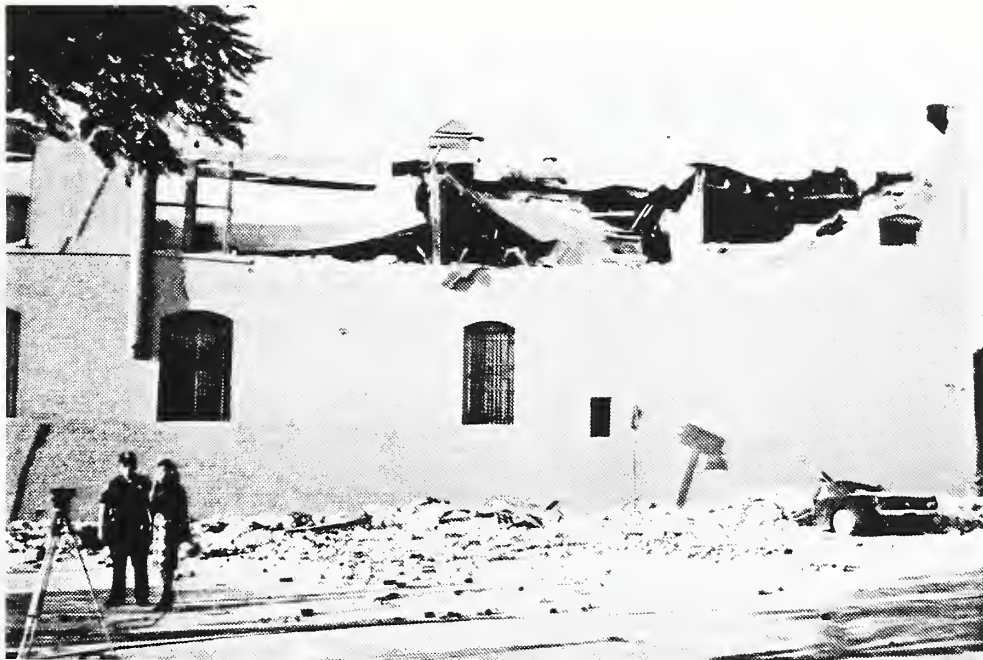
Photo 2 Collapsed unreinforced brick parapet and wall of a building in Uptown, Whittier. Falling bricks crushed cars parked adjacent to the building.

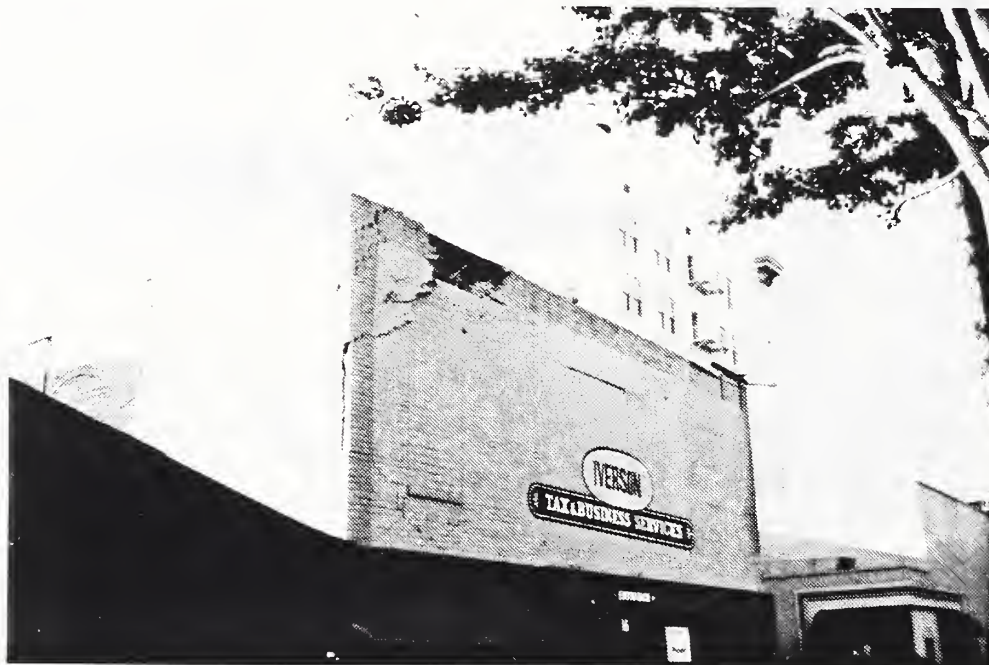
Photo 4 Partially collapsed and severely cracked unreinforced brick wall, Whittier.

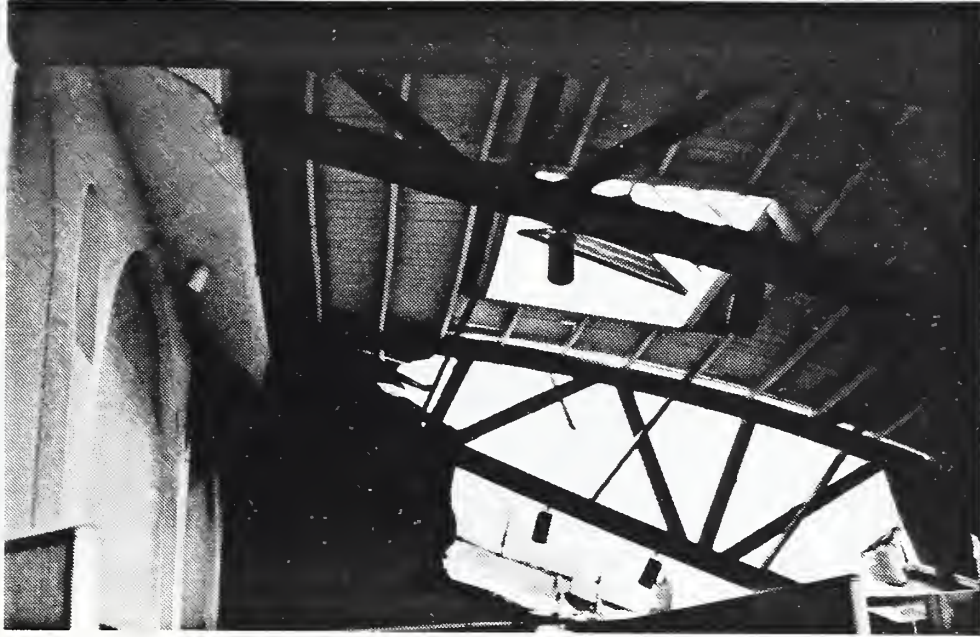
Photo 5 Wood trusses fell from a damaged masonry wall resulting in a partial collapse of the roof of a store, Whittier.

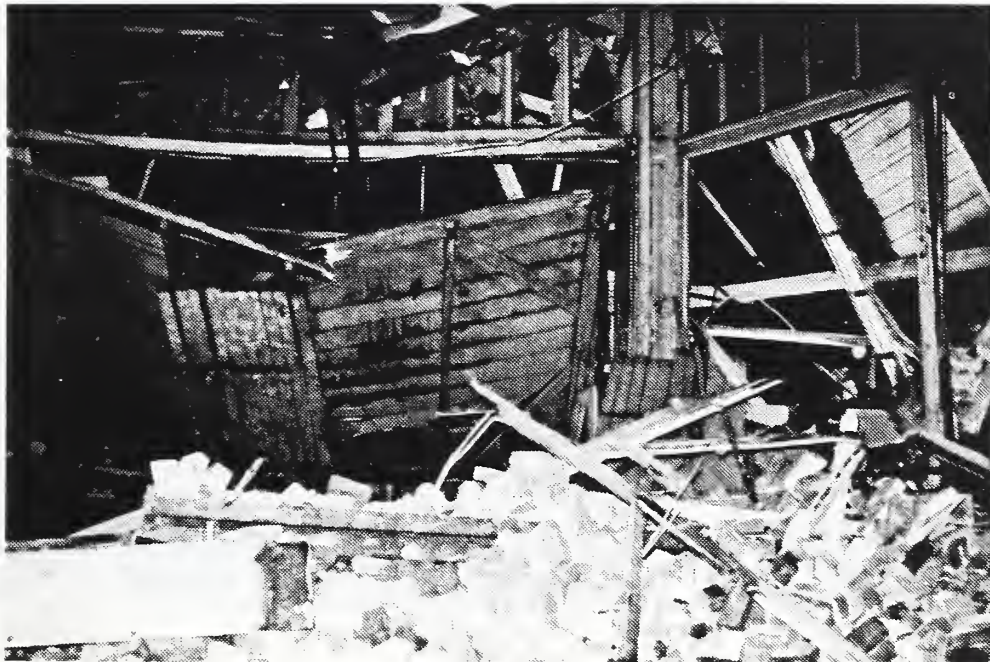
Photo 6 Masonry parapet of a three-story unreinforced masonry building fell, causing the collapse of an adjacent building, Pasadena.

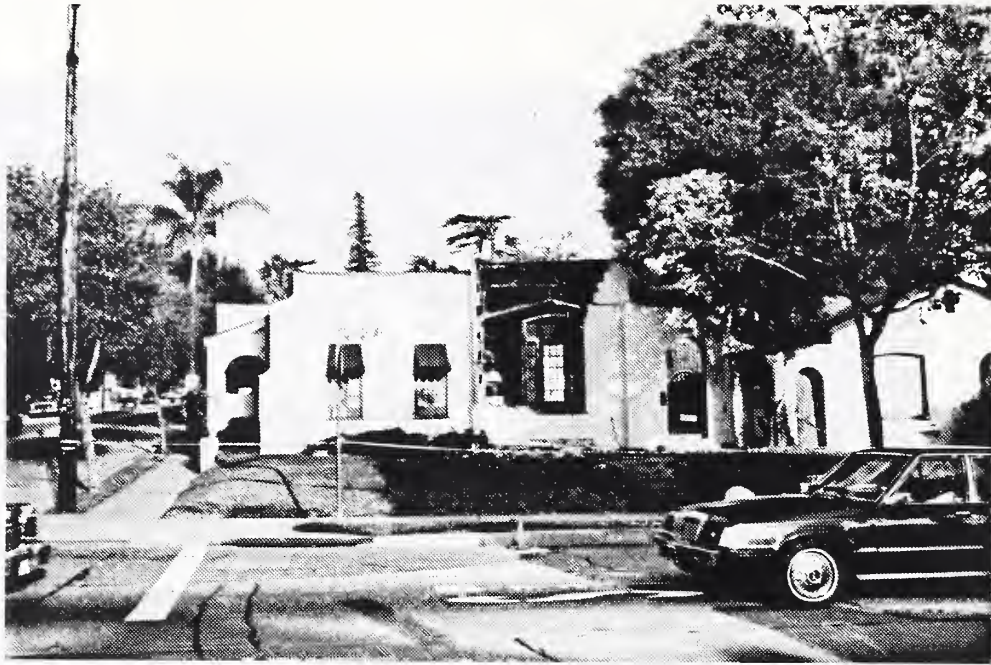
Photo 7 Many houses with unreinforced hollow clay tile walls sustained severe damage. This house at the corner of Greenleaf Avenue and Beverly Blvd. in Whittier lost the front wall.

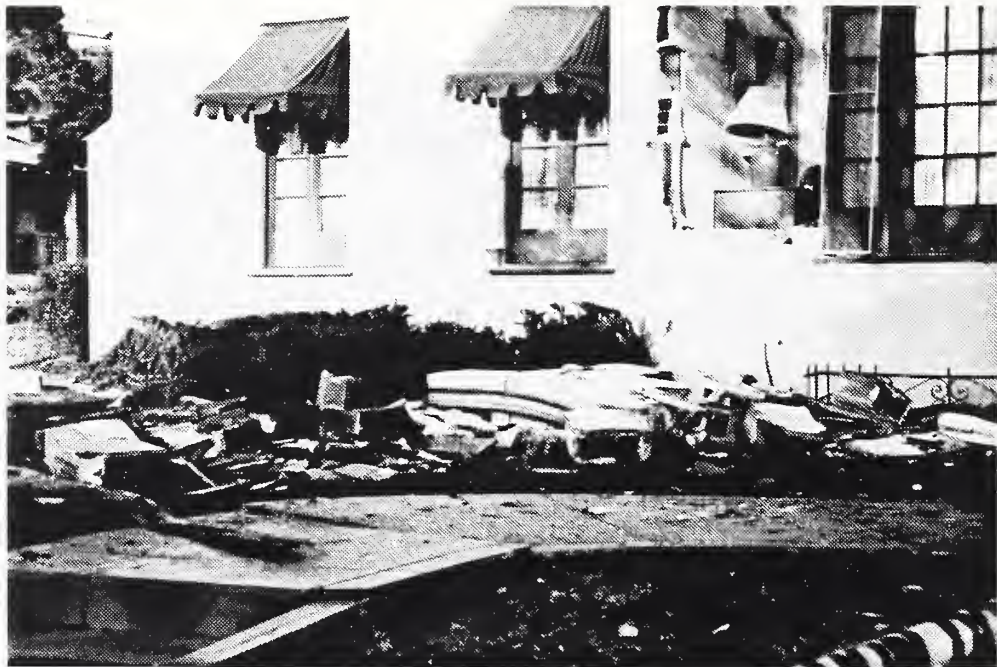
Photo 8 Large pieces of clay tile fell on the front yard of the house shown in Photo 7.

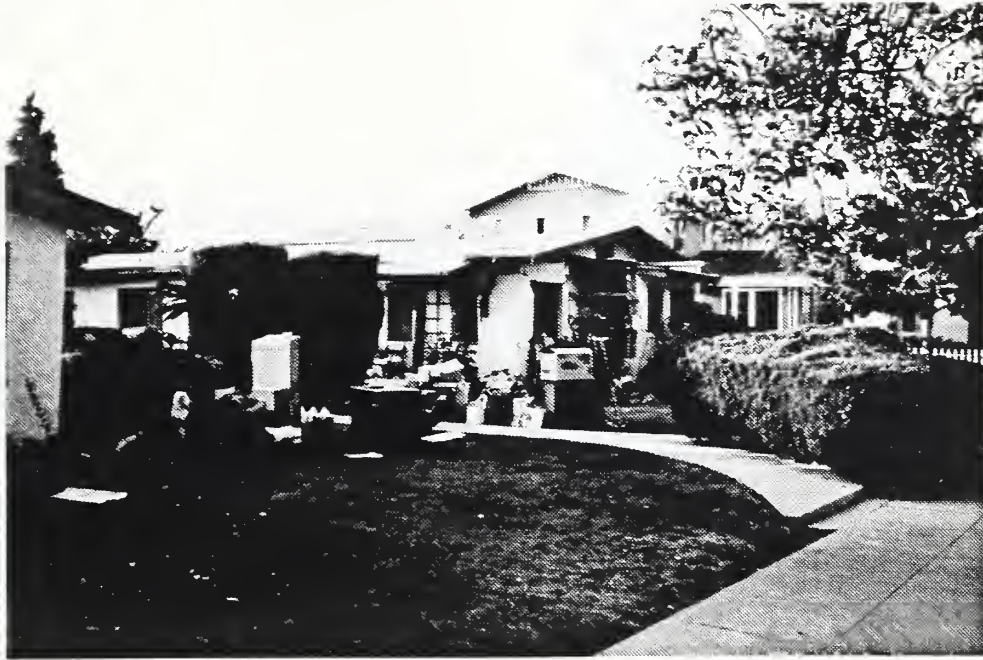
Photo 9 This house on Greenleaf Avenue lost part of the entrance and sustained severe cracks in the walls of unreinforced hollow clay tile.

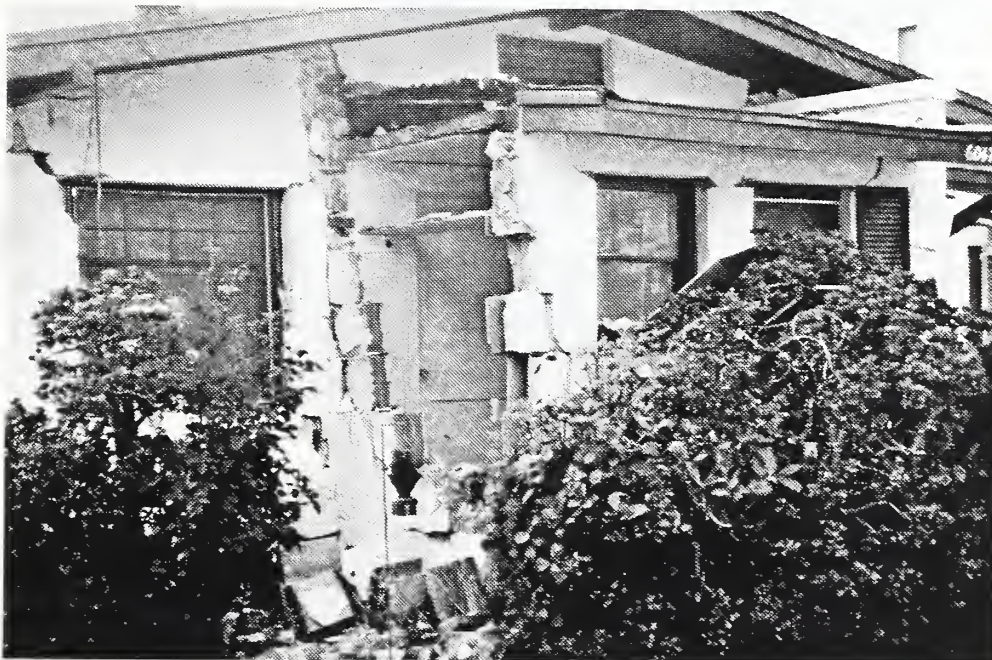
Photo 10 Close-up view of the partially-collapsed front entrance to the house in Photo 9. Exterior walls were unreinforced clay tile and stucco.

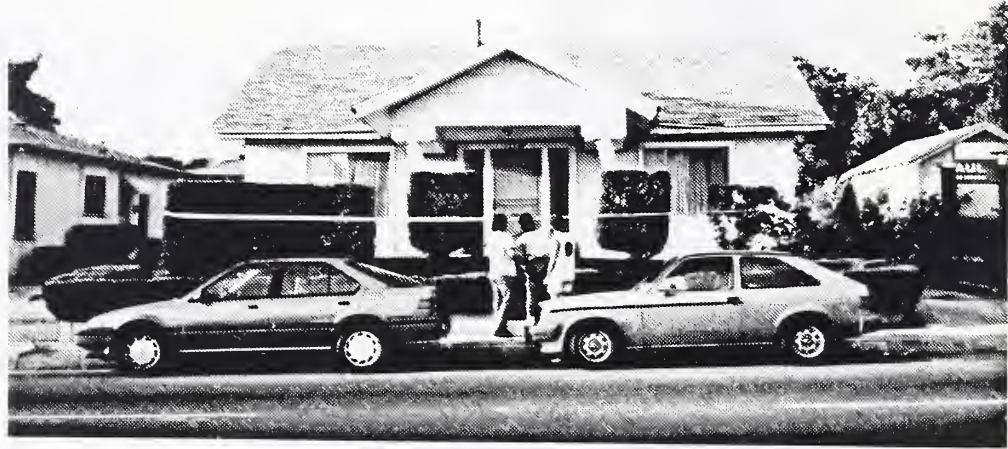
Photo 11 A wood-frame house on Beverly Blvd., Whittier, was damaged severely when it slid off its foundation wall.

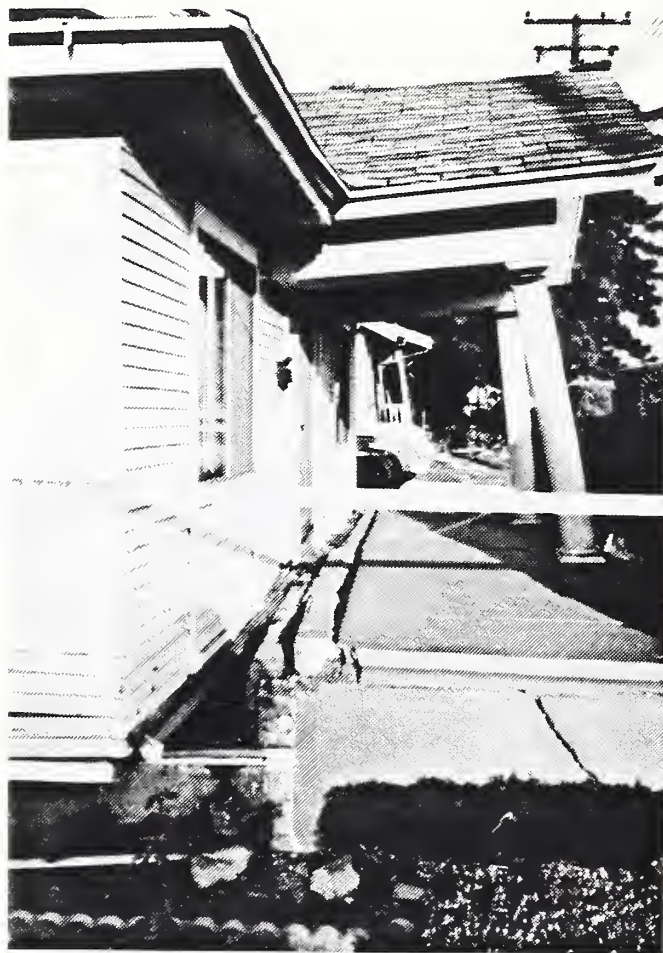
Photo 12

The house in Photo 11 dropped vertically about one ft. and moved laterally about one and a half ft.

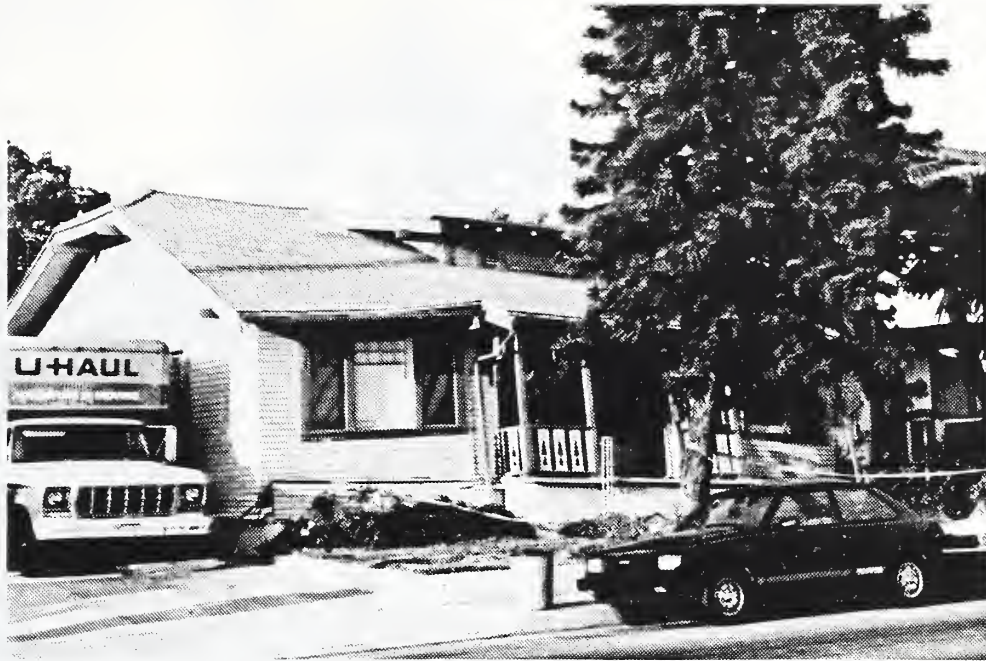
Photo 13 A wood-frame house adjacent to the house in Photo 11 on Beverly Blvd., Whittier, also sustained severe damage when the earthquake dislodged the house from its foundation wall.

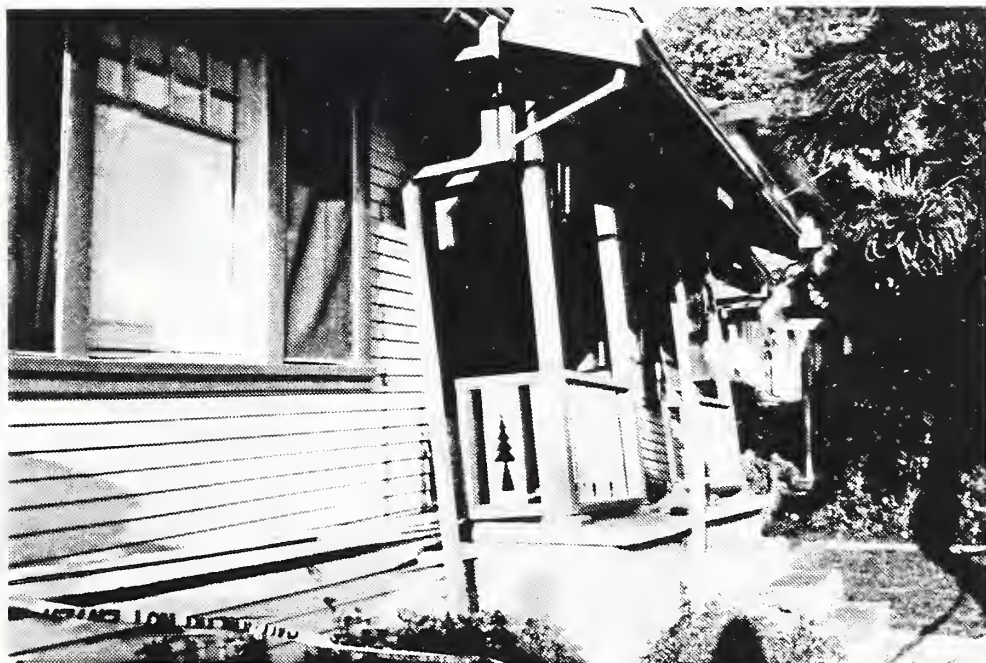
Photo 14 Close-up view of the house in Photo 13.

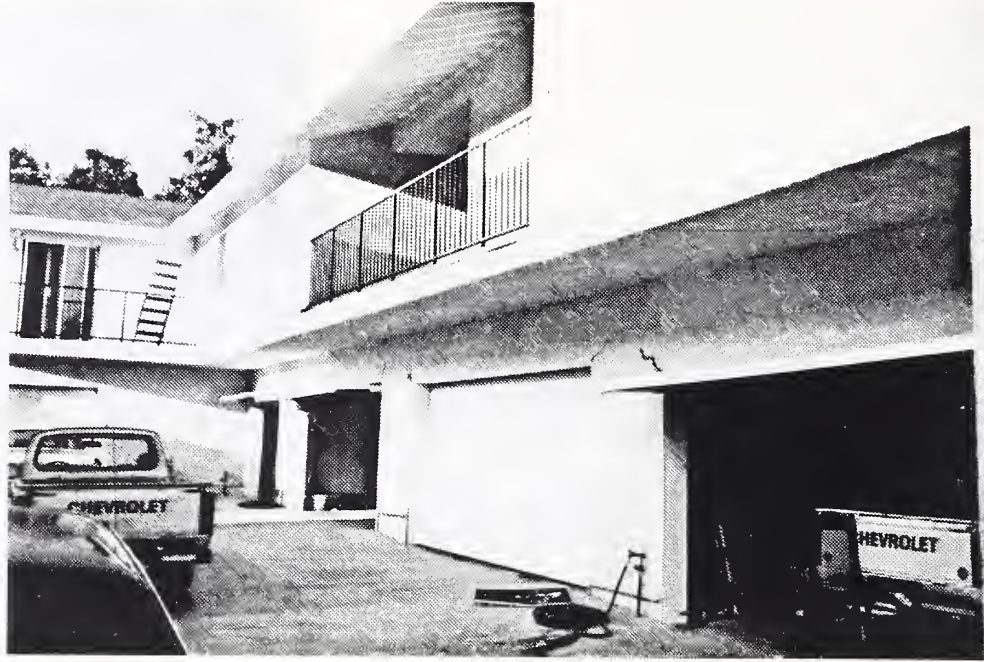
Photo 15 Damaged two-story wood frame apartment building in Whittier. Large garage door openings reduced the stiffness of the wall in the plane of the garage doors and reduced the resistance to lateral loads.

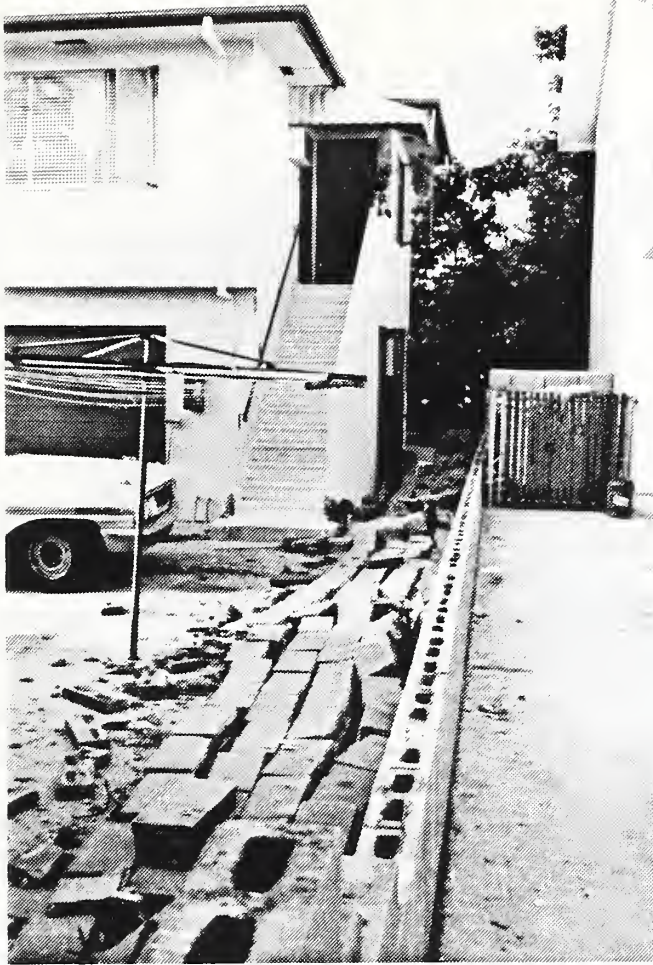
Photo 17

Collapsed unreinforced concrete block wall in the residential section of Whittier.

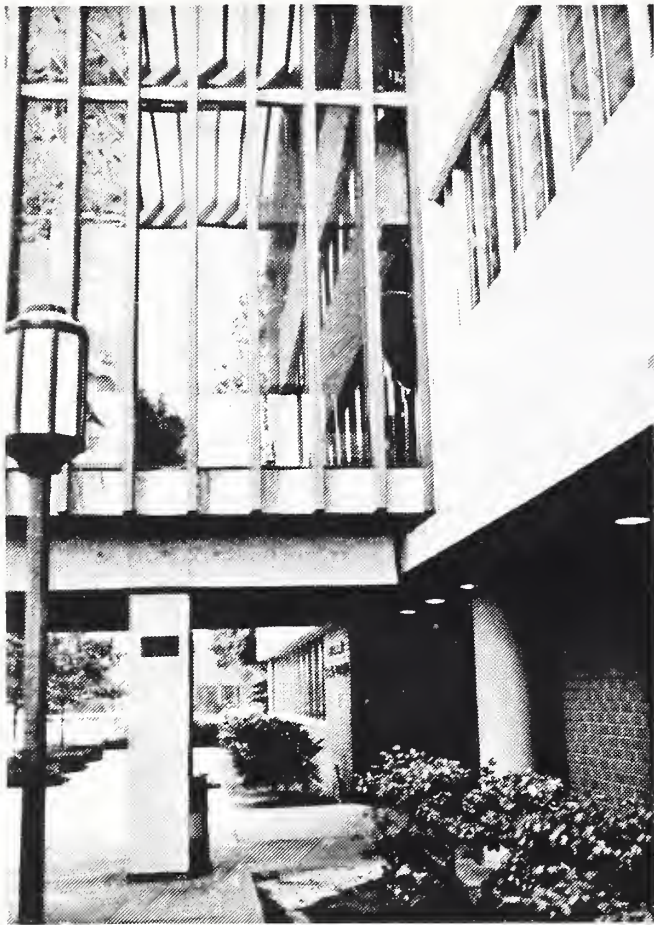
Photo 19

Glass panels at both ends of the walkway structure were broken due to an inadequate gap in the connection joint.

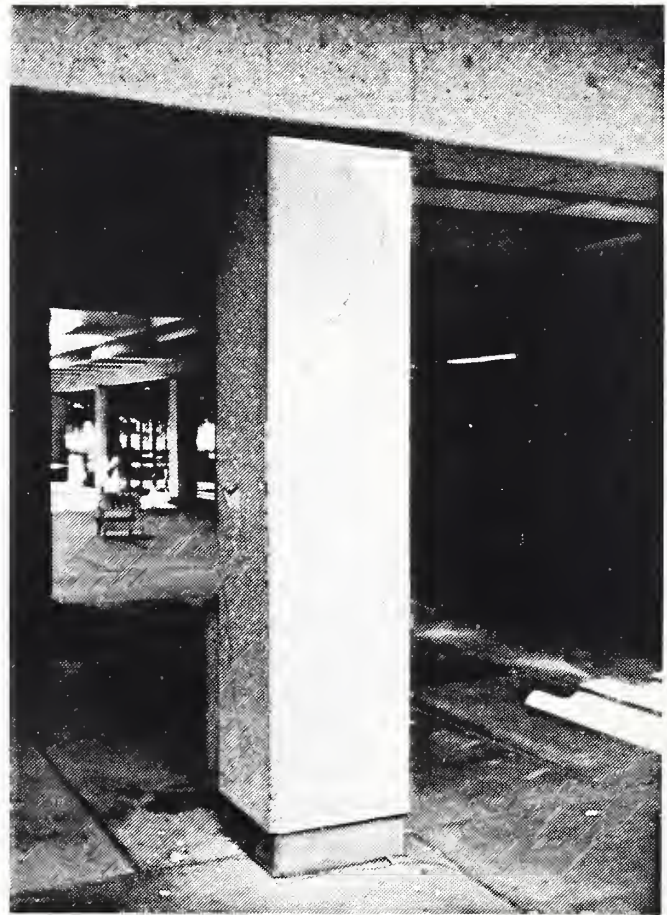
Photo 20

Cracks developed in some of the first-story columns of the walkway structure.

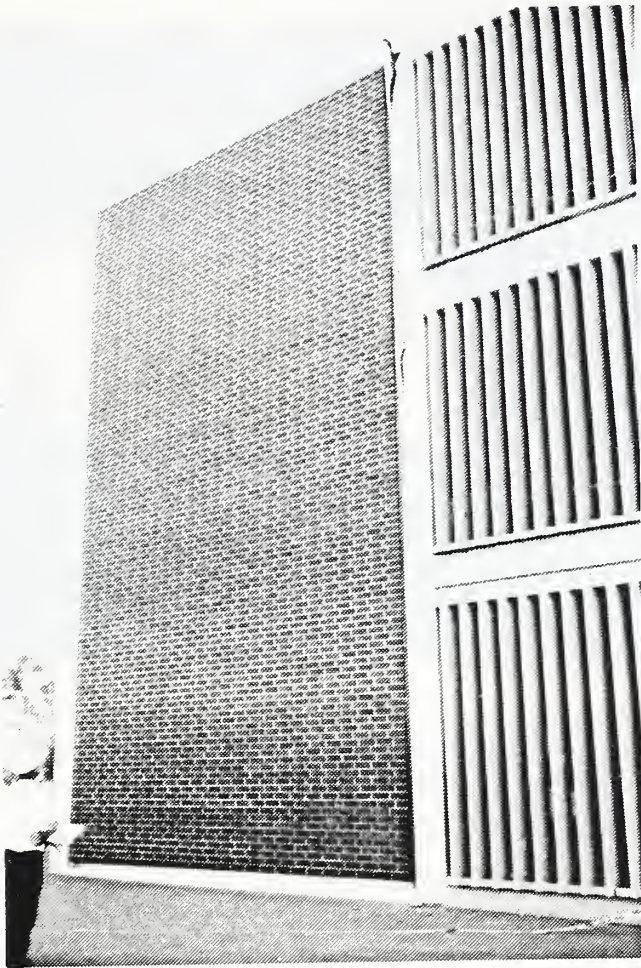
Photo 21

A class room building on the California State University campus. The exterior concrete frame for the precast concrete sun screen was damaged due to pounding of two structurally separated sections of the building.

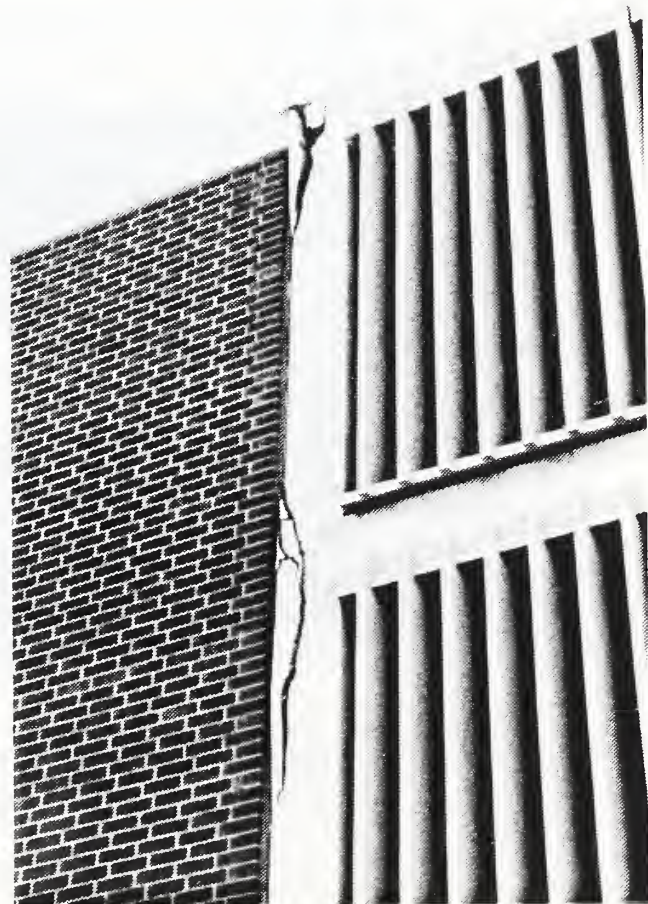
Photo 22

Close-up view of the damaged concrete frame.

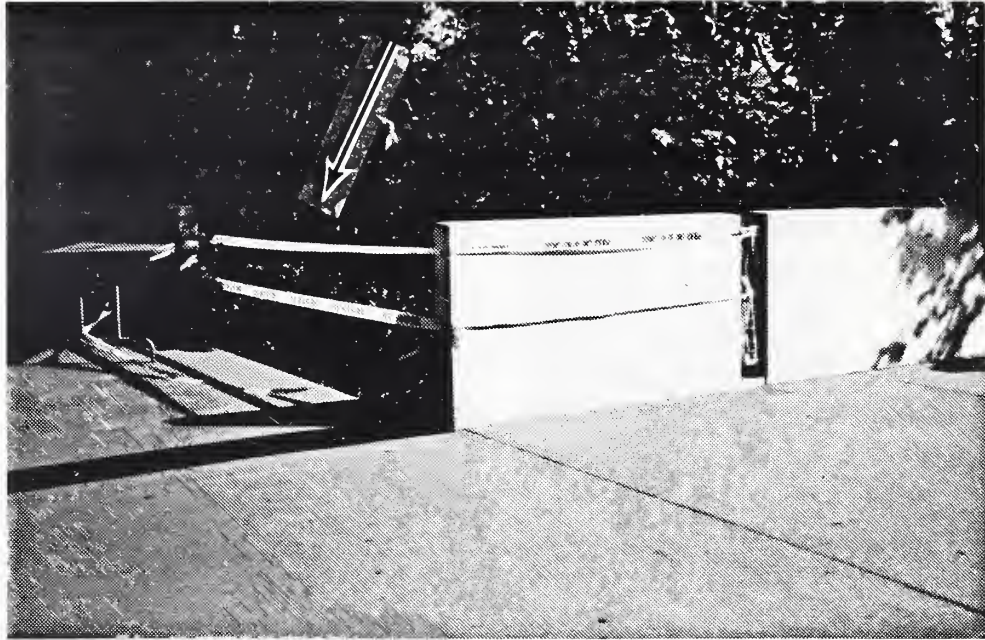
Photo 23 A precast concrete fascia unit fell when anchors held it to the concrete frame failed.

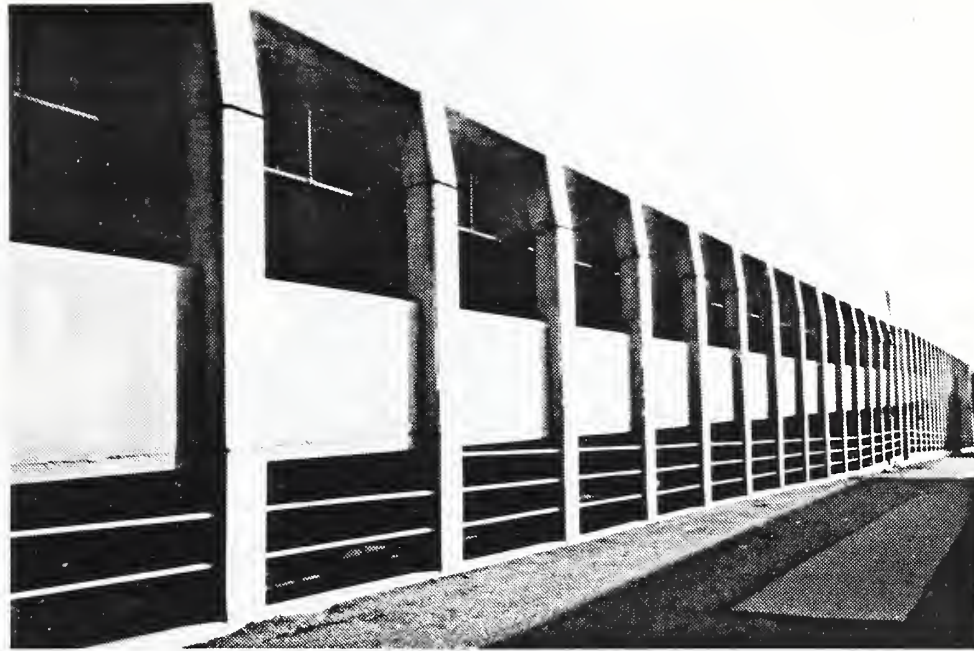
Photo 25 A damaged reinforced concrete parking garage at the Whittier Quad shopping center. Deep beams at the columns slant toward the inside of the structure due to the loss of support at the other side.

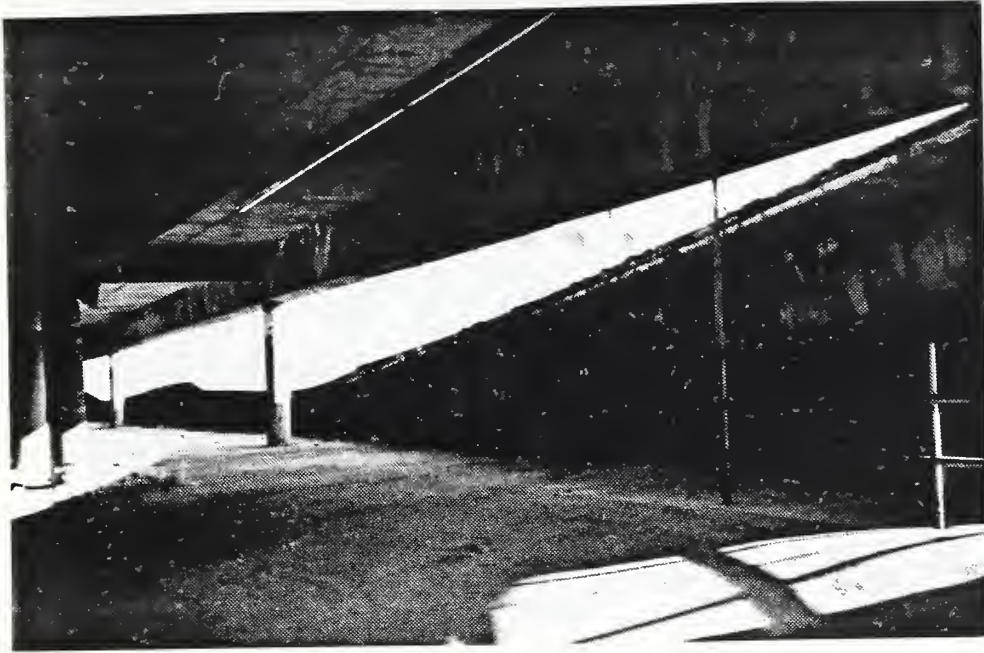
Photo 29 A collapsed upper level portion of the parking garage.

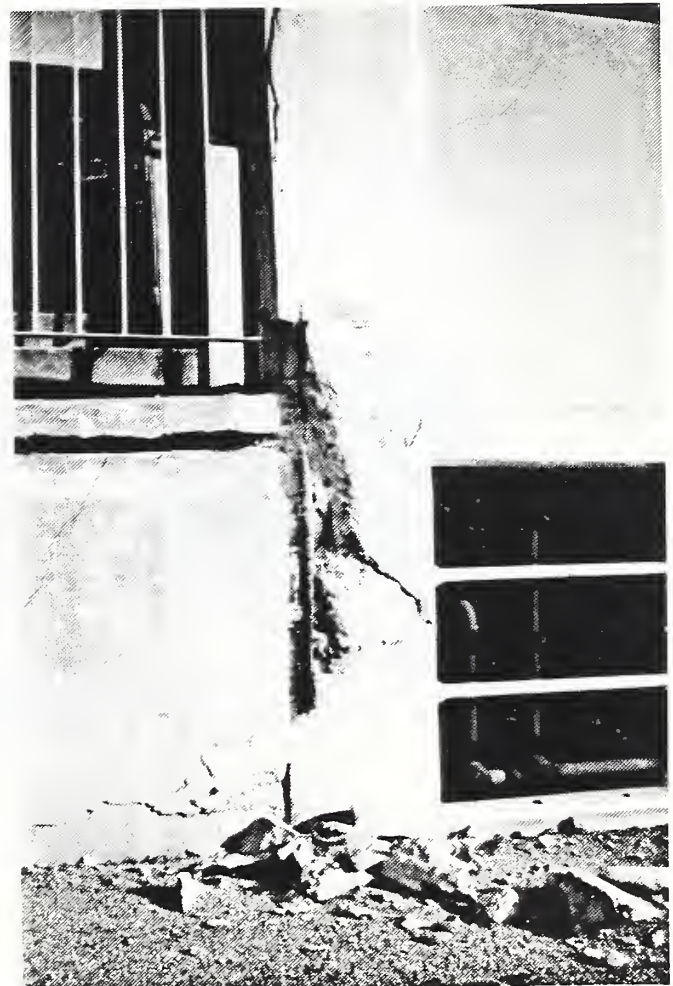
Photo 30

Damage to a concrete column between the ground level and the lower level. Note that no ties are around the vertical bar.

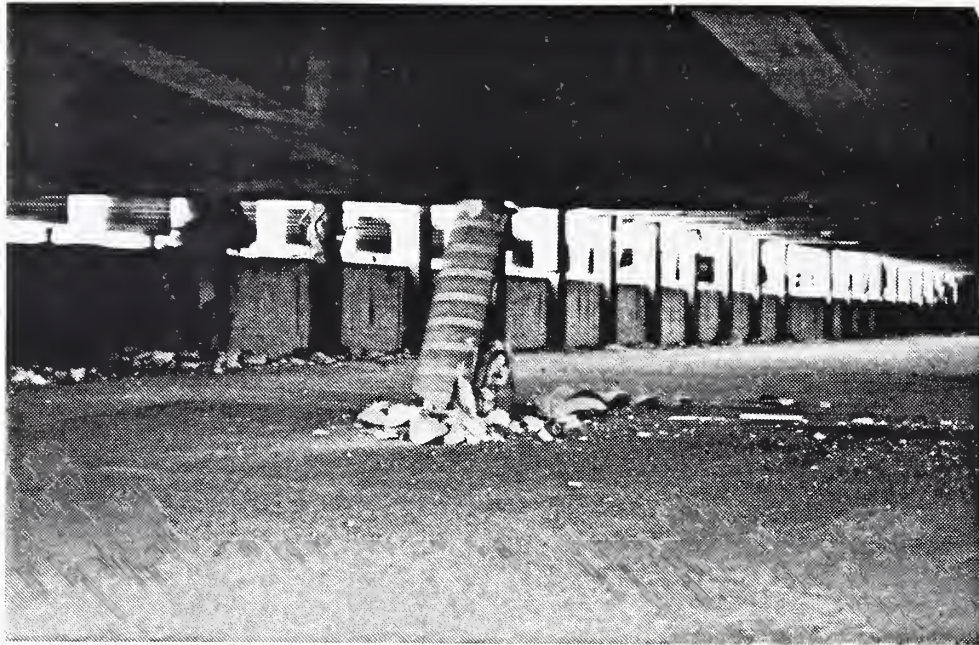
Photo 31 Non-ductile failure of a concrete column in the garage structure.

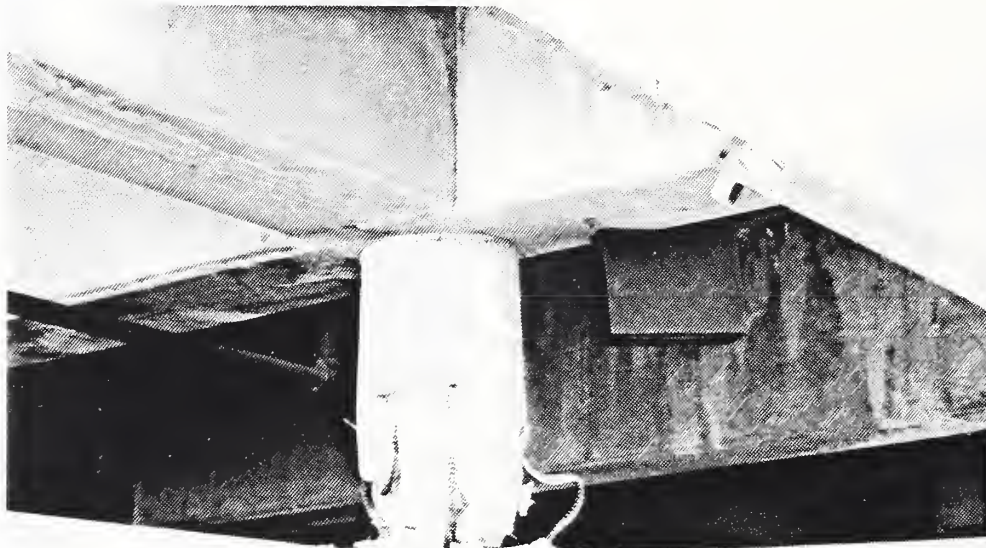
Photo 32 Non-ductile failure of a short column. Note fractured #2 tie and buckled vertical bars.

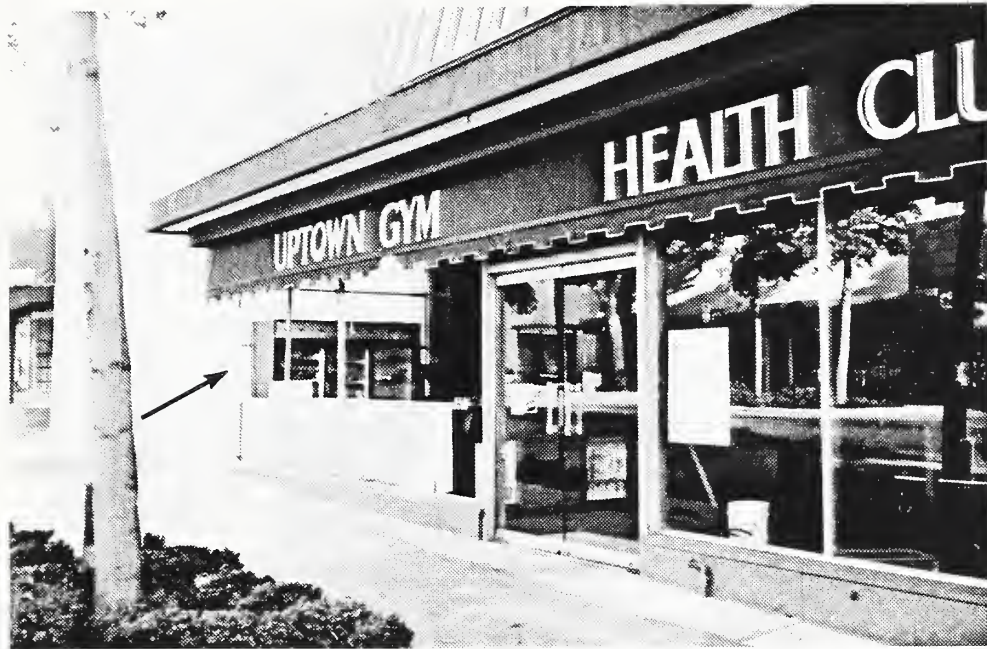
Photo 33 Distortion of the building caused damage to windows at the corner of the building in the Uptown Whittier shopping section.

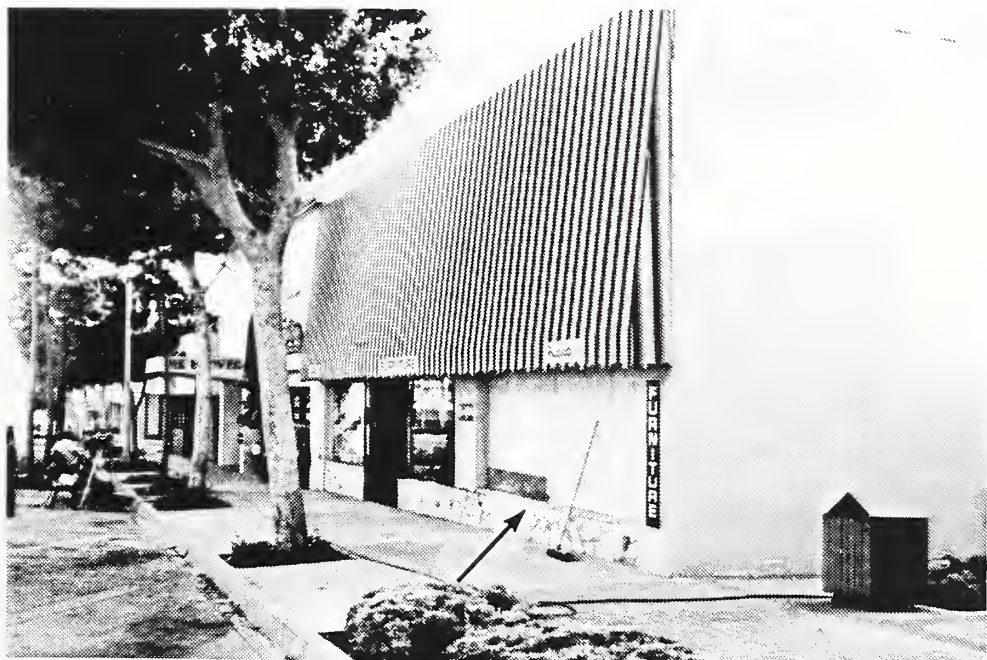
Photo 34 Damage glass in a store in the Uptown Whittier shopping section.

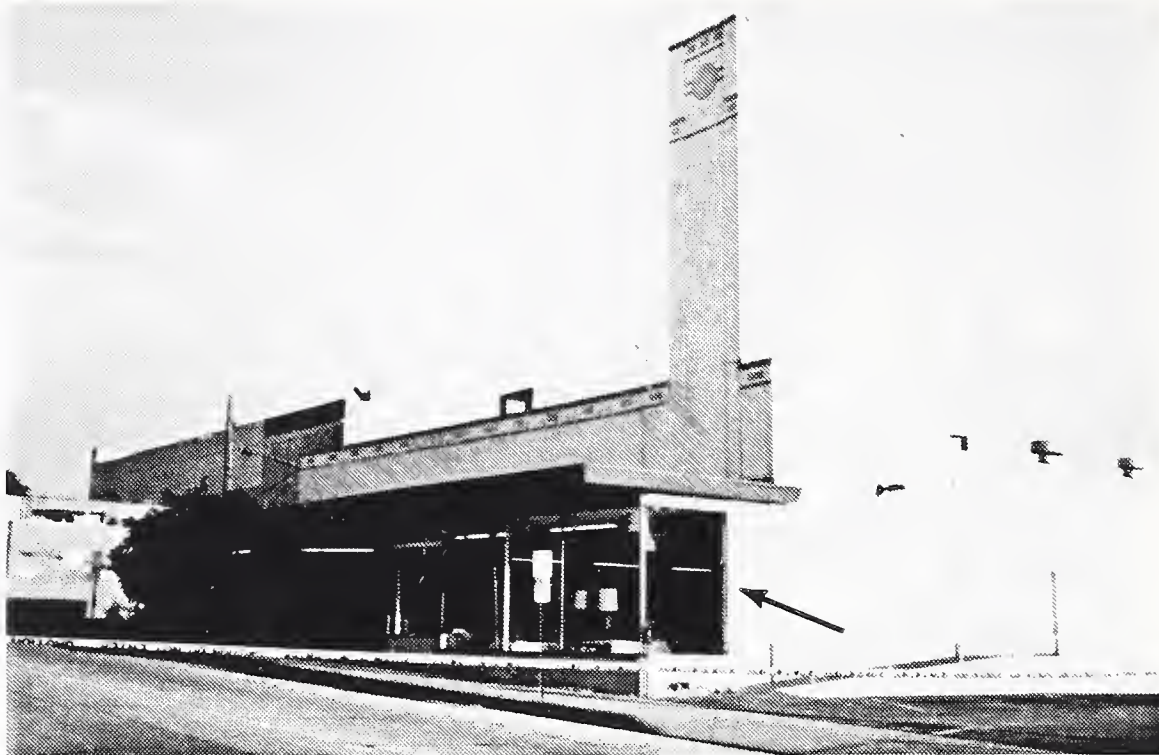
Photo 35 This remodeled masonry building experienced considerable damage to windows. Because large pieces of broken glass were strewn on the sidewalk, the building was cordoned off.

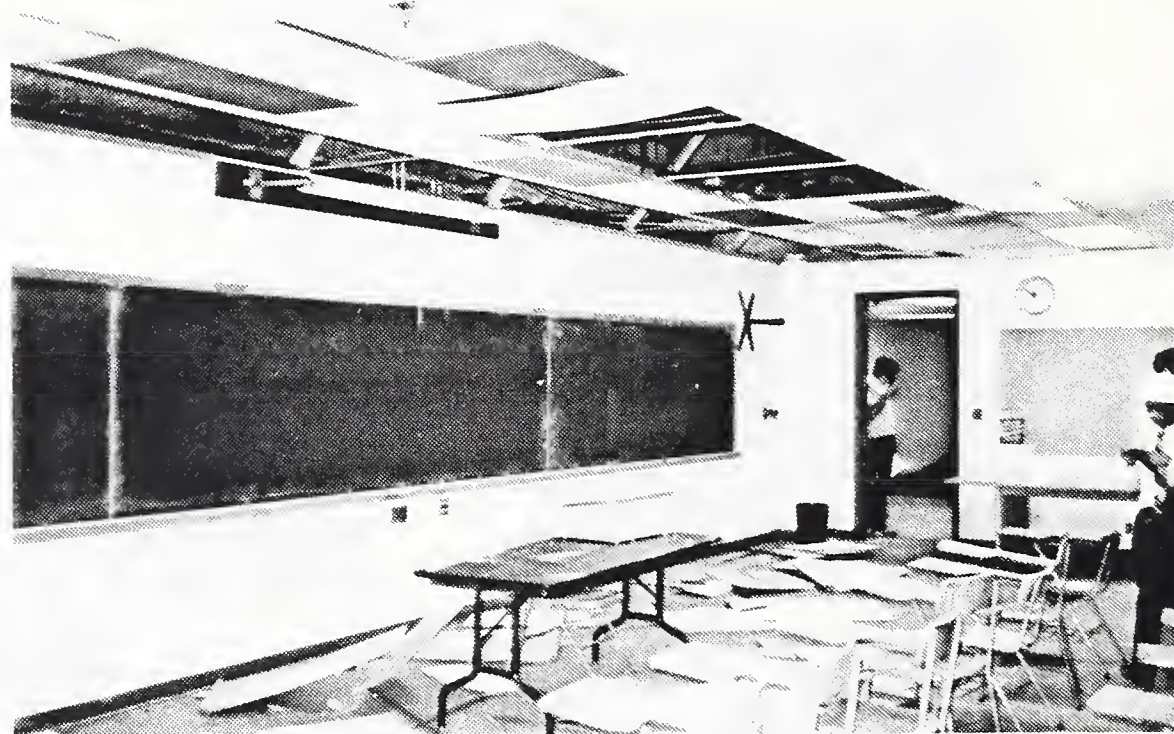
Photo 36 Fallen ceiling tiles in a classroom at the California State University at Los Angeles.

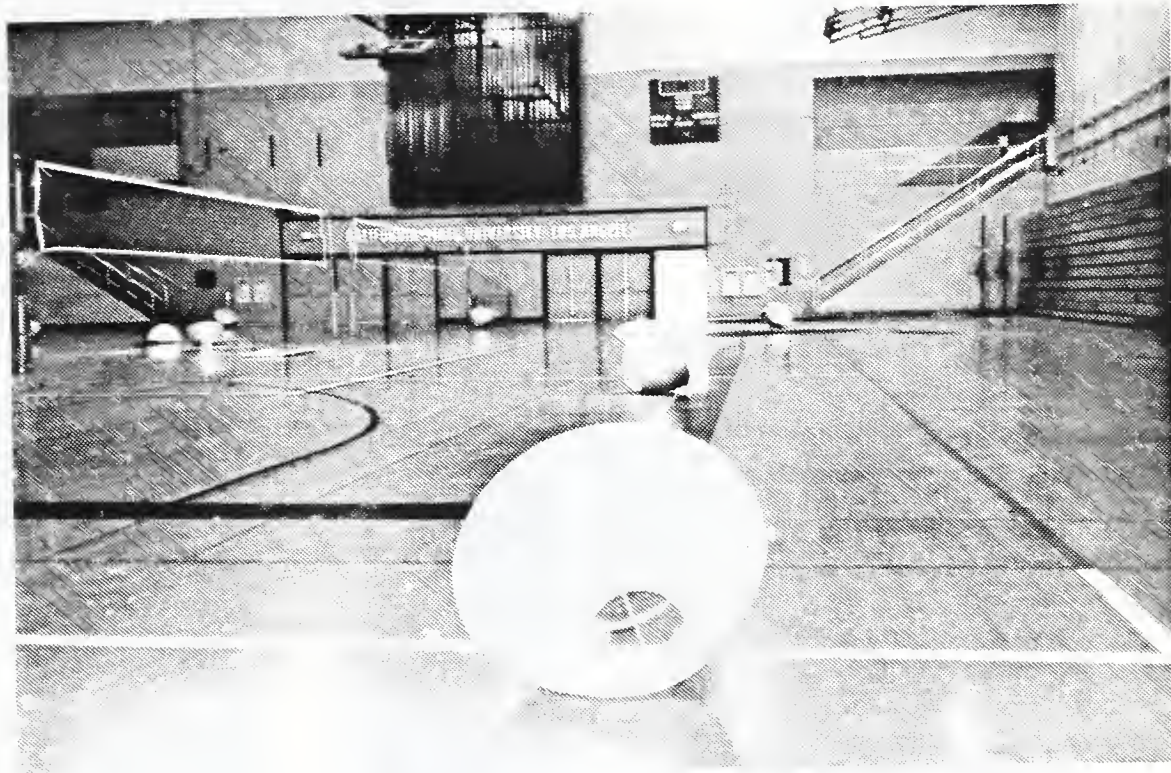
Photo 37 Fallen large light fixtures in the gymnasium at the California State University at Los Angeles.

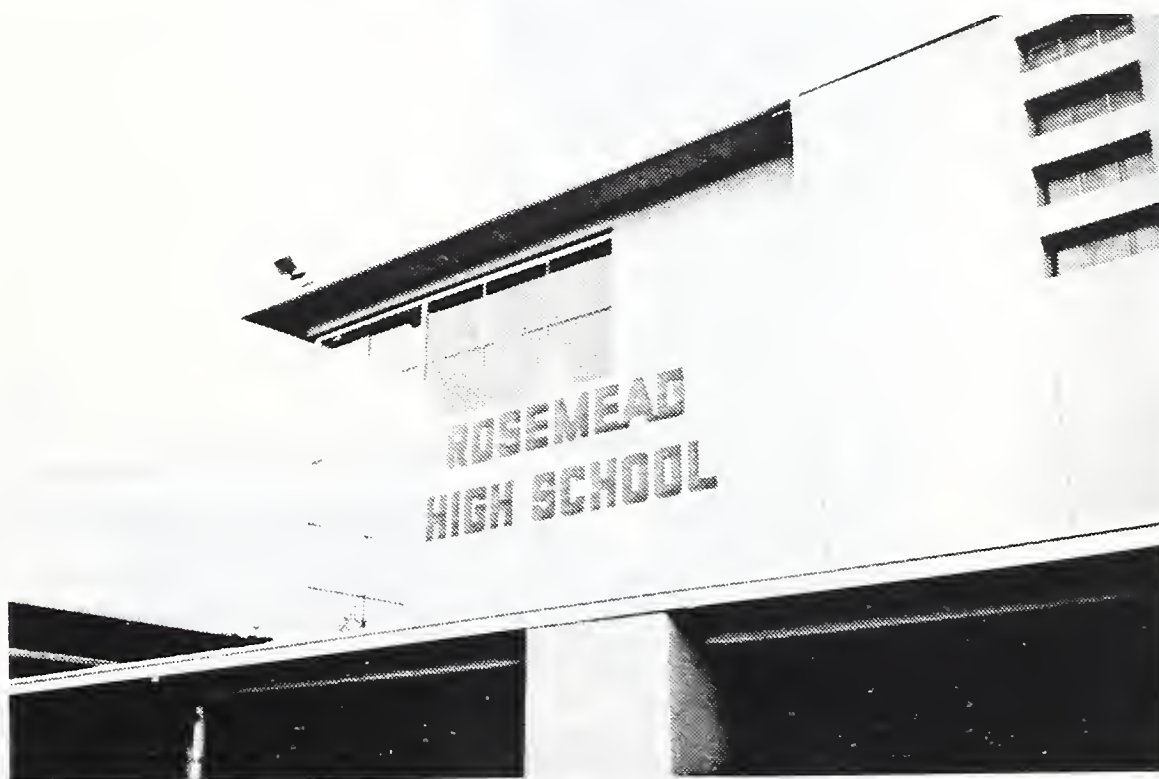
Photo 38 This school building experienced minor structural damage. Note no glass was broken at the corner of the building.

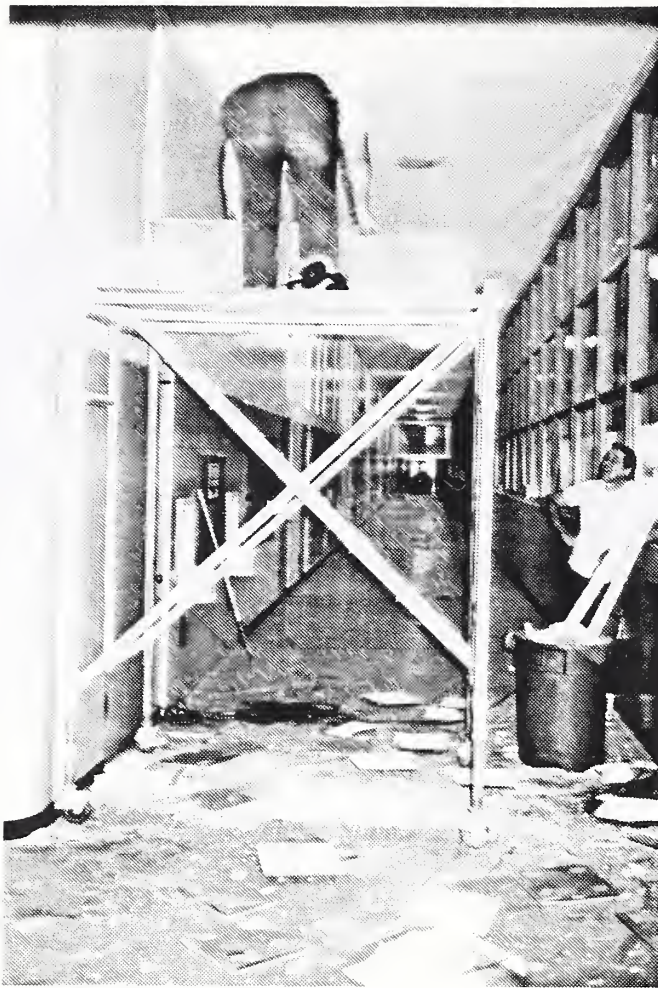
Photo 39

Acoustic ceiling tile fell in corridors and stair wells at Rosemead High School.

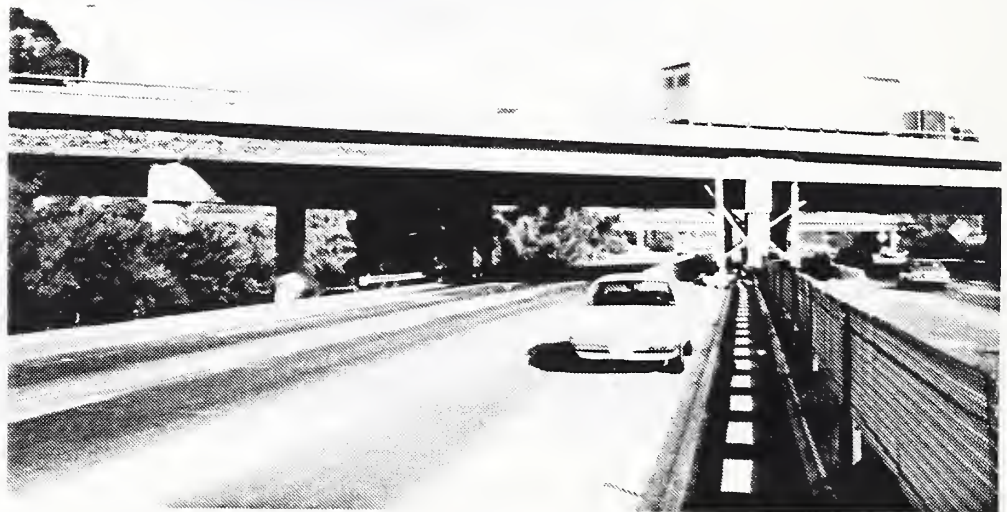
Photo 40 Interstate I-605/I-5 interchange. Temporary shores have been installed at the center bent which supports the I-605 overcrossing. The bent has five concrete columns.
