**NBSIR 87-3667**

# The Whittier Narrows Earthquake of October 1, 1987

## A Reconnaissance Report

By H. S. Lew

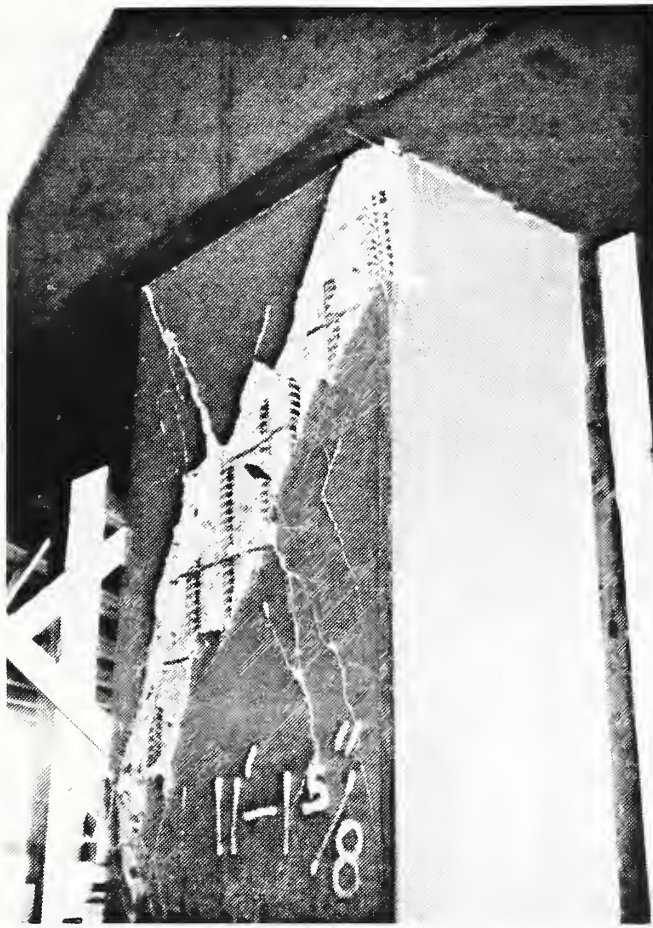
Photo 41

Close-up view of damaged column in the center bent.

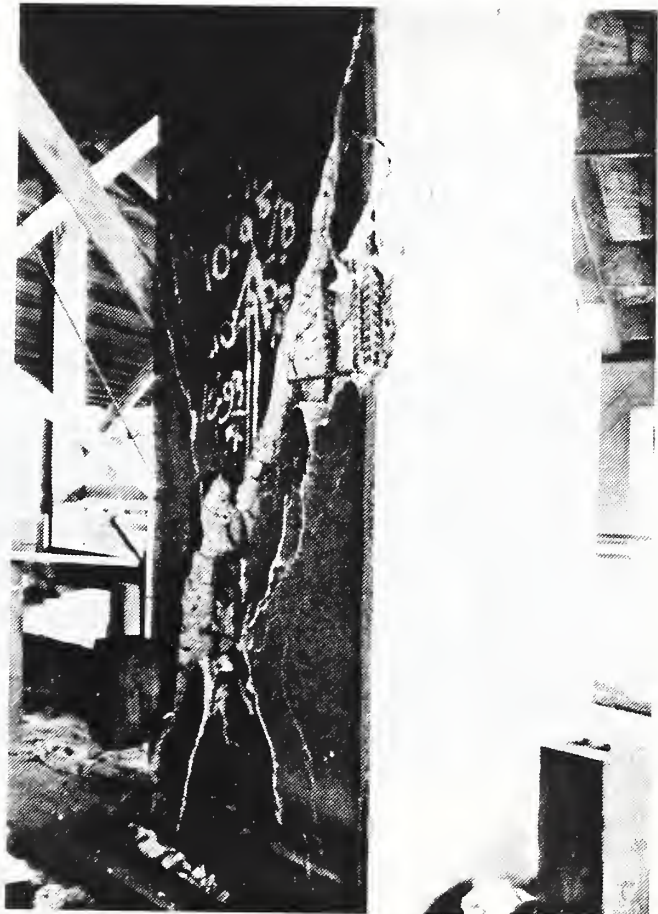
Photo 42

Close-up view of damaged column in the center bent.

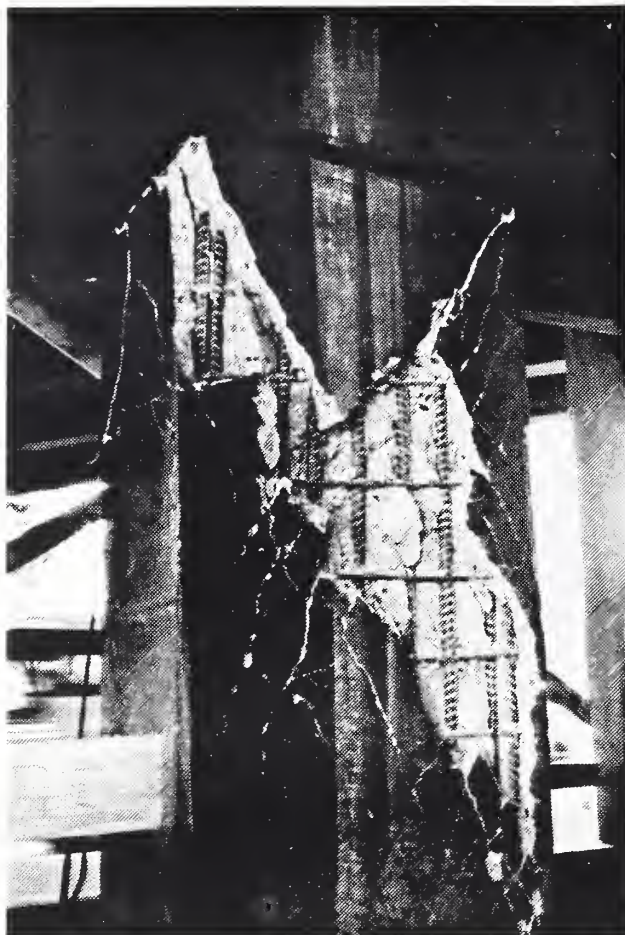
Photo 43

Close-up view of damaged column in the center bent. Note the cracked concrete core is confined by the ties.
