**NIST-SP 1118 Volume I**

# **Technical Study of the Sofa Super Store Fire - South Carolina, June 18, 2007**

March 2011

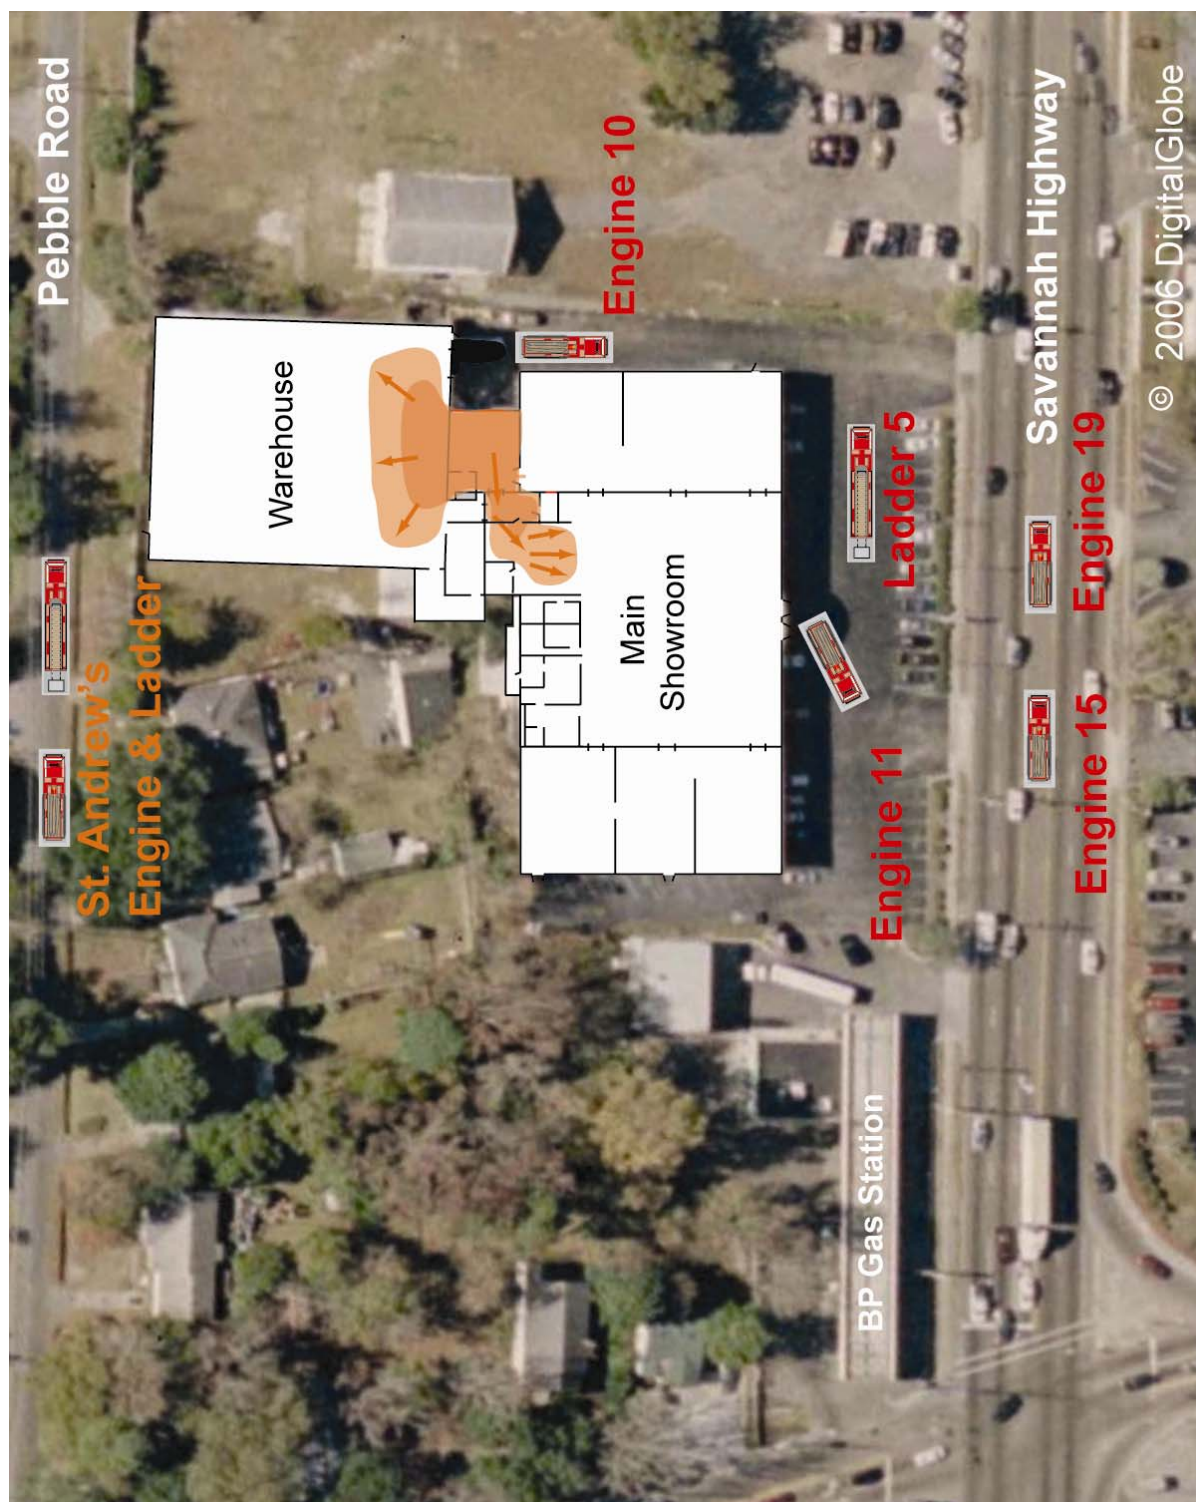
Figure 2-7. Fire was beginning to spread into the rear of the main showroom through the holding area and through the shared metal wall of the warehouse. This was estimated to occur at about 7:31 p.m. Background image used with permission of DigitalGlobe. Enhancements by NIST.

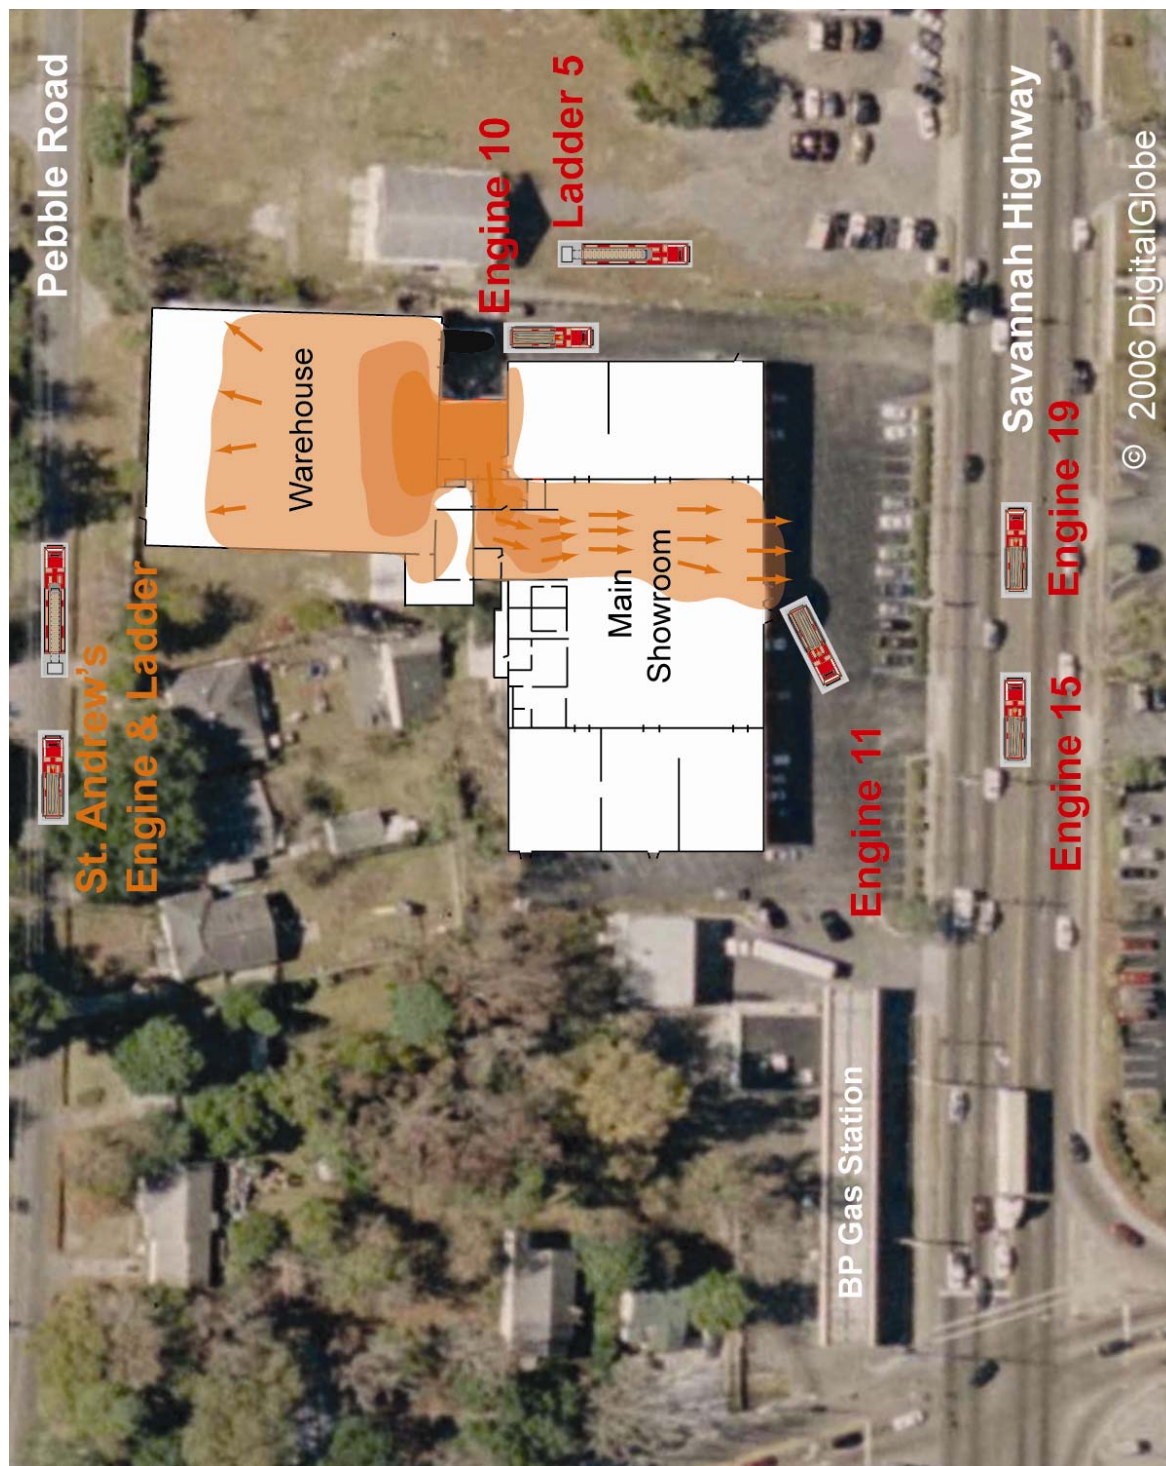
Figure 2-8. Fire spread rapidly from rear of main showroom to the front of the main showroom. Fire continued to spread towards rear of warehouse. This occurred by about 7:36 p.m. Background image used with permission of DigitalGlobe. Enhancements by NIST.

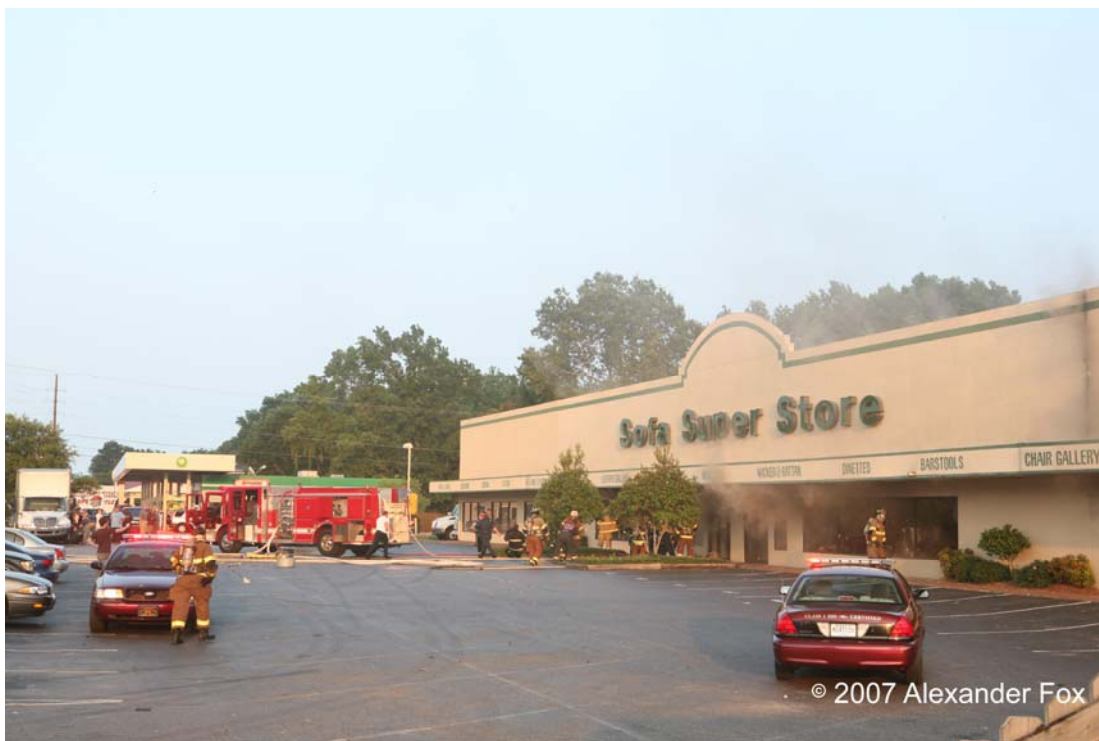
**Figure 3-7. Light brown smoke began to flow out of broken front windows. Photo taken at approximately 7:36 p.m. Photo used with permission of Alexander Fox.**

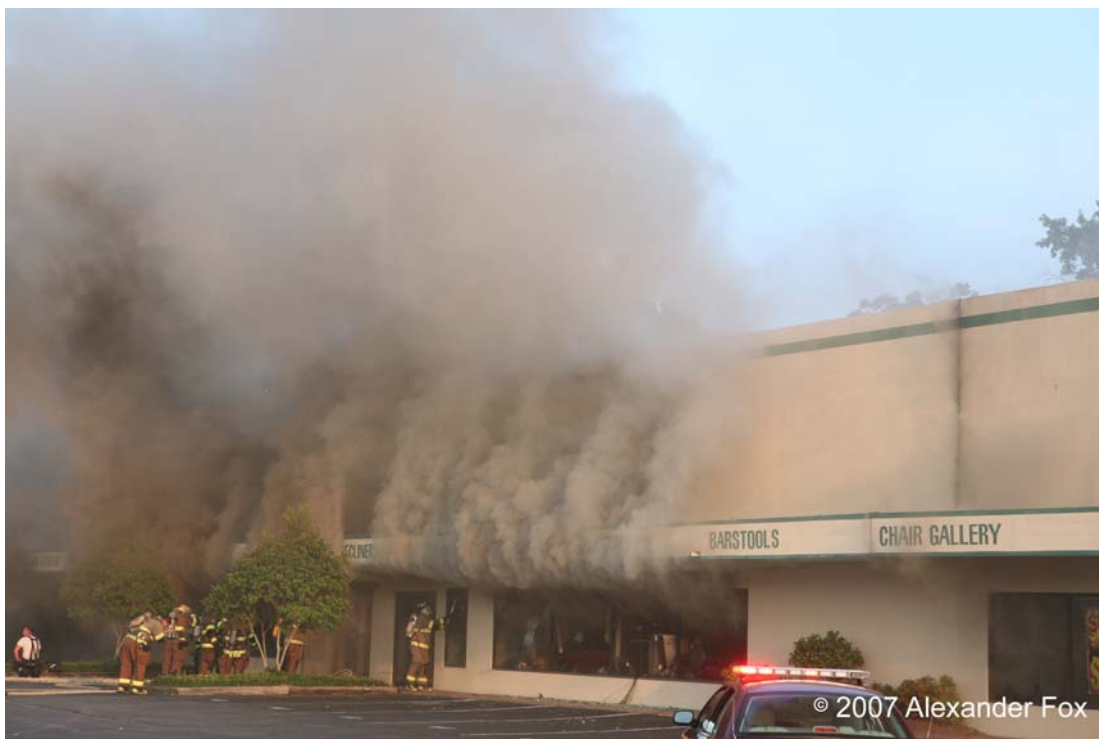
**Figure 3-8. Additional smoke moved out of broken windows. Photo taken at approximately 7:36 p.m. Photo used with permission of Alexander Fox.**

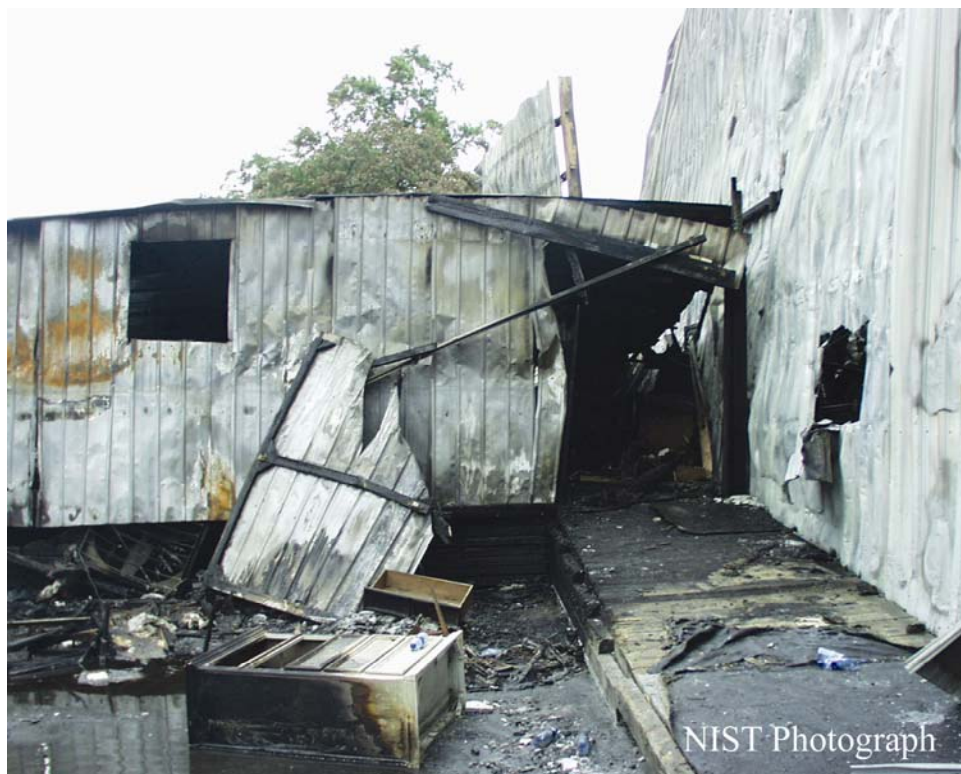
**Figure 4-7. Photograph showing the outside of the loading dock. This was identified as the area of fire origin.**
