NIST Special Publication 778

Performance of Structures During the Loma Prieta Earthquake of October 17, 1989

H. S. Lew, Editor

January 1990

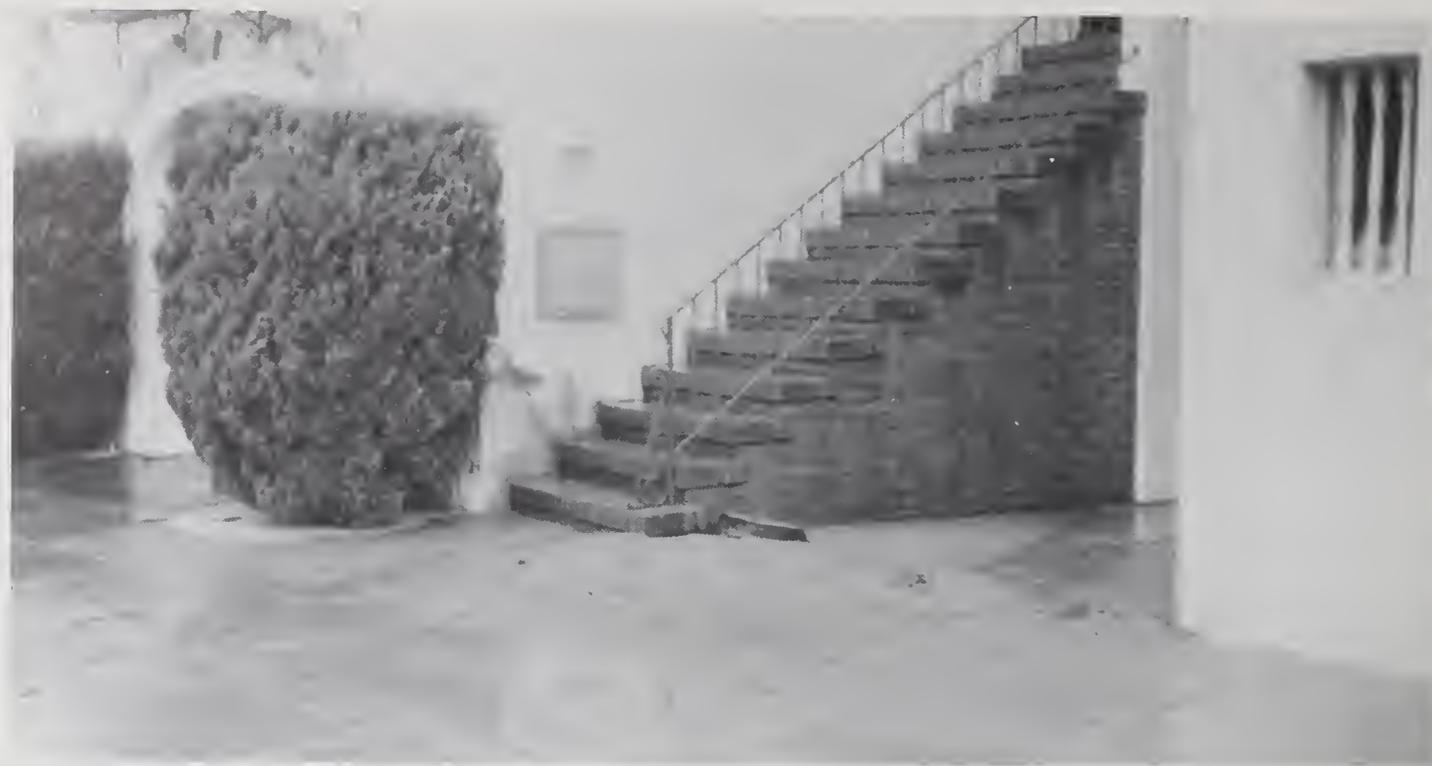
Figure 3.3.3 Sand boil in the Marina District of San Francisco.

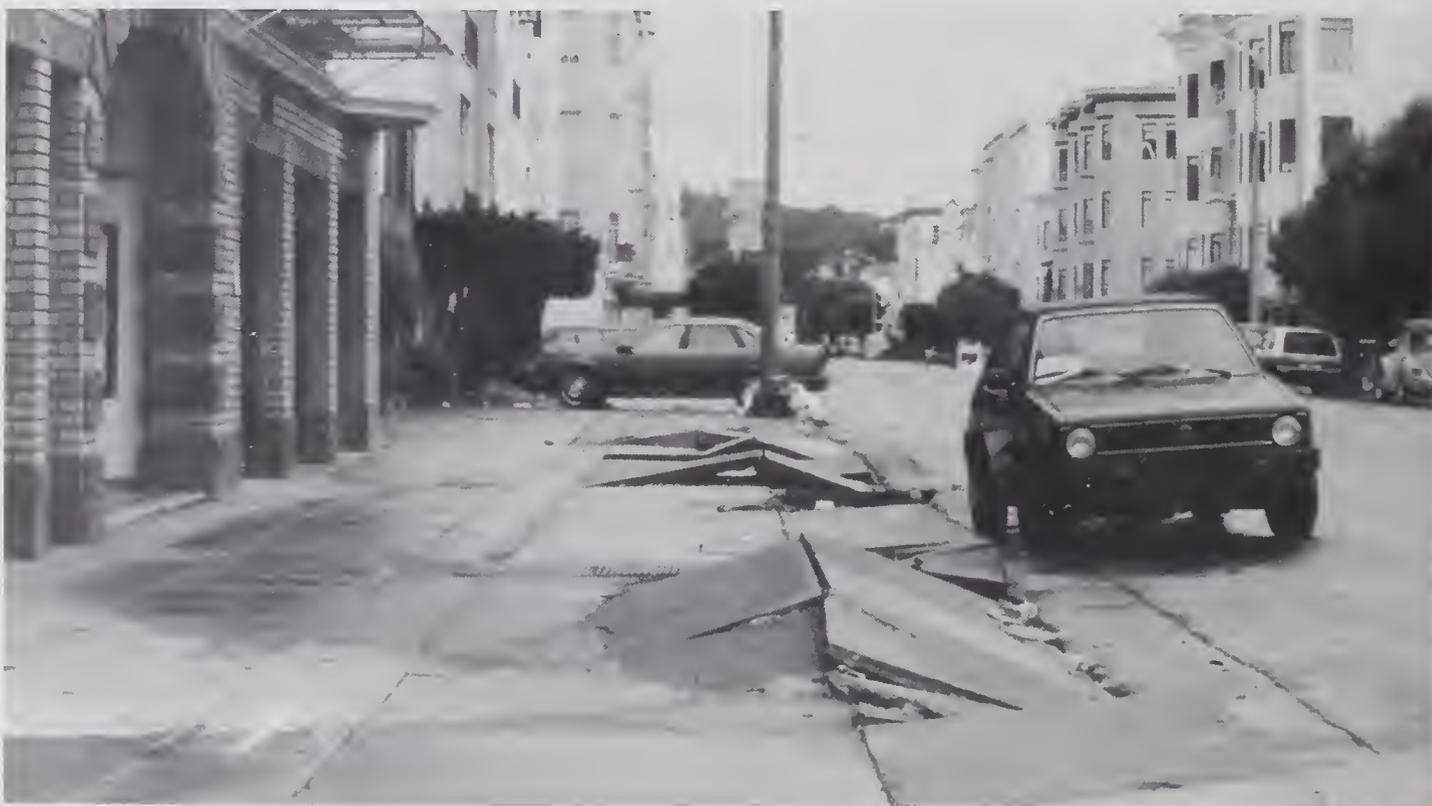
Figure 3.3.4 Typical liquefaction damage in the Marina District of San Francisco.

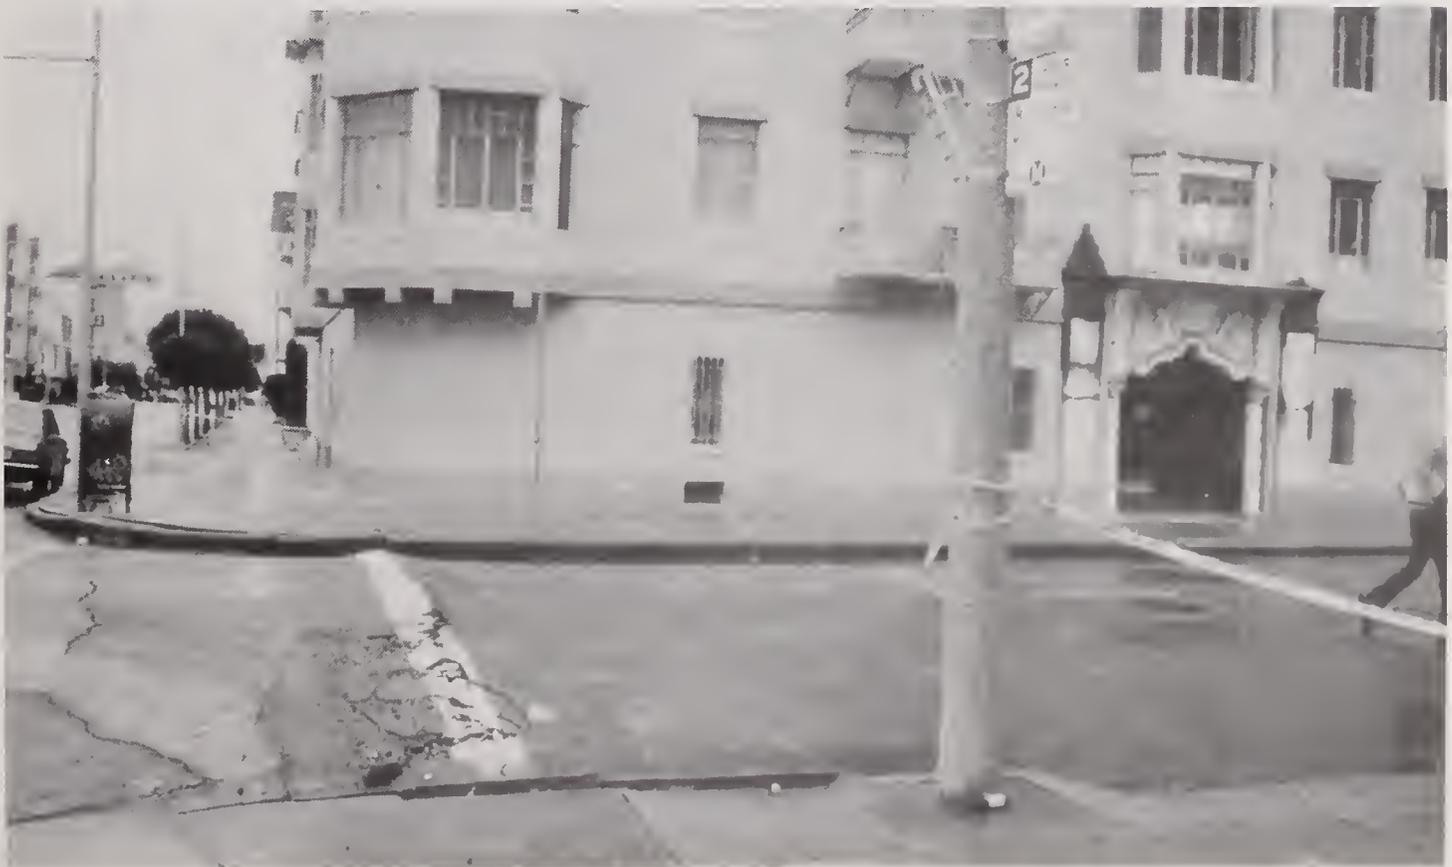
Figure 3.3.6 Pavement heave over utility pipe.

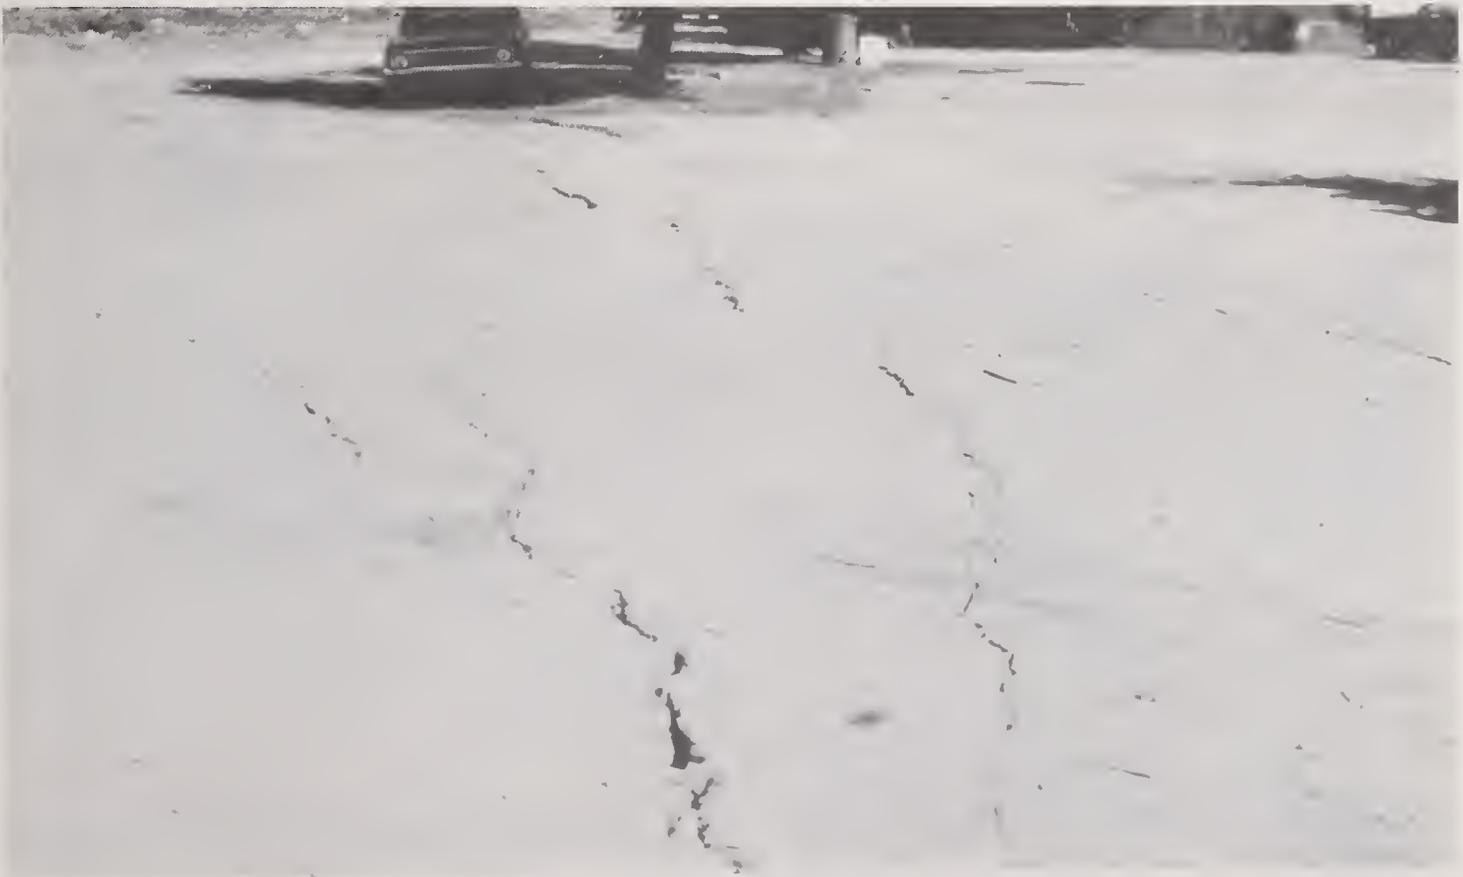
Figure 3.3.9 Tension cracks behind Pajaro River levee.

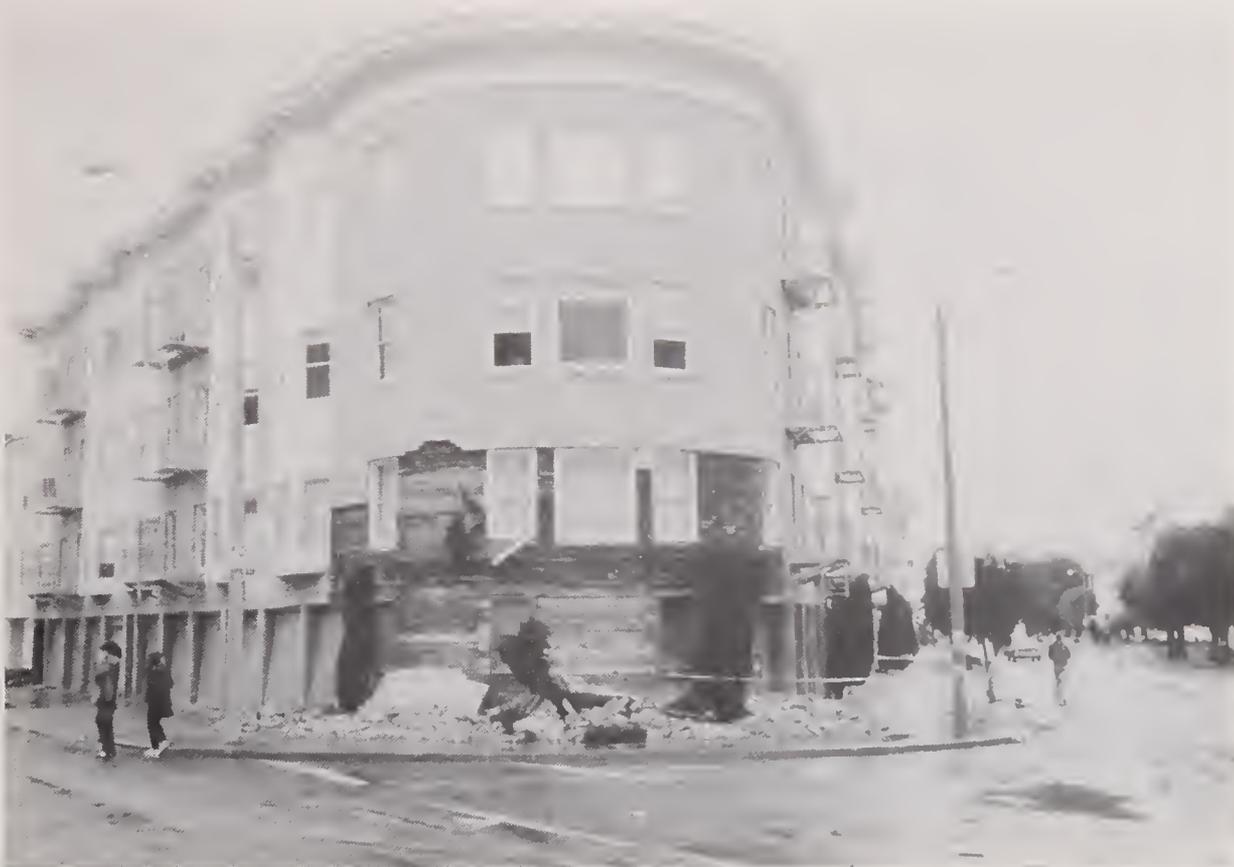
Figure 4.2.17 Example of building with failure of brick masonry facade (location #2).

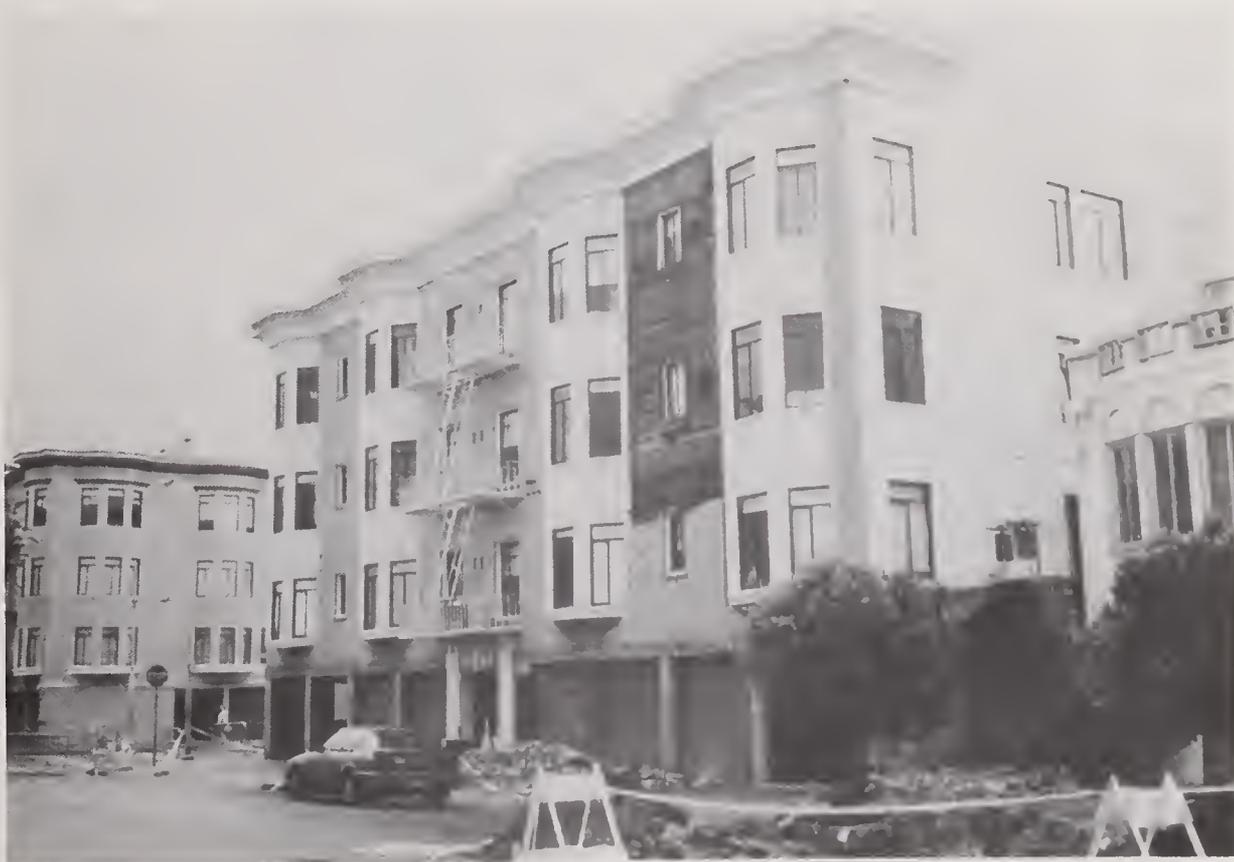
Figure 4.2.18 Example of building with failure of brick masonry facade (location #10).

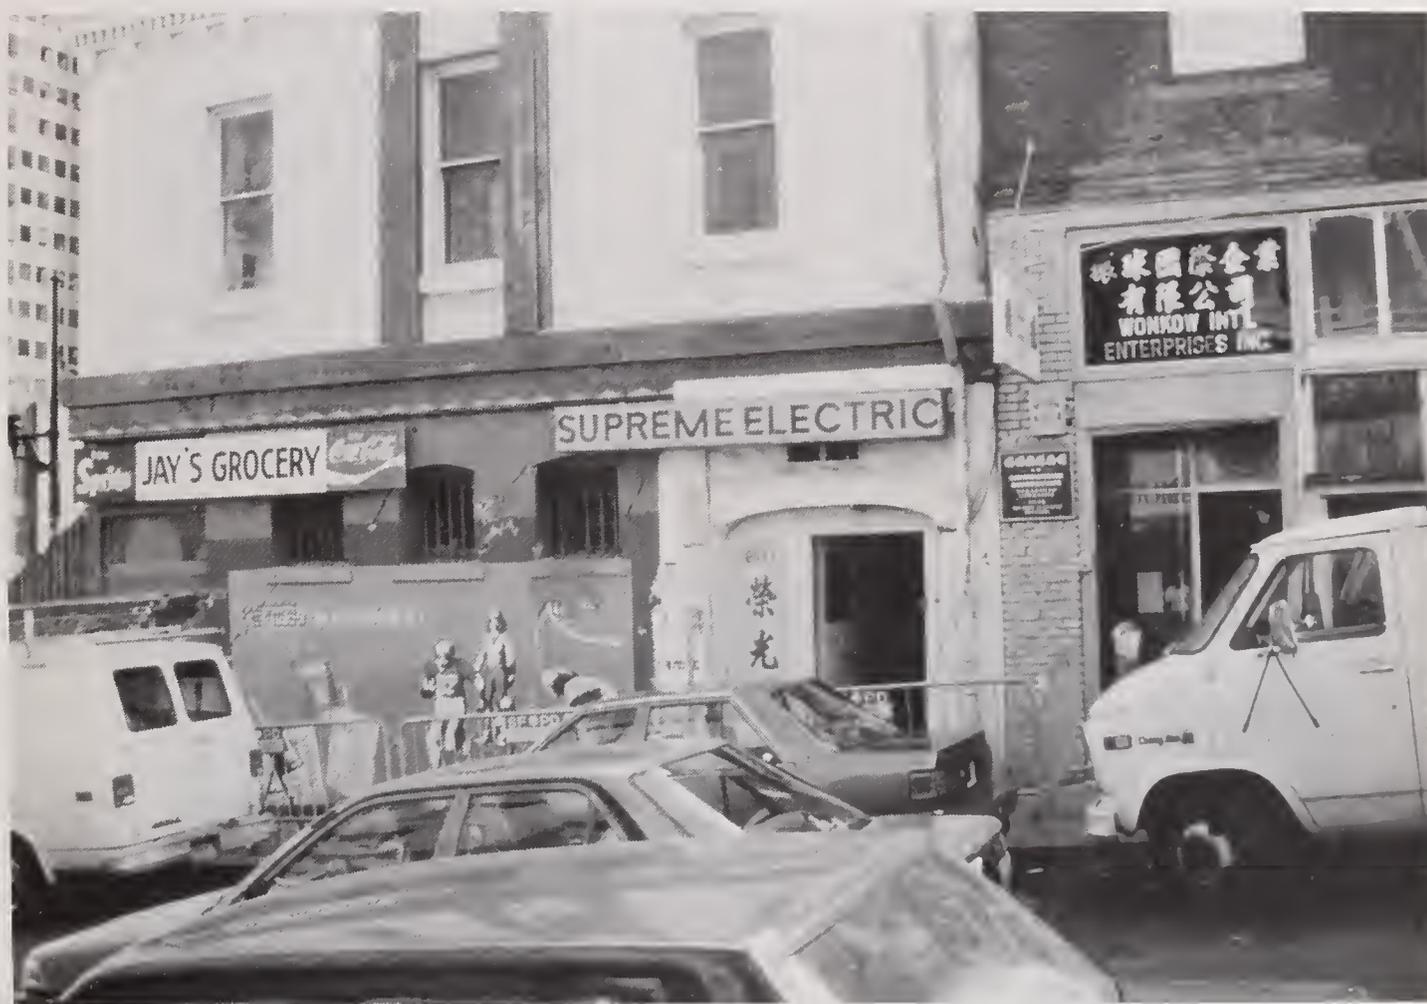
Figure 4.2.25 Example of damage to unreinforced masonry building in the Chinatown area (location #1).

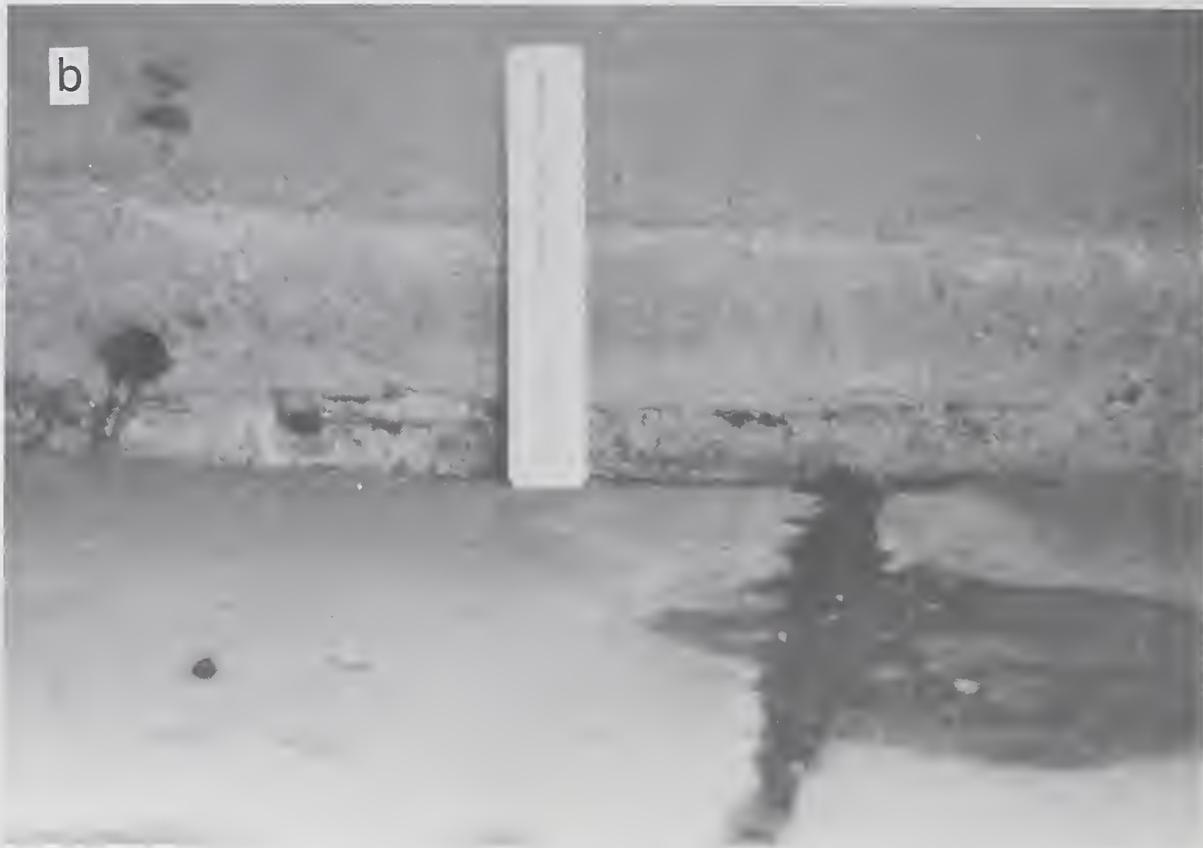
Figure 4.2.26 (a) Sidewalk showing distortions due to differential settlements, and (b) close-up view of intersection of sidewalk with retaining wall showing magnitude of differential movement.

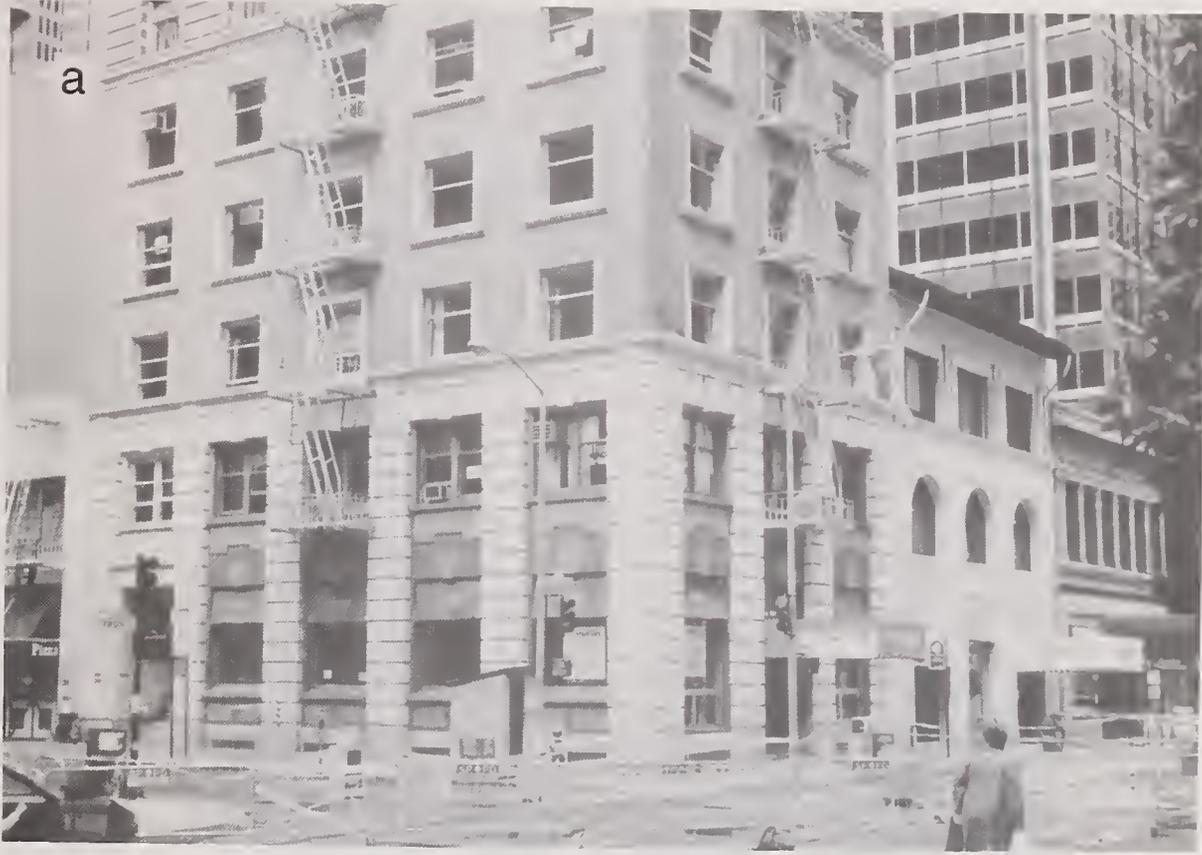
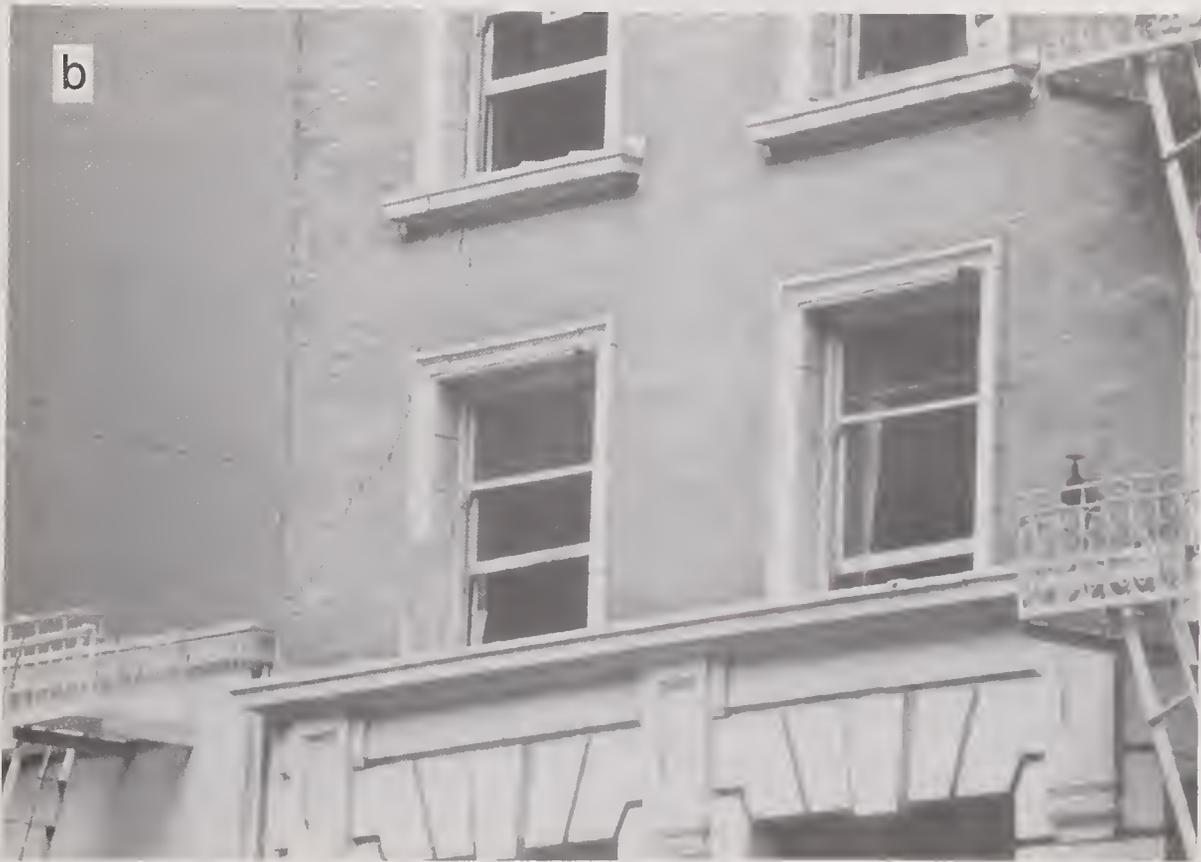
Figure 4.2.27 (a) Severely damaged Marine Building at corner of Front St. and California St.; (b) Close-up view of the northwest corner showing severity of cracking.

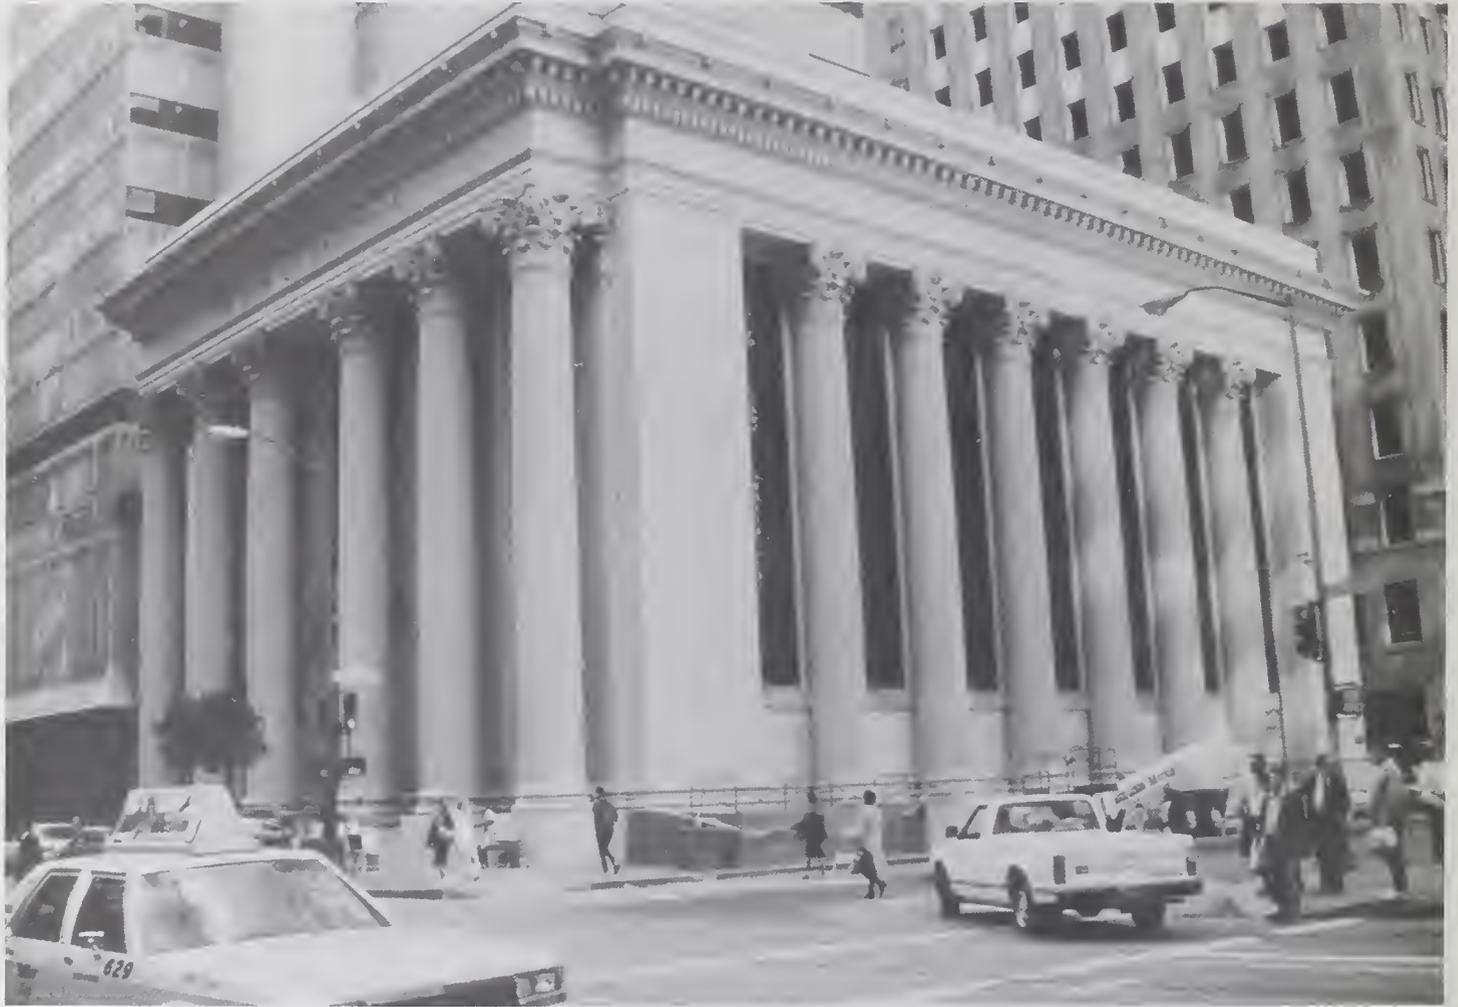
Figure 4.2.30 Damage to the stone facing of the Bank of California building.

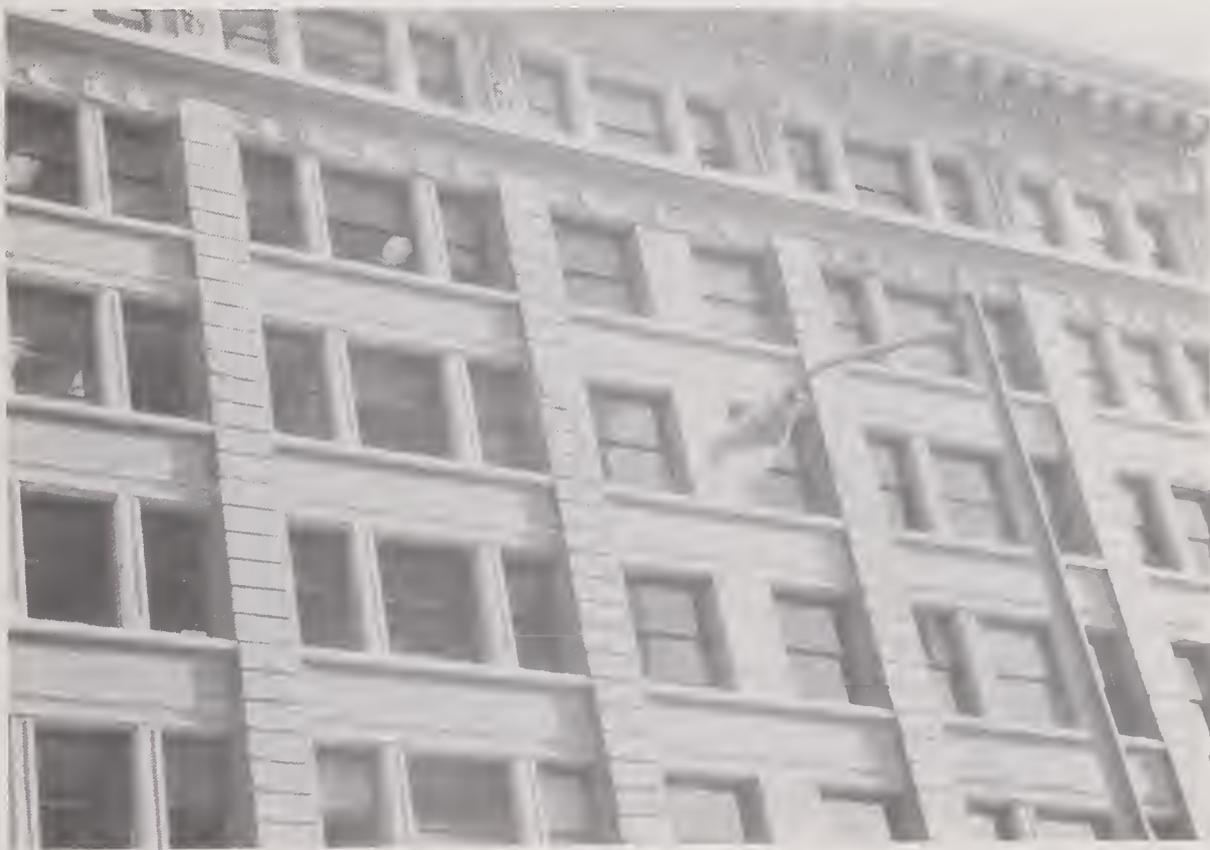
Figure 4.2.32 Example of damage to masonry cladding of Wells Fargo Bank building (location #7).

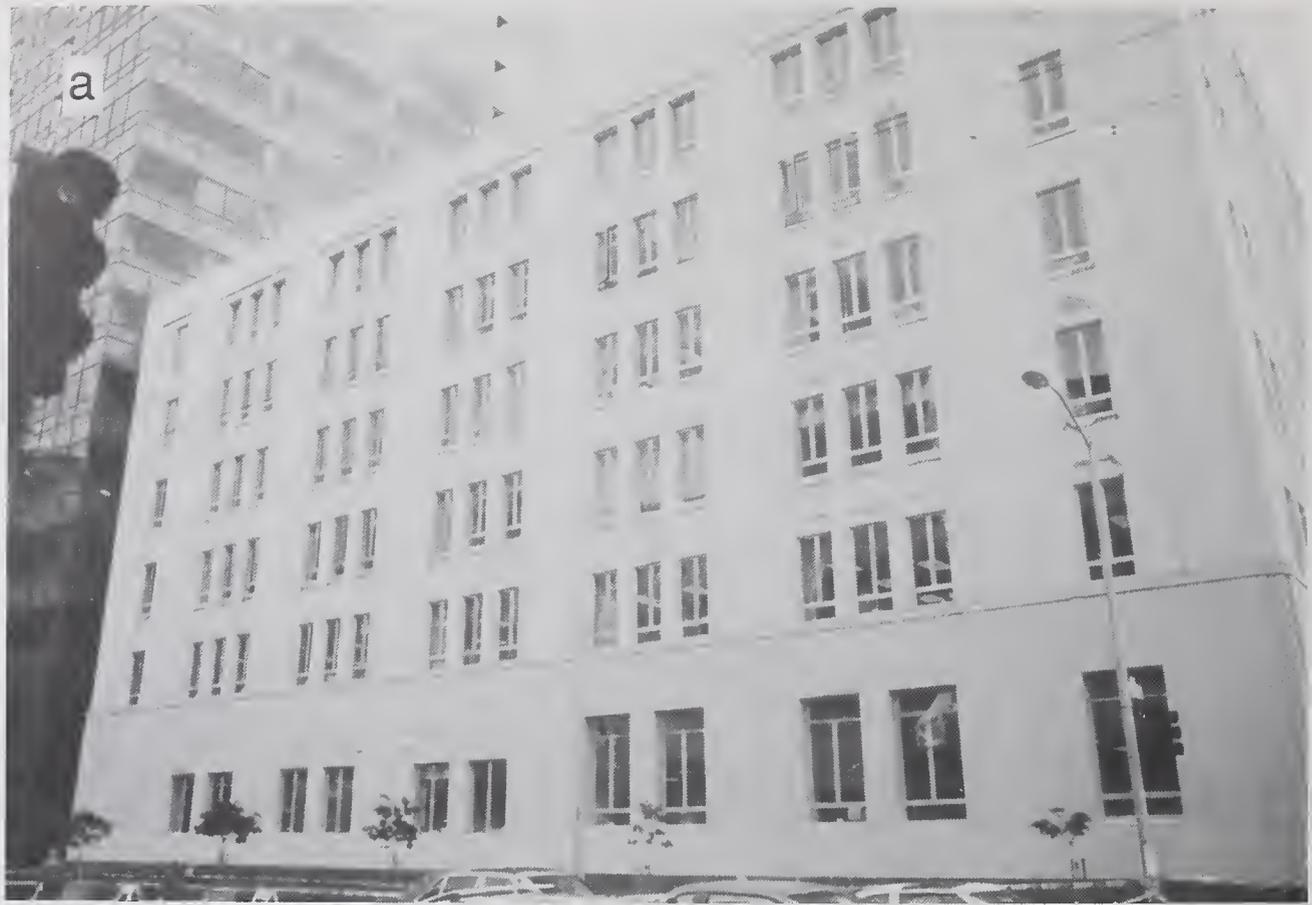
Figure 4.2.33 (a) Reinforced concrete, flat-slab building which sustained severe damage to the exterior walls (location #6); (b) close-up view of damage to spandrels.

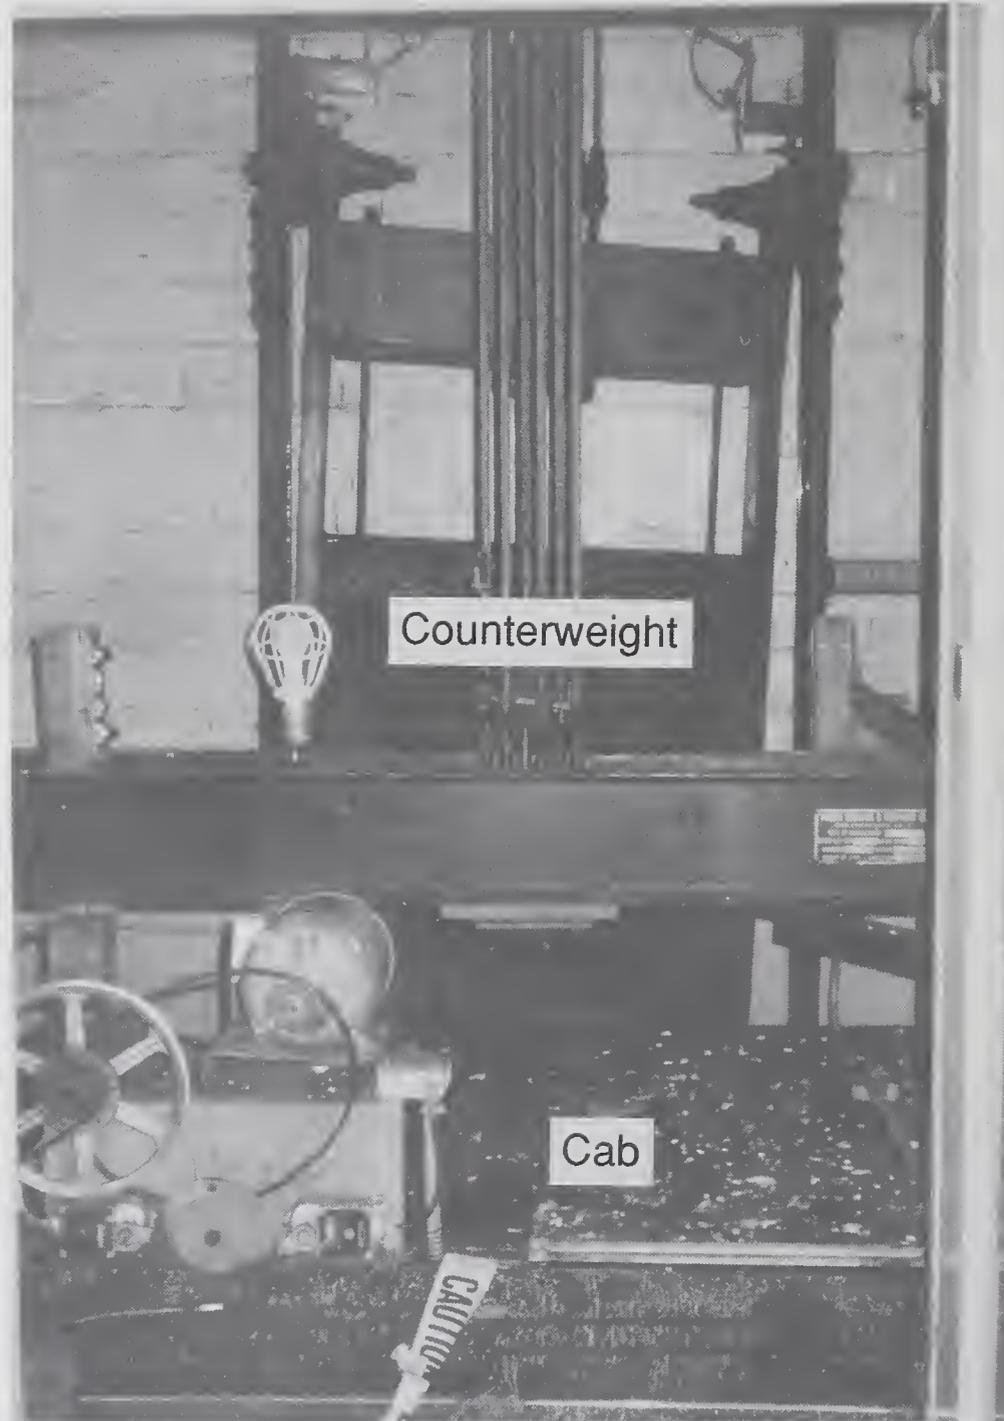
Figure 4.2.35 Elevator counterweight jumped out of its track and collided with the cab in the Old Federal Building (location #9).

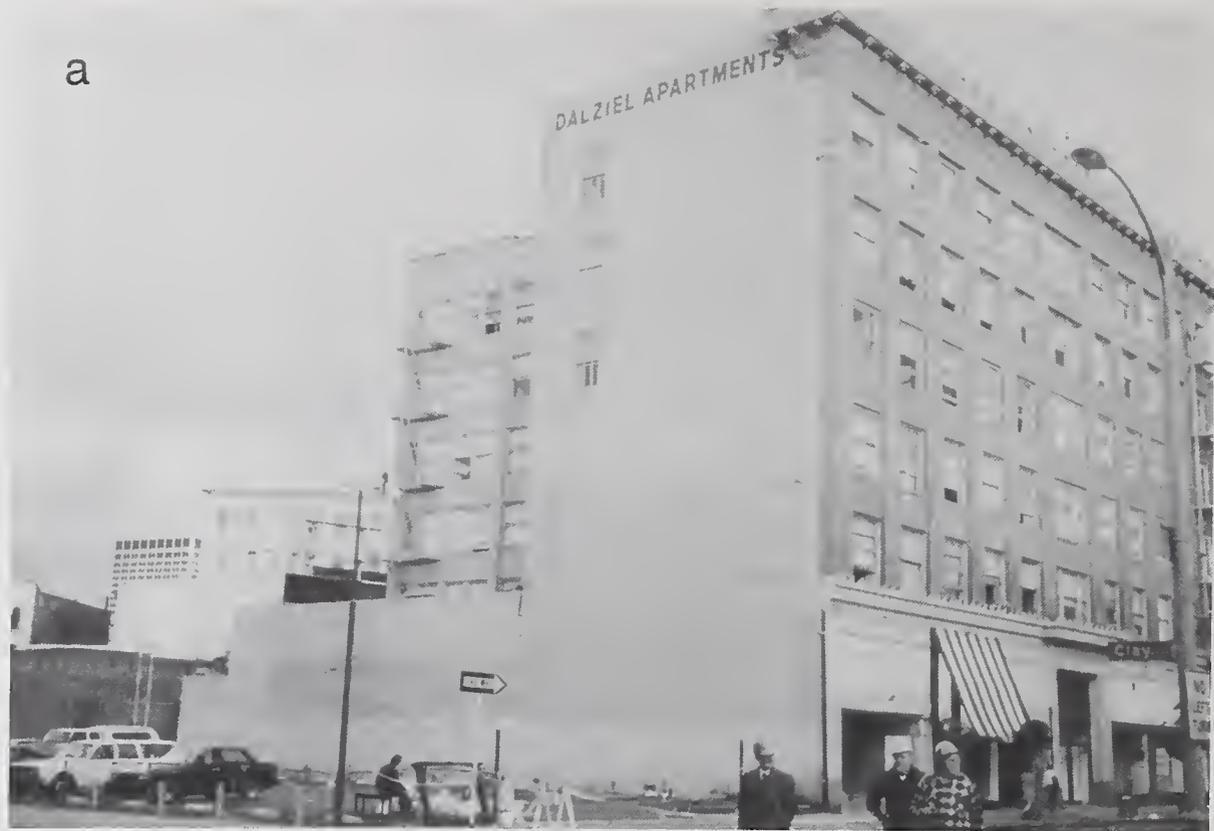
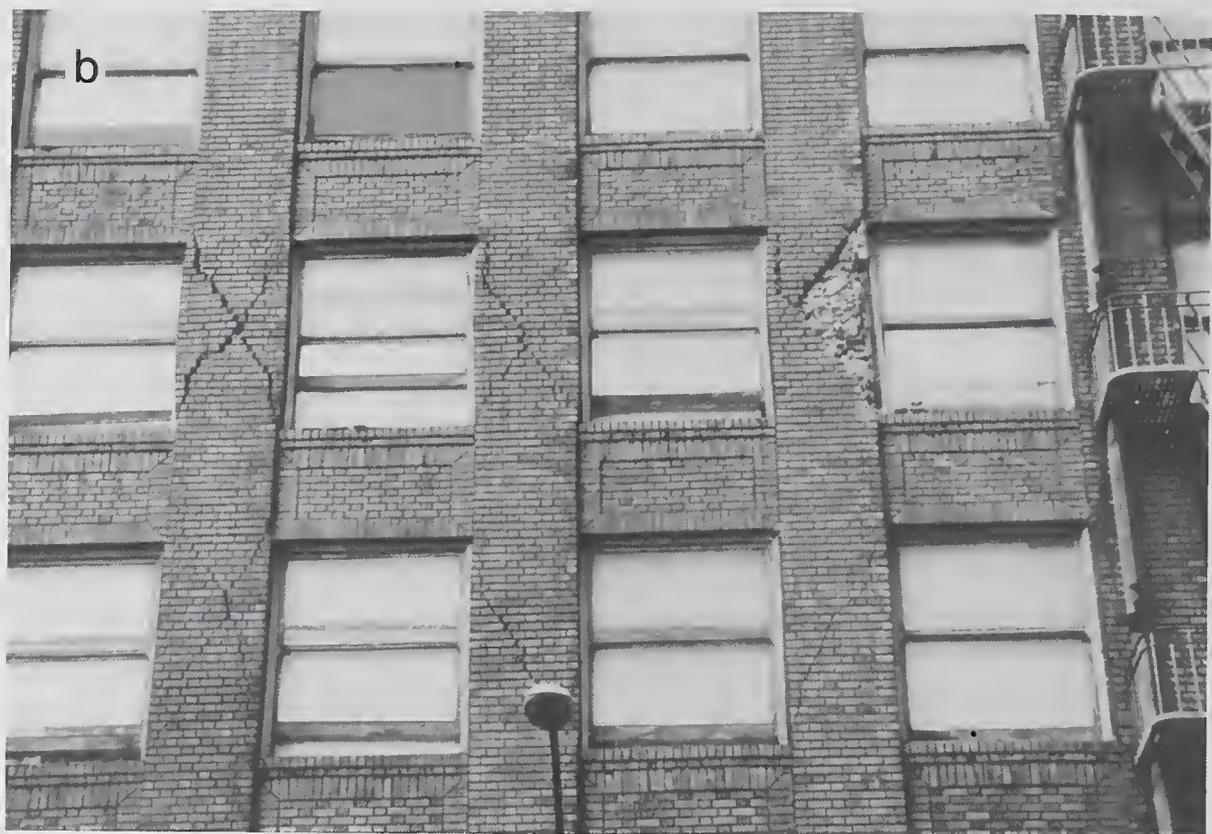
Figure 4.3.2 Dalziel apartment building: (a) overall appearance and (b) close-up view of cracking in masonry piers (location #1).

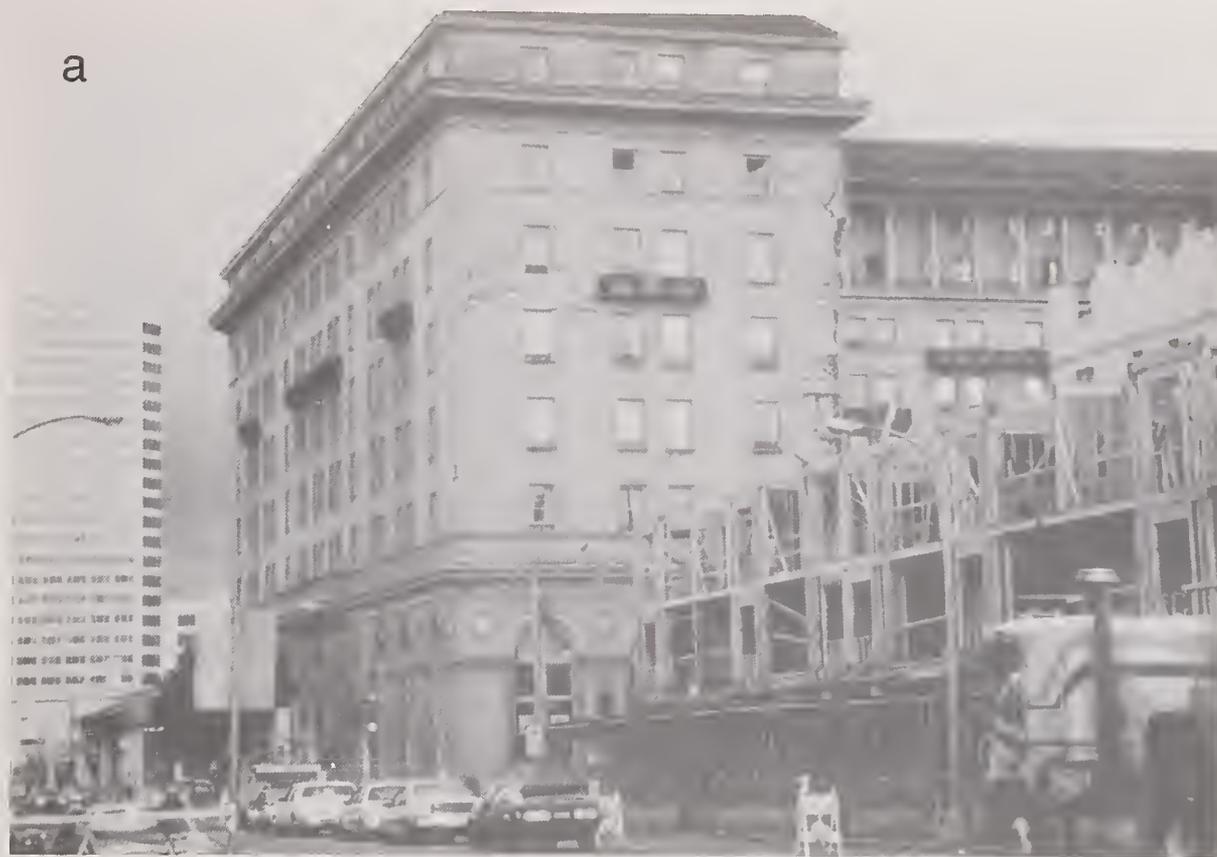
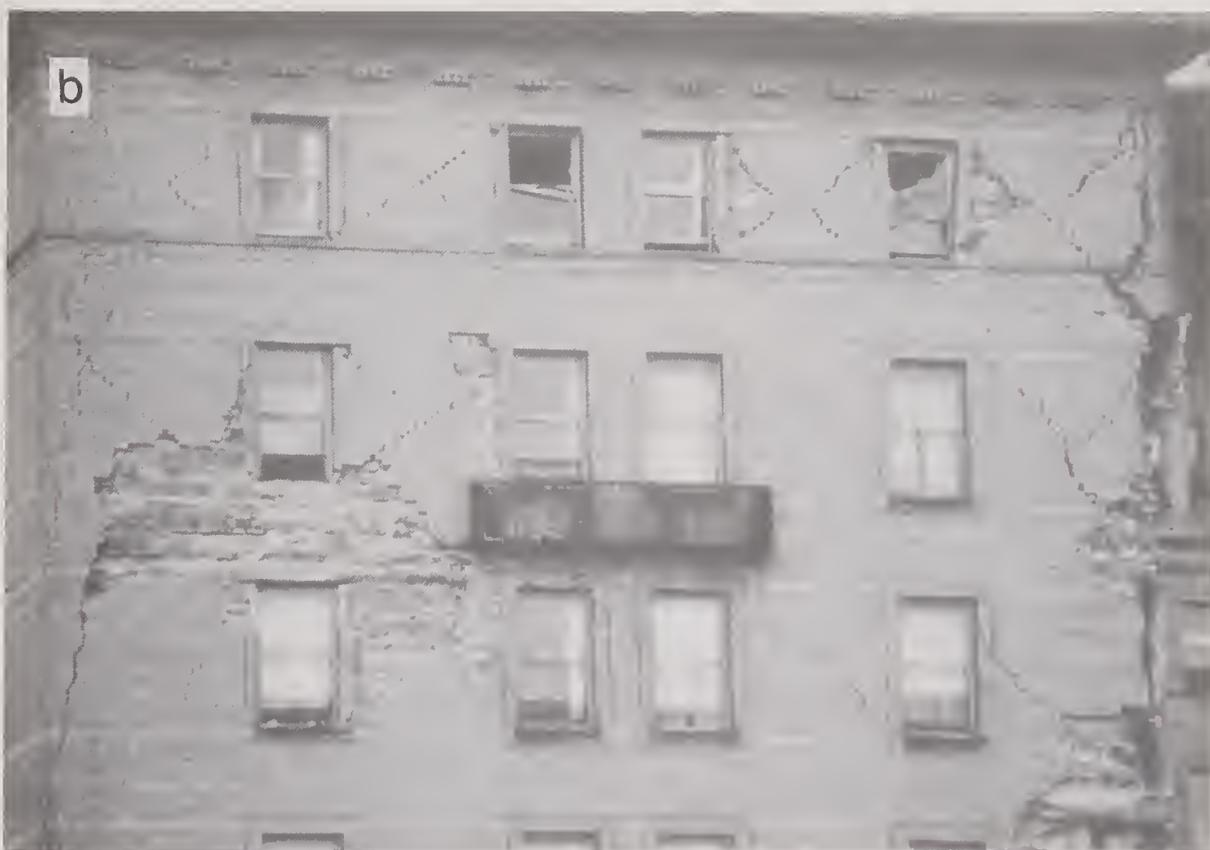
Figure 4.3.3 Oakland Hotel: (a) View of west wing and (b) close-up view of damaged masonry infill (location #6).

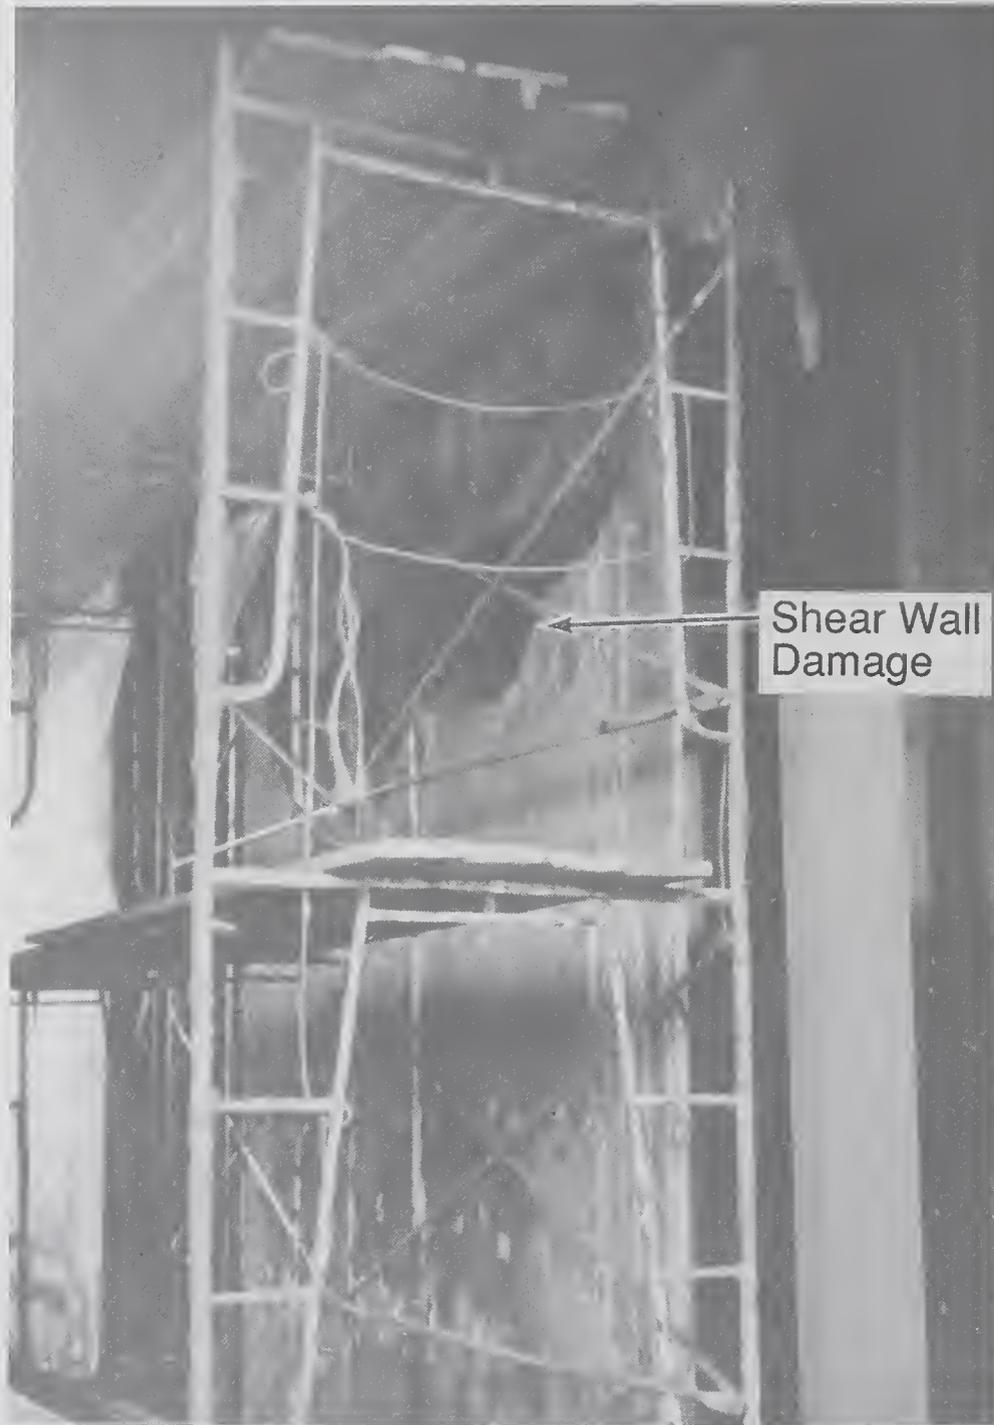
Figure 4.3.8 Damage occurred to the shear walls of a 16-story telecommunications building (location #7).
