NIST Special Publication 778

Performance of Structures During the Loma Prieta Earthquake of October 17, 1989

H. S. Lew, Editor

January 1990

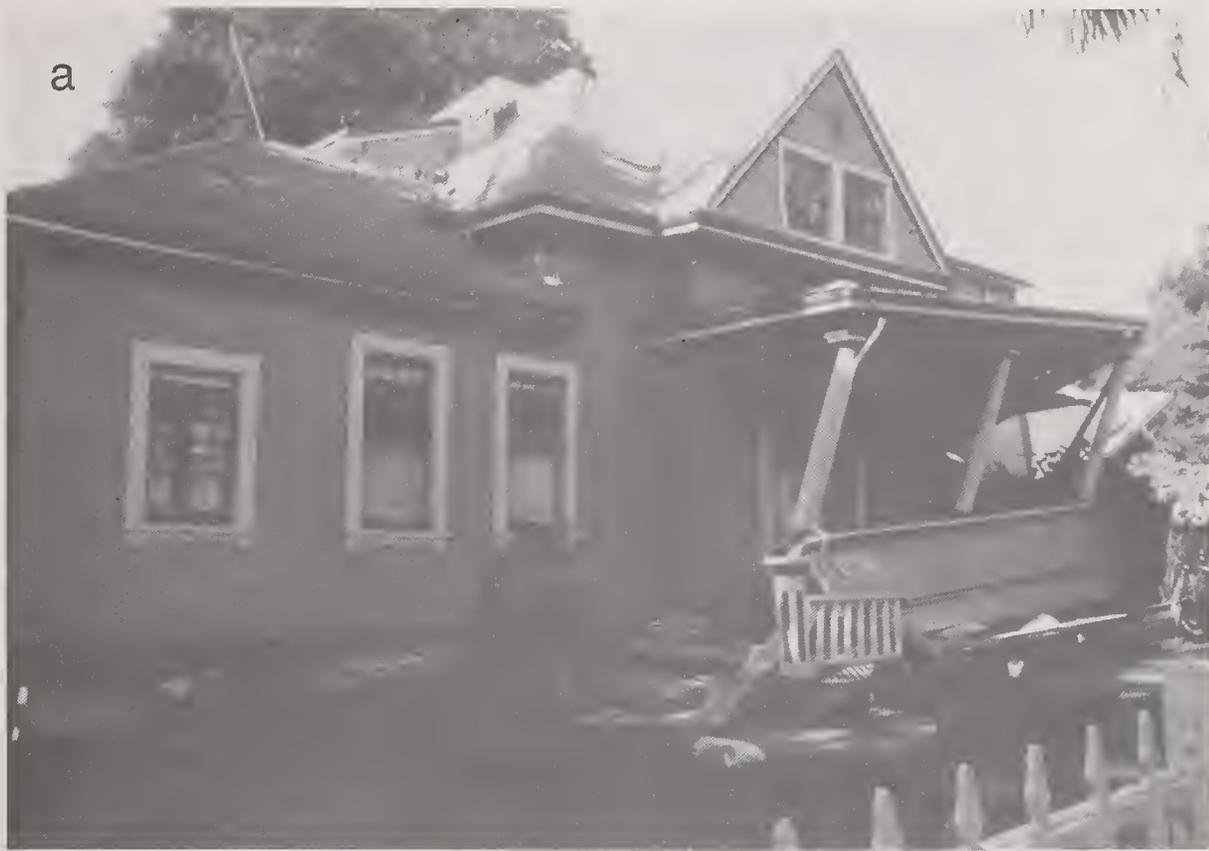
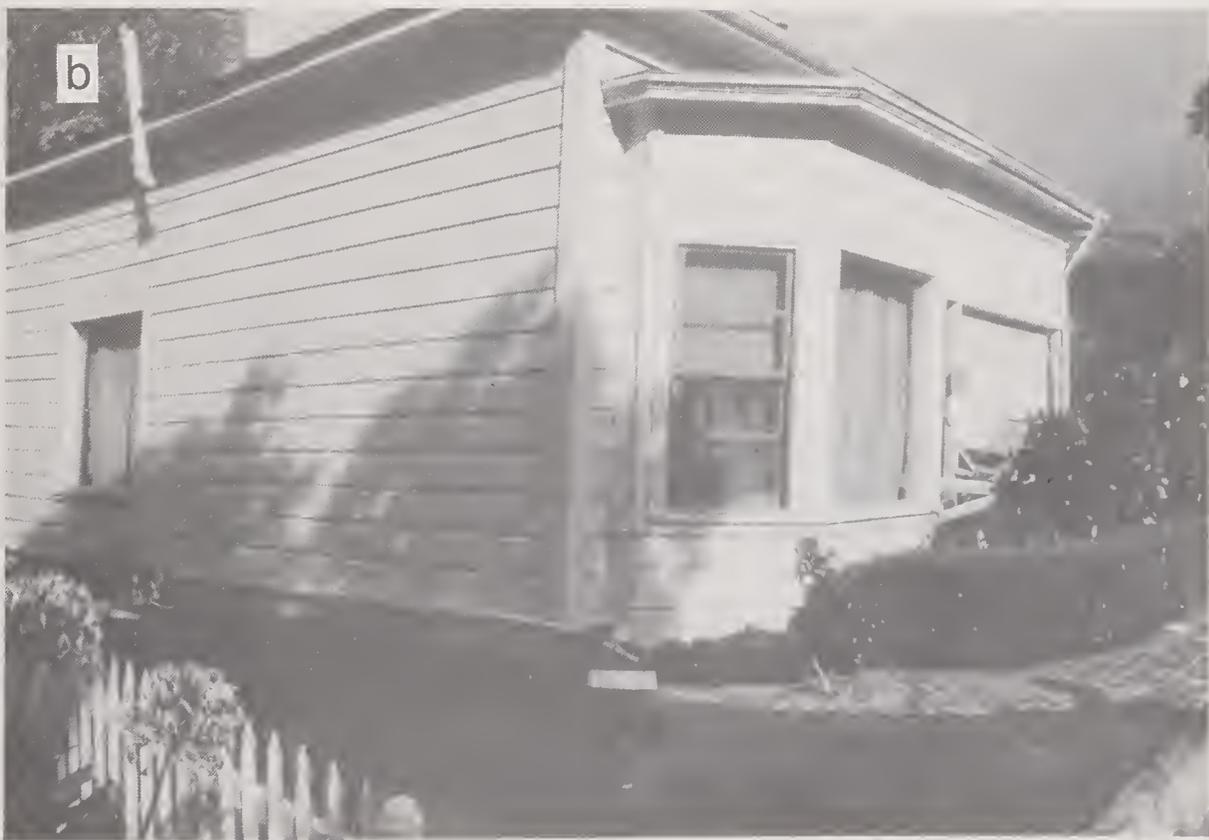
Figure 4.4.2 Examples of failures of houses in Los Gatos: (a) large house suffered large distortion and (b) a small house was rocked off of its foundation.

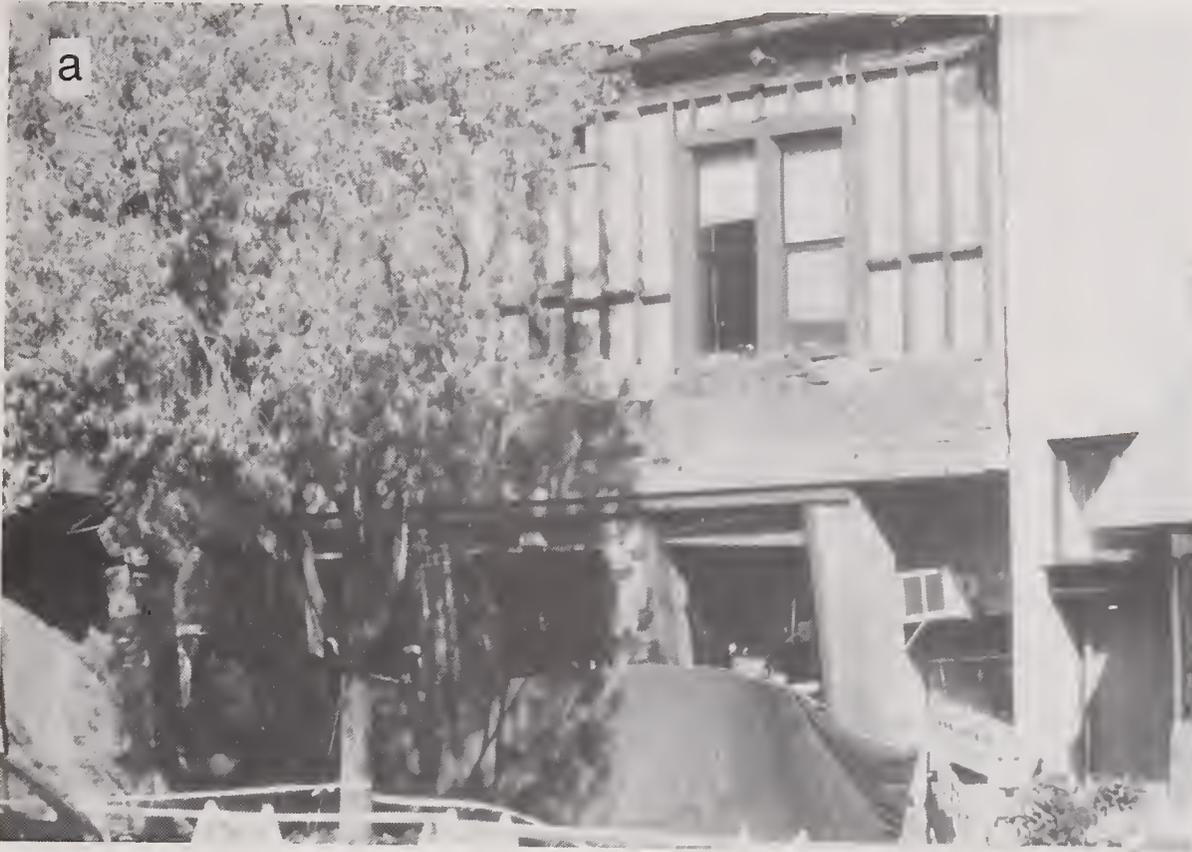
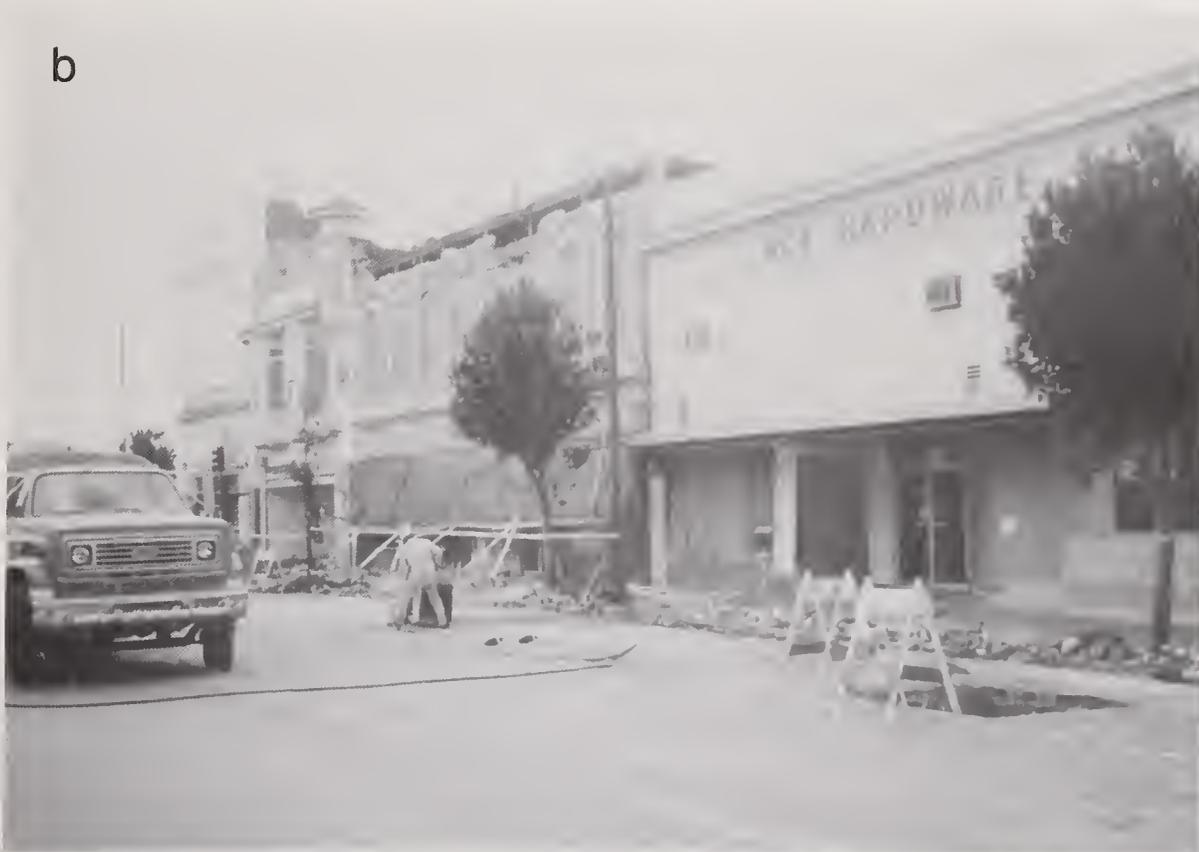
Figure 4.4.4 (a) Failure of wood-framed building with masonry walls and multiple opening in first story (Los Gatos); (b) typical damage to parapets and storefront windows (Watsonville).

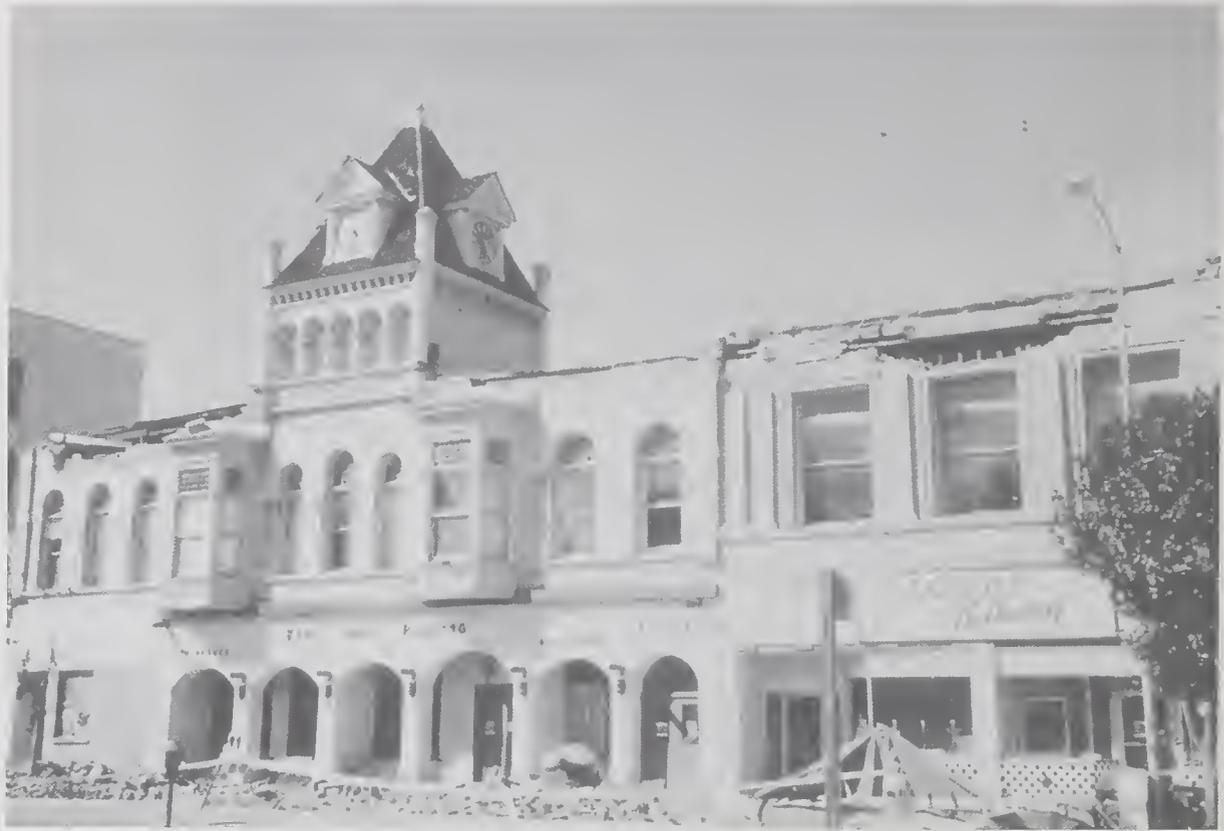
Figure 4.4.5 Falling brick from this old masonry building in Watsonville caused one death.

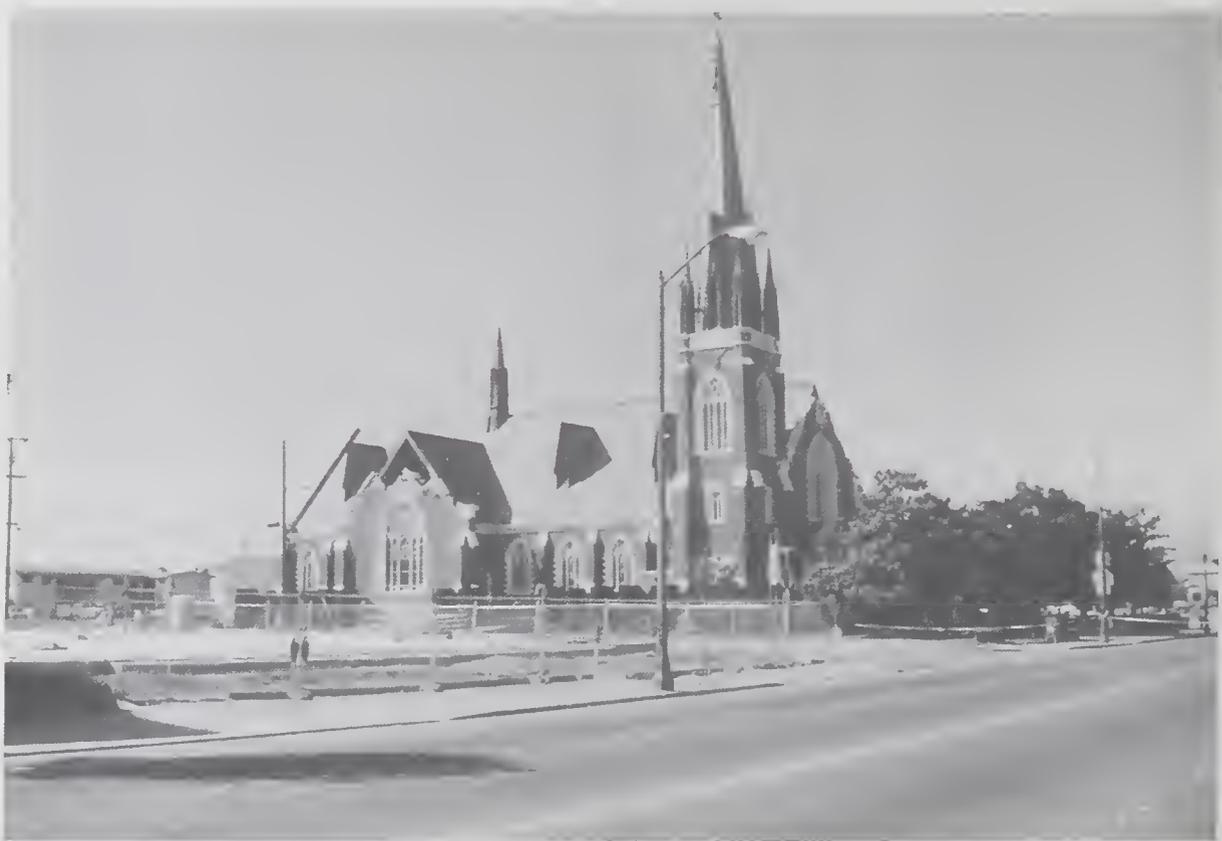
Figure 4.4.6 St. Patrick's Church in Watsonville was severely damaged.

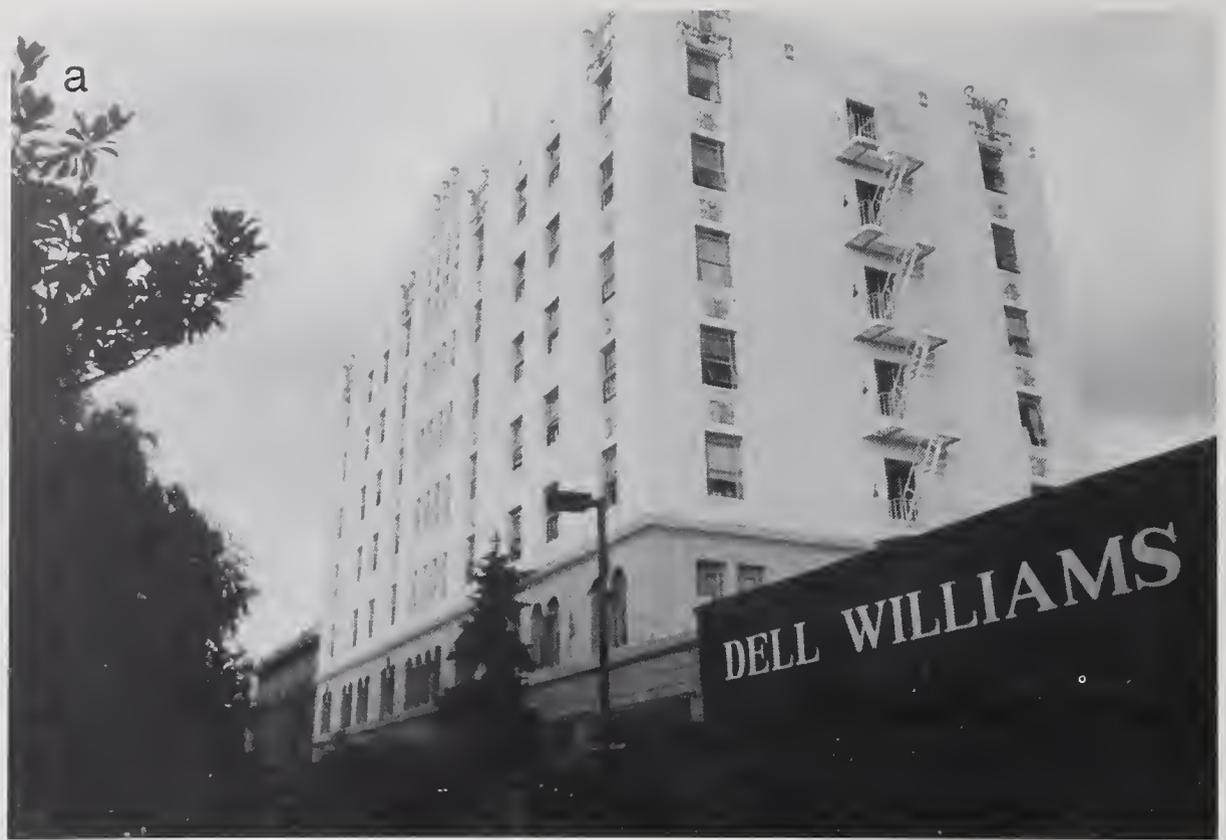
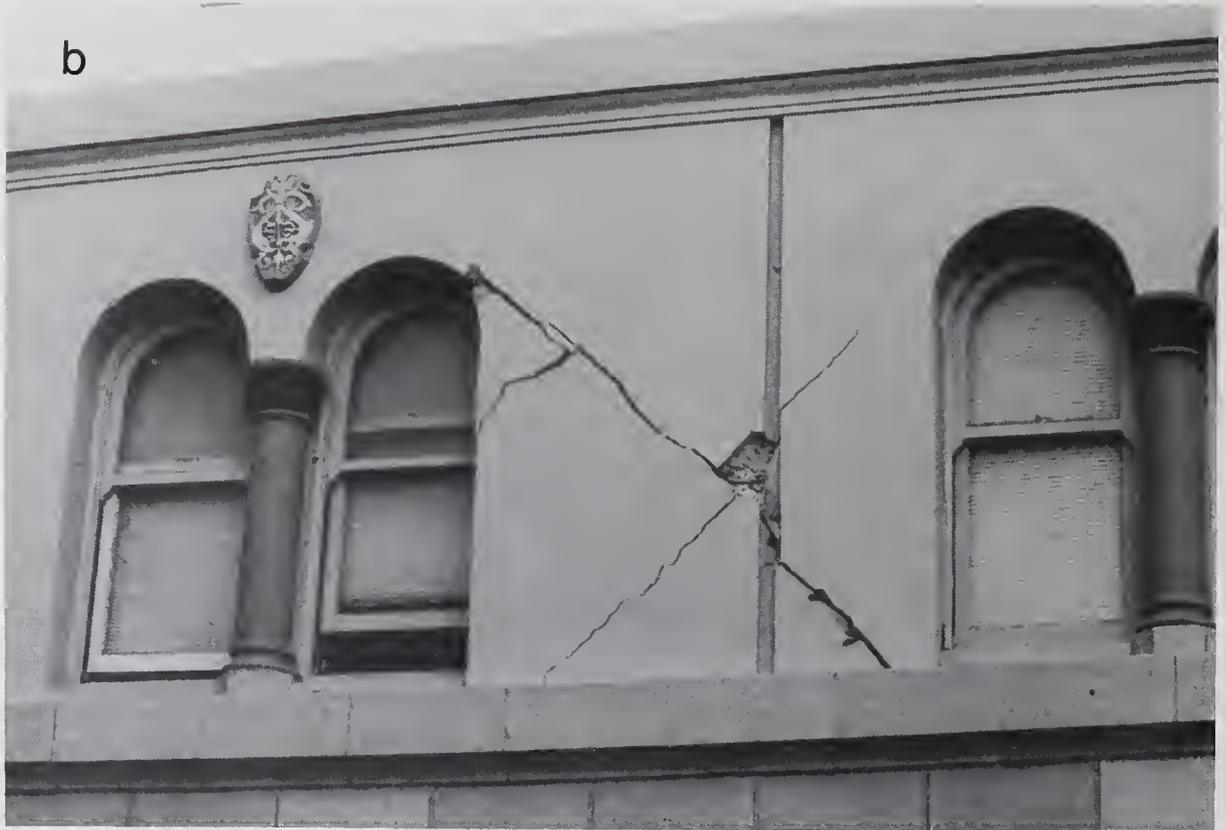
Figure 4.4.11 (a) Seven-story, reinforced concrete building suffered severe cracking; (b) Close-up view of damage to second-story walls.

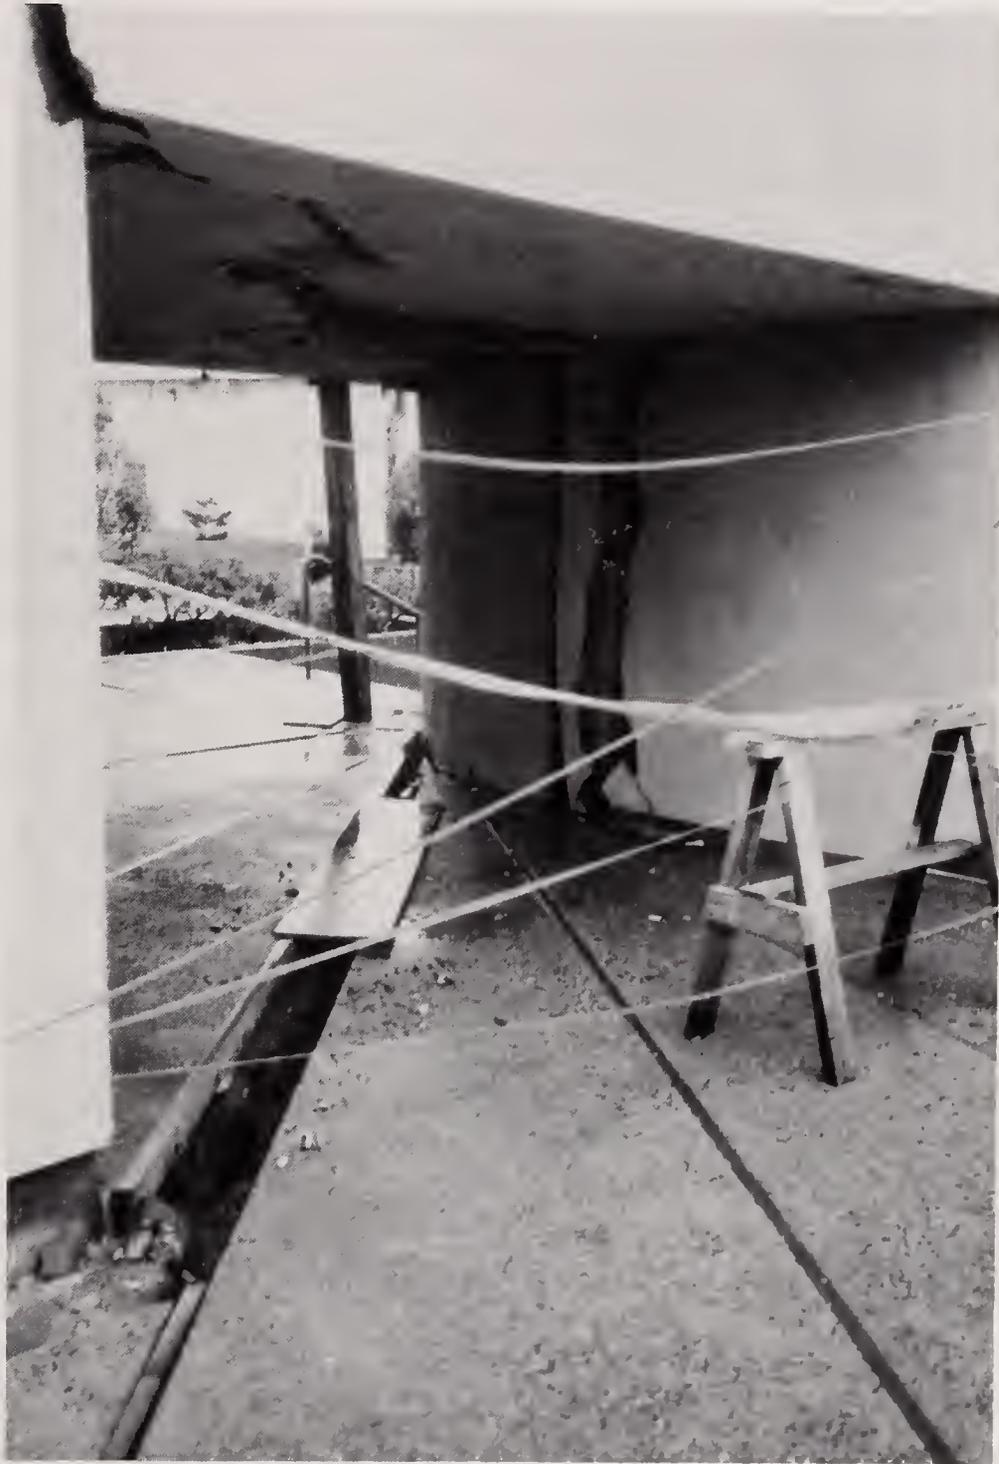
Figure 4.4.12 Damage to Marine Laboratory in Moss Landing as a result of soil liquefaction.

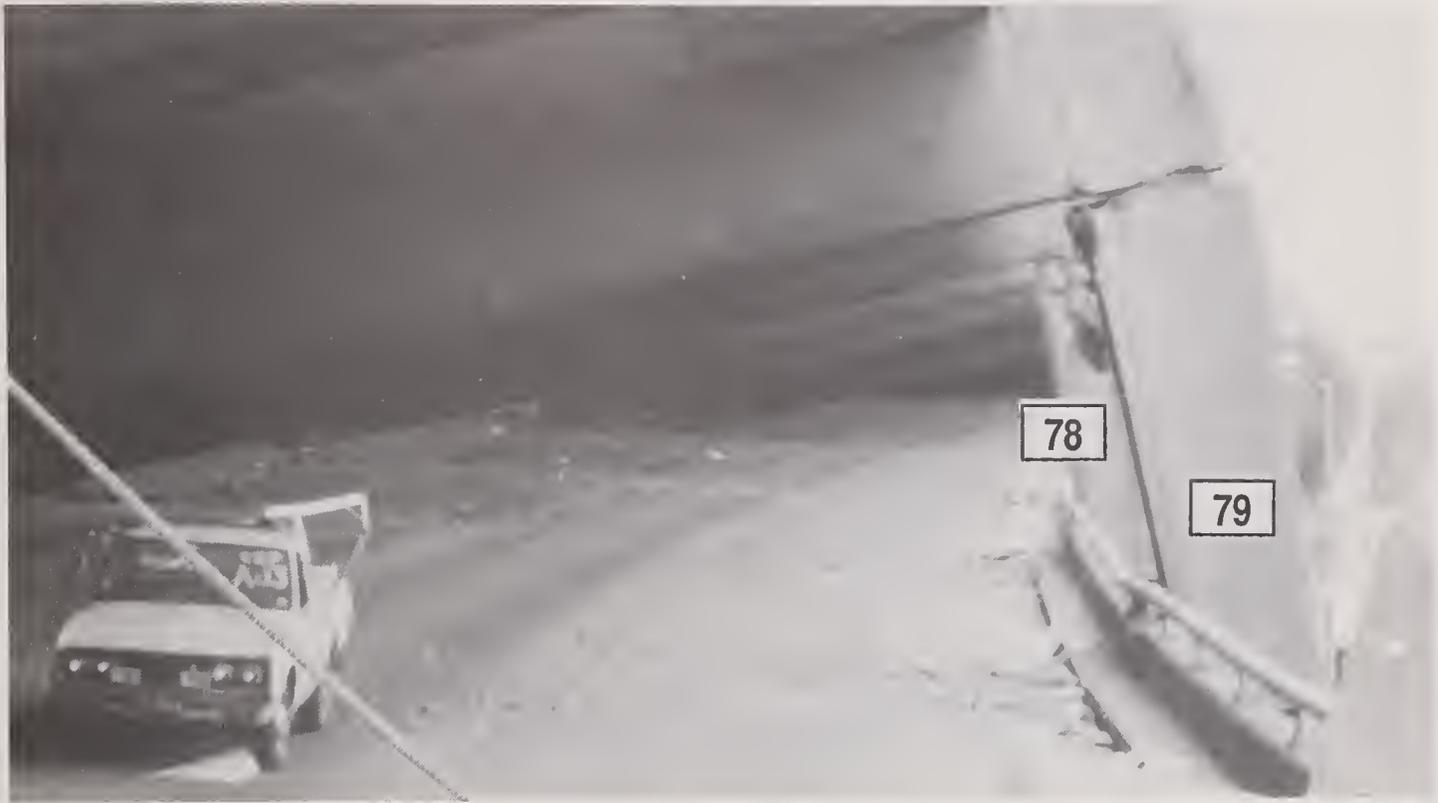
Figure 5.6.32 There was, apparently, a belief among motorists that it was safer to stop beneath the bent girders, as shown here, looking south from Bent 80.

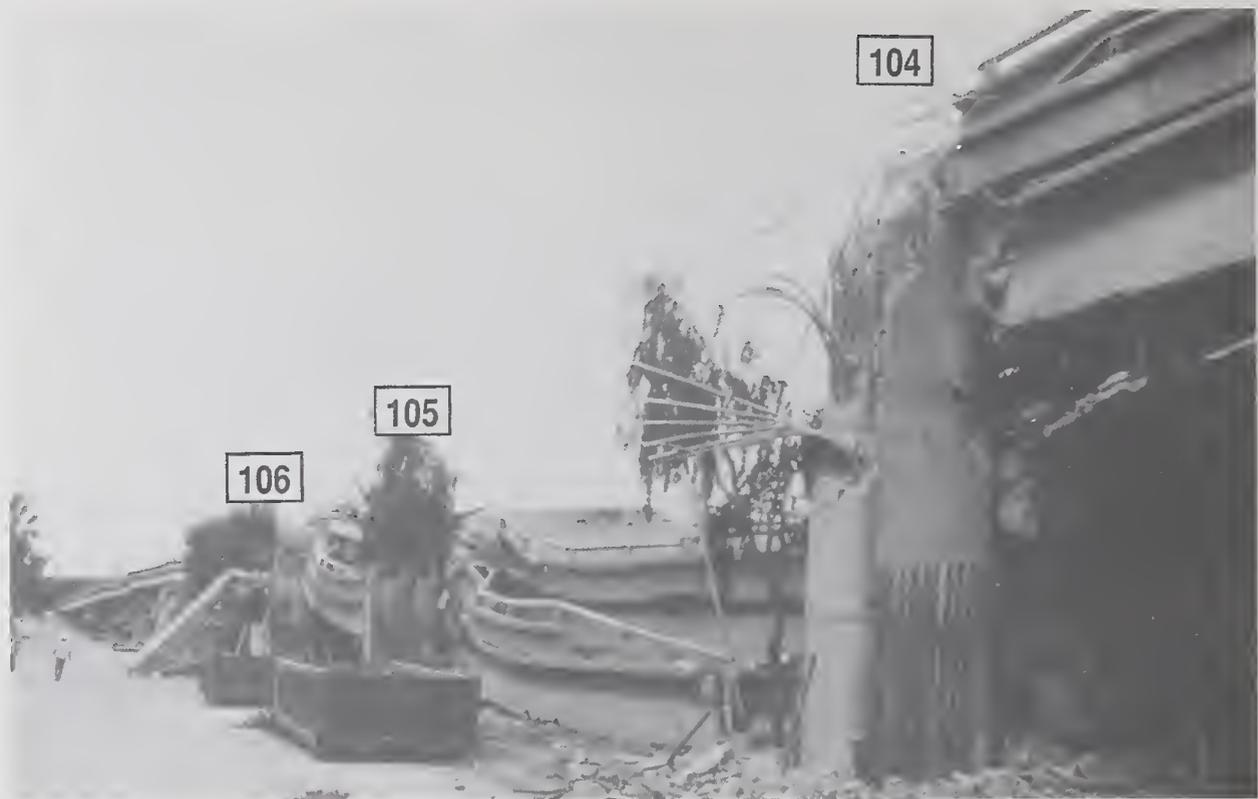
Figure 5.6.38 The section of Cypress Structure between Bents 104 and 106 was the only location in which both upper and lower bent frames failed.

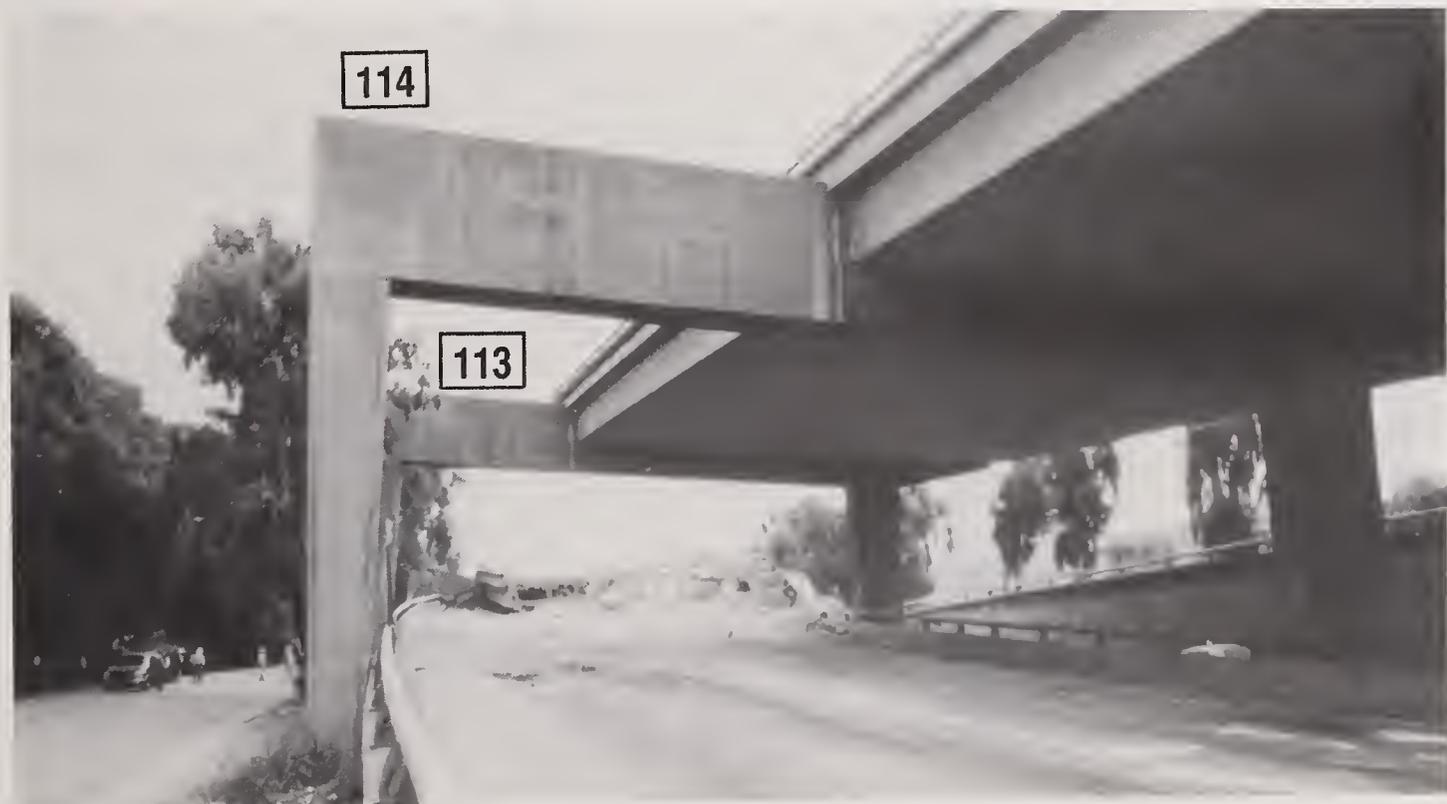
Figure 5.6.41 View looking south along the east side of Cypress Structure from Bent 115. The northern limit of the collapse extended to within six feet of Bent 113.

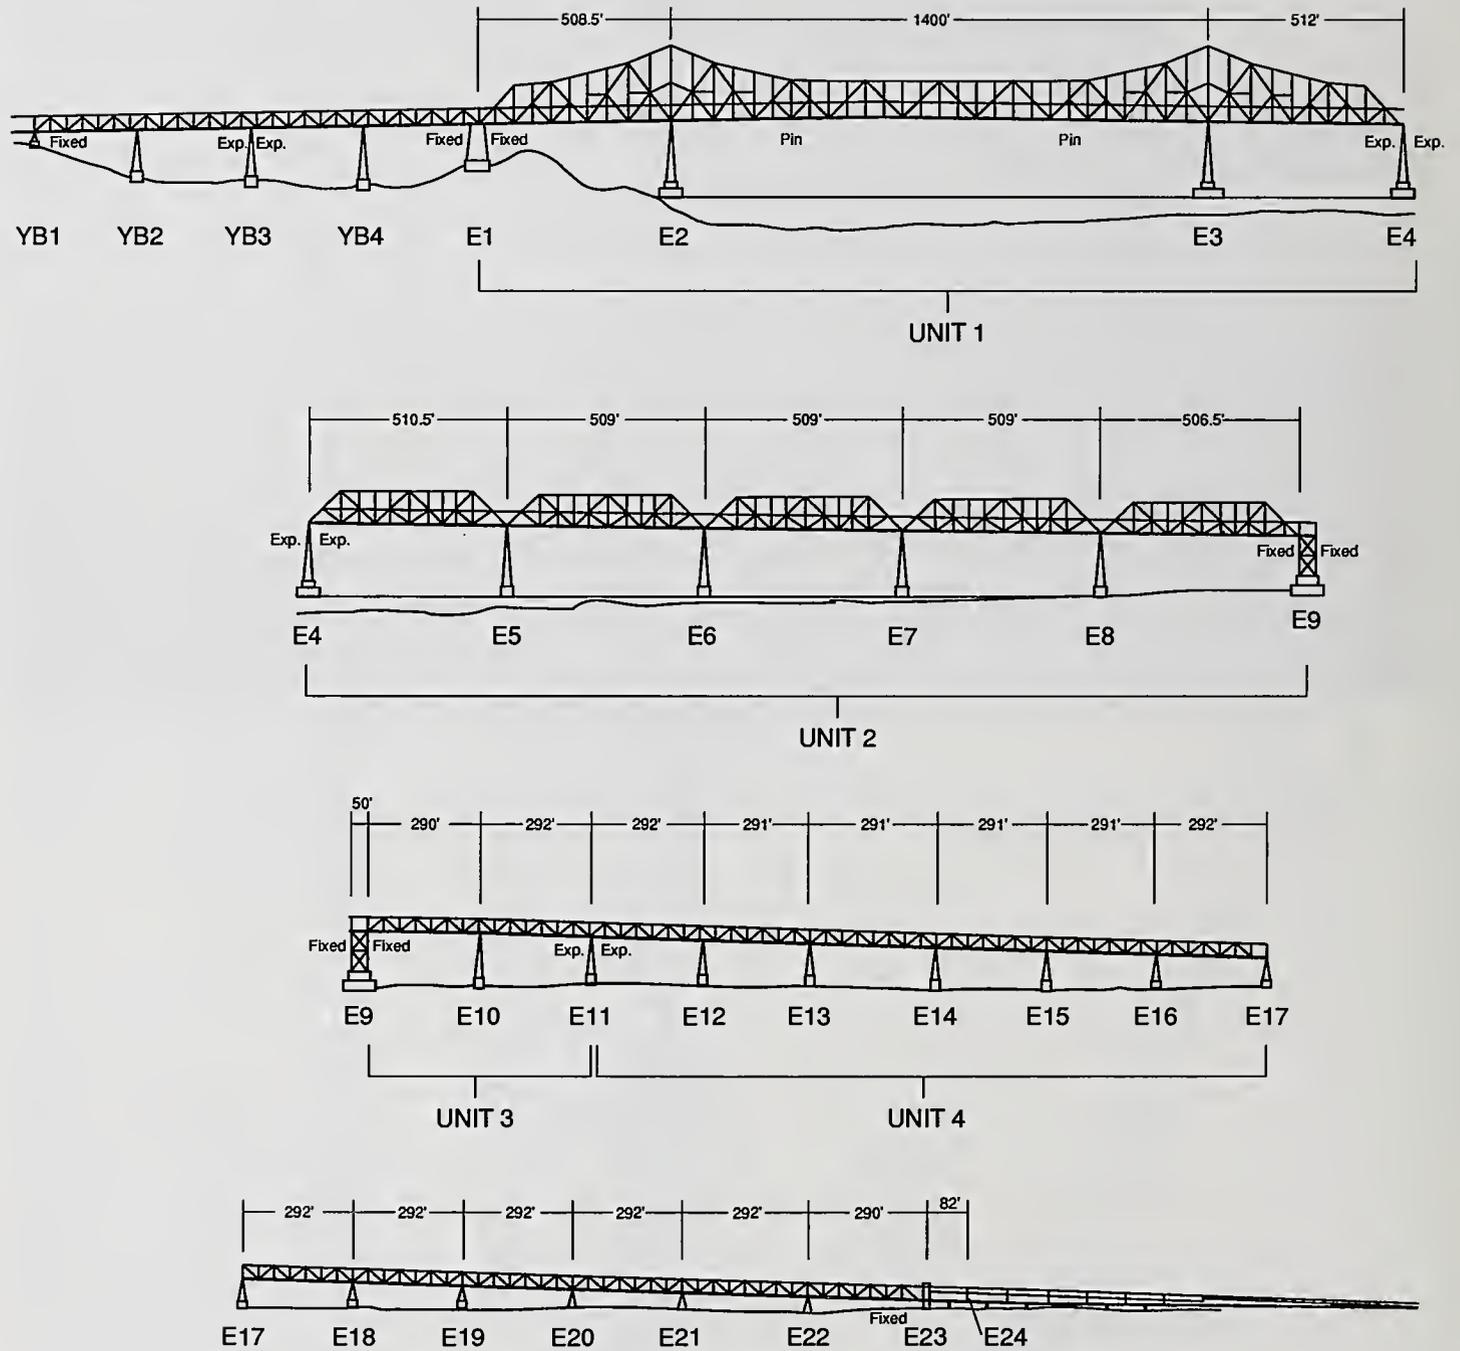
Figure 5.7.3 Detail of the east bay truss spans. Unit 3 was determined to have moved eastward as much as 10 inches, causing the collapse of the two deck segments at Pier E-9. Additional damage, generally involving the failure of retainer bolts, occurred between Piers E-17 and E-24.

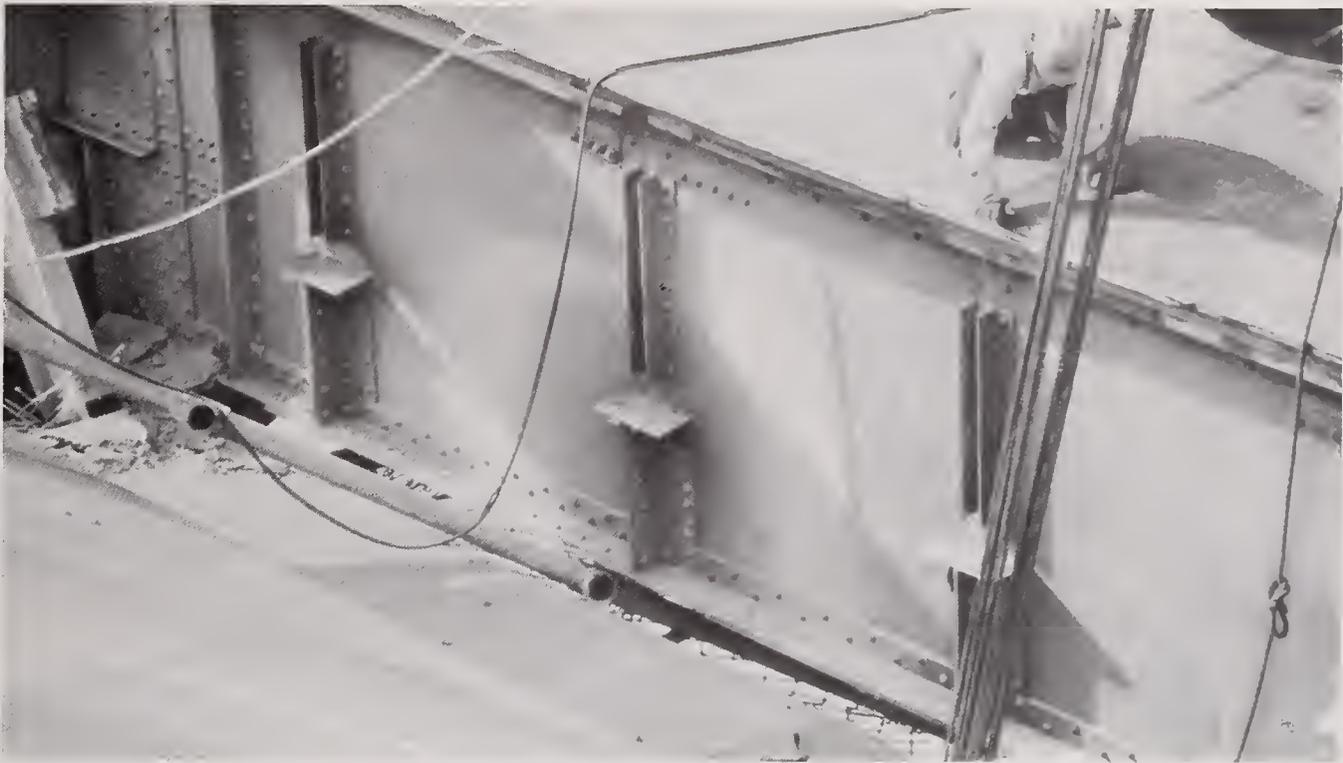
Figure 5.7.7 Close-up of the western girder seats for the lower road deck at Pier E-9. Lack of significant damage to these seats, and to those supporting the upper road deck, indicates that both upper and lower segments moved eastward by an amount sufficient to permit both to slide off the western seats and drop simultaneously.

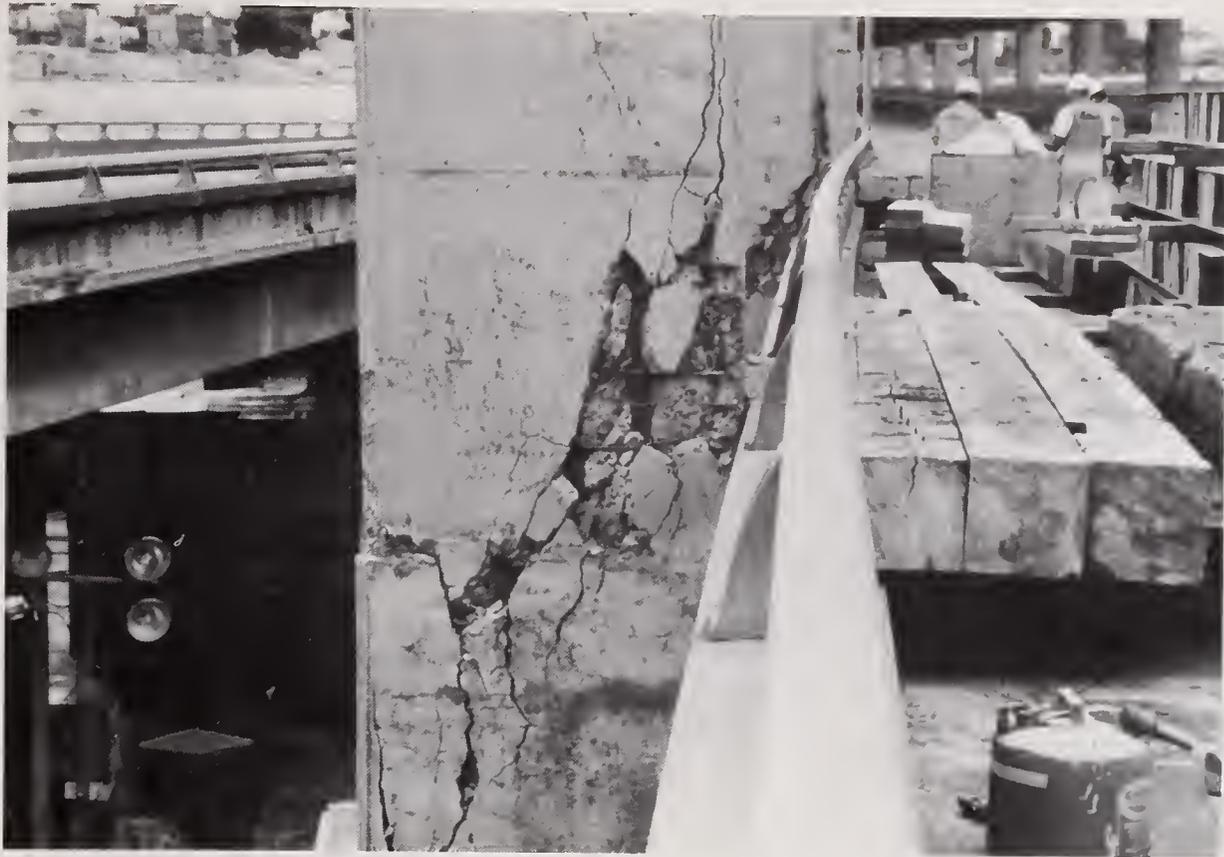
Figure 5.9.7 Diagonal cracking of the east-side column of Bent 52 (north face).

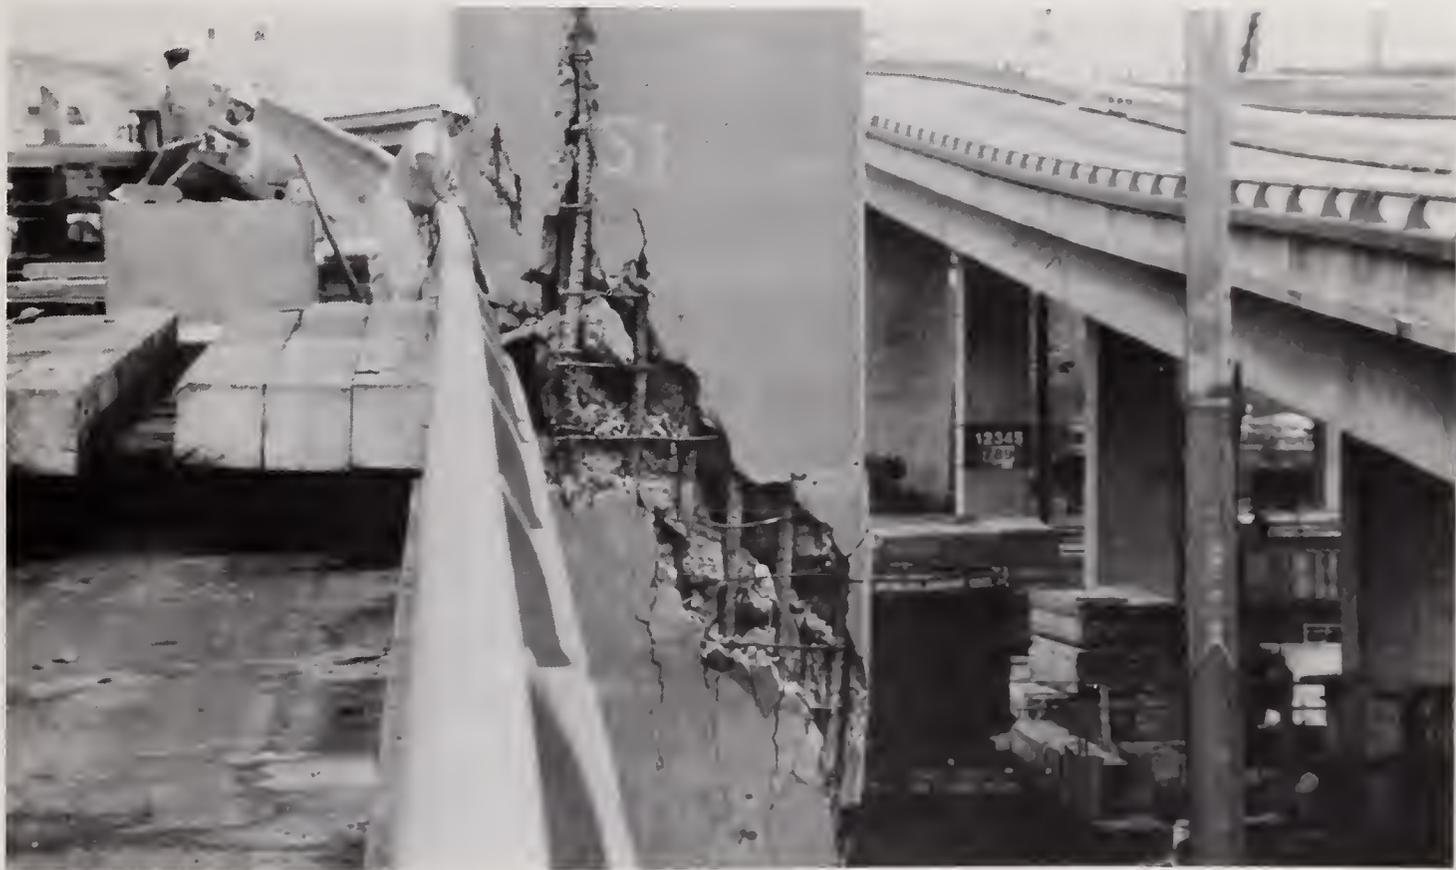
Figure 5.9.8 Diagonal cracking of the east-side column of Bent 51 (south face).

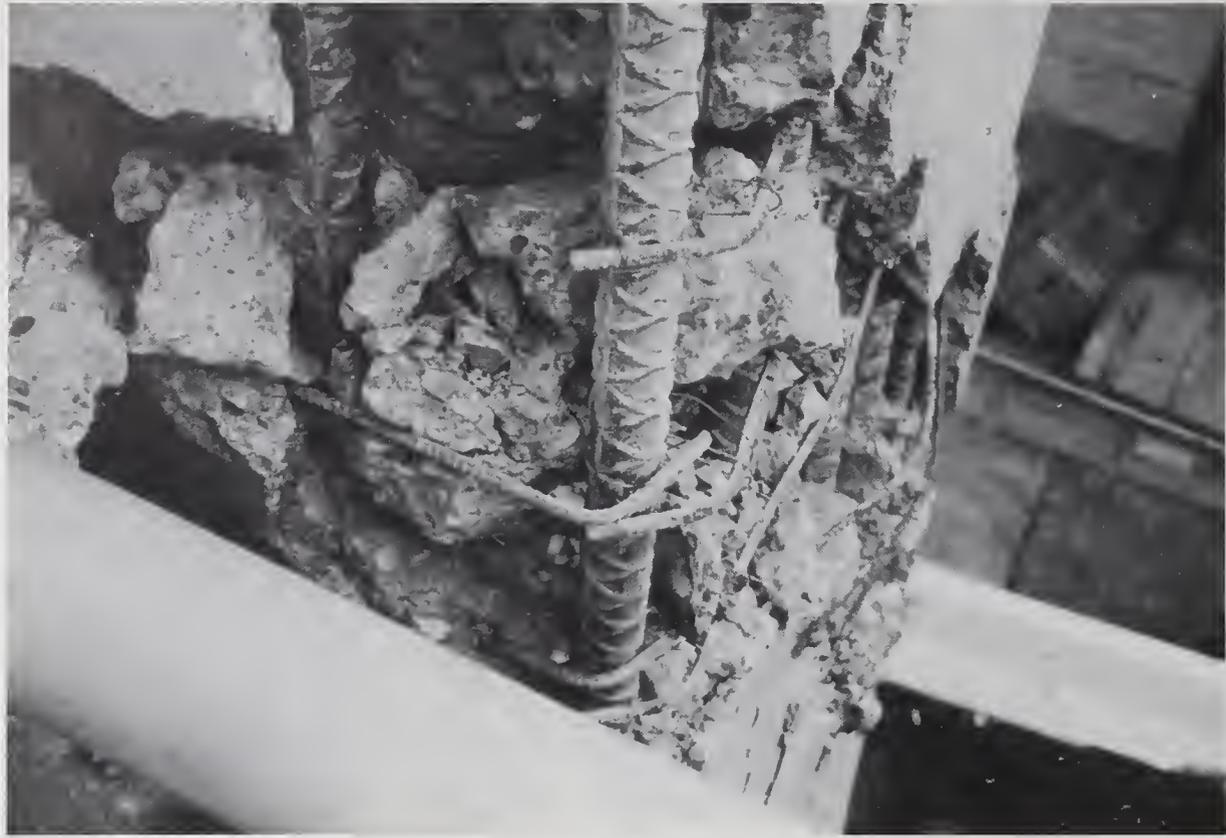
Figure 5.9.9 Close-up view of the failure zone of Bent 51, showing anchorage failure of ties.

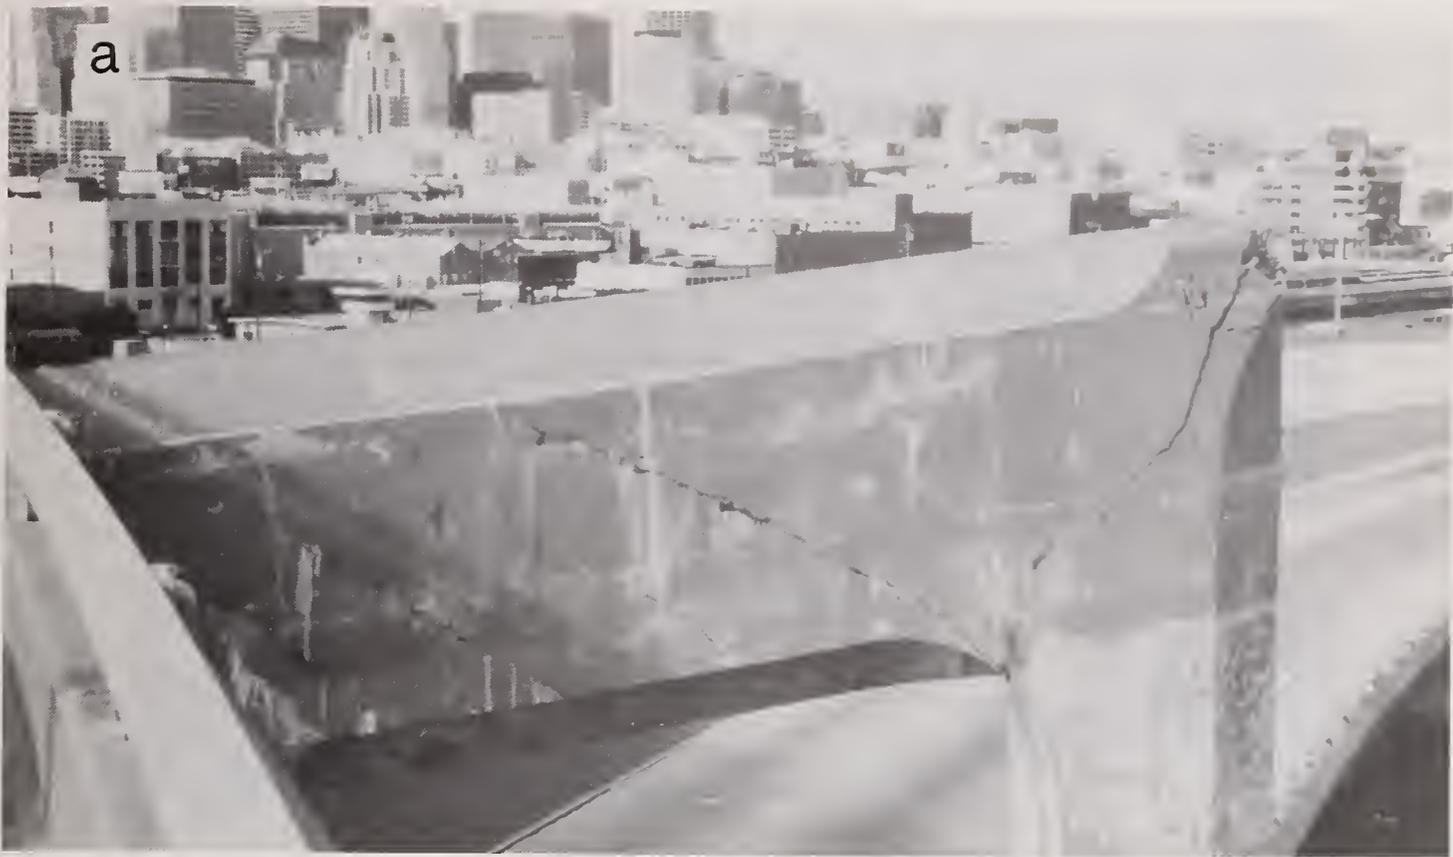
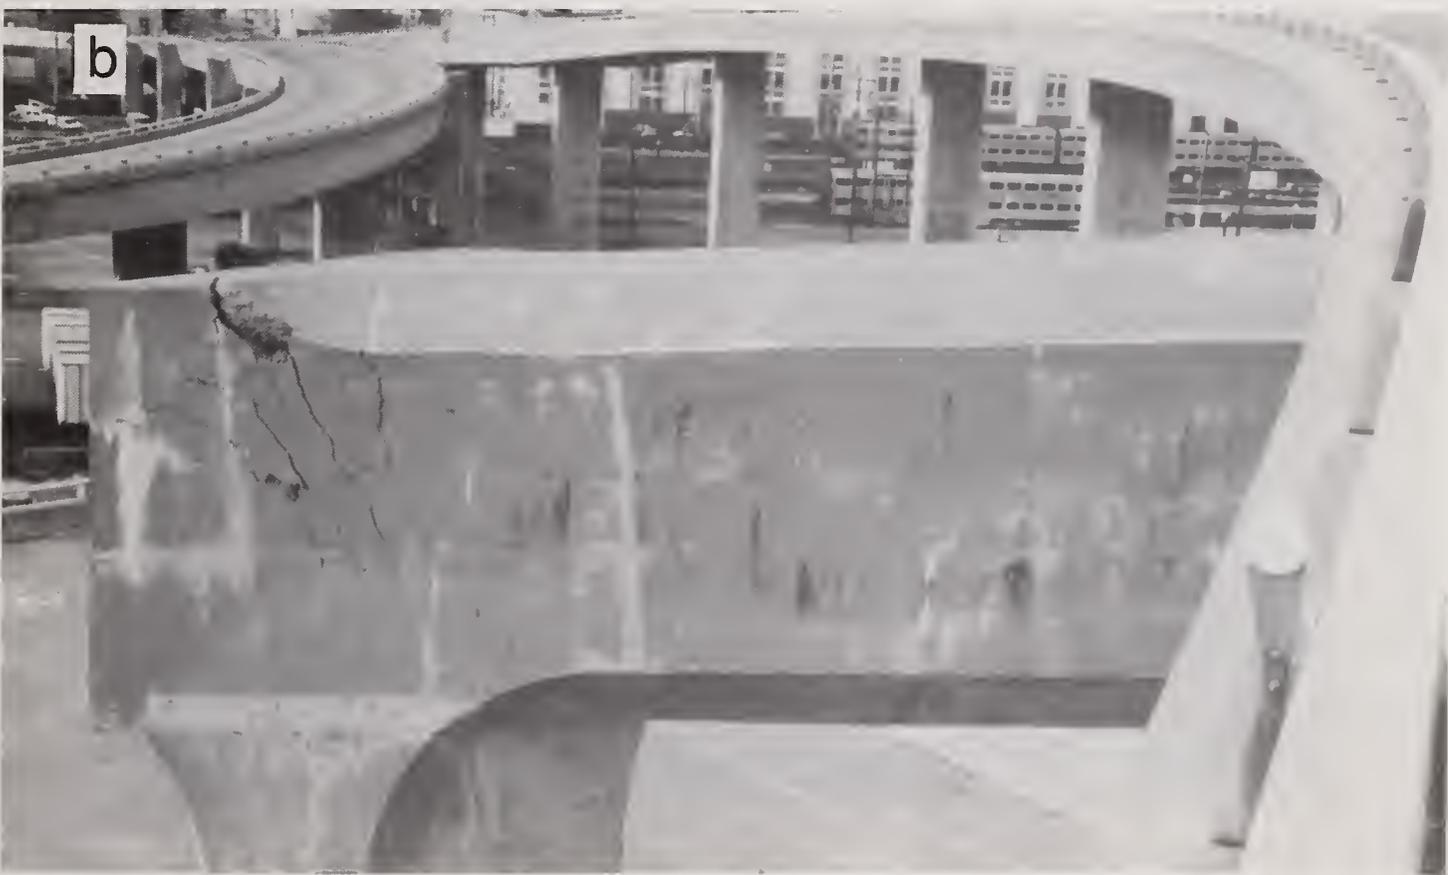
Figure 5.9.14 Damage to girder supporting exit ramp: (a) eastern portion and (b) western portion.
