NIST Special Publication 778

Performance of Structures During the Loma Prieta Earthquake of October 17, 1989

H. S. Lew, Editor

January 1990

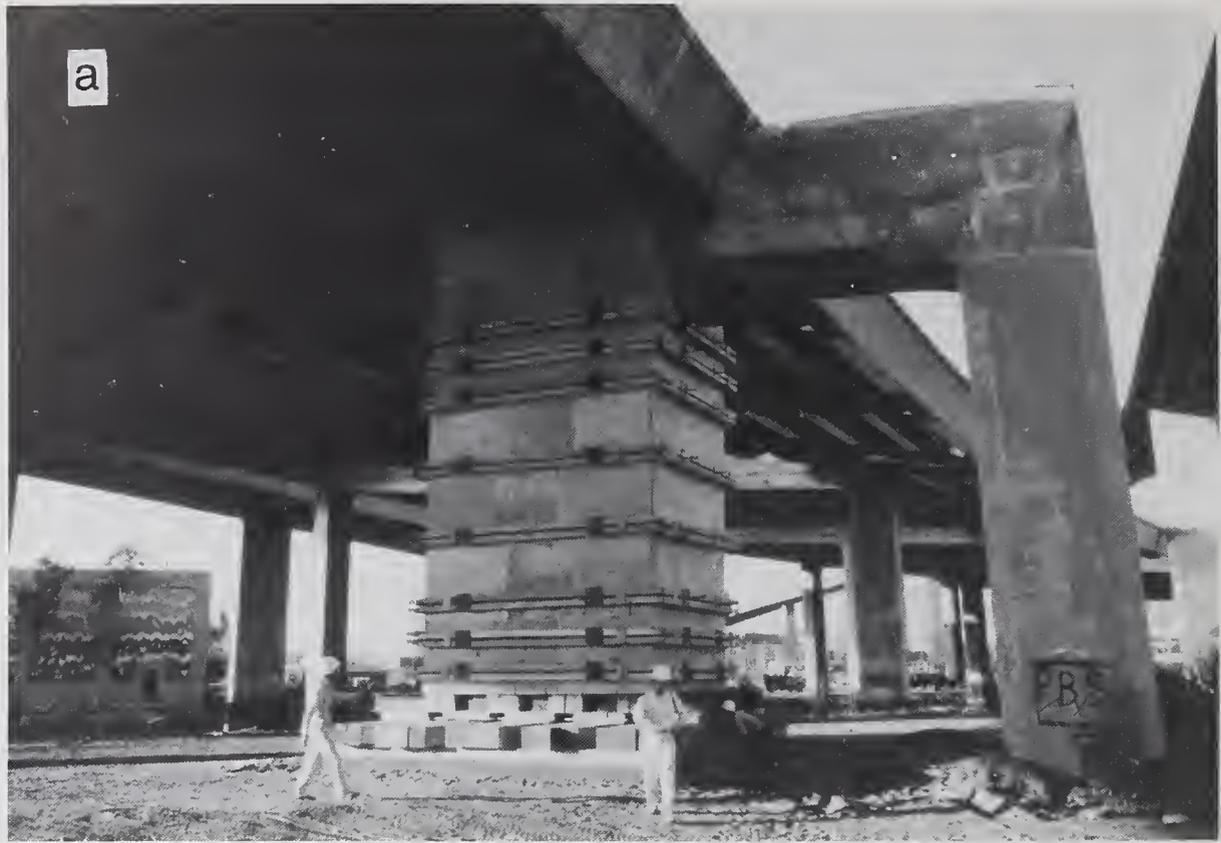
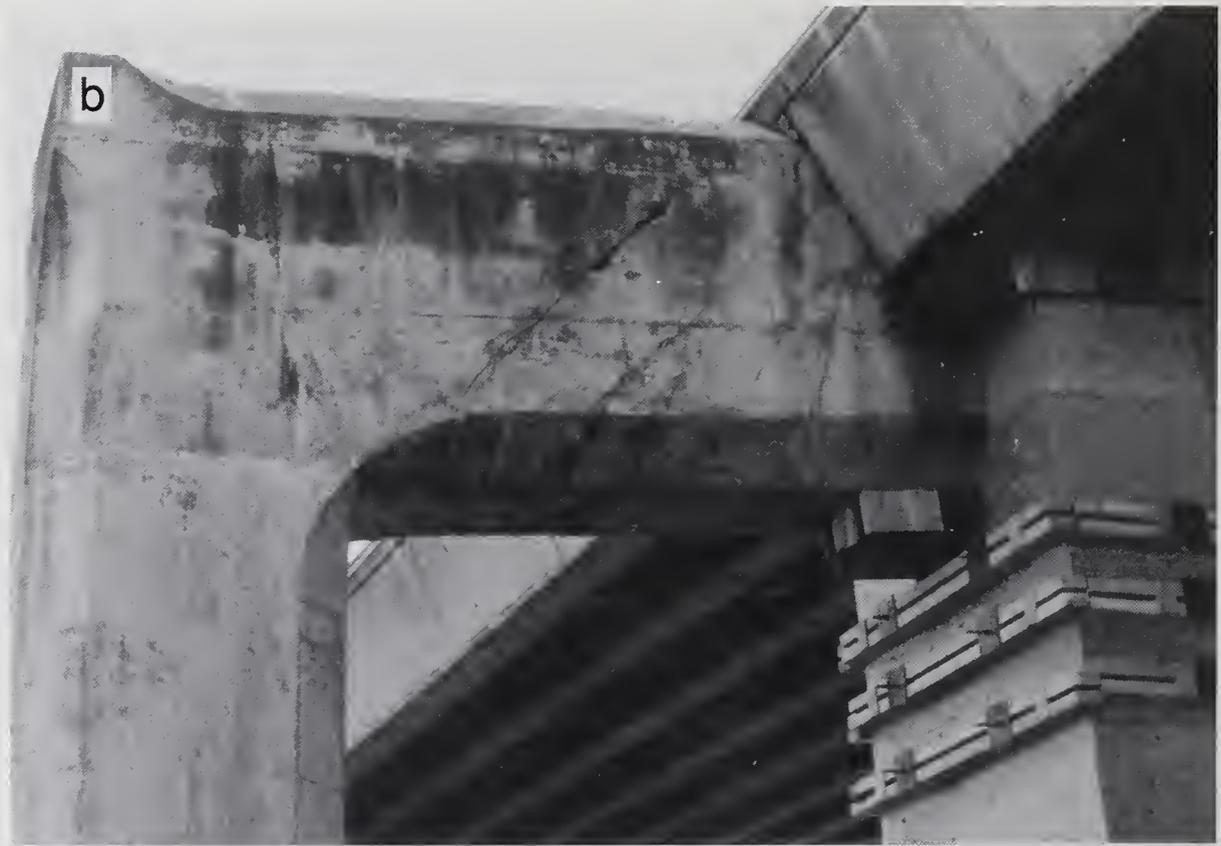
Figure 5.9.15 (a) Bent 32 supporting I-280 at Sixth St. exit ramp and (b) close-up of girder showing diagonal cracking.

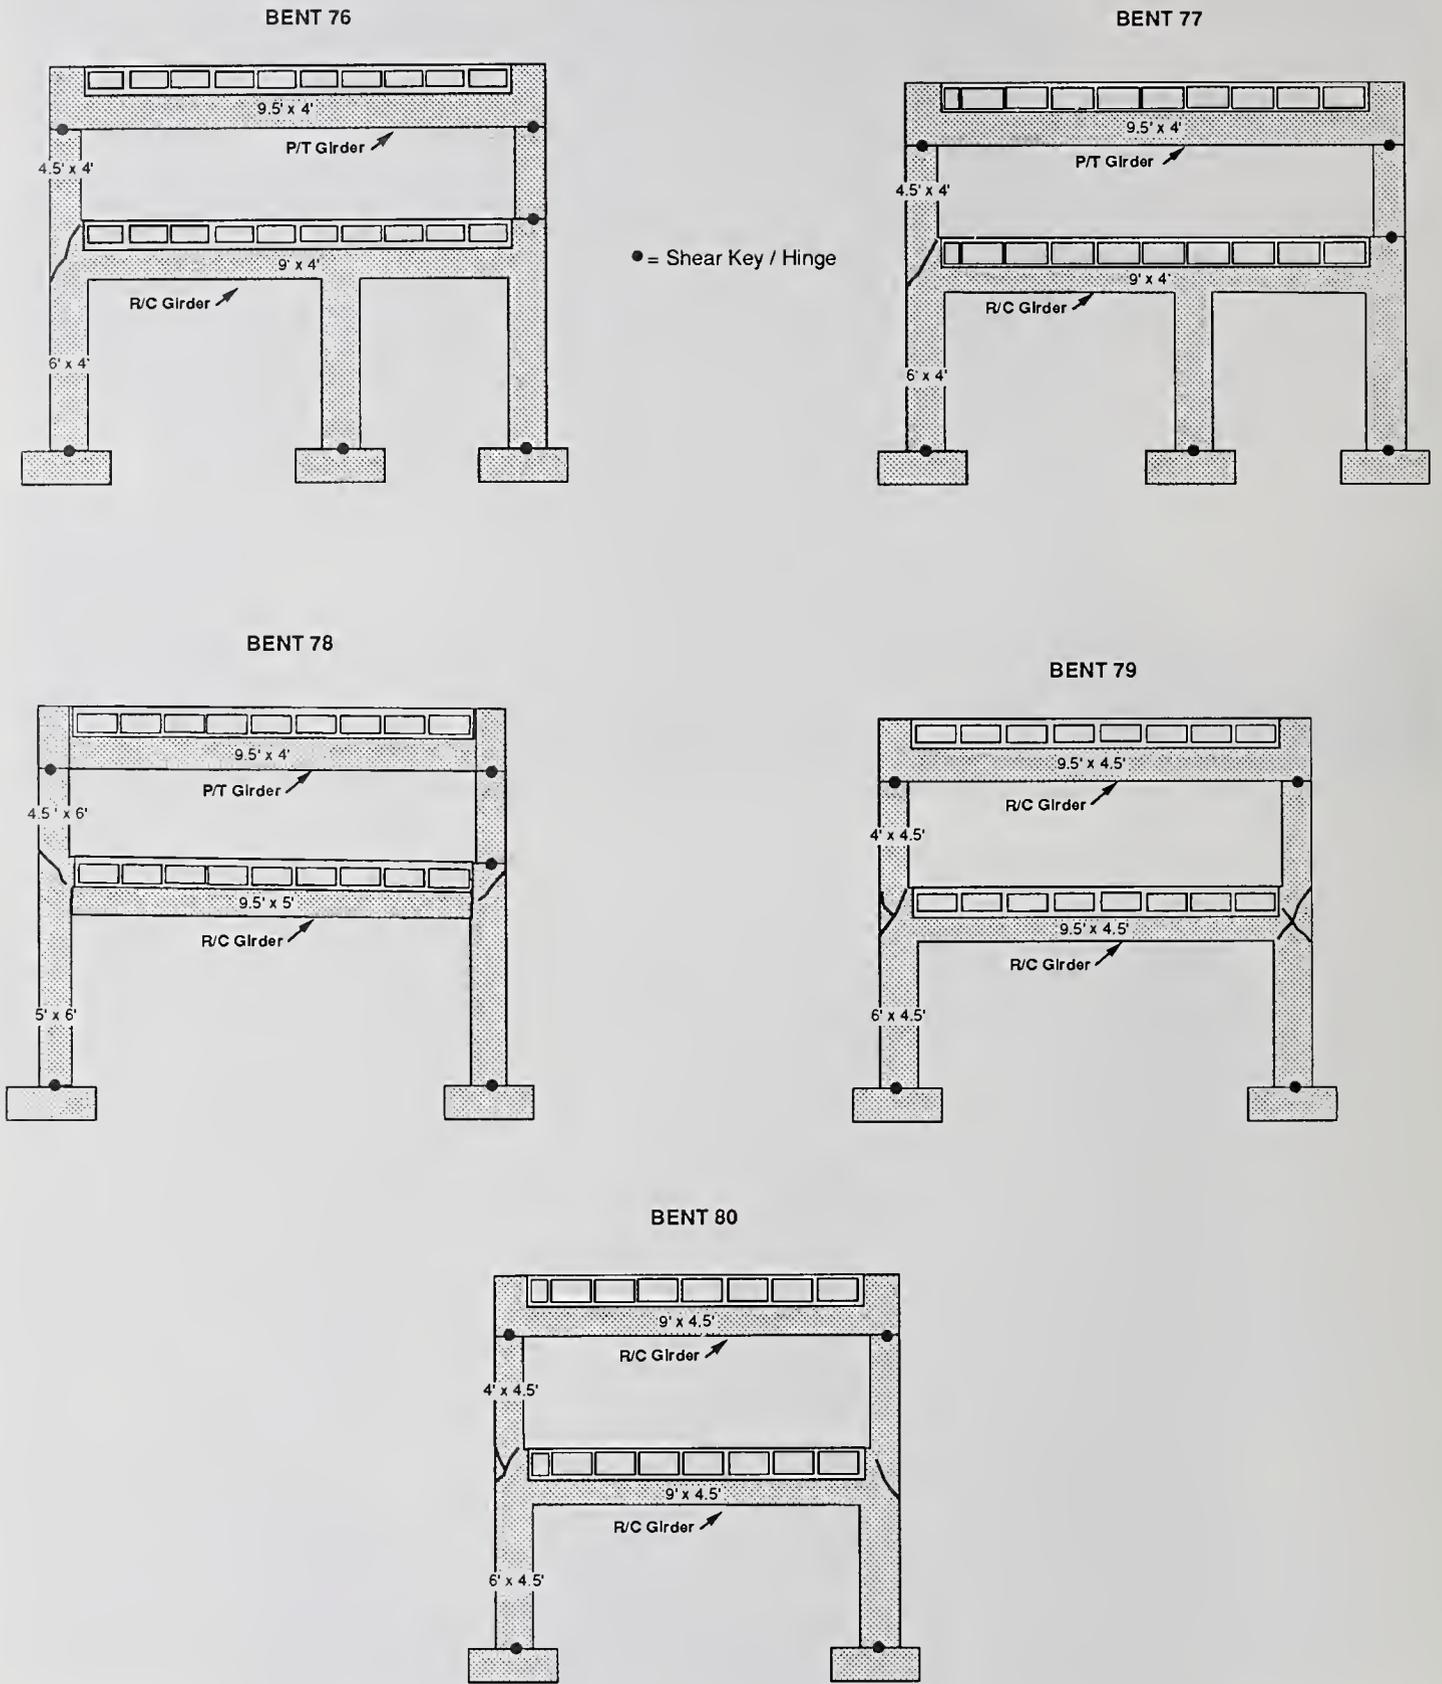
Figure 5.10.4 Schematic of bent configurations and damage at lower girder-column joints.

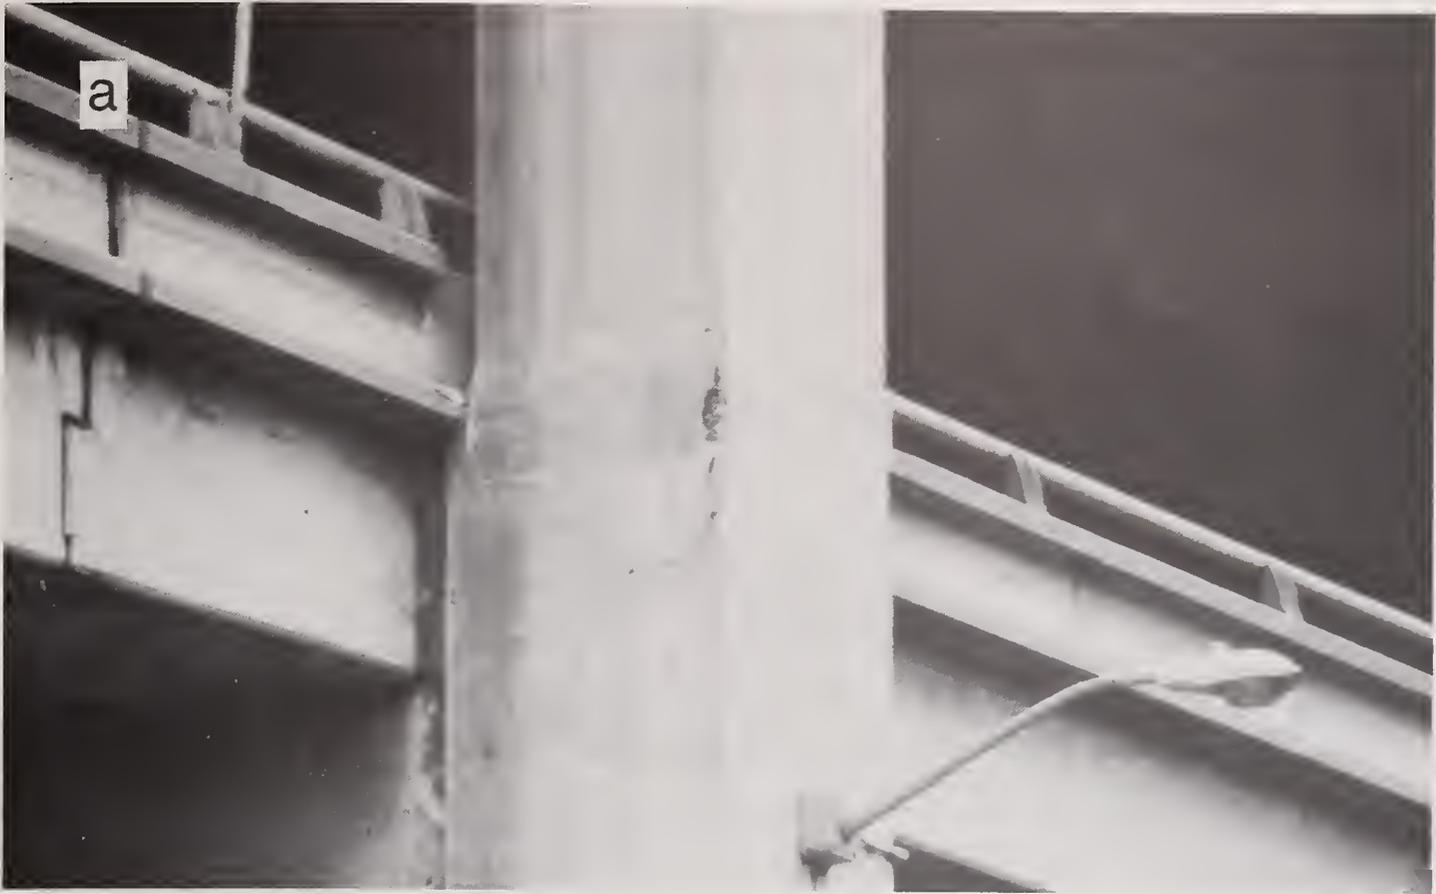
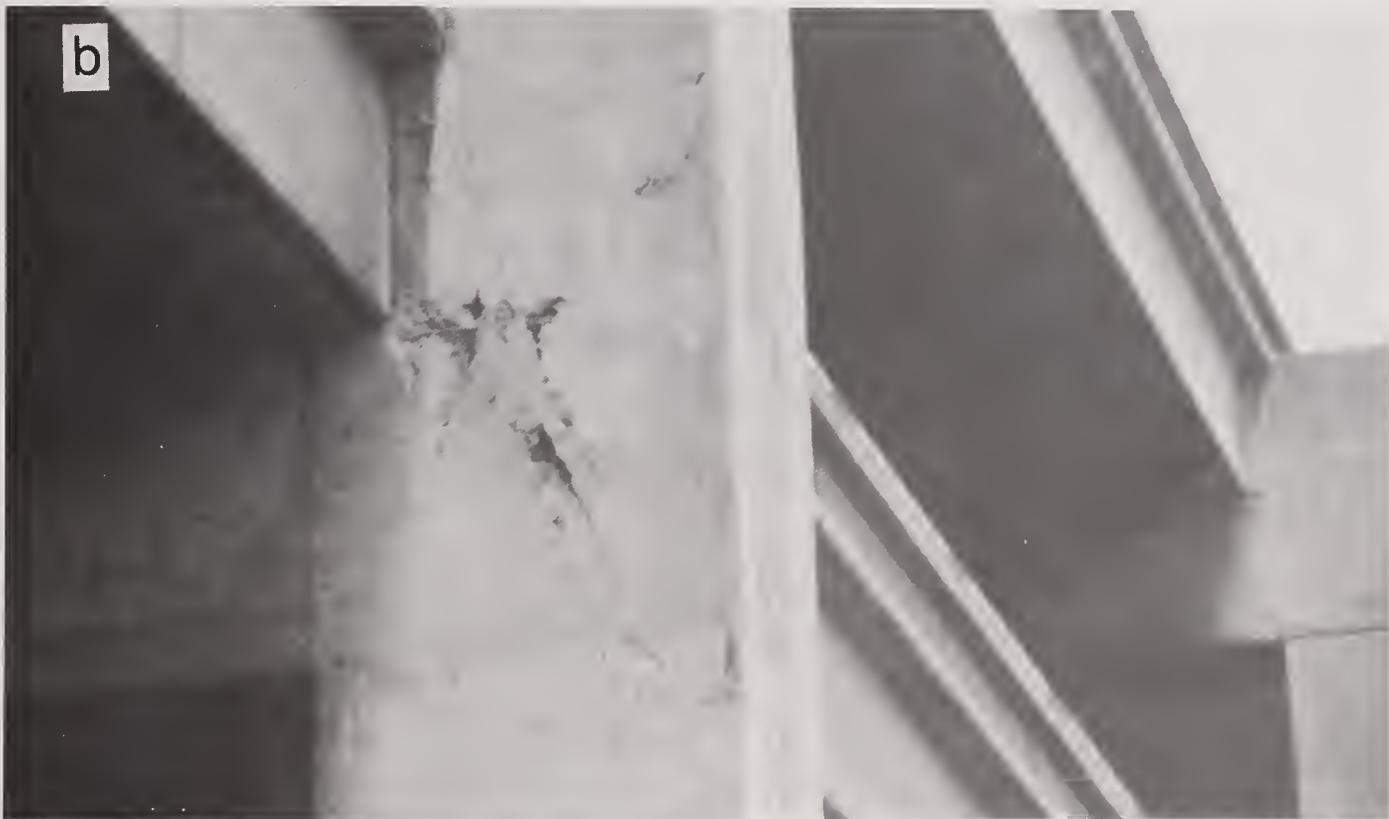
Figure 5.10.5 (a) Close-up view of west side of Bent 78 showing diagonal cracking in joint and vertical cracking at girder-column boundary; (b) close-up view of east side of Bent 79 showing diagonal cracking in joint.

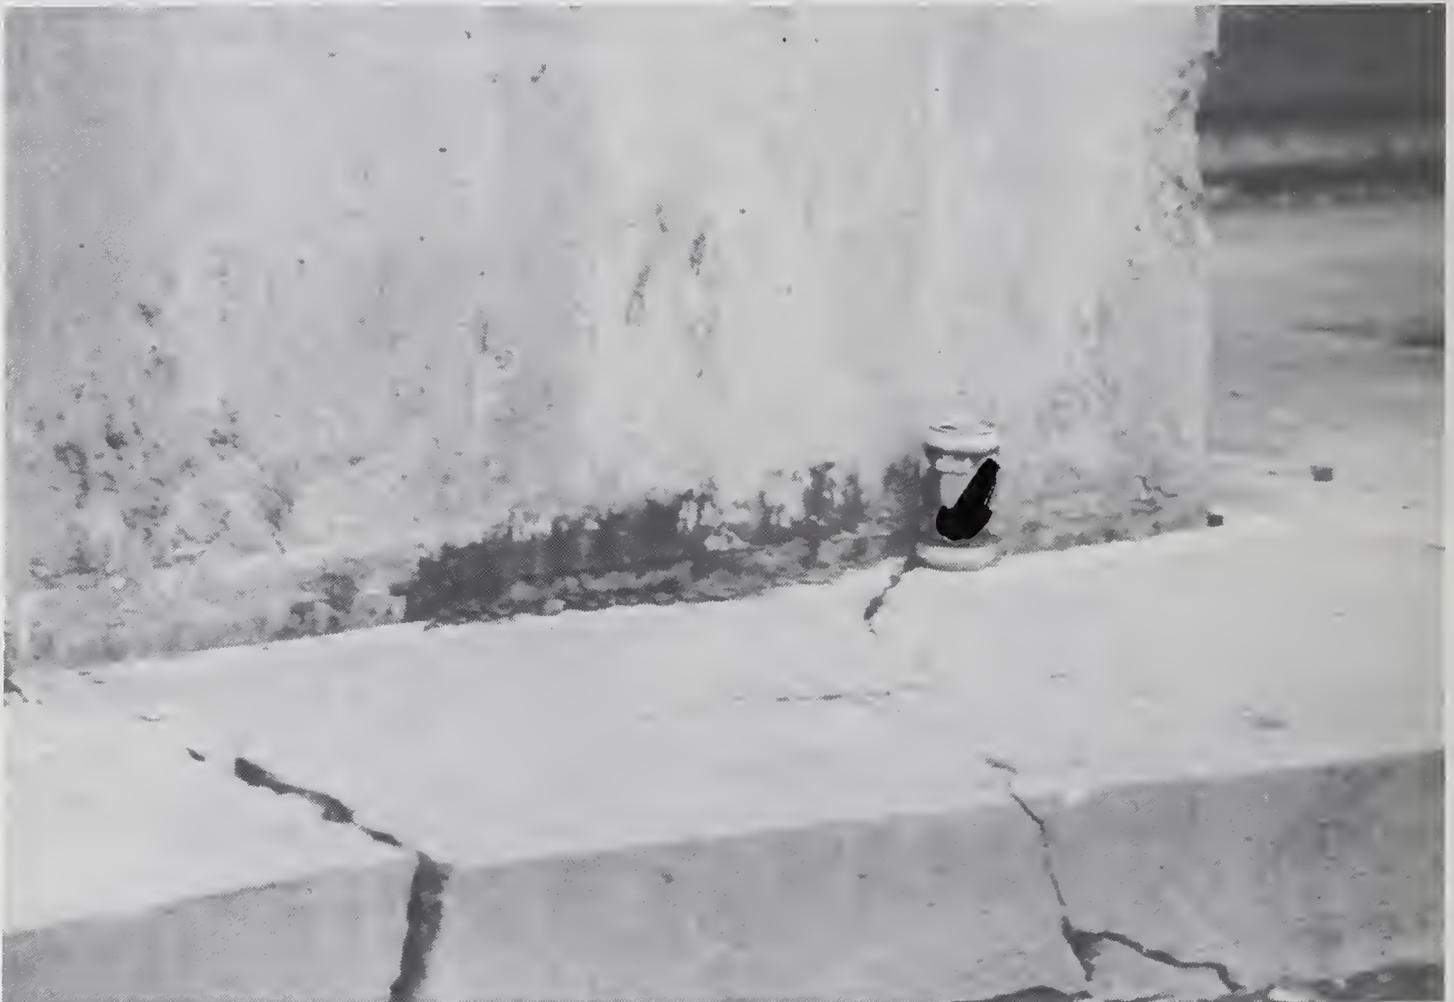
Figure 5.10.6 Evidence of large ground movement at east side base of Bent 77.

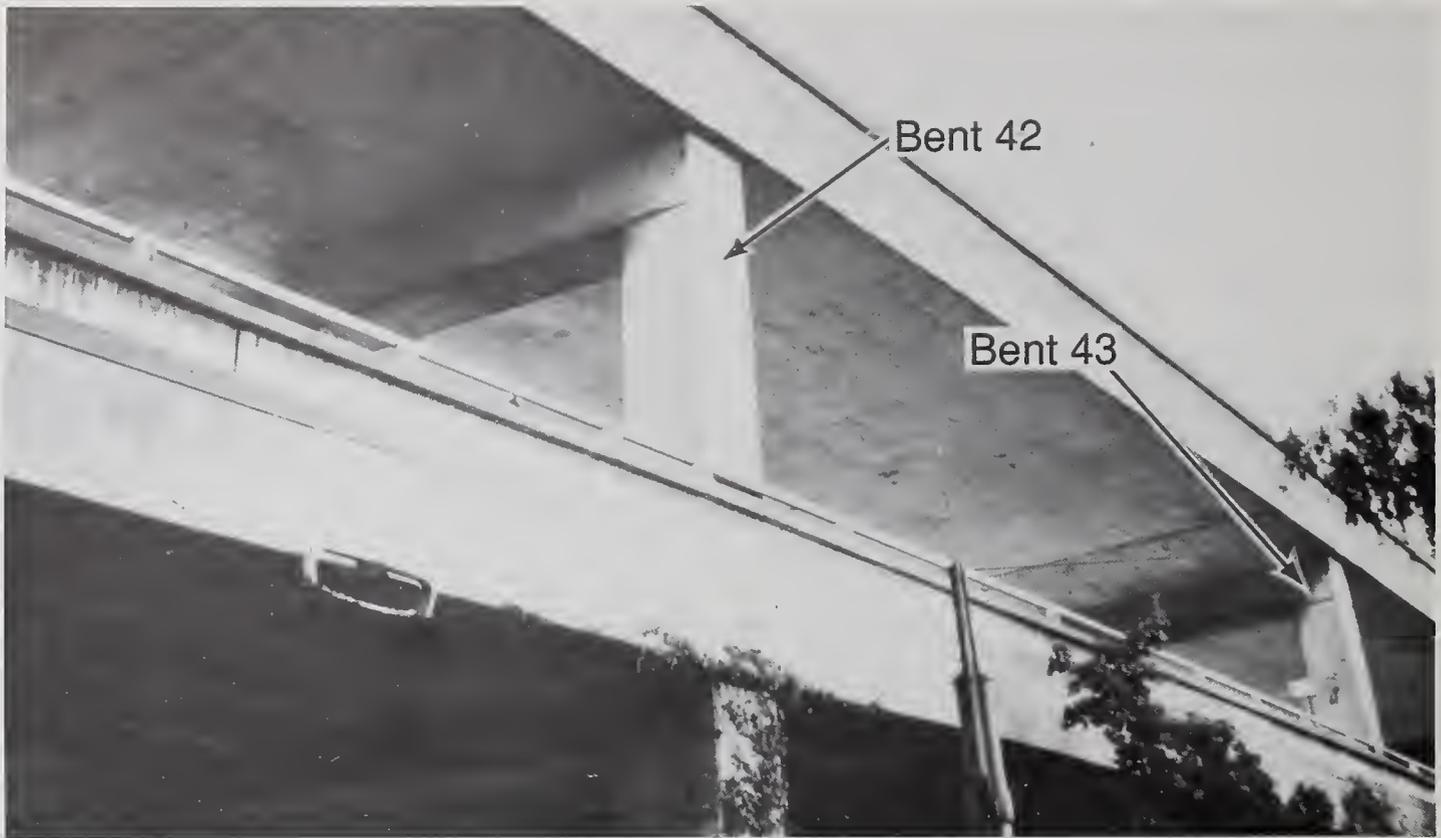
Figure 5.11.1 View of east side U.S. 101 north of Hayes St. showing damaged Bents 42 and 43.

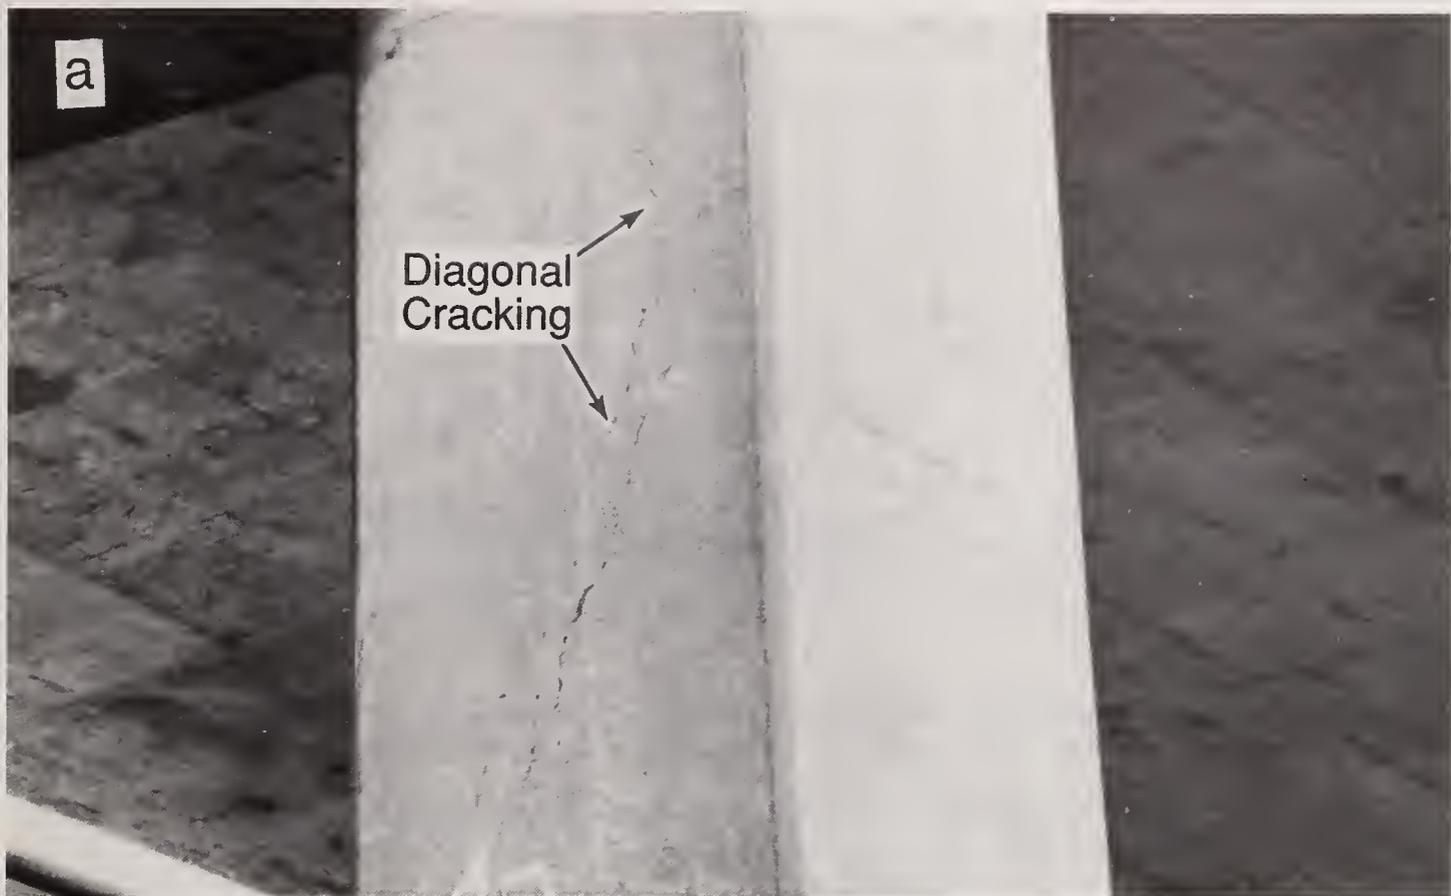
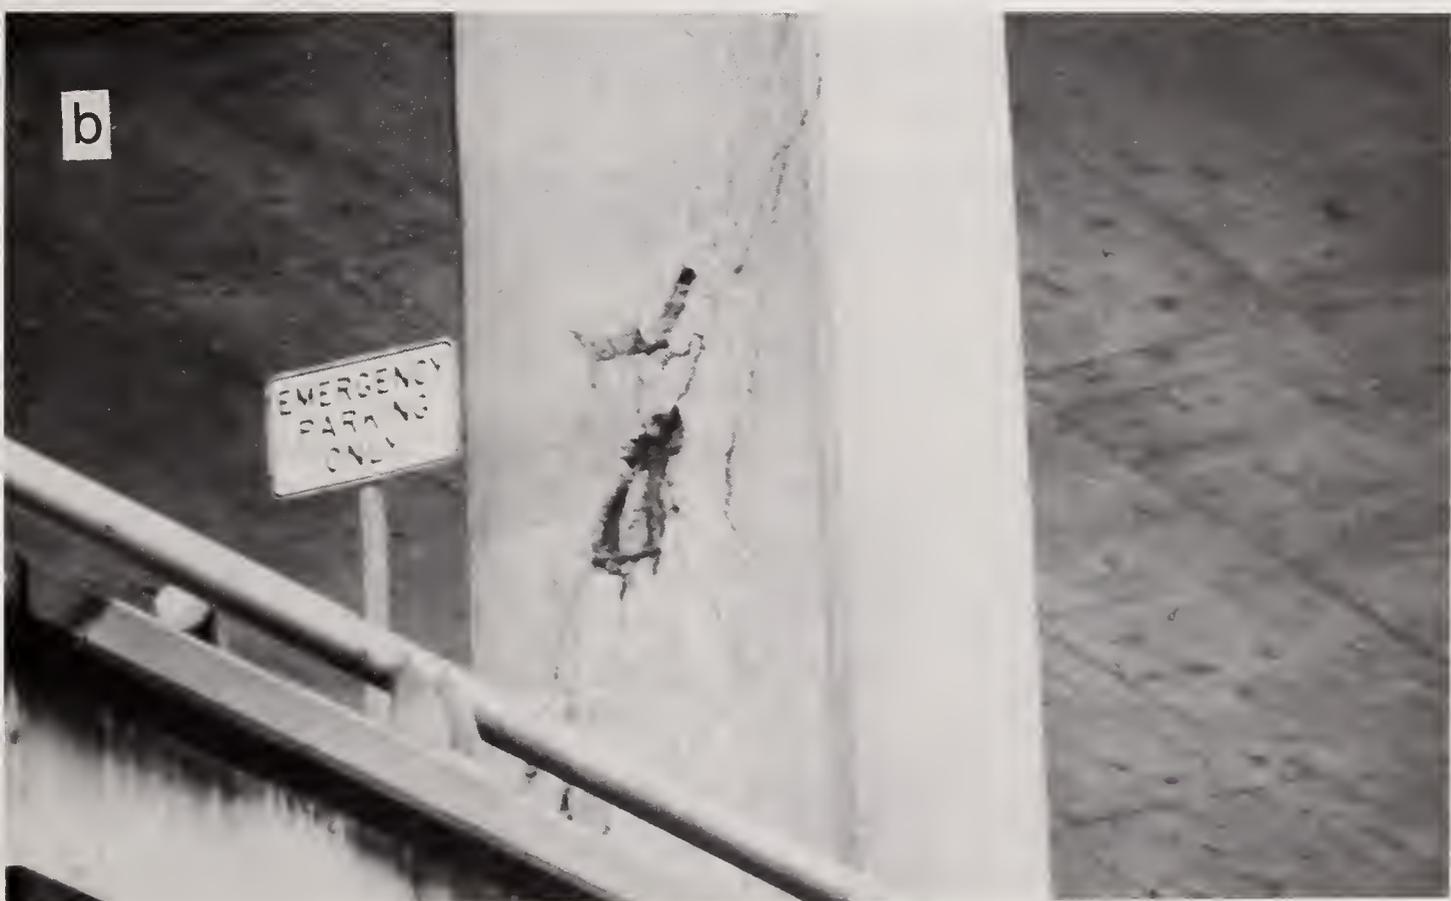
Figure 5.11.3 Close-up views of east side columns of (a) Bent 42 and (b) Bent 43.
