**Federal Building and Fire Safety Investigation of the
World Trade Center Disaster**

**Damage and Failure Modes of
Structural Steel Components**

Stephen W. Banovic
Timothy Foecke

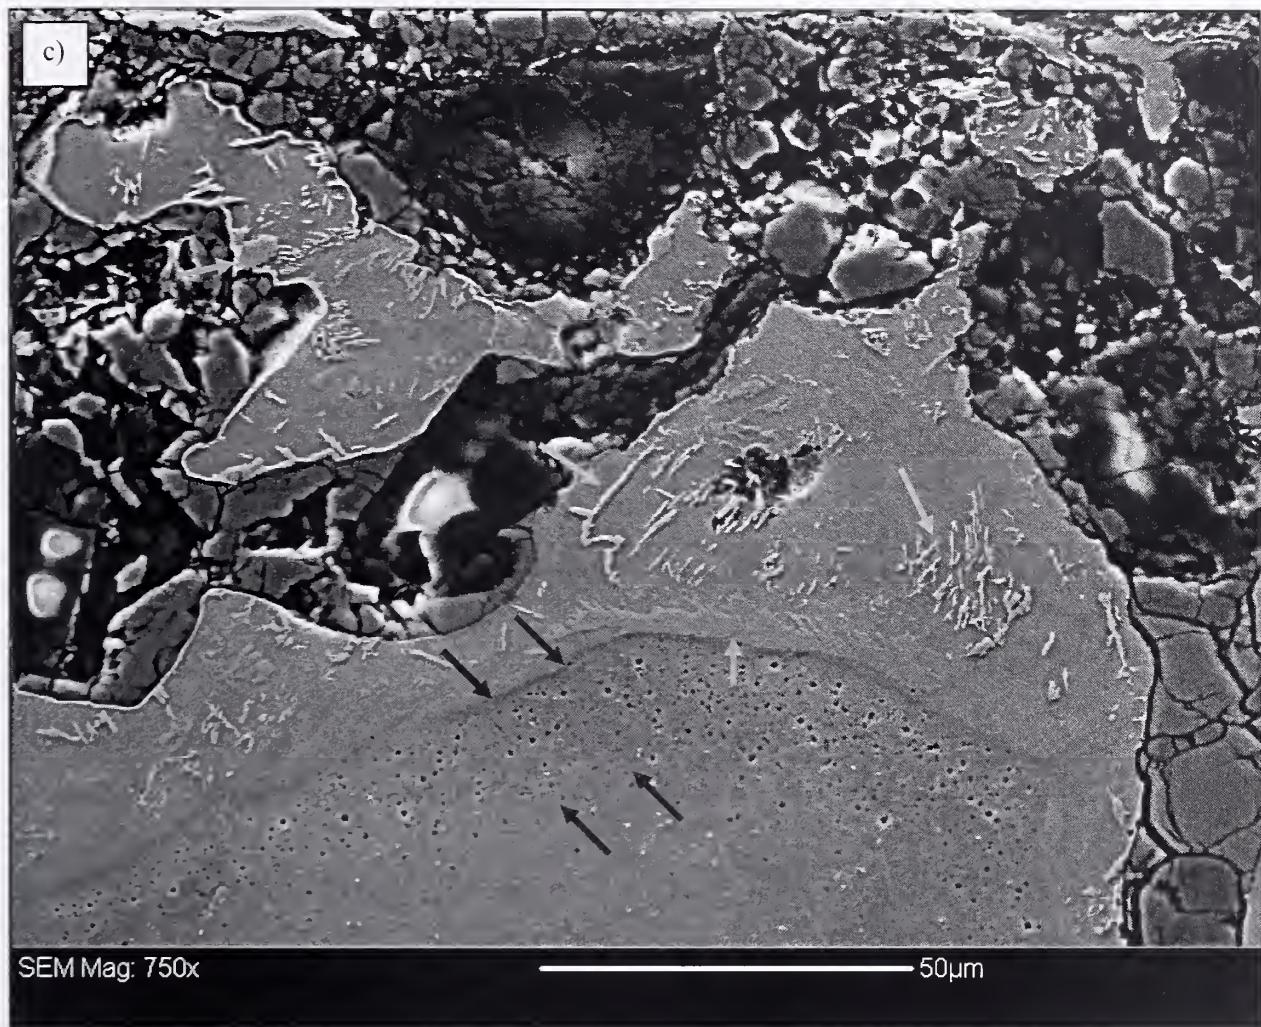
Figure 6–28. Secondary electron image showing the corrosion scale found on sample C-115. c) Blue arrows indicate the internal oxidation zone, green arrows indicate the “feathery” morphology and orange arrows indicated the “needle-like” morphology of corrosion phases observed. Two percent nital and 4 percent picral etch.

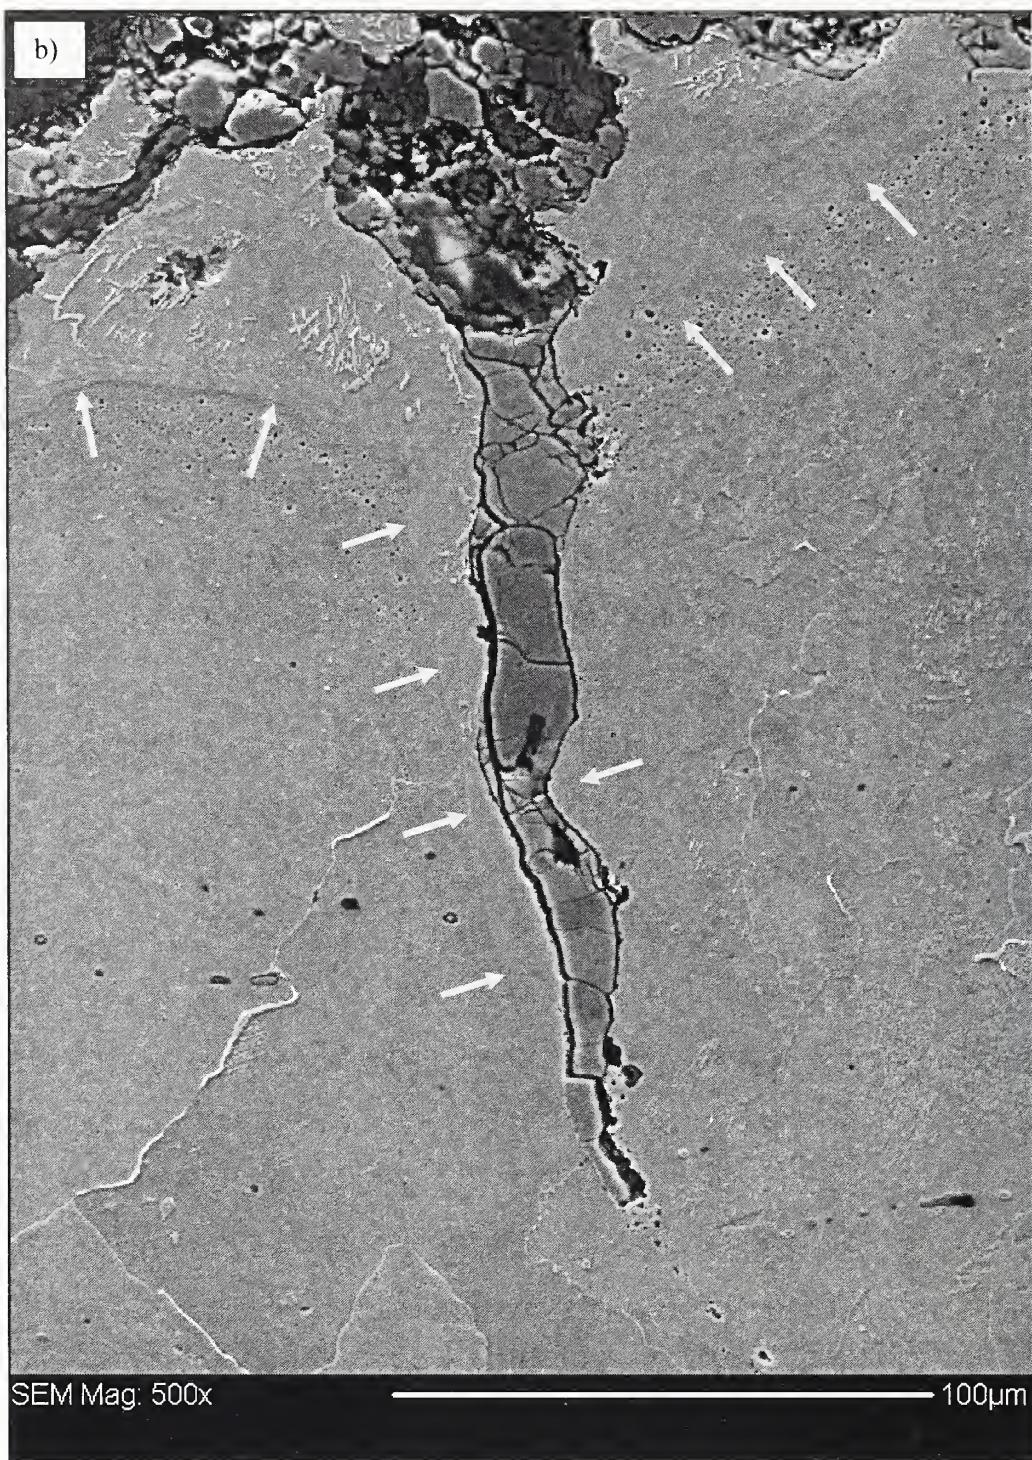
Figure 6–28. Secondary electron image showing the corrosion scale found on sample C-115. b) yellow arrows indicating the Fe-Ni layer between the penetrating corrosion product and internal oxidation zone. Two percent nital and 4 percent picral etch (cont.).

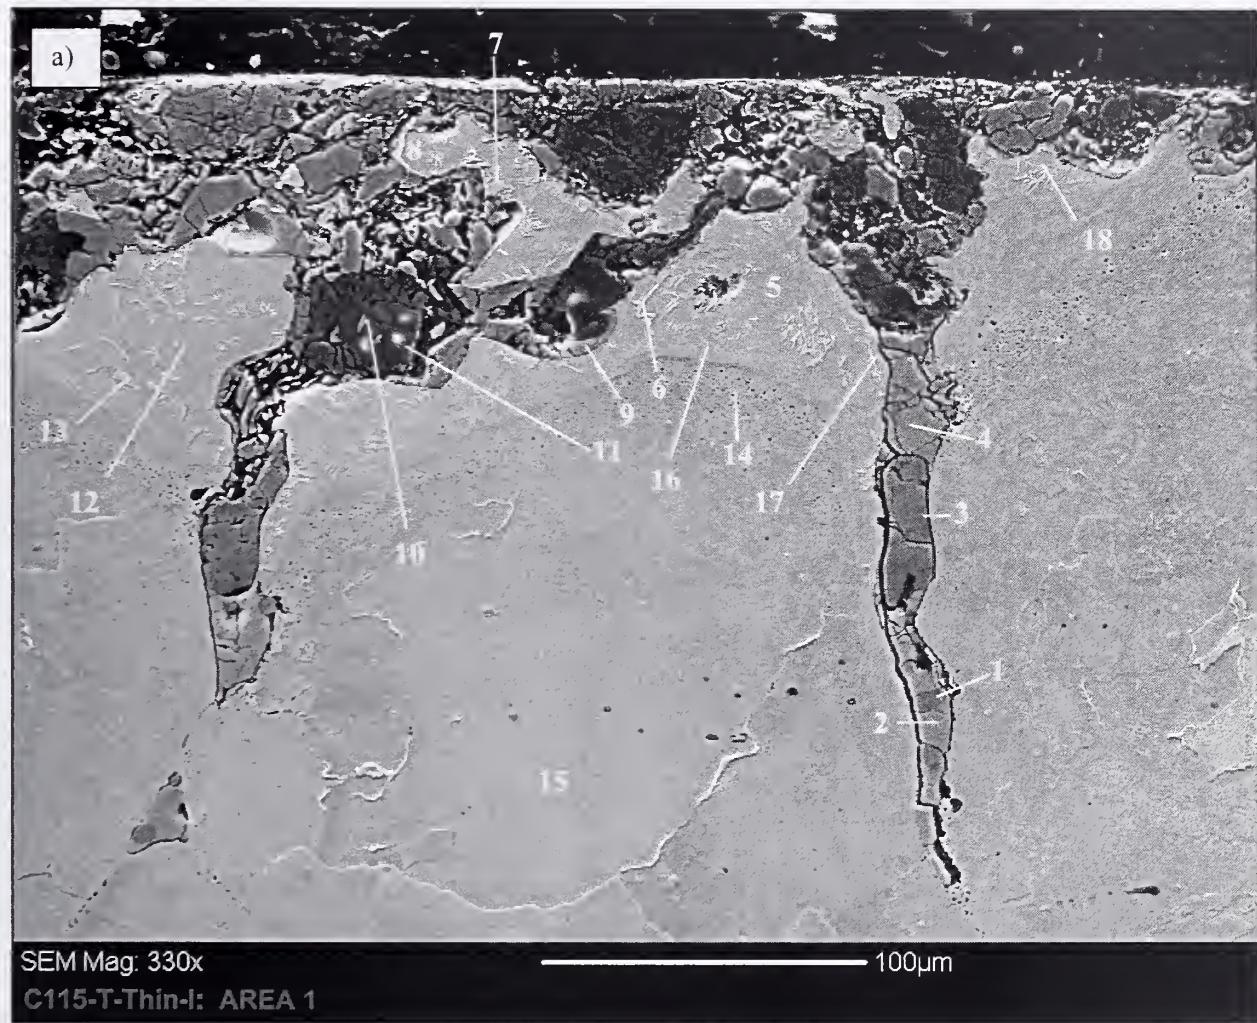
Figure 6–28. Secondary electron image showing the corrosion scale found on sample C-115. a) The location of EDS analysis (results shown in Table 6–3) were indicated. Two percent nital and 4 percent picral etch.

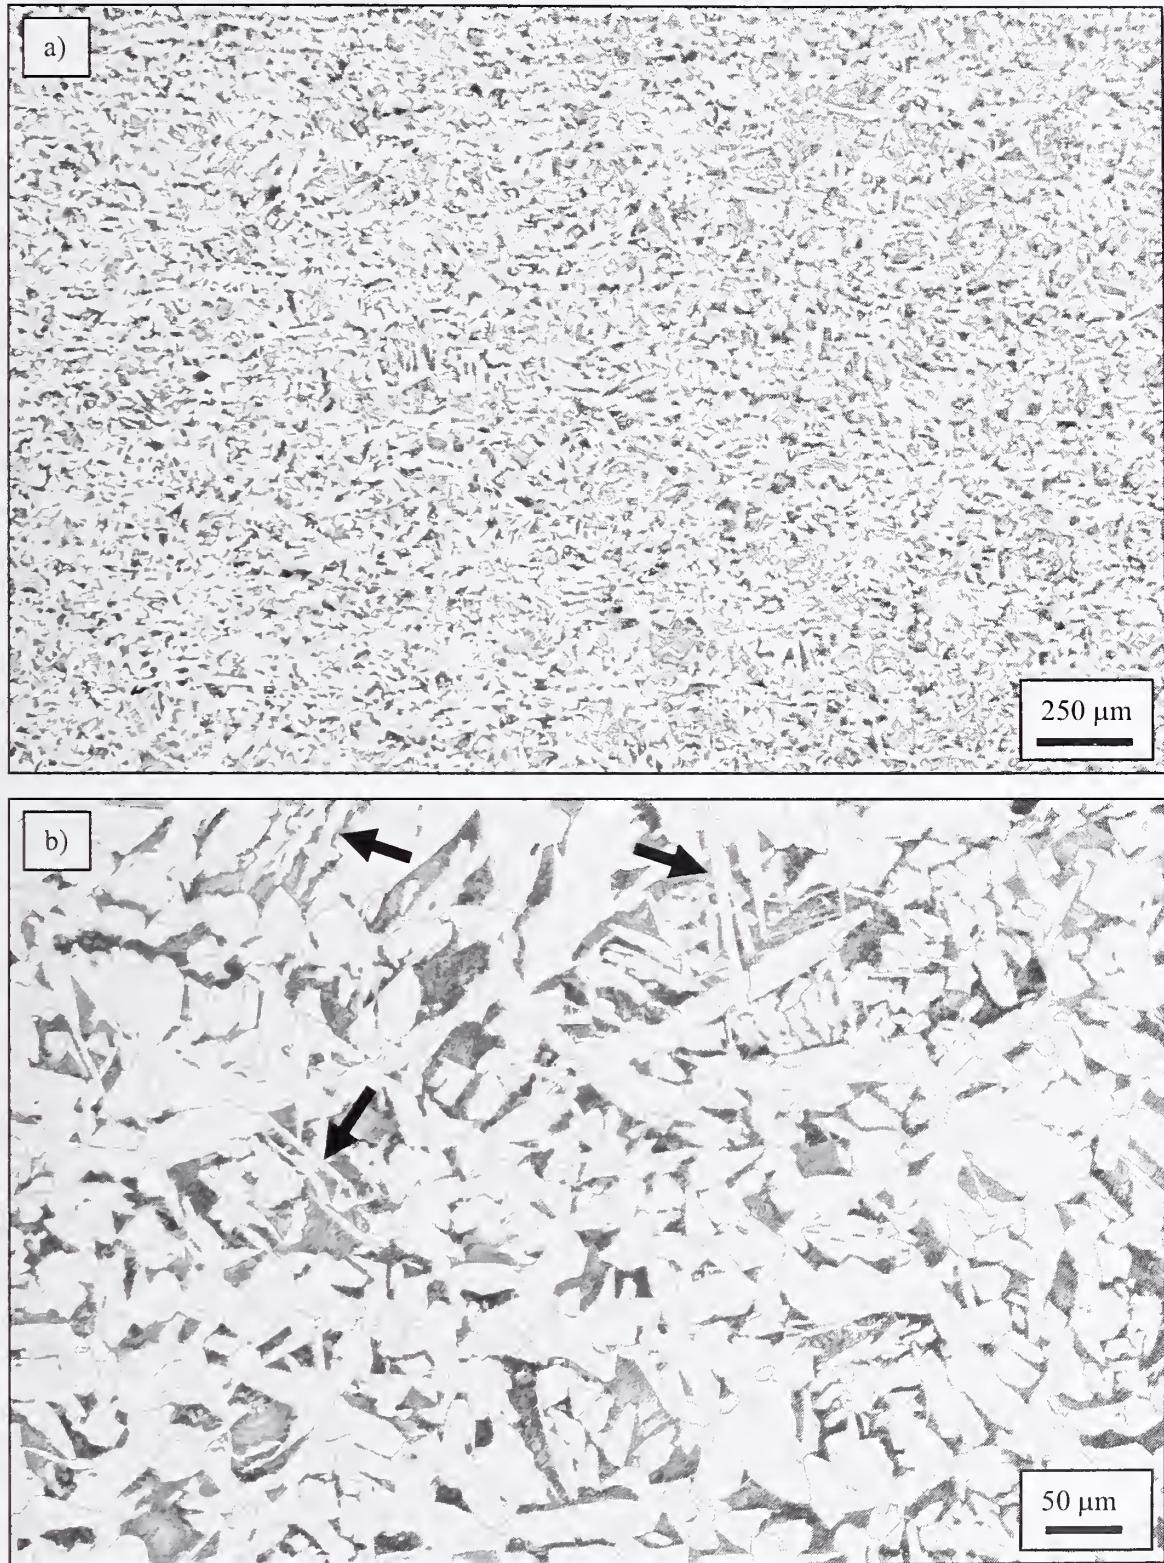
Figure 6–27. Light optical micrograph showing the structure of corrosion scale formed on sample C-115. A decarburization zone was not observed. Two percent nital and 4 percent picral etch.

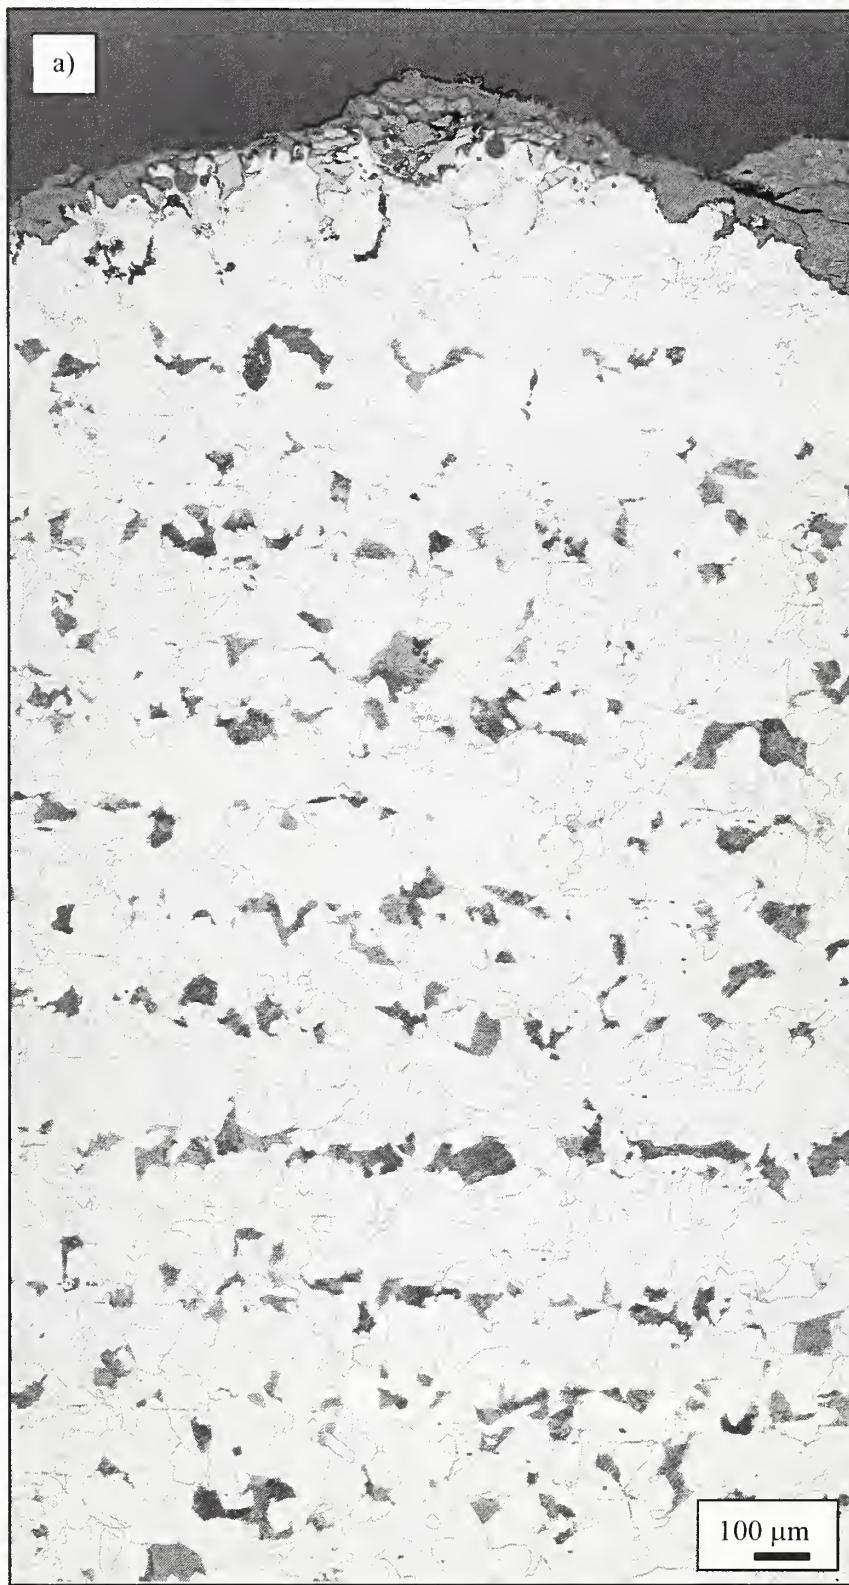
Figure 6–21. b) Light optical micrograph showing the microstructure near the metal-scale interface of the 50 ksi column labeled K-16 near where the corrosion process occurred. As-built location was not known. Two percent nital and 4 percent picral etch (cont.).

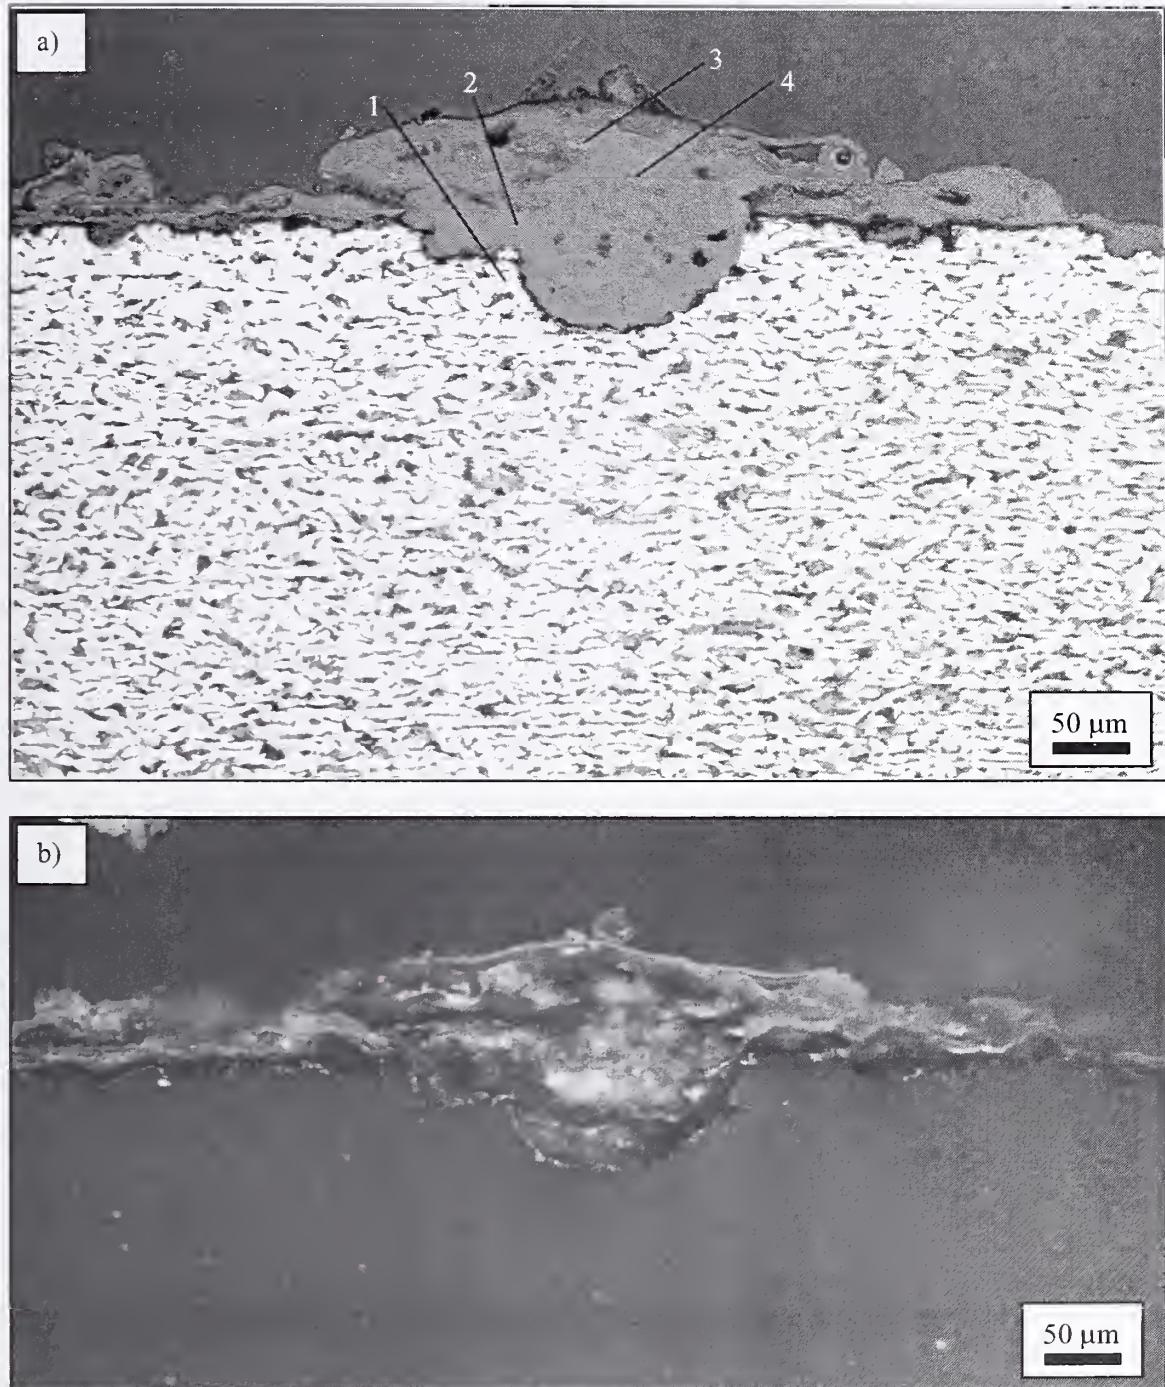
Figure 6–19. Light optical micrographs showing microstructure from flange of column 210 of panel K-1 (A209: 97-100) from the crumpled area above the 98th floor spandrel. c) Characteristic scale formation. Two percent nital and 4 percent picral etch.

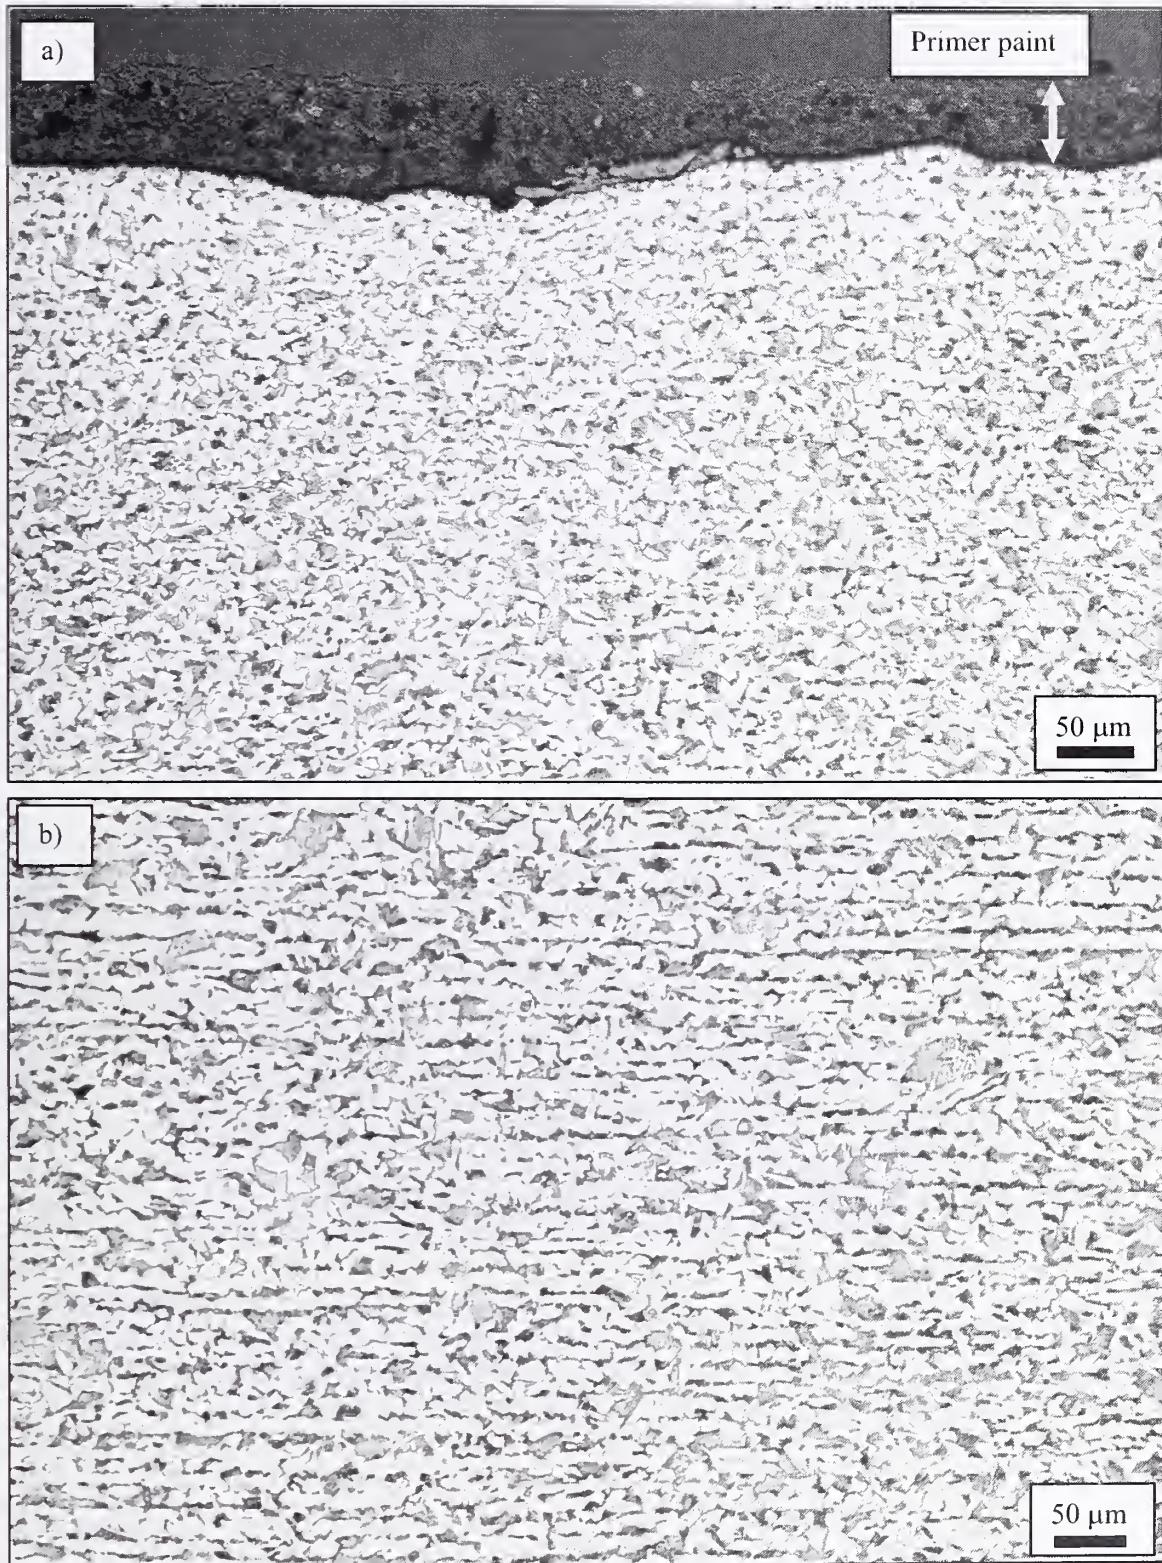
Figure 6–18. Light optical micrograph showing a characteristic microstructure taken at the centerline of a 60 ksi outer web plate. Sample is from panel C-40 (A136: 98-101), column 136 in the 99th floor region of WTC 1. Two percent nital and 4 percent picral etch.

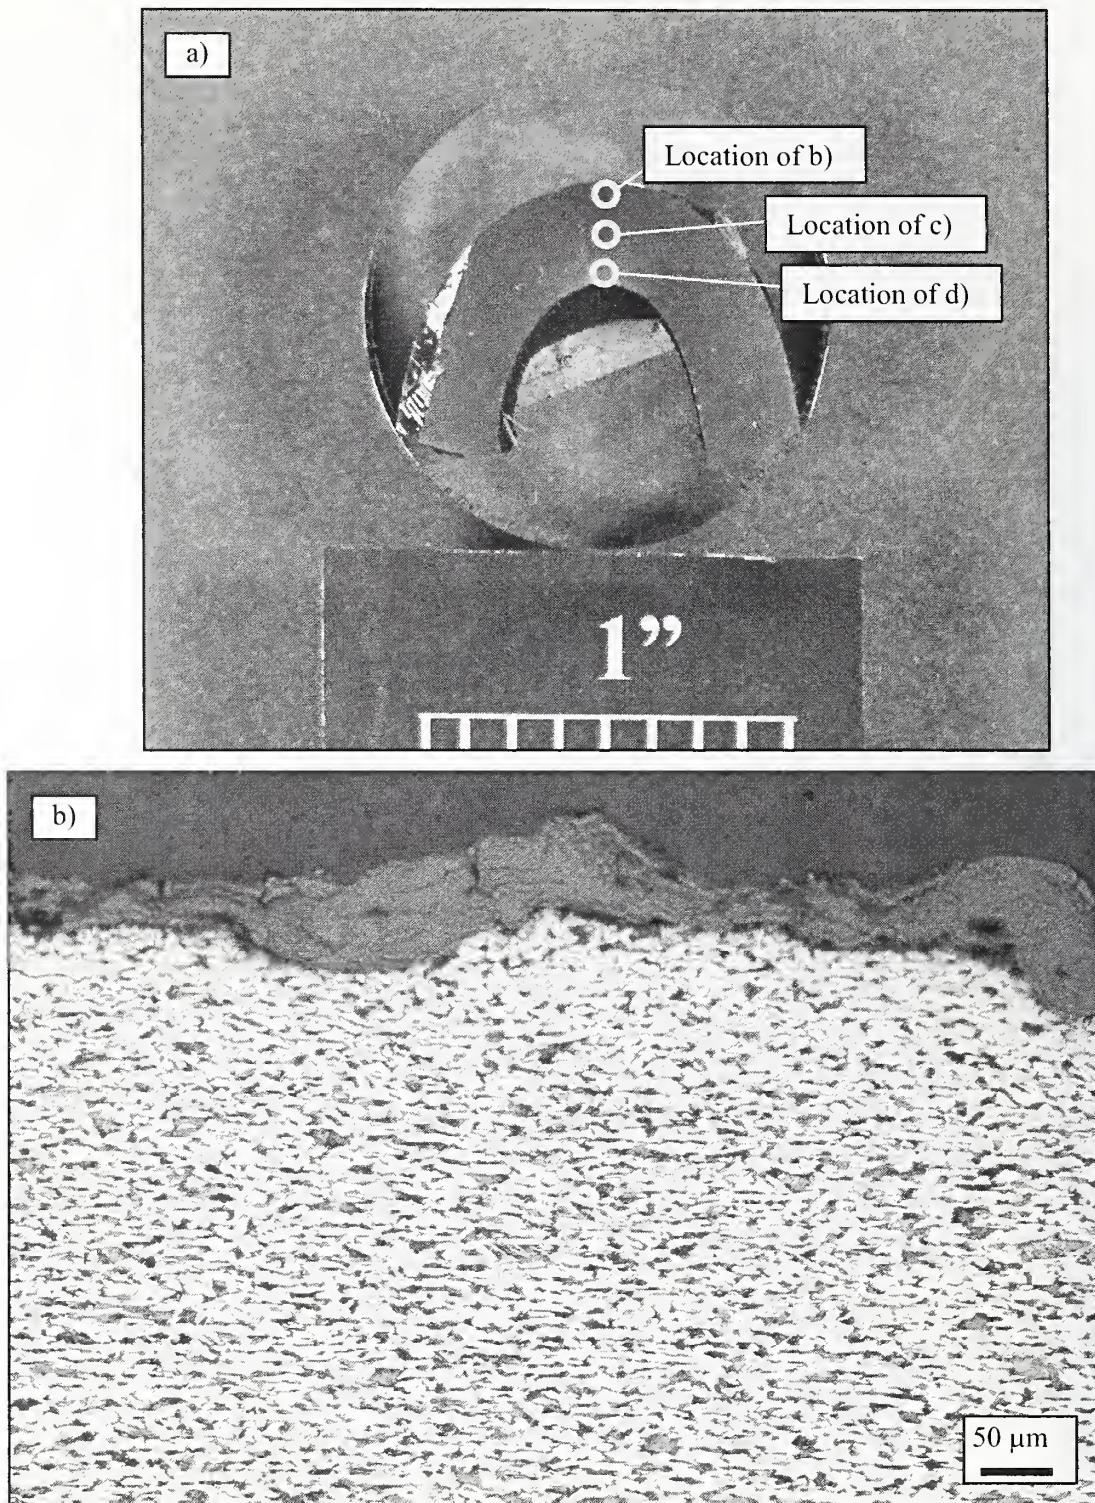
Figure 6-16. Light optical micrographs showing the microstructure from flange of column 210 of panel K-1 (A209: 97-100) from the crumpled area above the 98th floor spandrel. c) centerline of plate showing relatively undeformed grains of blocky ferrite and pearlite colonies. Two percent nital and 4 percent picral etch.

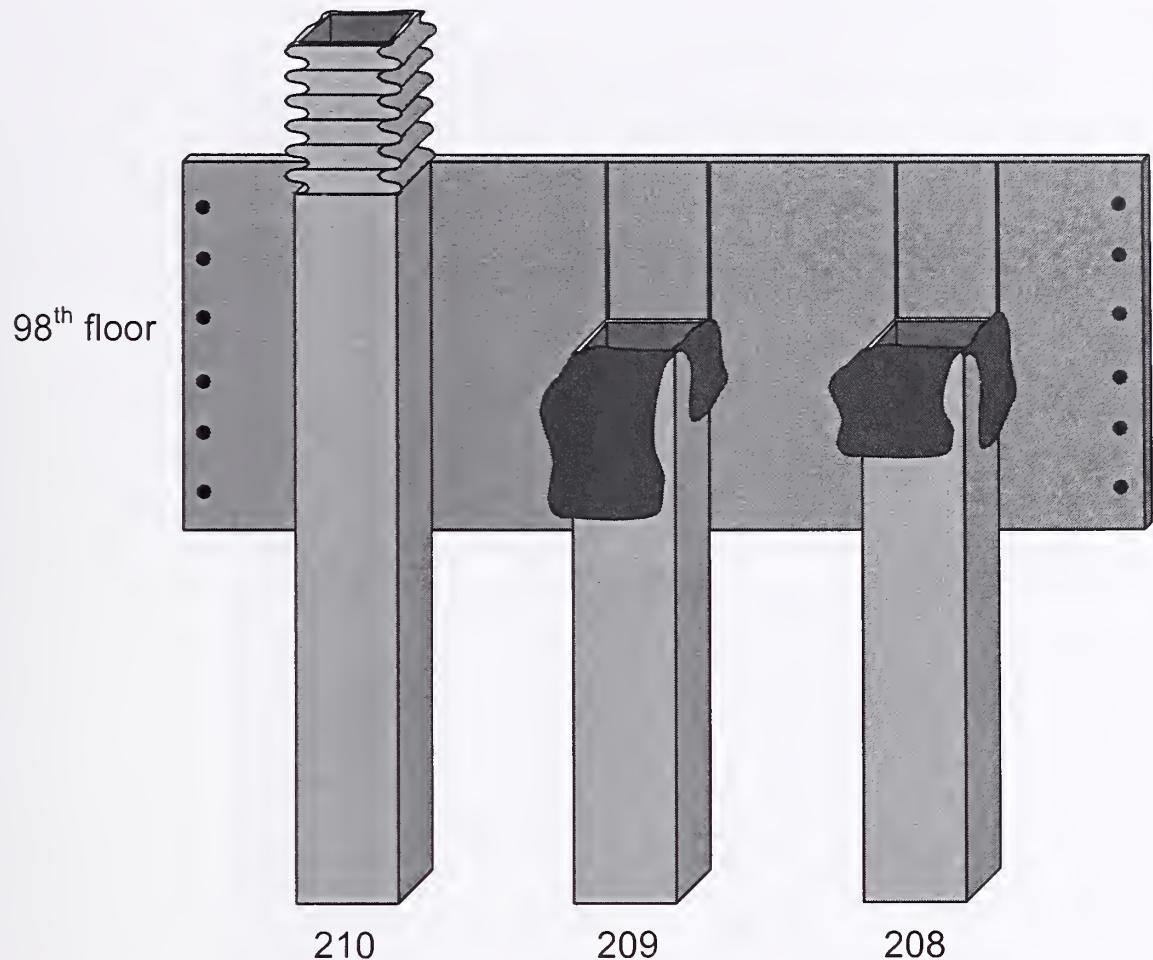
Figure 6-14. Panel K-1 (A209: 97-100). b) and c) crushed section above the 98th floor and d) relatively undeformed below the 98th floor spandrel. Removal areas of metallographic samples are shown in c) and d) by colored circles (cont.).

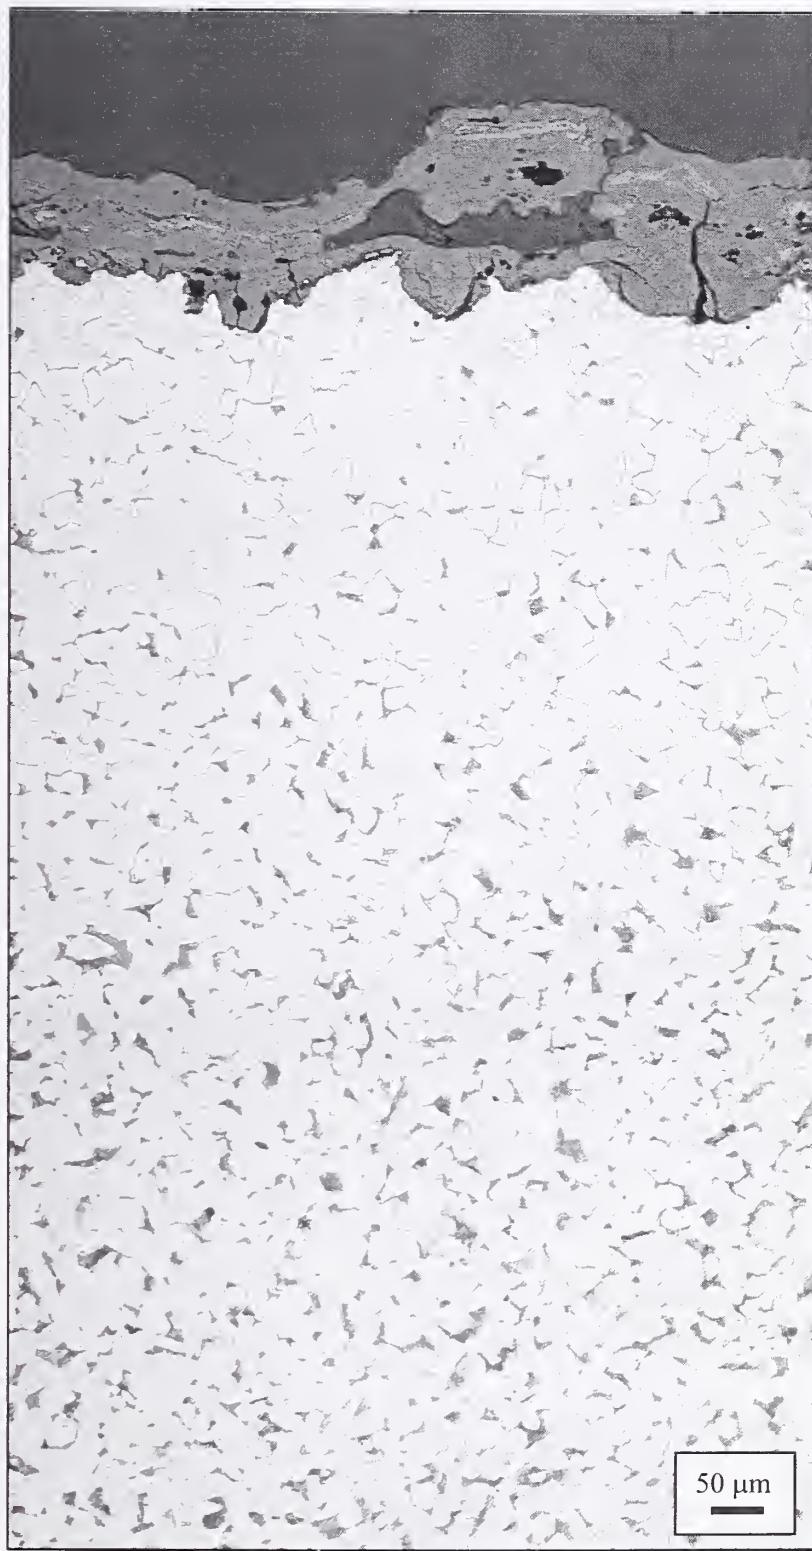
Figure 6-12. Light optical micrographs of the microstructure of a perimeter floor truss seat from the 99th floor of WTC 1, panel N-8 (A142: 97-100). a) Ferrite-pearlite microstructure and developed oxide scale. Two percent nital and 4 percent picral etch.

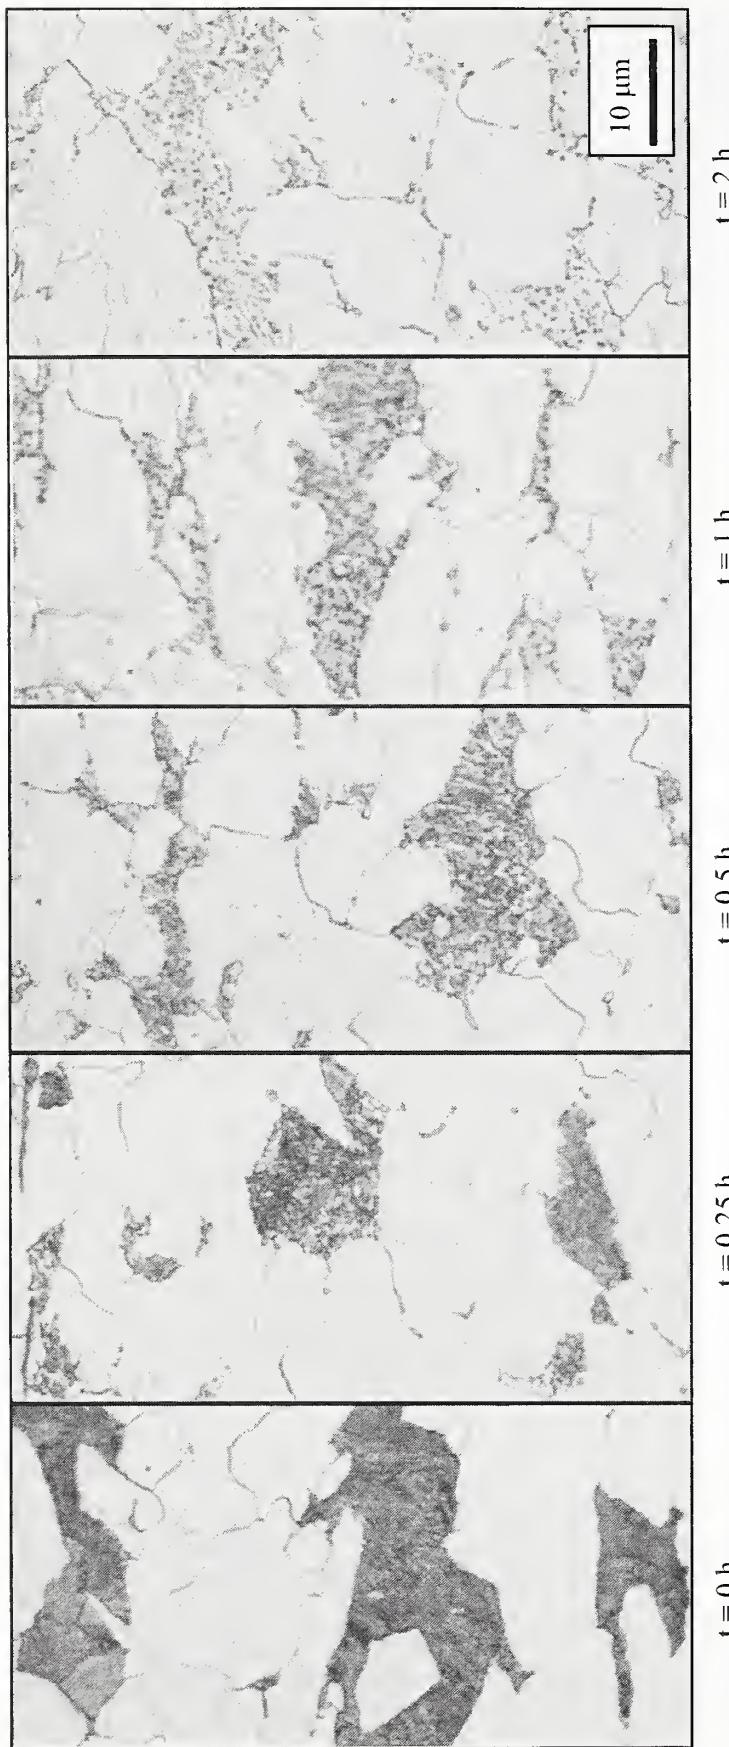
Figure 6–11. Light optical micrograph showing the partially decarburized zone found near the surface of a perimeter floor truss seat from directly above the airplane impact on the 99th floor of WTC 1, panel M-2 (A130: 96-99). Two percent nital and 4 percent picral etch.

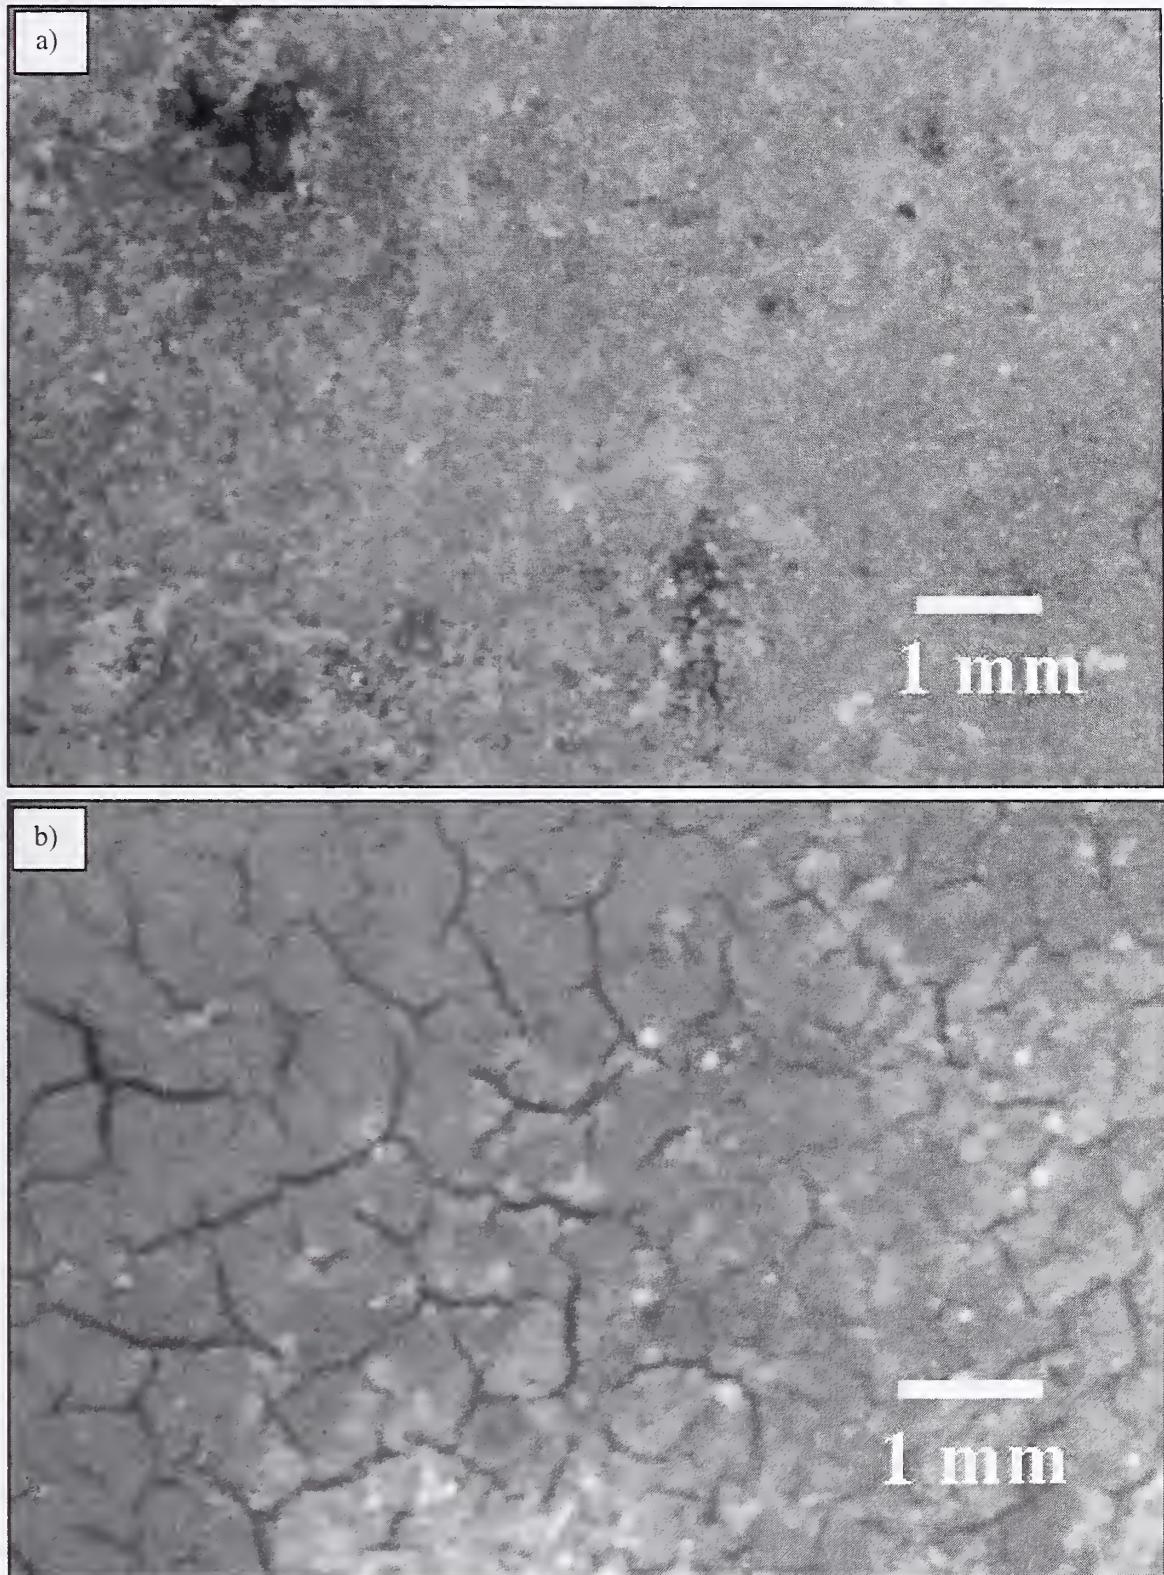
Figure 6–2. Crushed portion of column 210 in the area of the 98th floor of WTC 1 (panel K-1, A209: 97-100). Mud cracking of the paint was observed in crushed portion of this column. The cracking of the paint was a result of either temperature exposure over 250 °C, mechanical deformation, or environmental degradation.

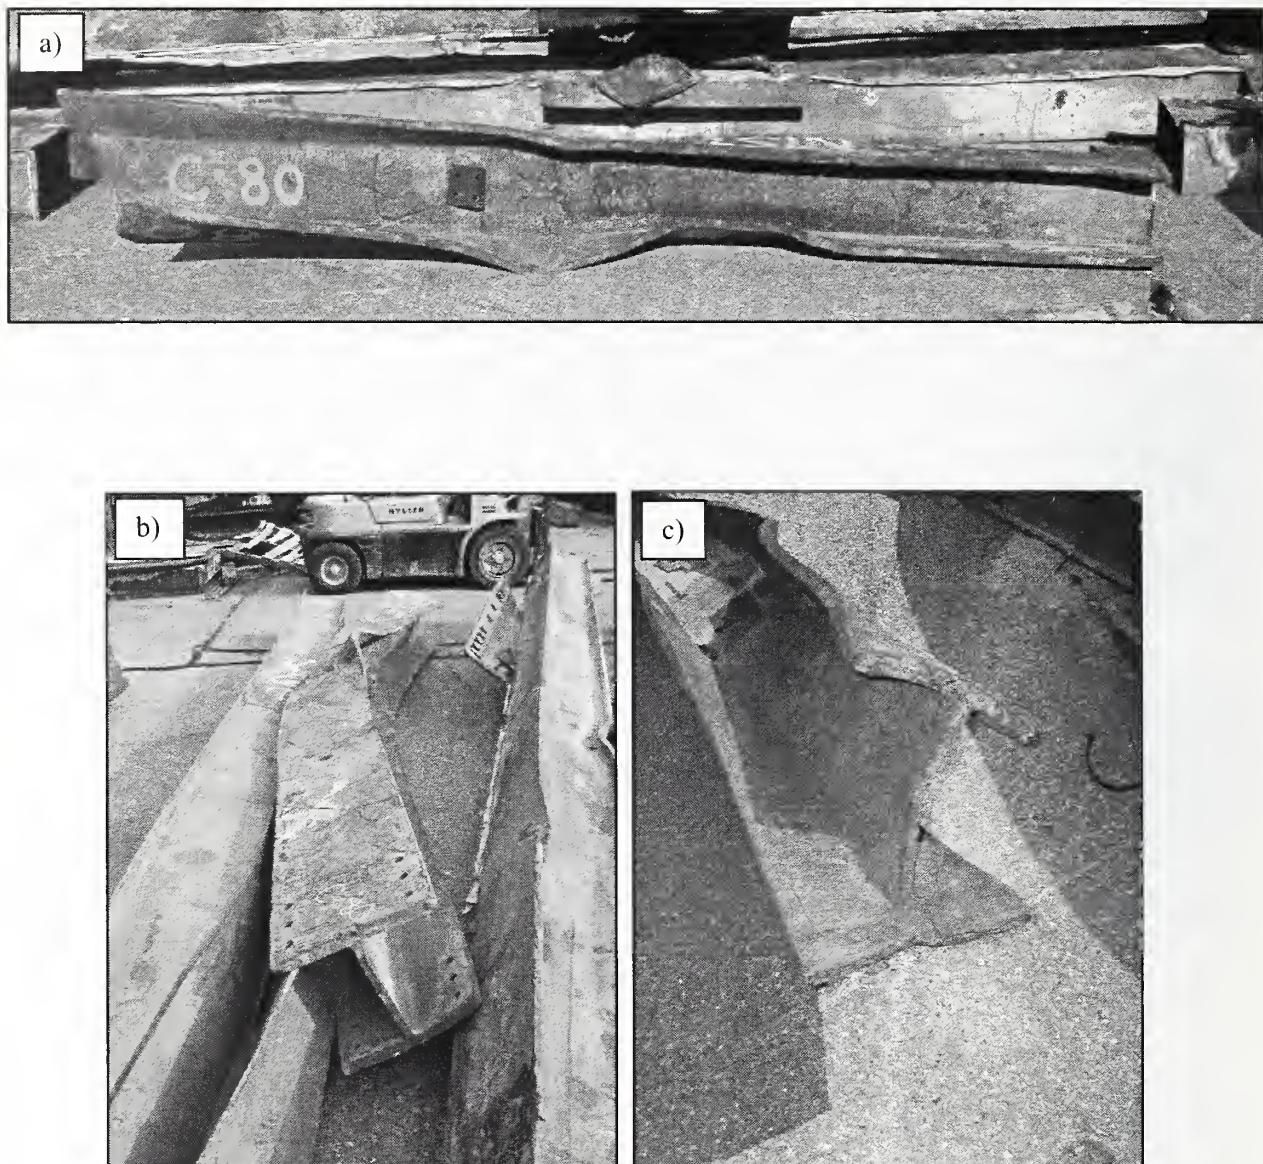
Failure of the limited number (three) of recovered core columns in the impact zone was a result of both splice connection failures and fracture of the columns themselves. One recovered core column (WTC 2, column line 801, floors 77 through 80) may have sustained damage as a direct result of the airplane impact in terms of a flange bent in a direction consistent with the travel of the airplane. However, the welded splice connection to the column above survived intact.

Figure 4–2. Overall view of recovered core columns C-88a (801B: 80-83) and C-88b (801B: 77-80) that were located in the impact zone of WTC 2. The north flange of C-88b may have sustained impact damage. Note that the welded column splice was still intact though the airplane may have struck a portion of this column.

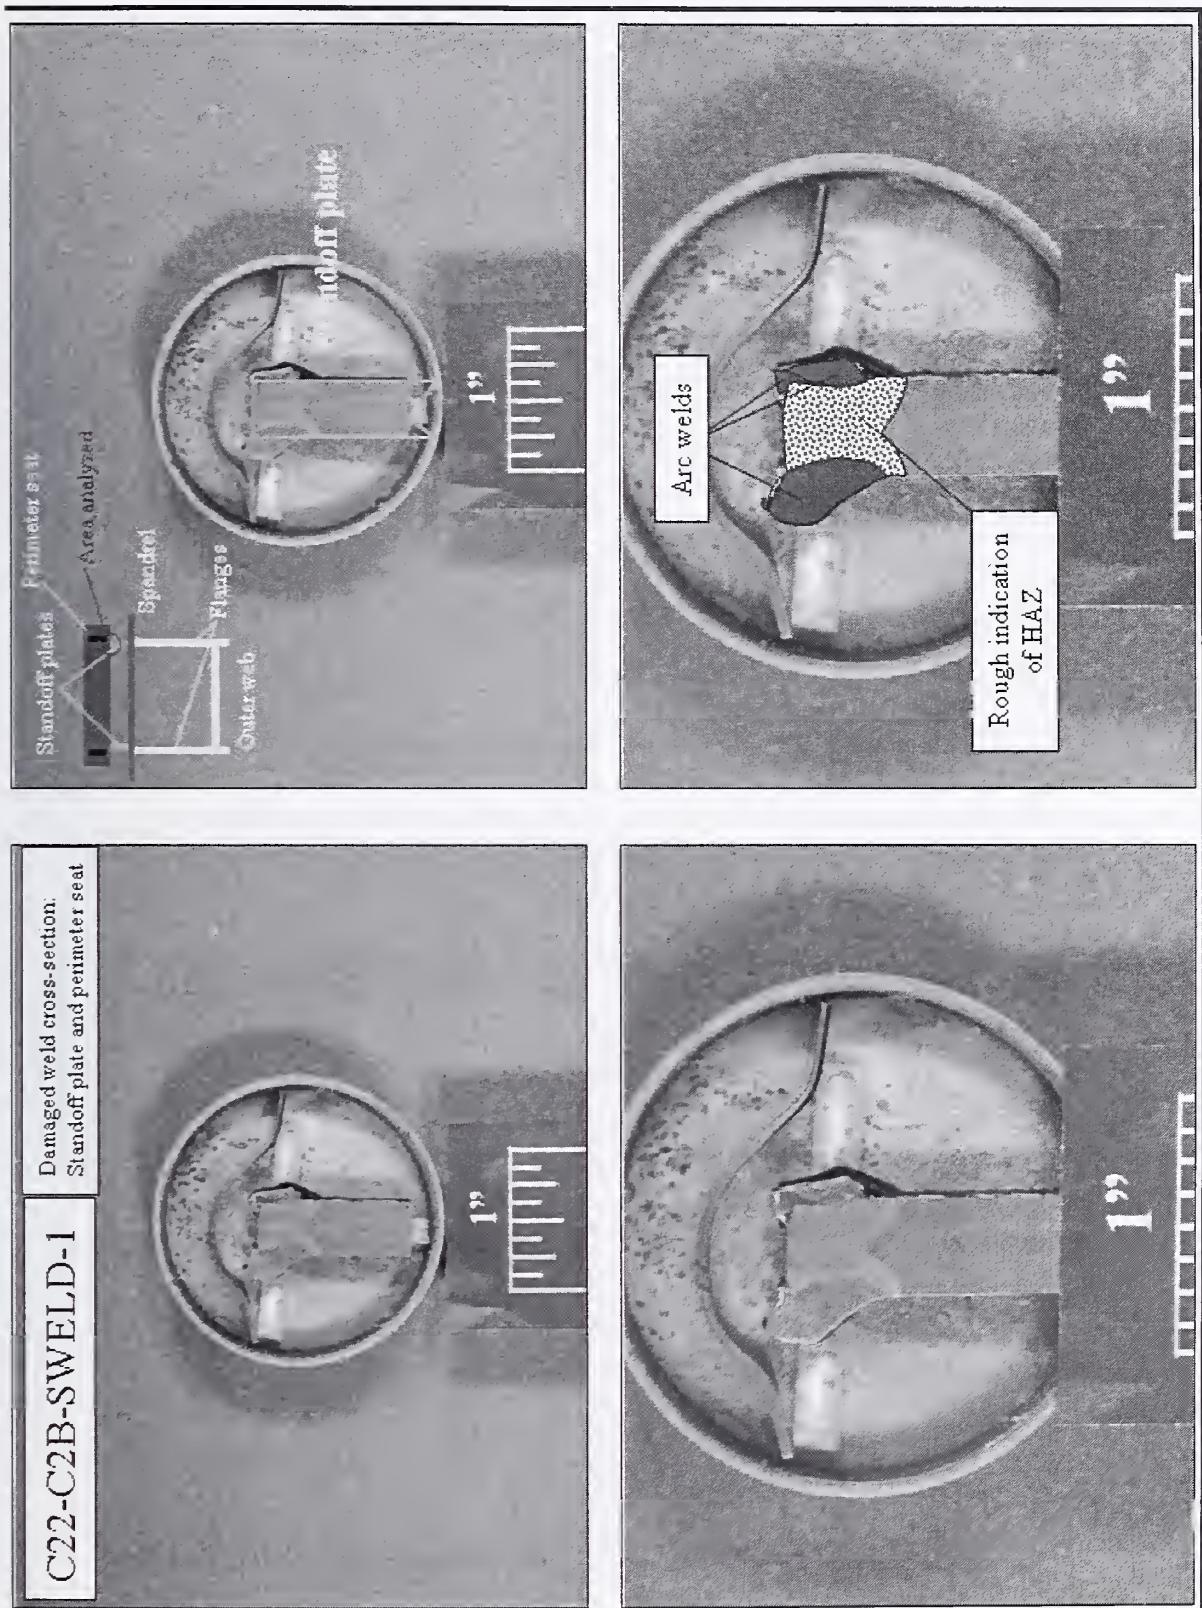
Failure of the perimeter panel floor truss seats typically occurred in the heat-affected zones near welds, and the fracture location was associated with the weld geometry (i.e., in the component with the lowest cross-sectional area). These areas with the lowest cross-sectional area were typically the standoff plates. However, there was no evidence to indicate that the type of joining method, materials, or welding procedures were improper.

Figure 3-54b. Etched cross-section of fracture near weld between standoff plate and truss seat. Sample was from panel C-22 (A157: 93-96, column 156, 94th floor). Two percent nital and 4 percent picral etch.
