**Federal Building and Fire Safety Investigation of the
World Trade Center Disaster**

**Damage and Failure Modes of
Structural Steel Components**

Stephen W. Banovic
Timothy Foecke

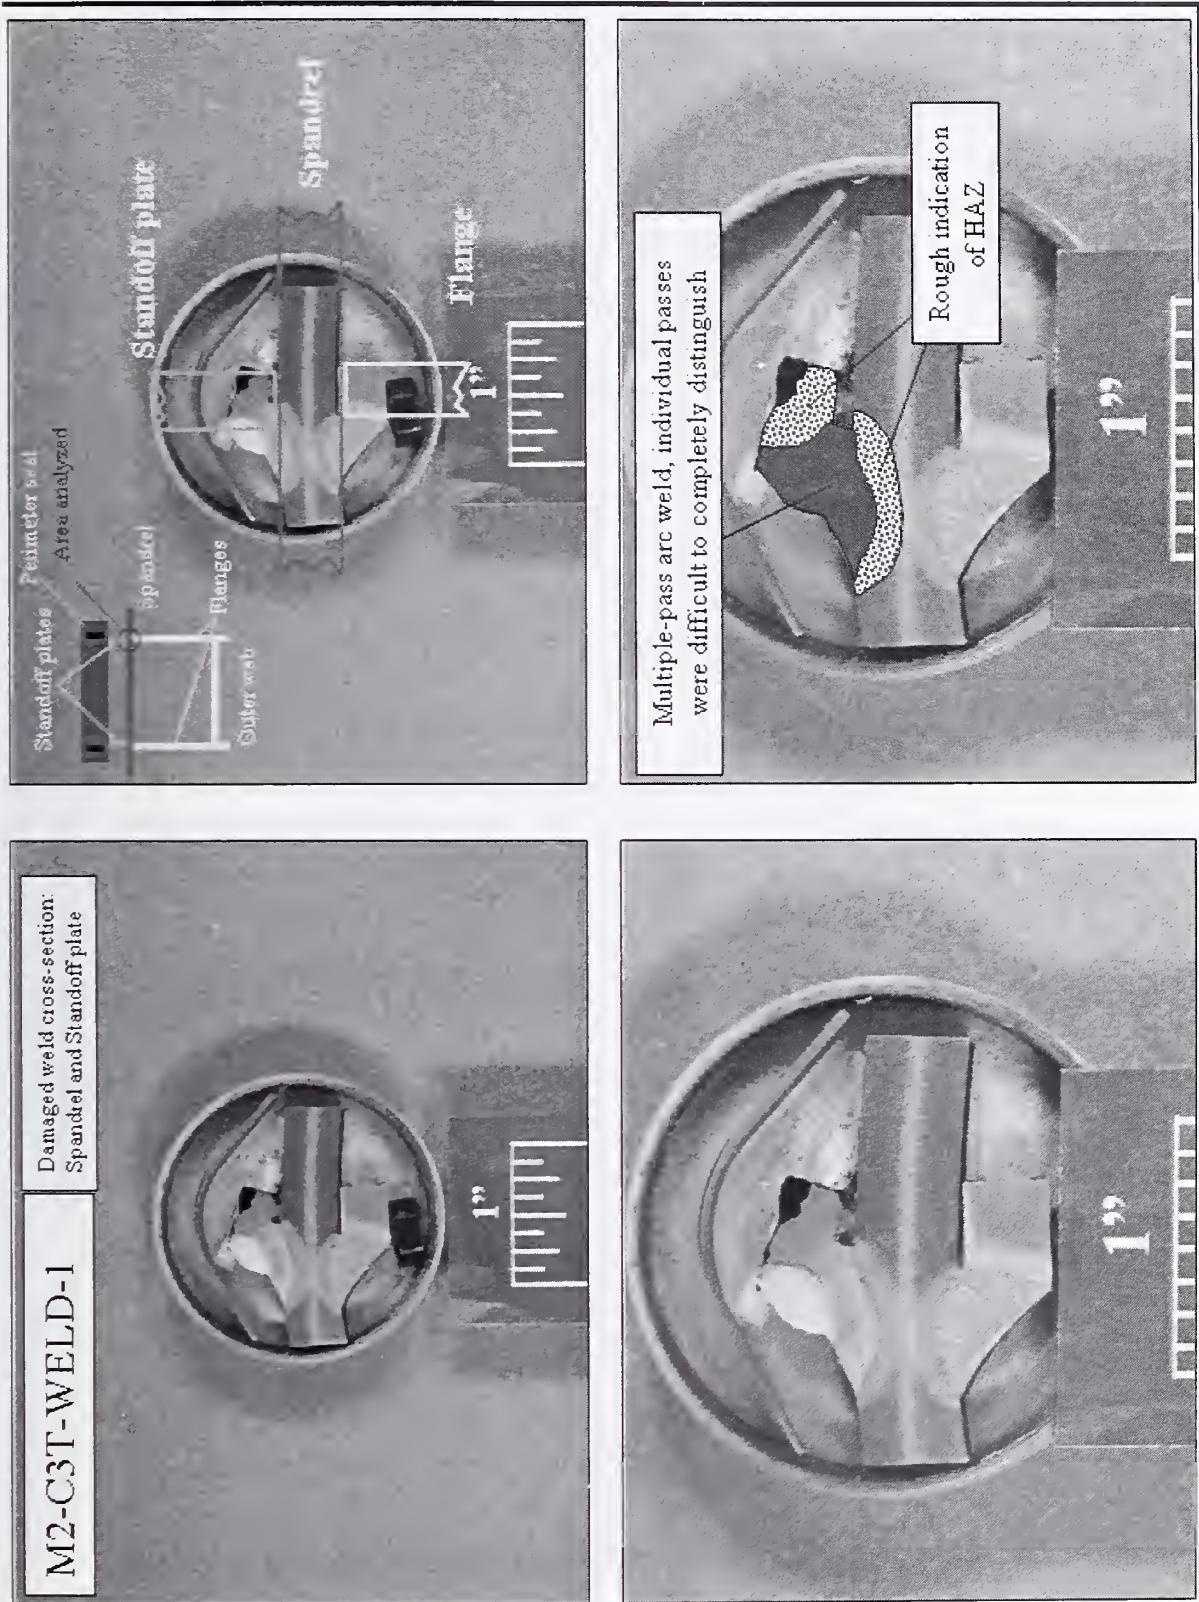
Figure 3-53b. Etched cross-section of fracture near weld between spandrel plate (36 ksi) and standoff plate (42 ksi). Sample was from panel M-2 (A130: 96-99, column 129, 99th floor). Two percent nital and 4 percent picral etch (cont.).

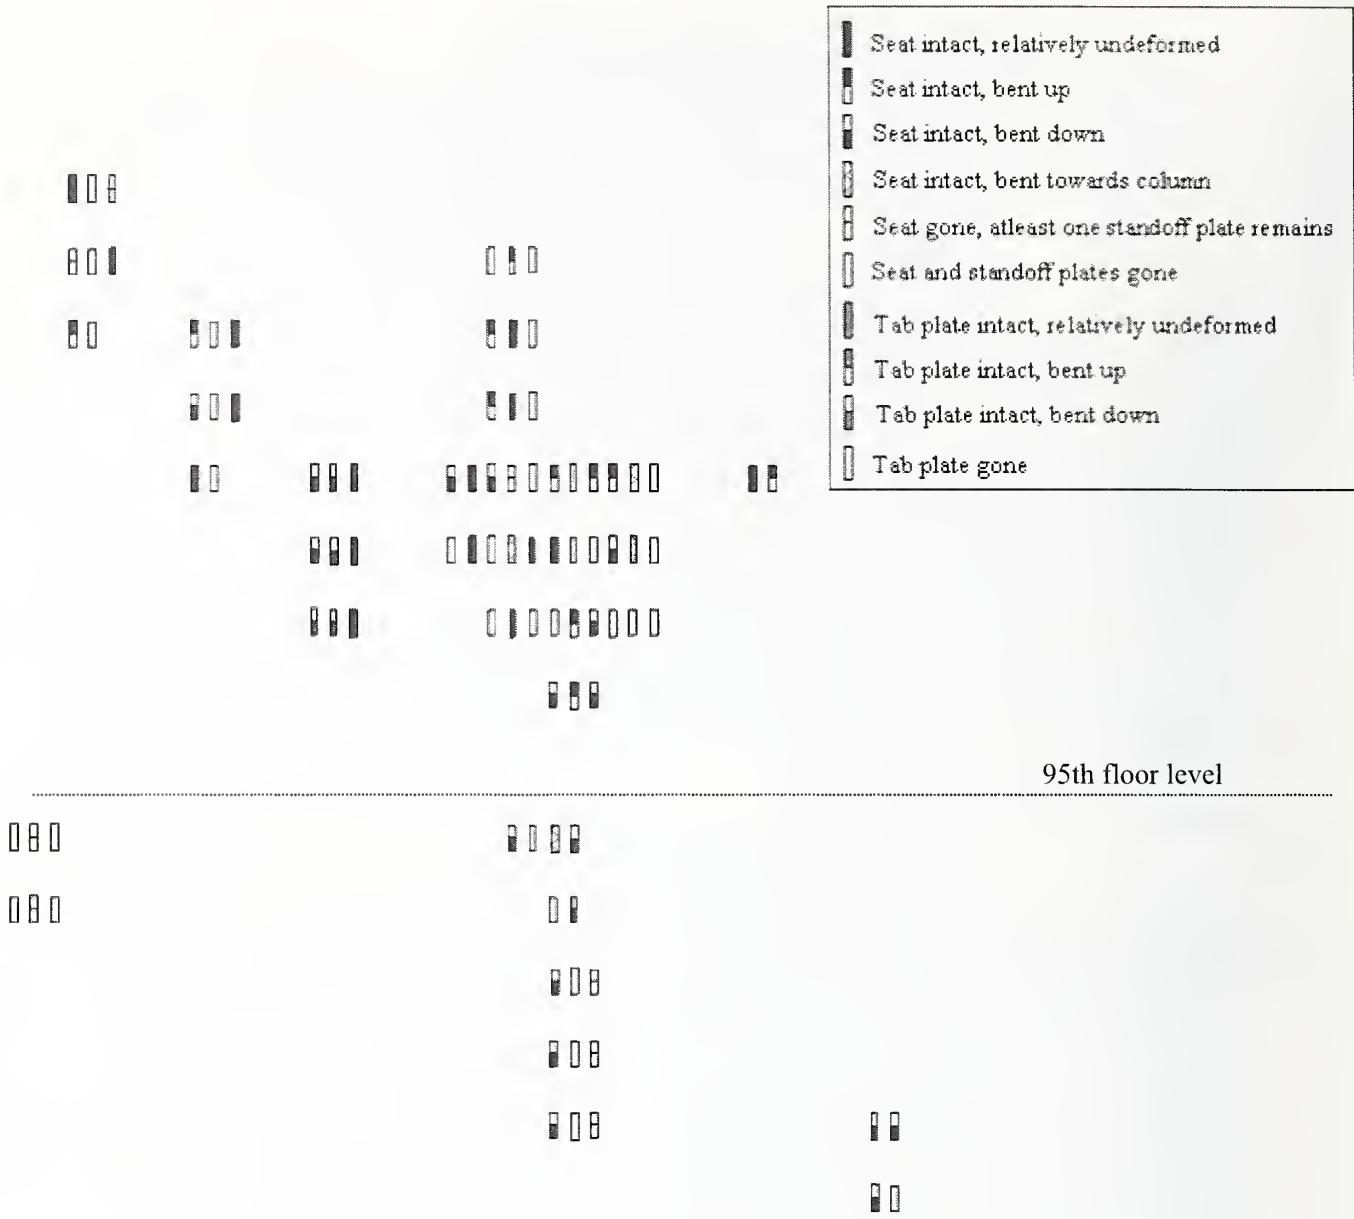
The damage to truss seats on perimeter panels differed above and below the impact zone. The majority of perimeter panel floor truss connectors (perimeter seats) below the impact floors were either missing or bent downward. Above this level, the failure modes were more randomly distributed. This trend was observed for both towers.

Figure 3-51b. WTC 1, damage of connectors. At or below the 95th floor, all connectors are either bent down or missing.

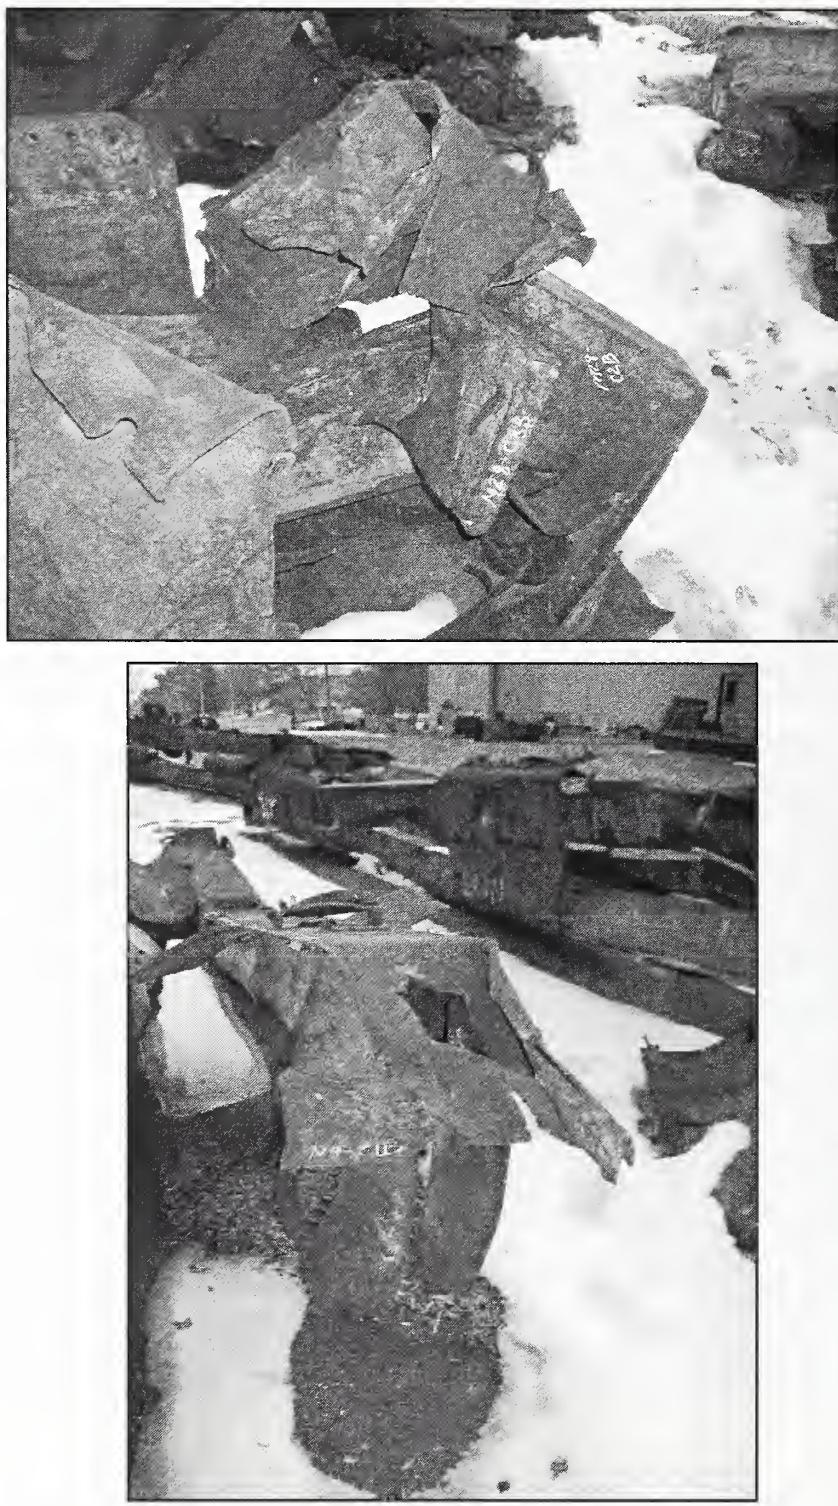
Figure 3–44. Photographic example of Type 3 failure mode for end plate connections, a welded connection with bolts intact, end plate of above or below adjoining column still attached. Sample shown is C-24 (B203: 74-77). Damage of this type may be due to any one of the extreme loading events.

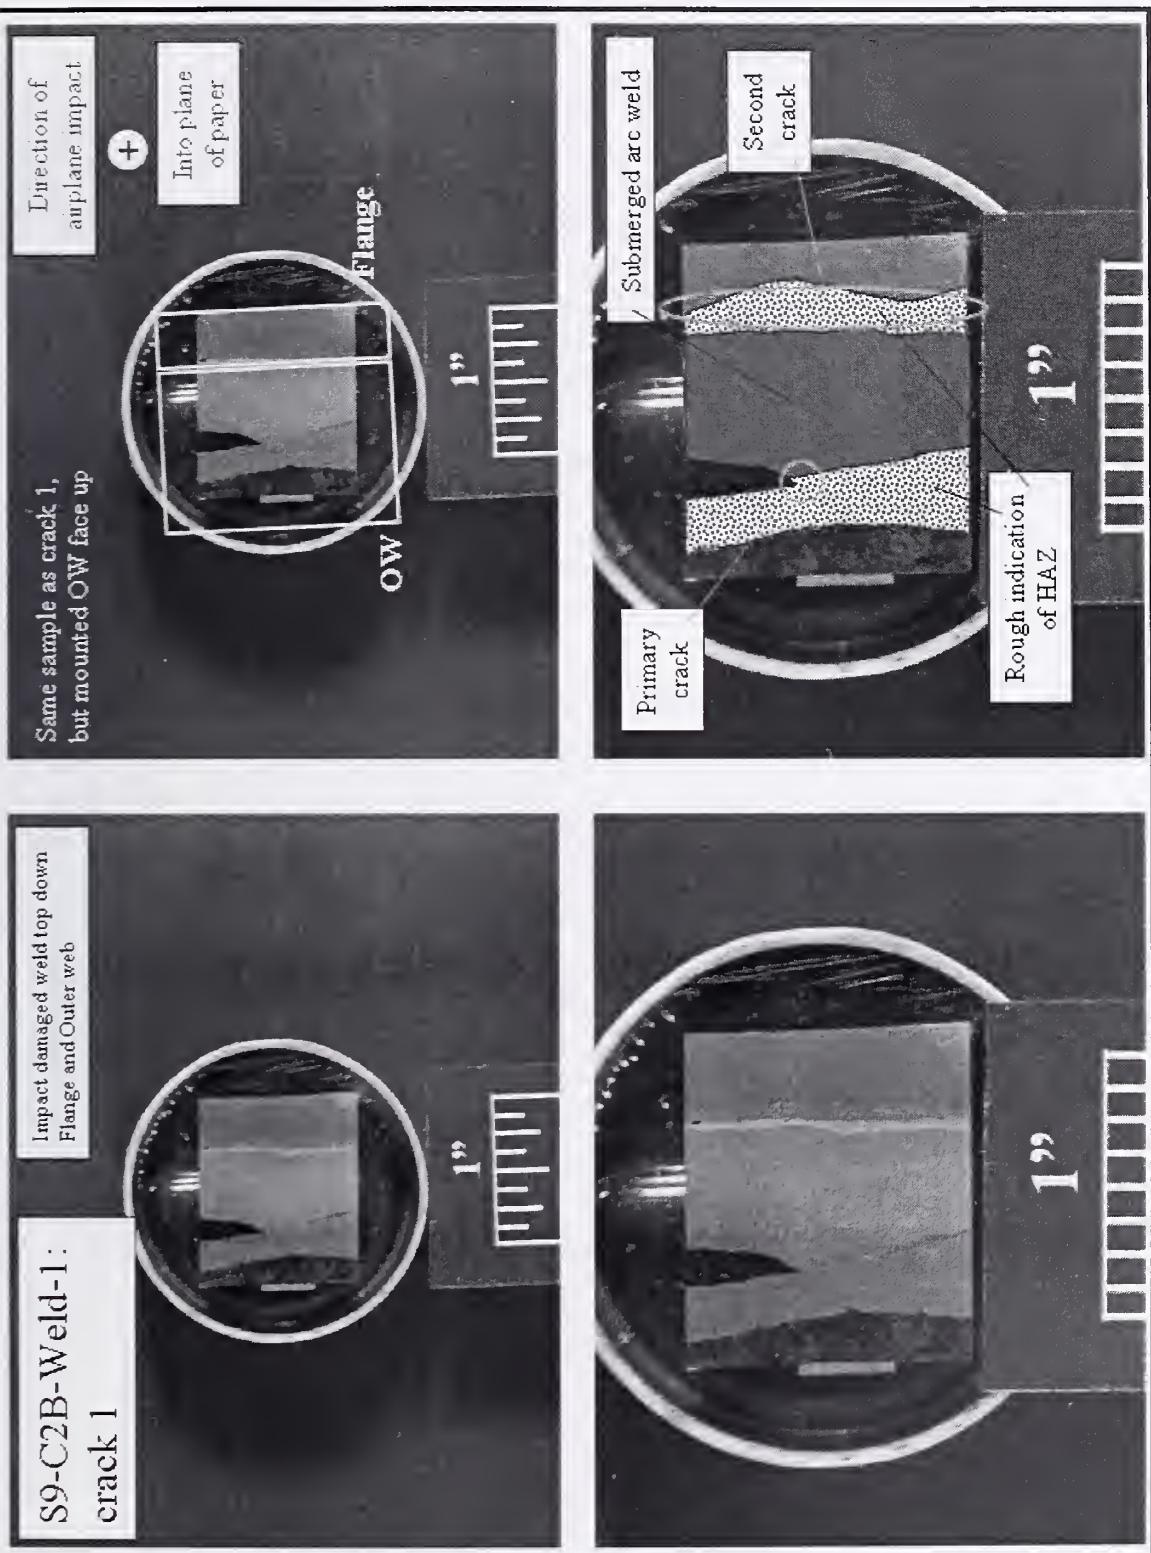
Conversely, fractures occurring parallel and directly next to welded joints exhibited few or no ductile characteristics. The geometry of the joint with respect to the direction of impact, stress concentrations due to the geometry, diminished properties of the heat-affected zone in the base metal, and the orientation of the crack propagation with respect to the rolling direction of the plate are expected to have contributed to the lack of ductility. There was no evidence to indicate that the type of joining method, materials, or welding procedures were improper. The welds appeared to perform as intended.

Figure 3–28. Light optical micrograph showing fracture of the outer web (from Fig. 3–27) occurring solely in the HAZ of the plate along the fusion line of the weld. Fracture may have been a result of airplane impact. Two percent nital and 4 percent picral etch. (panel S-9, A133: 97-100, column 133)

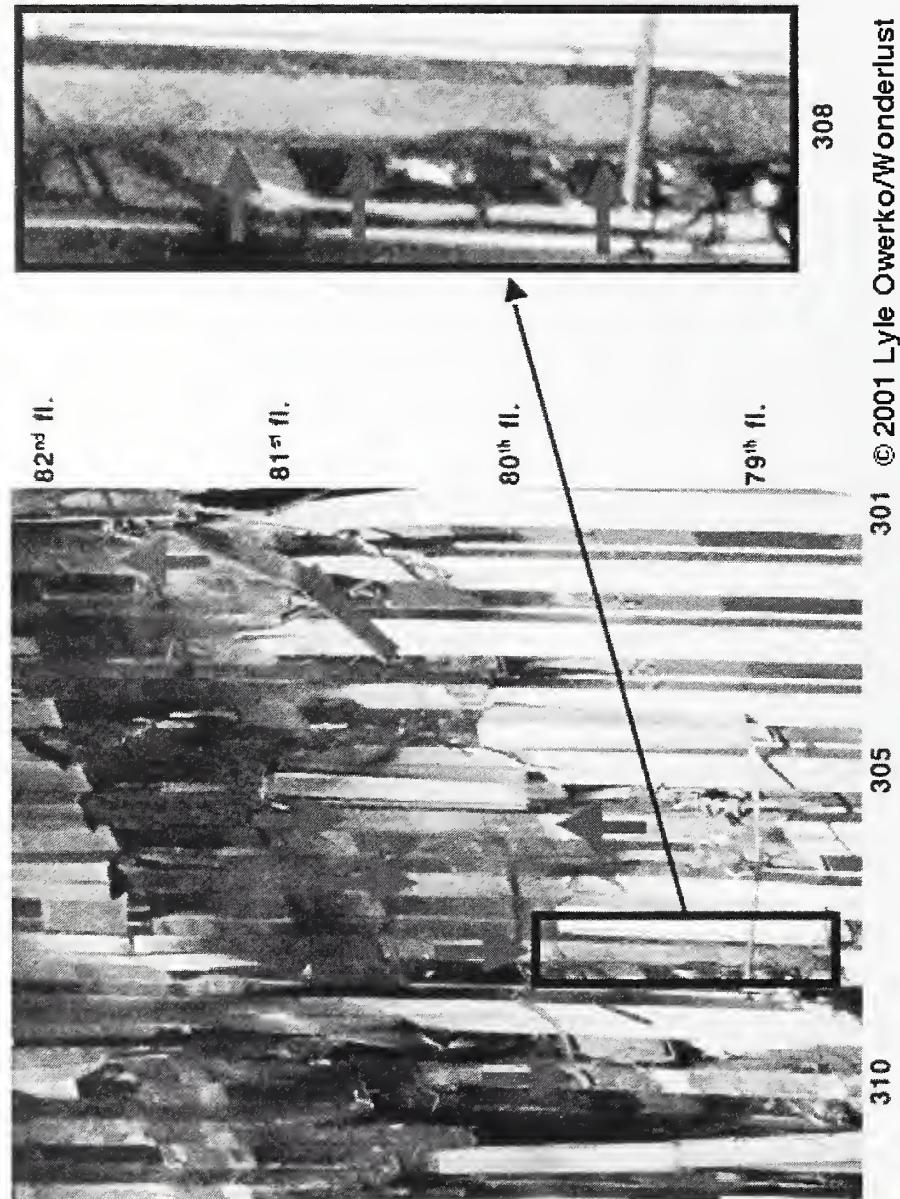
Figure 2–35. Image showing damage to sprayed fire-resistant material on east face of WTC 2 due to internal impact. Red arrows highlight areas where sprayed fire-resistant material has been damaged. The blowup to the right shows a column where the red Tnemec paint of the column is visible.

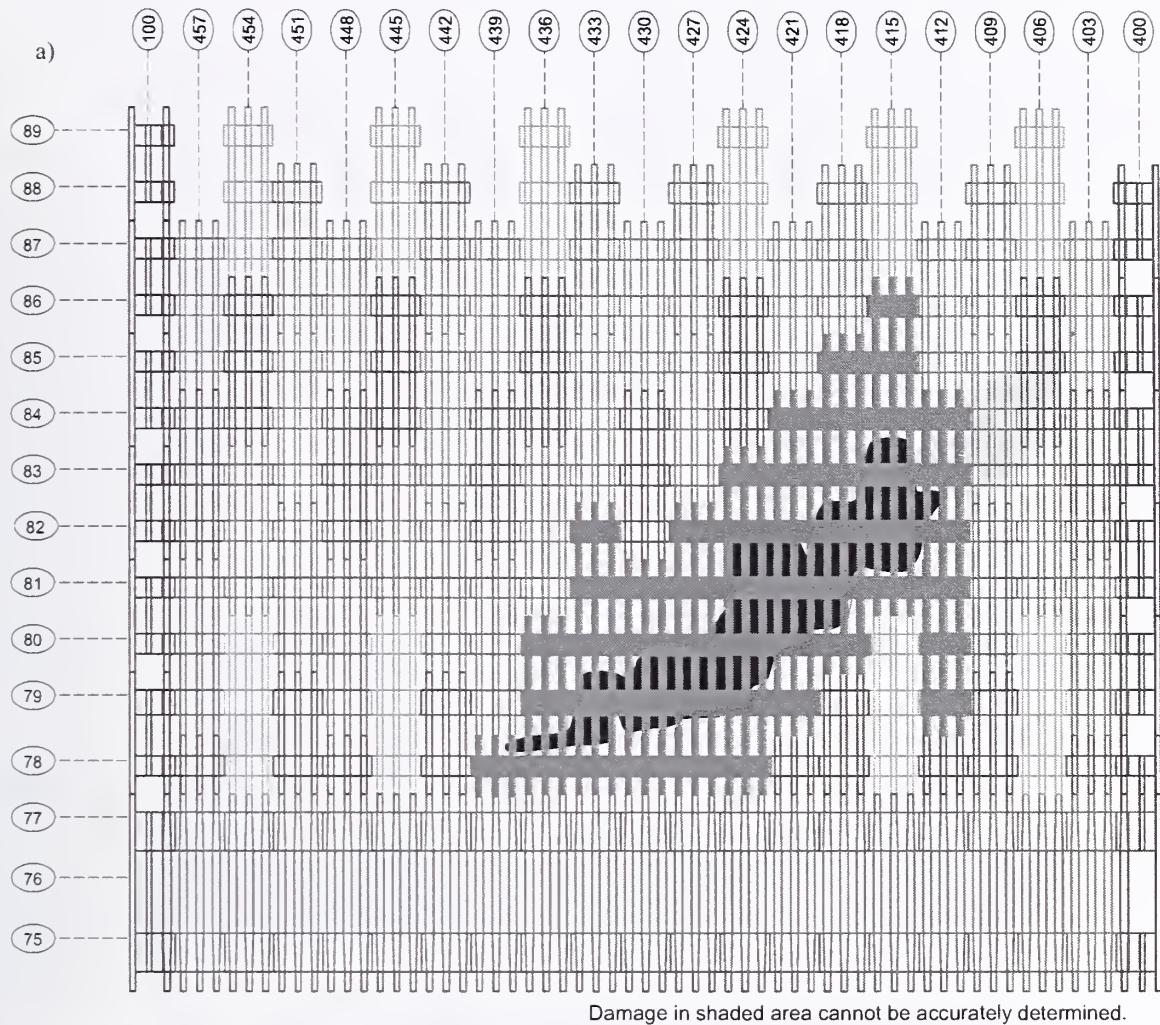
Figure 2–5a. Pictorial display showing the panels possibly damaged on the south face of WTC 2 around the airplane impact region.

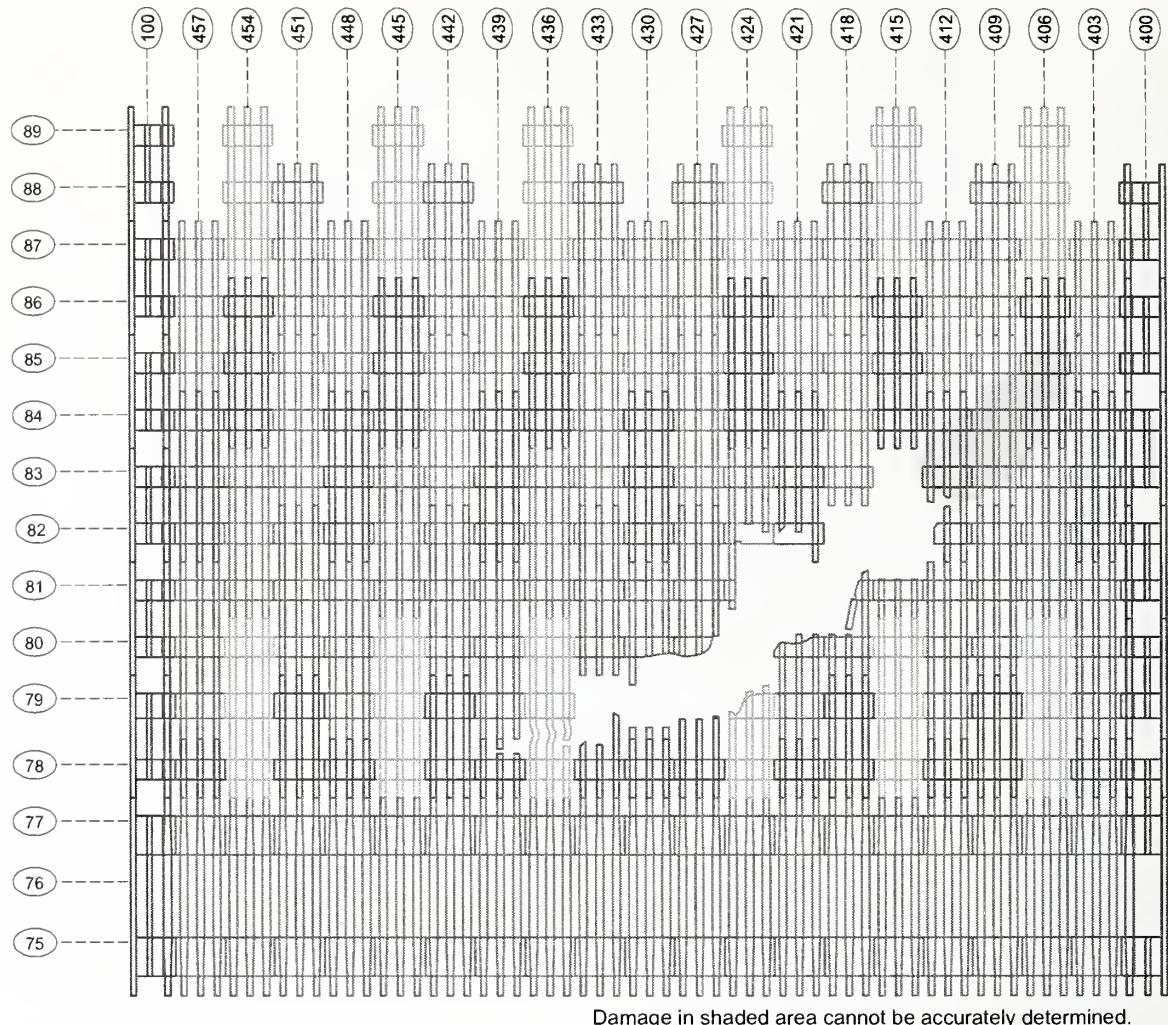
Figure 2–4. Estimated amount of damage to the south face of WTC 2, as determined by NIST.

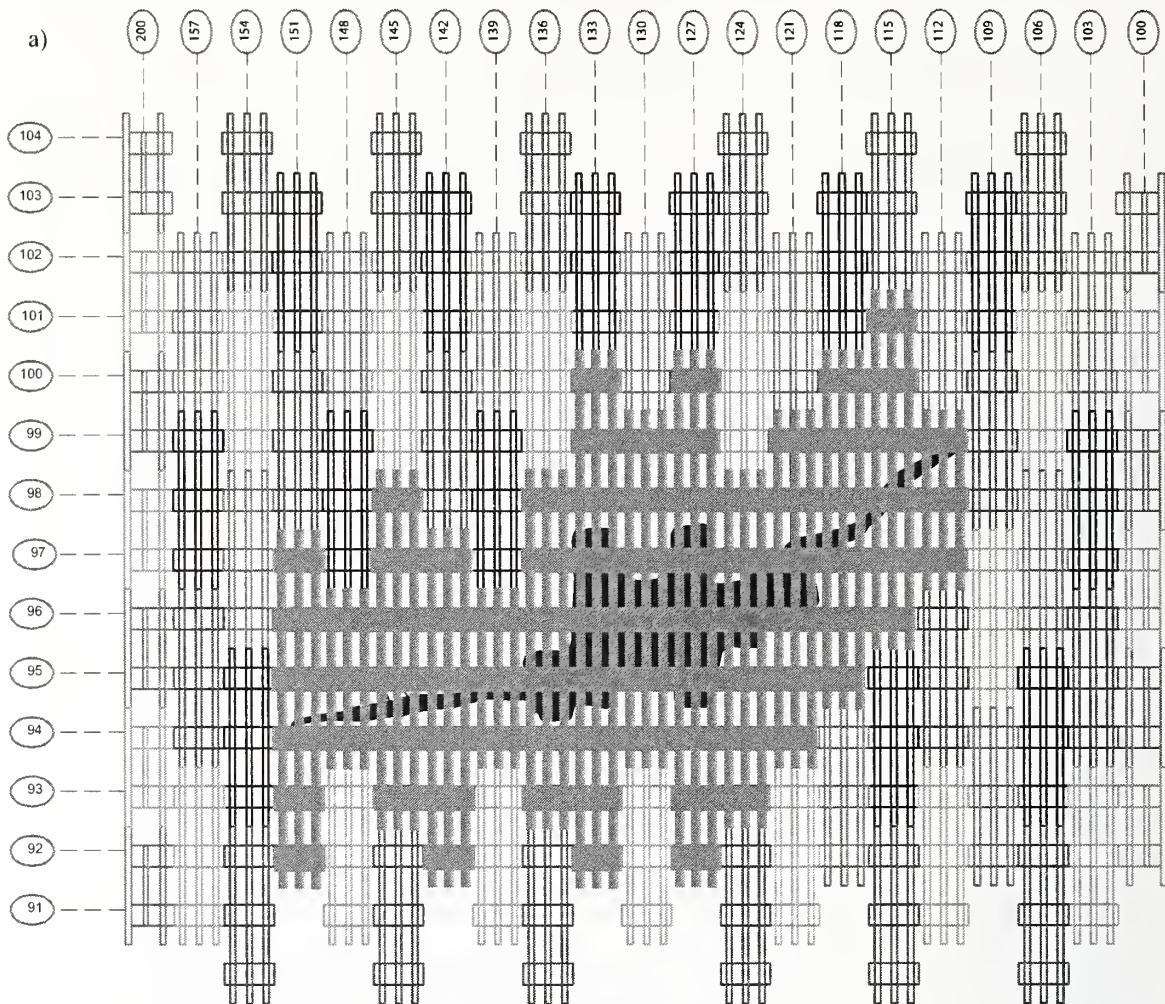
Figure 2-2a. Pictorial display showing the panels damaged on the north face of WTC 1 around the airplane impact region.

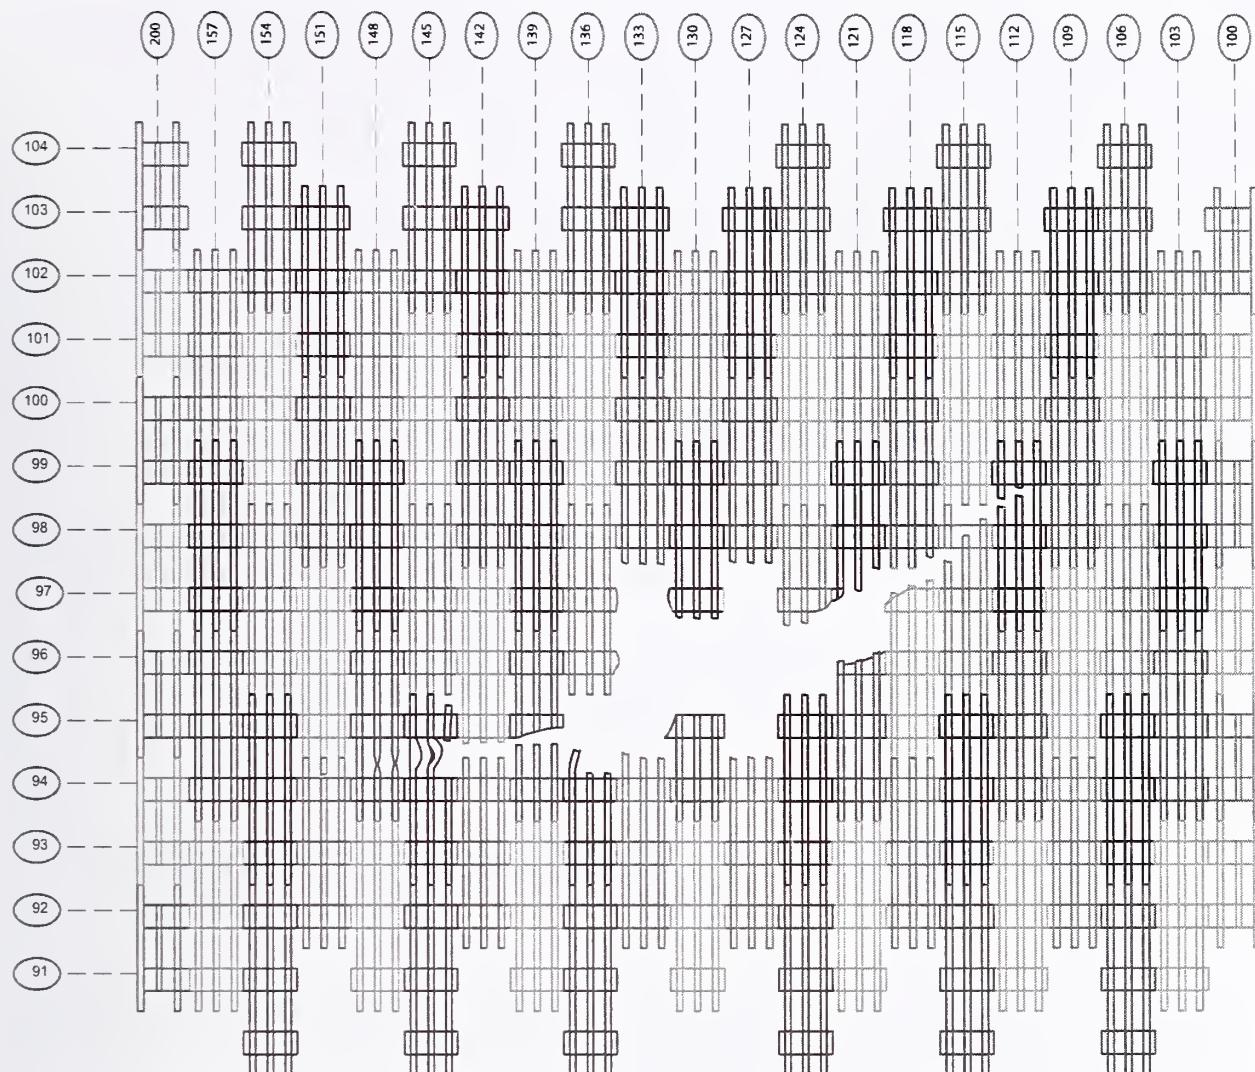
Figure 2–1. Estimated amount of damage to the north face of WTC 1, as determined by NIST.
