NBS BUILDING SCIENCE SERIES 165

# Engineering Aspects of the September 19, 1985 Mexico Earthquake

Following the September 19, 1985 Mexico earthquake, a team consisting of four engineers and one seismologist from the National Bureau of Standards (NBS) and the United States Geological Survey (USGS) was dispatched to Mexico City to provide technical advice to the US rescue effort and to assess structural damage. This report is primarily based on data gathered by the team, but it also contains a compilation of other available information. The report addresses the origin and characteristics of the observed ground motion, the ability of buildings designed in accordance with present and proposed seismic design provisions to resist this type of ground motion, and observed data on structural and foundation failures.

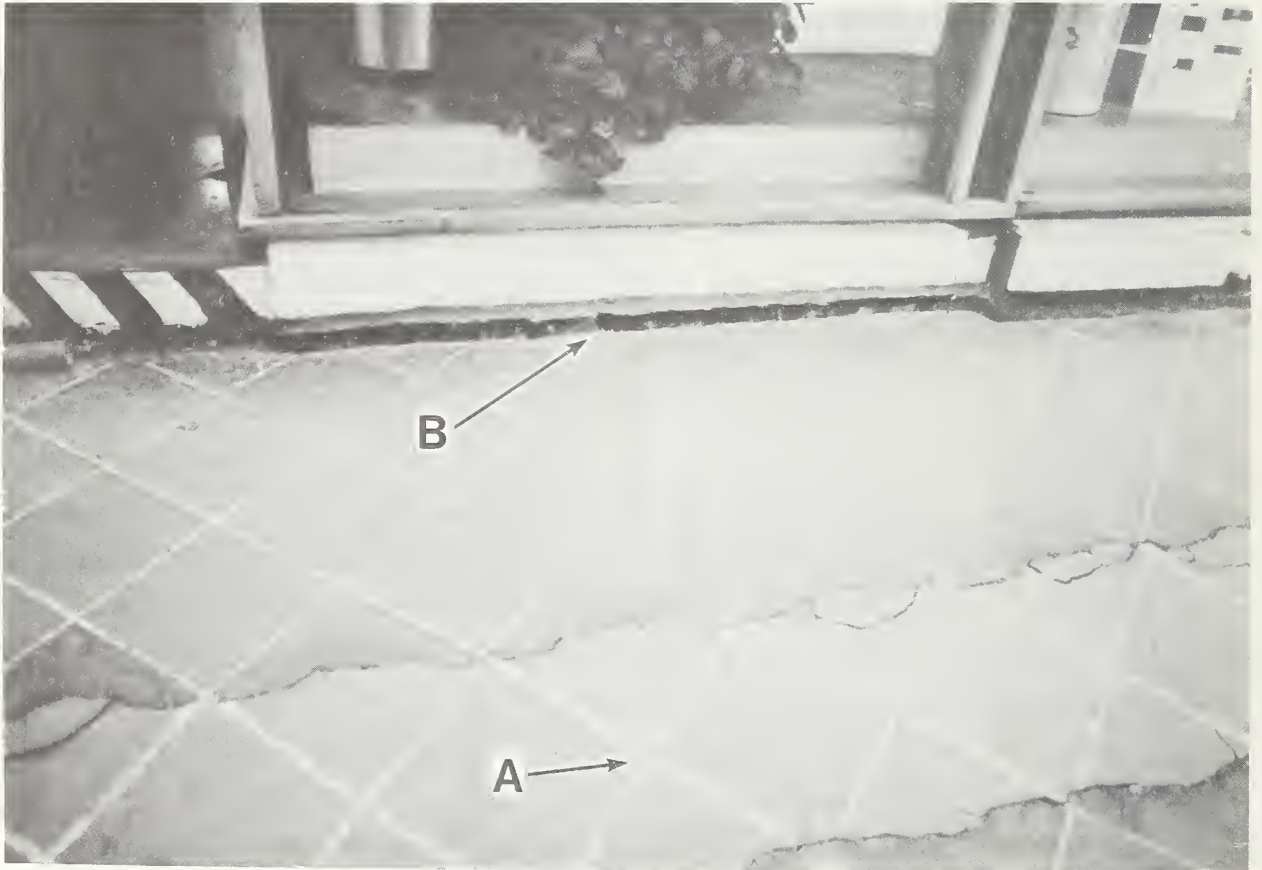
Figure 4.1. Differential displacements at the sidewalk near the Bank of America Building.

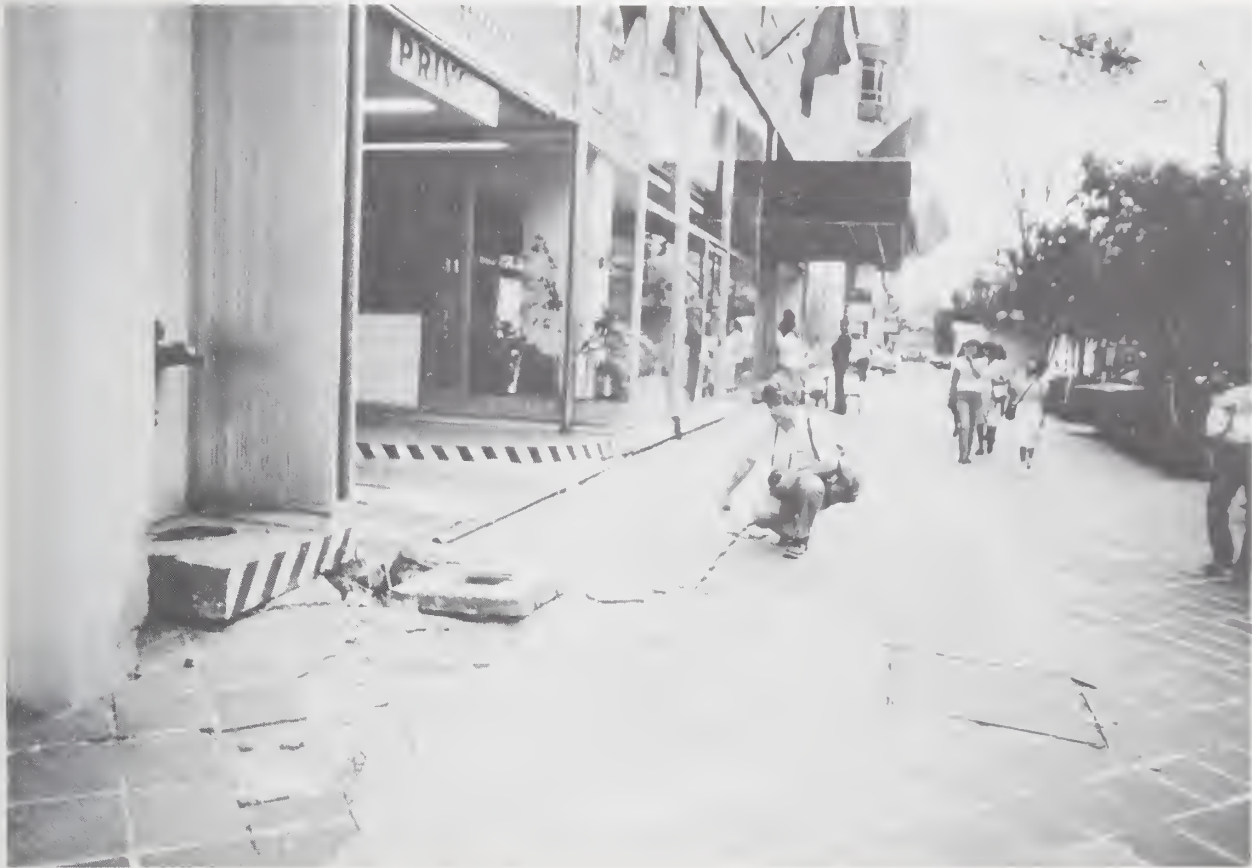
Figure 4.2. Disturbances caused by differential displacement between the sidewalk and the Bank of America Building.

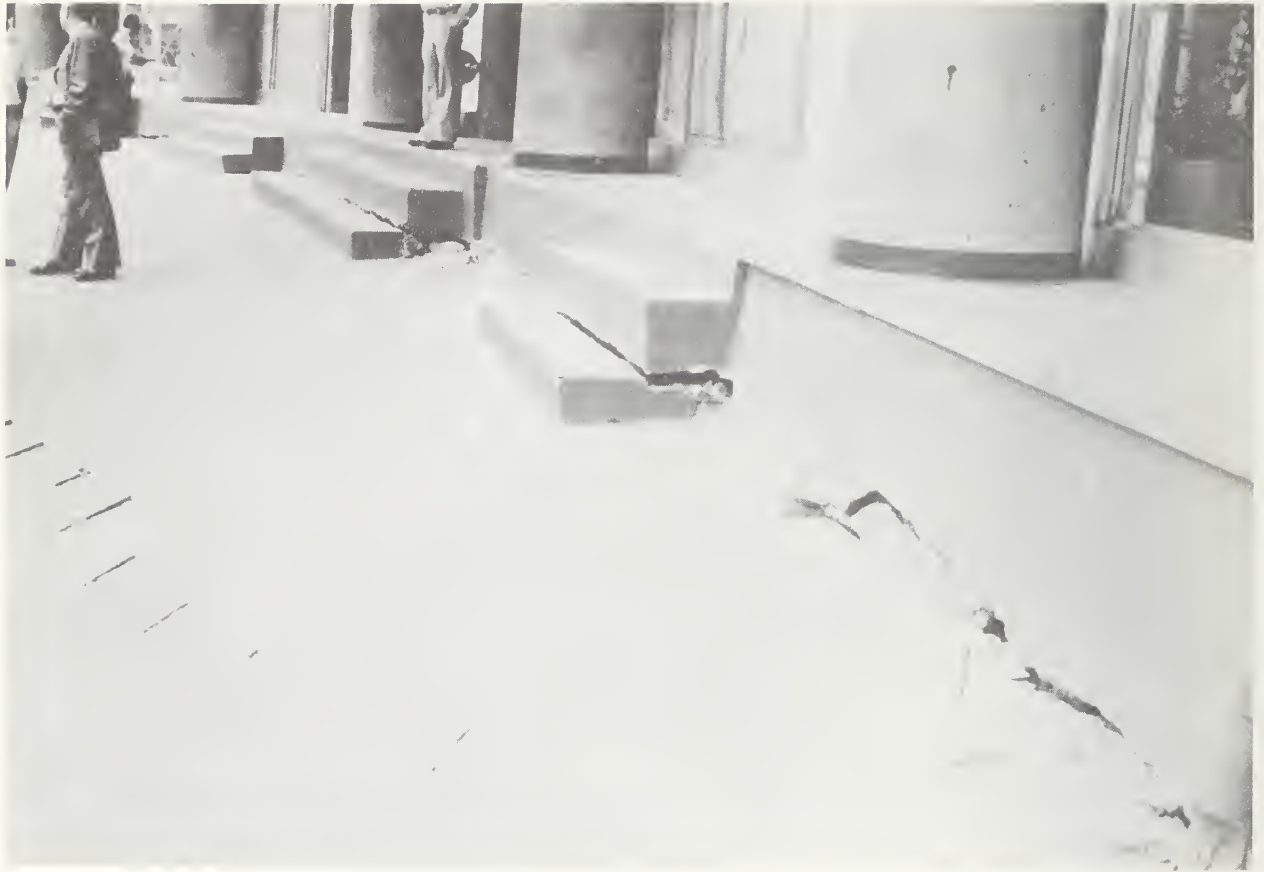
Figure 4.3 Differential displacement between sidewalk and building at the east corner of Versailles and Reforma.

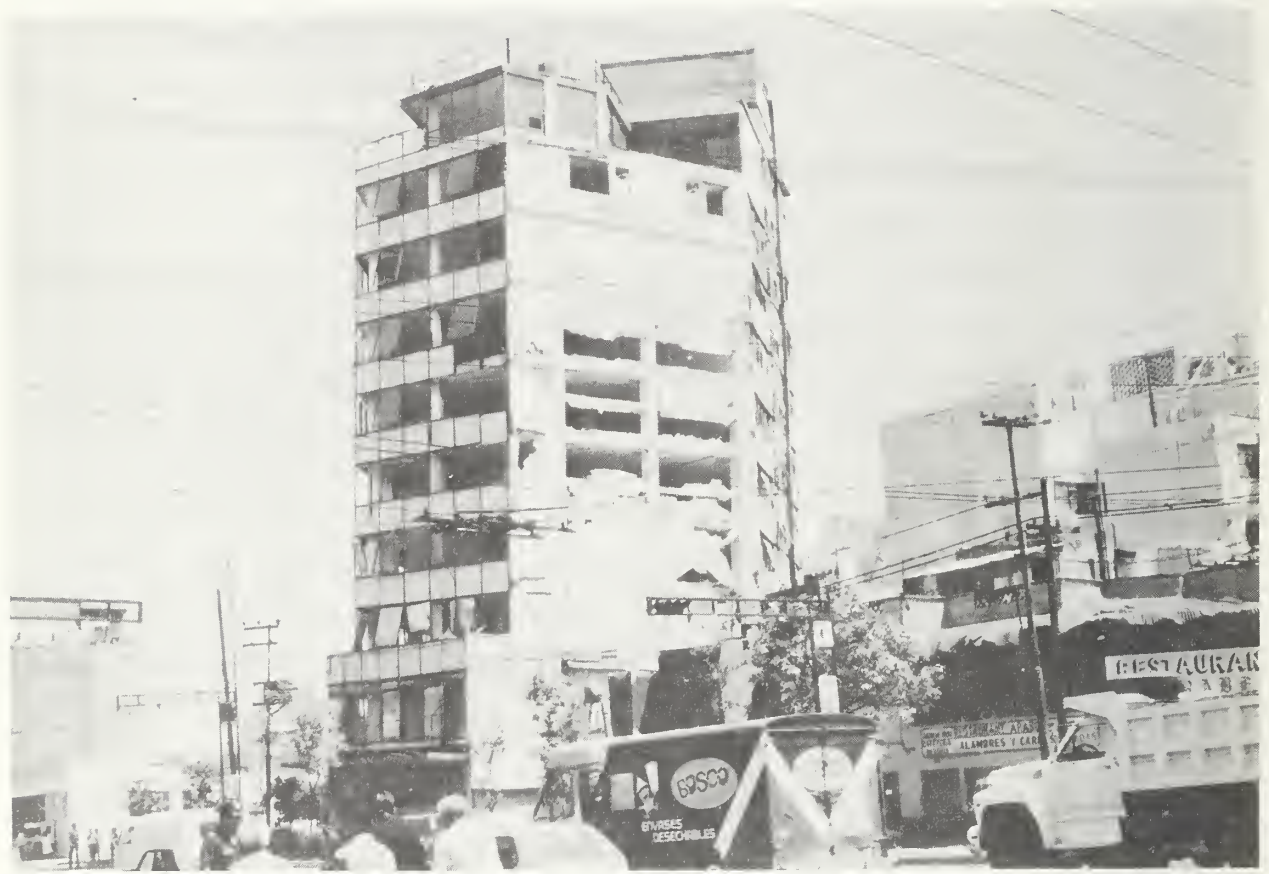
Figure 4.5. Tilted ten story building at Lazaro Cardenas and Fernando.

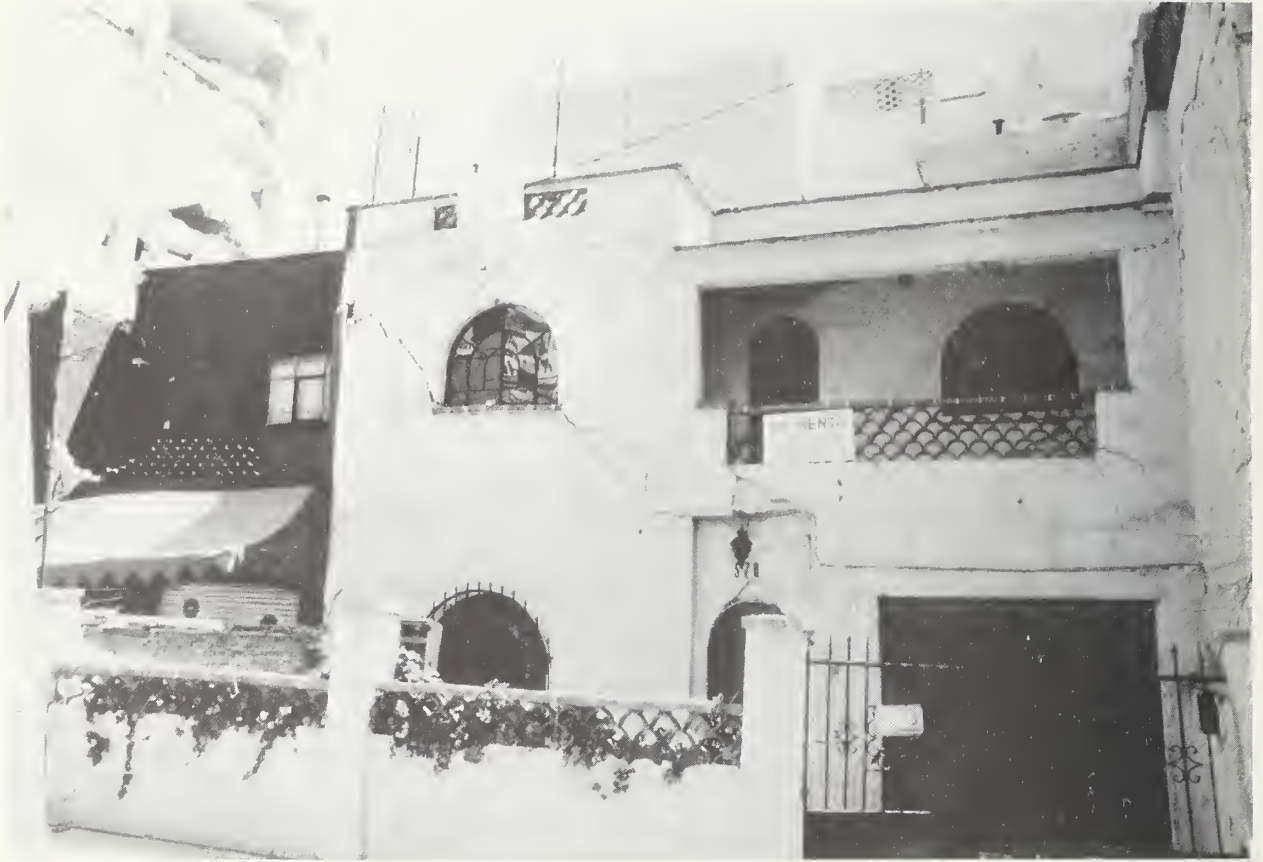
Figure 4.7. Damage to adjacent structures caused by the tilting of a ten story building at Lazaro Cardenas and Fernando.

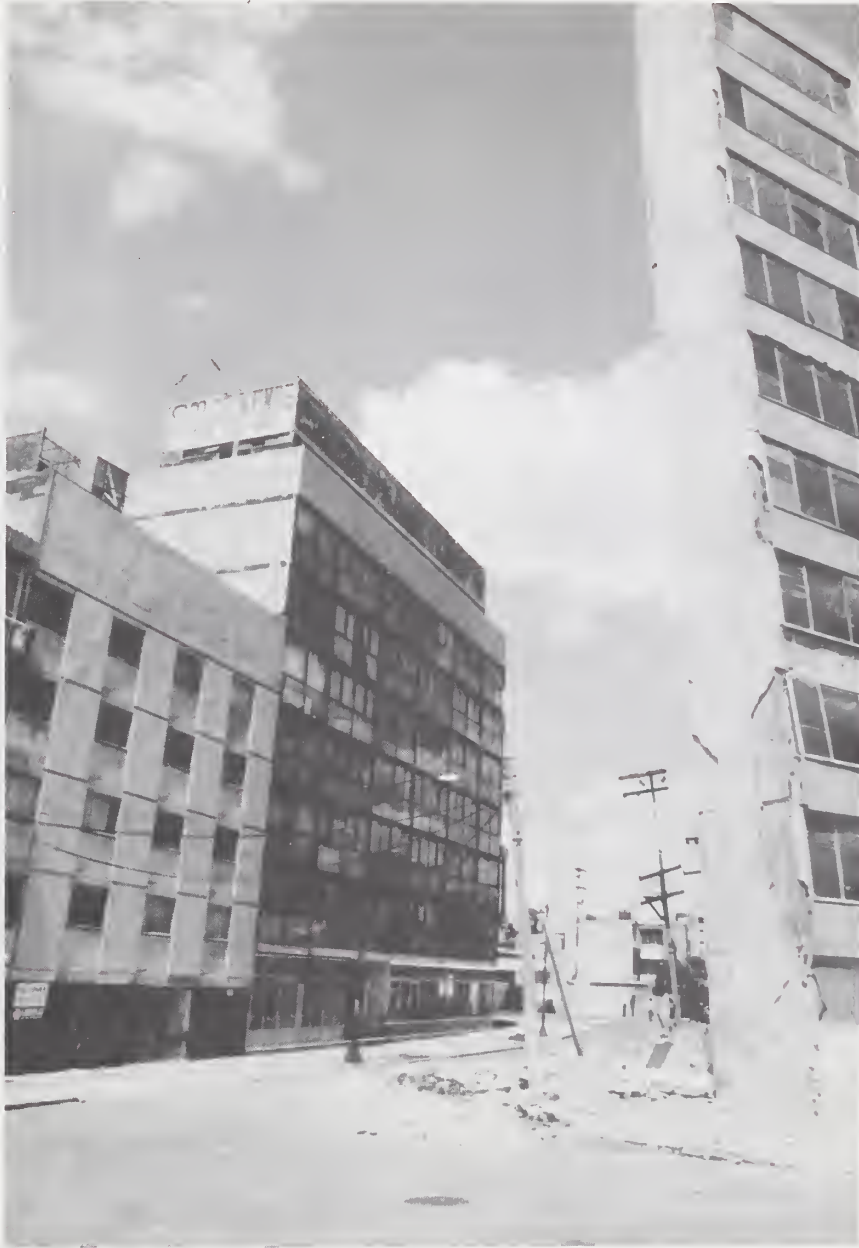
Figure 4.8. Tilted ten story building at University and Xola.

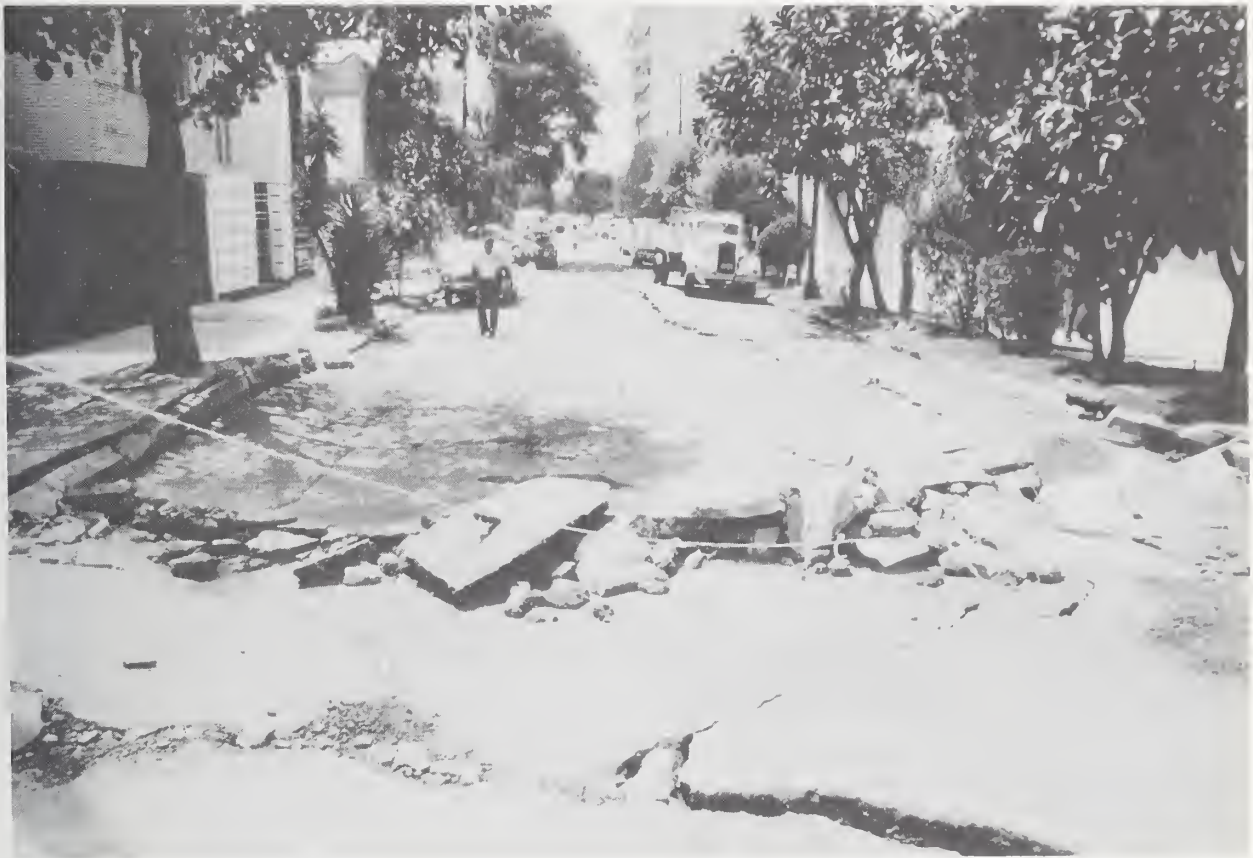
Figure 4.10. Ground disturbance on Galacia viewed from intersection of Toledo in a westerly direction.

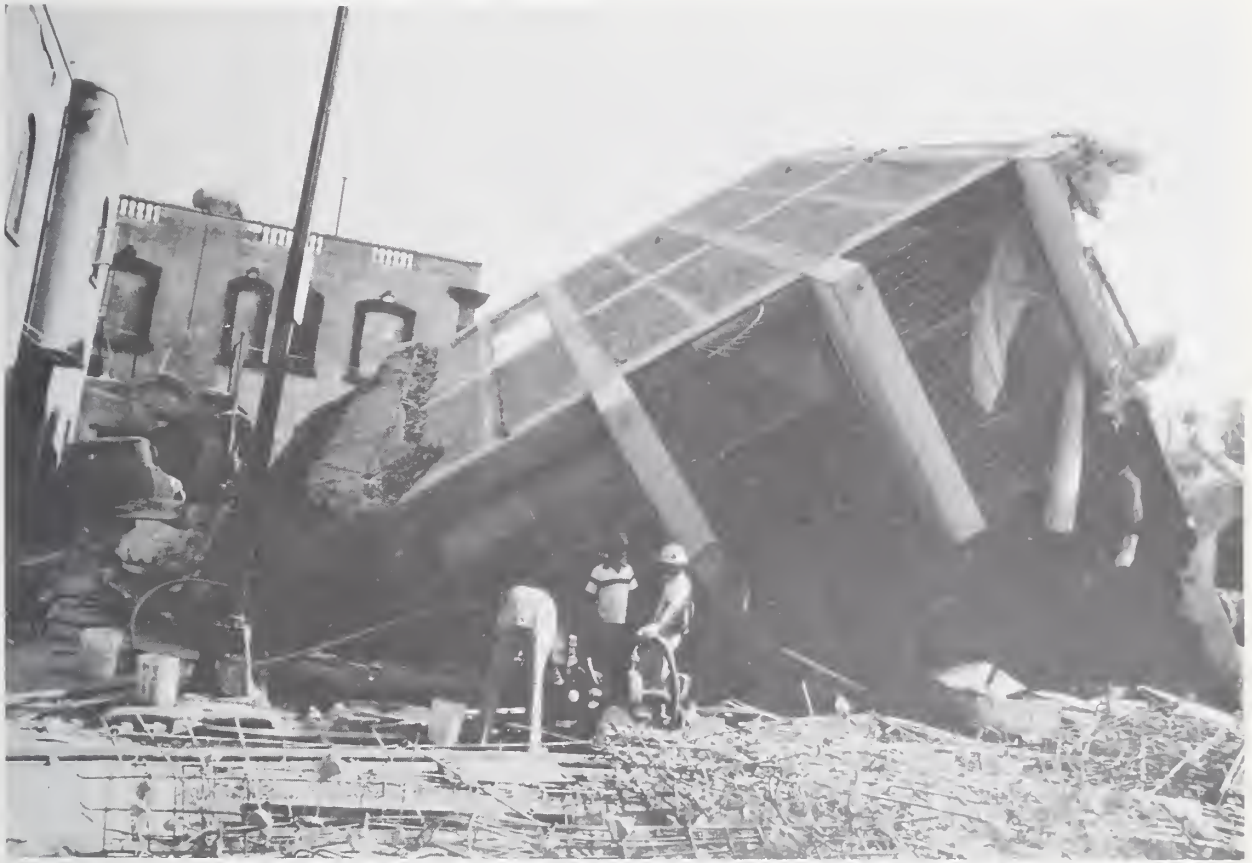
Figure 4.11. Oveturned building at southeast corner of Zacatecas and Orizaba.

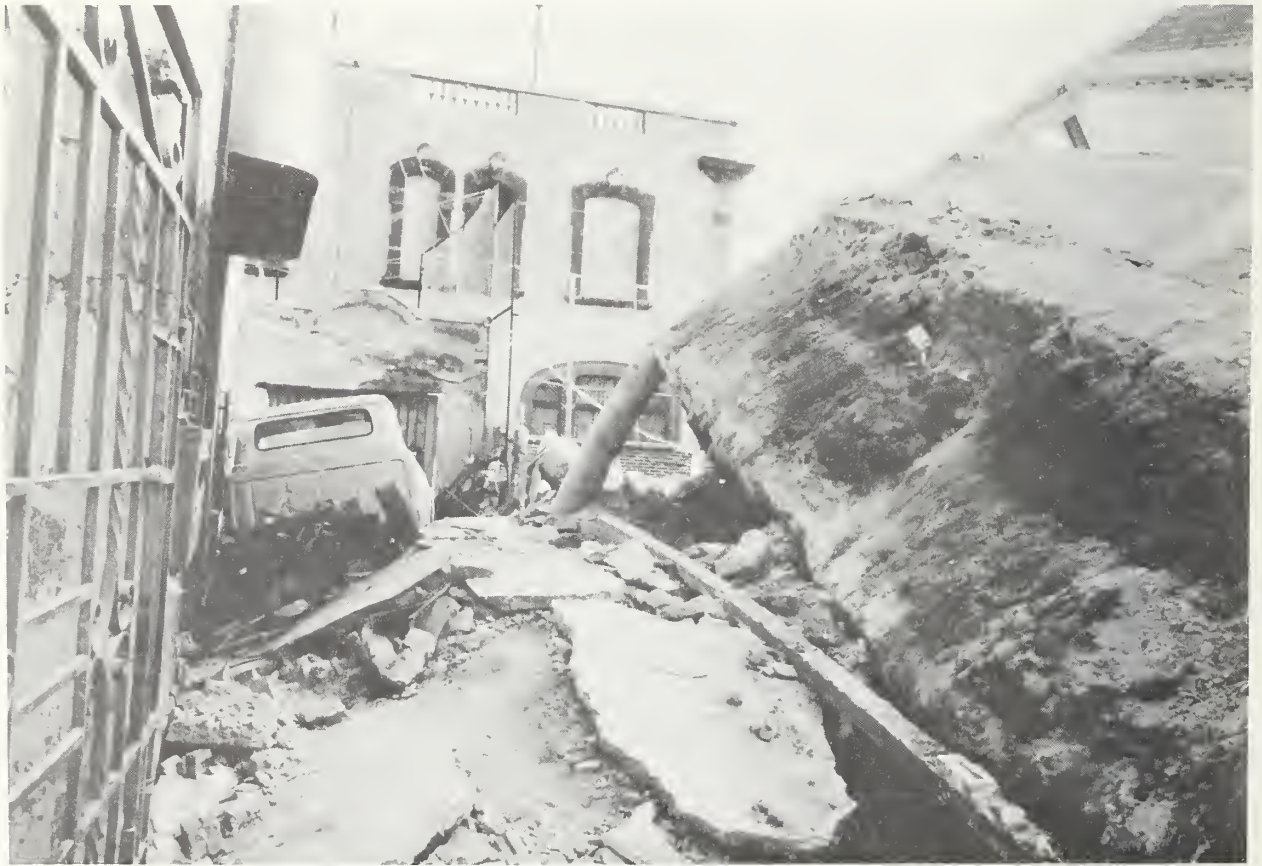
Figure 4.12. Exposed foundation of overturned building at Zacatecas and Orizaba.

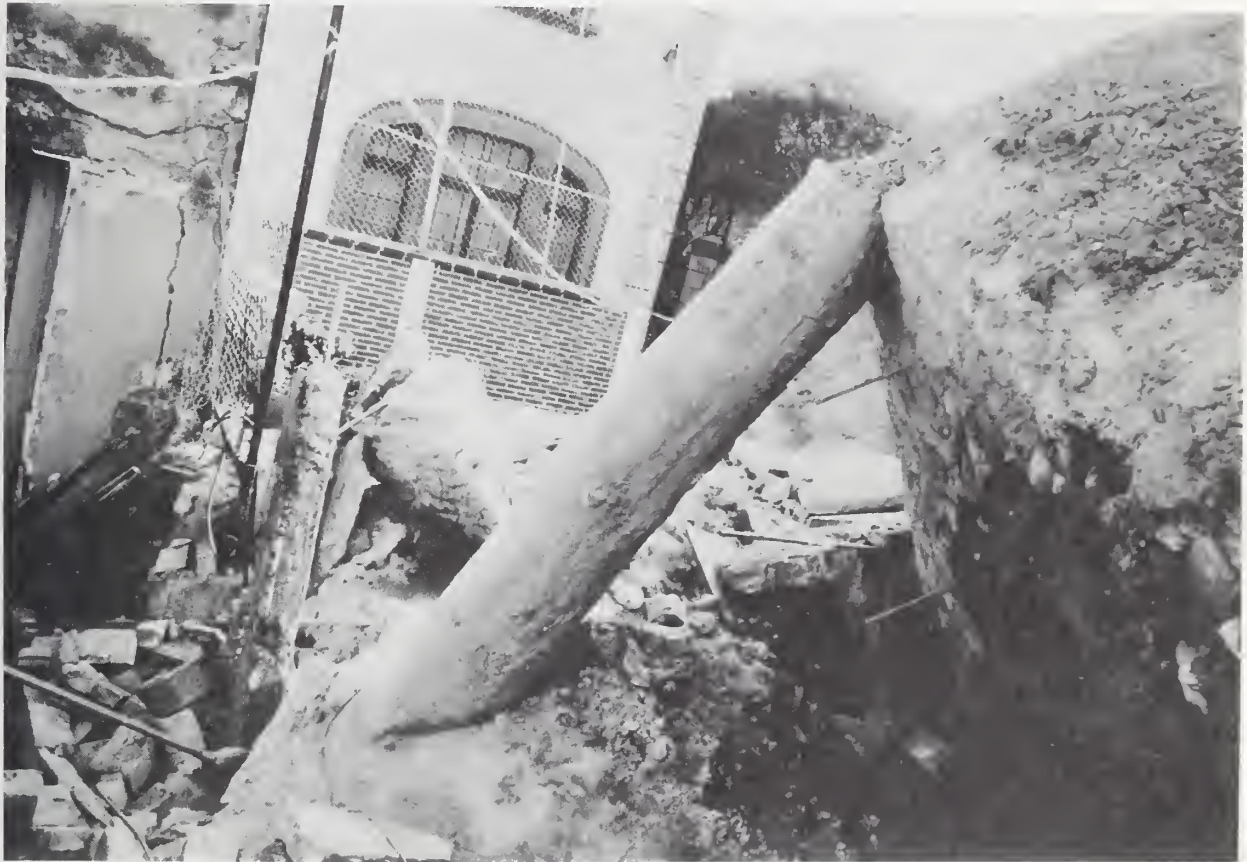
Figure 4.13. Exposed pile and dowels of the foundation of overturned building at Zacatecas and Orizaba.

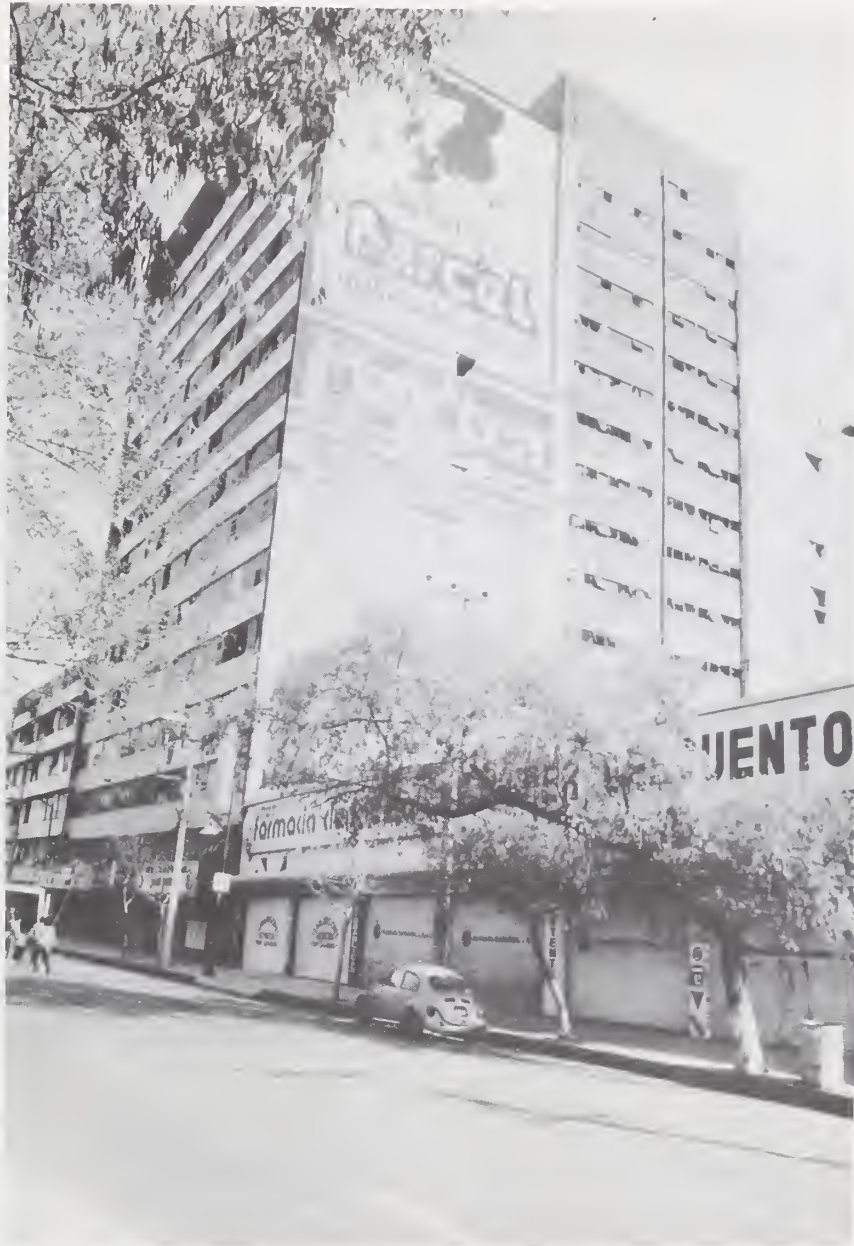
Figure 4.14. Building on the south side of Teresa de Mier which settled in one corner.

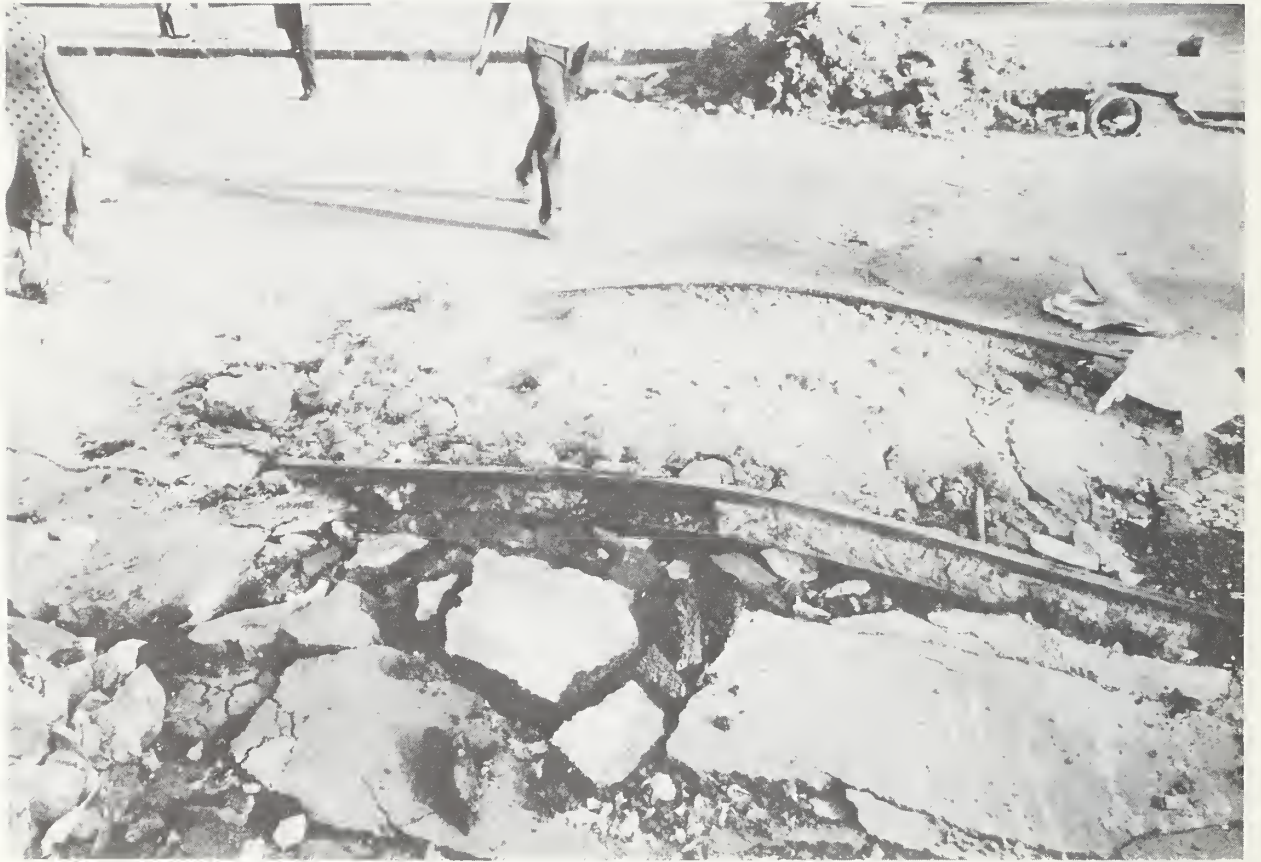
Figure 4.17. Buckled old trolley line on Obregon.

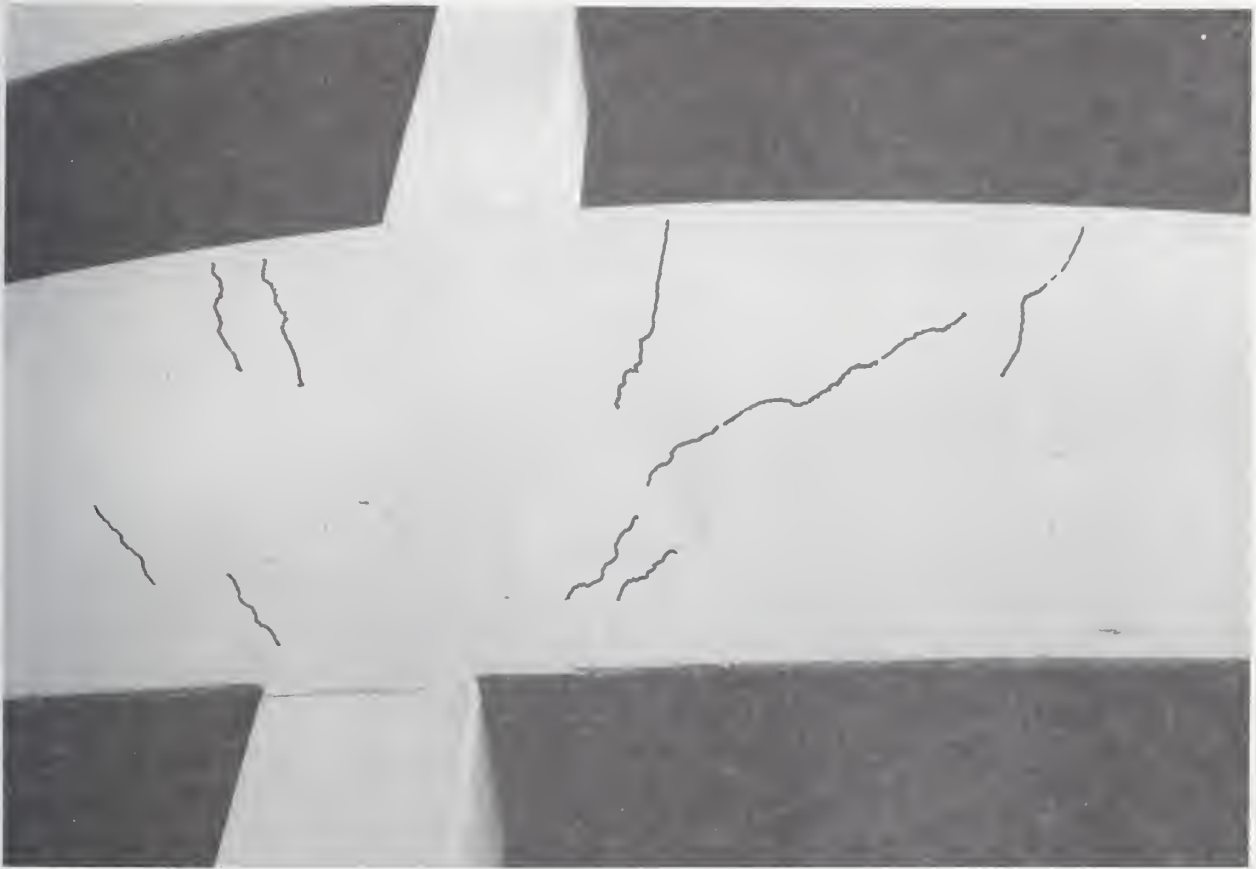
Figure 5.8. Pattern of hairline cracks near the beam column connection of the parking garage (cracks were highlighted for better visibility).

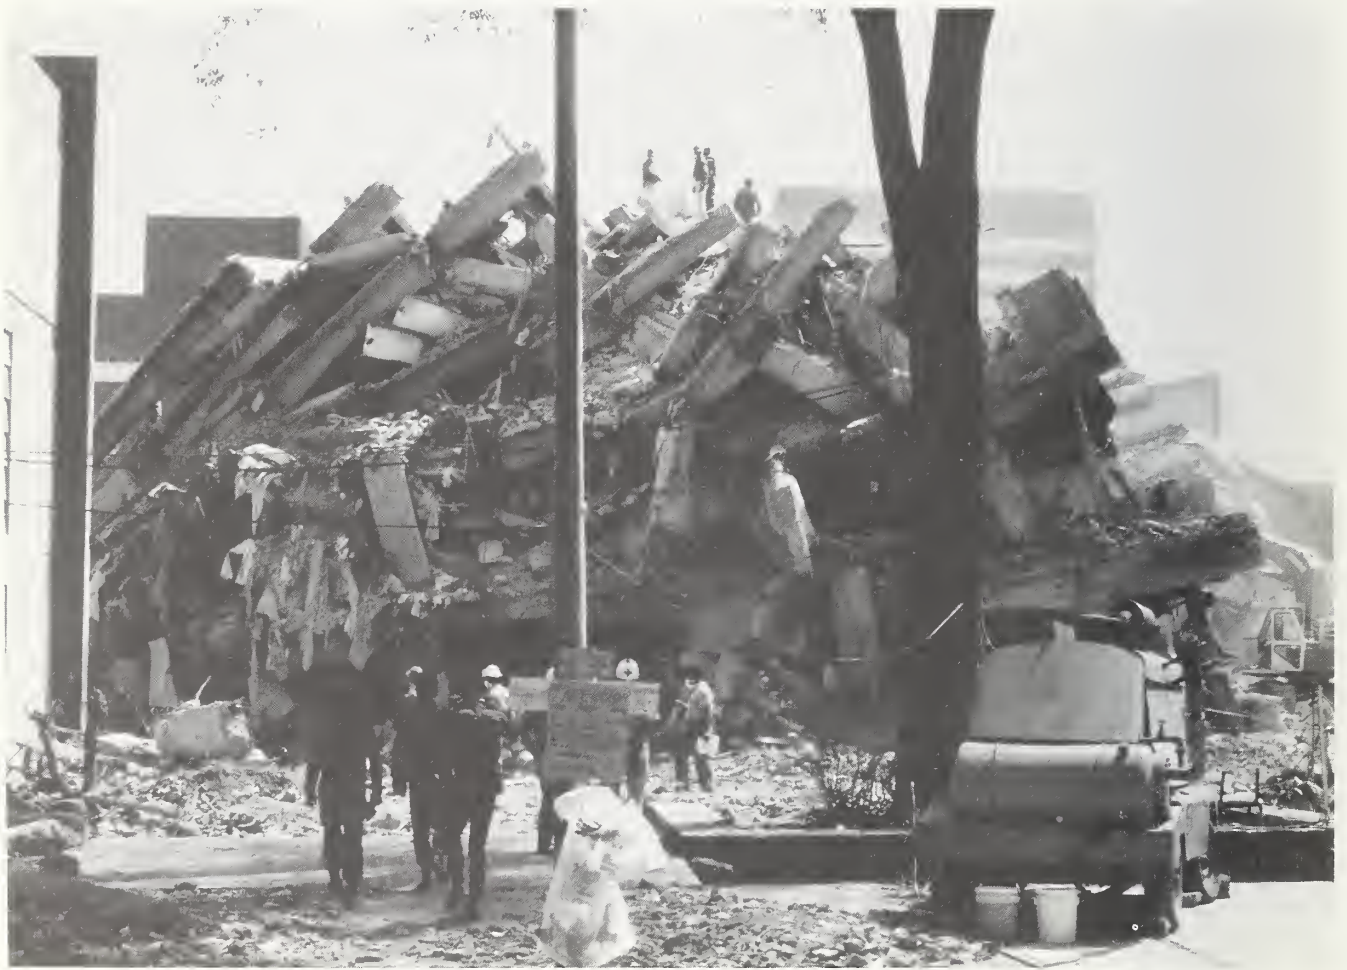
Figure 5.9. View of collapsed maternity wing of the Juarez Hospital looking south.

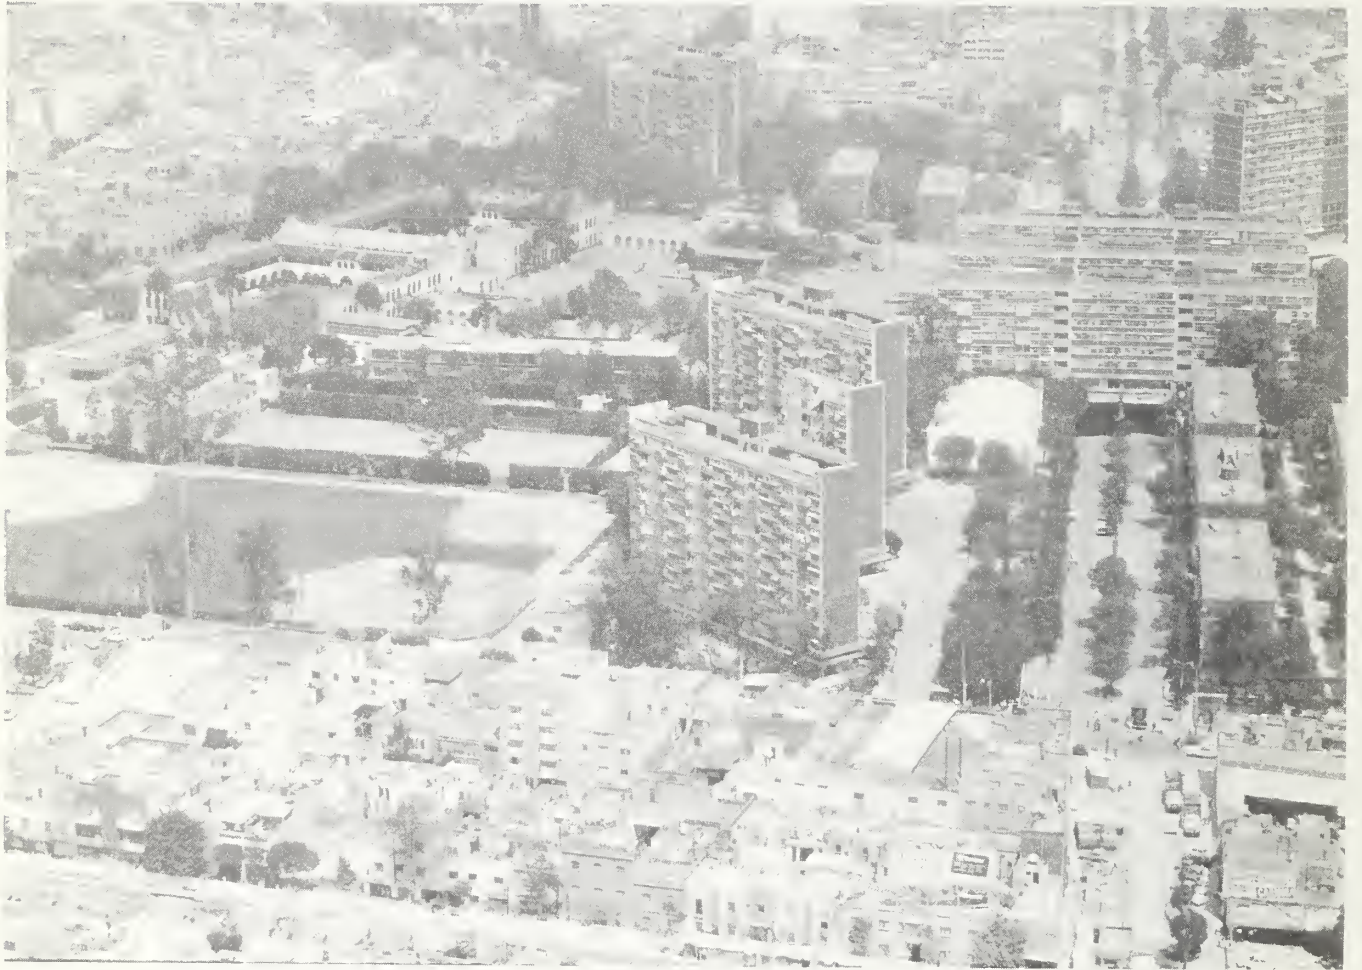
Figure 5.14. Damaged Urbana Juarez Apartment Complex west of General Hospital.

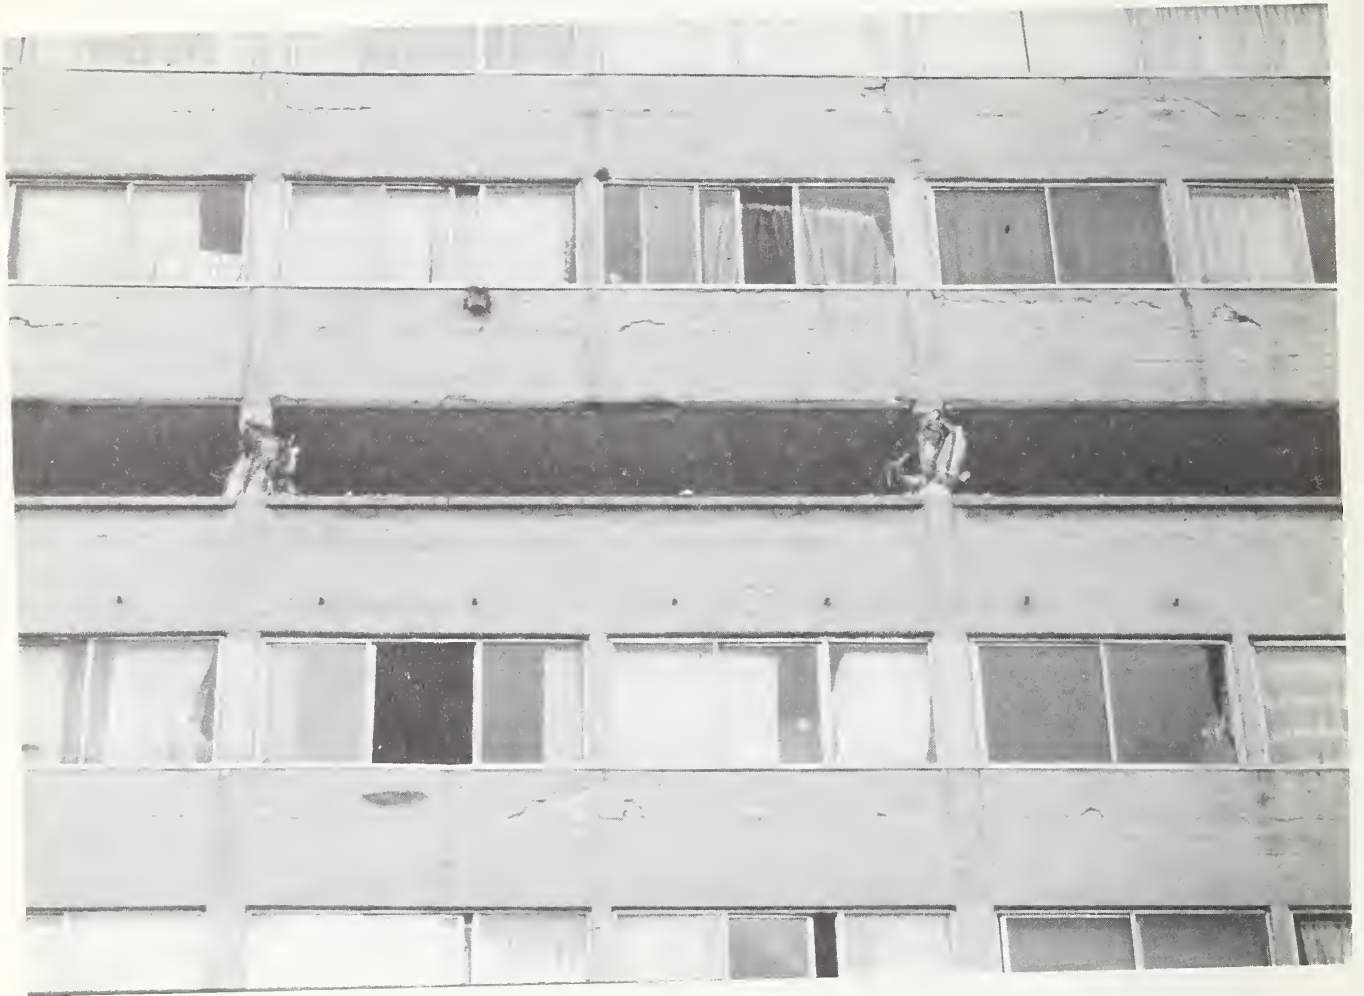
Figure 5.33. Failures in columns of the southern Nuevo Leon apartment tower (the only unit of the group of three to remain standing).

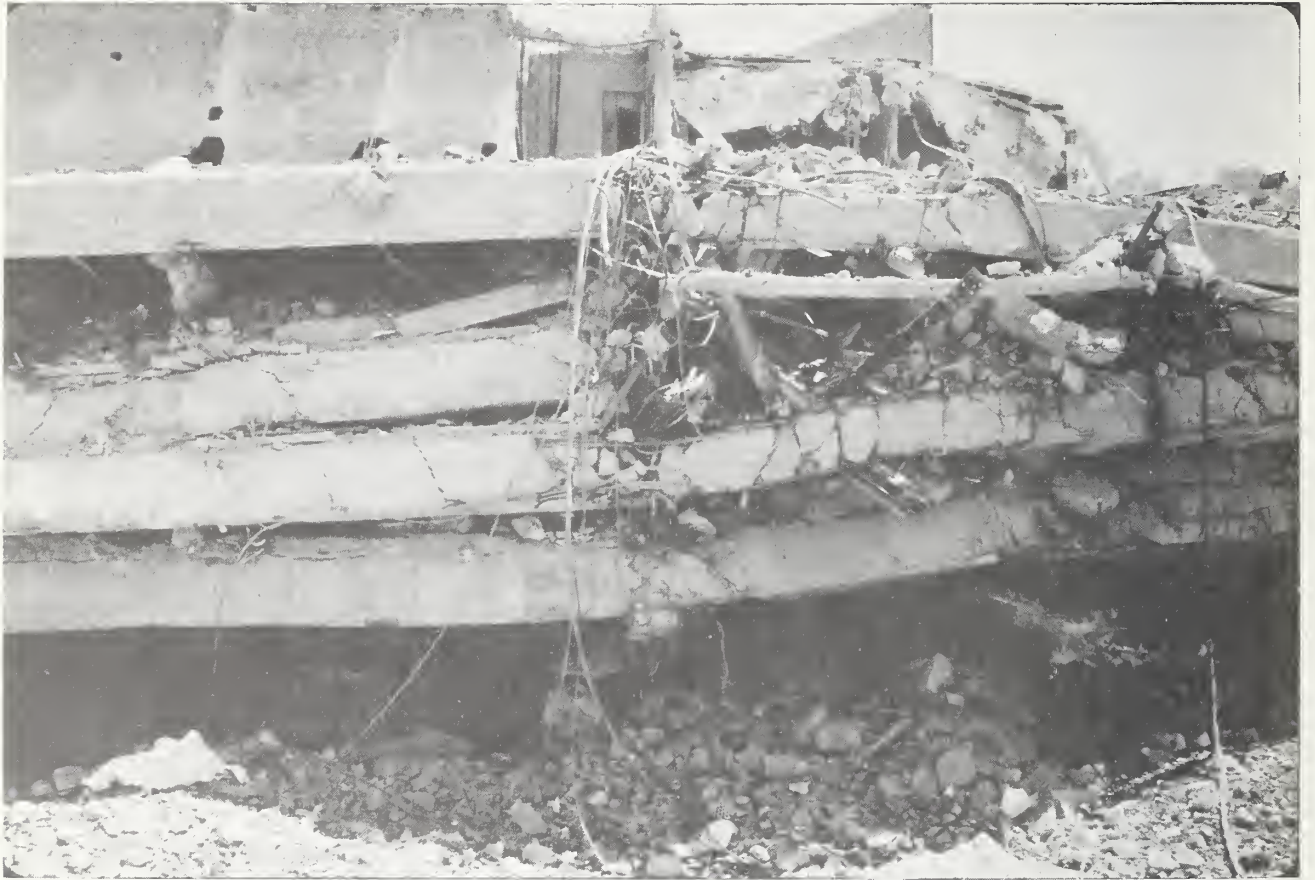
Figure 5.34. Collapsed office building near the corner of Neva and Barragan Streets.

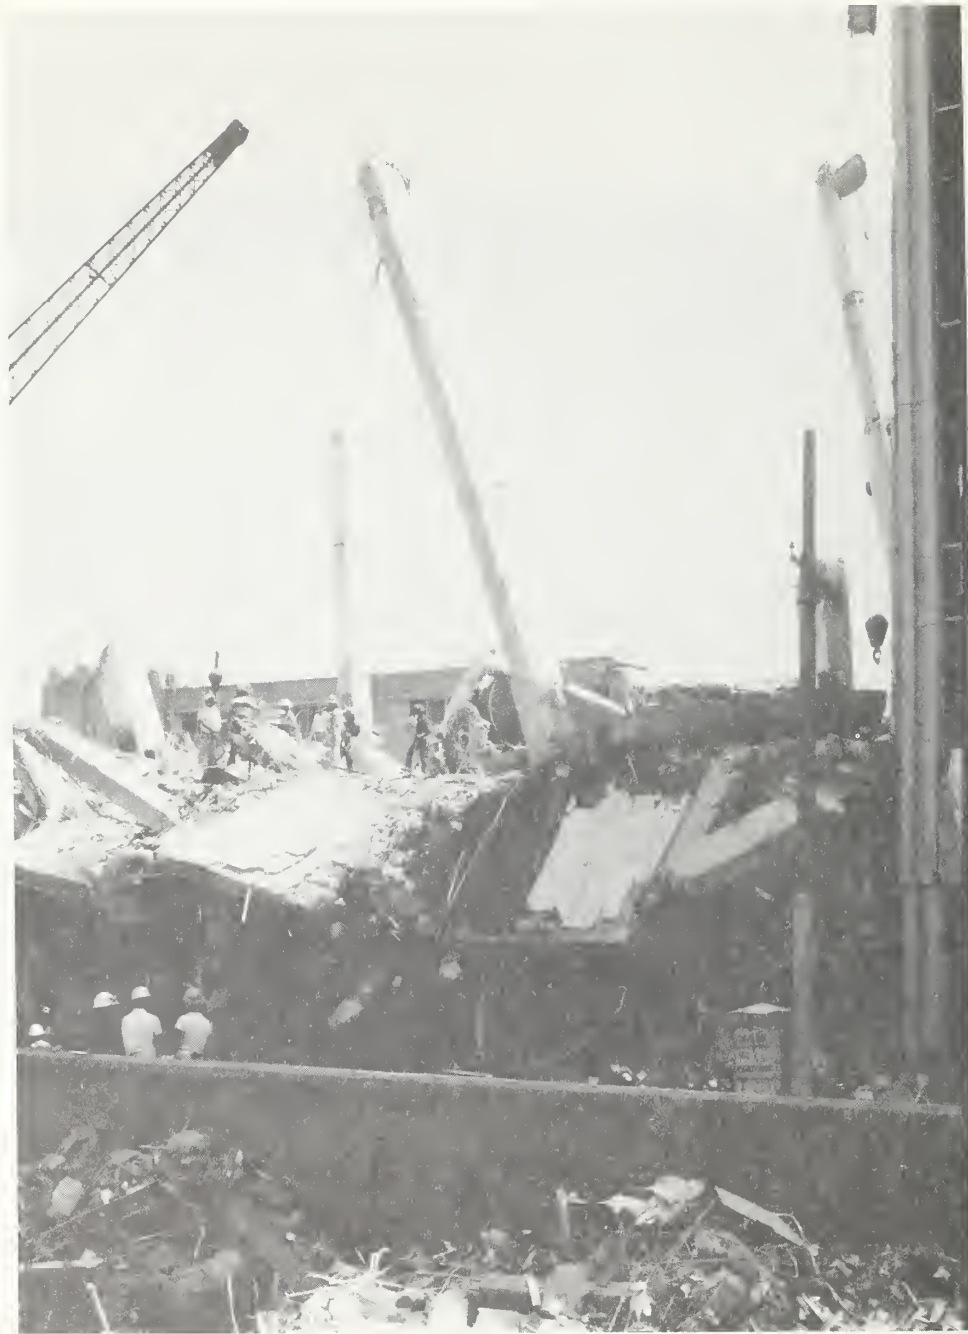
Figure 5.36. Punching shear failure of the 10 story Bancomer Building.

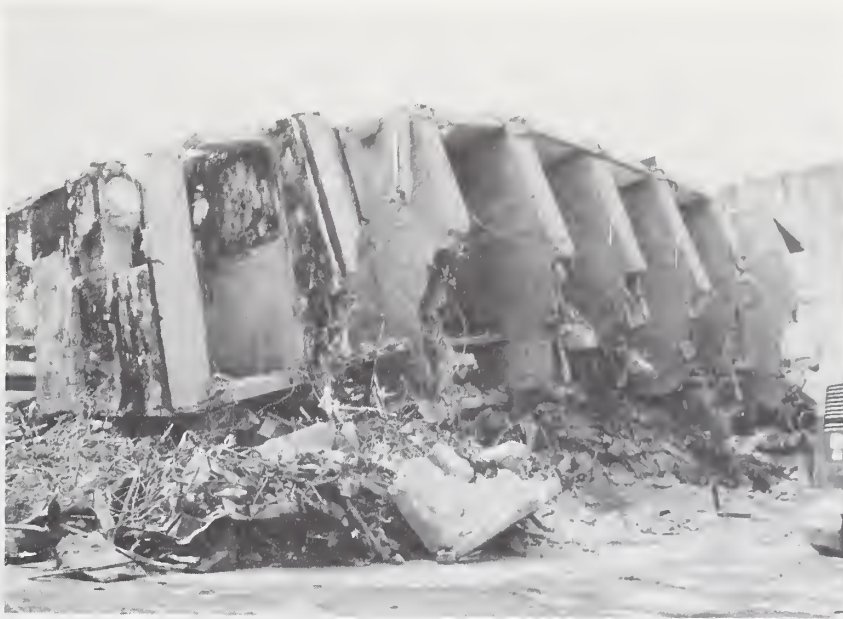
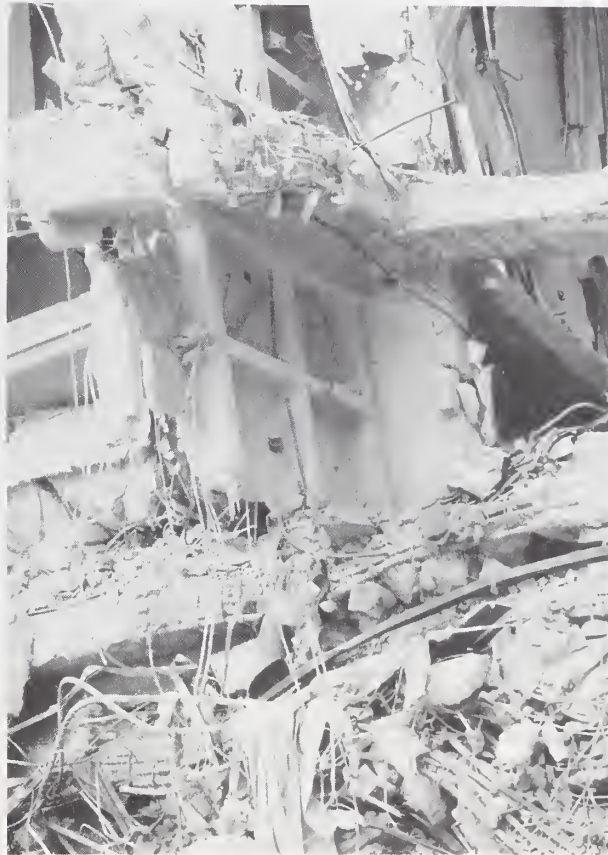
Figure 5.39. Collapsed 10 story apartment building in the corner of Dinamarca and Chapultepec. This waffle slab structure failure is attributed to base column failure and possible pounding with the neighboring structure.
