NBS BUILDING SCIENCE SERIES 165

# Engineering Aspects of the September 19, 1985 Mexico Earthquake

Following the September 19, 1985 Mexico earthquake, a team consisting of four engineers and one seismologist from the National Bureau of Standards (NBS) and the United States Geological Survey (USGS) was dispatched to Mexico City to provide technical advice to the US rescue effort and to assess structural damage. This report is primarily based on data gathered by the team, but it also contains a compilation of other available information. The report addresses the origin and characteristics of the observed ground motion, the ability of buildings designed in accordance with present and proposed seismic design provisions to resist this type of ground motion, and observed data on structural and foundation failures.

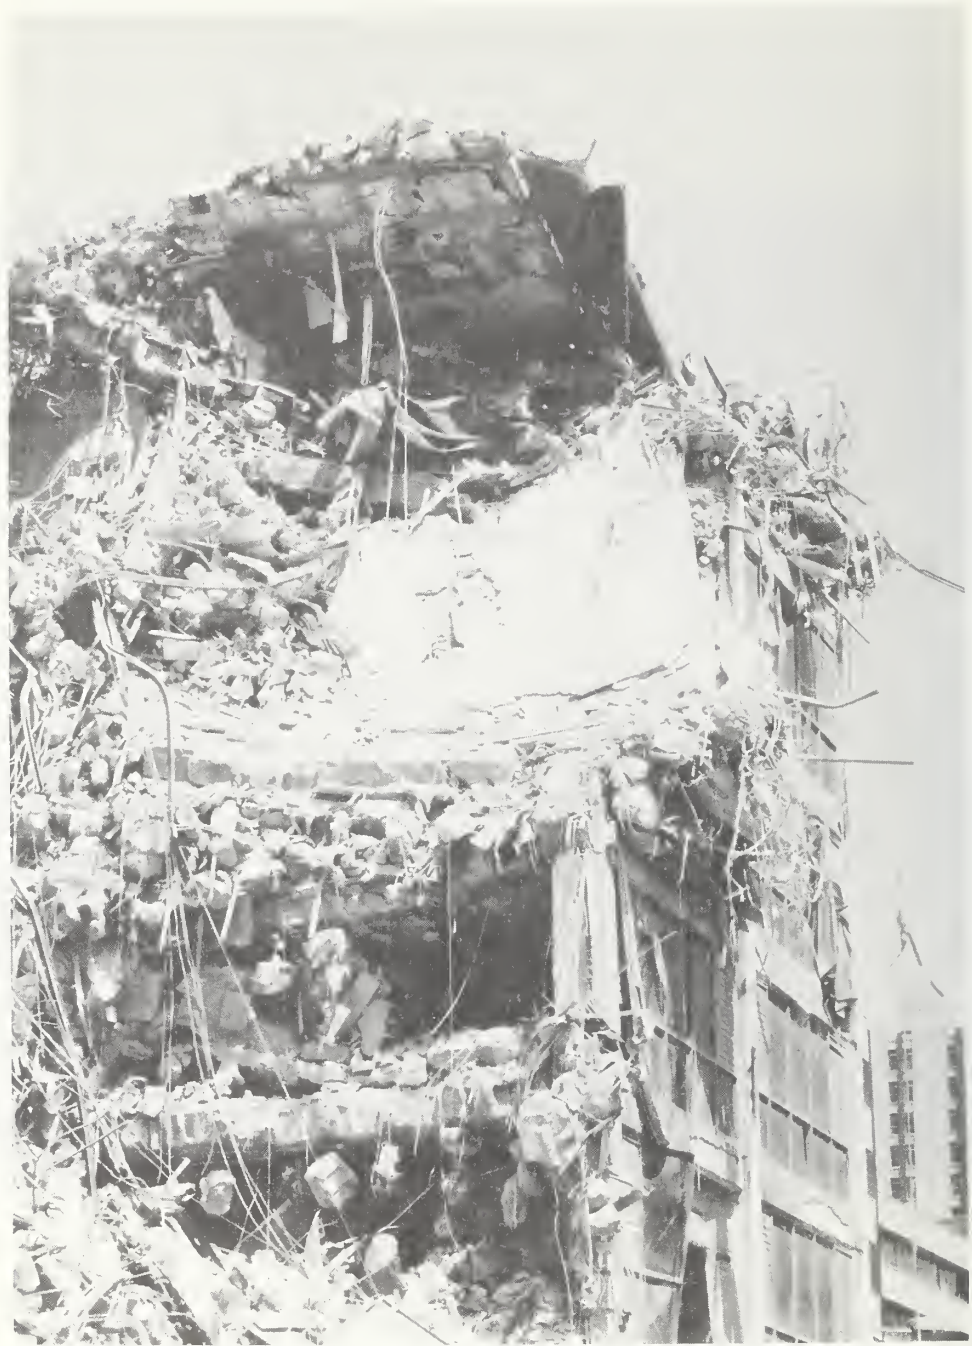
Figure 5.42. The "floor dropout" phenomenon observed in waffle slab structures with concrete block for pan forming.

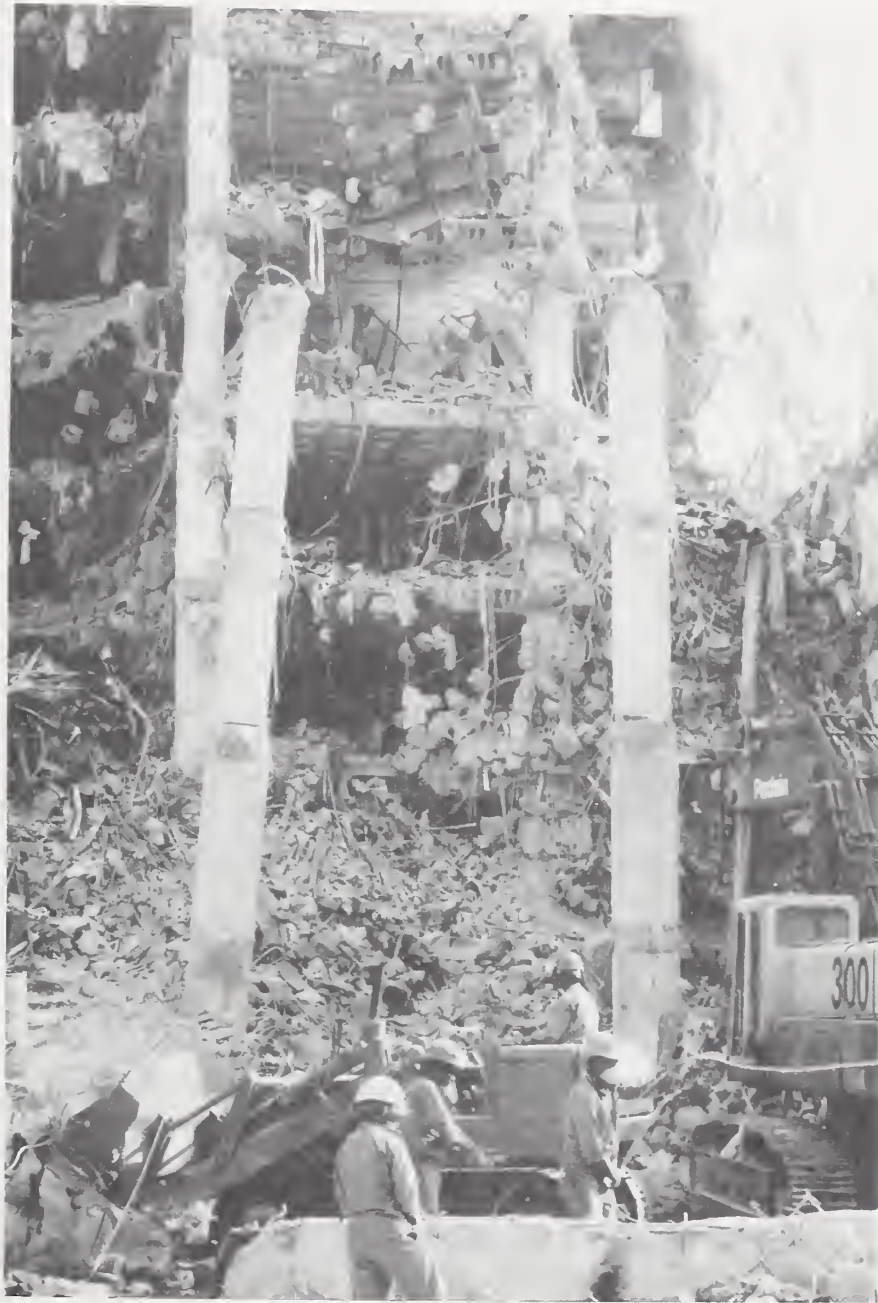
Figure 5.43. Punching shear failure in concrete-cinder block floor.

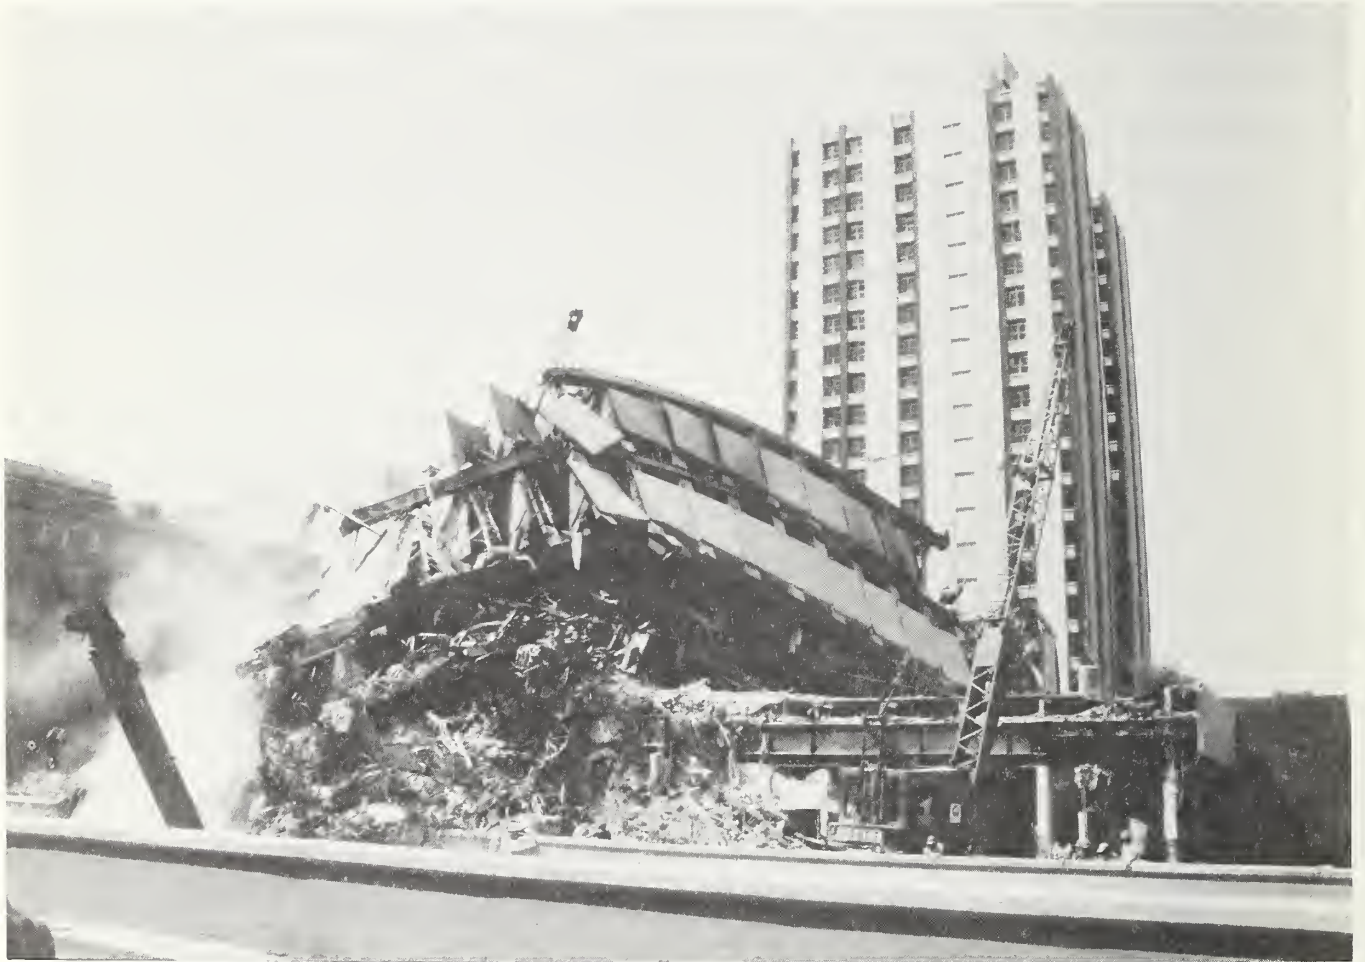
Figure 5.44. Southern towers of the Consumo Pino Suarez Complex shortly after collapse.

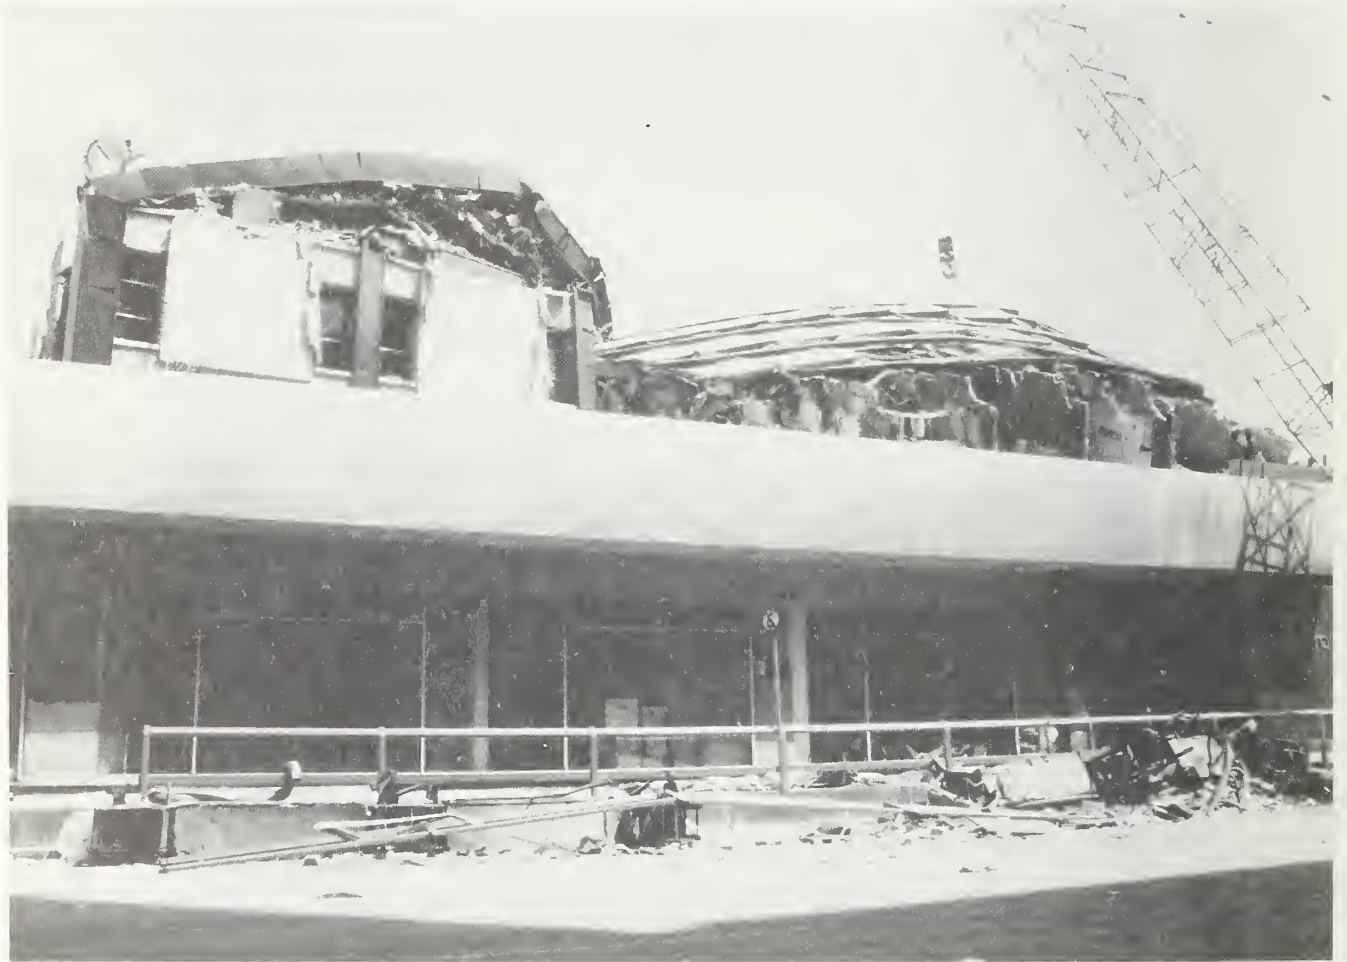
Figure 5.53. Closeup of fractured column line near second story, north side, of the southernmost 23-story structure in Pino Suarez Complex, shortly after collapse.

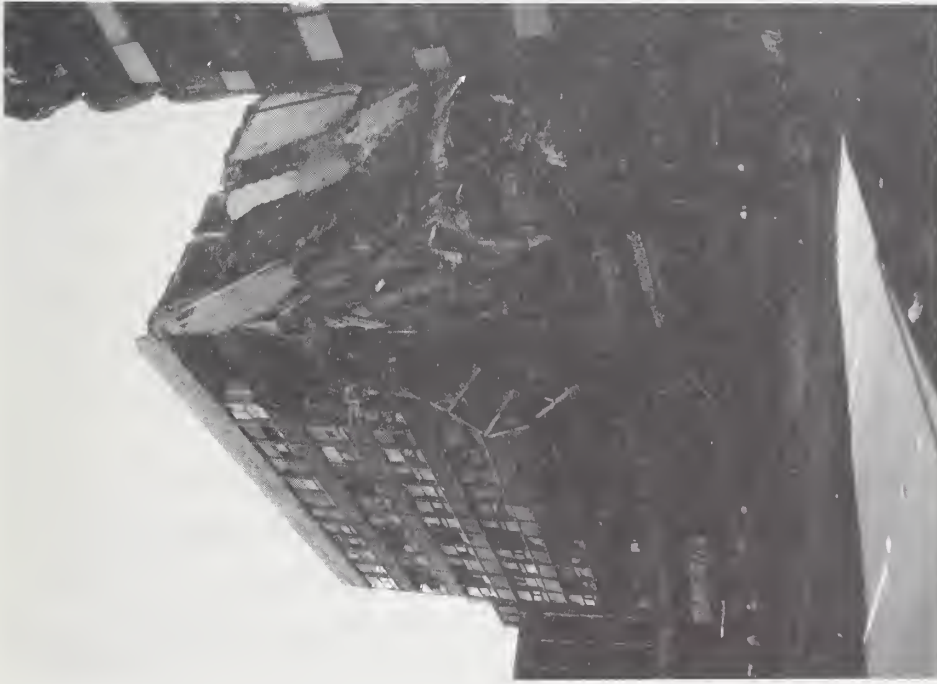
(a) Seven story office building on Ave. 20th de Novembre which collapsed due to pounding.

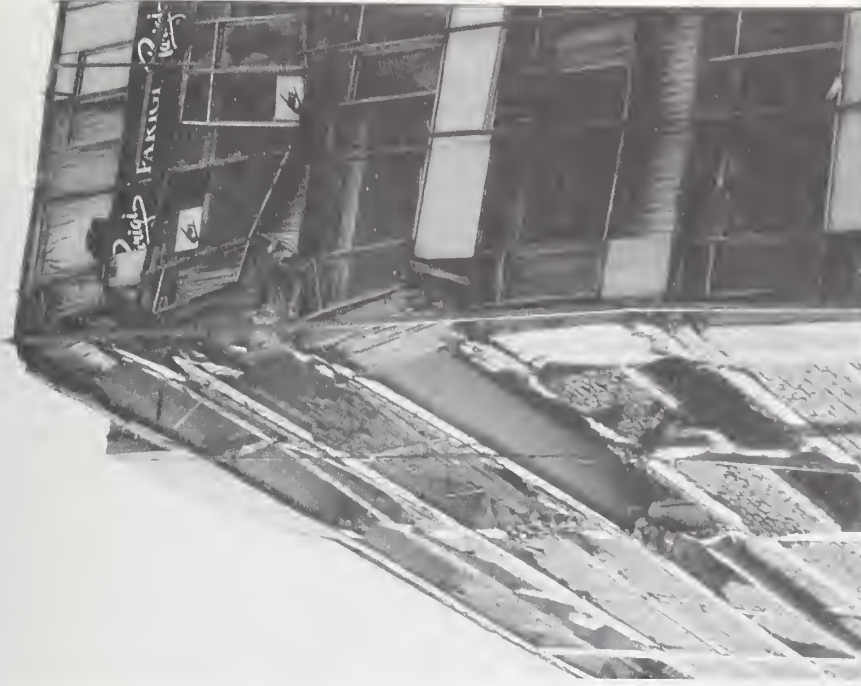
(b) Neighboring nine story building showing impact damage to columns.

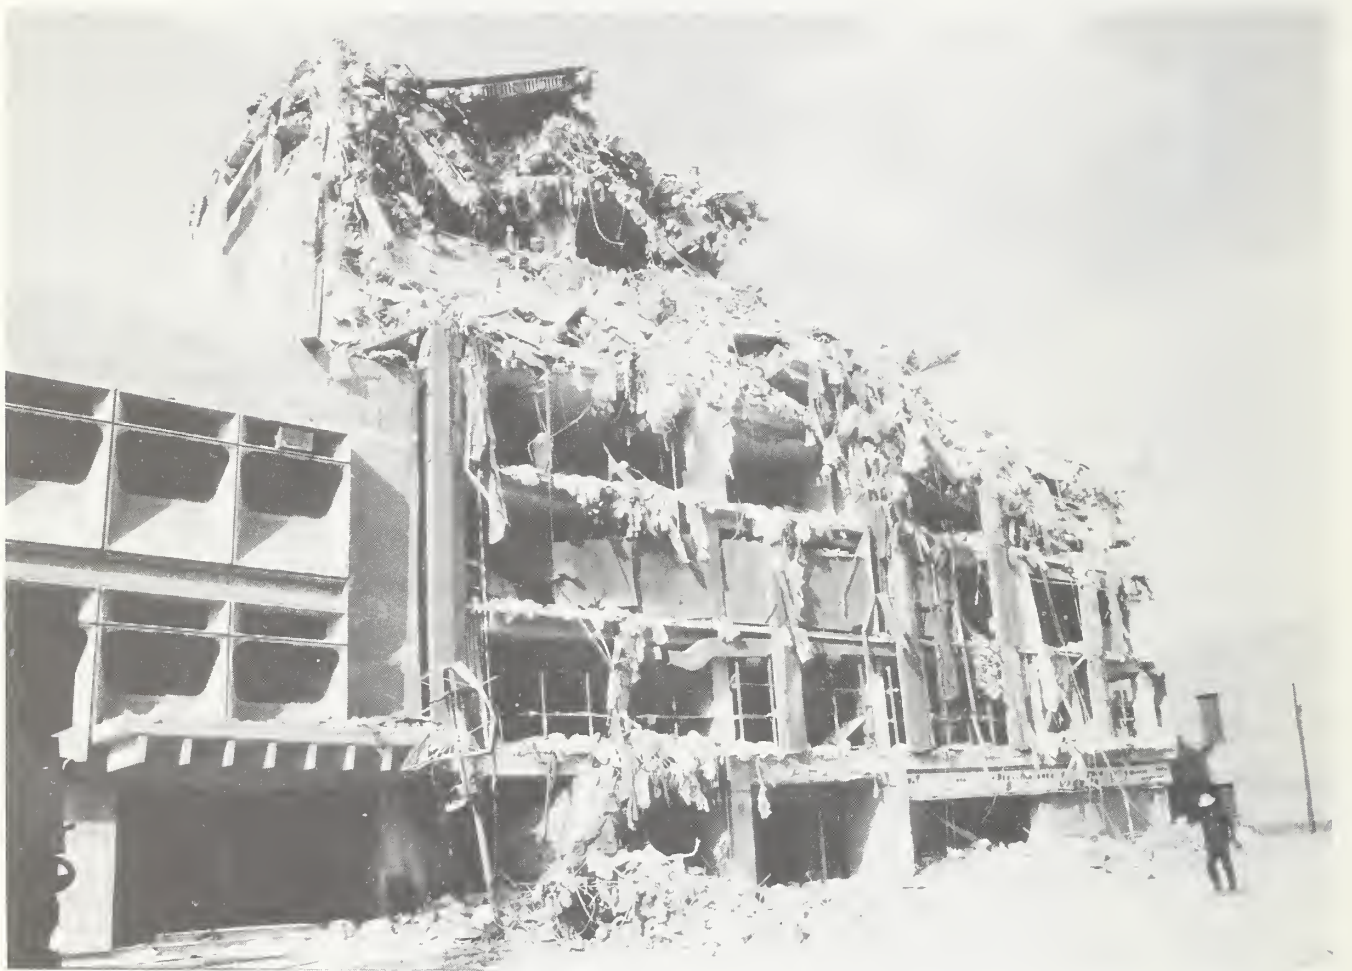
Figure 5.59. Pounding damage between buildings of dissimilar heights and stiffnesses. The upper floor of this 9-floor clothing store collapsed following pounding with its much stiffer neighboring 3-story structure. The separation between the structures was approximately 10 cm.

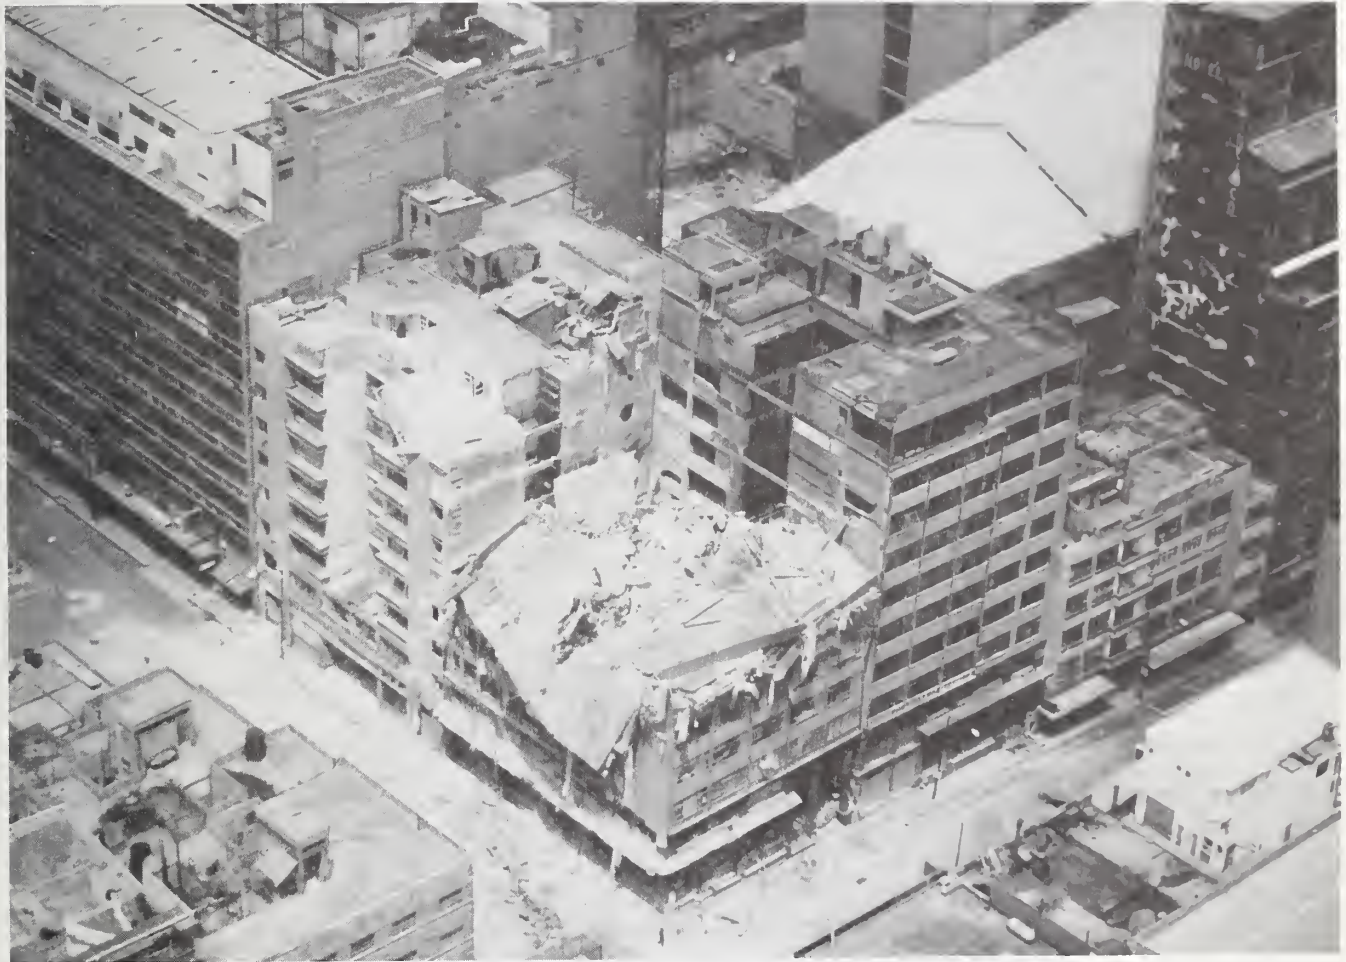
Figure 5.66. Torsionally induced pounding in corner building south of Alameda Park, near Torre Latino Americana.

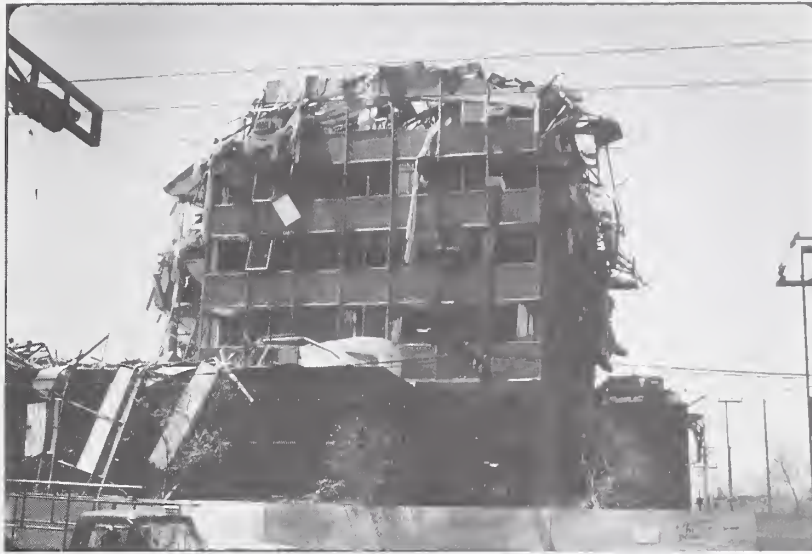
(a) Upper story failure in office building on Ave. Lazaro Cardenas.

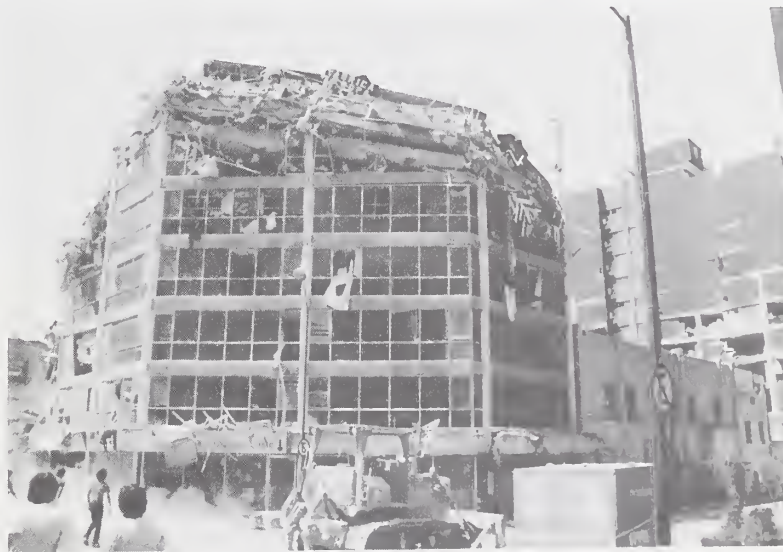
(b) Upper story failure in clothing store.

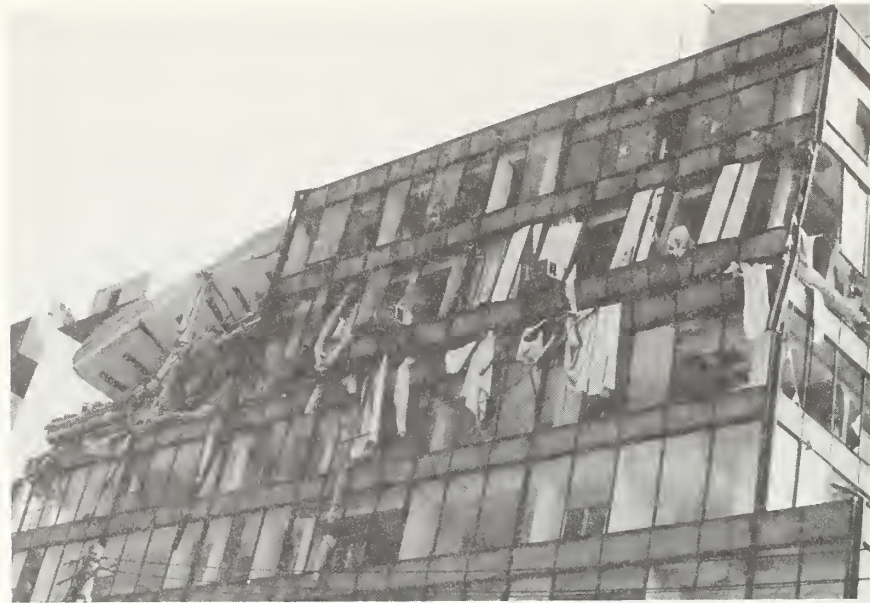
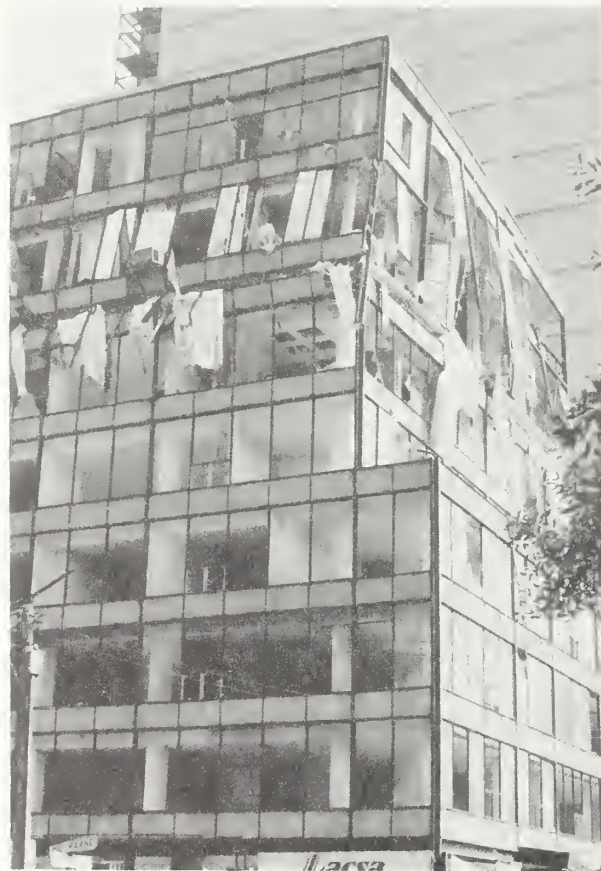
Figure 5.68. LASCA Building on Paseo de la Reforma and Marne, showing large change in column stiffness in upper two floor penthouse.

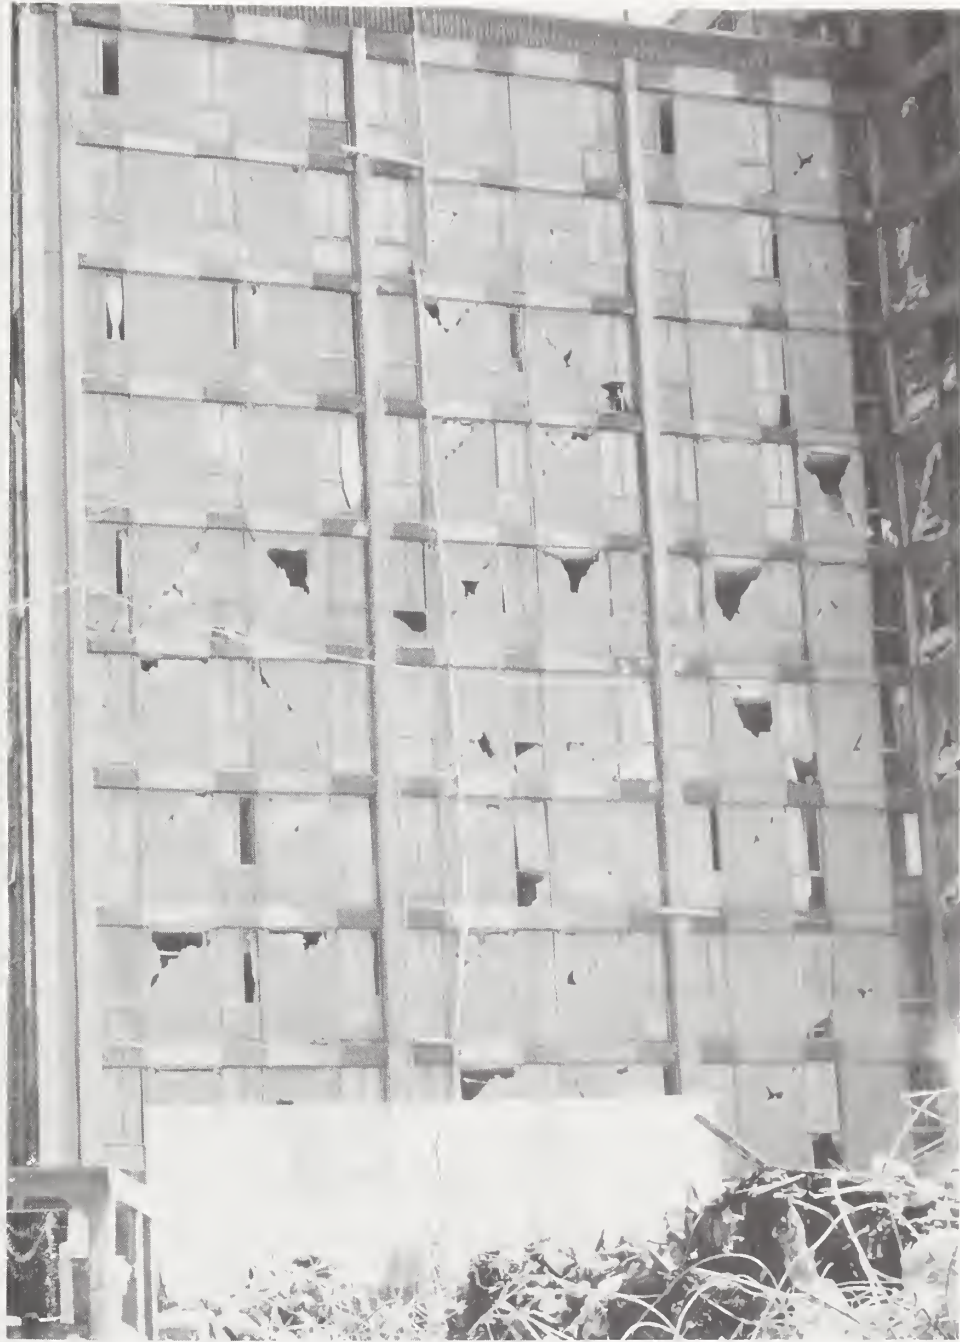
Figure 5.72. Significant diagonal shear cracking in a masonry infill structure on Ave. T. de Mier. Enough energy was dissipated in the walls to prevent collapse of the building.
