# NATIONAL BUREAU OF STANDARDS REPORT

9829

## EXAMINATION OF STOCK POD SECURITY CHAIN

Bureau of Research and Engineering  
U. S. Post Office Department  
Washington, D. C.

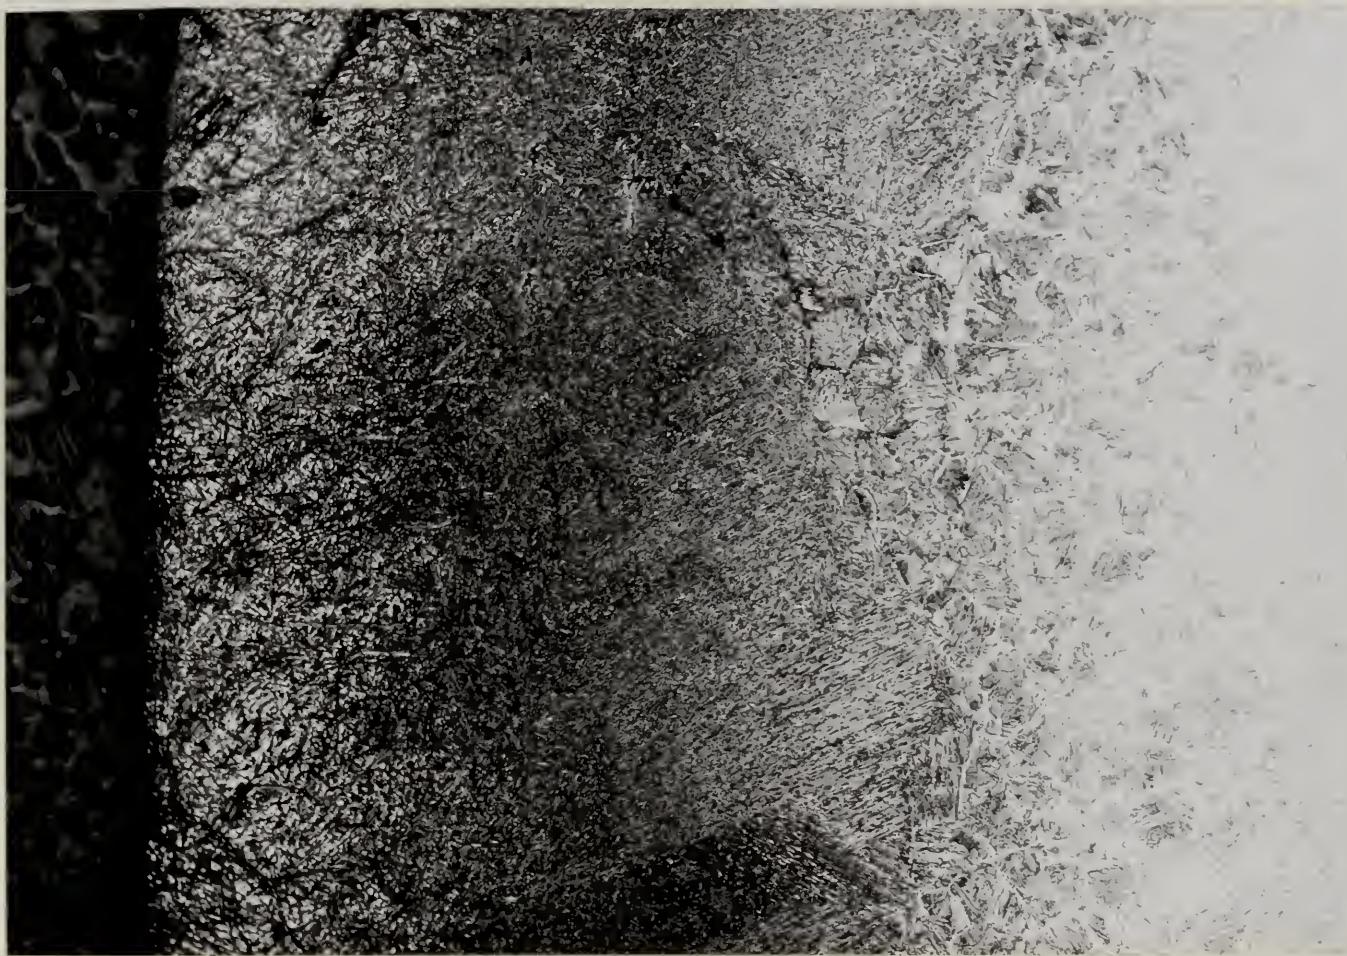
Metallographic Examination and Hardness Tests: One link was sectioned and prepared for metallographic examination. The depth of the carburized case was found to be approximately 0.04 inch. Figure 1 shows the gradation of the carbon penetration from the outer edge, where it is at a maximum, to the core where it approaches the carbon content of the carbon steel used in the fabrication of the chain. Examination of the microstructure at a higher magnification (figure 2) revealed the following microstructural conditions:

Figure 1. Microstructure of a section from a stock POD security chain link. Carburized case is approximately 0.04 inch thick. Photomicrograph shows the gradation of the carbon penetration from the outer edge (darker area) where it is at a maximum to the lighter etching core area where it is at a minimum approaching the carbon content of the core. Etched with nital. X 100.

However, it was determined that the stock chain was susceptible to failure due to the extreme brittleness of the carburized case. In order to improve the ductility without decreasing the hardness, it is recommended that the chain be given an additional heat treatment after carburization. This should consist of reheating to a temperature of 1425°F, holding at this temperature for one-half hour and then quenching immediately in water. Care should be taken to prevent surface decarburization. Hardening should be followed by tempering at 350°F for 1 1/2 hours.

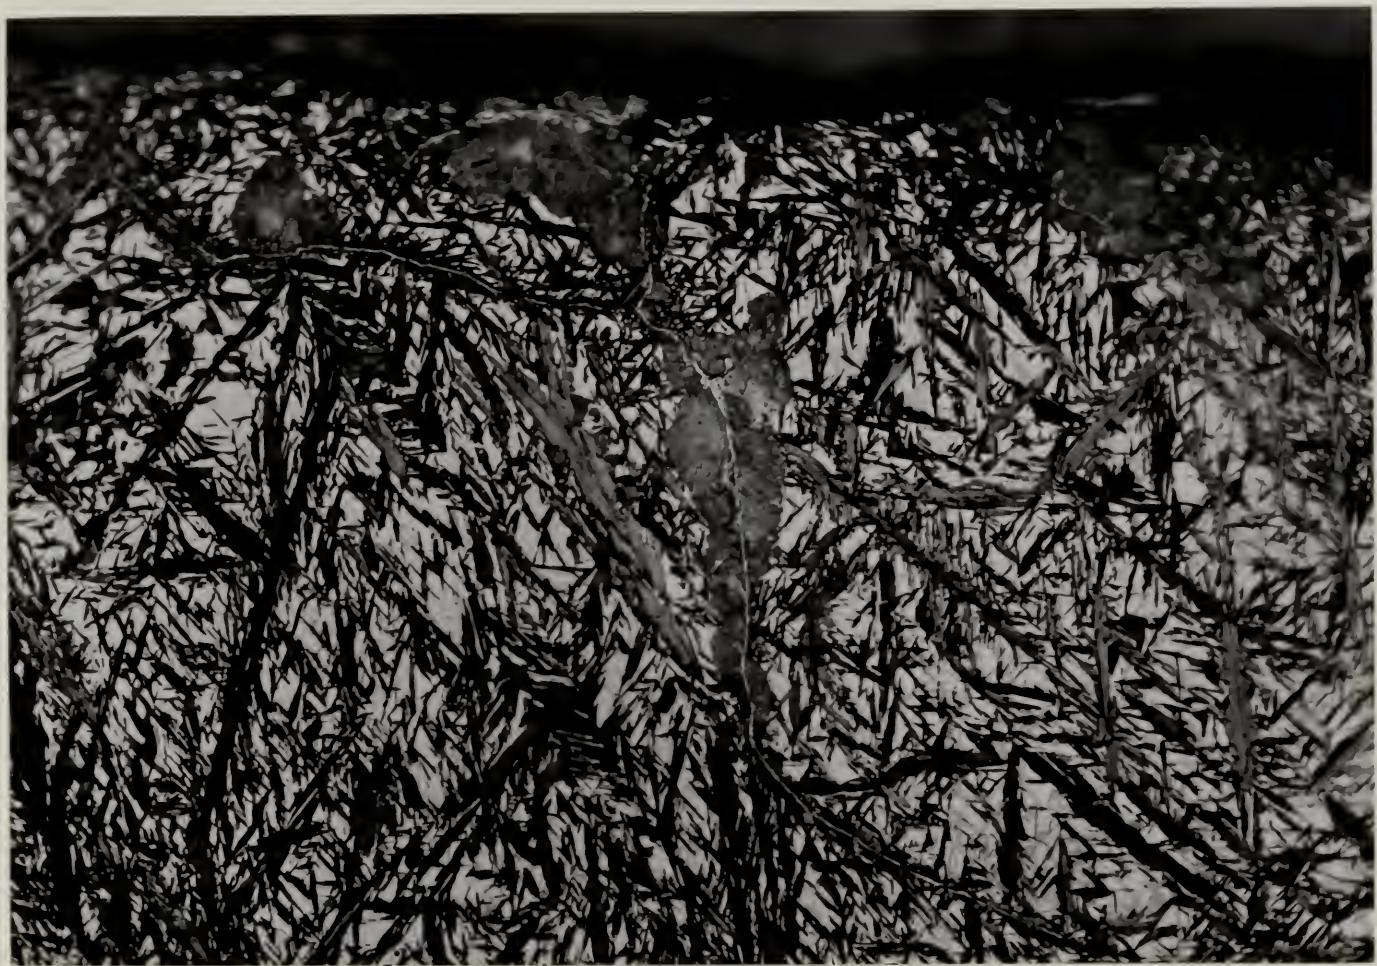
- a. Tempered martensite plates (dark needlelike structures).
- b. Untempered martensite (light gray areas).
- c. Nodular pearlite (dark gray areas).
- d. Cementite at the grain boundaries.
- e. Large prior austenitic grain size as indicated by the size of the tempered martensite plates and the boundaries outlined by cementite.

This structure, because of conditions b, d, and e above, would tend to be brittle. We believe it was produced by quenching the chain directly from the carburizing temperature without a subsequent tempering treatment. The long length of time or high temperature required to carburize to a 0.04 inch depth would have produced the large austenite grains. A delay in quenching or cooling at a rate less than the critical cooling rate could produce cementite boundaries and pearlite. The darkened martensite plates indicate that the initial martensite was formed at high temperatures and was tempered during the cool down, rather than during a subsequent tempering treatment. The fact that the smaller martensitic areas appear untempered indicates that no adequate tempering treatment was applied after cool down.

Figure 2. A portion of the area shown in Figure 1 showing the following conditions: (a) tempered martensite plates (dark needlelike structures), (b) untempered martensite (light gray areas), (c) nodular pearlite (dark gray areas), (d) cementite at the grain boundaries and (e) large prior austenitic grain size as indicated by the size of the tempered martensite plates and the boundaries outlined by cementite. Etched with nital. X 500.

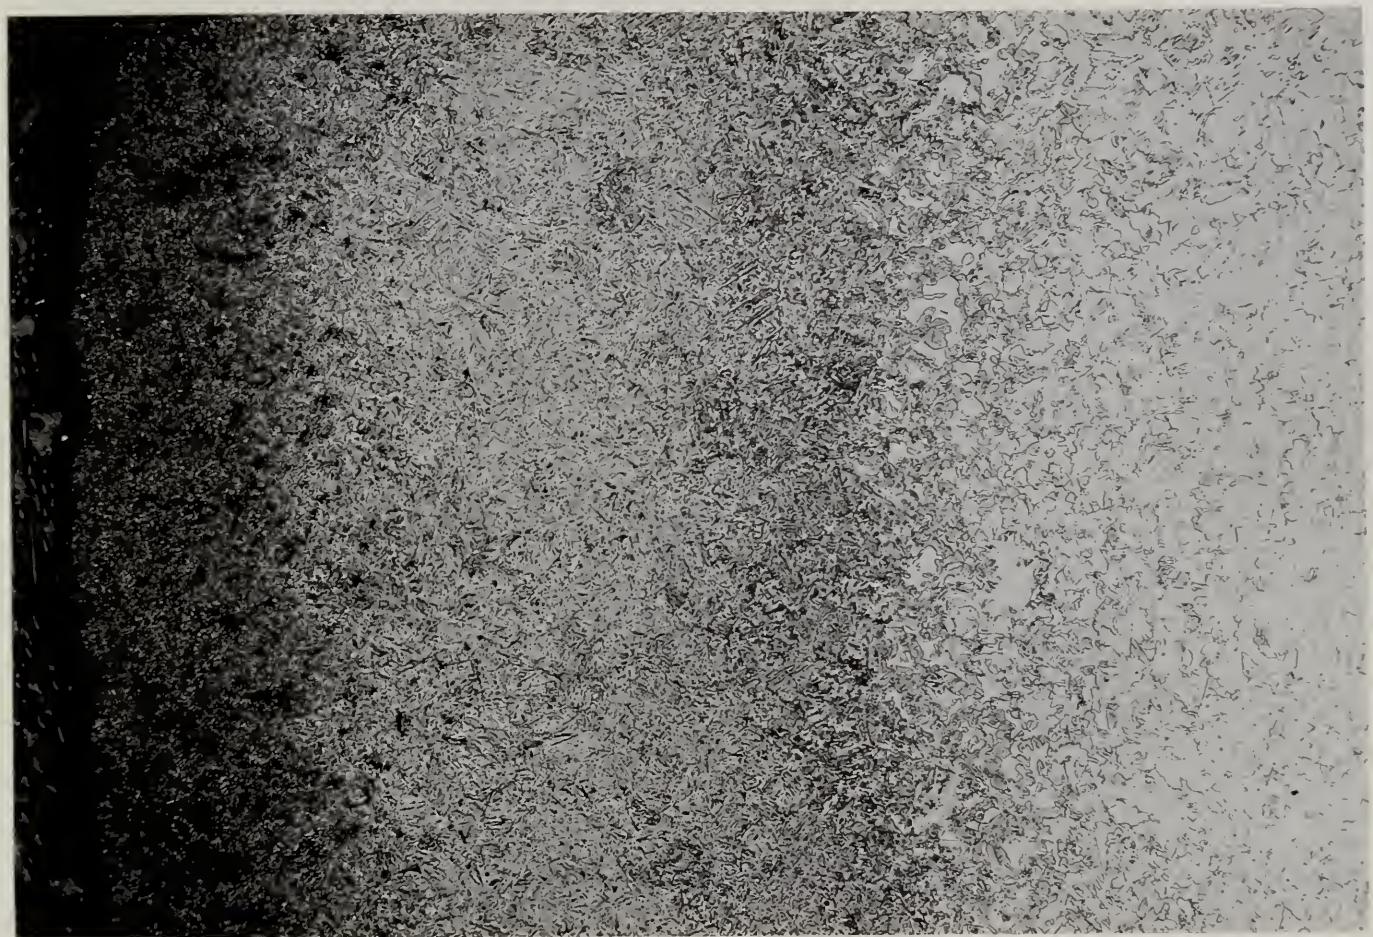
Metallographic examination of the case in a section cut from one of the specimens (figures 3 and 4) revealed that the grain had been refined considerably, with the result that all martensite present had fine plate size. There was no evidence of cementite at grain boundaries; instead it was dispersed as fine spheroids. Nor was there any trace of pearlite. All of the martensite appeared uniformly tempered. A comparison of figures 2 and 4, both at the same magnification, strikingly reveals the improvement brought about in the structure by this heat treatment. Microhardness determinations were obtained for comparison with those obtained for the stock POD security chain. The hardness at the surface was  $R_C$  63-64. This is sufficiently hard to resist the abrasive action of a file.

Figure 3. Microstructure of stock POD security chain after (1) reheating to 1425°F for 20 minutes and water quench and (2) tempering for 1 1/2 hours at 350°F and air cool. Matrix of carburized case is tempered martensite with some small particles (not visible at this magnification) of  $\text{Fe}_3\text{C}$ . Core matrix is ferrite with some pearlite. Etched with nital. X 100.

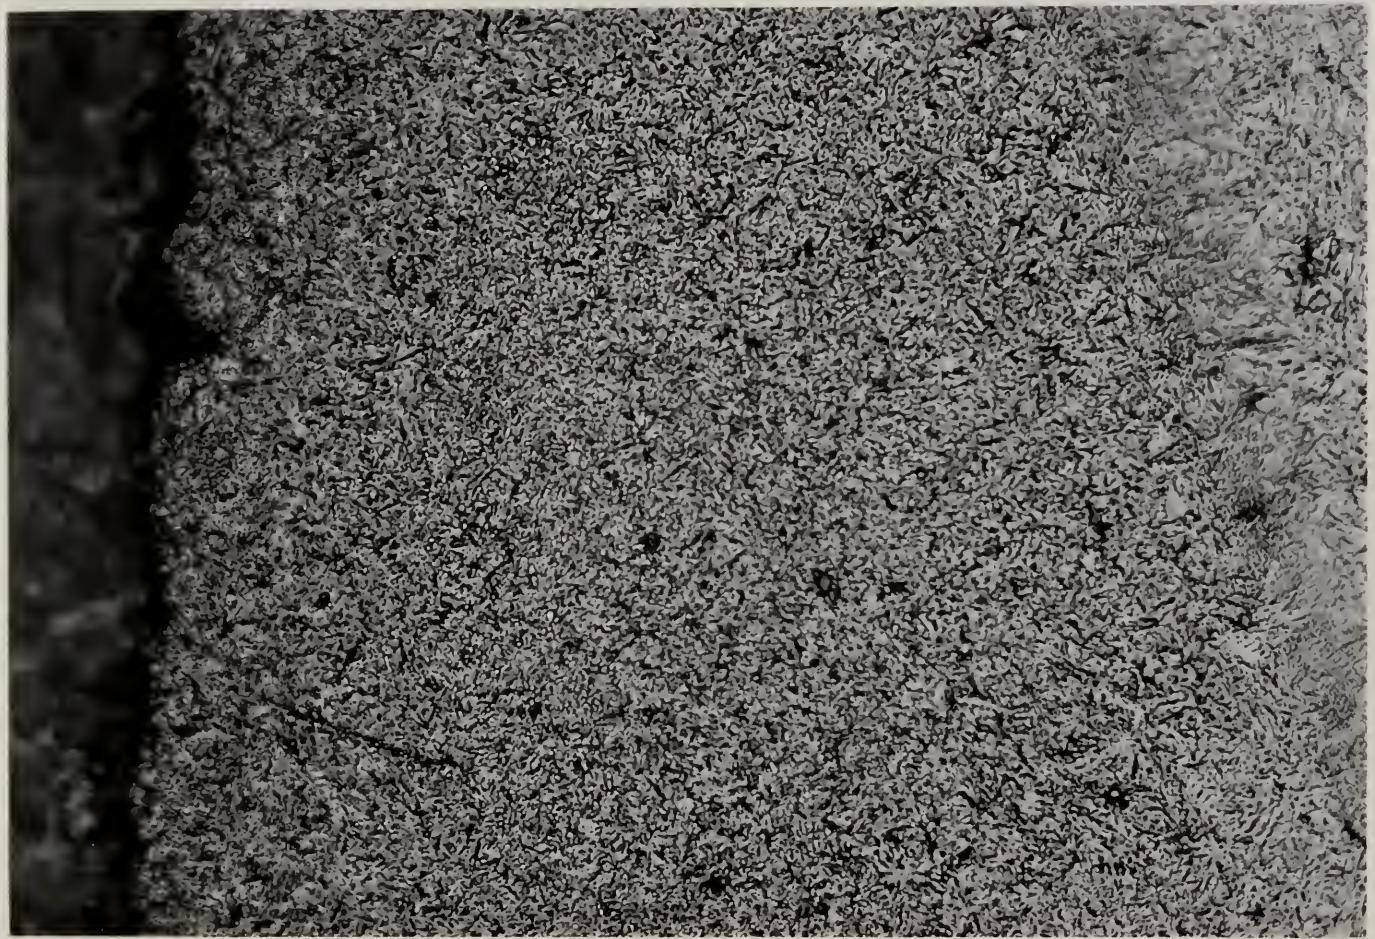
Figure 4. Portion of carburized case area of stock POD security chain after additional heat treatments noted in Figure 3. Grain size is very fine. Spherodized particles of  $\text{Fe}_3\text{C}$  are scattered throughout the martensite matrix. Etched with nital. X 500.
