NIST NCSTAR 1

Federal Building and Fire Safety Investigation
of the World Trade Center Disaster

Final Report on the **Collapse of the World Trade Center Towers**

September 2005

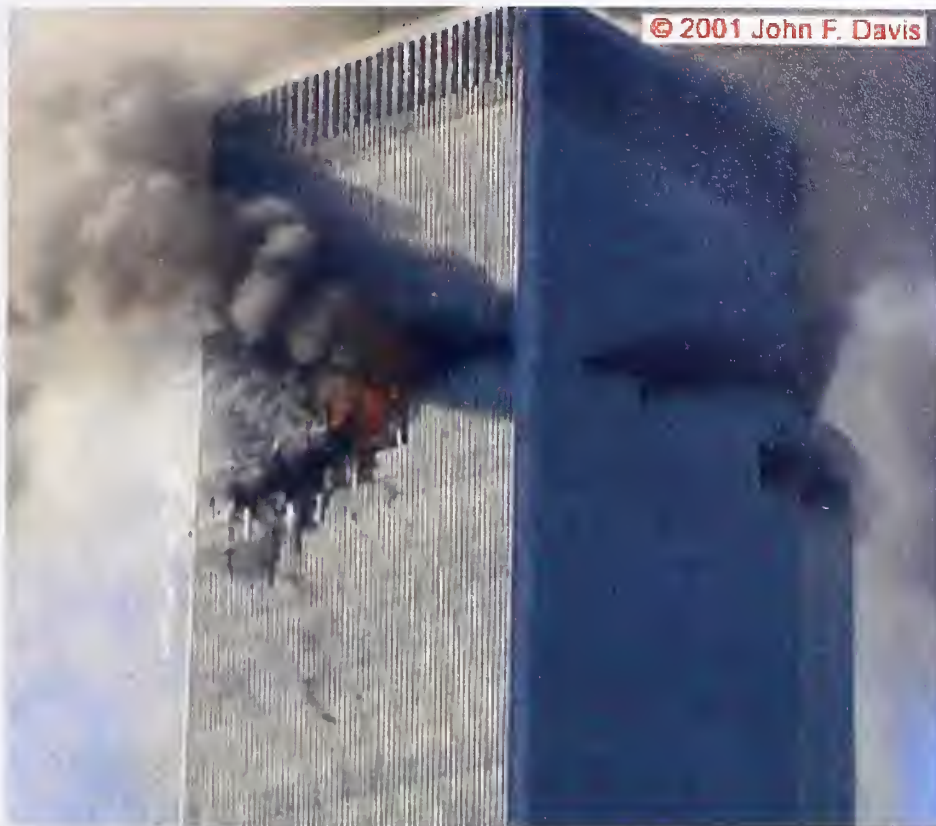
Figure 2–2. Aircraft entry hole on the north side of WTC 1, photographed 30 s after impact.

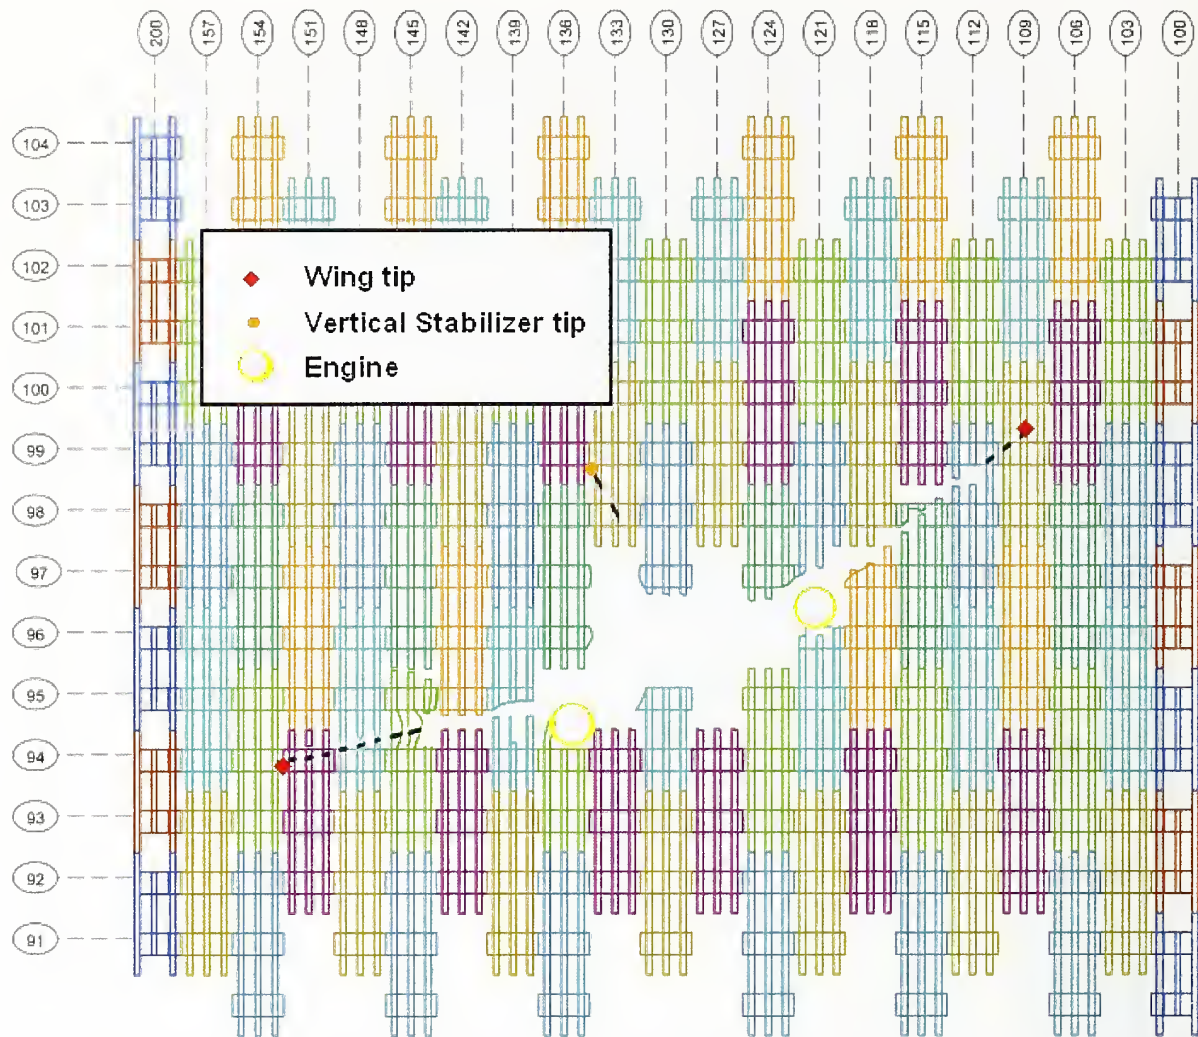
The aircraft did the most damage to the 95th and 96th floors. The fuel-heavy inner left wing hit the 95th floor slab, breaking it over the full 60 ft depth of tenant space and another 20 ft into the building core. The fuselage was centered on the 96th floor slab and filled the 95th and 96th floors top to bottom. The severity of the impact was clear. A wheel from the left wing landing gear flew through multiple partitions, through the core of the building, and became embedded in one of the exterior column panels on the south side of the tower. The impact severed the bolts connecting the panel to its neighbors, and the panel and tire landed on Cedar Street, some 700 ft to the south. A second wheel landed 700 ft further south. Within the two floors, 15 to 18 perimeter columns and five to six core columns were severed, and an additional one to three core columns were heavily damaged. A 40 ft width of the 96th floor slab was broken 80 ft into the building. The insulation was knocked off nearly all the core columns and over a 40 ft width of floor trusses from the south end of the core to the south face of the tower.

Figure 2–3. South face damage of WTC 1 with key aircraft component locations marked.

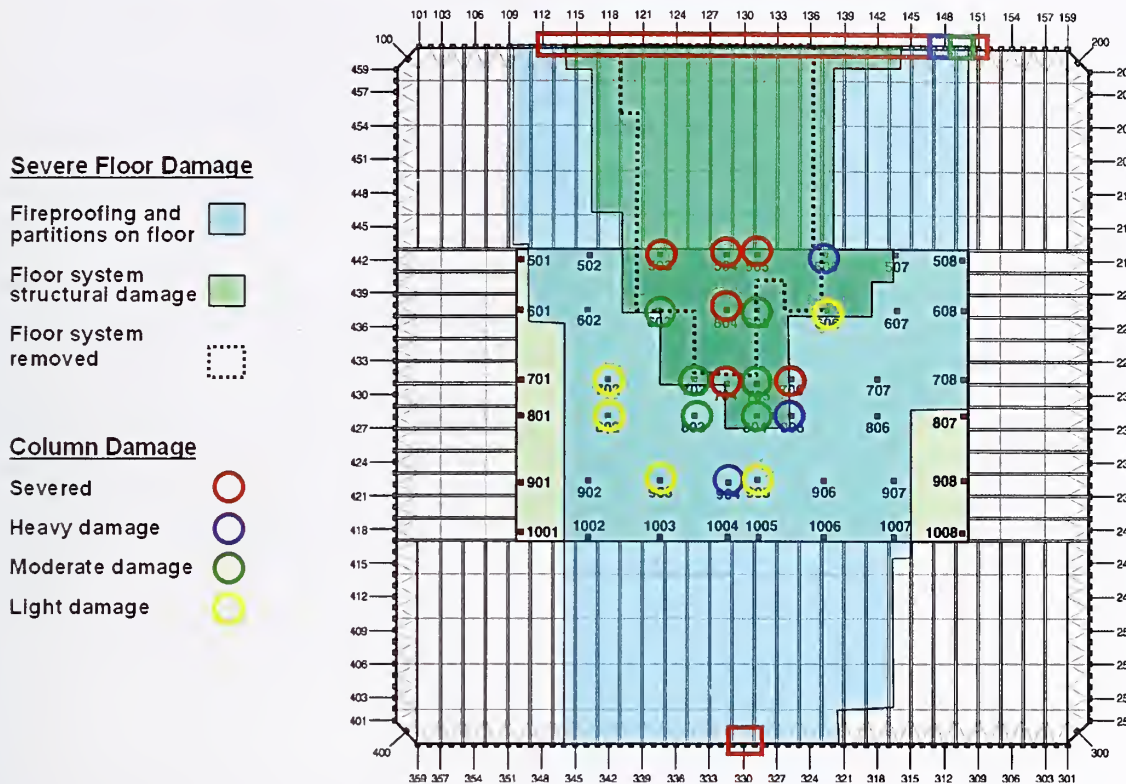
- 43 of 47 core columns stripped of insulation on one or more floors.
- Insulation stripped from trusses covering 60,000 ft² of floor area.

Figure 2-4. Simulation of cumulative aircraft impact damage to floors 93 through 98 in WTC 1.

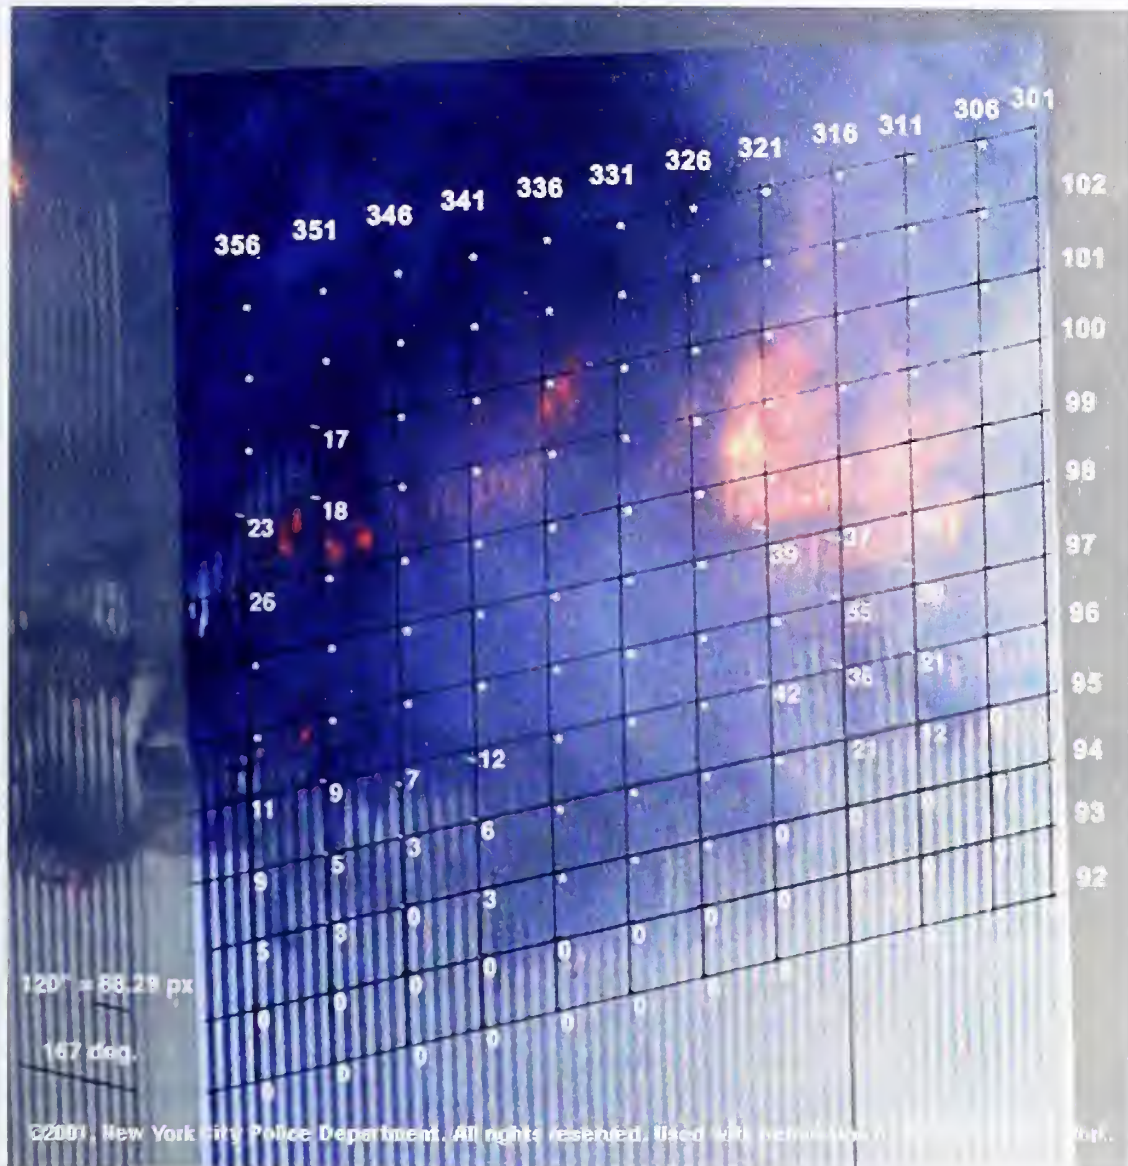
The sagging of the floors had increased. Although the floors on the north side of the tower had sagged first, they contracted due to cooling when the fires moved toward the south. Now, the south side floors had sagged to the point where the south perimeter columns bowed inward (Figure 2–12). By 10:23 a.m., the south exterior wall had bowed inward as much as 55 in.

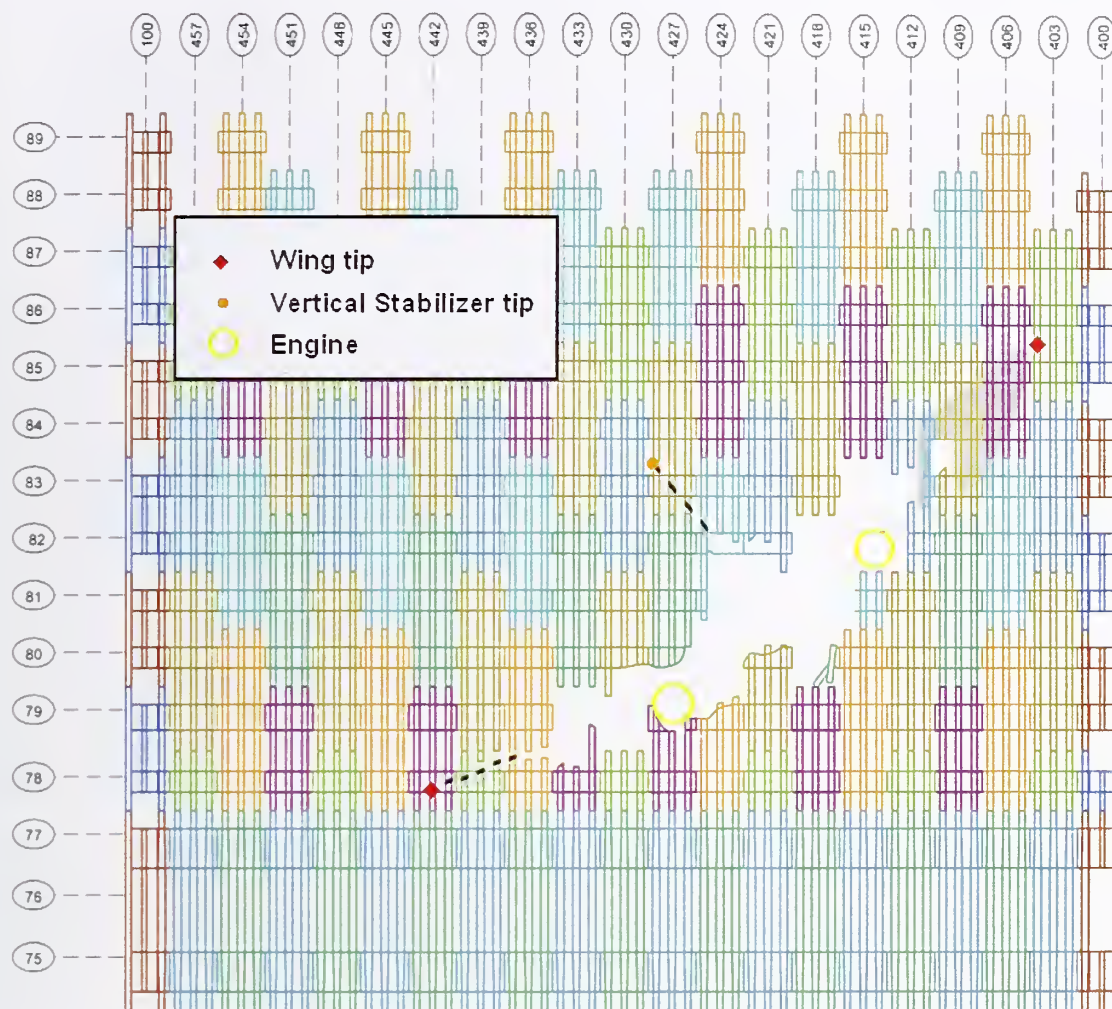
bank angle was steeper than that of AA Flight 11, this entry wound stretched over nine floors, from 77 to 85, rather than eight in WTC 1 (Figure 3–2). The occupancy of those floors is shown in Table 3–1.

Damage in shaded area cannot be accurately determined.

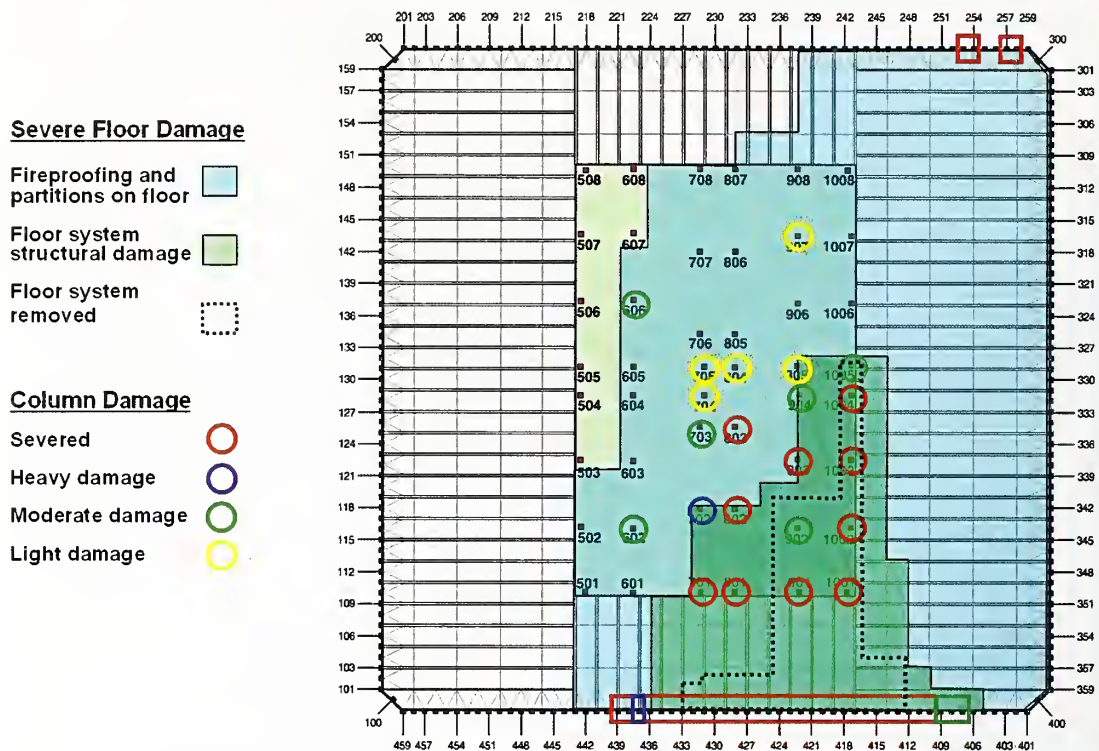
and aluminum sheet of the wing did little damage to the building structure or the SFRM on the columns and trusses on these floors. There were 433 broken windows on the north, east, and south facades.

Figure 3–3. Simulation of aircraft impact damage to the 78th through 83rd floors in WTC 2.

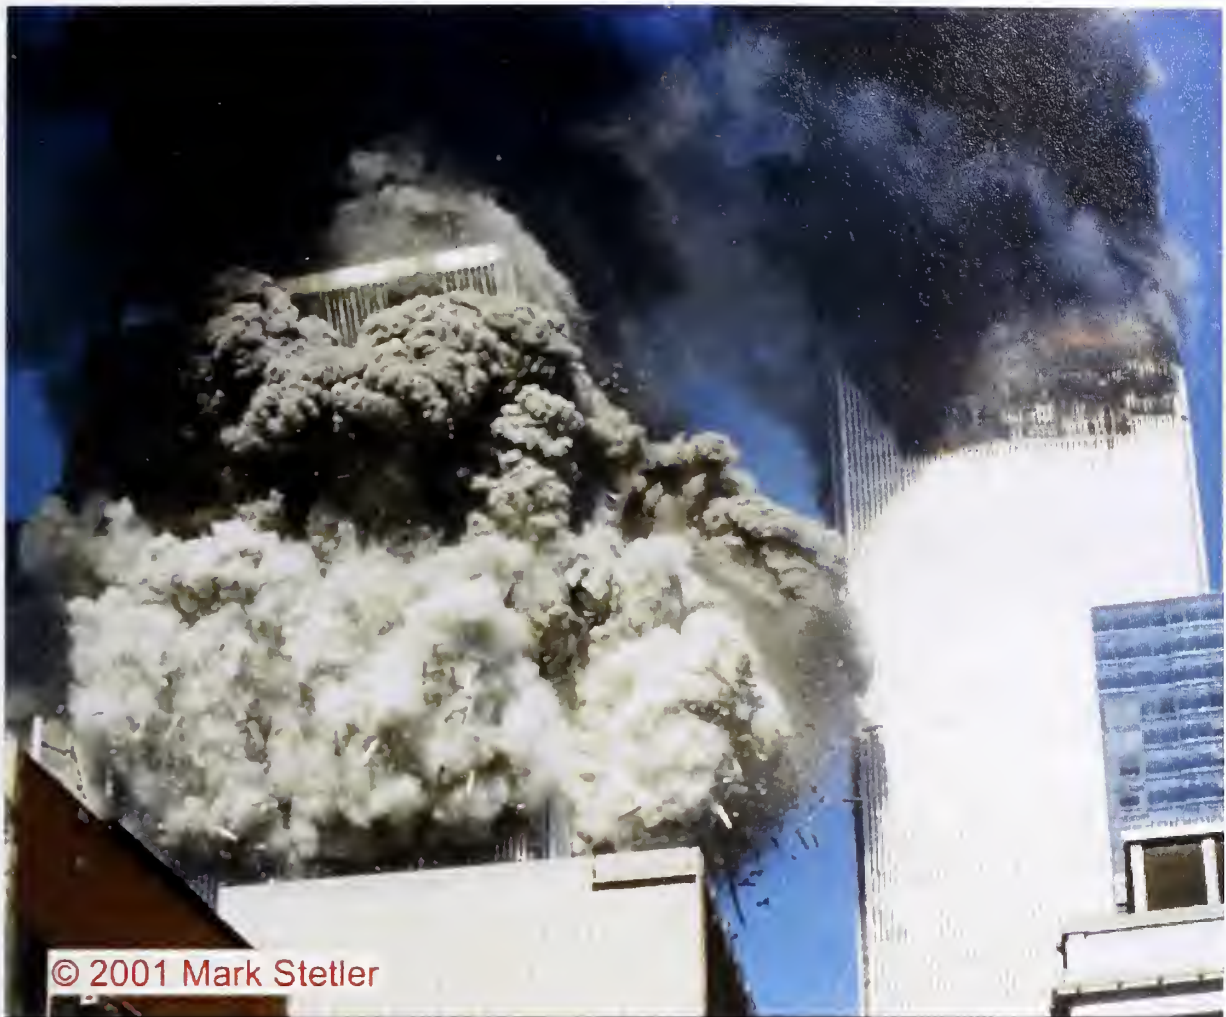
The physical condition of the tower had deteriorated seriously. The inward bowing of columns on the east wall spread along the east face. The east wall lost its ability to support gravity loads, and, consequently, redistributed the loads to the weakened core through the hat truss and to the adjacent north and south walls through the spandrels. But the loads could not be supported by the weakened structure, and the entire section of the building above the impact zone began tilting as a rigid block to the east and south (Figure 3–5). Column failure continued from the east wall around the corners to the north and south faces. The top of the building continued to tilt to the east and south, as, at 9:58:59 a.m., WTC 2 began to collapse.

Figure 3–5. Photograph of WTC 2 tilting to the southeast at the onset of collapse.

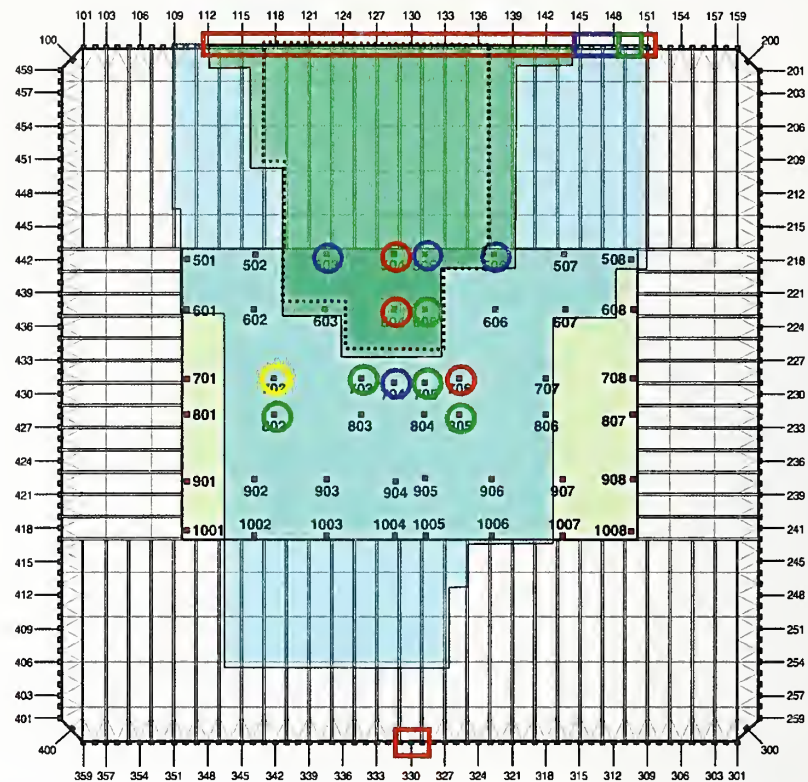
Figure 6-22. Combined structural damage to the floors and columns of WTC 1, Case A.

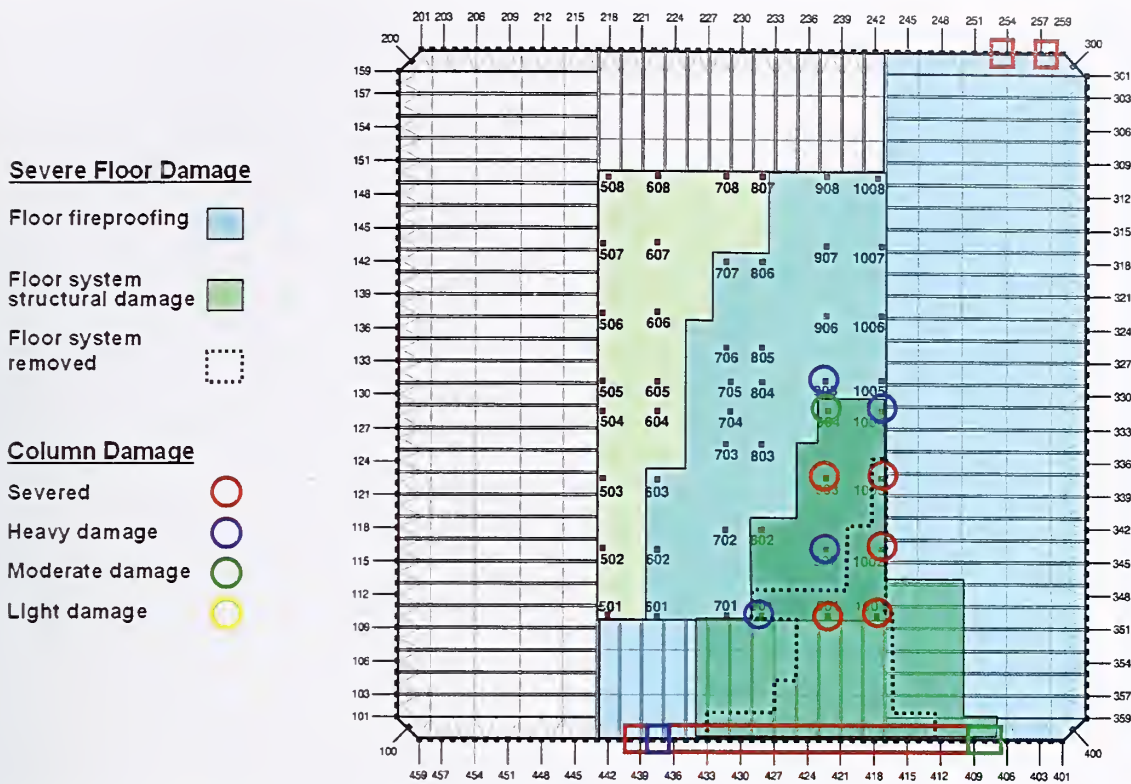
Figure 6-24. Combined structural damage to the floors and columns of WTC 2, Case C.

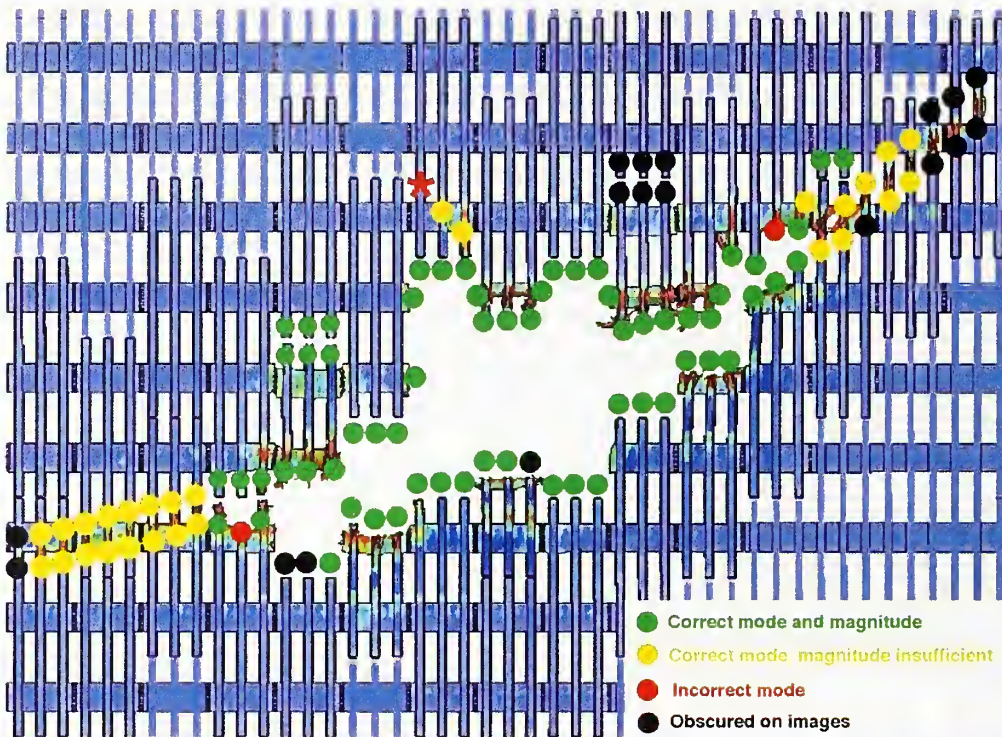
Figure 6-28. Schematic of observed damage (above) and Case C calculated damage (right) to the south face of WTC 2.

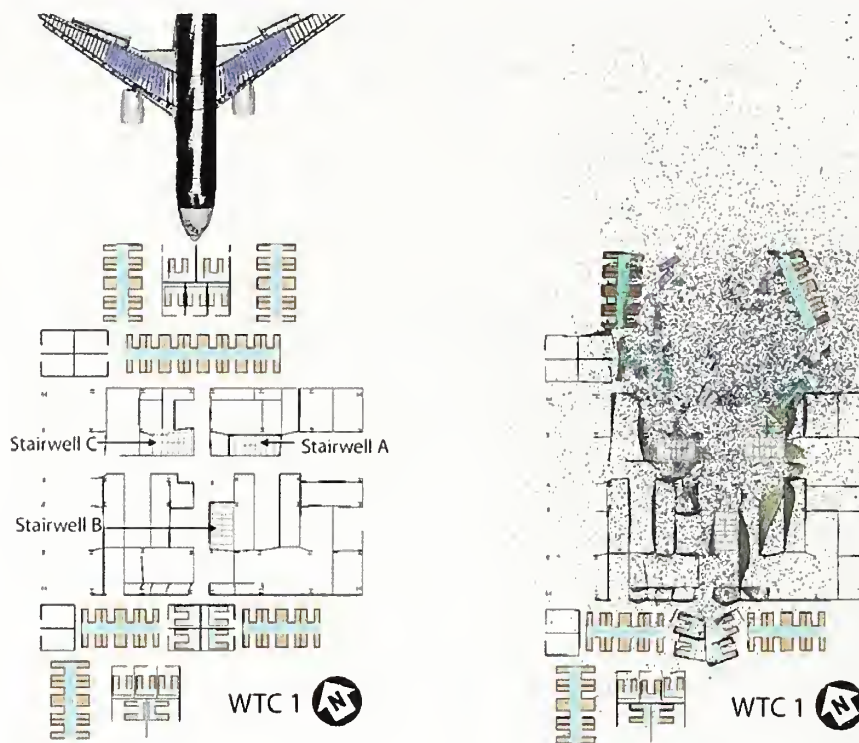
Figure 7-1. Simulated impact damage to 95th floor of WTC 1, including stairwells, 0.7 s after impact.

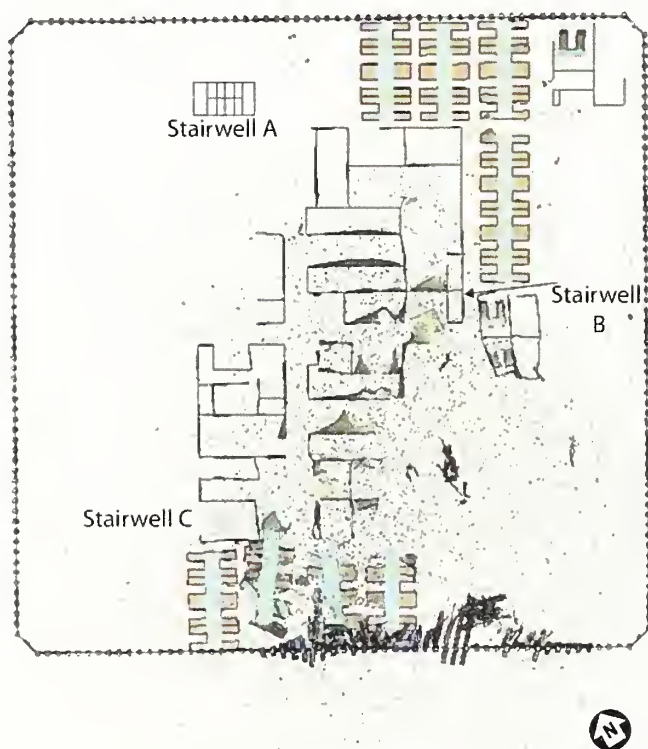
Figure 7-2. Simulated impact damage to WTC 2 on floor 78, 0.62 s after impact.
