**Electrospark Deposition for the Repair of
Army Main Battle Tank Components**

ARL-TR-3849

July 2006

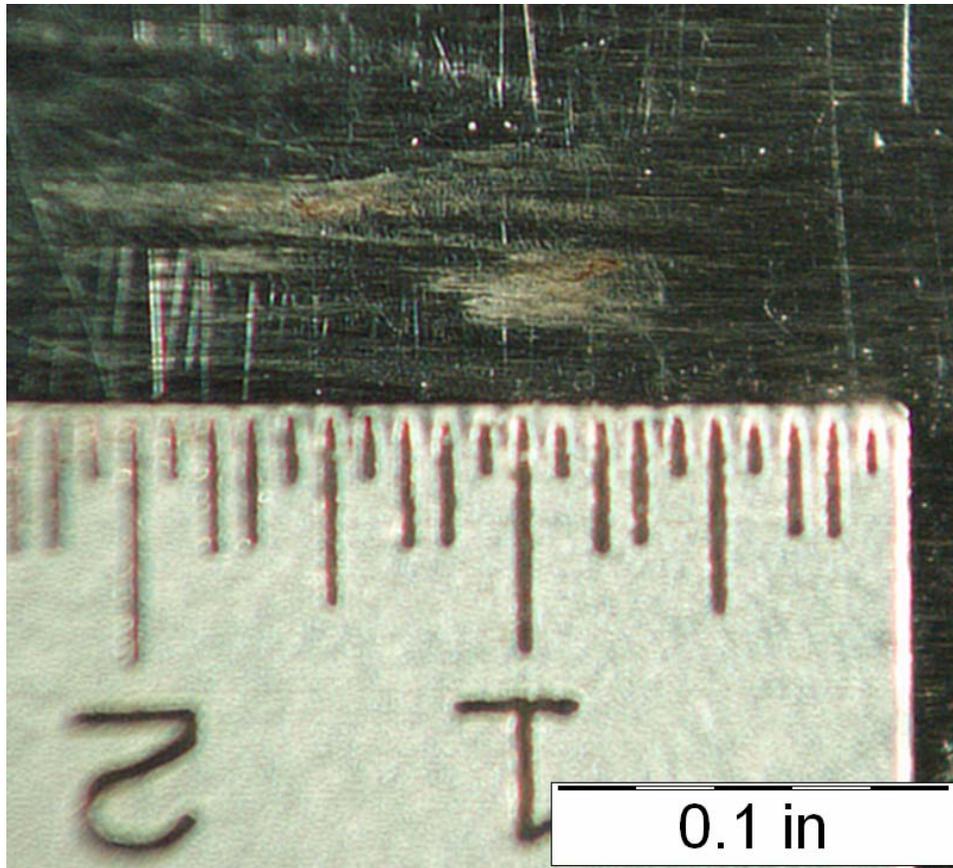
The M1A1 main battle tank components presented in this report were fabricated from alloy steels. After years of service, large corrosion pits ($1/8 \times 3/8$ in and 0.060 in deep) and wear formed (figure 8). Systems were dead-lined based on surface anomalies discovered during inspection. Insufficient replacement parts were available. There was no approved repair procedure for these components, and conventional weld repair technologies had been eliminated at Anniston Army Depot (ANAD) to repair these large pits. Approximately 8% of the components overhauled at ANAD in 2003 were determined to be defective and were removed from the systems and put in storage.

Figure 8. An example of corrosion pits noted on a helical gear shaft (magnified 20×).

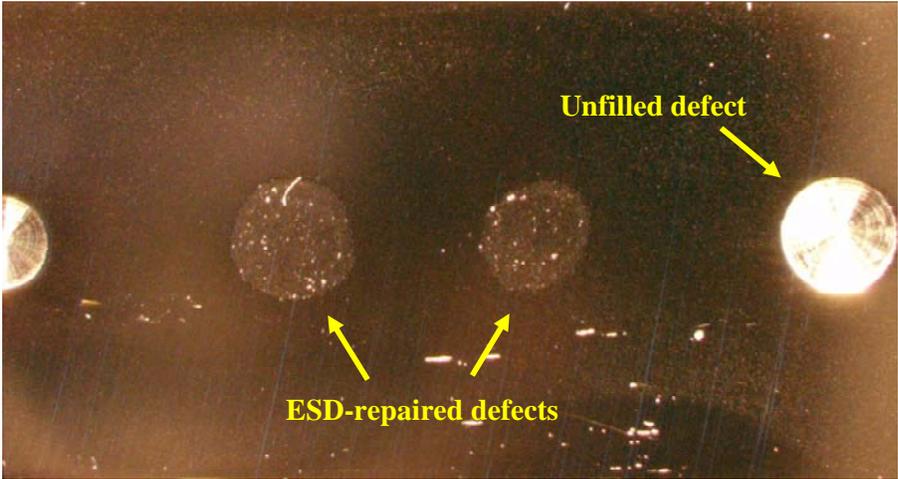
Figure 11. Optical macrograph showing two ESD-filled defects as well as one unfilled defect (magnified 2×).

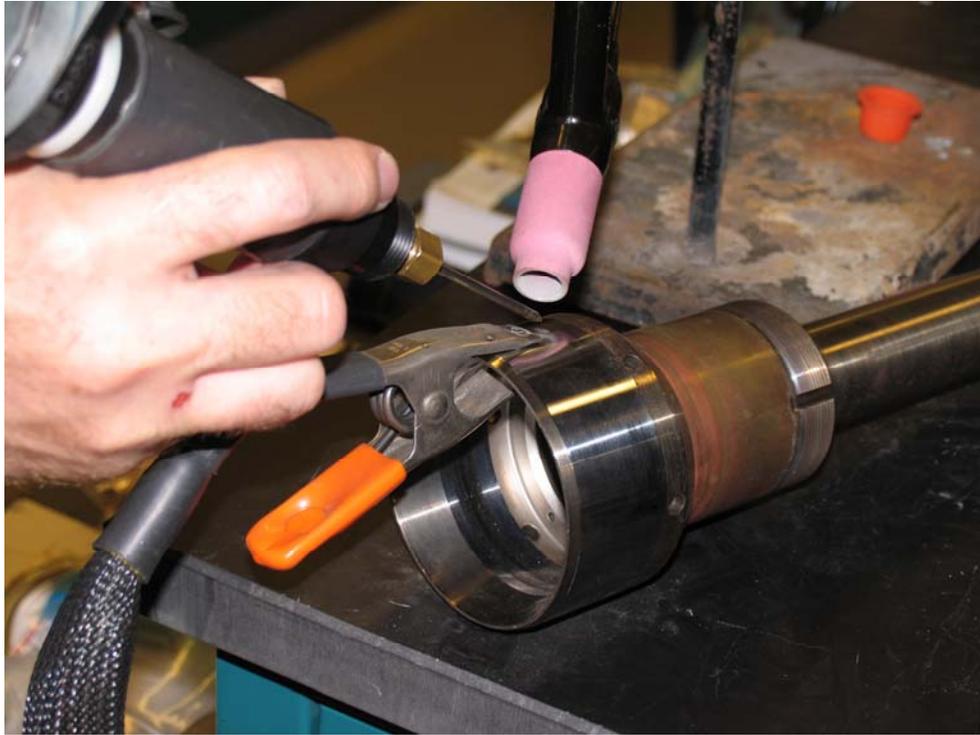
Figure 14. ESD being performed on an actual helical gear shaft containing defects at ARL.

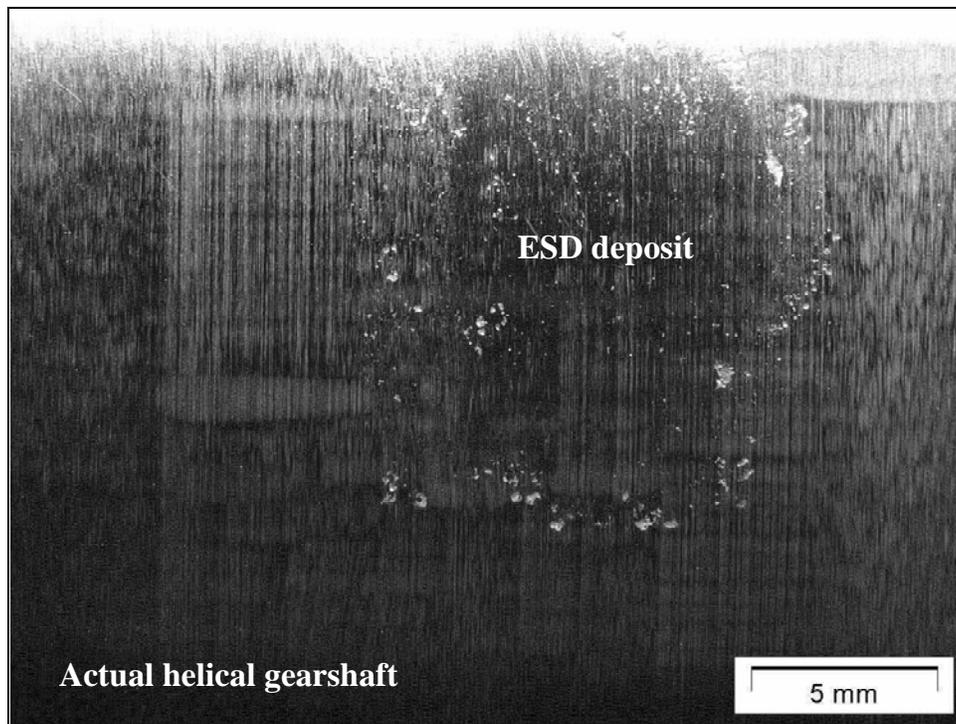
Figure 16. Porosity around the ESD deposit ("halo effect") of a chrome-plated sample (magnified 5×).

- ESD has been demonstrated to be a viable repair of corrosion pits and wear on both AISI 4130 and 9310 steels for use on nonrotating components.
- Caution must be taken when repairing chrome-plated components in order to reduce/eliminate the “halo effect.”

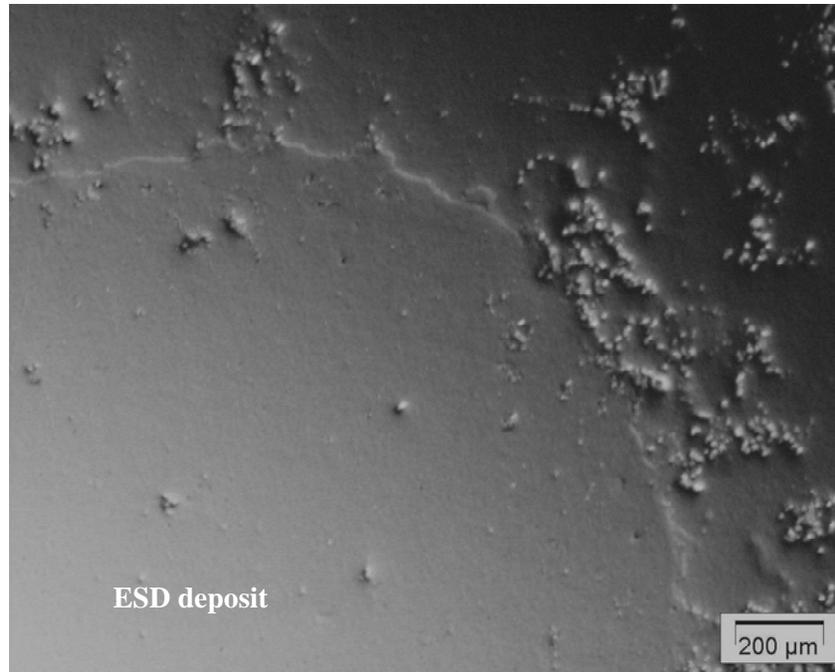
Figure 17. Magnified view of figure 16 utilizing the differential interference contrast mode for optical viewing (magnified 50×).

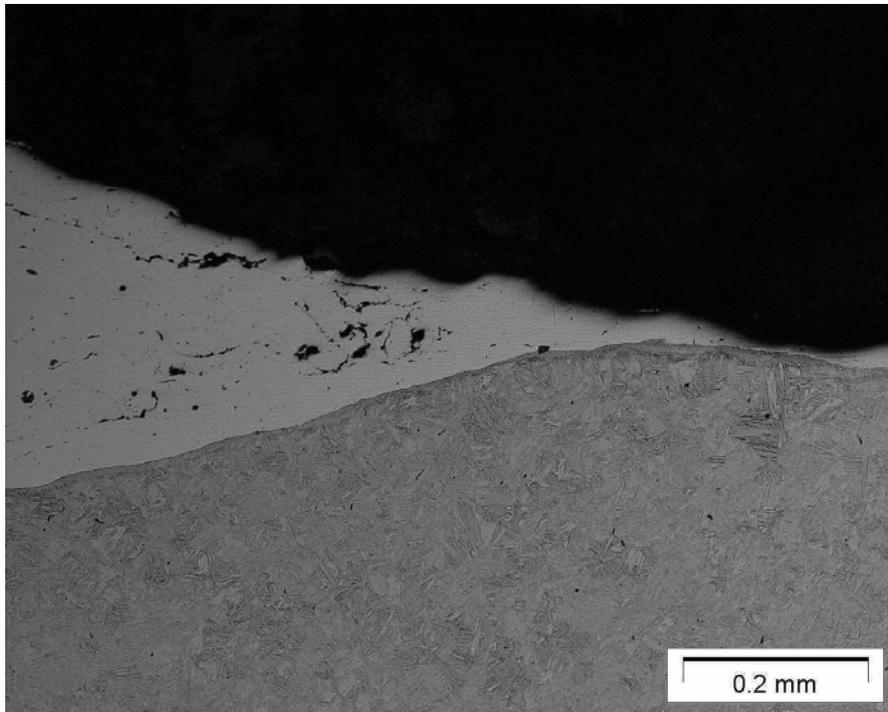
applying the ESD/chrome interface. Figure 18 shows a polished cross section displaying the porosity associated with the “halo effect,” while figure 19 shows no anomalies for a different chrome-plated ESD deposit.

Figure 18. Polished and etched cross section showing porosity associated with the “halo effect” in a chrome-plated 9310 steel sample. Etchant: 2% nital (magnified 500×).

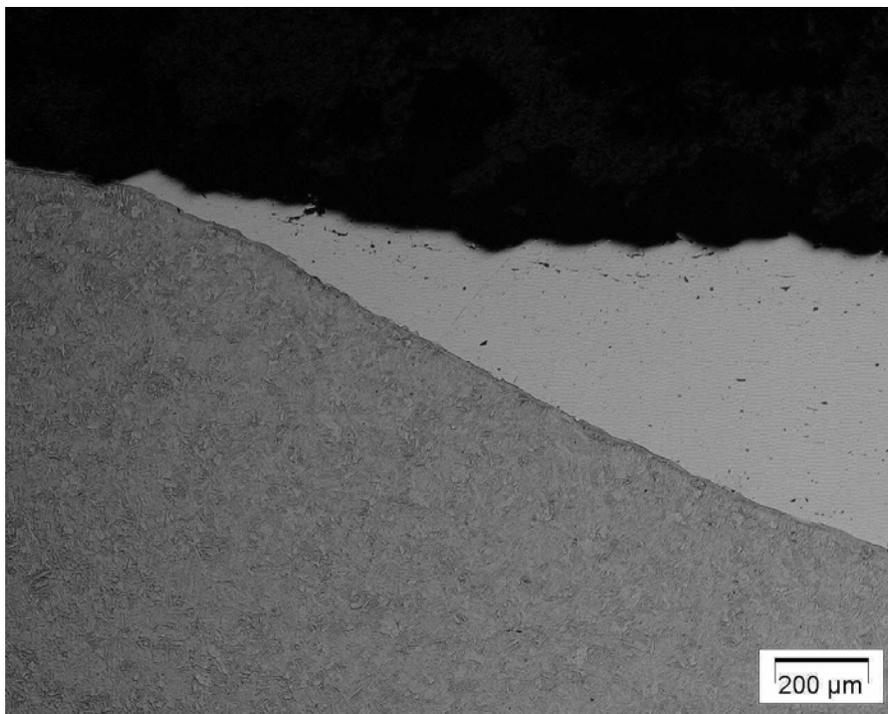
Figure 19. Polished sample cross section of an ESD-filled, chrome-plated defect showing no anomalies (magnified 200×).

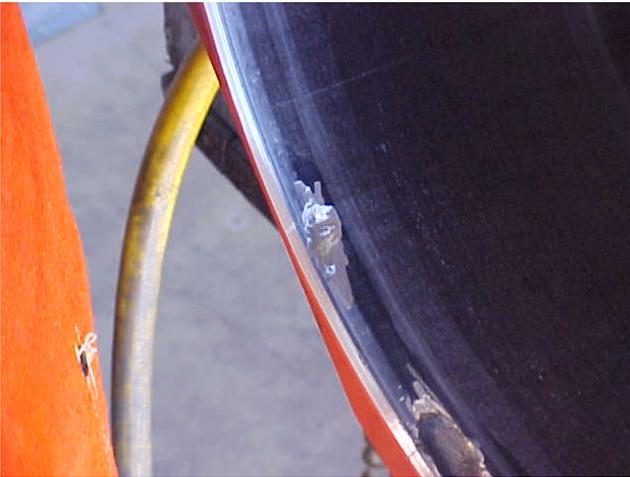
PITS PREPARED FOR ESD REPAIR

- a. Clean cradle using vapor degreaser.
- b. Using hand-held grinder w/wire brush, remove corrosion from pit.
- c. Using hand-held grinder w/grinding tool, break the sharp edges of the pit. If possible, maintain a width to depth ratio of 10:1 minimum to 20:1. The finish on the excavated defect should be in the 32-64 rms range for best ESD results.

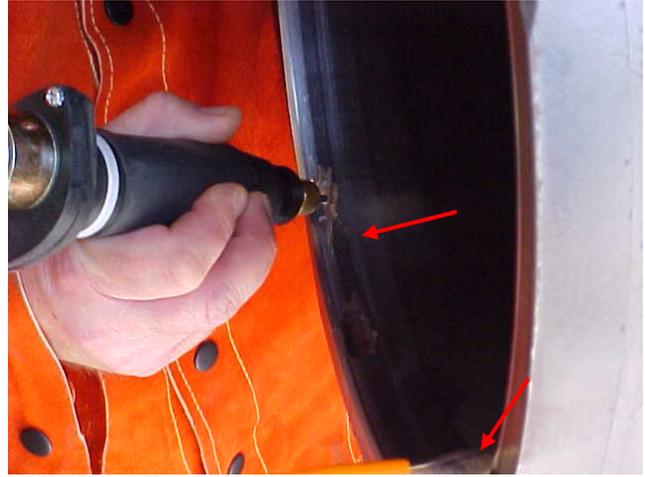
REPAIR PROCESS

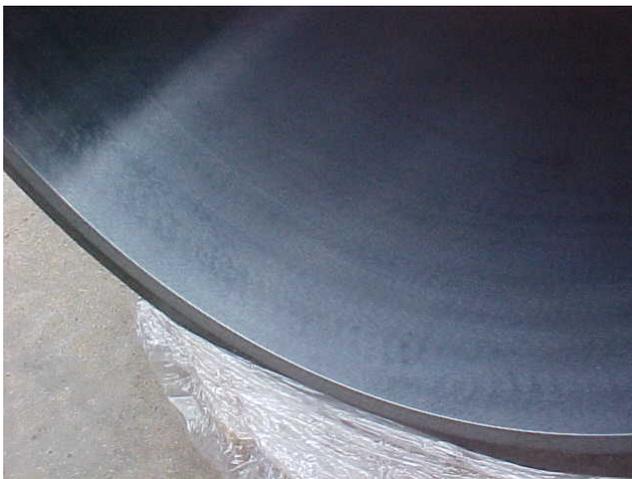
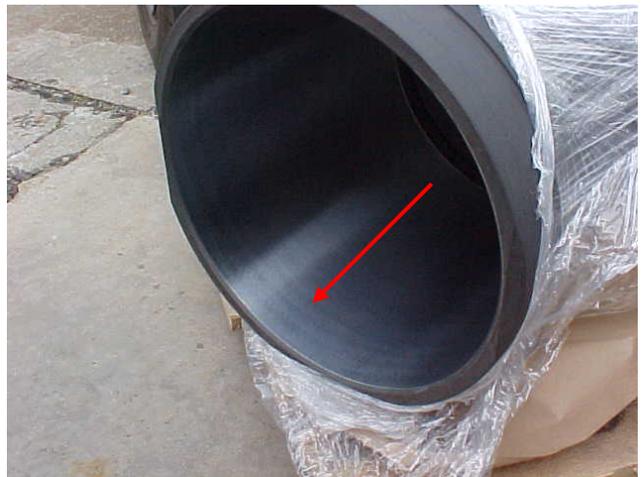
AFTER ESD REPAIR, CHROME PLATING, AND FINISH GRINDING

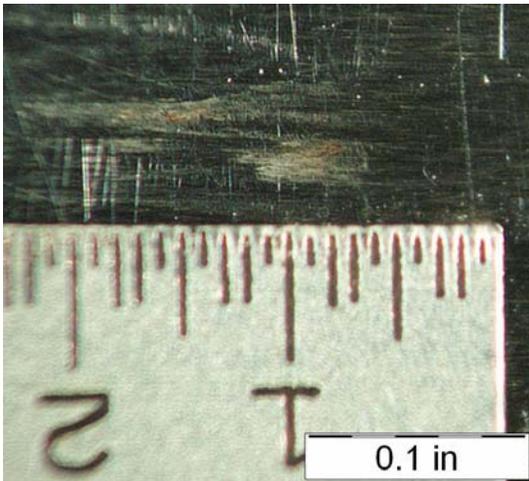
CORROSION PIT FOR ESD REPAIR

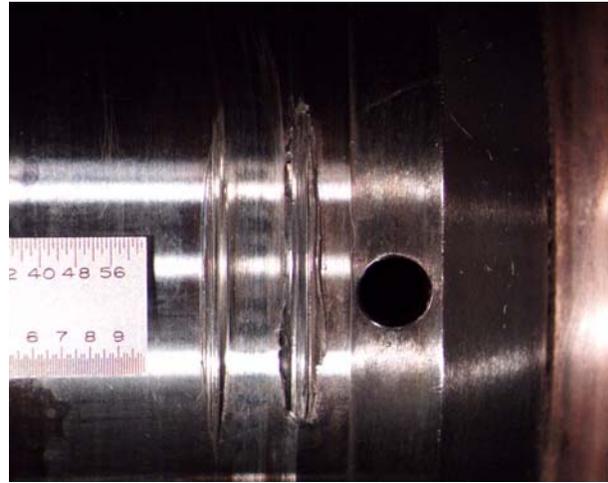
WEAR MARK FOR ESD REPAIR

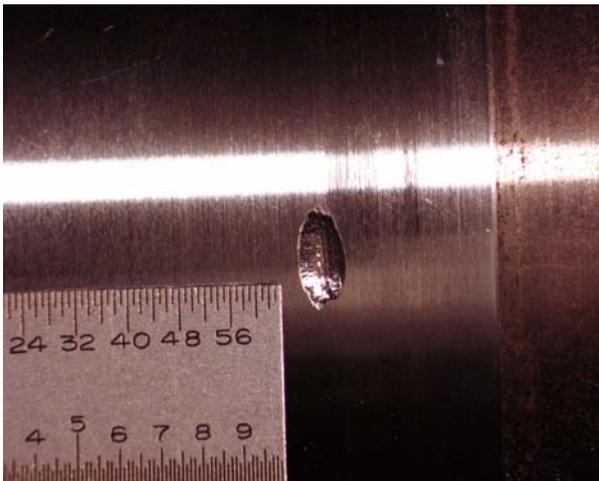
CORROSION PIT PREPARED FOR ESD

- d. Clean gear shaft using vapor degreaser.
- e. Using hand-held Dremel® tool (or equivalent), remove corrosion from pit.
- f. Using hand-held Dremel® tool (or equivalent), break the sharp edges of the pit or wear mark. If possible, maintain a width to depth ratio of 10:1 minimum to 20:1. The finish on the excavated defect should be in the 32-64 rms range for best ESD results.

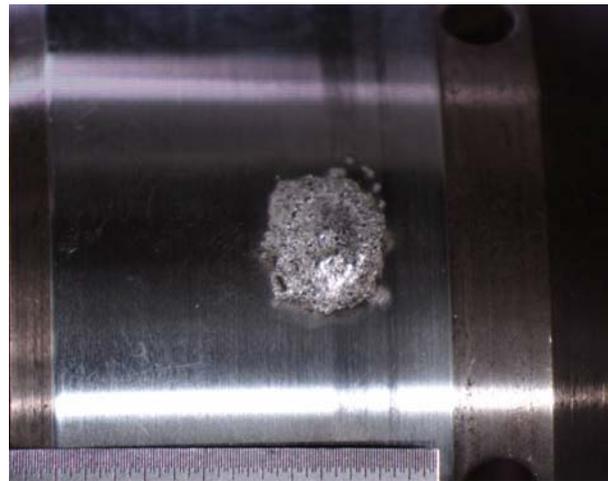
CORROSION PIT FILLED IN BY ESD

l. Using the ESD Equipment with the rotating torch (ASAP Model AH-98-MKIDD), the following settings/parameters and the electrode listed in paragraph 2c, fill the pit or wear mark to .005" - .010" above the parent material surface. This will ensure complete cleanup during grinding.

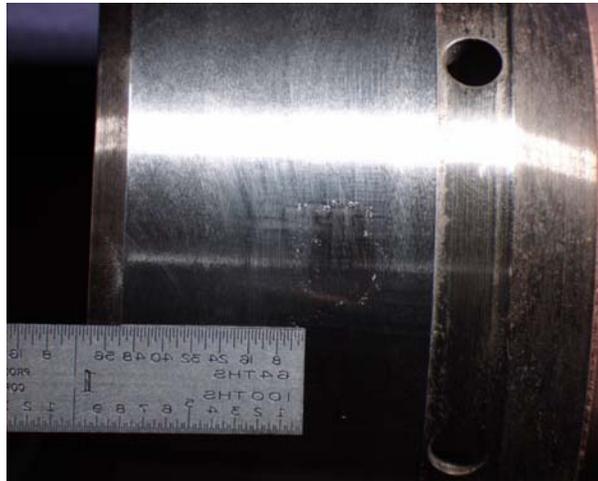
CORROSION PIT AFTER ESD REPAIR AND FINISH GRINDING
