# *H. L. Hunley*

## Recovery Operations

A Collaborative Project of:  
Naval History and Heritage Command,  
South Carolina Hunley Commission,  
and  
Friends of the Hunley

Naval History and Heritage Command  
Washington, D.C.  
2016

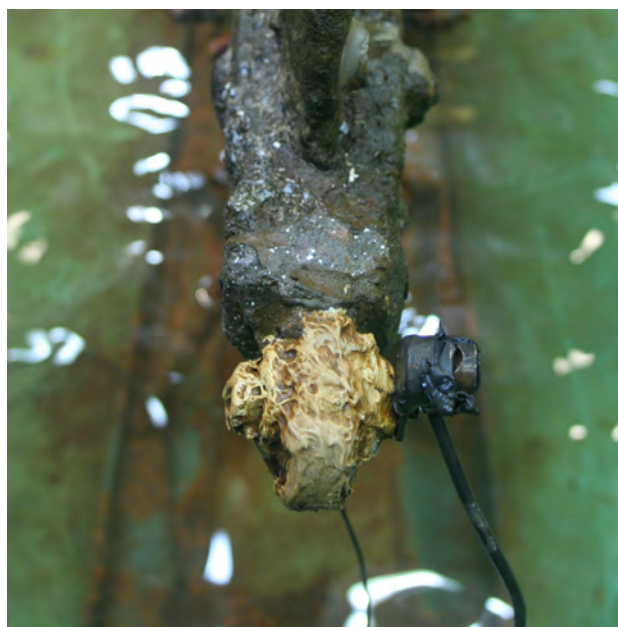
Figure 7.4. A negative cable for the impressed current system was attached to the bow where the spar was once mounted. A coating of epoxy protected the exposed metal. (Photo by H. G. Brown, NHHHC)

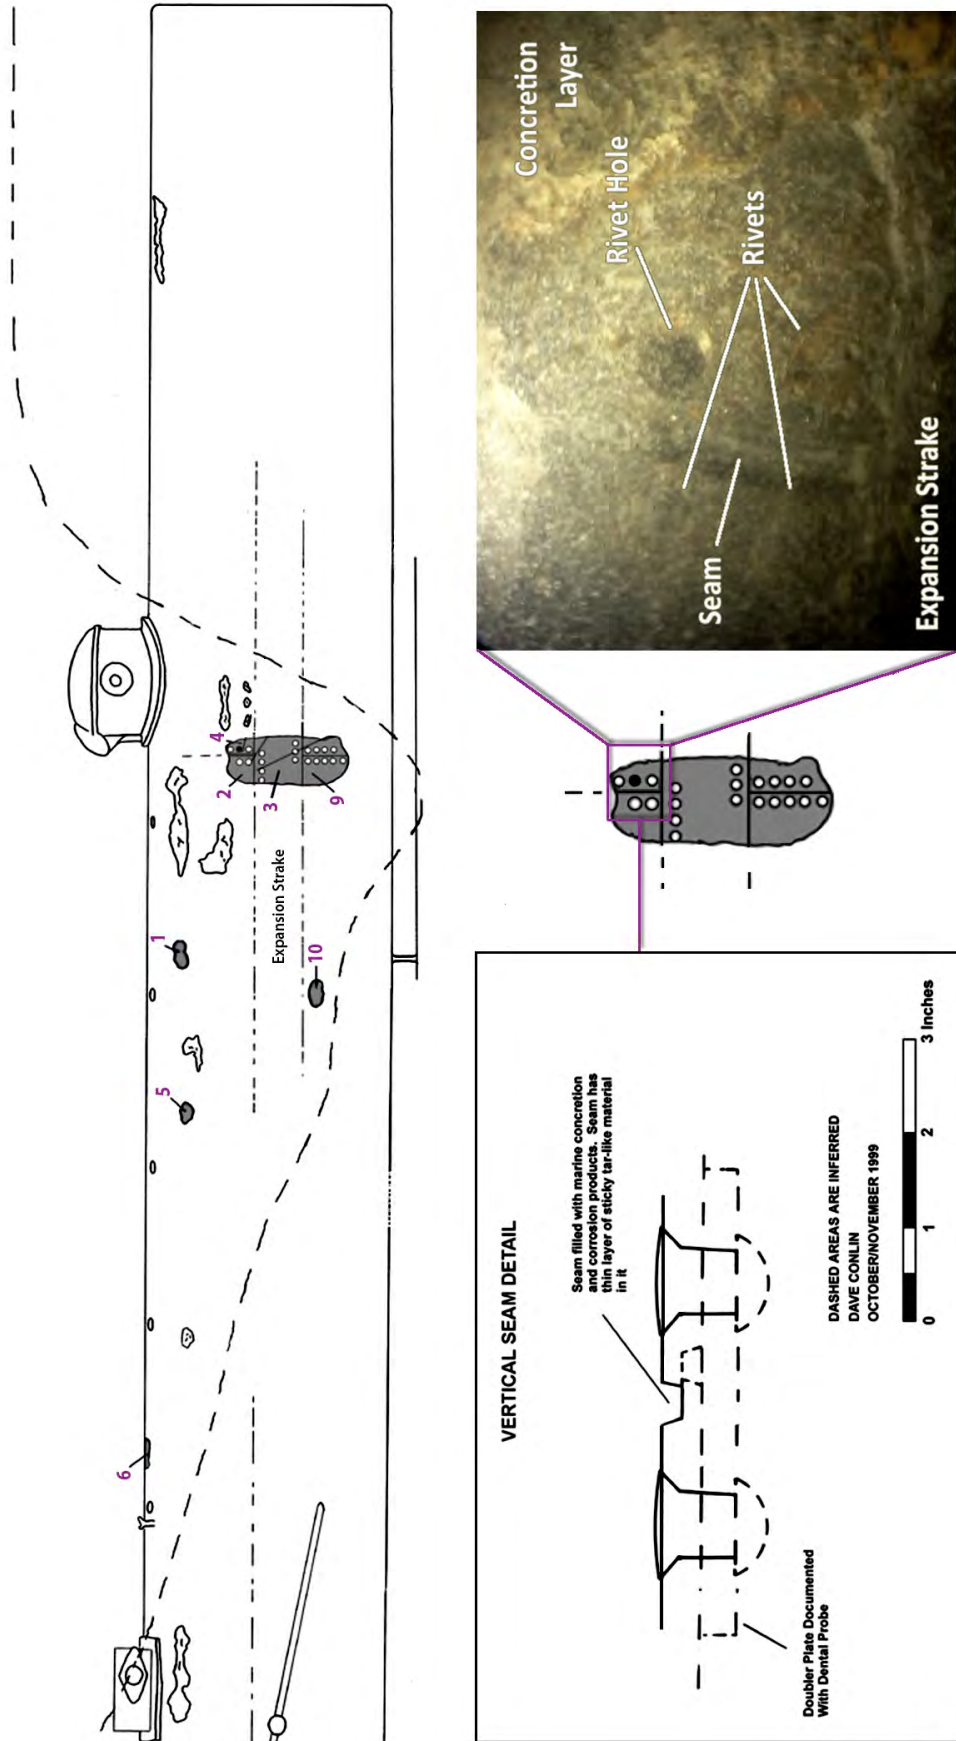
Figure 8.1. Portside view showing thickness testing locations 1–6 and 9–10 (Areas 7 and 8 were located on the starboard side). The area where a vertical plate seam intersects with the expansion strake (photo, lower right) provided a wealth of useful data for the finite element analysis. The missing rivet allowed for limited investigation of the interior seam structure (reconstruction, lower left). (Diagram and photo by David L. Conlin, NPS)

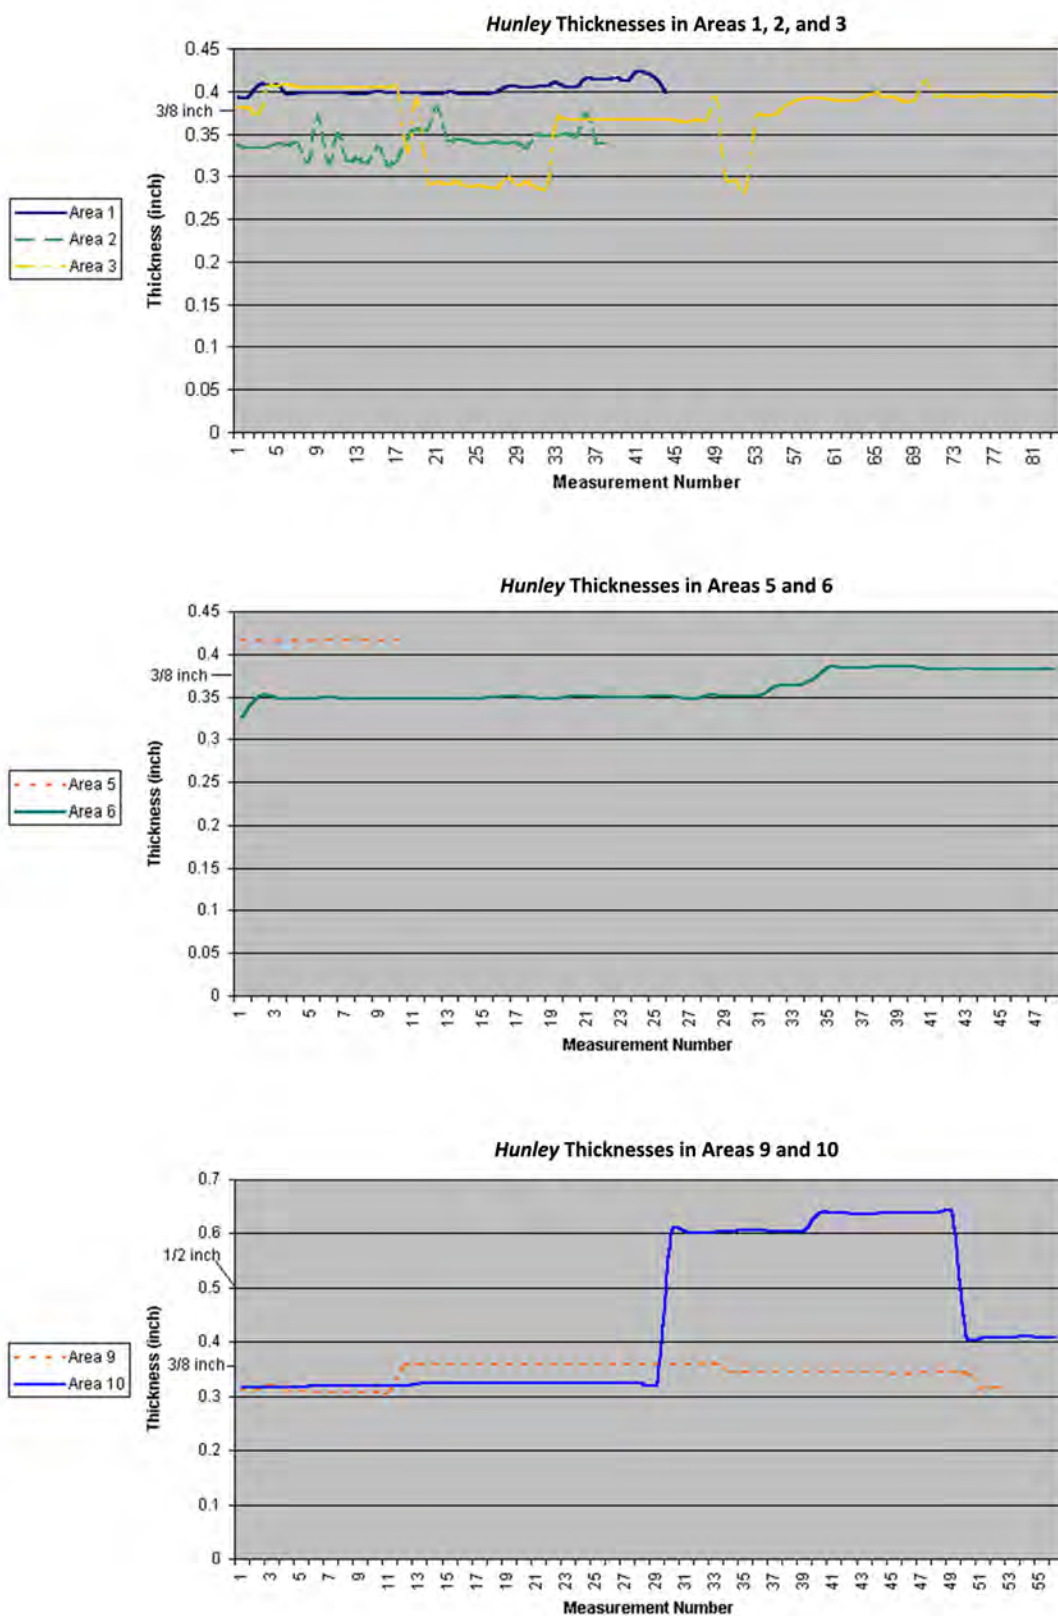
Figure 8.3. Graphs of the ultrasonic thickness readings from the port side of Hunley's hull. (Graphs by David L. Conlin, NPS)

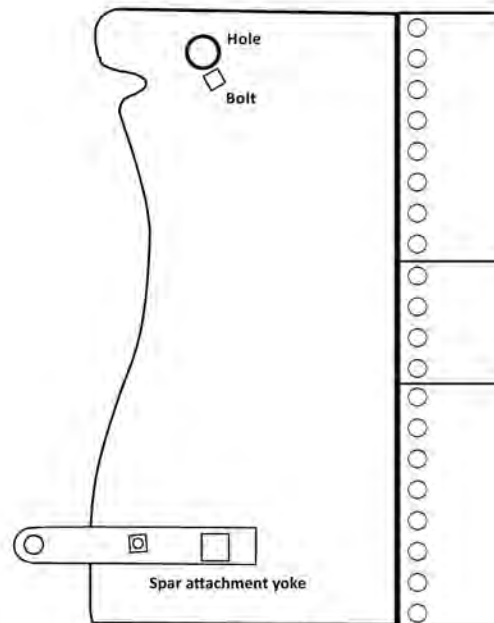
Figure 12.6. Portside view of the bow casting, showing deterioration of leading edge (rivet spacing approximate). (Diagram by Mari Hagemeyer, NHHHC).

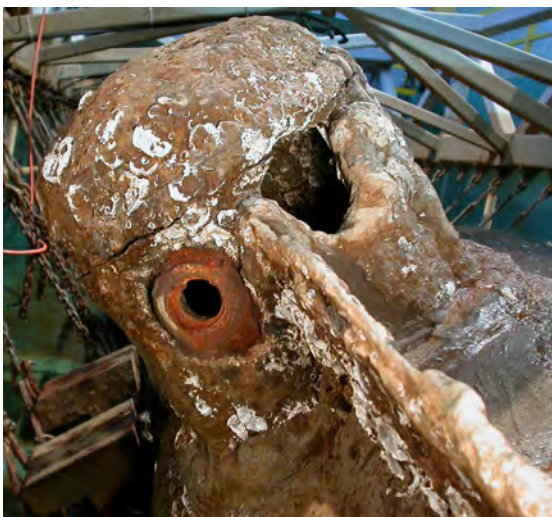
Figure 12.17. Hole in the forward conning tower encompassing the total loss of the port viewport (Courtesy of FOTH).

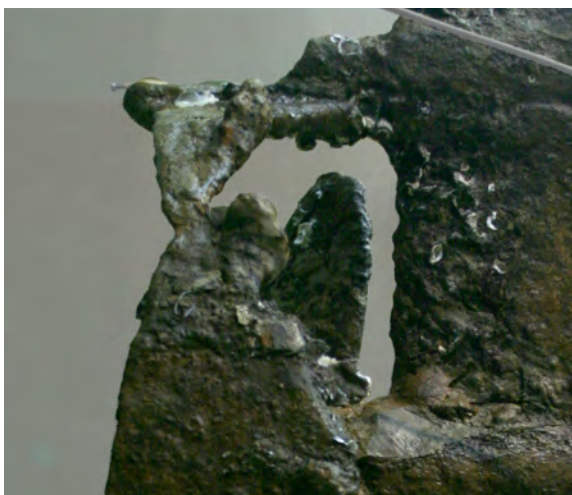
Figure 12.20. Damage to the top starboard quarter of the propeller shroud. (Photo by H. G. Brown, NHHHC).

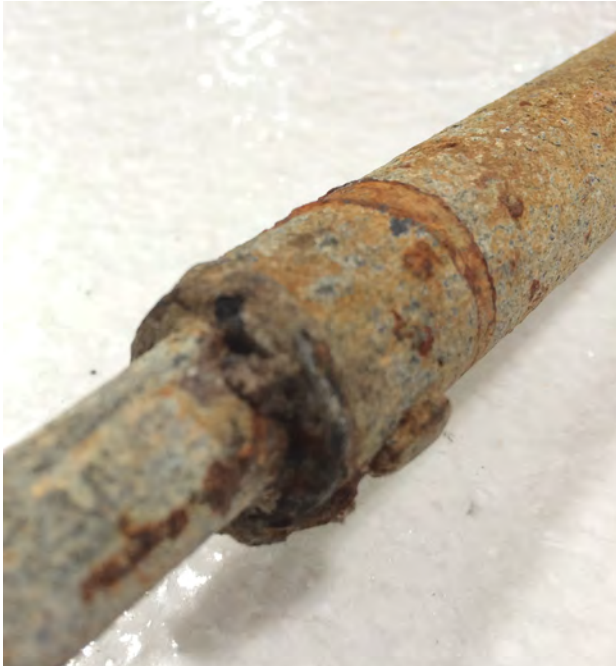
*Figure 15.3. Photograph of the joint shows a band of rust indicating the position of a possible clamp or bracket. (Photo by Michael Scafuri, courtesy of FOTH)*
