Mitigation Assessment Team Report

Hurricane Isaac in Louisiana

Building Performance Observations,
Recommendations, and Technical Guidance

FEMA P-938 / March 2013

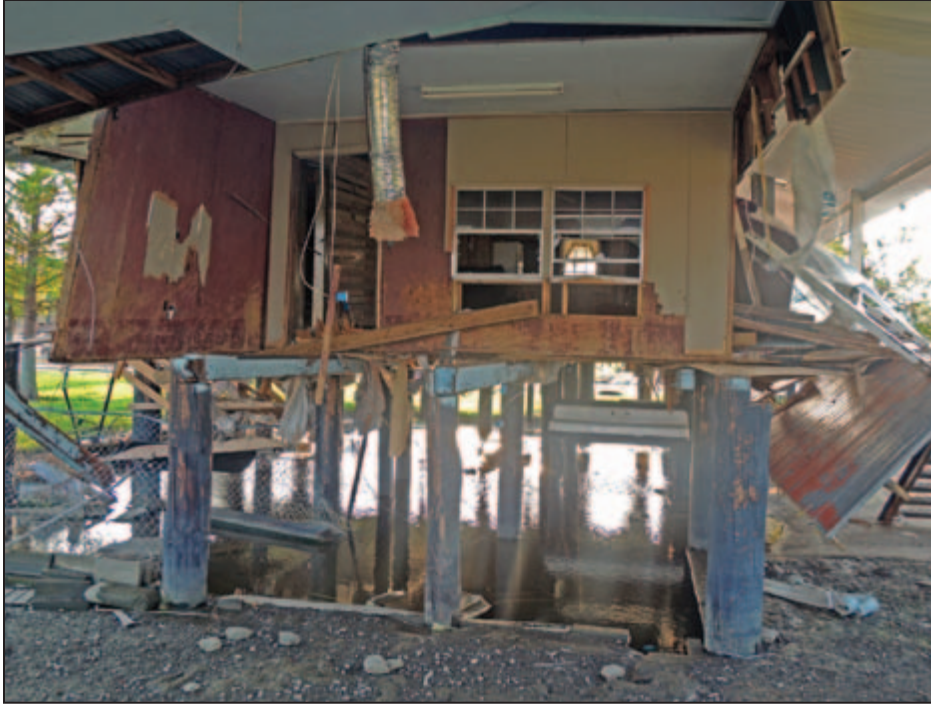
Figure 3-1:
Wave and surge damage to a residential building. The house is located in Zone V along Lake Pontchartrain's western shoreline (Saint John the Baptist Parish, LA).

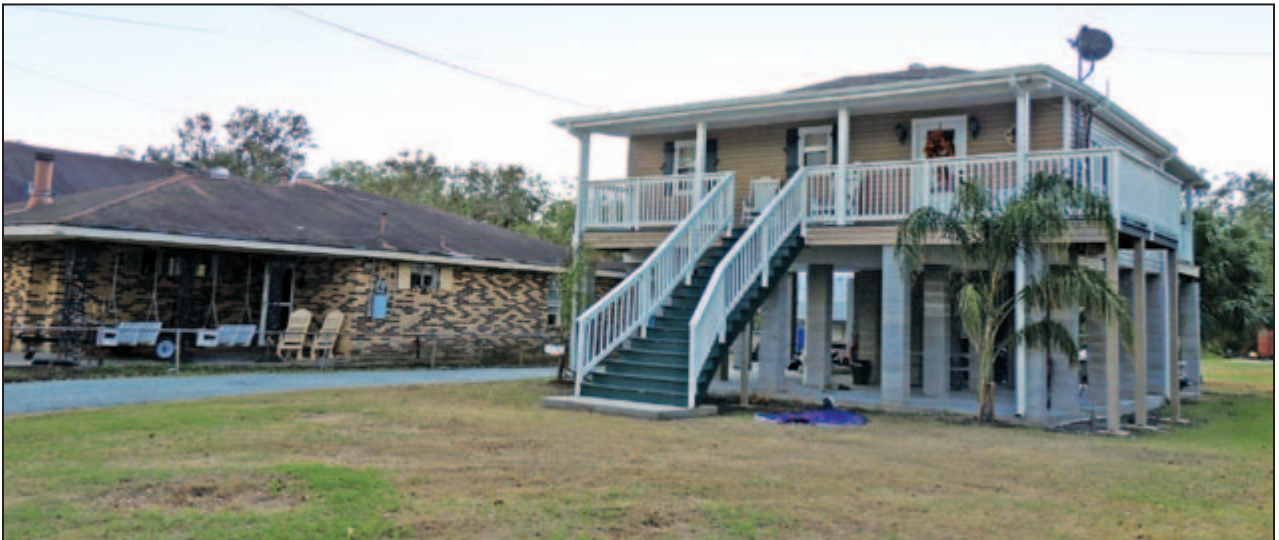
Figure 3-2: Damage was observed in most at-grade slab foundation residences, while minimal damage was observed in adjacent elevated properties (Barataria, LA).

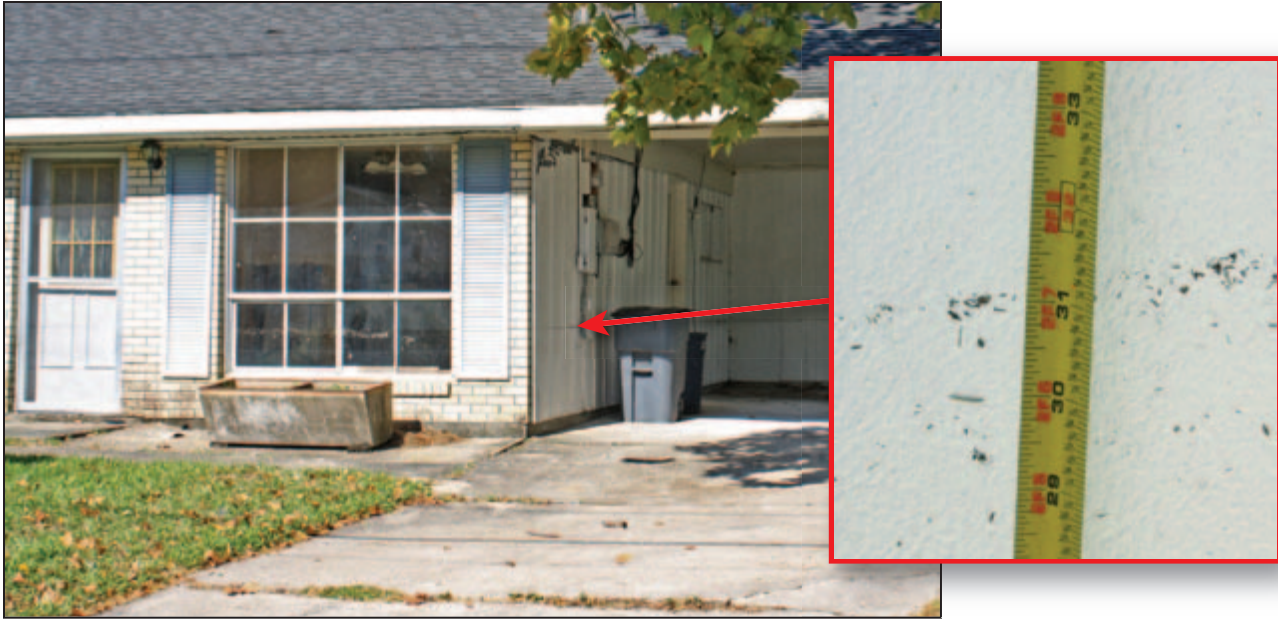
Figure 3-3: Typical flood depth of at-grade slab foundation residences; inset illustrates flood depth of 31 inches above the at-grade slab foundation (Slidell, LA).

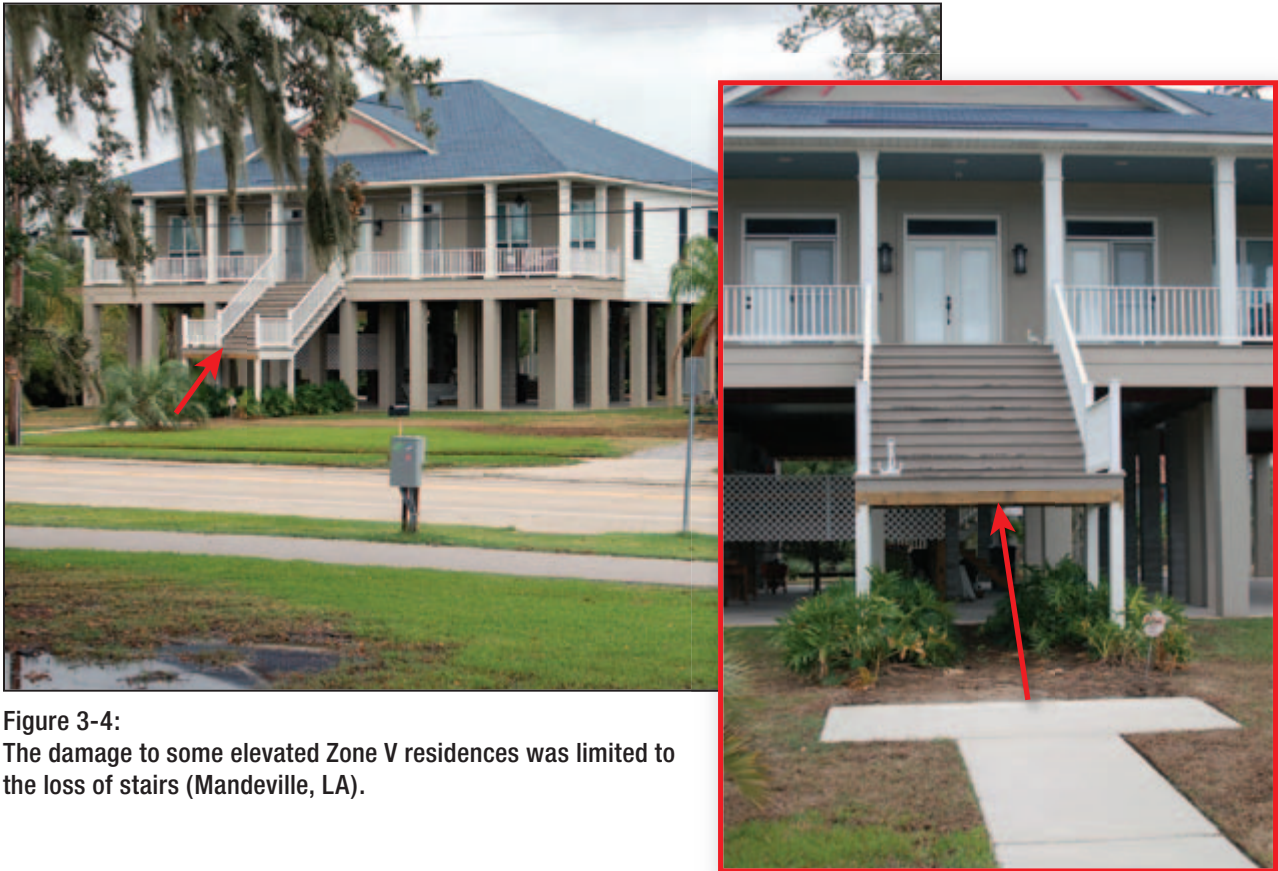
Figure 3-4: The damage to some elevated Zone V residences was limited to the loss of stairs (Mandeville, LA).

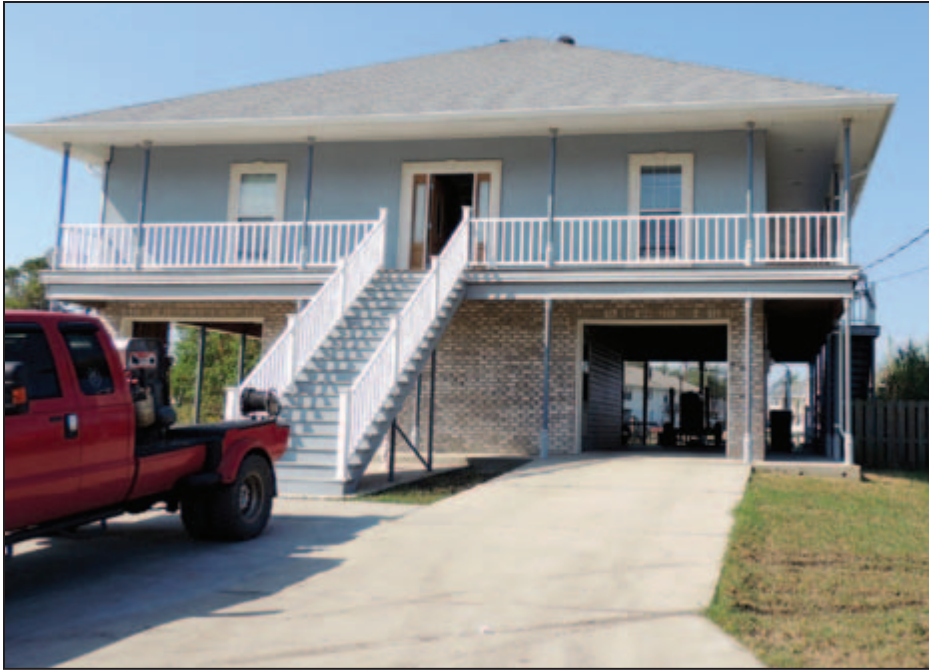
New construction and post-Katrina elevation projects consistently had minimal, if any, damage compared to adjacent non-elevated properties (see Figure 3-5). No flood damage was observed for the residential buildings the MAT visited that were constructed under the FEMA Hazard Mitigation Grant Program (HMGP) Pilot Mitigation Reconstruction Program.

Figure 3-5:
Minimal damage was observed in most elevated residences. The USGS HWM near this location was 9.74 feet, compared to an effective BFE of Zone A14 (EL12), Katrina ABFE of Zone AE (EL13), and preliminary FIRM of Zone VE (EL16) (Orleans Parish, LA).

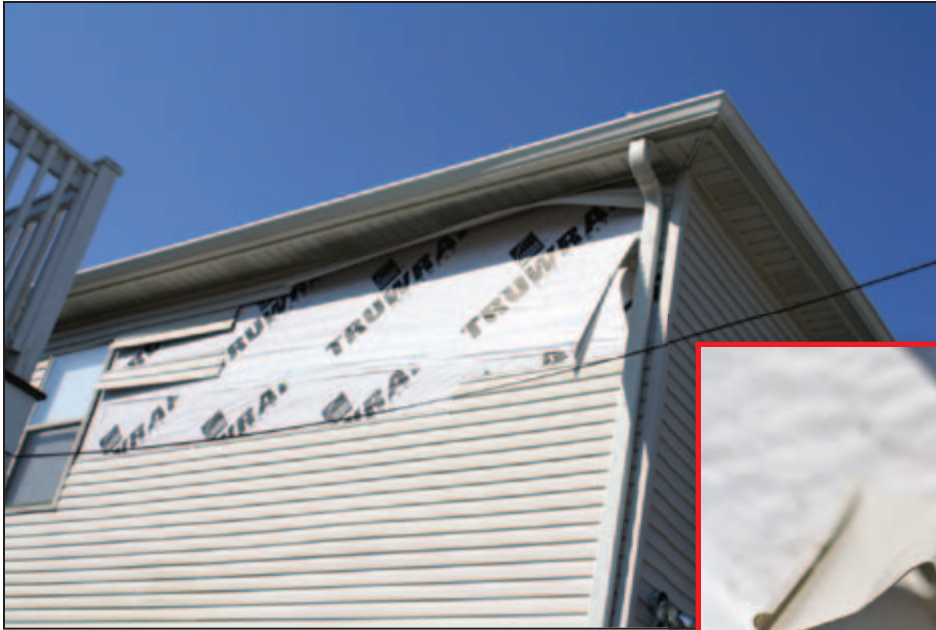
Figure 3-6: Loss of standard vinyl siding to recently elevated residential building; use and/or damage of high-wind siding was not observed by the MAT (Plaquemines Parish, LA).

- + **Raised floor system covering.** Proper fastener selection and attachment methods are recommended to reduce damage to raised floor system exterior covering on the underside of elevated buildings. Use materials that can withstand the wind loads expected on the structure.

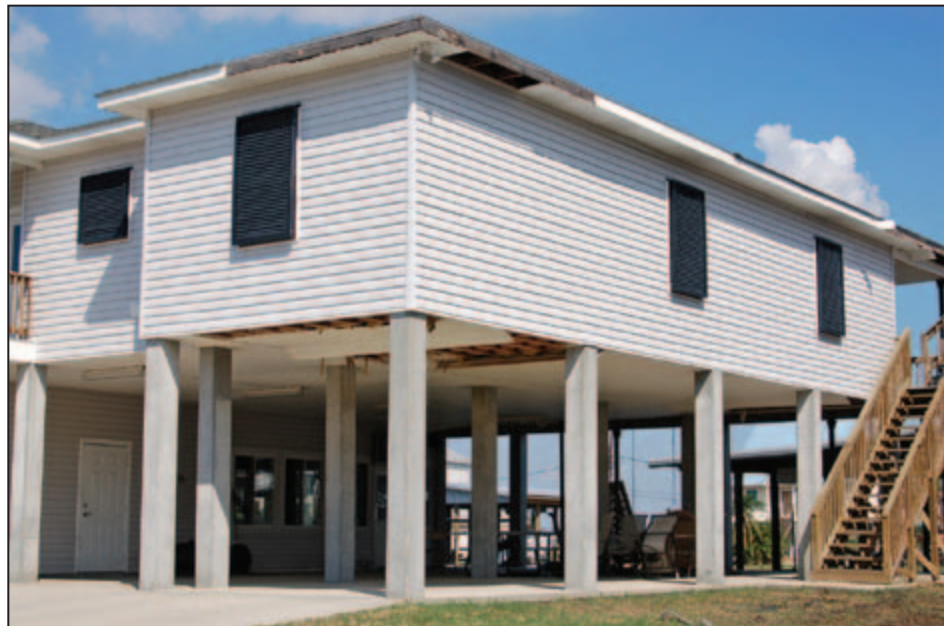
Figure 3-7:
Roof soffit and fascia
damage to Exposure
C residential building
(Plaquemines Parish, LA).

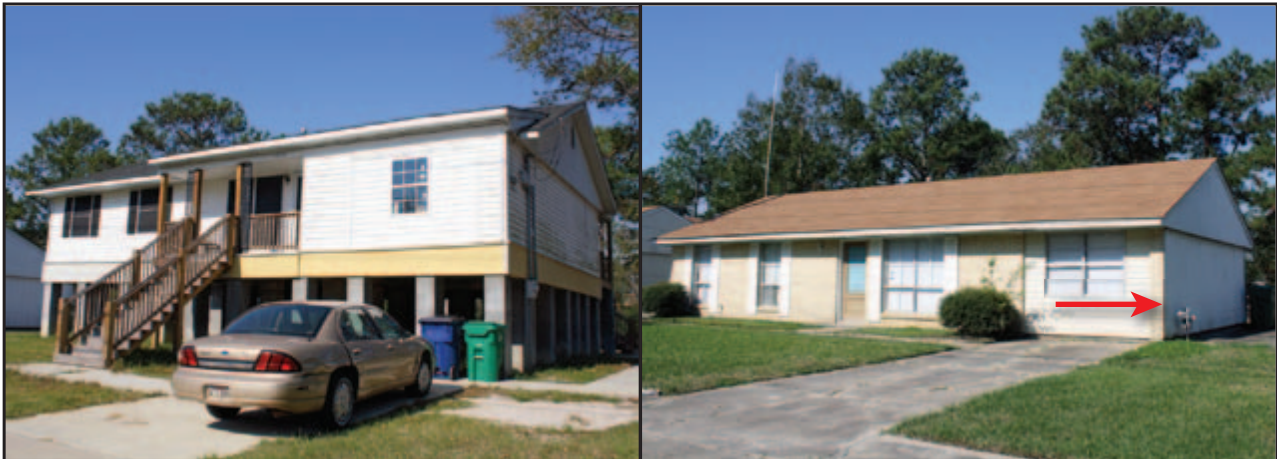
Figure 3-9: Neighboring residential buildings; the elevated residence had no observed damage, while the non-elevated home had significant interior damage caused by more than 2 feet of flooding (red arrow indicates flood depth) (Slidell, LA).

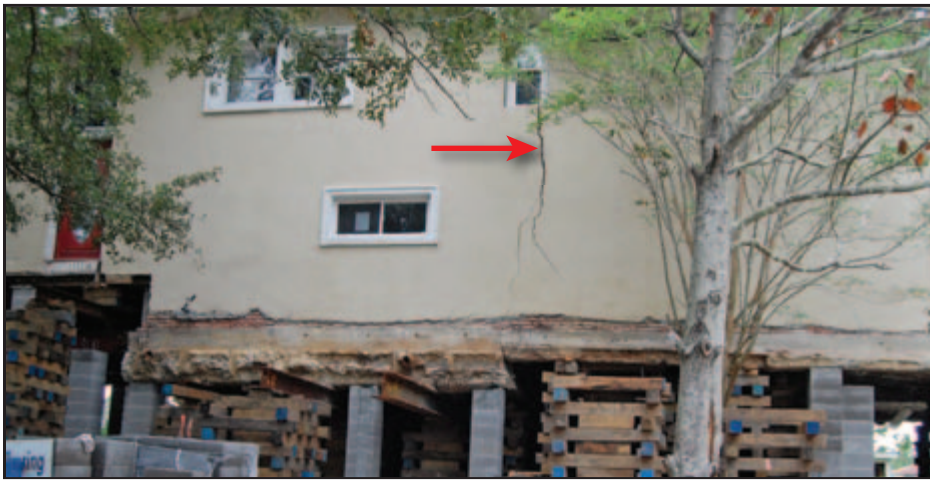
Figure 3-11:
Slab-on-grade elevation
with structural cracks due to
differential lifting
(Slidell, LA).

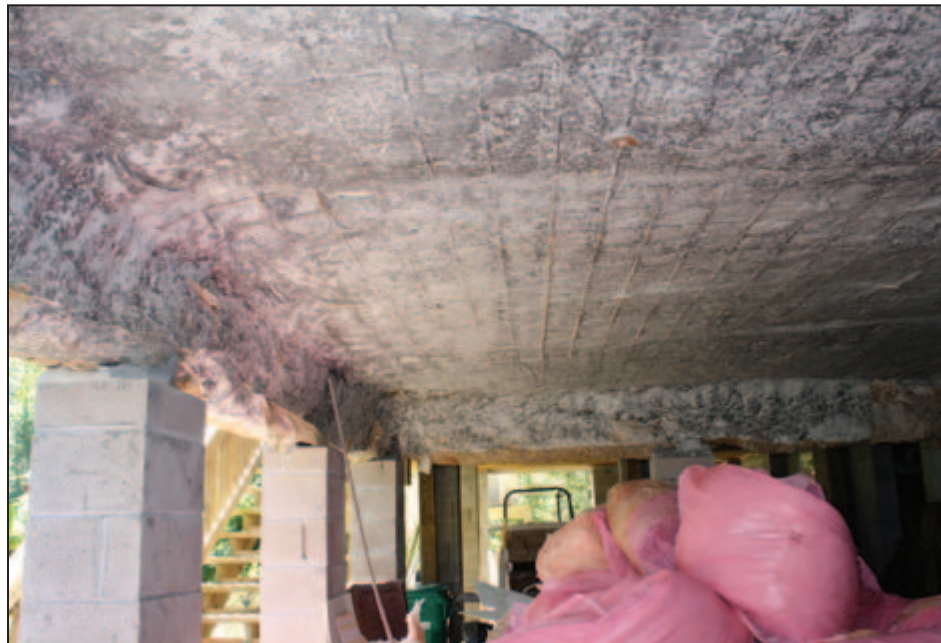
Figure 3-13:
Elevated slab with
insufficient steel cover
(Slidell, LA).

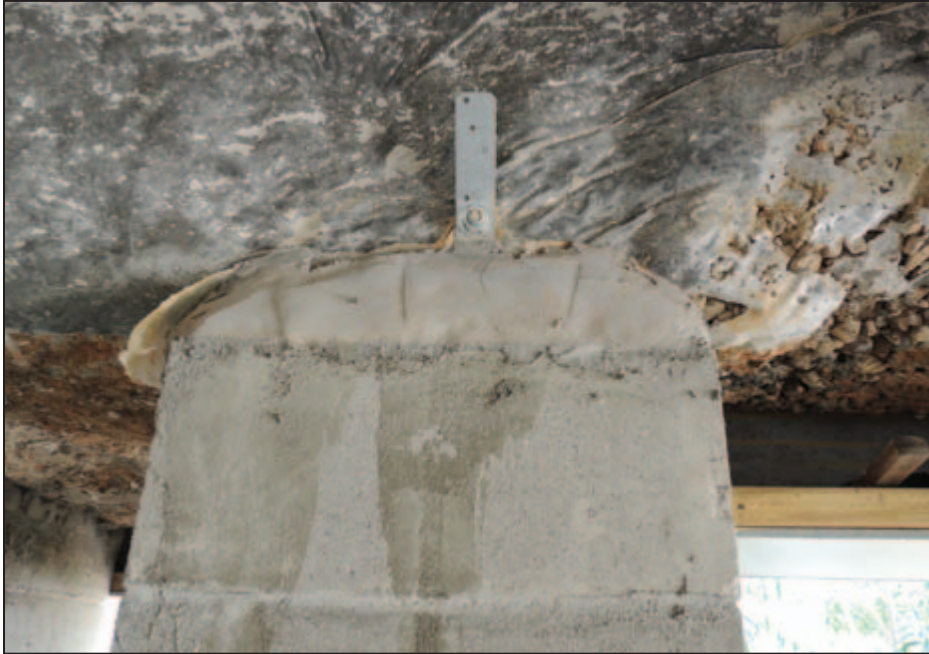
- **Lack of pier-to-slab connections:** Different types of elevated foundation-to-floor framing connections were observed, including bolted connections for pile foundations and grouted connections for pier foundations. However, elevated slabs were often observed to have no visible connection to their piers. Where connections were observed, they appeared to be structurally insufficient, as shown in Figure 3-14.

Figure 3-14: Structurally insufficient connection to pier. This house had a total of 7 such connections out of 17 piers supporting the structure (Mandeville, LA).

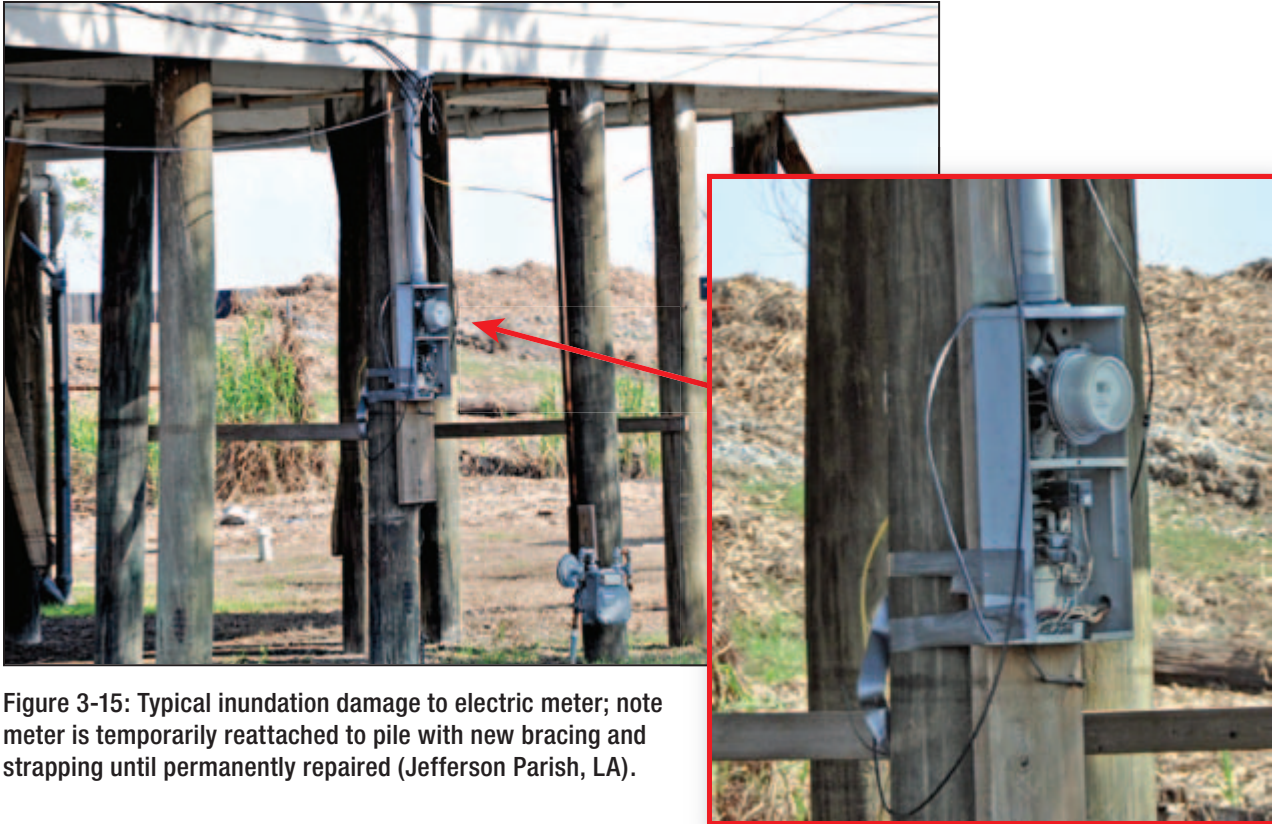
Figure 3-15: Typical inundation damage to electric meter; note meter is temporarily reattached to pile with new bracing and strapping until permanently repaired (Jefferson Parish, LA).

When allowed by the local utility company, placing all electrical equipment above the flood level prevents floodwater from damaging it. The MAT observed several residences where components were elevated and accessible by stairs, walkways, or decks. These elevated structures typically supported condensers and other mechanical equipment (e.g., generators). When the equipment was properly elevated above potential flood levels, the damage to it was minimal.

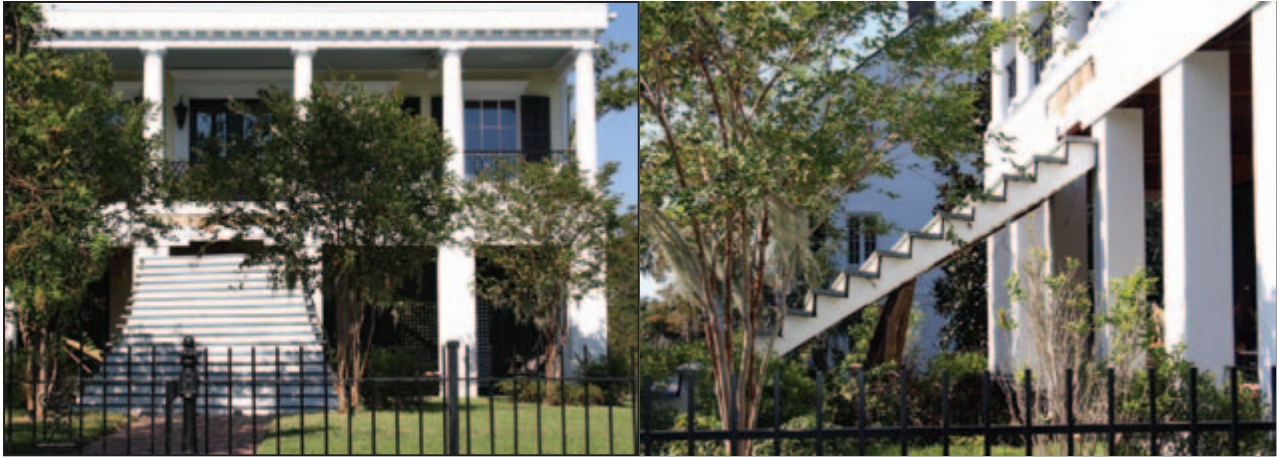
Figure 3-20: Front and side view of stair damage to elevated waterfront residential building due to closed riser, inadequate foot anchoring, and insufficient connection with the building frame (Mandeville, LA).

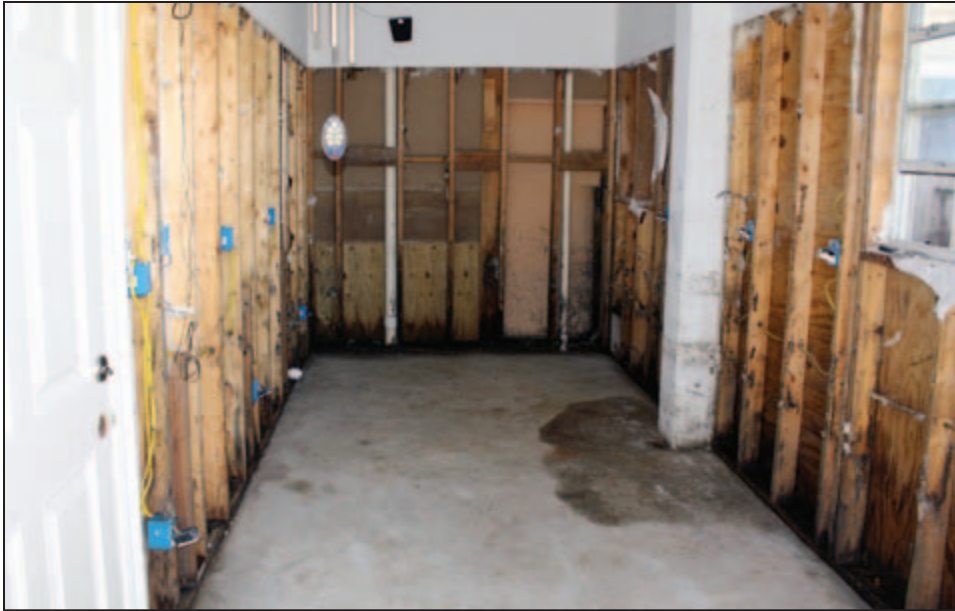
Figure 3-23:
Enclosed area that was not finished with flood-resistant materials, nor did it have flood openings (Plaquemines Parish, LA).

- + **Enclosed areas.** Enclosed areas below the BFE should be constructed of flood damage-resistant materials and should have walls designed to break away under flood loads.

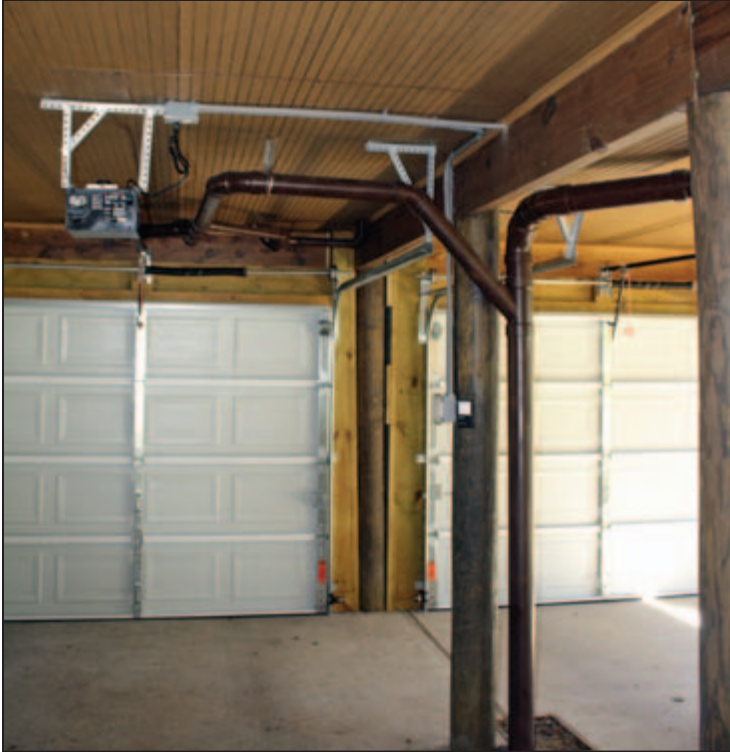
Figure 3-25:
Elevated house with combustible materials
and vehicle parking below elevated space
(Mandeville, LA).

- + **Fire separation and flood damage-resistant materials.** For elevated buildings on open foundations with enclosed parking underneath, introduce fire separation on the exposed underside of the building. Fire separation should meet the guidelines of the 2012 International Residential Code Table R302.6 for habitable rooms above a garage, which requires not less than 5/8-inch Type X gypsum board or equivalent. Considerations should be made to ensure that this material is also flood damage resistant.

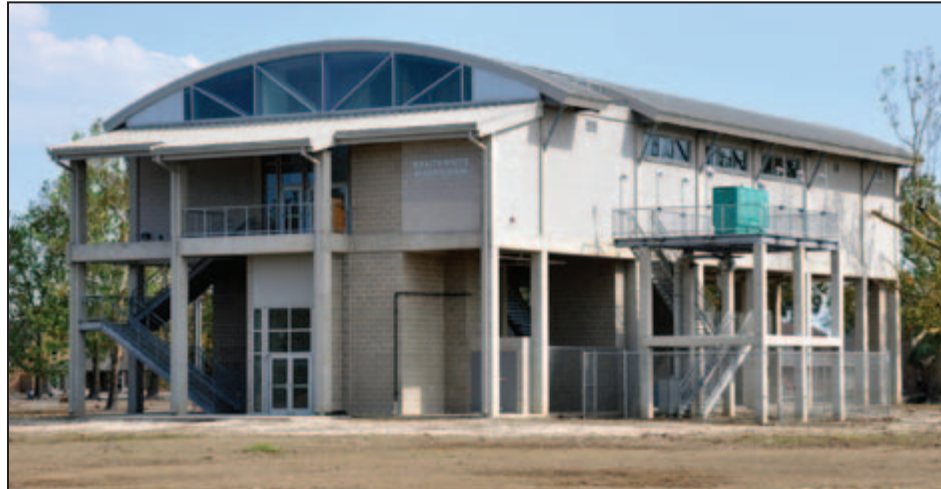
Figure 4-2:
HWM visible on glass at entrance to elevators below lowest floor of Braithwaite Auditorium (Braithwaite Park [East Bank] – Plaquemines Parish, LA).

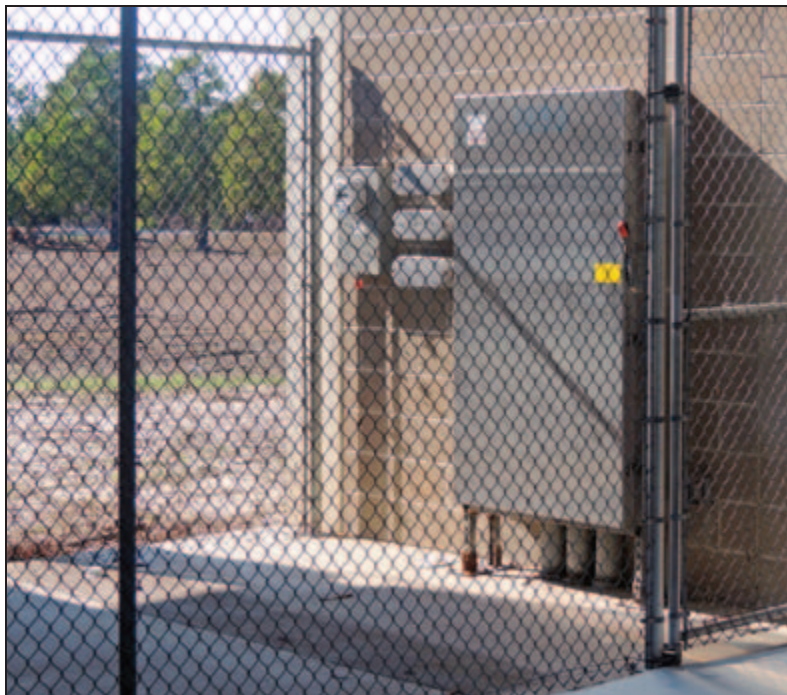
Figure 4-6:
The Braithwaite Auditorium generator transfer switch and other electrical components were built at grade and damaged by floodwaters (Braithwaite Park [East Bank] – Plaquemines Parish, LA).

- + **Siting of critical facilities, community centers, and schools.** Site new and replacement community centers, critical facilities, and schools outside the 500-year floodplain where possible; where not possible, elevate the critical facilities and all utility equipment above the 500-year elevation or the best available BFE information.
- + **Infrastructure.** Where possible, site electrical substations, pump stations, and cellular towers outside the 500-year floodplain; where not possible, elevate facilities and electrical equipment above the 500-year elevation.

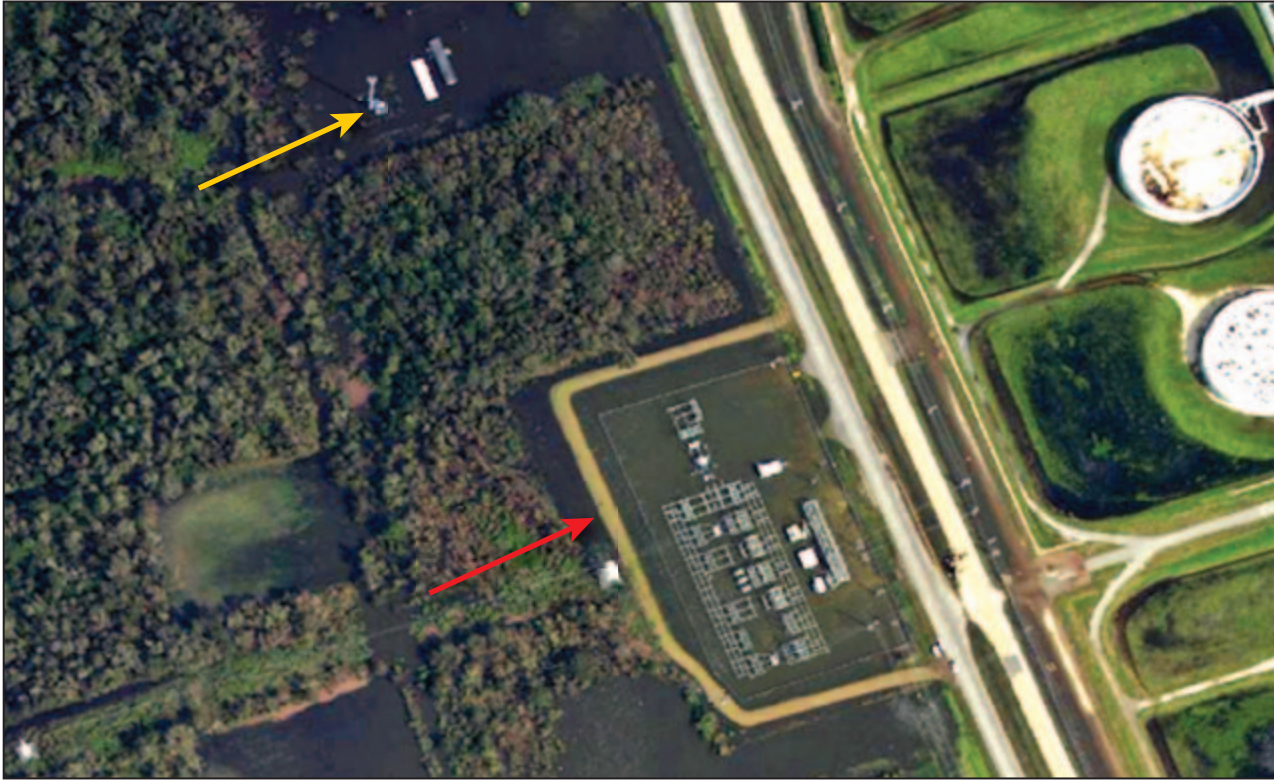
Figure 4-17: The protective berm (red arrow) was overtopped, resulting in damage to the substation; note cellular tower (yellow arrow) northwest of the substation (Belle Chase [West Bank] – Plaquemines Parish, LA).

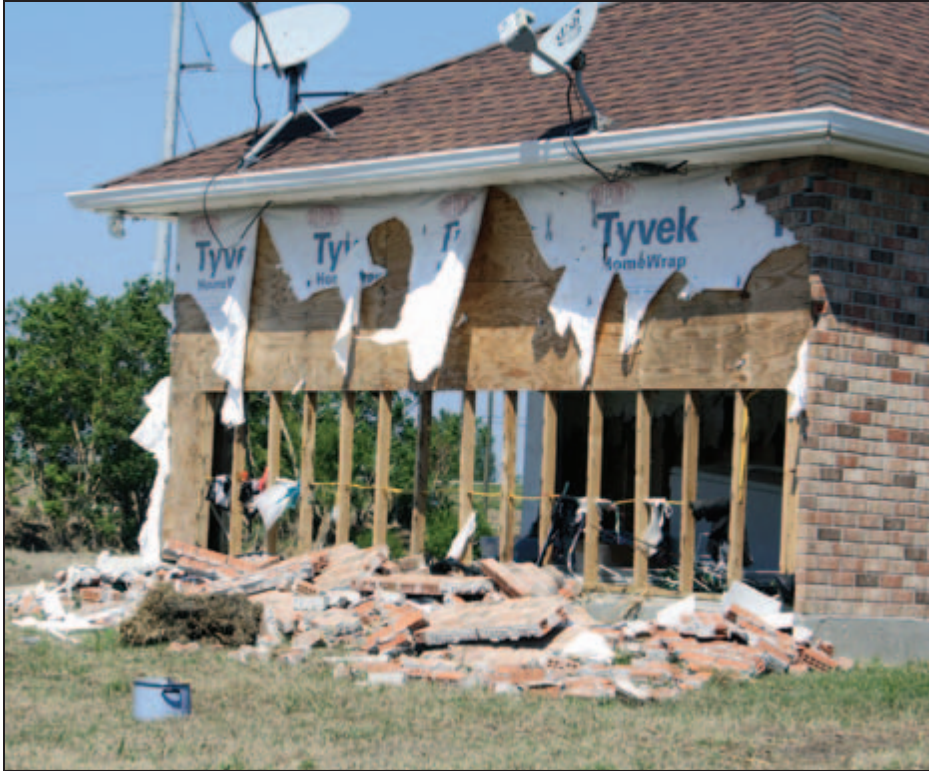
Figure 5-5:
Exterior damage to the
garage of the non-elevated
residence (Plaquemines
Parish, LA).

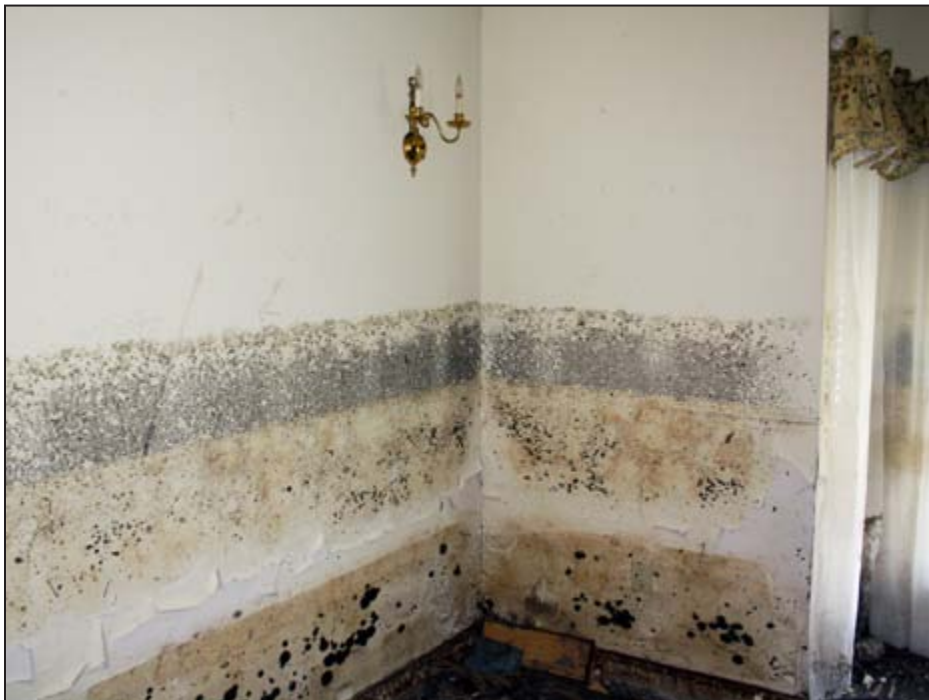
Figure 5-6:
Interior damage to the
non-elevated residence
(Plaquemines Parish, LA).

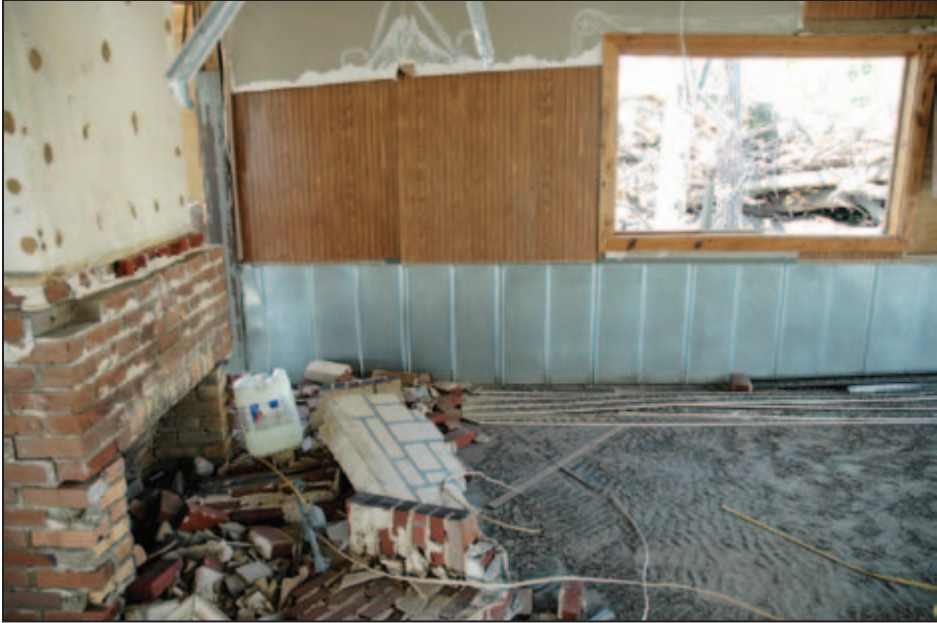
Figure 5-13: Interior damage from Hurricane Katrina to nonresidential building on Lakeshore Drive (Mandeville, LA).

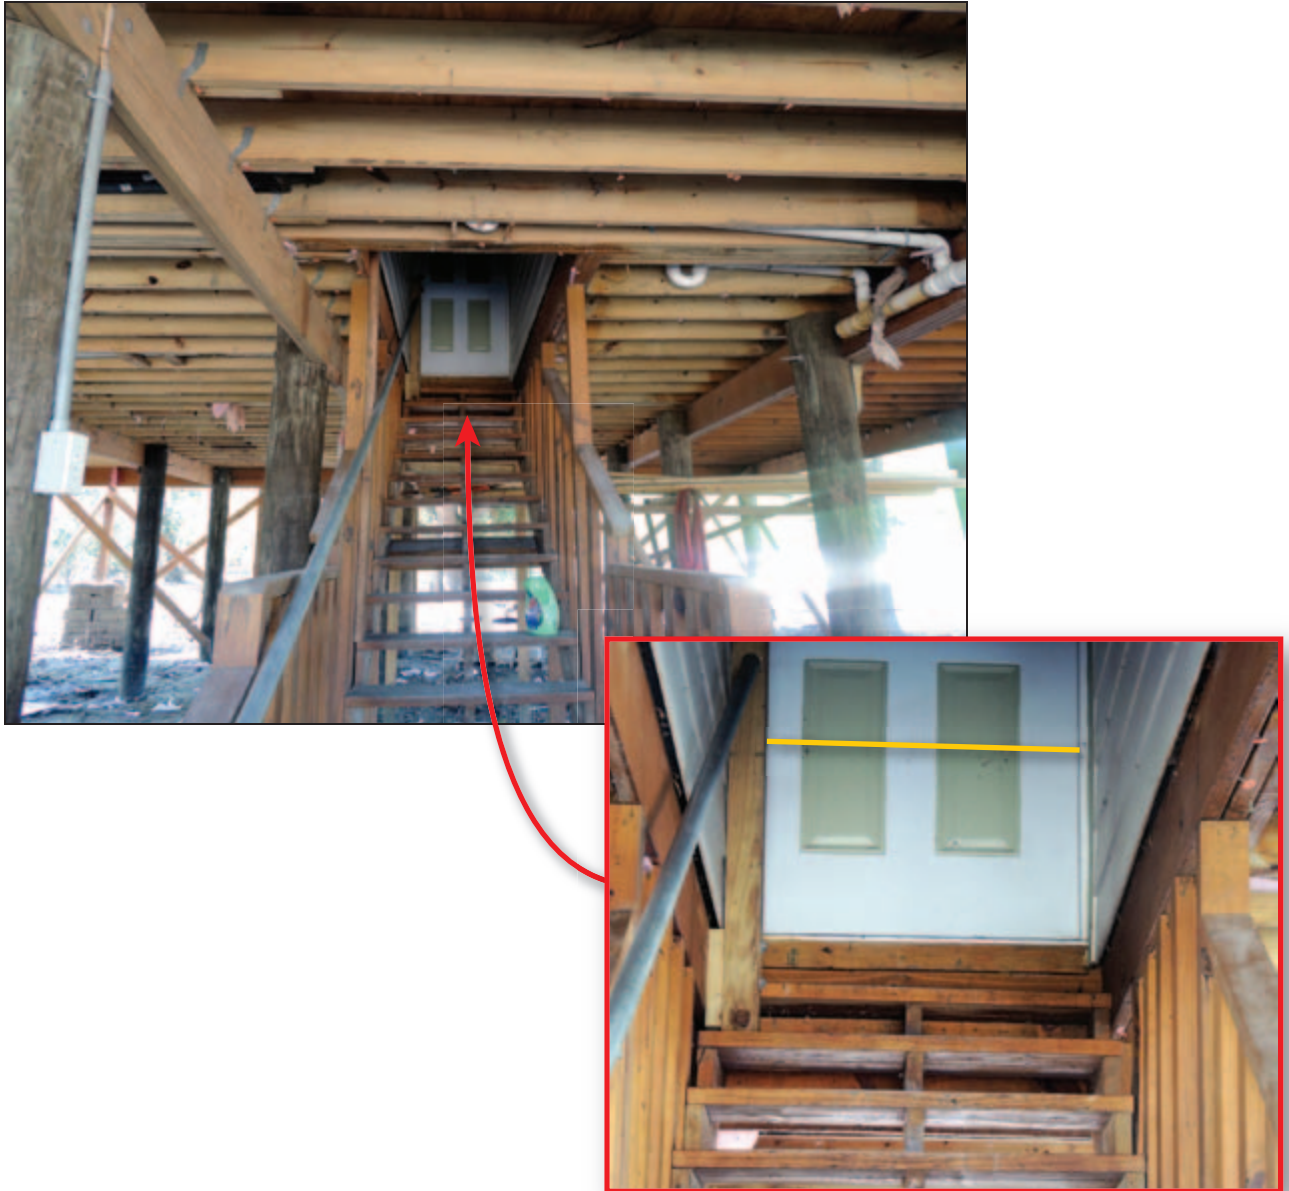
Figure 5-16: Elevated house built in 2009 on Highway 39 had approximately 2 feet of water infiltrate the first floor; inset: yellow line illustrates observed HWM on door (Plaquemines Parish, LA).

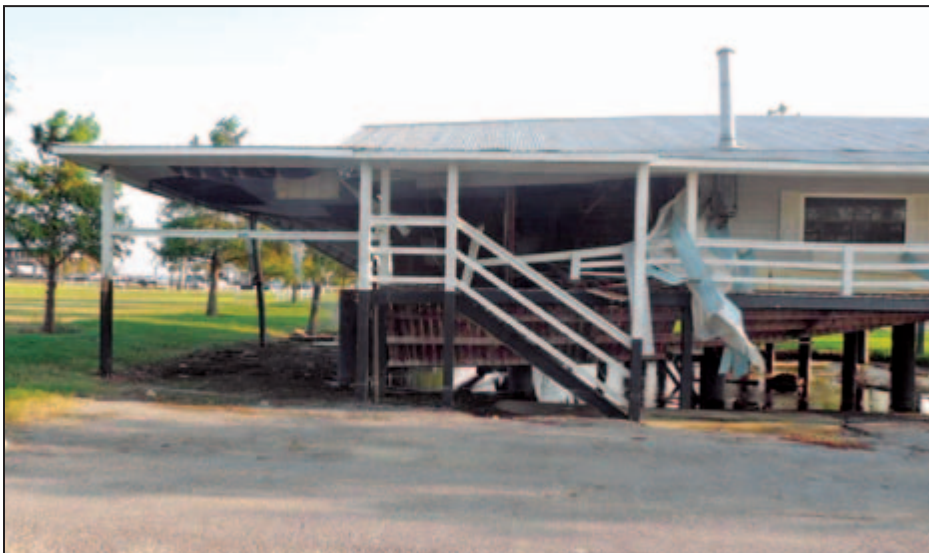
Figure 5-19: Surge damage to lakefront residential structure (Structure B in Figure 5-18) (St. John the Baptist Parish, LA).

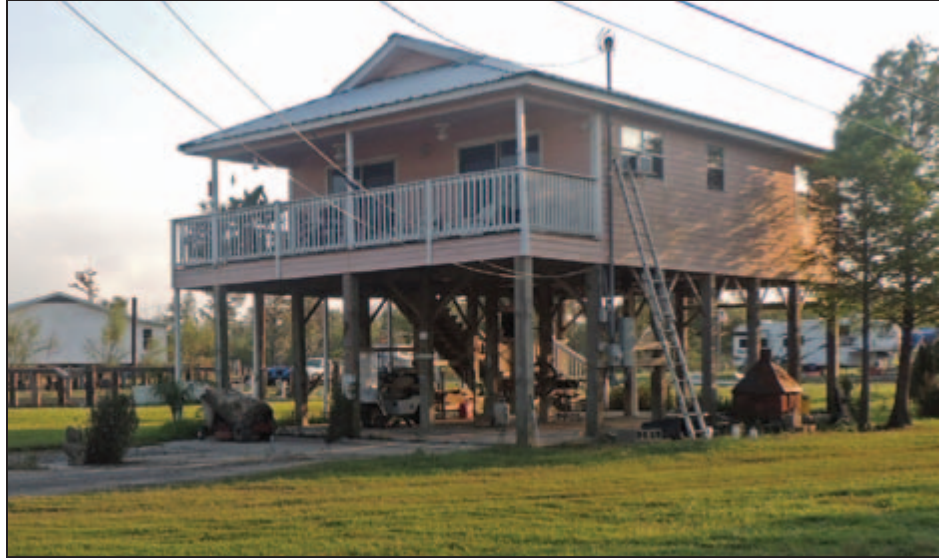
Figure 5-21:
Remains of residential building that was approximately 2 to 3 feet above grade (Structure D in Figure 5-18) (St. John the Baptist Parish, LA).

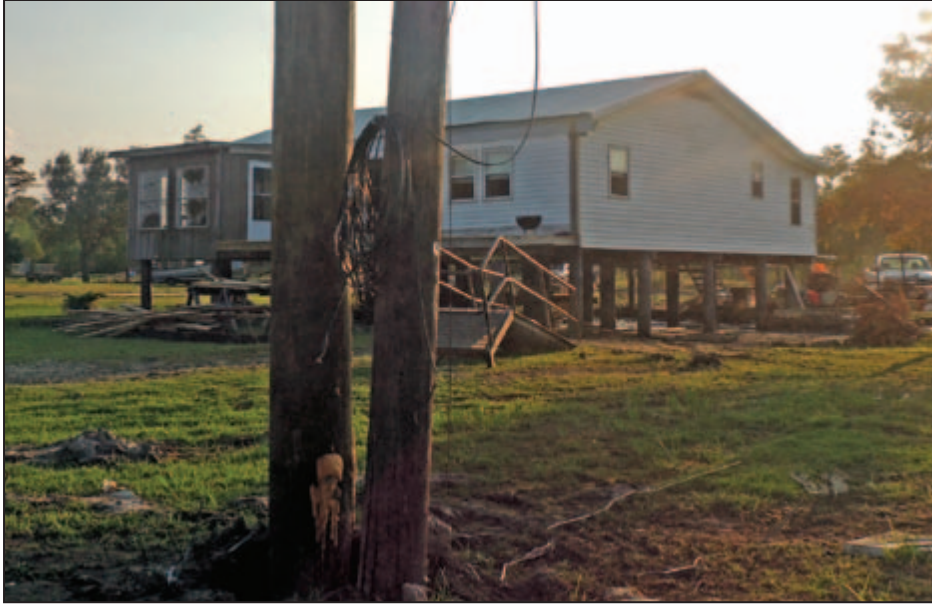
Figure 5-23:
Residential building elevated approximately 3 to 4 feet above grade that lost stairs and received other damage below the lowest floor (Structure C in Figure 5-18) (St. John the Baptist Parish, LA).

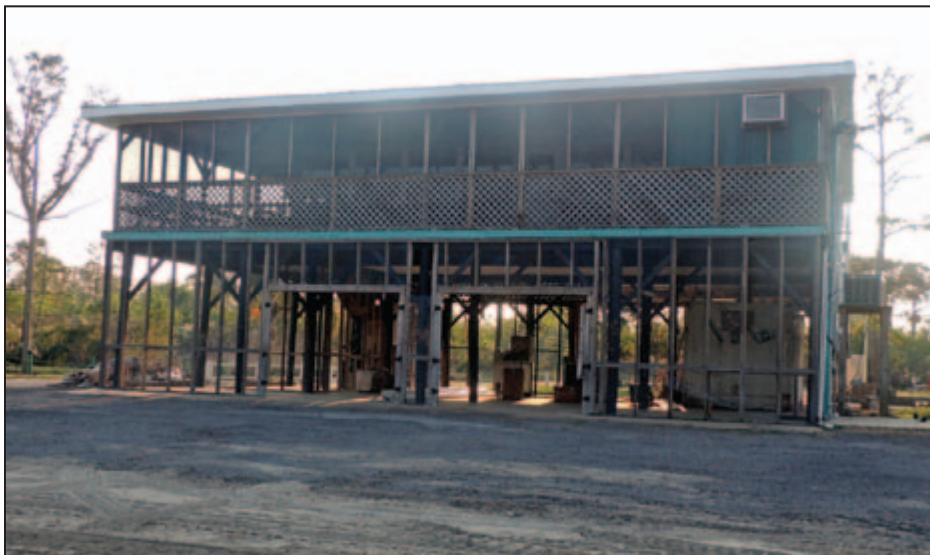
Figure 5-24:
Nonresidential structure with damage to the screen surrounding the area under the lowest floor (Structure A in Figure 5-18) (St. John the Baptist Parish, LA).

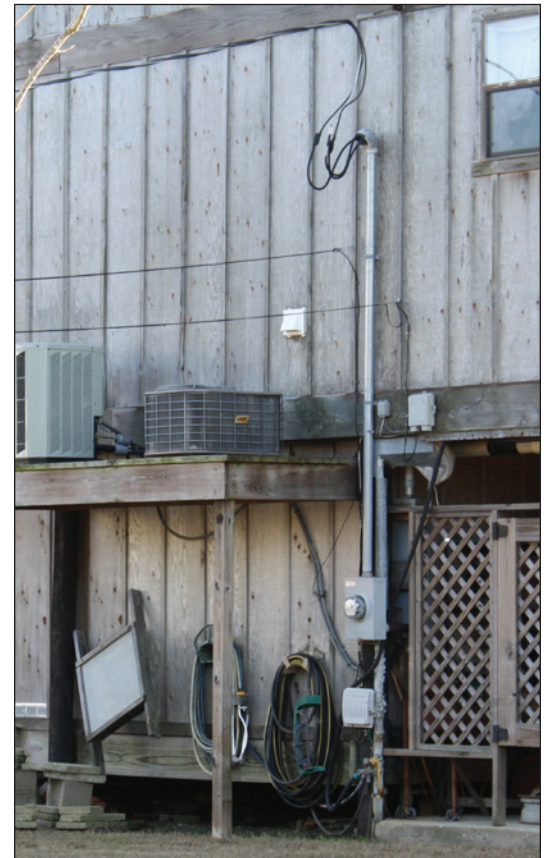
Figure 1. Electrical components installed below the lowest floor system are subject to increased flood damages and lengthy outage durations (St. Tammany Parish, LA)
