U.S. Fire Administration/Technical Report Series

Seven Fatality Fire at Remote Wilderness Lodge

Grand Marais, Minnesota

USFA-TR-055/July 1991

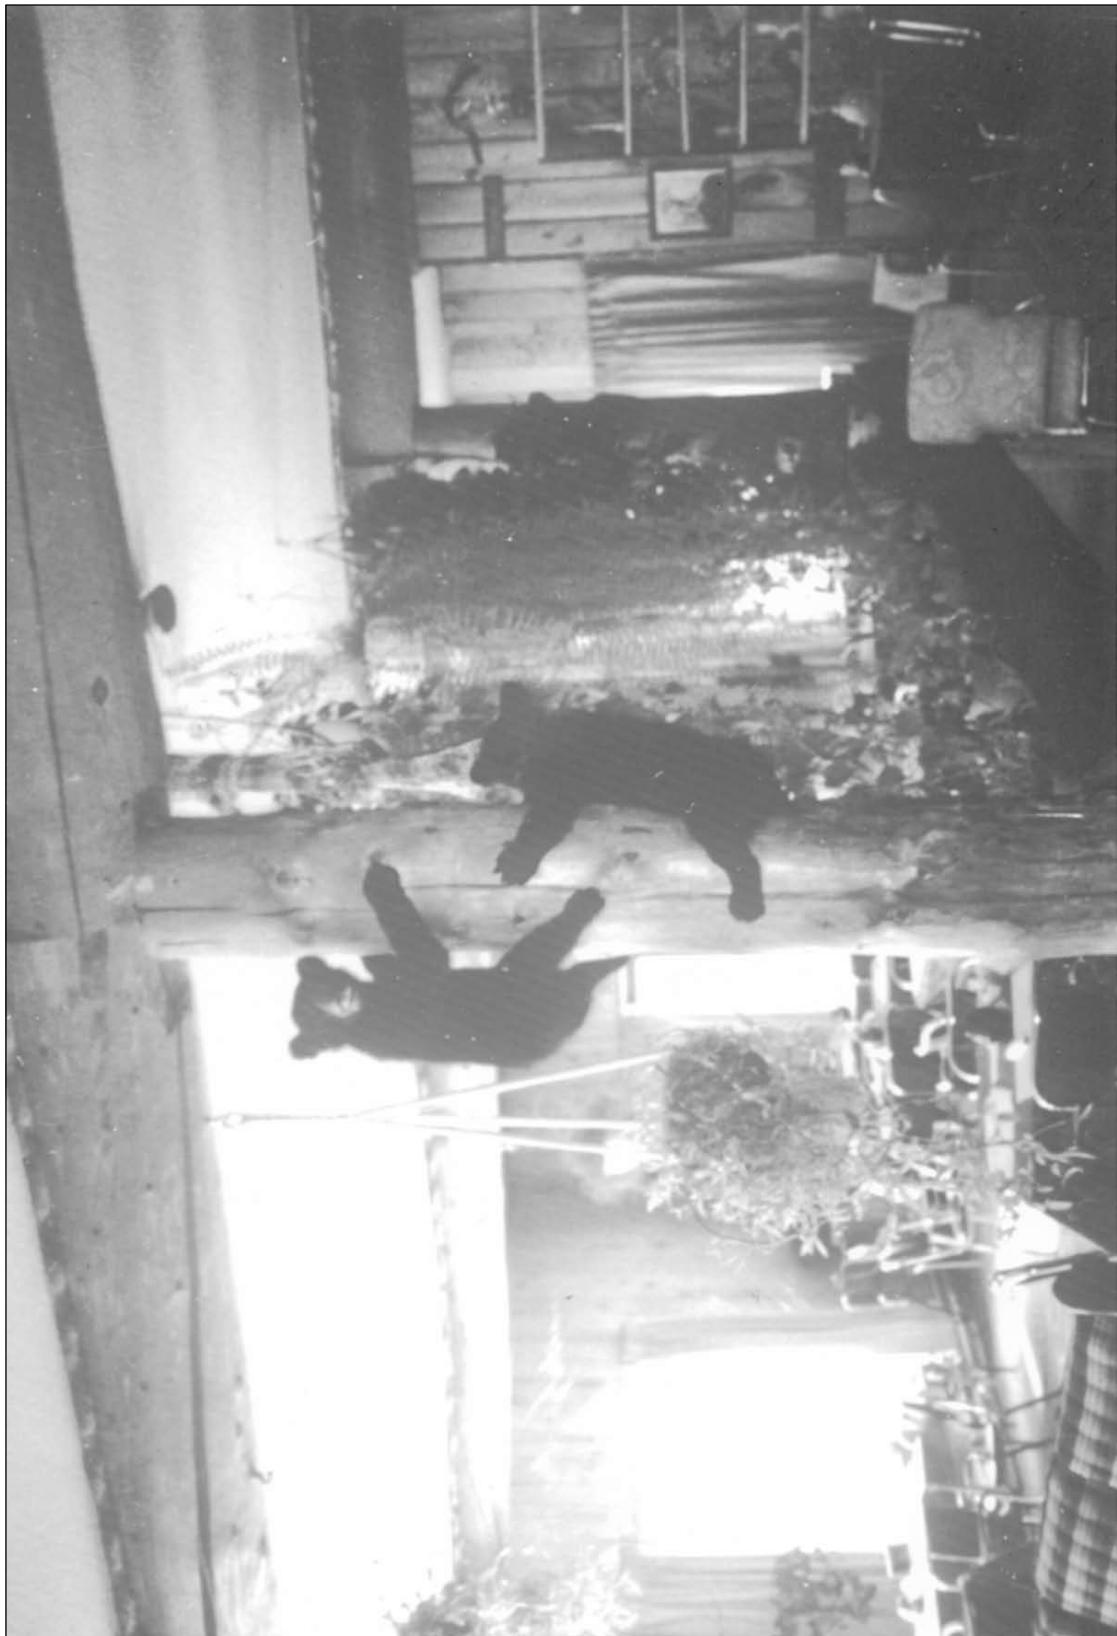
It was stated the ceiling construction on the first floor was drywall with exposed beams. However, there were indications from witnesses and photos that the drywall had large gaps where it met at the beams. This allowed fire to travel to the floor construction above and probably contributed significantly to the fire spread.

Photo provided by the Minnesota State Fire Marshal
Dining room and lounge area on first floor. Note ceiling separations at log beams.

5. Decorative elements, such as the exposed ceiling beams in this case, require that special efforts be made to insure the fire-resistive integrity of the construction.

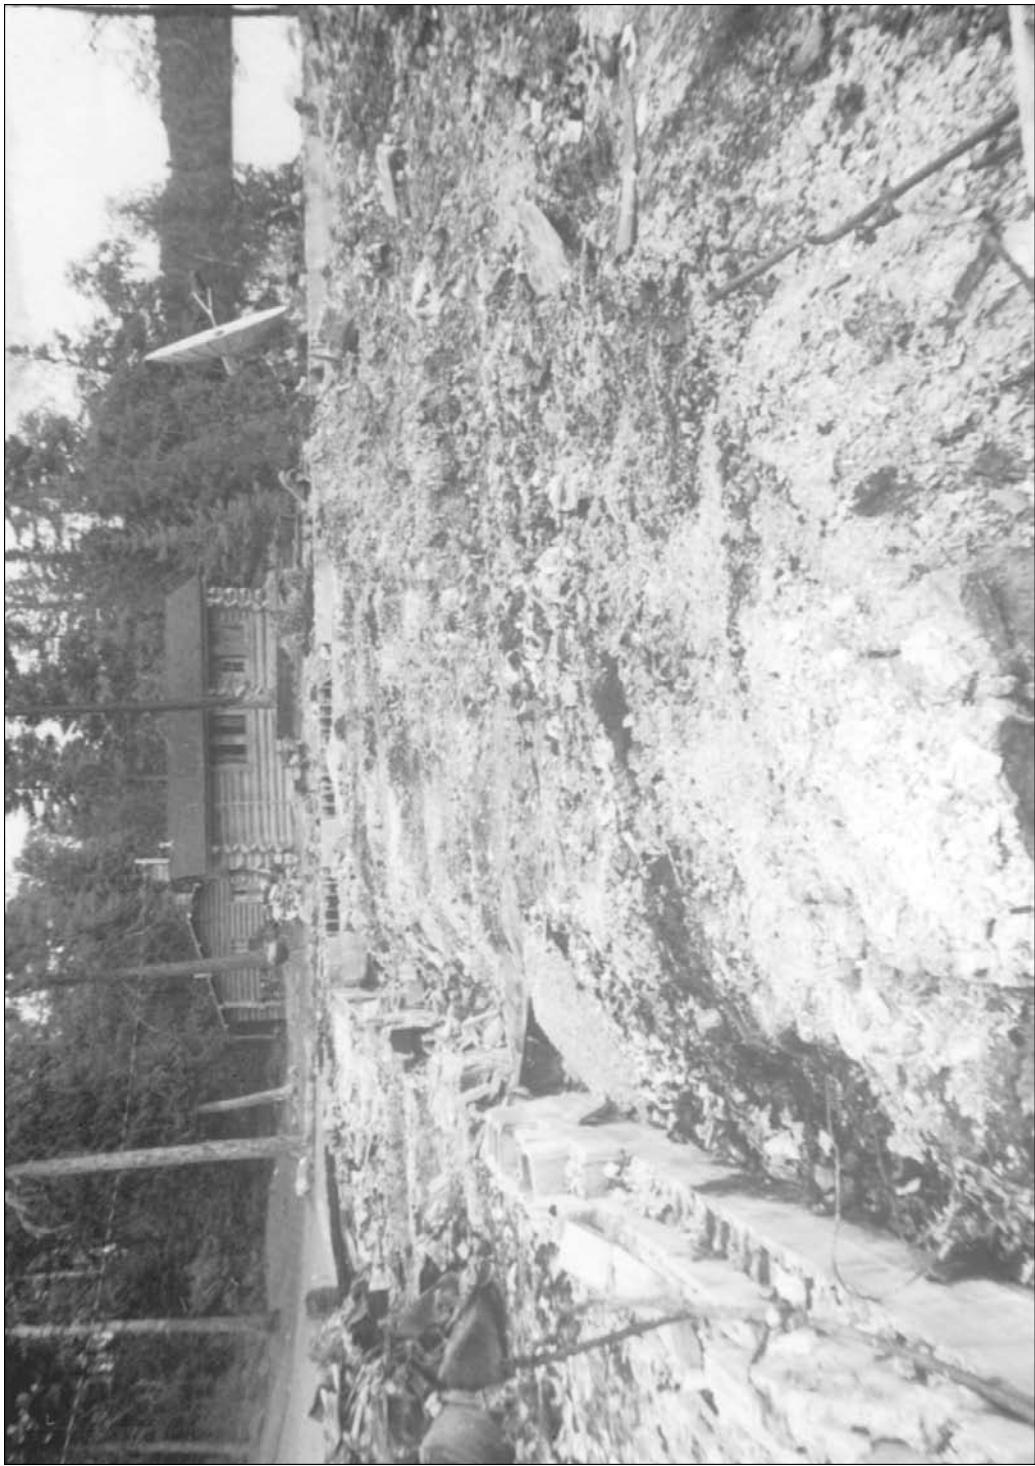
Photo by James W. David
View along north foundation wall shows total destruction of lodge by the fire.

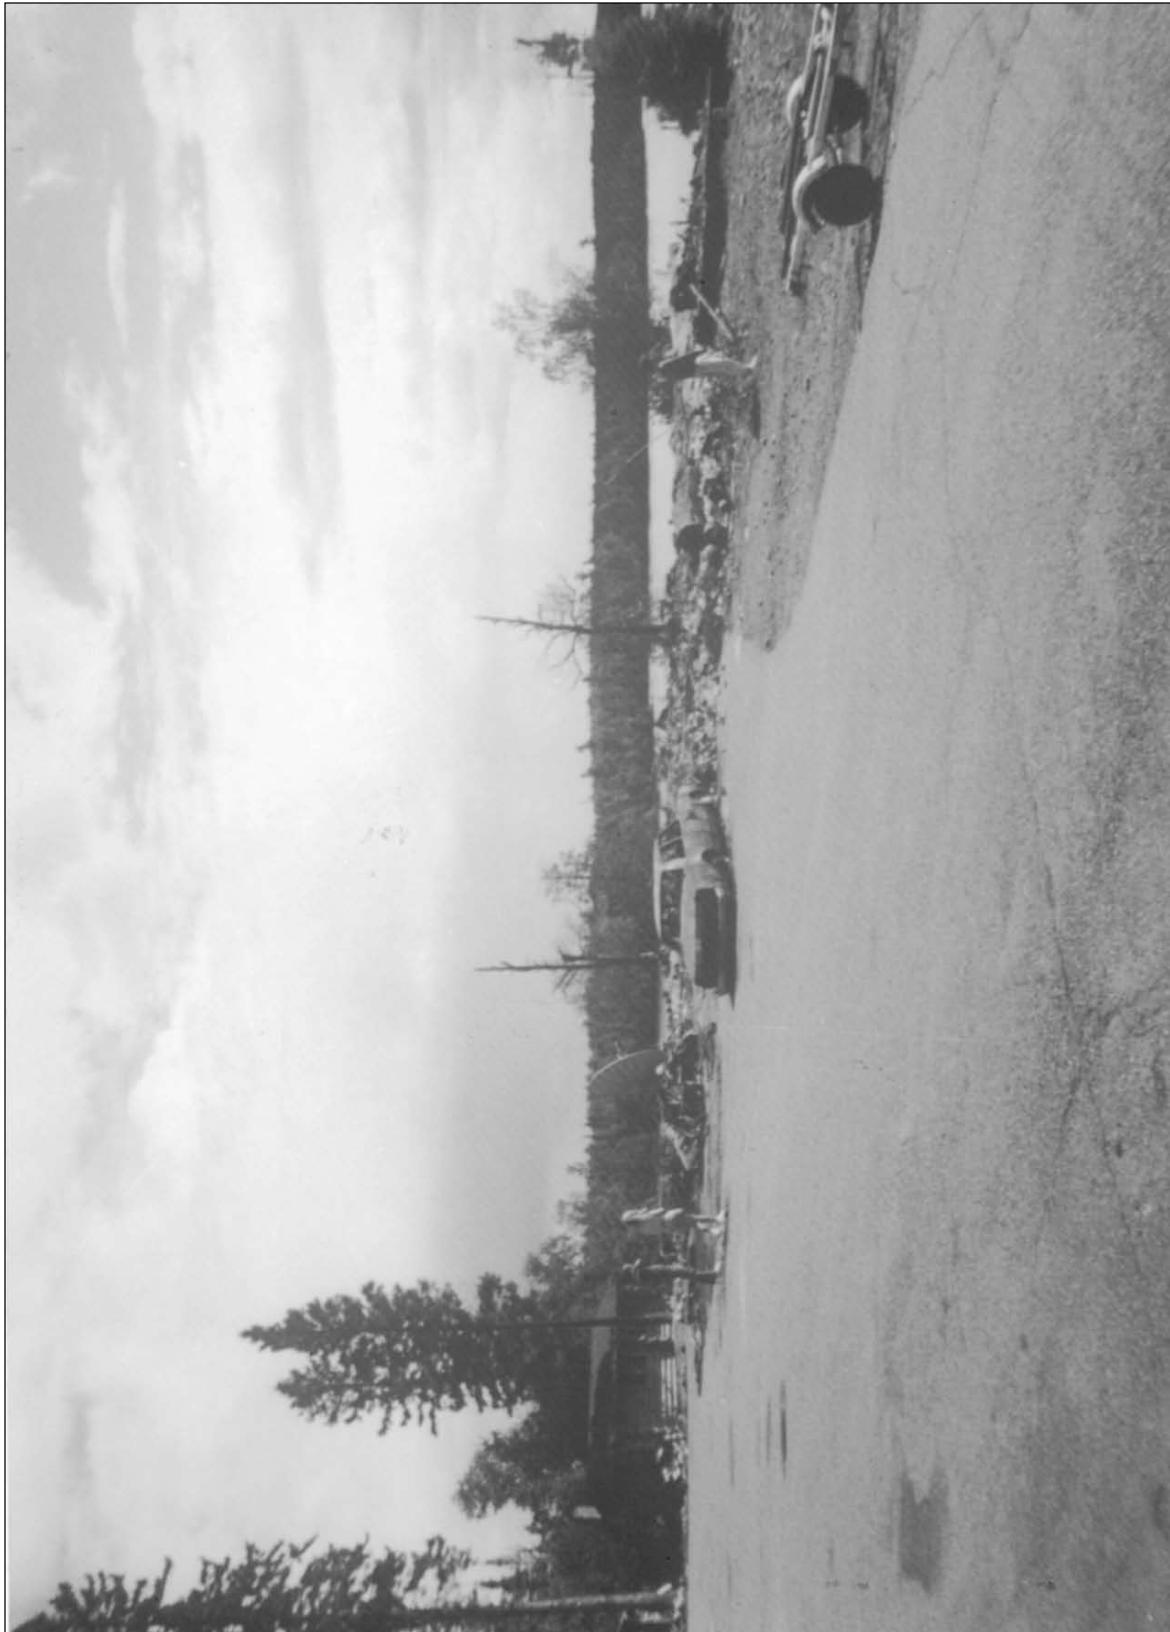
Remains of Lodge from west drive, facing lake.

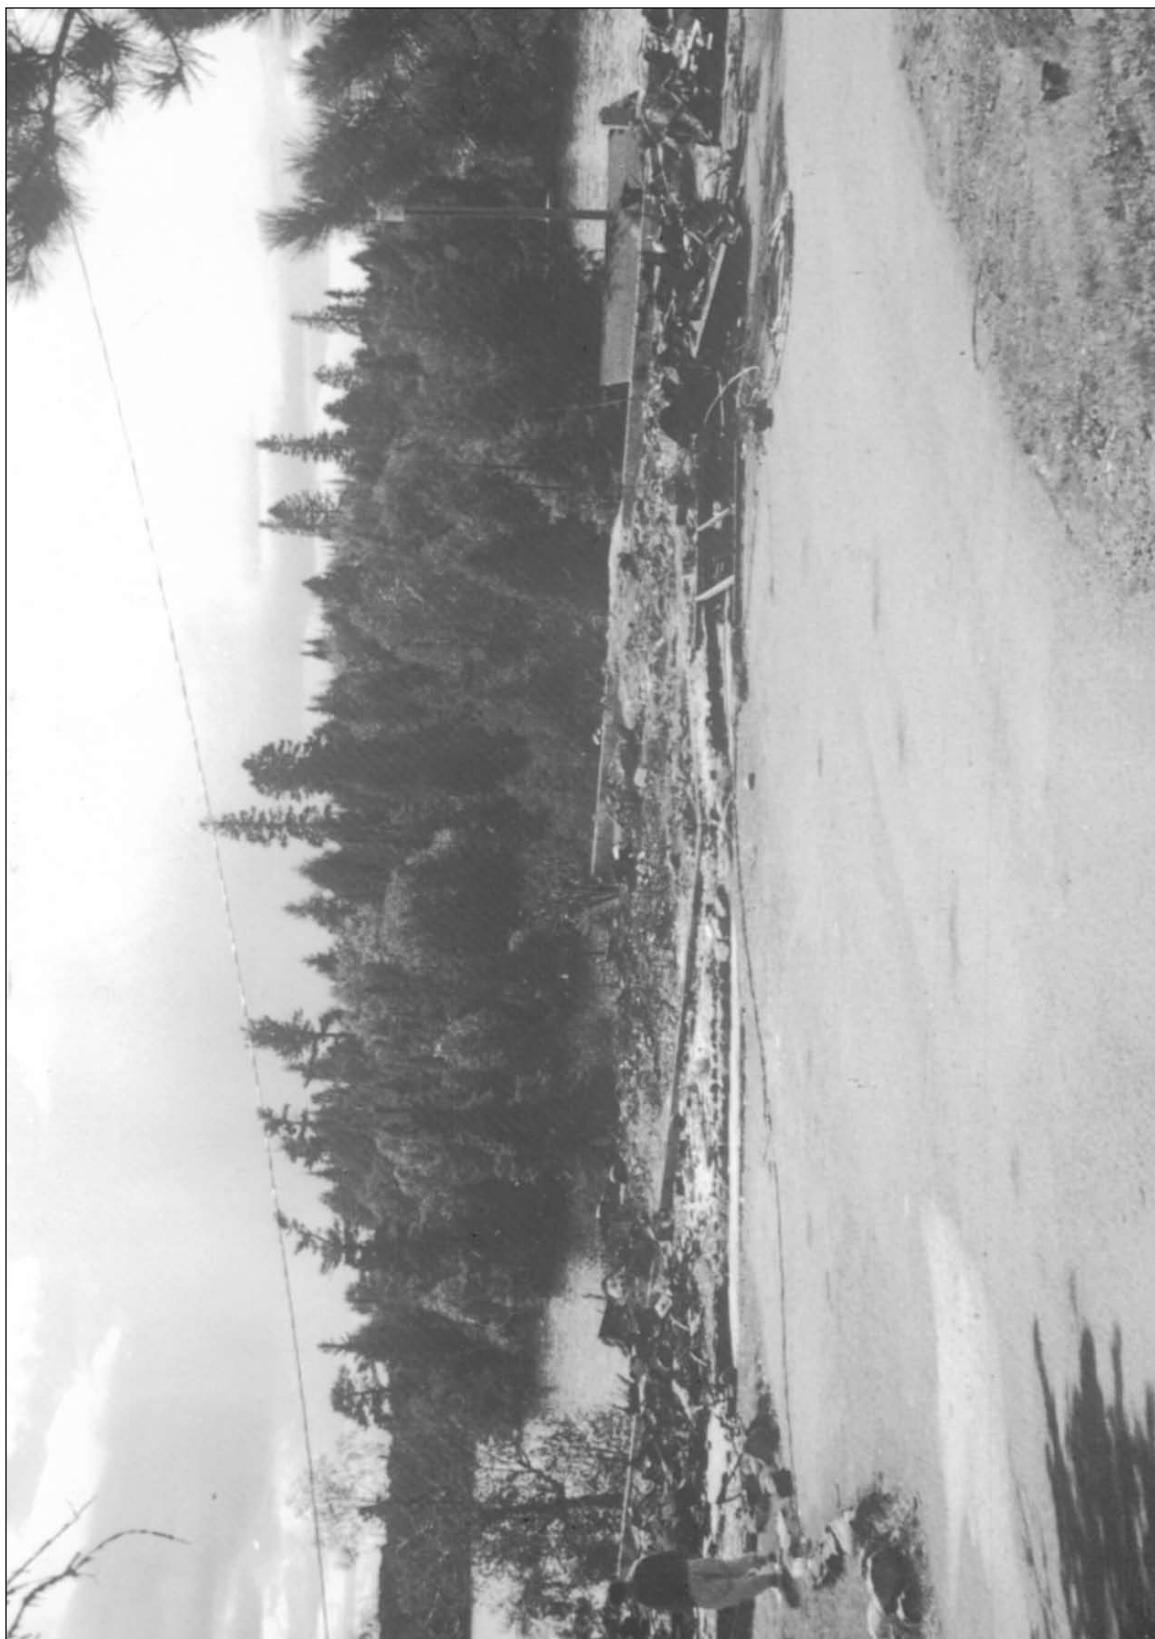
Remains of Windigo Lodge from east drive, facing lake.

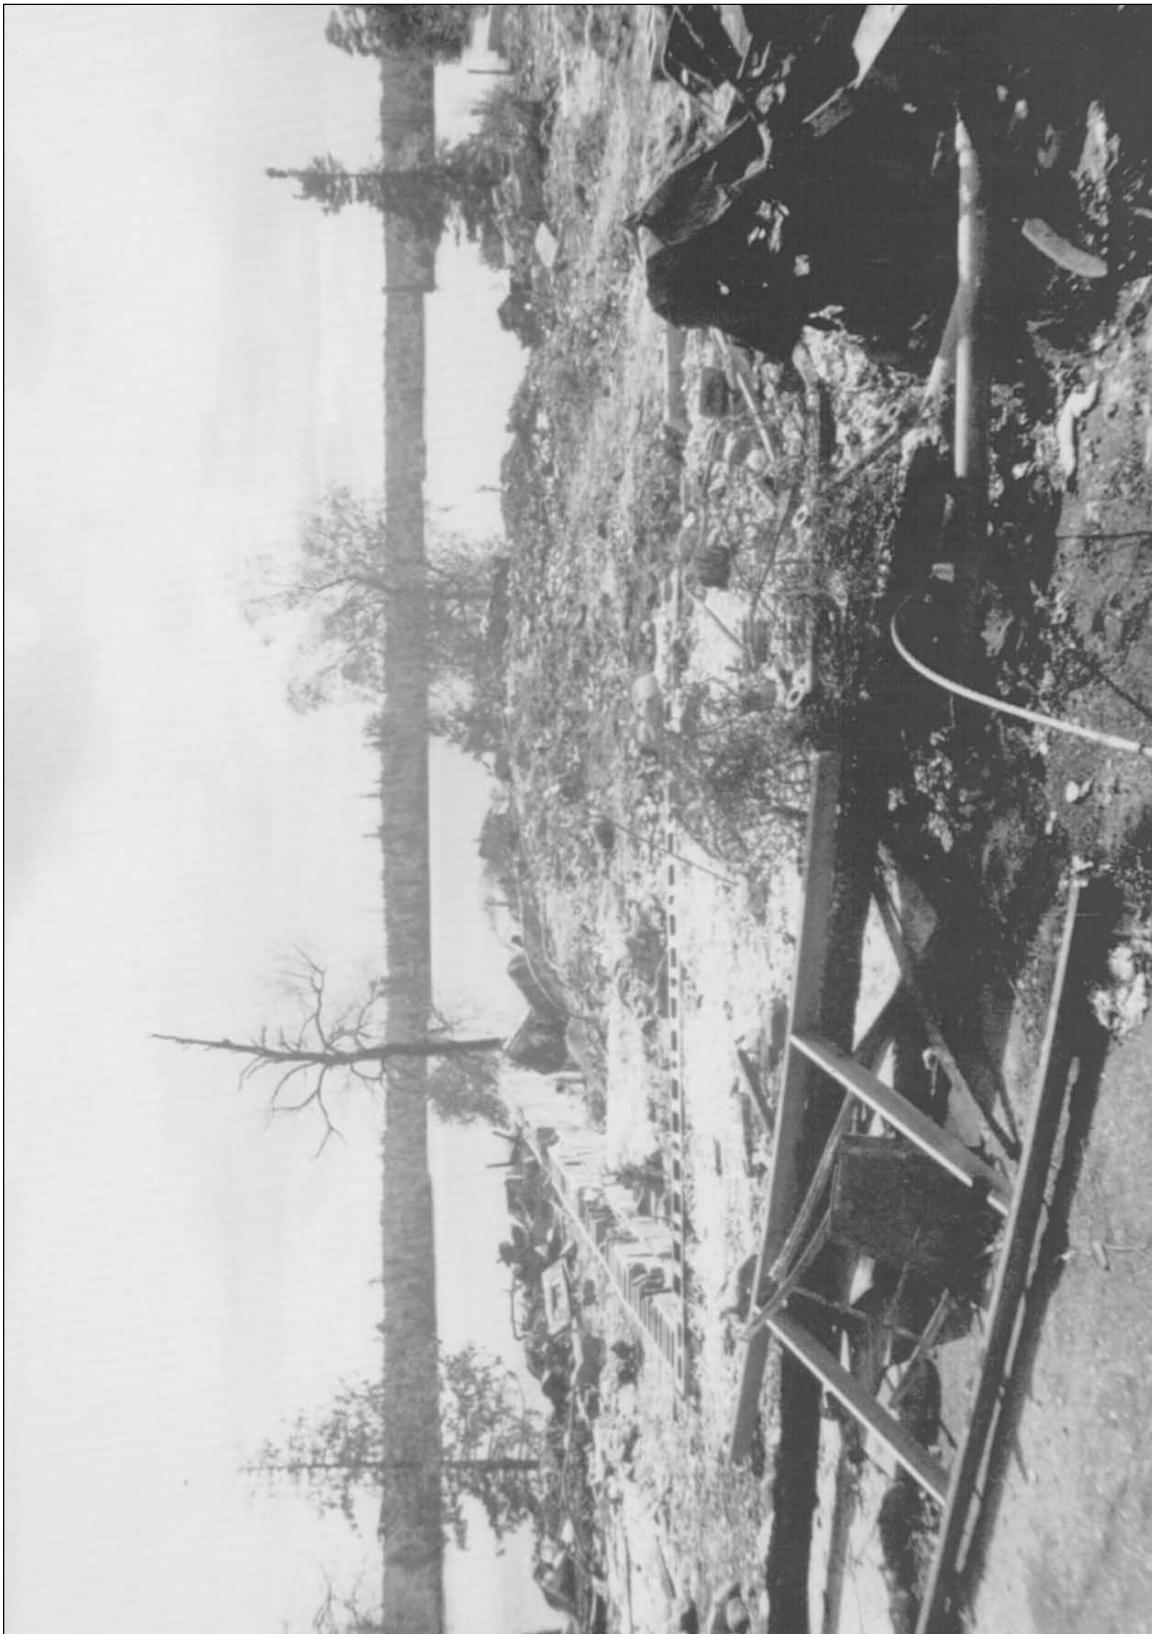
Entire structure was consumed by fire; east and north foundation walls shown here.

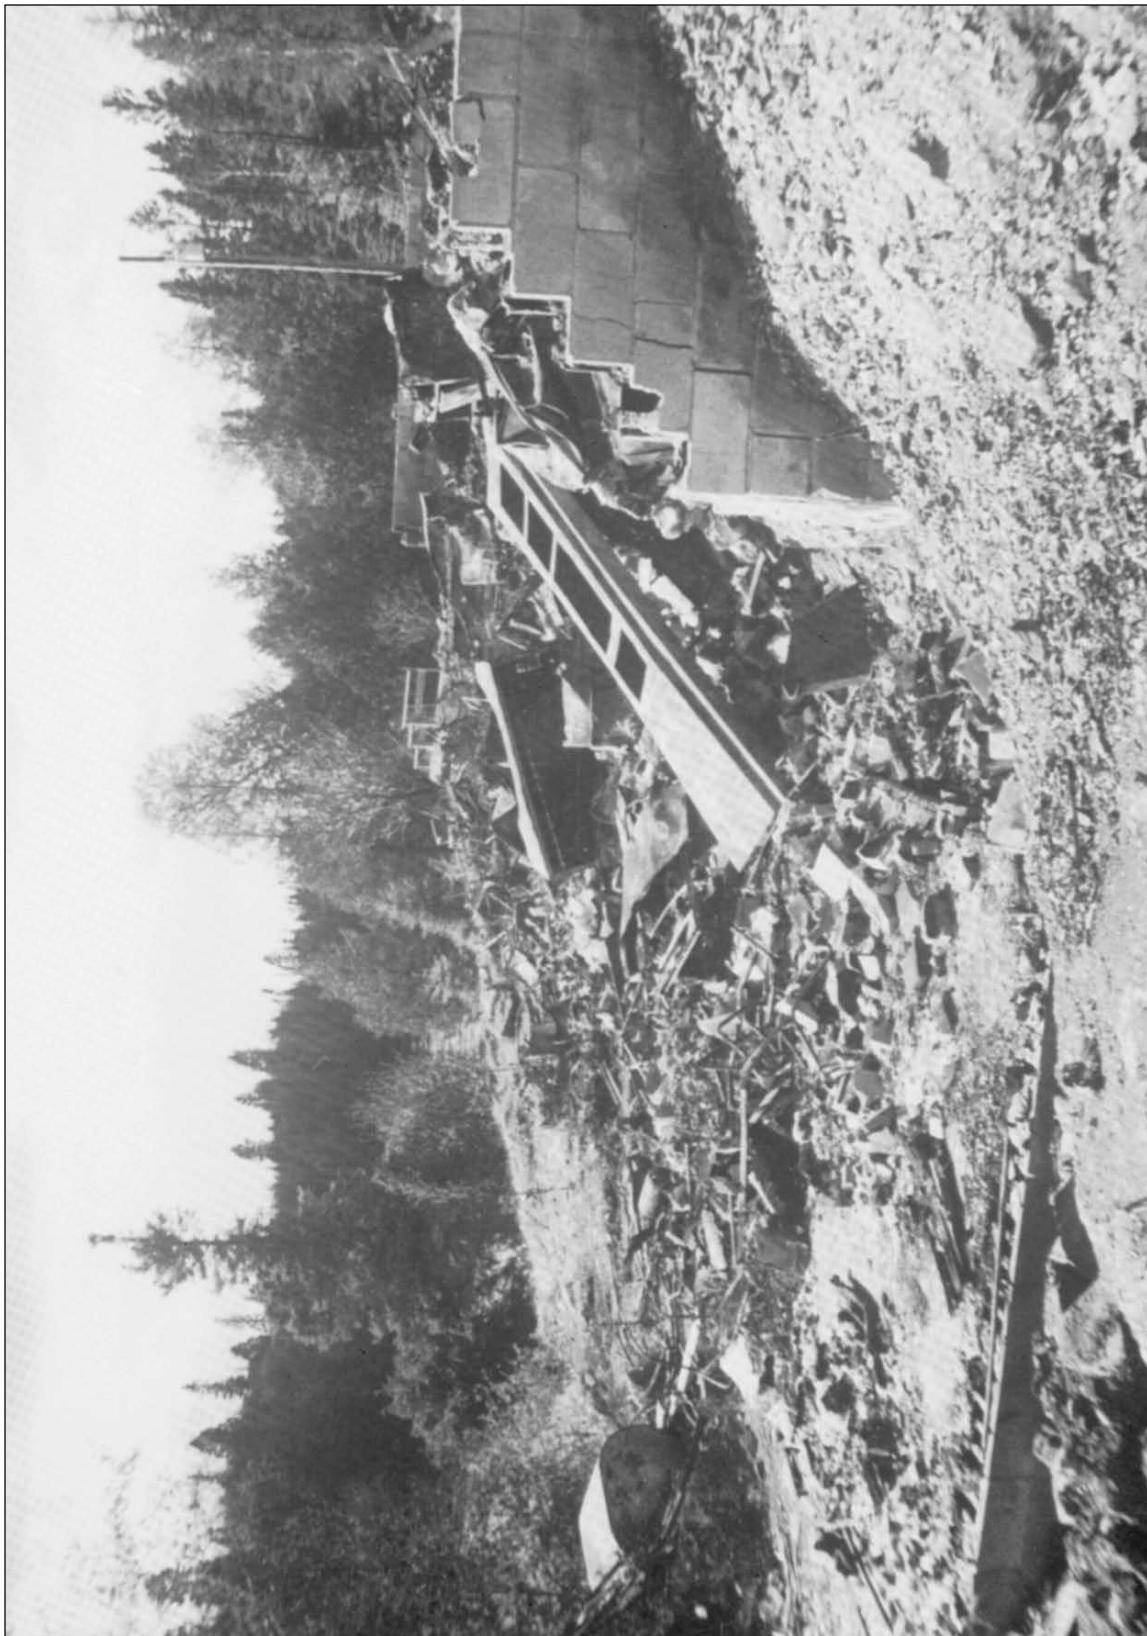
Photo by James W. David
East foundation wall and basement walkout to lake (off photo to left); basement wood frame construction consumed by fire.

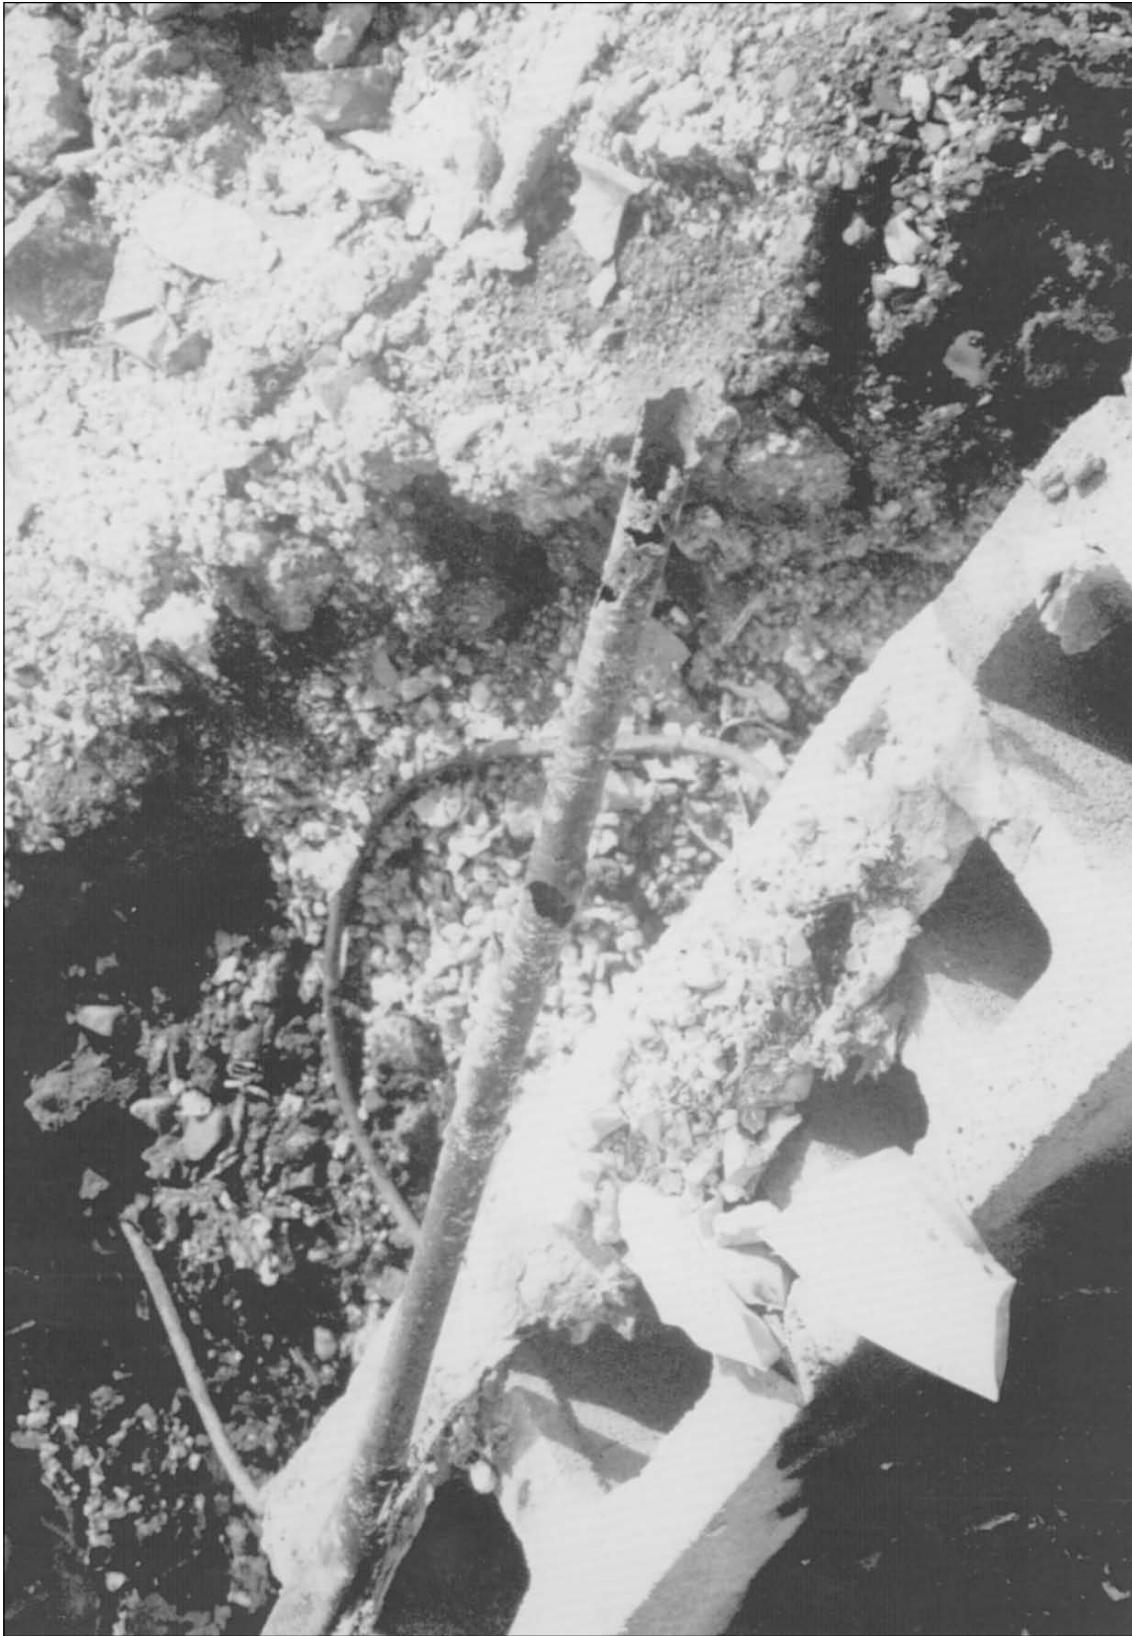
Damage to 3/4-inch copper water pipe from intense heat of the fire.
