U.S. Fire Administration/Technical Report Series

# Twelve-Fatality Hotel Arson

Reno, Nevada

USFA-TR-164/May 2008

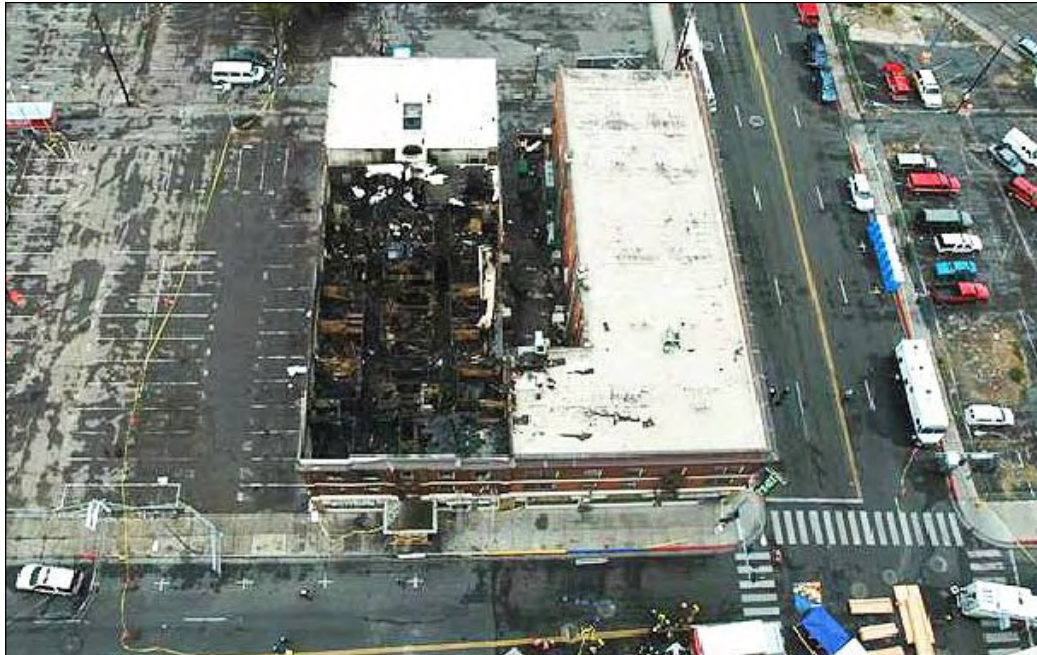
**Figure 14. Extent of Fire Damage—North Wing.**

**Fire Investigation Process**—A systematic postfire investigation was conducted of the building, moving from areas of least fire damage to areas most heavily damaged. Scene processing began with an inspection of the exterior of the building. The entire exterior of the building was photographed from the ground, from overhead using aerial apparatus, and from the roof of Harrah's Hotel and Casino across the street from the Mizpah Hotel. It was determined that the fire had been contained to the north wing, and did not extend into the south wing, which was the goal of the

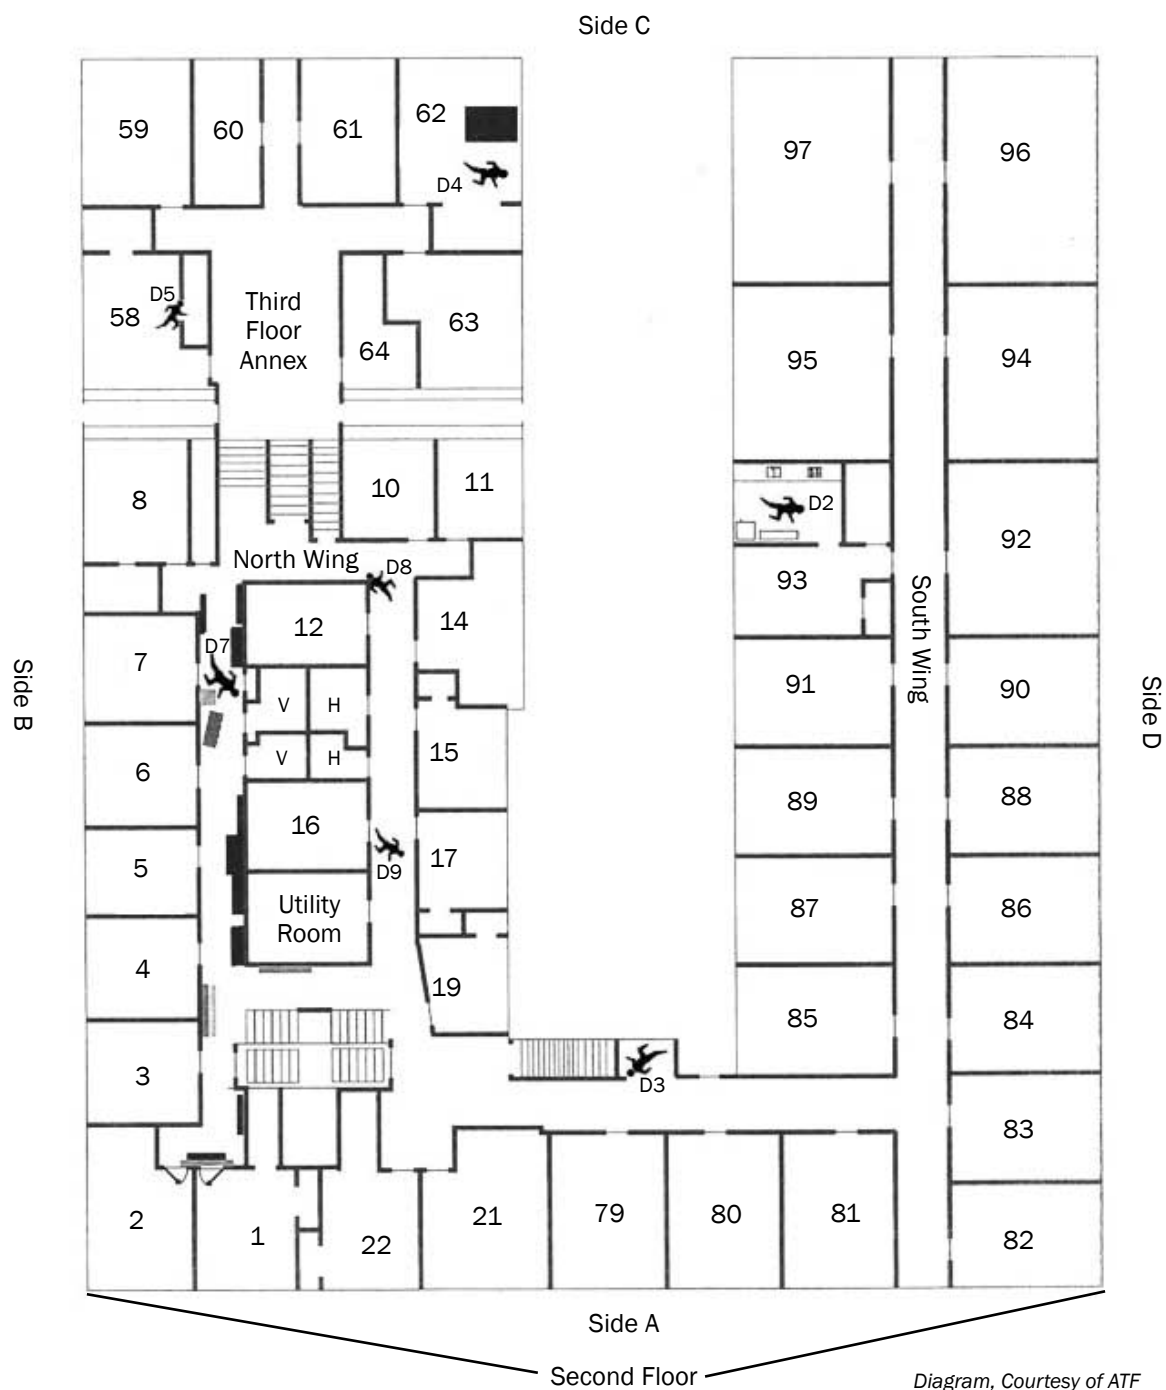
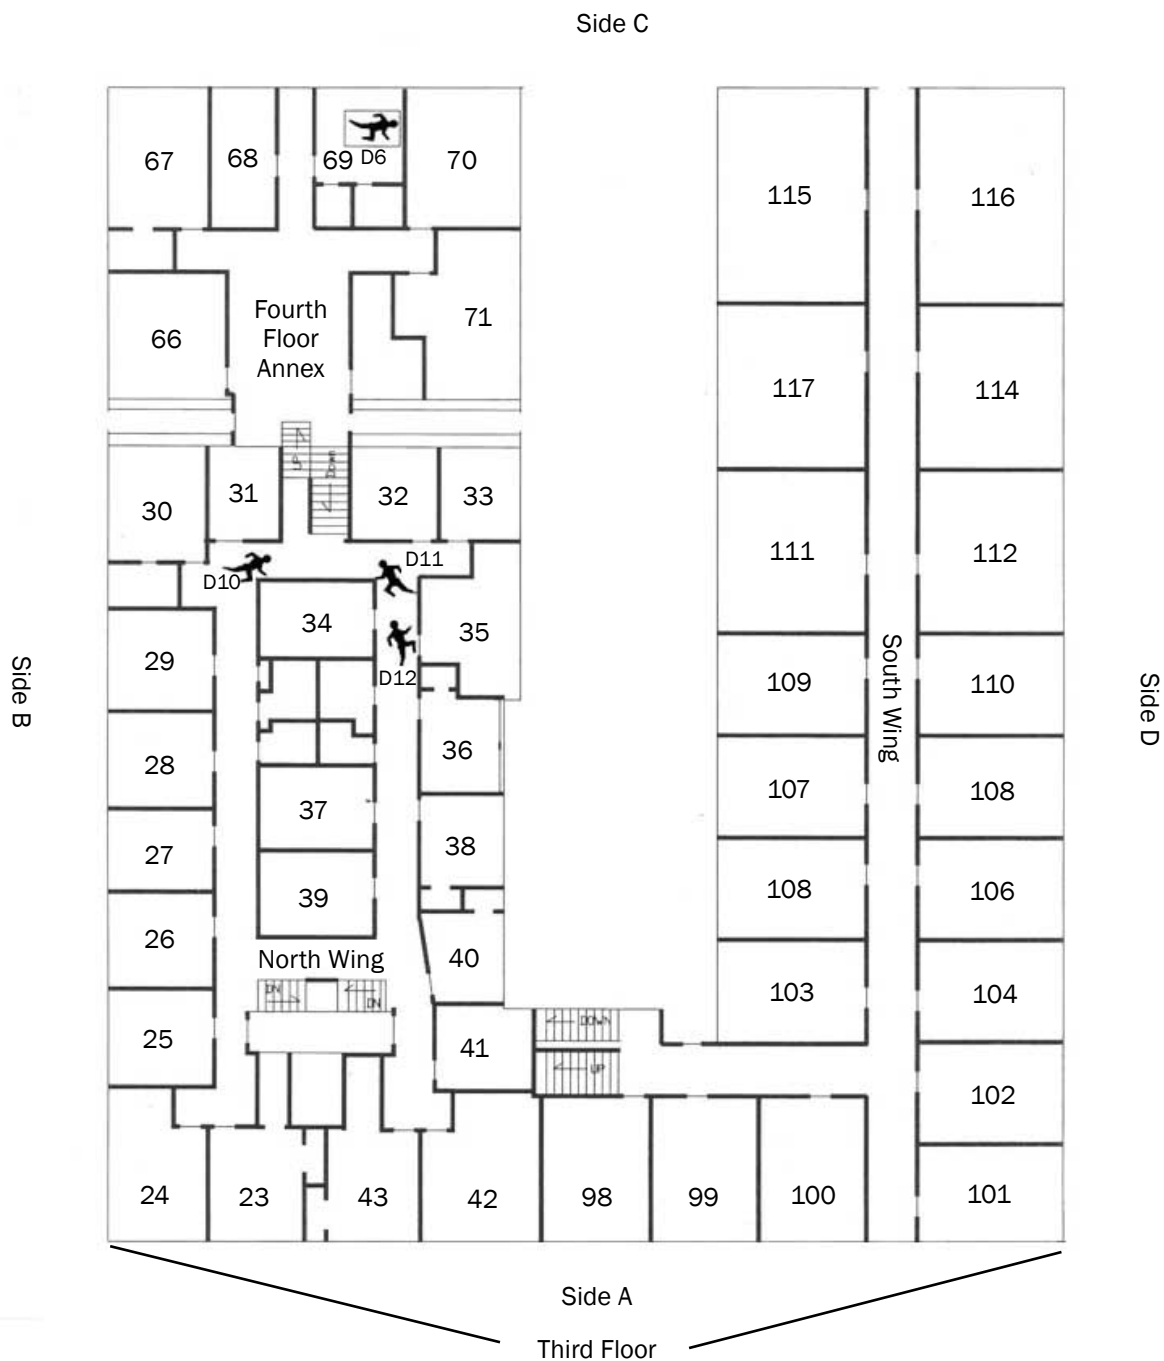
According to the IC, many of the building occupants who attempted to exit the building through the interior corridor perished in the fire. Seven of the 12 fire fatalities were found in the hallways during the postfire investigation. Figure 15 and Figure 16 show the locations where the fire victims were found.

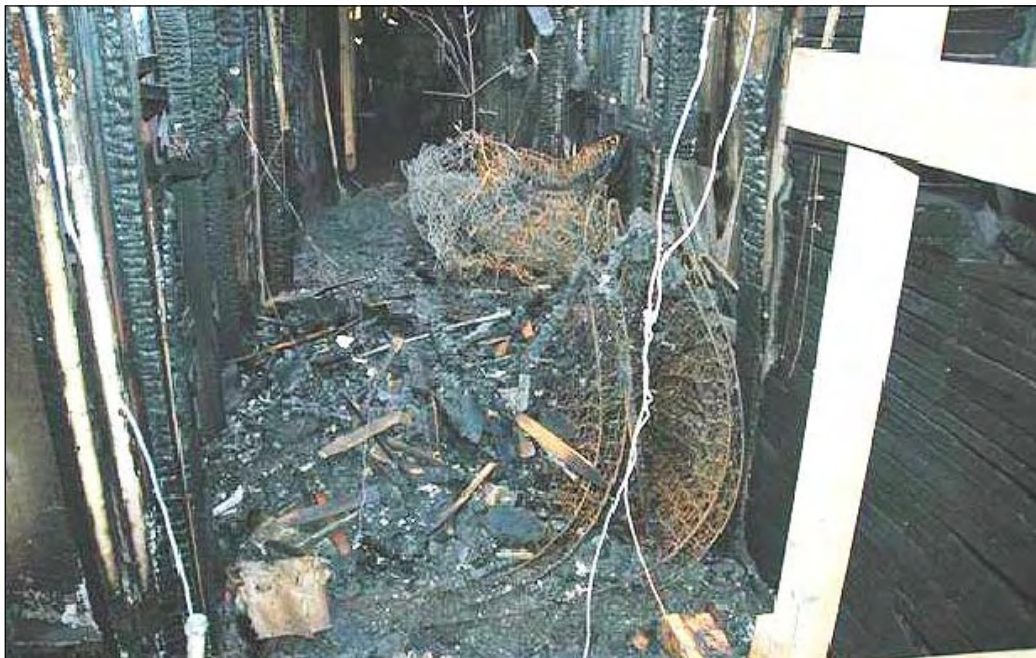
**Figure 17. Remnants of Mattresses in the Hallway of the Second Floor.**

The burn patterns along the north and south hallways of the north wing were representative of the 16 mattresses and box springs found along the second-floor hallways. Figure 17 shows the remnants of mattresses along the second-floor hallway. Some mattresses had been stacked together three deep. The mattresses supplied the fuel for the rapidly spreading fire through the hallways.

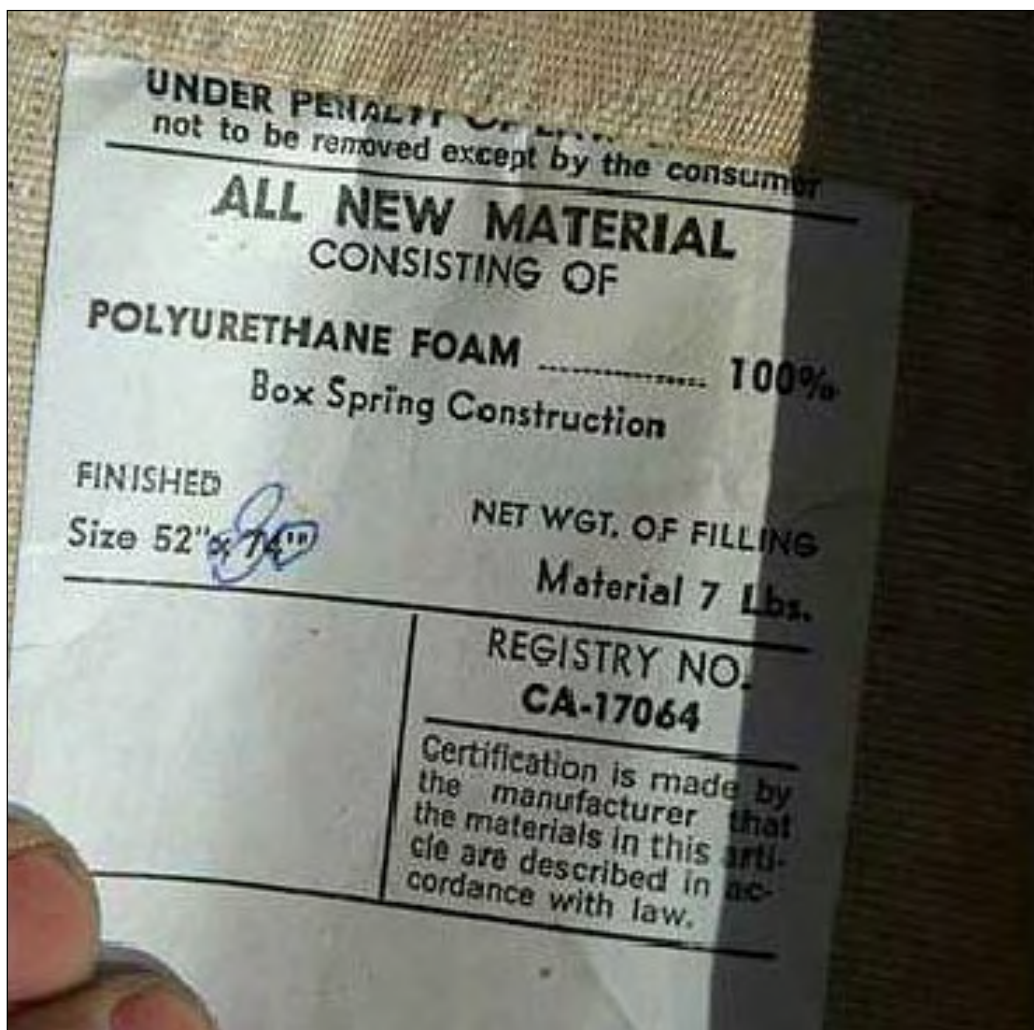
**Figure 17. Remnants of Mattresses in the Hallway of the Second Floor.**

**Fuel Load**—Several factors influenced the rapid spread of the fire. The first was fuel load. There were mattresses in the north hallway the day of the fire; the bulk of those old mattresses were ready for removal from the hotel. These were all twin institutional-grade mattresses and box springs, which measured 52 inches wide and 74 inches tall. The mattress tags read that the mattresses were 100-percent polyurethane foam, having a net weight of seven pounds of filling. Figure 18 is a photo of a mattress tag taken by ATF agents; it lists the type and quantity of padding contained in the mattresses that were stacked along the hallway walls.

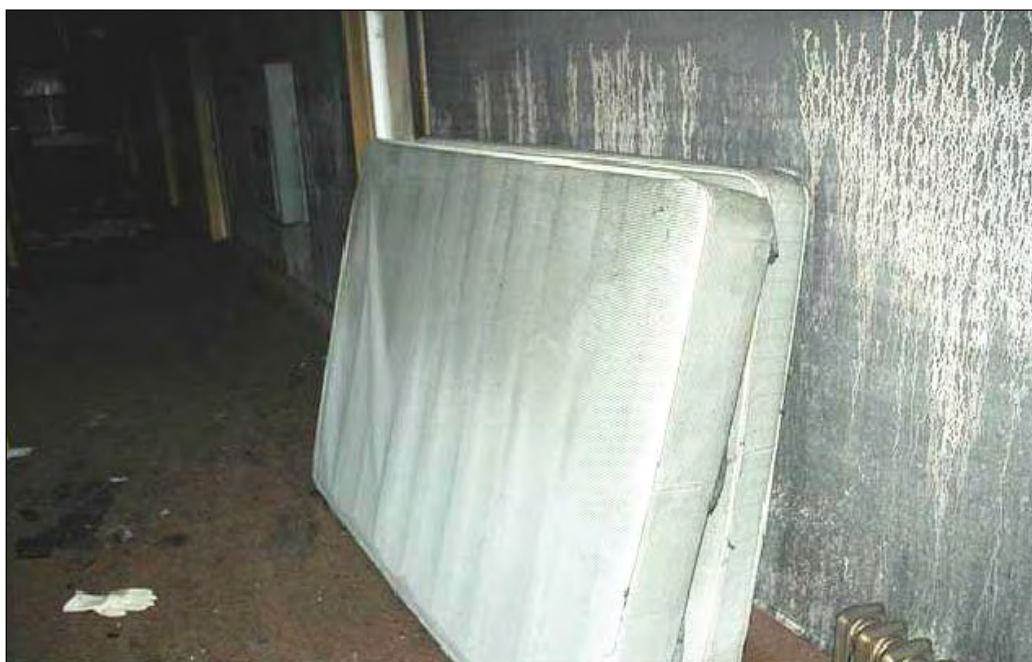
**Figure 19. Typical Mattresses That Lined the Second and Third Floor Hallways.**

The manner in which the mattresses were stacked against the wall aided in the spread of the fire. The mattresses were stacked vertically, and in some cases horizontally against the hallway wall. This placement allowed air to circulate around the mattresses, rapidly spreading the fire. Figure 19 shows the typical mattresses and how they were stacked along the walls of the hallways.
