# UNITED STATES COAST GUARD

## REPORT OF INVESTIGATION INTO THE FIRE ONBOARD THE CARNIVAL SPLENDOR WHICH OCCURRED IN THE PACIFIC OCEAN OFF THE COAST OF MEXICO ON NOVEMBER 8, 2010, WHICH RESULTED IN COMPLETE LOSS OF POWER

MISLE INCIDENT INVESTIGATION ACTIVITY NUMBER: 3897765

16732  
July 15, 2013

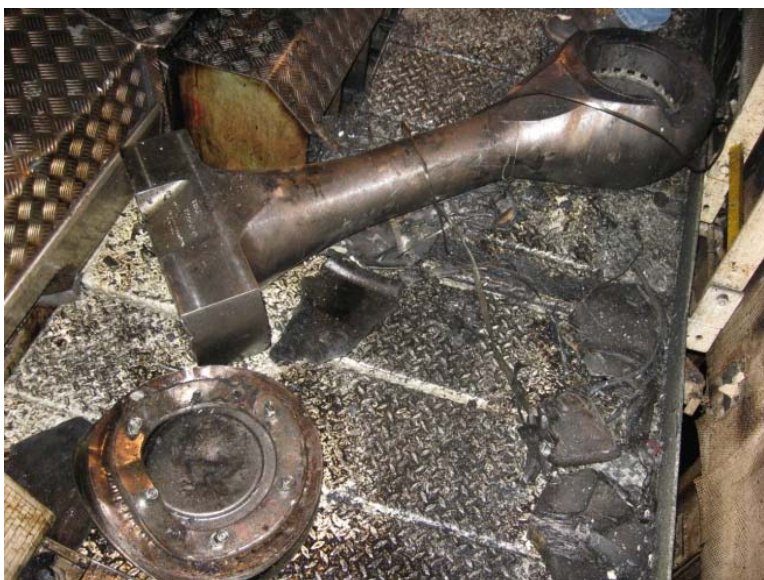
Post-casualty inspection of the DG 5 prime mover revealed a catastrophic failure primarily involving the components of one set of cylinders. The failures of the two connecting rod and piston assemblies in the A1 and B1 locations on DG 5 destroyed the engine so that it was no longer usable. The connecting rod upper components sheared from the connecting rod lower parts on two cylinder sets. Connecting rod upper part B1 was in two pieces in the oil sump, while connecting rod A1 (780 lbs) had ejected out of the crankcase.

**Photograph 1 - Connecting rod, upper part A1 (780 lbs) ejected from DG5 and found on deck plates in aft engine room.**

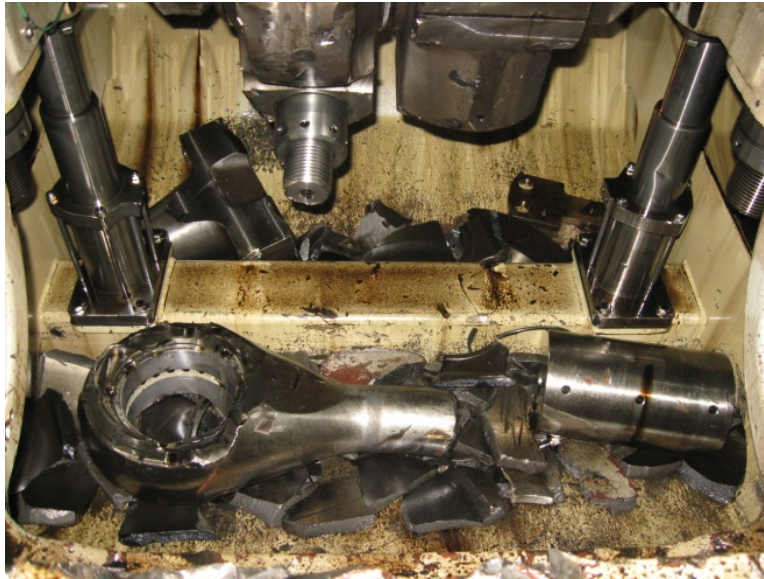
Both pistons were broken and were liberated from the crankcase. Both piston crowns were cut from each piston skirt. The B1 piston gudgeon pin was found in the sump, while A1 was ejected from the crankcase. The heaviest component ejected was the crankshaft counterweight which landed on the starboard side of the engine between DG 5 and DG 6 in the primary burn area. The free end side of the counterweight of crank number one had been ejected from the crank case damaging the engine block on its way. The lower halves of each connecting rod were seized on the crank pins (crank shaft journals). The lower parts of the cylinder liners were each destroyed and the engine block severely damaged.

**Photograph 2 - - Connecting rod, upper part B1 in two pieces found in the oil sump**

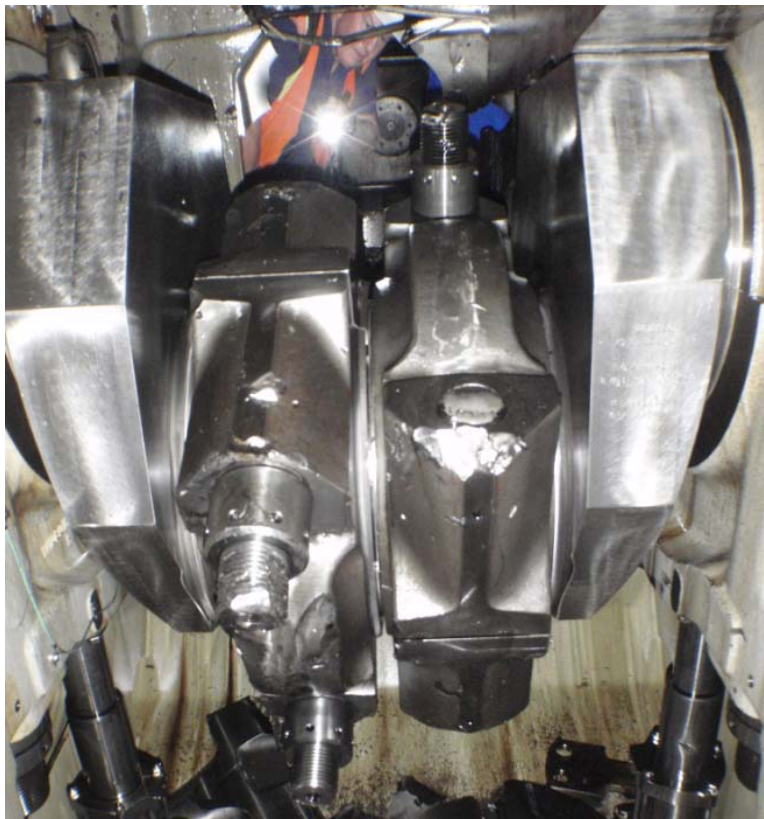
**Photograph 3 - Lower halves of A1 and BA connecting rods for DG5, each were seized on the crank pins (crankshaft journals).**

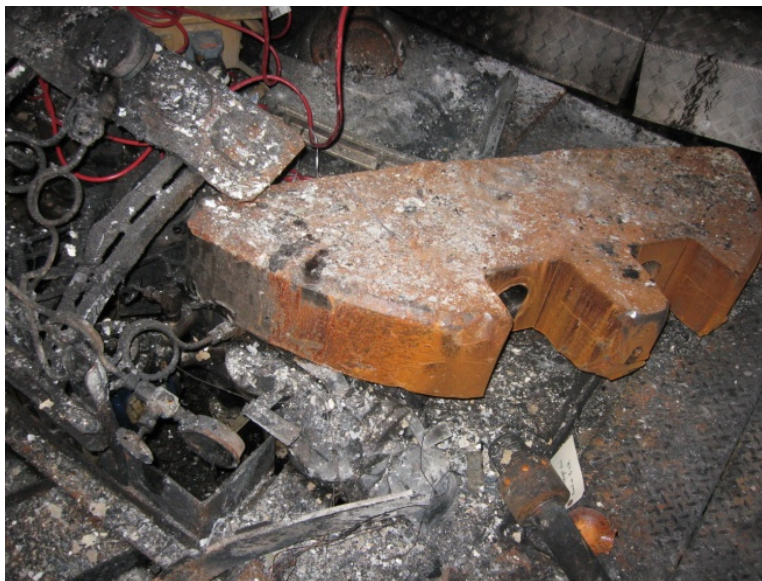
**Photograph 4 - Crankshaft counterweight from DG5, A1/B1 cylinder. Counterweight was ejected from engine and landed between DG5 and DG6 in the primary burn area.**

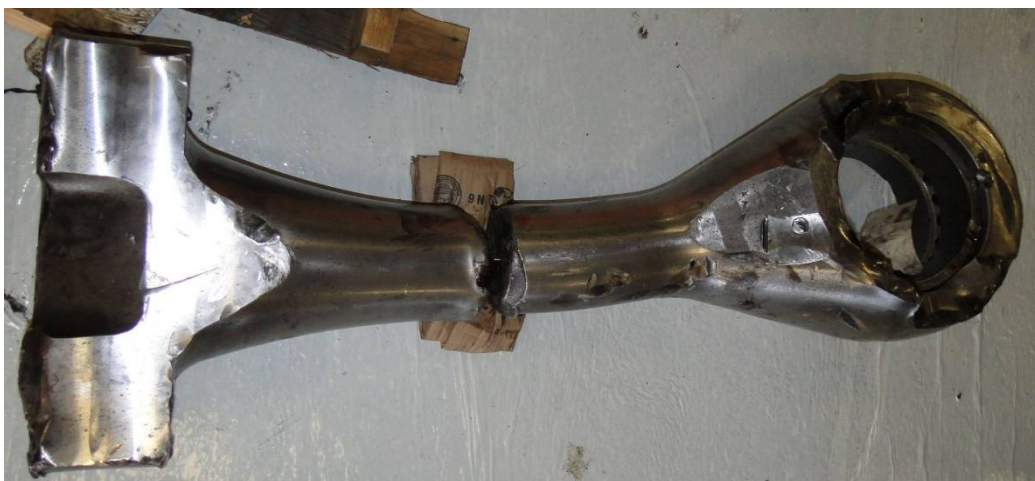
**Photograph 5 - B1 Connecting Rod for DG5  
Post-casualty photo provided by Wartsila**

*“Results of the evaluation conducted indicated that the subject connecting rod failed by progressive fracture in the nature of high cycle, low stress fatigue. The origin of the connecting rod fracture could not be determined due to the severe impact damage to the fracture surface. Nevertheless, the crack origin of a secondary fatigue crack evident approximately 5.5 in. above the primary fracture surface was determined to be at the*

*extrados of the bent connecting rod shank. This indicated that the fatigue crack most likely initiated as a result of increased surface stresses at the extradados after the connecting rod shank was bent. It further indicated that it is likely that the fracture origin of the primary fracture was also located in an area of raised surface stress at or near the connecting rod extradados."*

LPI reported that the stress state in the connecting rod was "not present from the beginning of the diesel engine's service life" and that the "bend in the connecting rod shank elevated surface stress in the shank to a sufficient level to initiate fatigue cracking which propagated and caused the connecting rod to fracture."

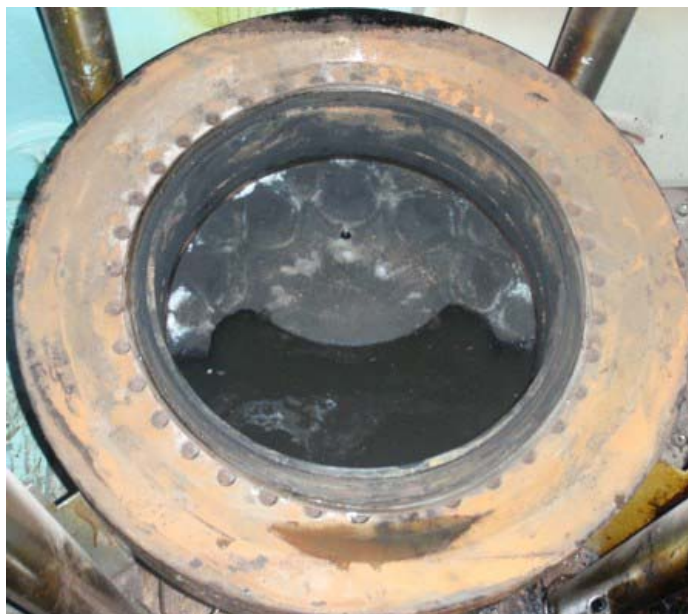
Photograph 6 (below) was taken by Carnival employees during the head gasket replacement. The cylinder surfaces show significant carbonization which indicates incomplete combustion. While this phenomenon may have been attributed to a bent connecting rod, the engineers involved in the work did not make that diagnosis, and did not observe any problems with the engine which led them to believe there were issues with the B1 connecting rod.

**Photograph 6 - DG5, B1 cylinder liner, piston crown and gasket**  
**Photo taken by Carnival employees during head gasket replacement on November 5, 2010**

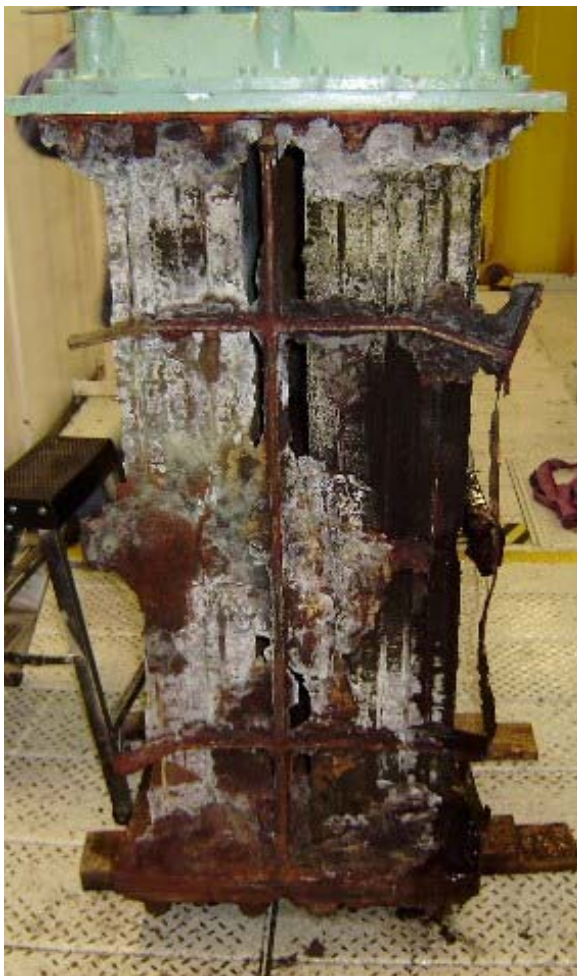
Onboard the Carnival Splendor as recently as July 12, 2010, the B bank of DG5 was discovered to have a severely corroded, destroyed and leaking air cooler heat exchanger. The cause of the corrosion was suspected to be: 1) failed drainage of the condensate formed on the outside of the tubes and away from the heat exchanger, 2) a leaking heat exchanger tube, and 3) backflow from other operating engines when the engine is secured or during temporary exposure from other leakages such as when the exhaust gas boiler flooded back to the engine during refilling. Photograph 7 shows the bottom of the heat exchanger having rusted away almost a complete steel 27 plate between its frames. Photograph 8 shows the plate of a new heat exchanger having slightly different construction.

**Photograph 7 - Corroded heat exchanger from DG5.**  
Photo provided by Wartsila, taken on July 12, 2010

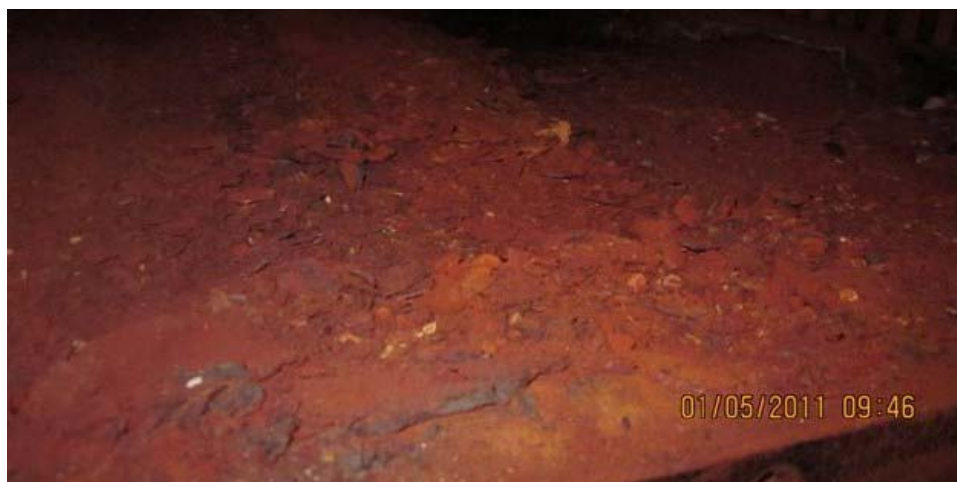
Post-casualty inspection of the DG5 air coolers revealed significant quantities of ferrous oxide scaling and rust in the air cooler base area and outlet areas of the B side of DG 5 air cooler, as shown in Photograph 9 and Photograph 10. The heat exchangers were tested and found not to be leaking. The receiver runs the length of the engine and connects to the air inlets of both banks of heads. In Photograph 11, scale is shown in a drain valve connection on the pressure side of the orifice when the engine is running. There is no evidence of screens or other devices to protect against the clogging of the drains by rust particles within the air cooler. Photograph 12 provided by Carnival shows the sight glass of the B1 cooler. The sight glass developed a visible haze over the inspection port which obstructed the viewing port and made observation of water flow very difficult.

**Photograph 9 - DG5 air cooler, outlet area**

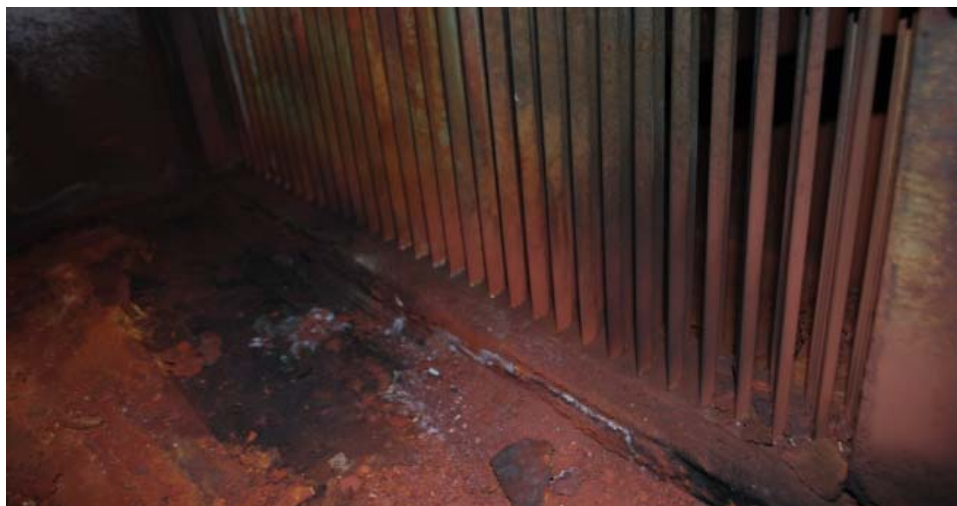
**Photograph 10 - DG5 air cooler, outlet area**

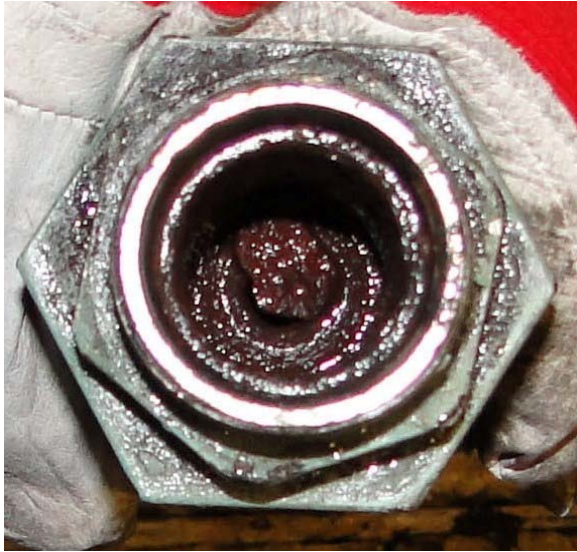
**Photograph 11 - DG5 air cooler, drain valve connection.**

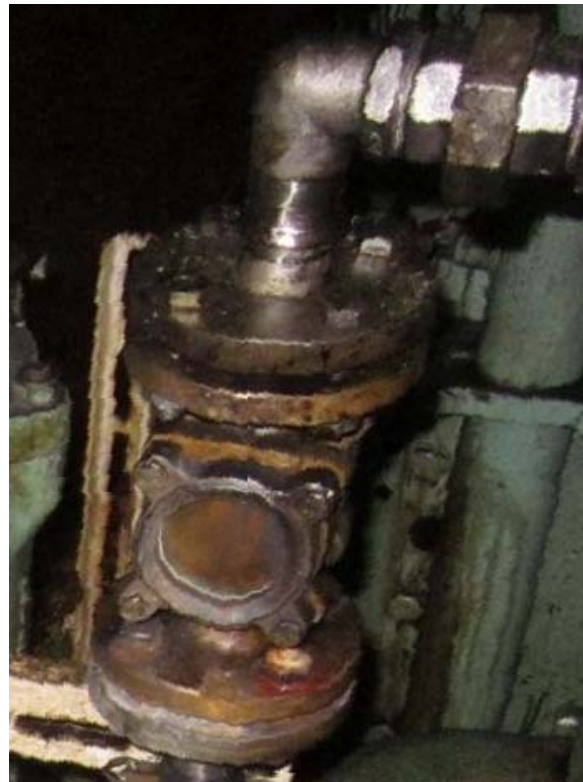
**Photograph 12 - DG5 air cooler, sight glass for B1 cooler.**

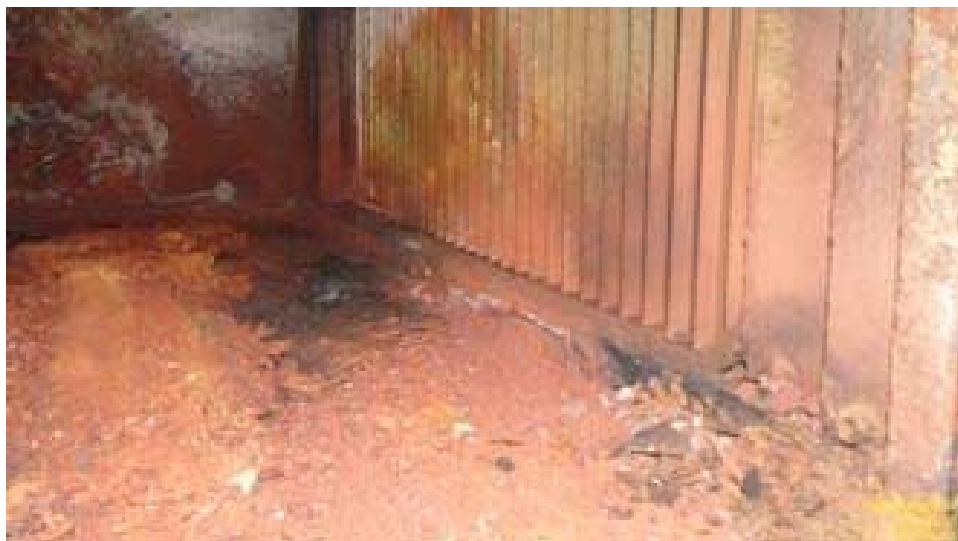
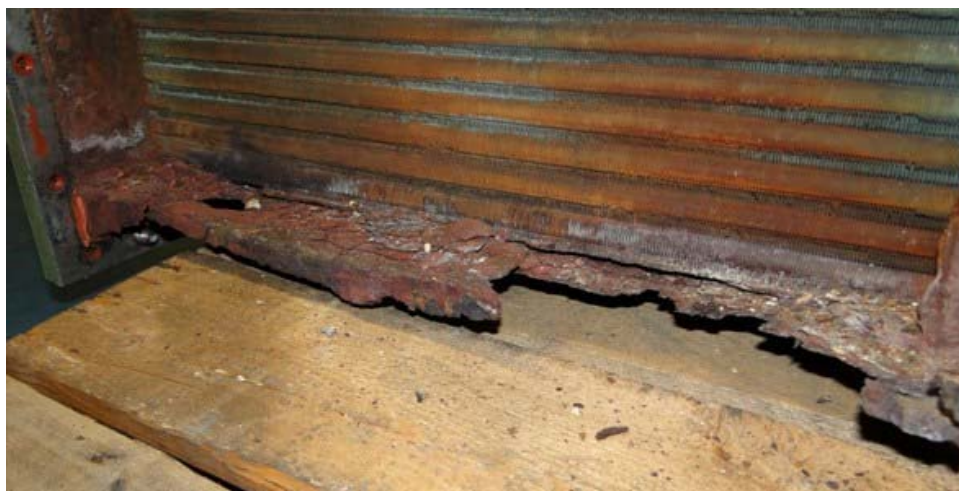
Post-casualty, the A side of the DG5 air cooler was also found in a stage of deterioration. Its casing area was also heavily contaminated with ferrous oxide/rust. Its base also showed significant evidence of deterioration.

**Photograph 13 - DG5, A side air cooler.  
Photo taken by Wartsila**

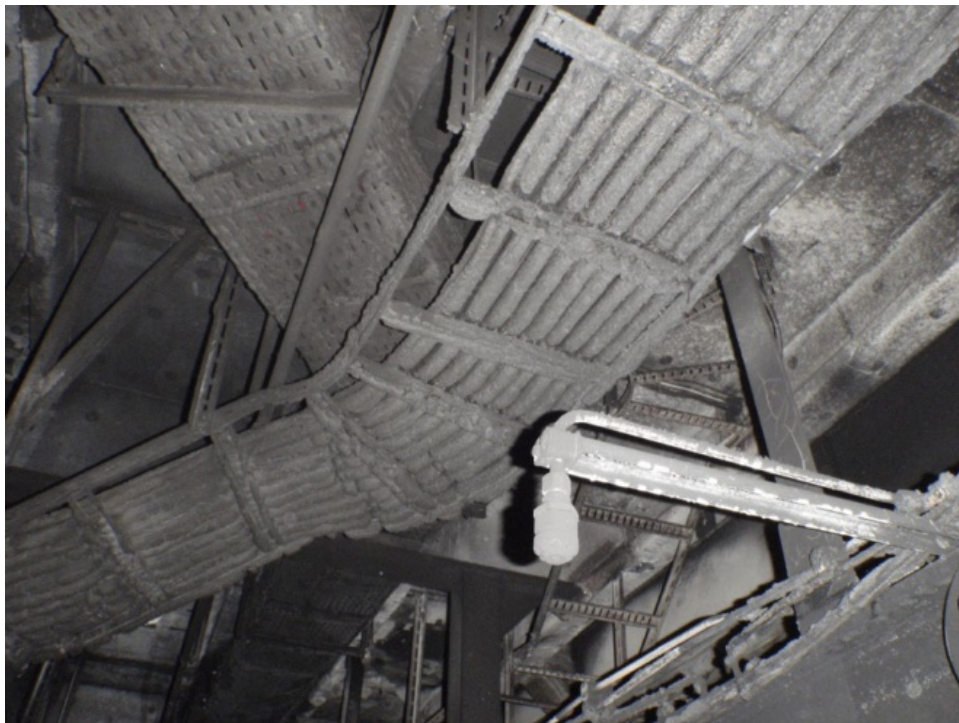
**Photograph 18 – Overhead cable runs above DG5 and DG6  
Note the location of the Hi-Fog nozzle below the cables runs**

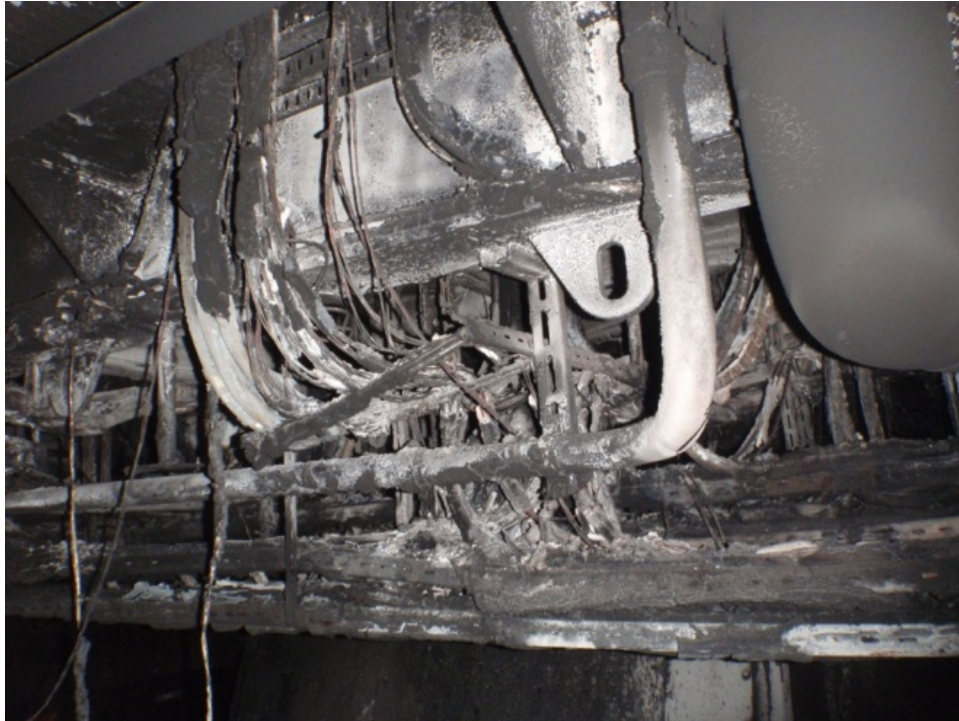
**Photograph 19 – Vertical cable runs; note bare cables due to fire damage**

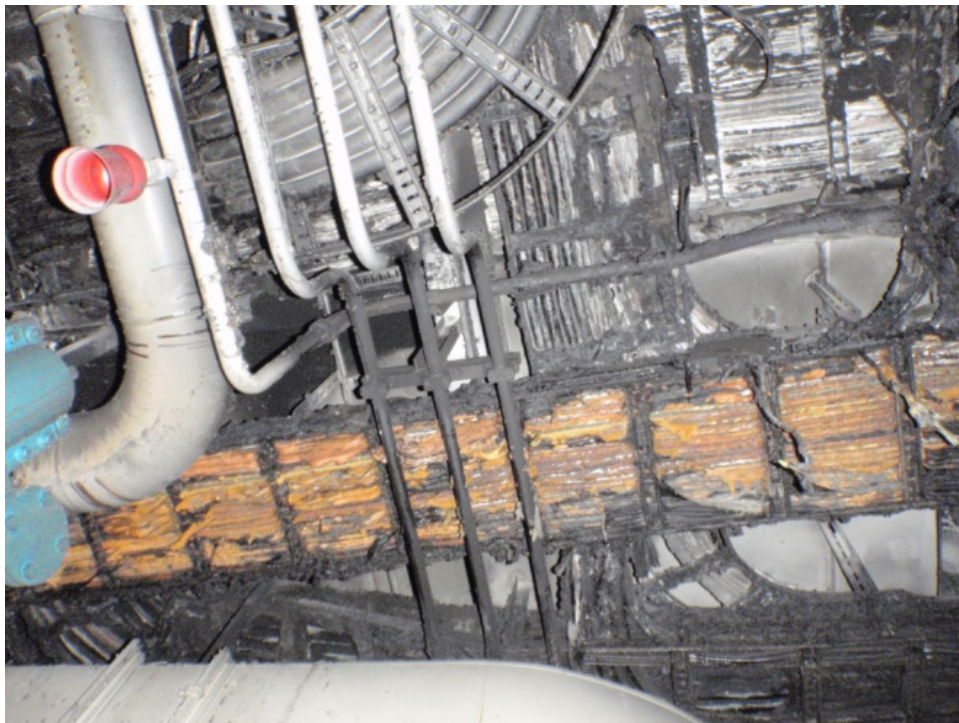
**Photograph 20 – Cables above DG4 showing melted orange cable covering**

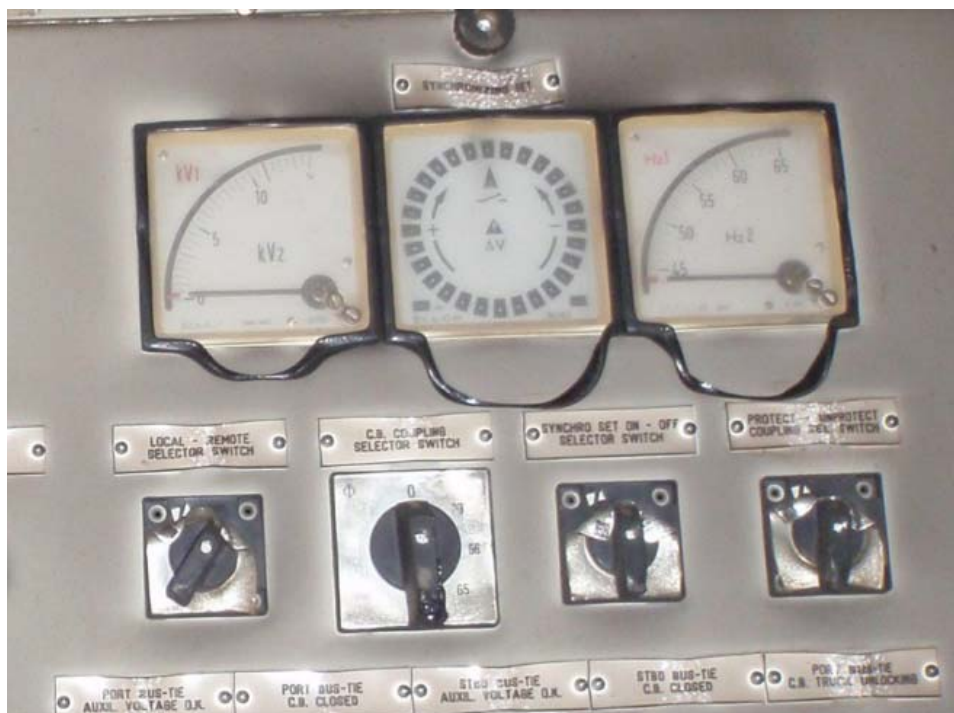
**Photograph 21 – Console in starboard switchboard room showing melted plastic components.**

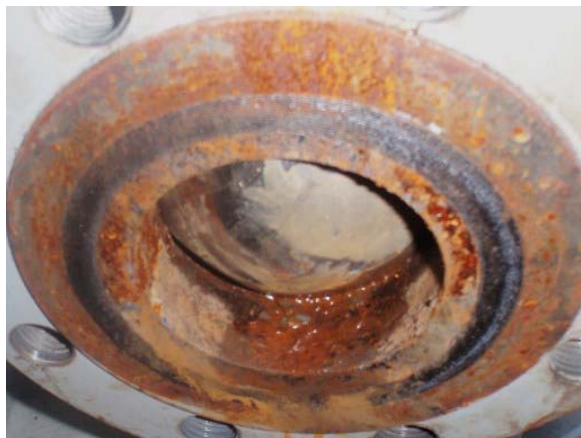
When the piping segment associated with the discharge leading to the aft machinery space was taken apart a small amount of moisture drained out and some corrosion was noted (see

**Photograph 22 - CO2 system, 3-inch ball valve to aft machinery spaces**

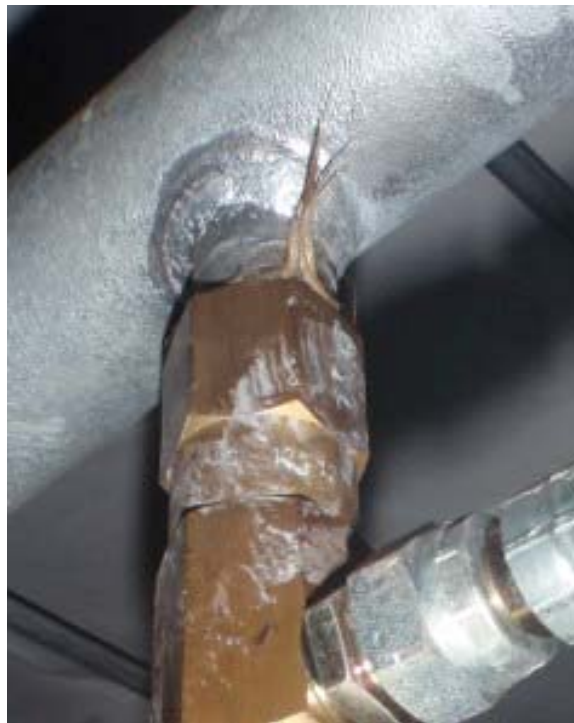
Photograph 22). In addition, hemp type packing was noted at various pipe fittings and seal screwed connections (see Photograph 23).

**Photograph 23 - Photo showing hemp packing in CO2 system fittings**

Many connections using hemp leaked. In one control cabinet, the control valve handles had been incorrectly fitted. A number of the fasteners securing the actuating arms to different control valves were discovered loose.
