# HISTORIC STRUCTURE REPORT The Wright Cycle Company Building

(HS - 01)

Dayton Aviation Heritage National Historical Park  
Dayton, Ohio

March 31, 1999  
Final Submission

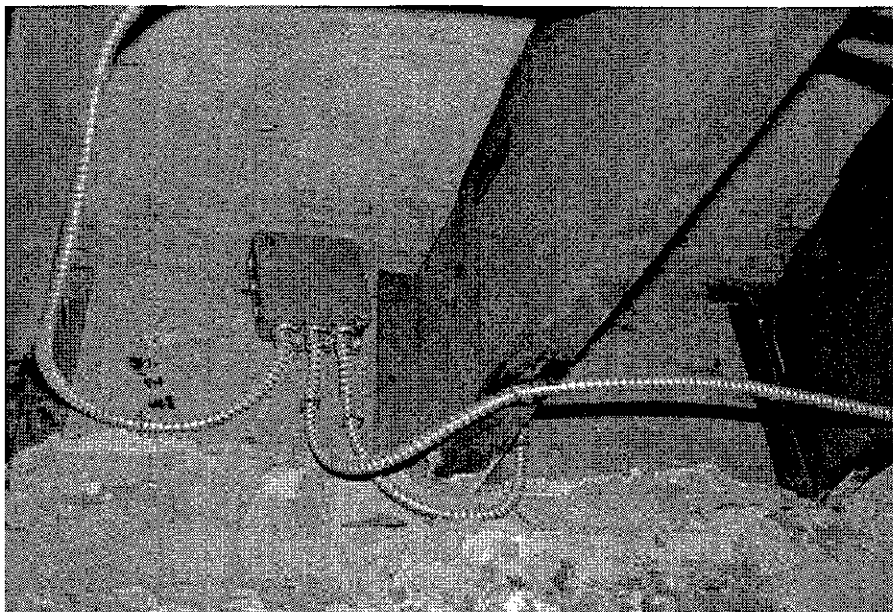
*Figure 4 View of the joists rolled on the south bearings and new metal joist hangers, 1996 (Fitzpatrick Structural Engineering).*

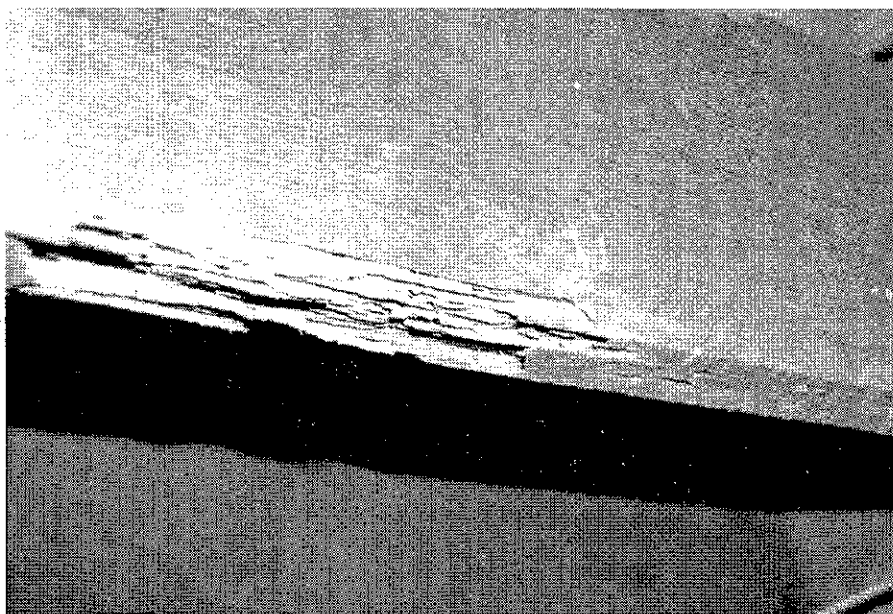
This insect damage appears to have ceased and the new members have reinforced this western end of the first floor. The four western-most members have been replaced with newer 2x12s (nominal). The fifth western-most

*Figure 5 View of the insect damaged joist, 1996 (Fitzpatrick Structural Engineering).*
