# GUIDELINES FOR REHABILITATING HISTORIC COVERED BRIDGES

**Edited by Christopher H. Marston and Thomas A. Vitanza**

National Park Service, Historic American Engineering Record  
National Park Service, Historic Preservation Training Center  
Federal Highway Administration, Turner-Fairbank Highway Research Center

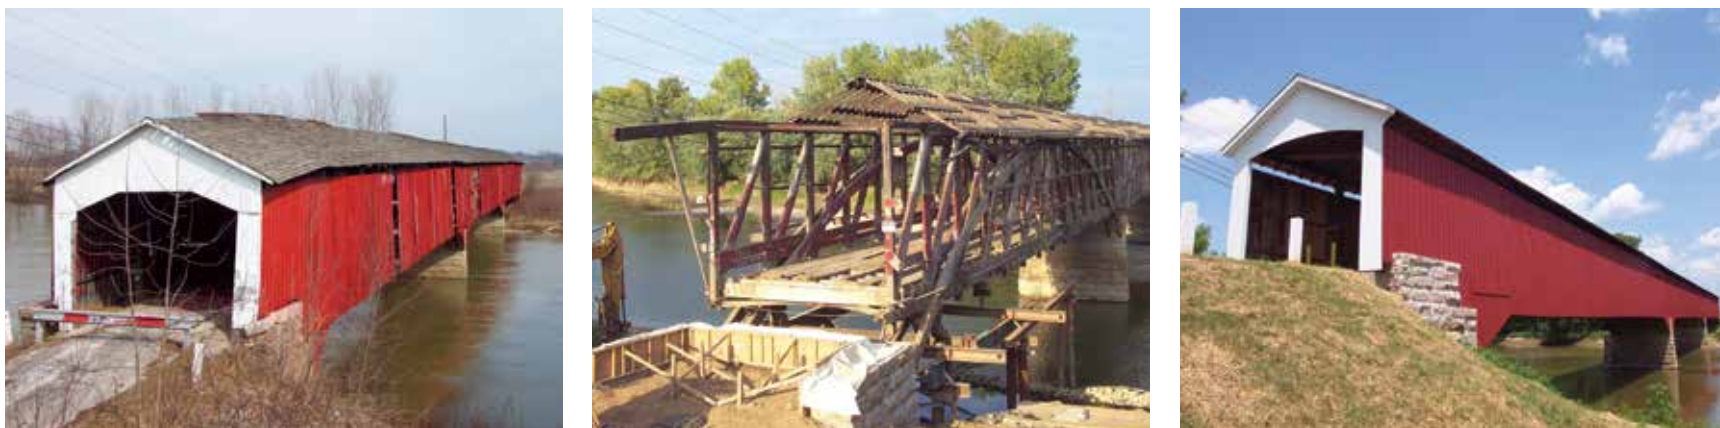
**Figure 0.6a-c** Before/During/After photos of Medora Bridge, IN. A complete rehabilitation was necessary due to failing abutments and a deteriorated roof causing decay in truss members. The crew carefully took apart the abutments, poured a new reinforced concrete slab, and put the original stones back in place.

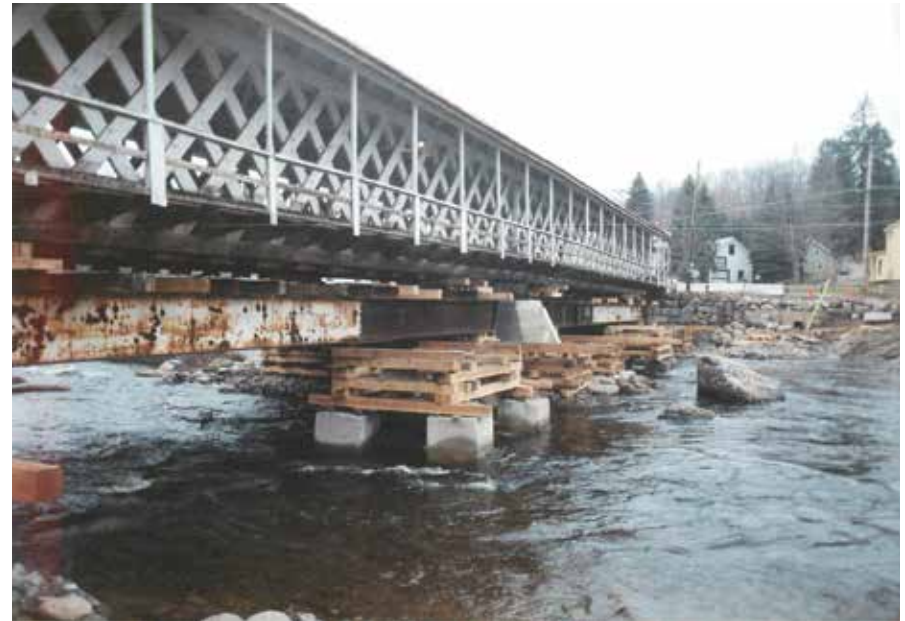
**Figure C1.8** Shoring underneath bridge. Sean T. James, 1998.

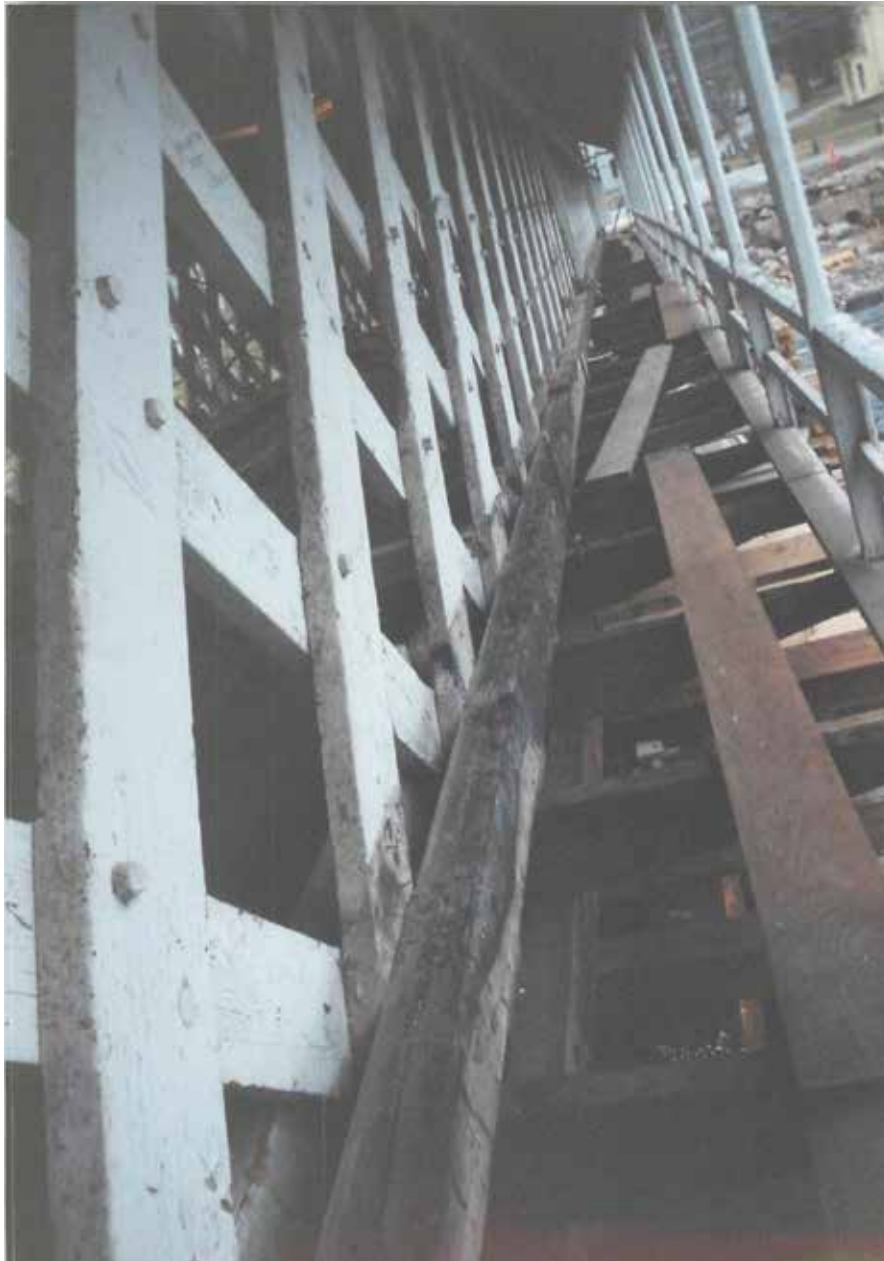
**Figure C1.10** Previous fire damage of lower chord. Sean T. James, 1998.

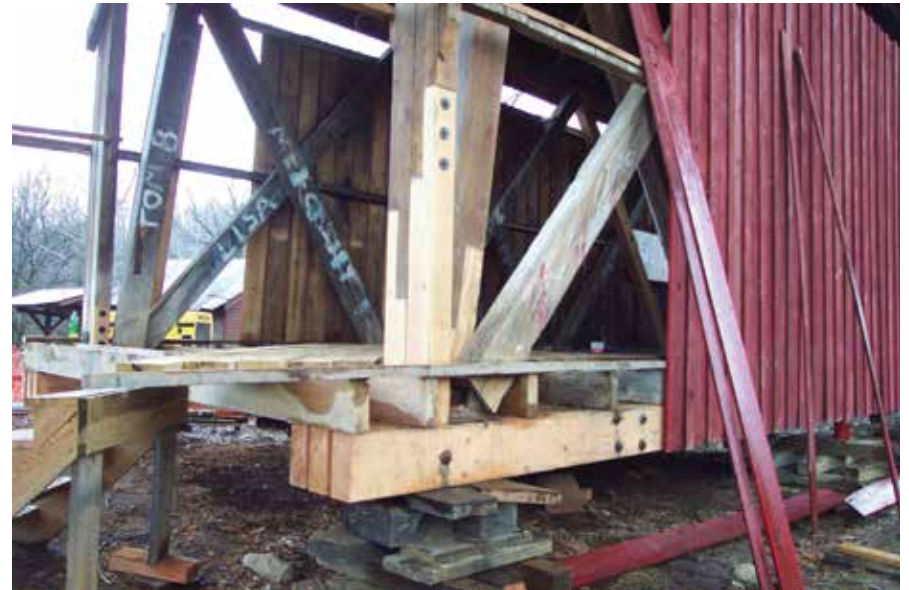
**Figure C2.8** Decay at the bearings required extensive reconstruction. At the southwest corner, shown here, the two shorter lower chord timbers were replaced, while new ends were spliced onto the longest chord timber, both end posts, and a diagonal. J. A. Barker Engineering, March 2004.

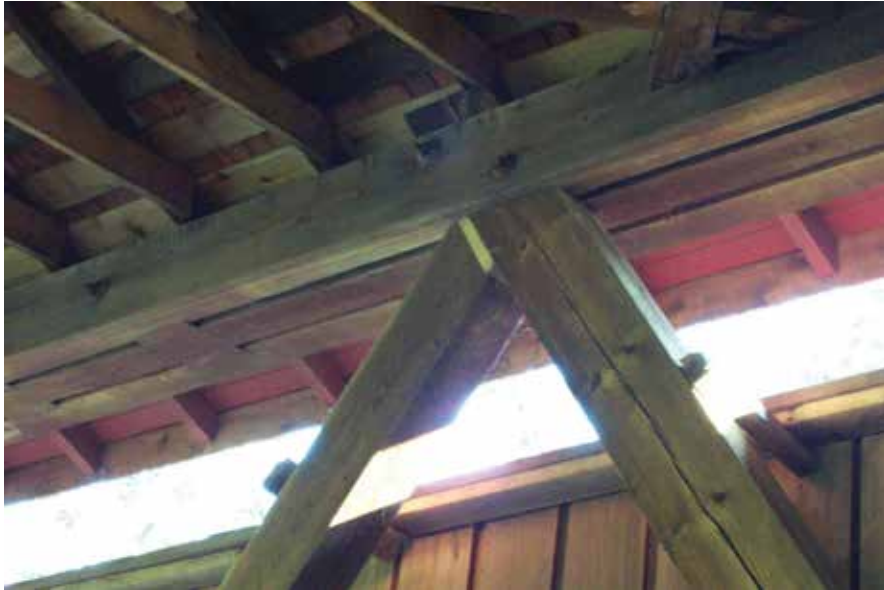
**Figure C2.9** Trusses were jacked to restore camber, then held in that position by inserting shims at the top of truss compression diagonals, as shown here. J. A. Barker Engineering, 2004.

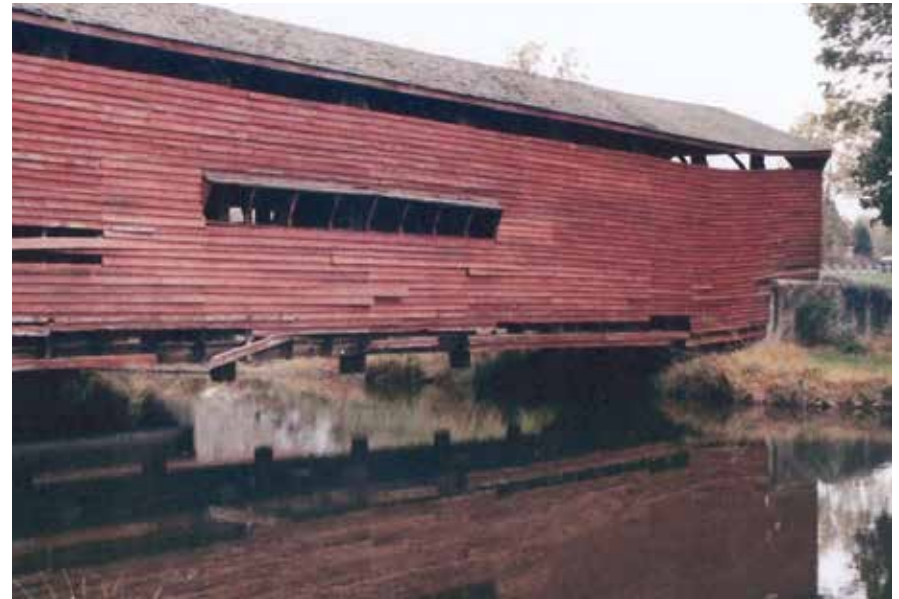
**Figure C5.4** View of the bridge four years before the rehabilitation project. Failures in the lower chord contributed to the noticeable negative camber. W. Earl Simmers, 2005.

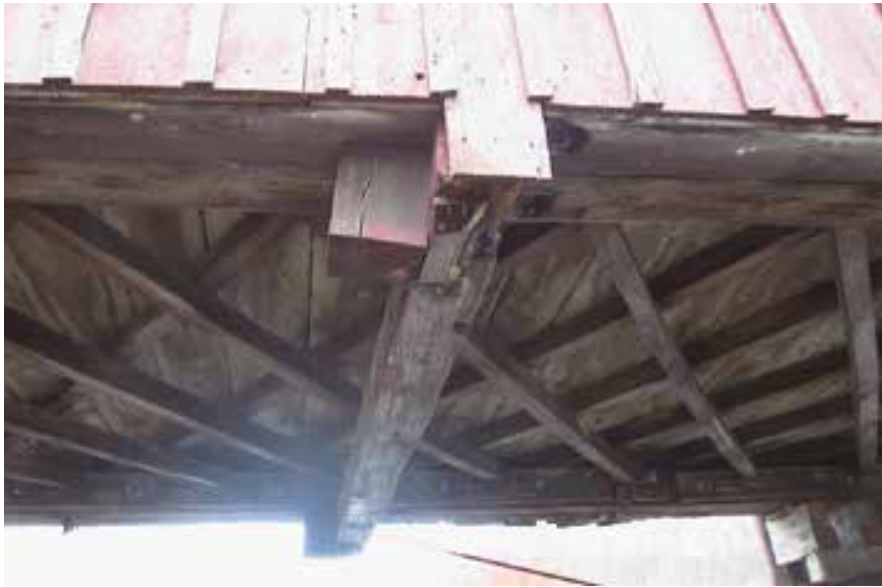
**Figure C8.4** Lattice floor joist system, and lower tie beam added after original construction. SCLA.

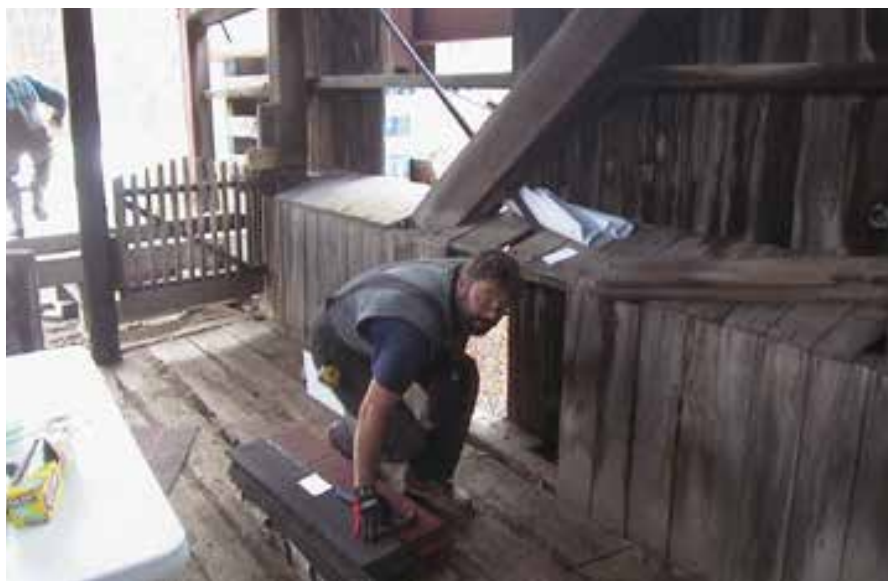
**Figure C8.5** Human and livestock gates at east portal. Note the diagonal repair rods through the truss braces, which were installed early in the twentieth century. SCLA.

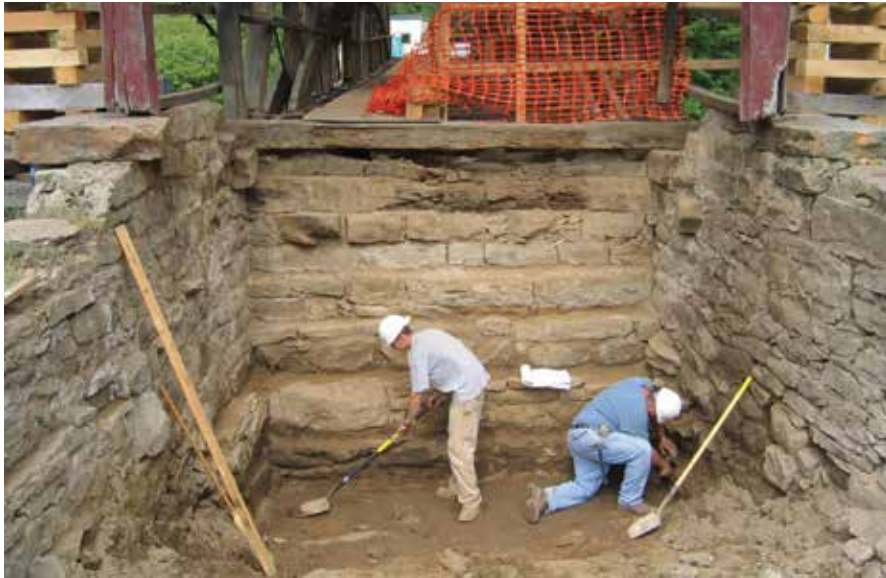
**Figure C8.11** Excavated abutment before reinforcement. SCLA.

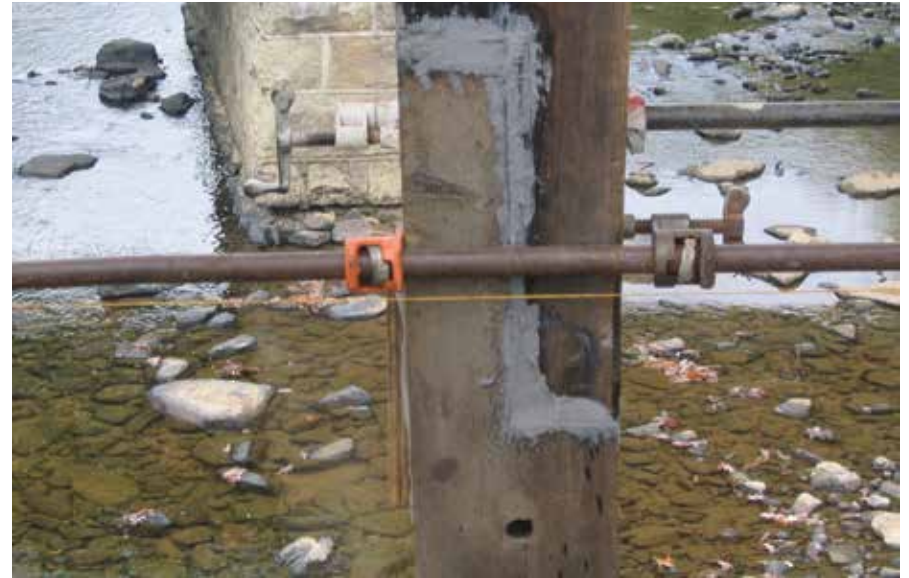
**Figure C8.12** GFRP post repair. SCLA.

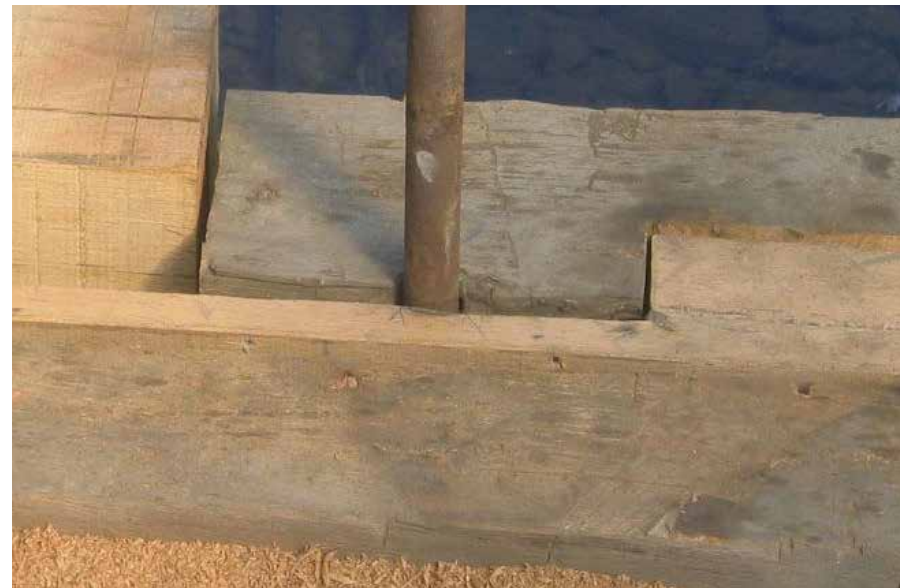
**Figure C8.13** Joggle splice repair. SCLA.

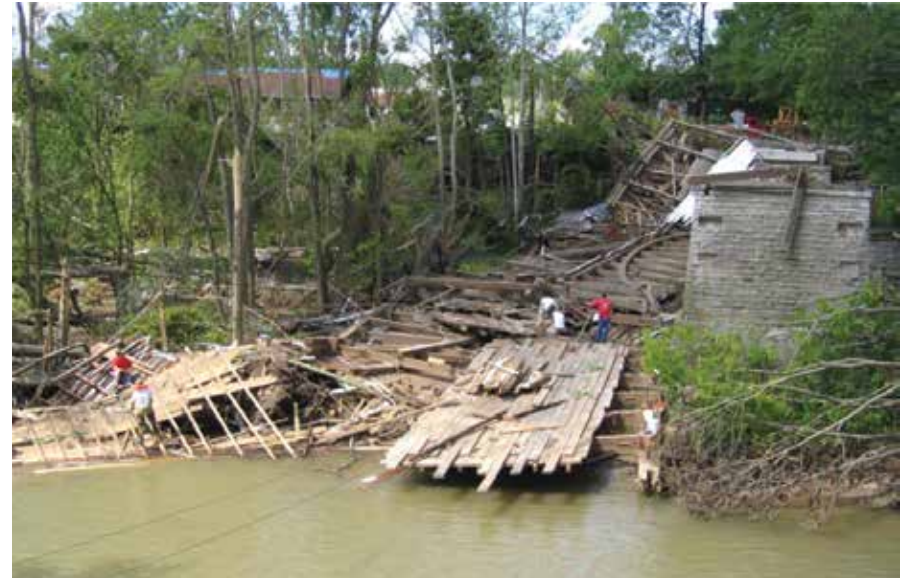
**Figure C9.4** Moscow Bridge after the tornado. It seems hopeless. Wayne Goodman, Indiana Landmarks, 2008.

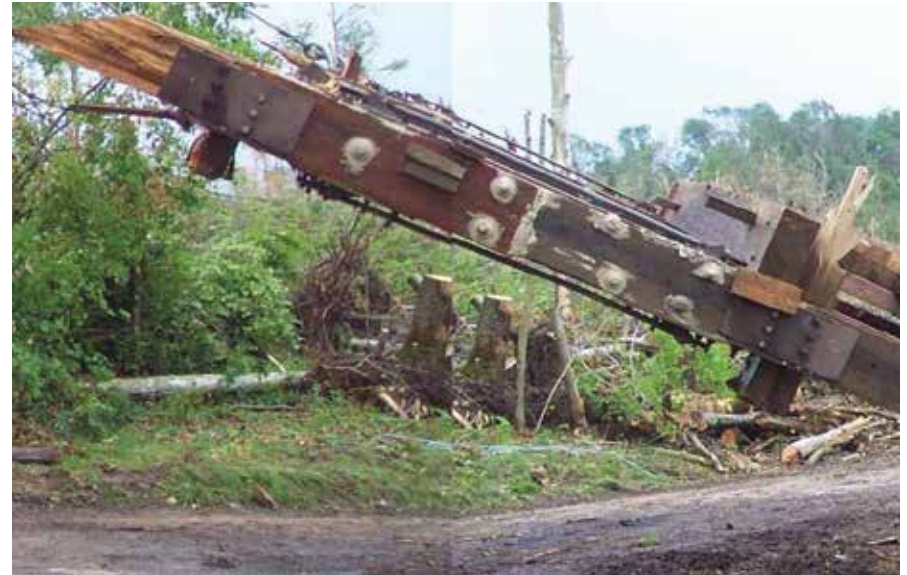
**Figure C9.6** Pulling the bridge out of the water. Previous repairs included liberal use of epoxy adhesives, making it impossible to reuse these lower chord timbers. James Barker, J.A. Barker Engineering, Inc., 2008.

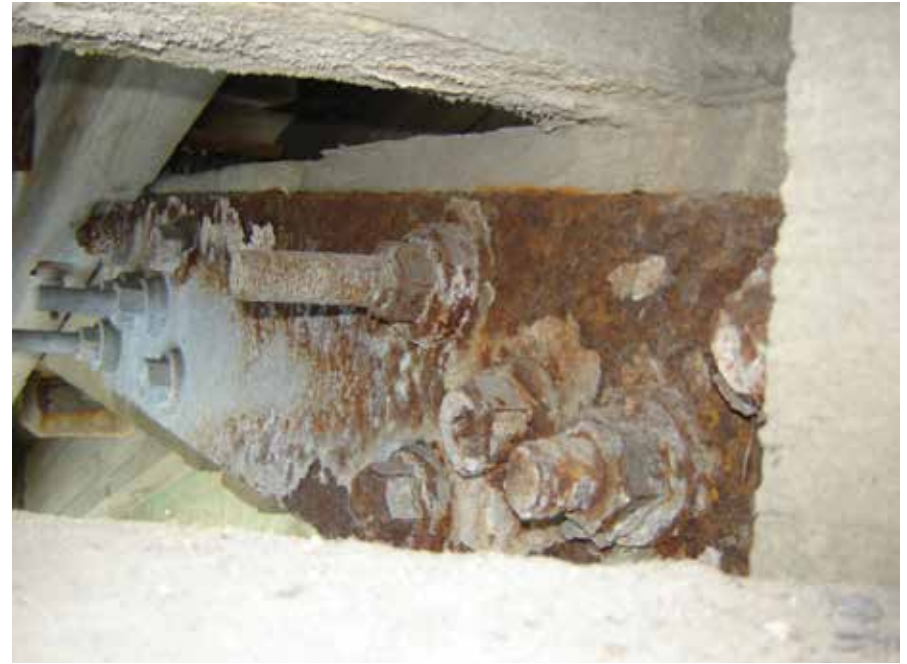
**Figure C10.5** Severely corroded splice plate of interior truss at west span. Josif Bicja, August 2007.

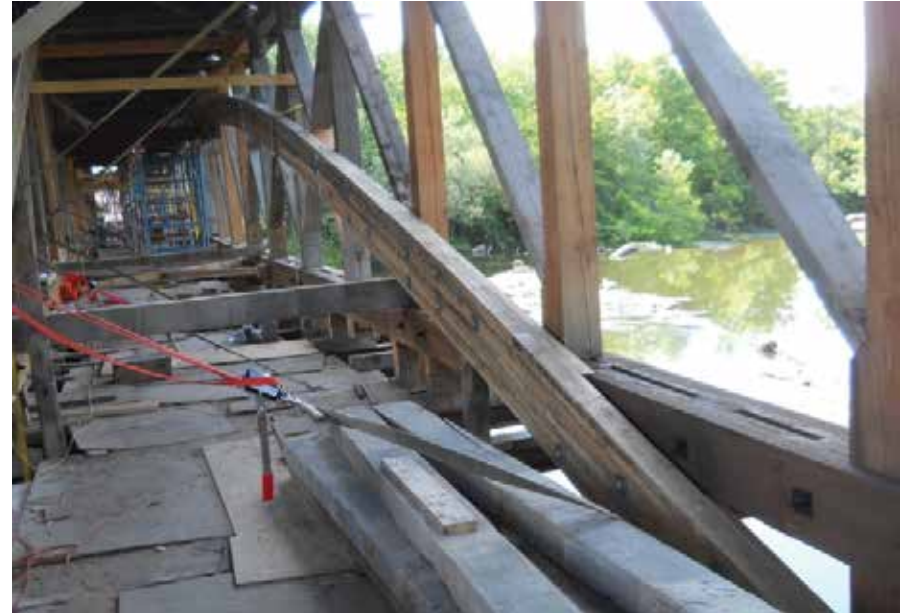
**Figure C10.19** Replaced portion of north arch, east end. Josif Bicja, July 2012.

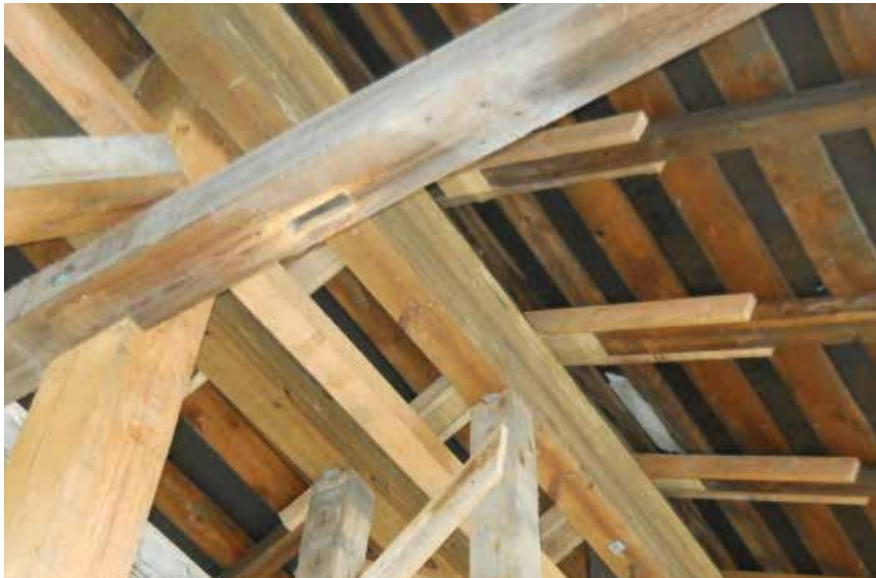
**Figure C10.18** Typical sistered roof rafters. Josif Bicja, July 2012.

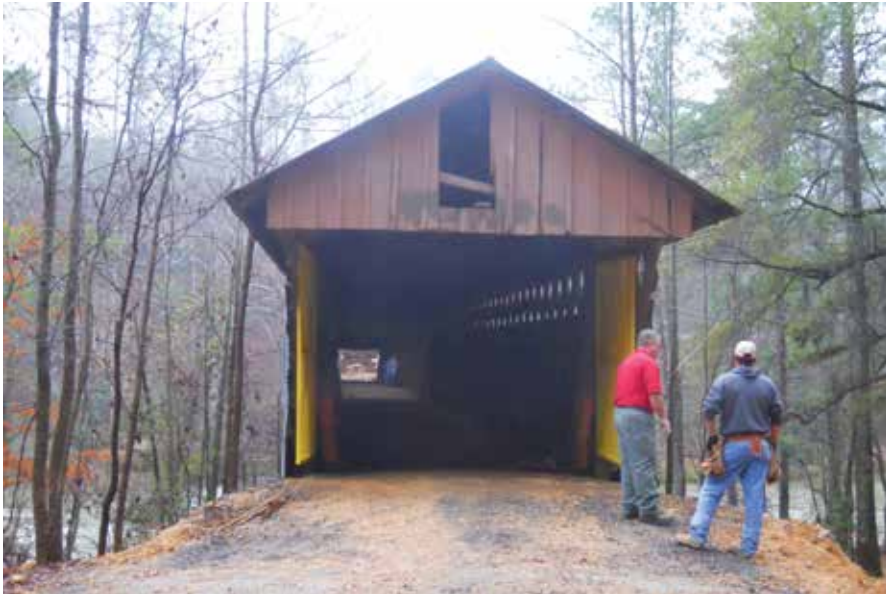
**Figure C11.8** Abutment 1 showing gable with missing boards. TranSystems, 2012.

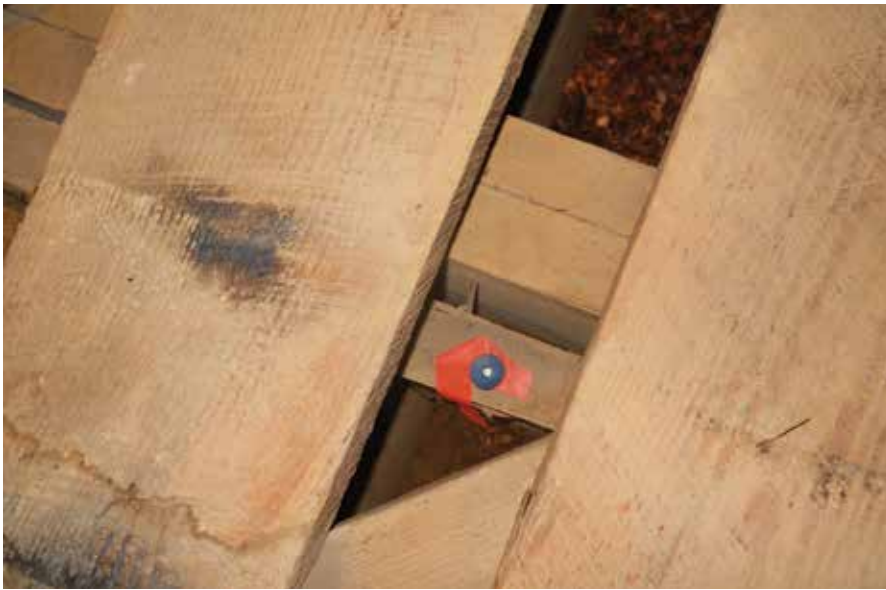
**Figure C11.9** Span 1, near floor beam 2, showing separation between stringer 4 boards. TranSystems, 2012.

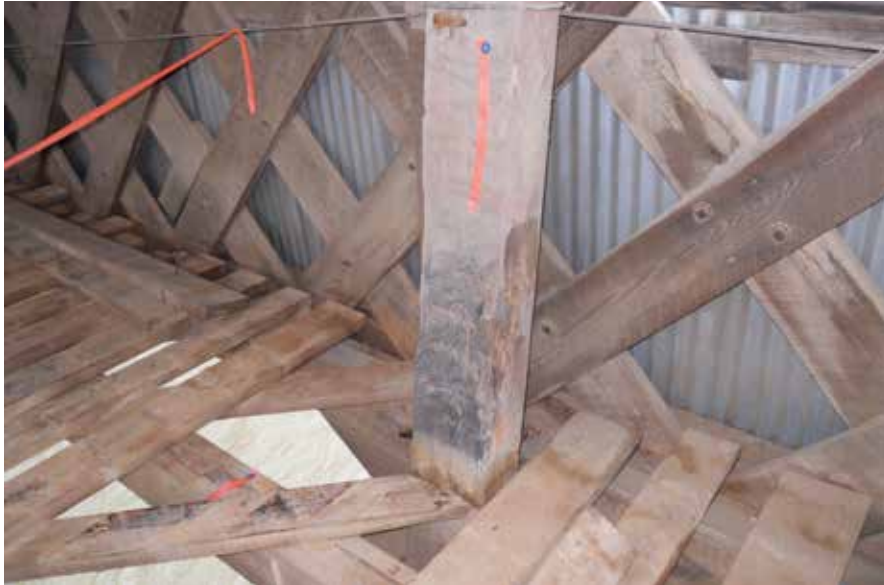
**Figure C11.10** Vertical post at Pier 2 revealed deterioration on south side. TranSystems, 2012.

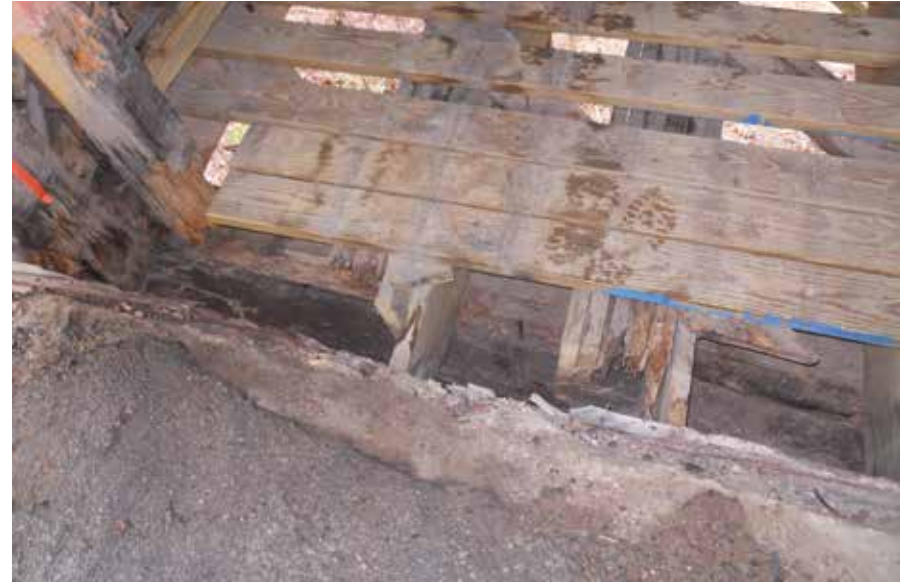
**Figure C11.12** Abutment 4 showing deteriorated ends of stringers. TranSystems, 2012.

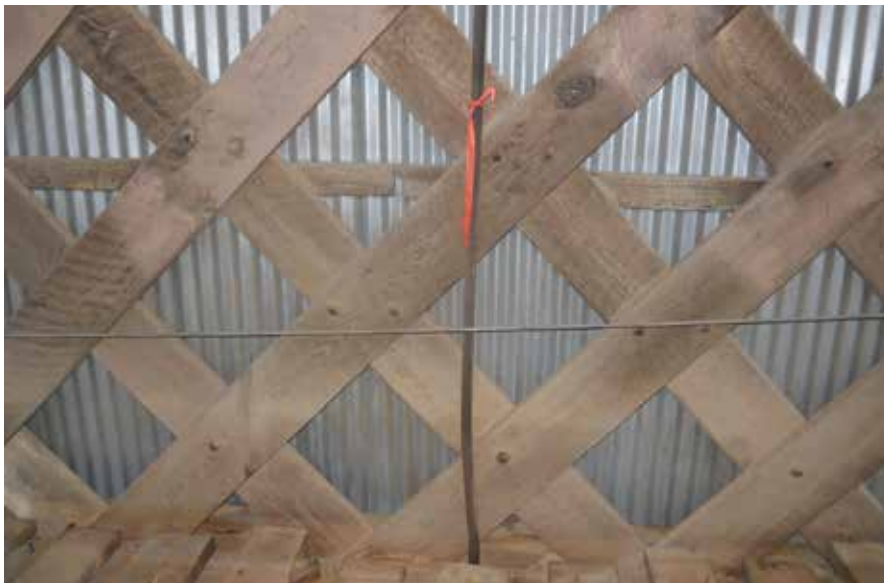
**Figure C11.11** Span 3, south (right) side with bent hanger rod 1. Condition also observed at north hanger rod at floor beams 5 and 6. TranSystems, 2012.

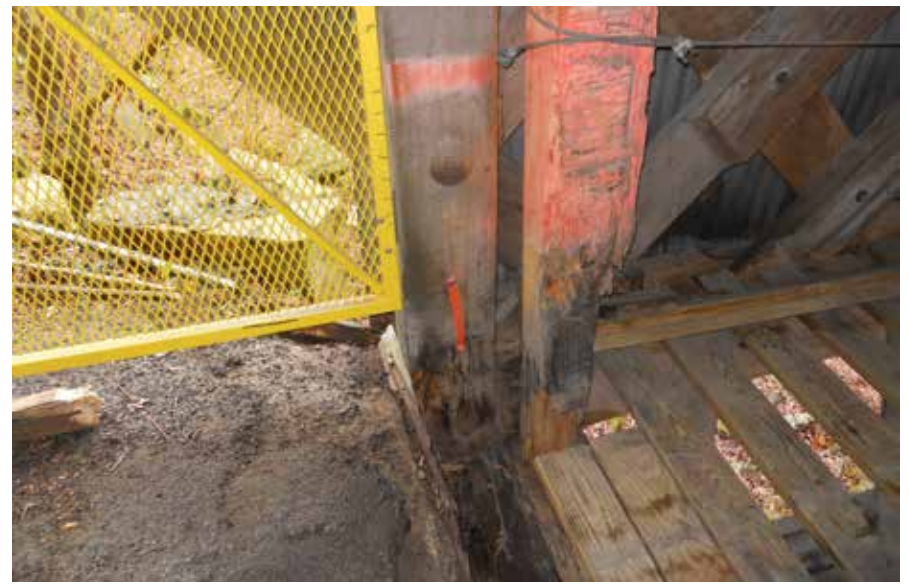
**Figure C11.13** Right vertical post is rotted at abutment 4. TranSystems, 2012.

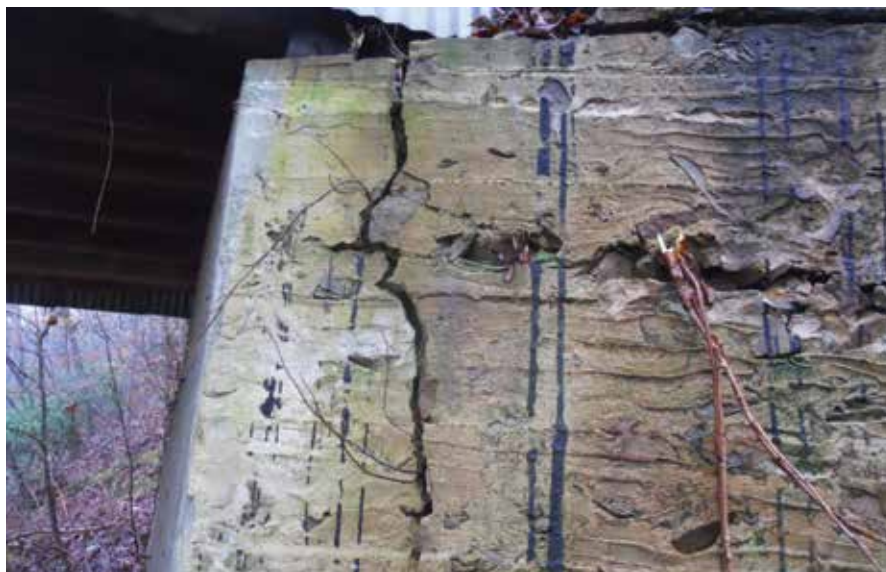
**Figure C11.14** Wide crack in abutment 4 breastwall. TranSystems, 2012.
