552-554 BROADWAY
New York, New York

Preservation Tech Notes

HISTORIC GLASS NUMBER 2

Repair and Rehabilitation of Historic Sidewalk Vault Lights

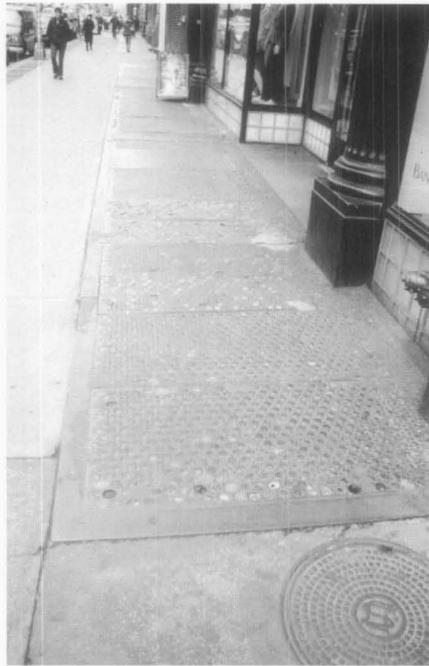
Figure 2. At the outset of the restoration project, the original cast-iron and glass vault lights in front of the building's storefront were in poor condition.

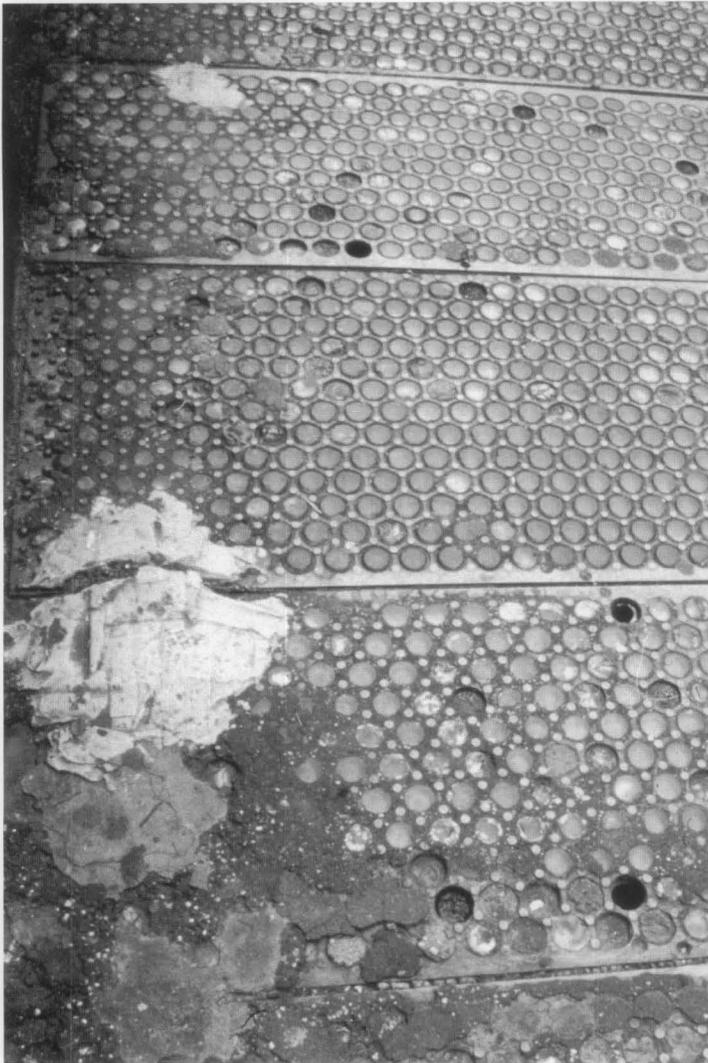
At the outset of the project, the vault lights at 552-554 Broadway were in poor condition (see figure 3). As with many old vault light installations, broken glass lenses and deteriorated seals allowed considerable water infiltration through the individual panels and the surrounding framework. A majority of the glass lenses were either cracked, missing or replaced with a variety of materials including wood, concrete and asphalt (see figure 4). Of the twenty-one cast-iron panels, six sections had areas which were cracked or missing altogether. Two original vault light panels had been replaced with steel diamond-plate hatchway doors to the basement and a variety of materials had been applied over the remaining panels in repeated attempts to prevent further leaks. Worn and lacking a protective coating, the cast-iron panels

Displaced panels and uneven asphalt and concrete patches presented trip hazards at sidewalk level.

Figure 3. The individual cast-iron panels were displaced and coated in some areas with asphalt and concrete. A number of glass lenses were missing, allowing water to enter the basement of the building.

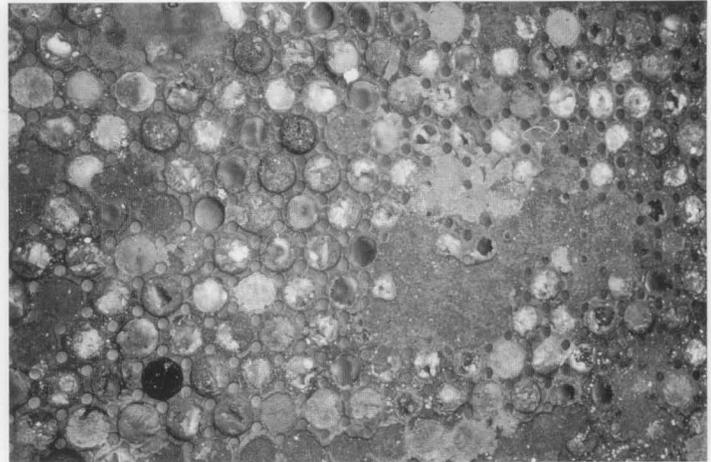
Figure 4. A detailed view of one of the panels illustrates the typical conditions prior to work. Although the original cast-iron knobs were still visible through the asphalt and concrete, many of the round openings were covered over or infilled. Nearly all of the remaining glass lenses were cracked.

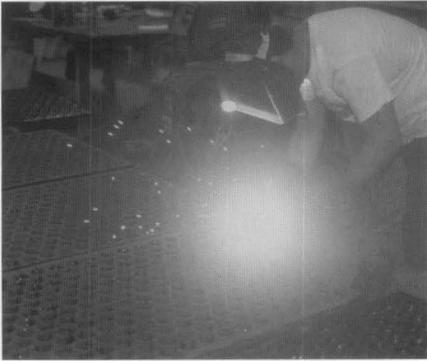
At the outset of the restoration program, six of the twenty-one vault light panels were found to be cracked. Rather than replace them with newly cast panels, the contractor chose to repair the damaged units using two different techniques: welding cracked sections and splicing in replacement

pieces. Due to inconsistent heating and the presence of impurities in the blast furnace mixture, historic cast-iron is a notoriously brittle material. This brittleness makes historic cast-iron susceptible to cracking and a challenge to weld properly.

The contractor had developed a system for repairing cracked or damaged vault covers. Primary considerations were to ensure that the pieces to be welded were correctly positioned and level and that the cast-iron was properly preheated. Then, using a wire-feed MIG (metal inert gas) welder, the two pieces were joined together (see figure 6). The welded seam was ground down to the level of the adjacent panel

surface so that the repair would not be visible after painting. The result was a strong, durable and complete cast-iron panel. When replacement sections were required, the contractor drew from a small stockpile of salvaged panels identical to those at 552-554 Broadway.

Figure 6. Cracked panels were repaired by welding in new material from a stock of salvaged panels maintained by the cast-iron contractor. The welded seams were then ground down before repainting.
