Mason-Willis-Dixon House
Portsmouth Village
Cape Lookout National Seashore

Historic Structure Report

December 2015

JOSEPH K. OPPERMAN-ARCHITECT, P.A.

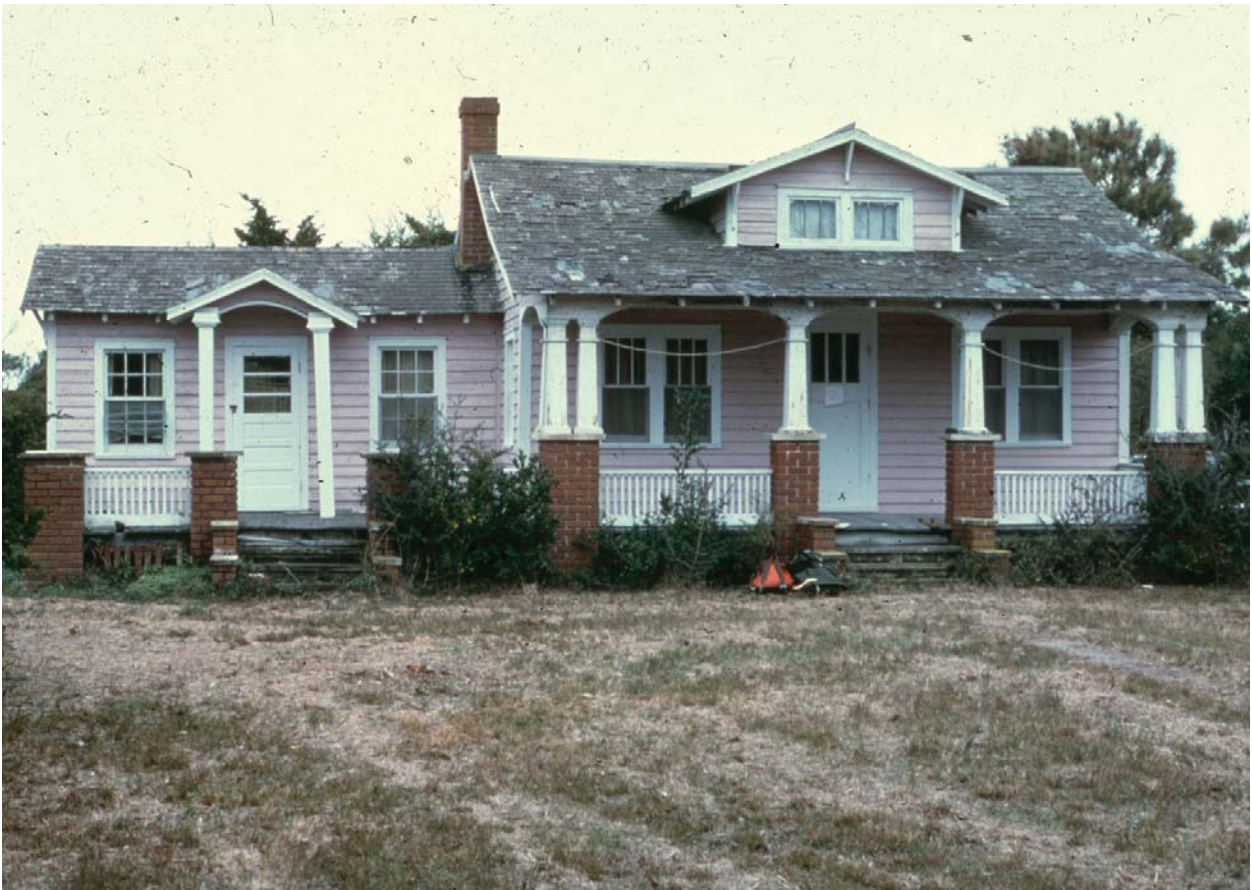
Figure 29. Condition of the house in 1977, also showing the 1960s replacement doors, the 1960s replacement six-over-six sash of the west wing, and the retained Craftsmen-style vertical-pane sash beneath the front porch. (CALO acc. 03355)

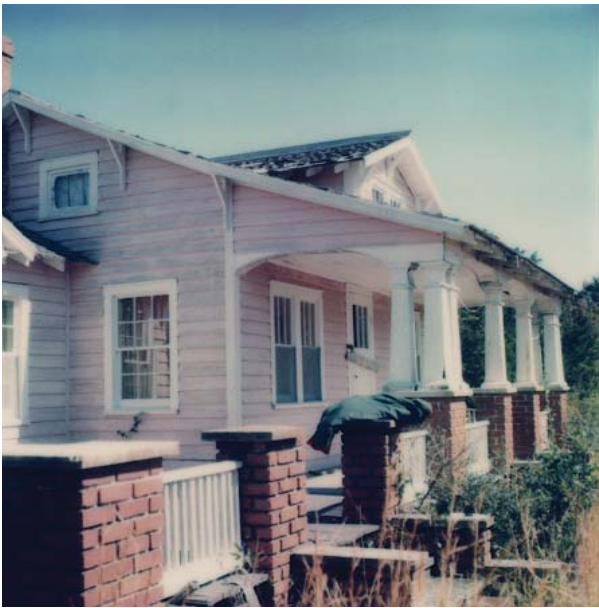
Figure 30. Condition of roof and porch, missing fascia, 1977. (CALO Coll. f79)

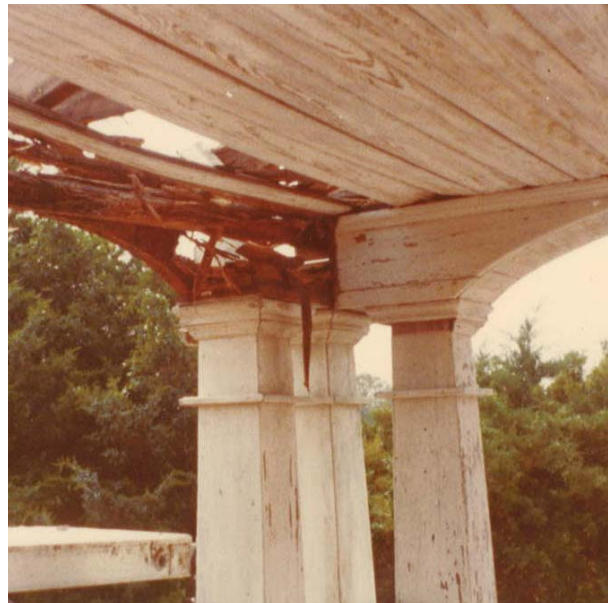
Figure 34. Damage in arches, 1979. (CALO Polaroid album)

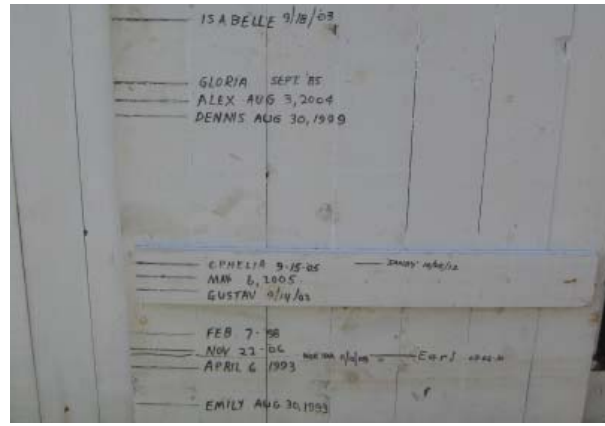
Figure 51. Record of high water marks from storm surge flooding on Theo Salter House shed (NPS 519).

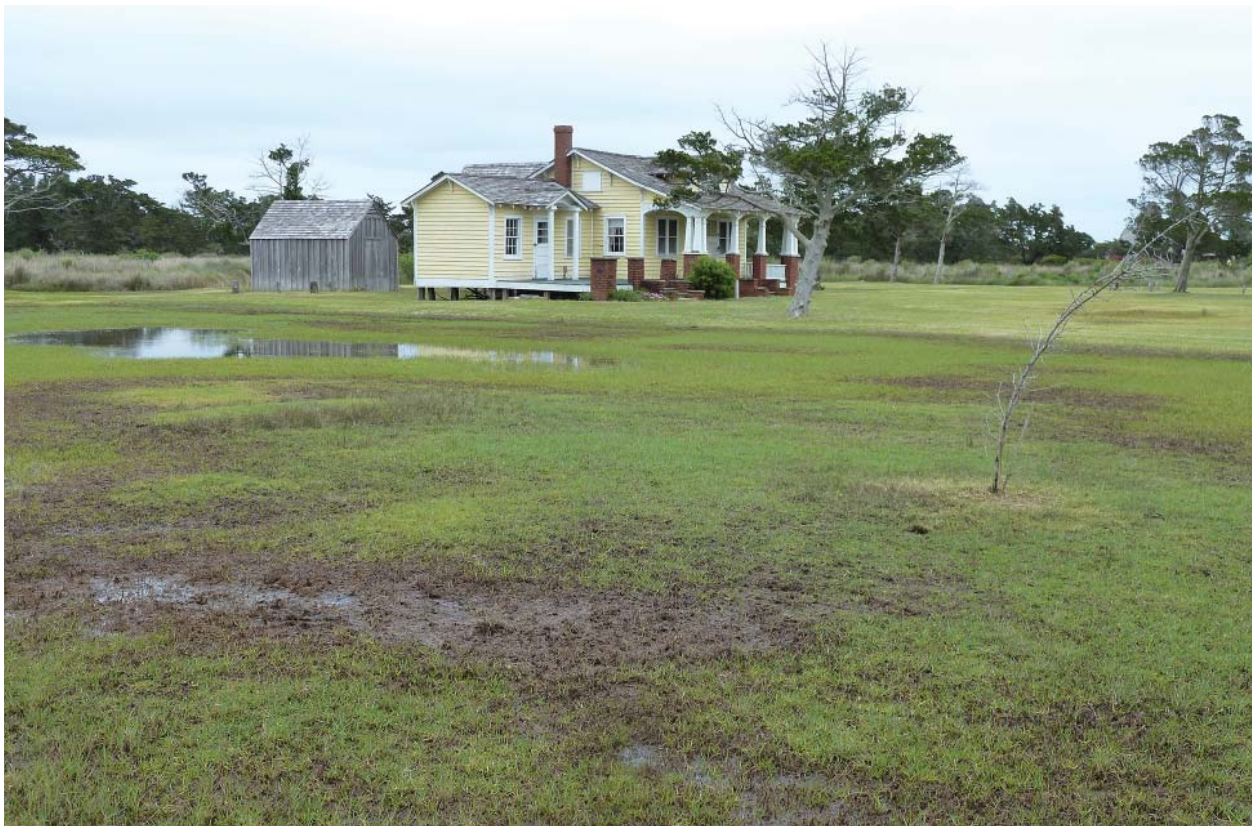
Poor drainage is characteristic of most of Portsmouth, but the natural process of decay of vegetation and generation of new humus has created a bowl-like depression beneath the house, trapping water and keeping the area damp for extended periods of time. This not only contributes to rotting of wood posts but also creates ideal conditions for termite infestation.

Figure 54. Typical site conditions on the west side of the house.

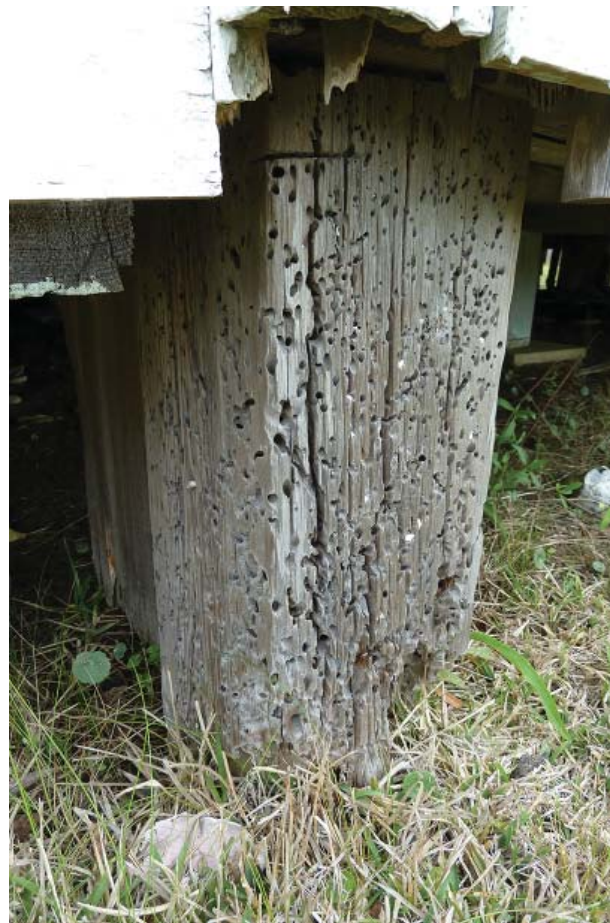
Figure 56. Example foundation post created from salvaged lumber, showing damage characteristic of *Teredo navalis*, or shipworm. The damage must have occurred prior to the lumber's reuse as a foundation post.

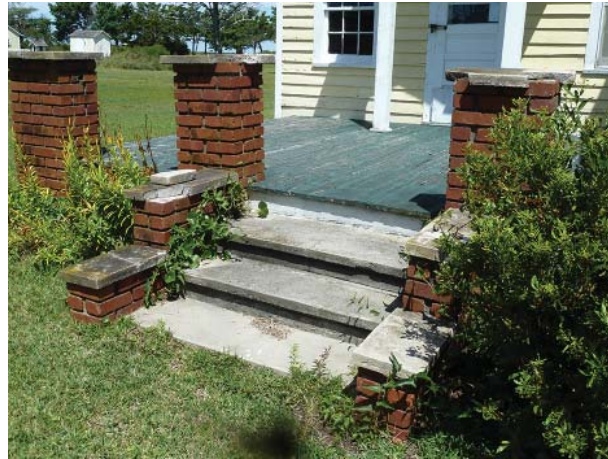
Much of the mortar in the front porch piers dates to their construction but remains in fair condition. The mortar in the exposed piers on the deck is badly eroded. All but three of the concrete caps on the piers and cheek walls are cracked and broken, with significant material loss in some.

Figure 62. Steps to deck.

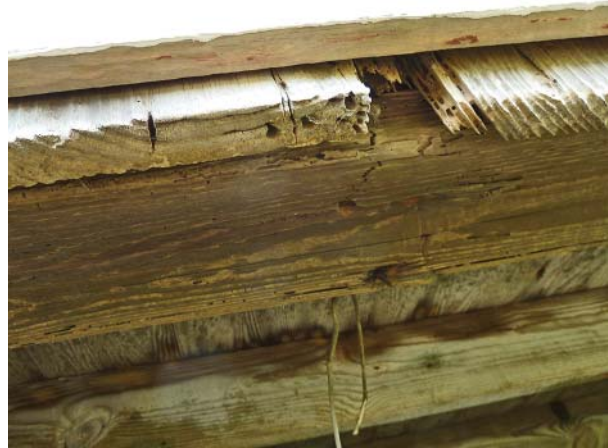
The wood framing appears to be in generally fair condition, and ridge lines remain straight and floors level. Insect damage can be observed in some of the sills, and there is likely to be hidden damage elsewhere in the building. The house is, like many others of the period, under-structured by modern standards, especially in terms of spacing

Figure 66. Typical sill and bottom ends of vertical sheathing on the main block of the house.

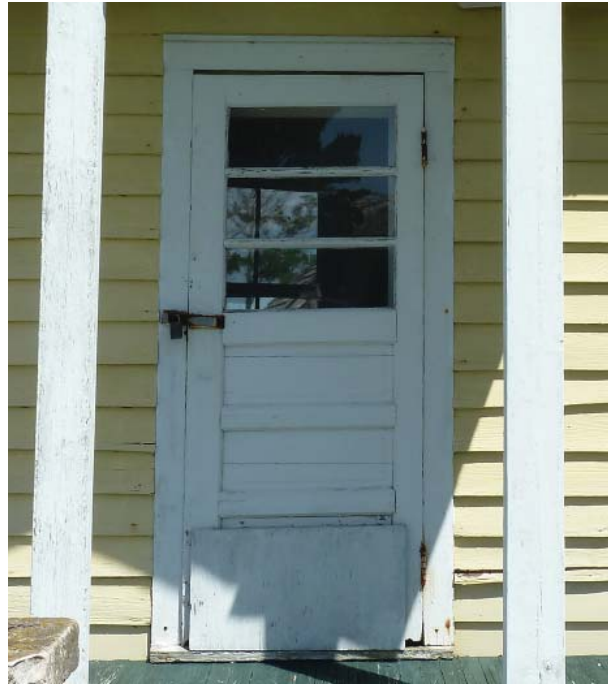
The main front door remains in generally good condition, but the front kitchen door has severe damage to the bottom rail. The door at the rear of Room 104 is new but has no exterior hardware and no steps to the ground.

Figure 70. Front door to kitchen (west) wing.

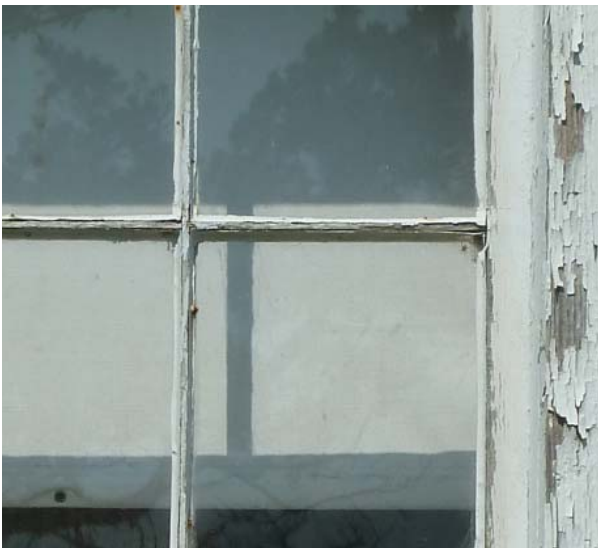
Figure 79. Typical detail showing poor condition of many of the windows.

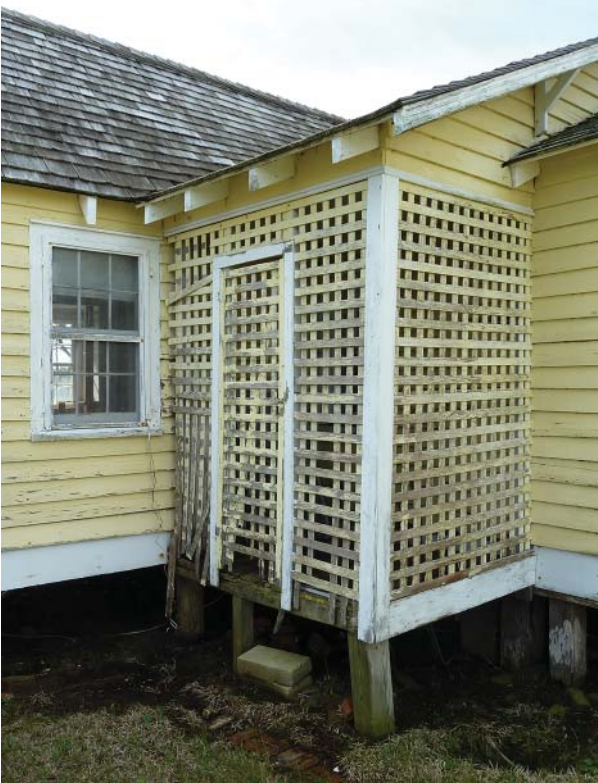
The lattice on the lower portion of the north wall of the lattice room is badly damaged as is the

painted finish on the entire room. The door steps are missing entirely.

Figure 88. Lattice room at northwest corner.

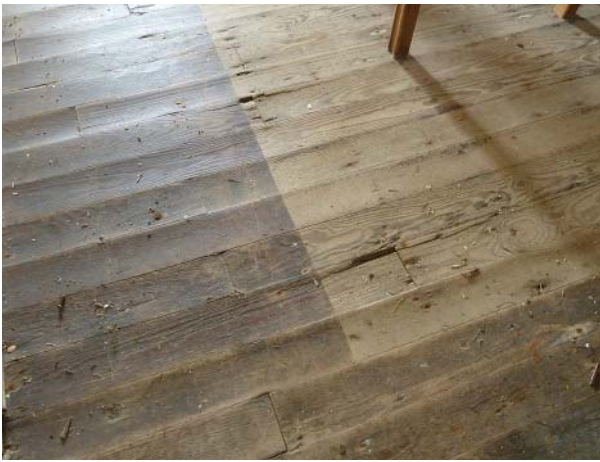
Wood flooring is in poor condition, primarily from multiple floods, including the terrible hurricane that washed over the Outer Banks in 1933. These events have left much of the flooring cupped and most of the fasteners showing evidence of oxidation.

Figure 120. Wood flooring typical of that found throughout the house.

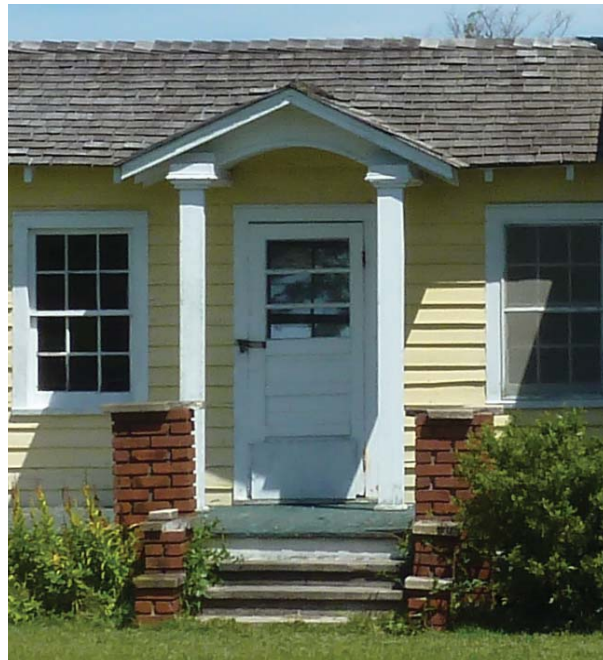
the mortar in the exposed piers on the deck is badly eroded. All but three of the concrete caps on the piers and cheek walls are cracked and broken, with significant material loss in some. The east cheek wall at the steps to the deck leans significantly to the east.

Figure 131. Tilted brick cheek wall at steps to front deck.
