Mason-Willis-Dixon House
Portsmouth Village
Cape Lookout National Seashore

Historic Structure Report

December 2015

JOSEPH K. OPPERMAN-ARCHITECT, P.A.

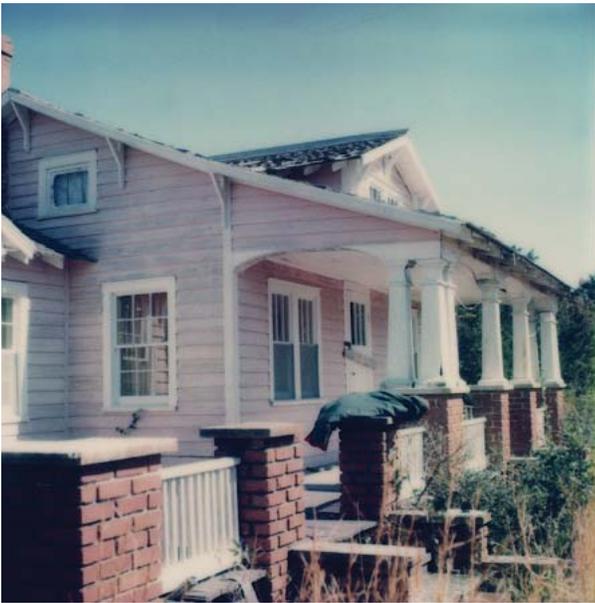
Figure 30. Condition of roof and porch, missing fascia, 1977. (CALO Coll. f79)

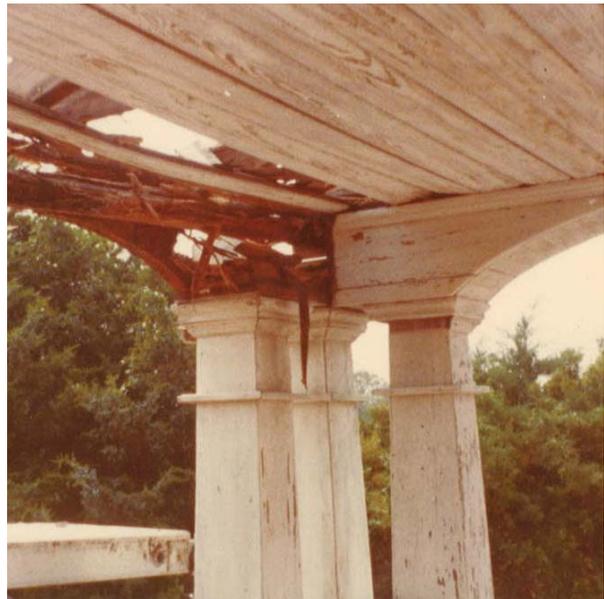
Figure 34. Damage in arches, 1979. (CALO Polaroid album)

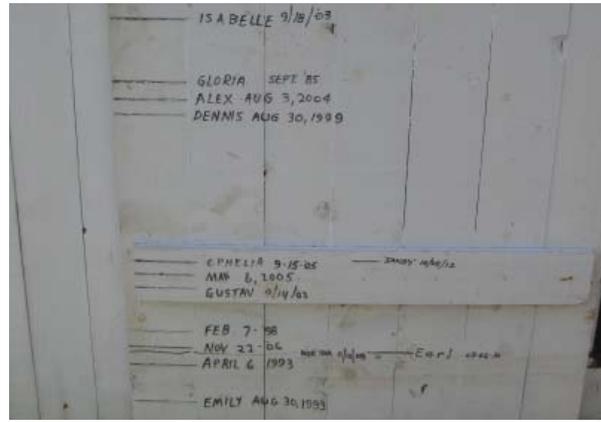
Figure 51. Record of high water marks from storm surge flooding on Theo Salter House shed (NPS 519).

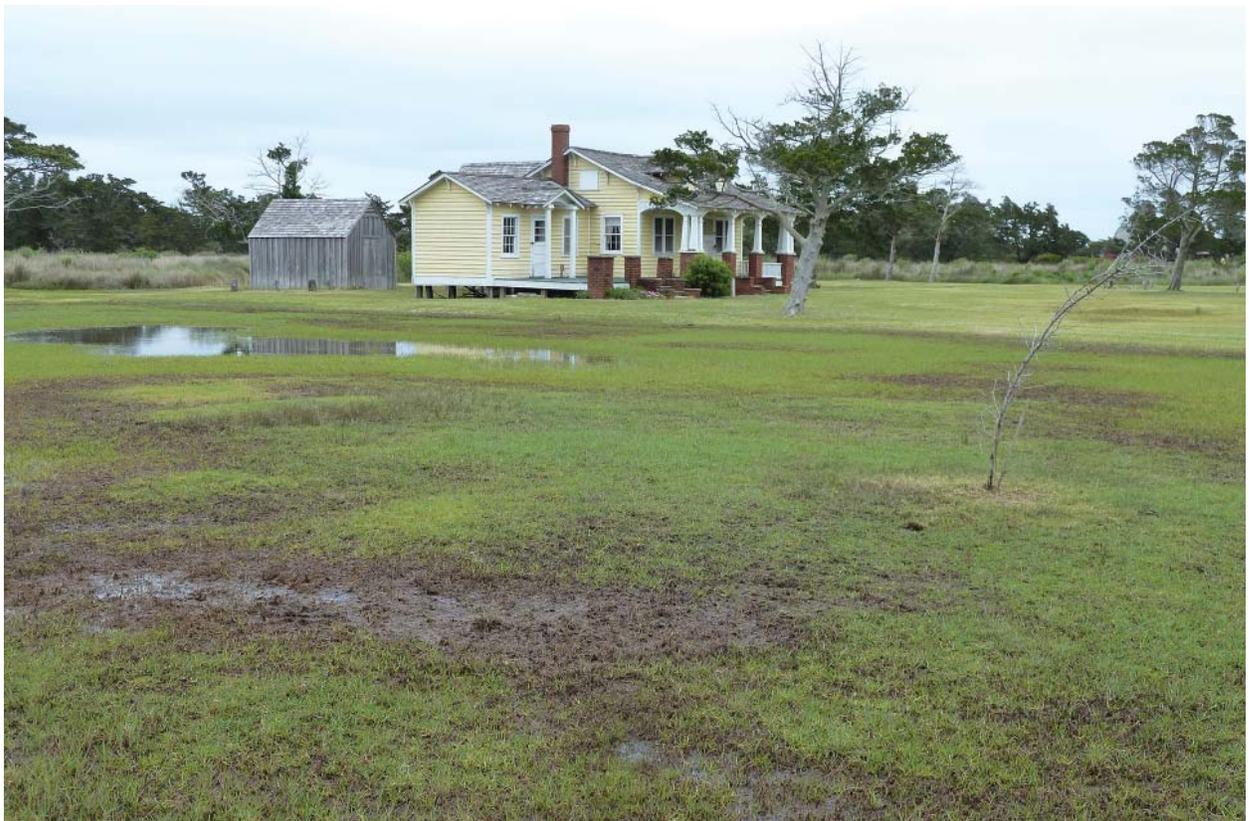
Poor drainage is characteristic of most of Portsmouth, but the natural process of decay of vegetation and generation of new humus has created a bowl-like depression beneath the house, trapping water and keeping the area damp for extended periods of time. This not only contributes to rotting of wood posts but also creates ideal conditions for termite infestation.

Figure 54. Typical site conditions on the west side of the house.

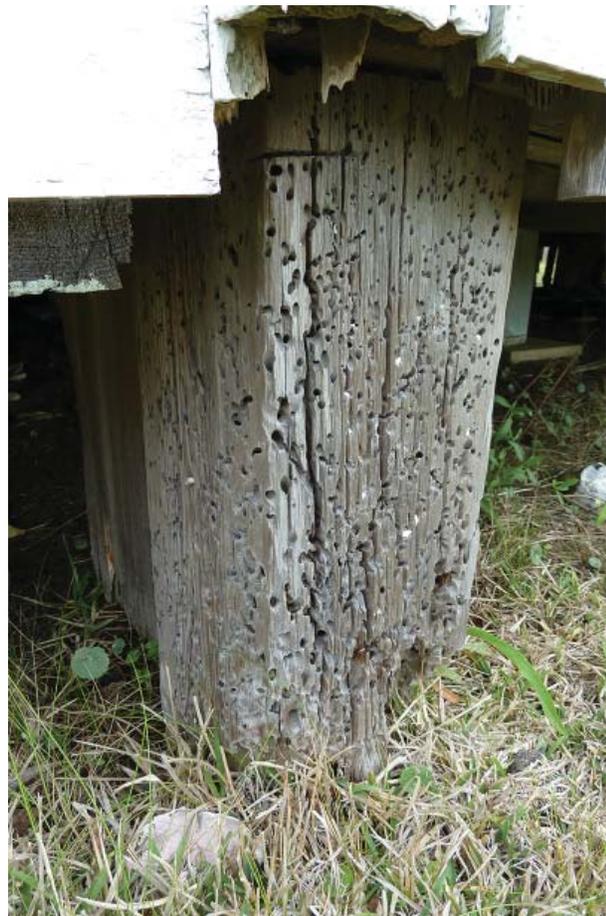
Figure 56. Example foundation post created from salvaged lumber, showing damage characteristic of *Teredo navalis*, or shipworm. The damage must have occurred prior to the lumber's reuse as a foundation post.

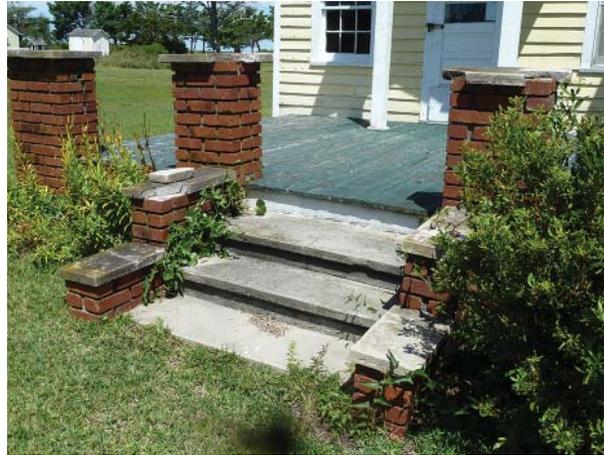
Much of the mortar in the front porch piers dates to their construction but remains in fair condition. The mortar in the exposed piers on the deck is badly eroded. All but three of the concrete caps on the piers and cheek walls are cracked and broken, with significant material loss in some.

Figure 62. Steps to deck.

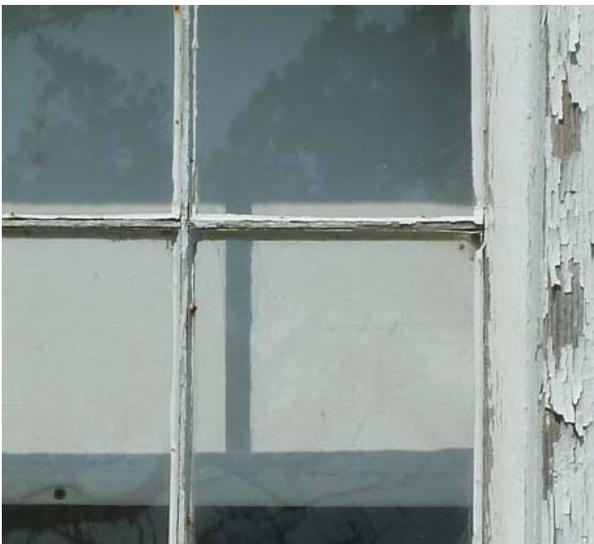
Sash are missing from the windows on the east and north sides of the north wing but most of the rest are in fair condition. Painted finishes are in poor condition with peeling paint and staining from rusting nails. Glazing of windows is in poor condition. Many of the wood-framed screens are missing and those that remain are in poor condition.

Figure 79. Typical detail showing poor condition of many of the windows.

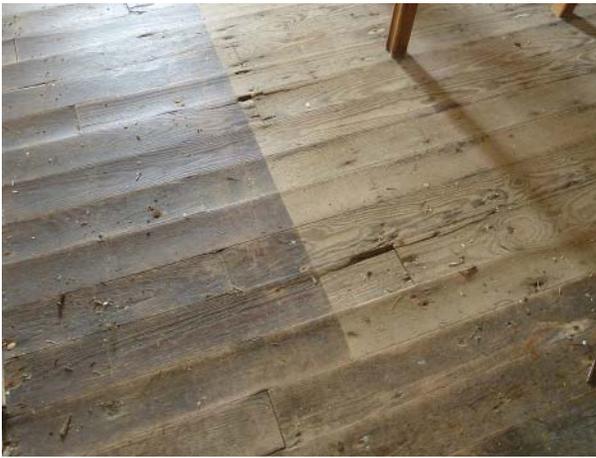
Wood flooring is in poor condition, primarily from multiple floods, including the terrible hurricane that washed over the Outer Banks in 1933. These events have left much of the flooring cupped and most of the fasteners showing evidence of oxidation.

Figure 120. Wood flooring typical of that found throughout the house.

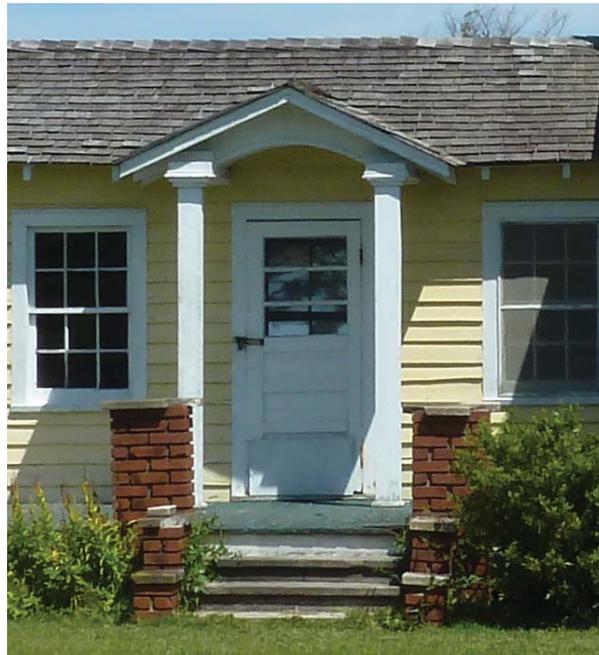
the mortar in the exposed piers on the deck is badly eroded. All but three of the concrete caps on the piers and cheek walls are cracked and broken, with significant material loss in some. The east cheek wall at the steps to the deck leans significantly to the east.

Figure 131. Tilted brick cheek wall at steps to front deck.
