**OFFICE OF SURFACE MINING**  
**REPORT ON OCTOBER 2000**  
**BREAKTHROUGH AT THE BIG BRANCH SLURRY IMPOUNDMENT**

**Martin County Coal Corporation**  
**Big Branch Slurry Impoundment**  
**Martin County, Kentucky**

**March 2002**

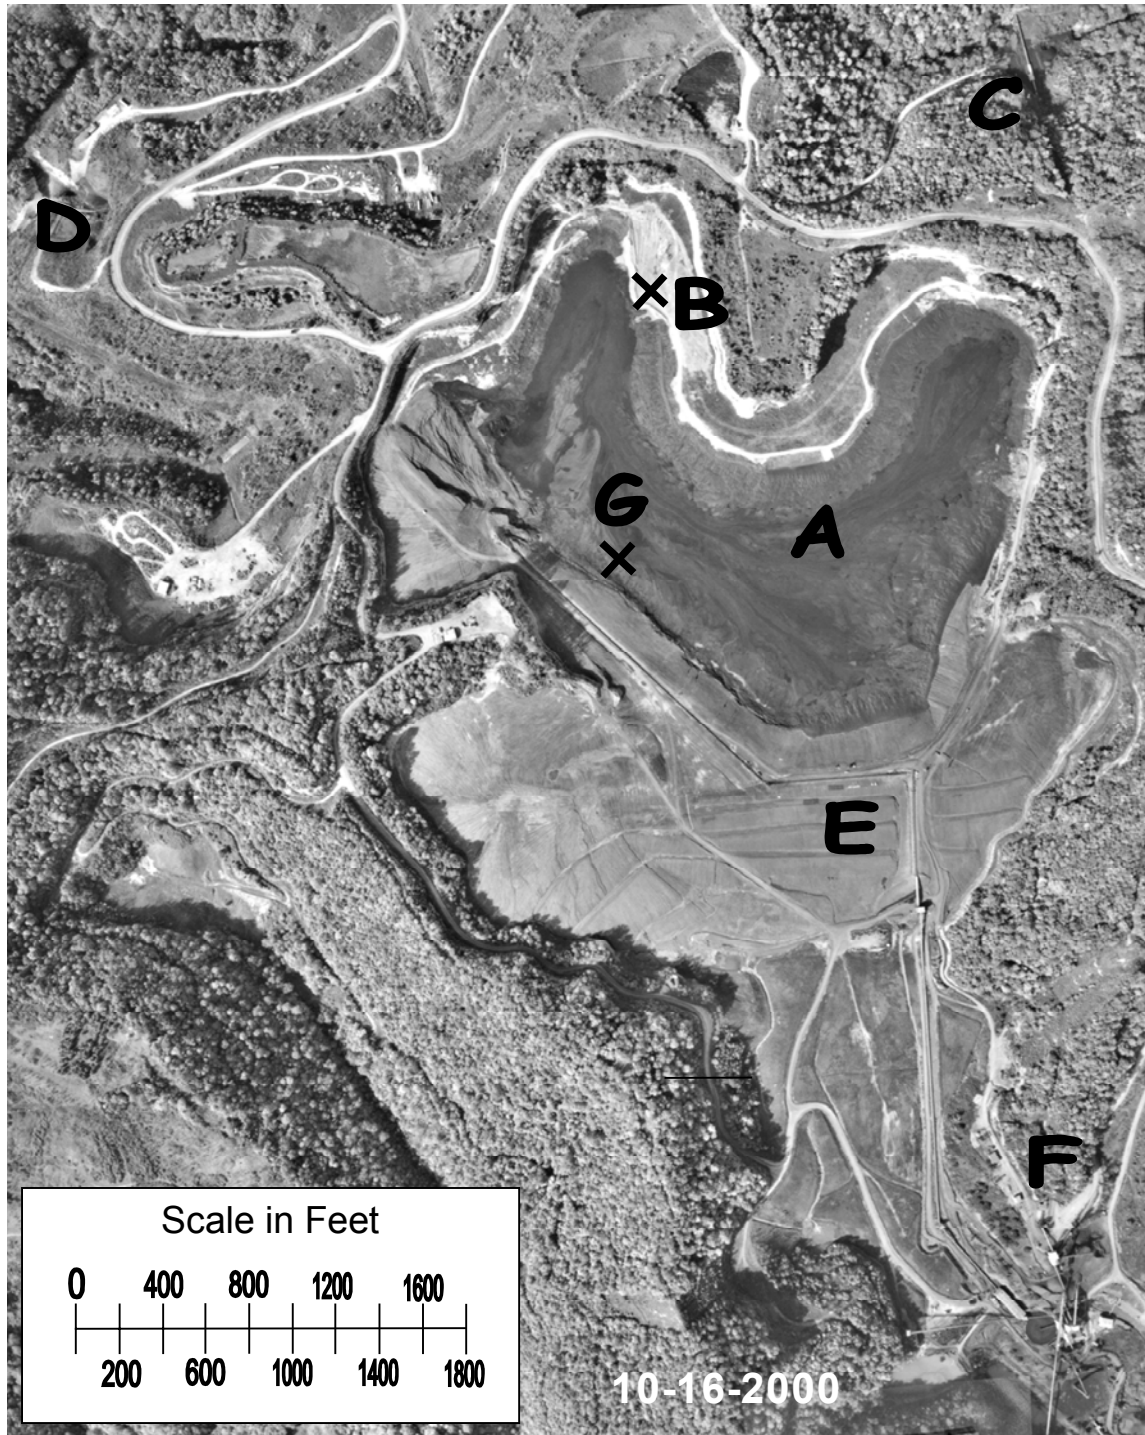
**Photo 1. Aerial Photograph of Big Branch Slurry Impoundment - October 16, 2000.**  
**Source: Photo Science, Inc. A) Impoundment. B) 2000 breakthrough location.**  
**C) Number 2 North Mains Portals. D) South Mains Portal. E) Embankment (dam).**  
**F) Preparation plant. G) 1994 breakthrough location.**

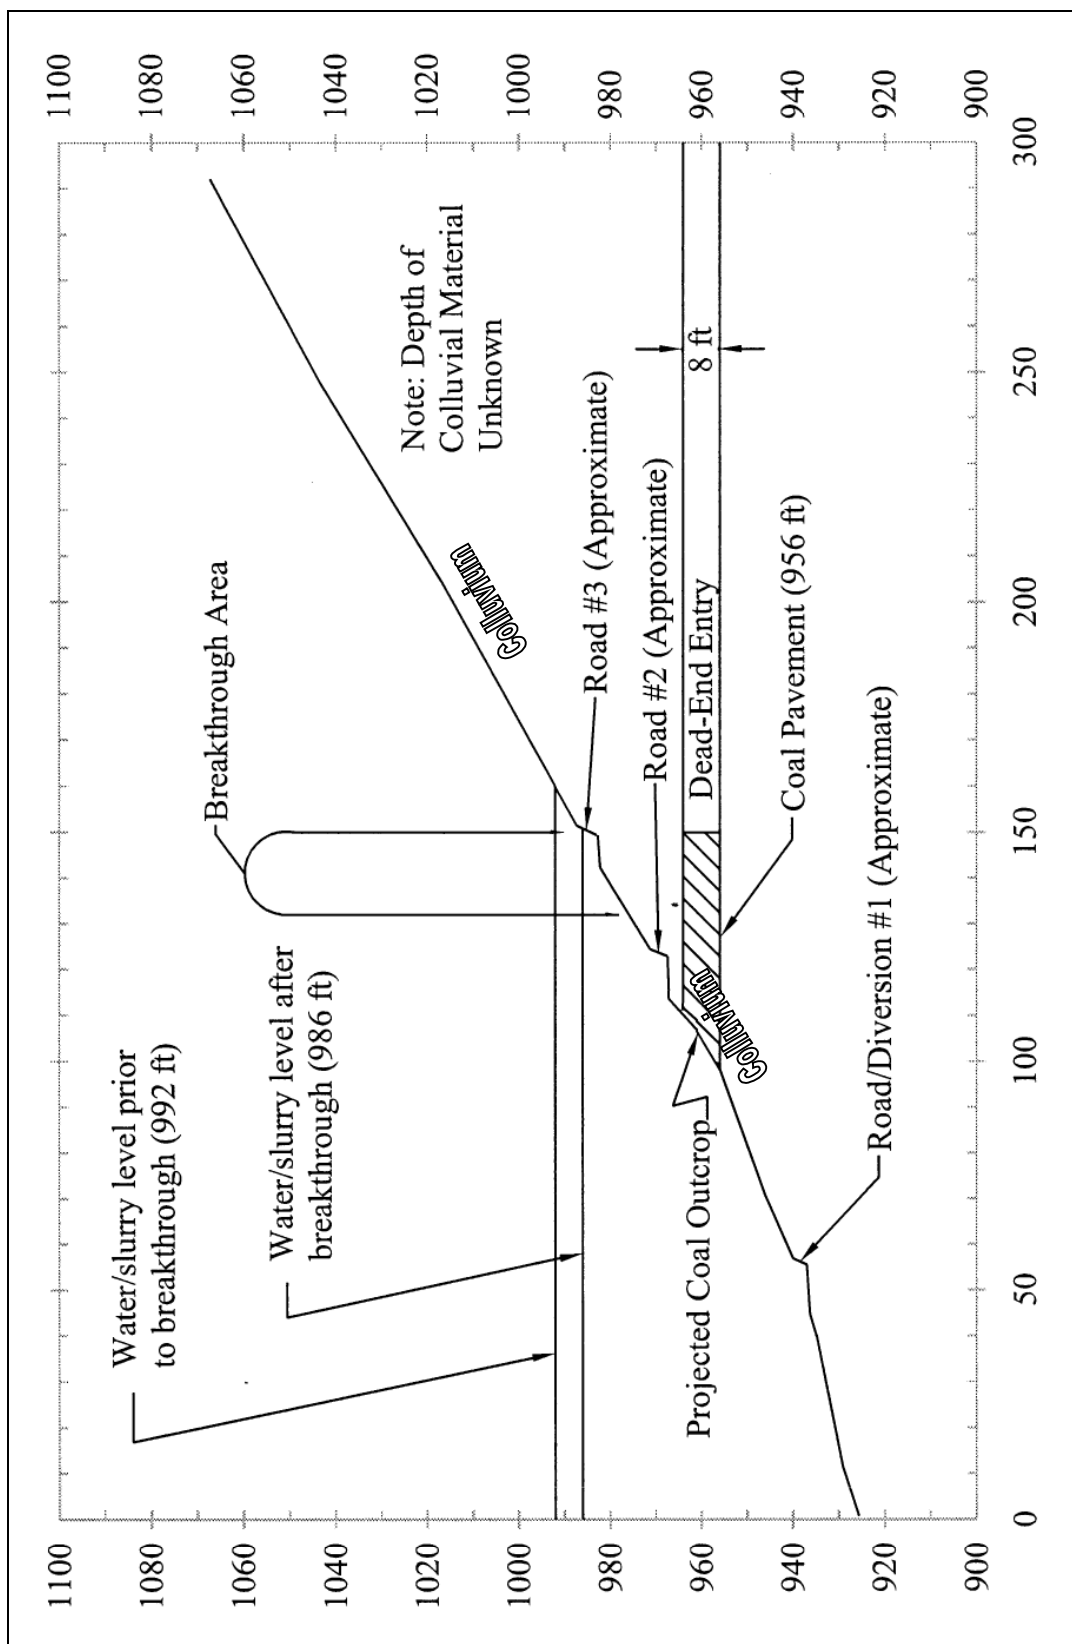
Figure 3. Cross-Section A-A' at May 1994 Breakthrough. Drawn by OSM.

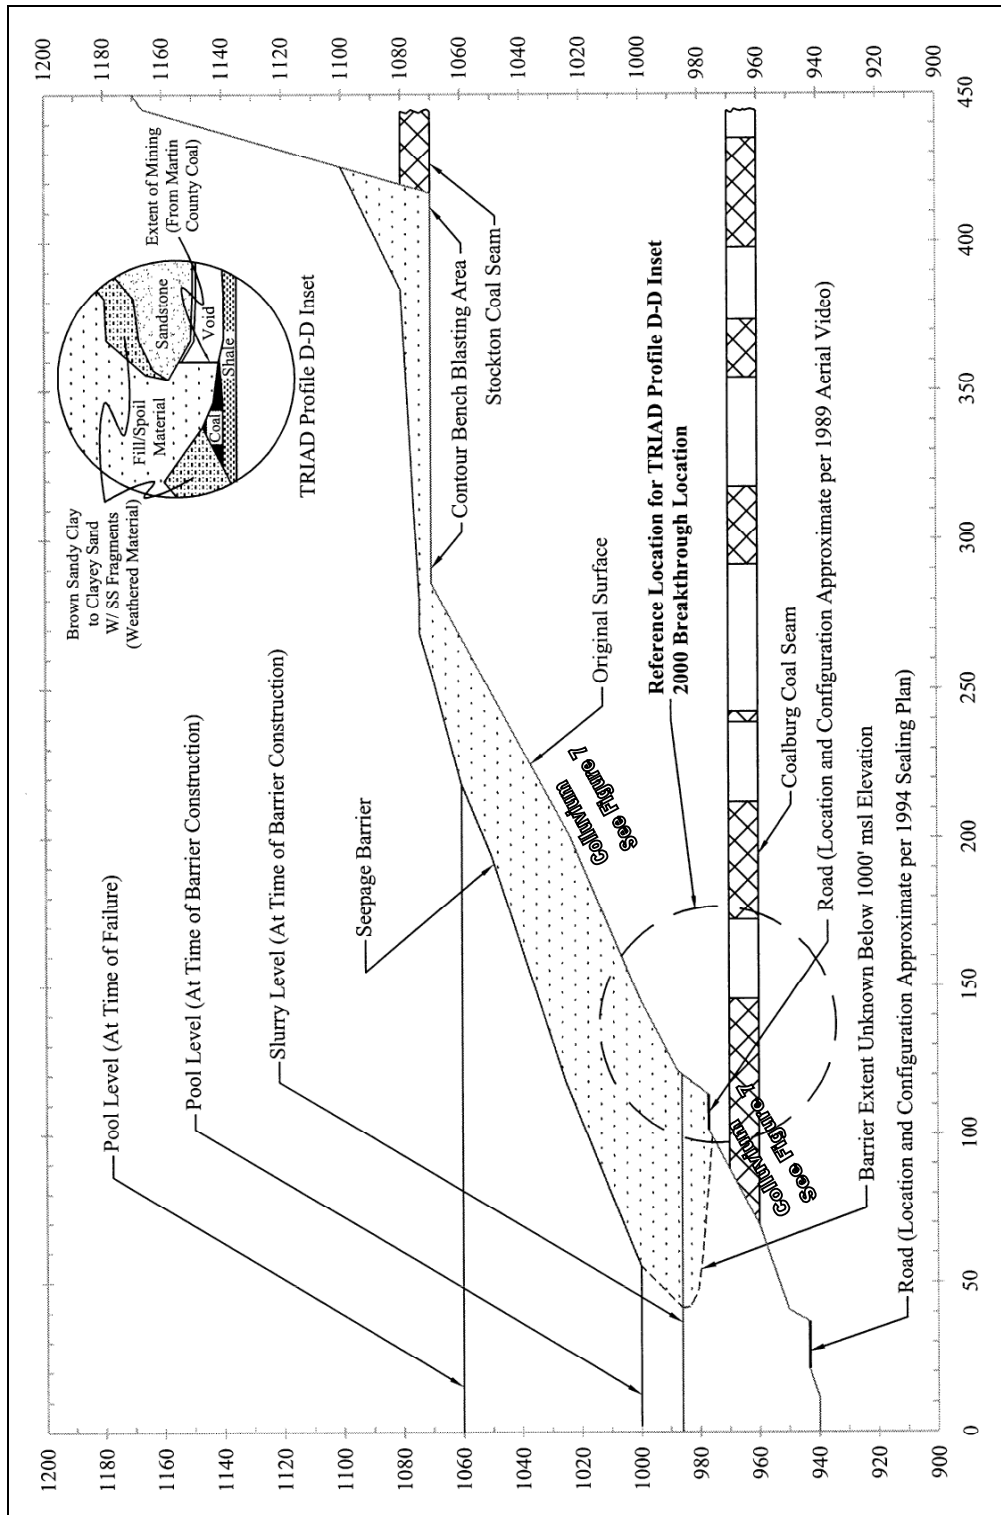
**Figure 4. Cross-Section B-B' of Seepage Barrier Constructed at 2000 Breakthrough. Drawn by OSM with Triad Profile D-D inserted.**

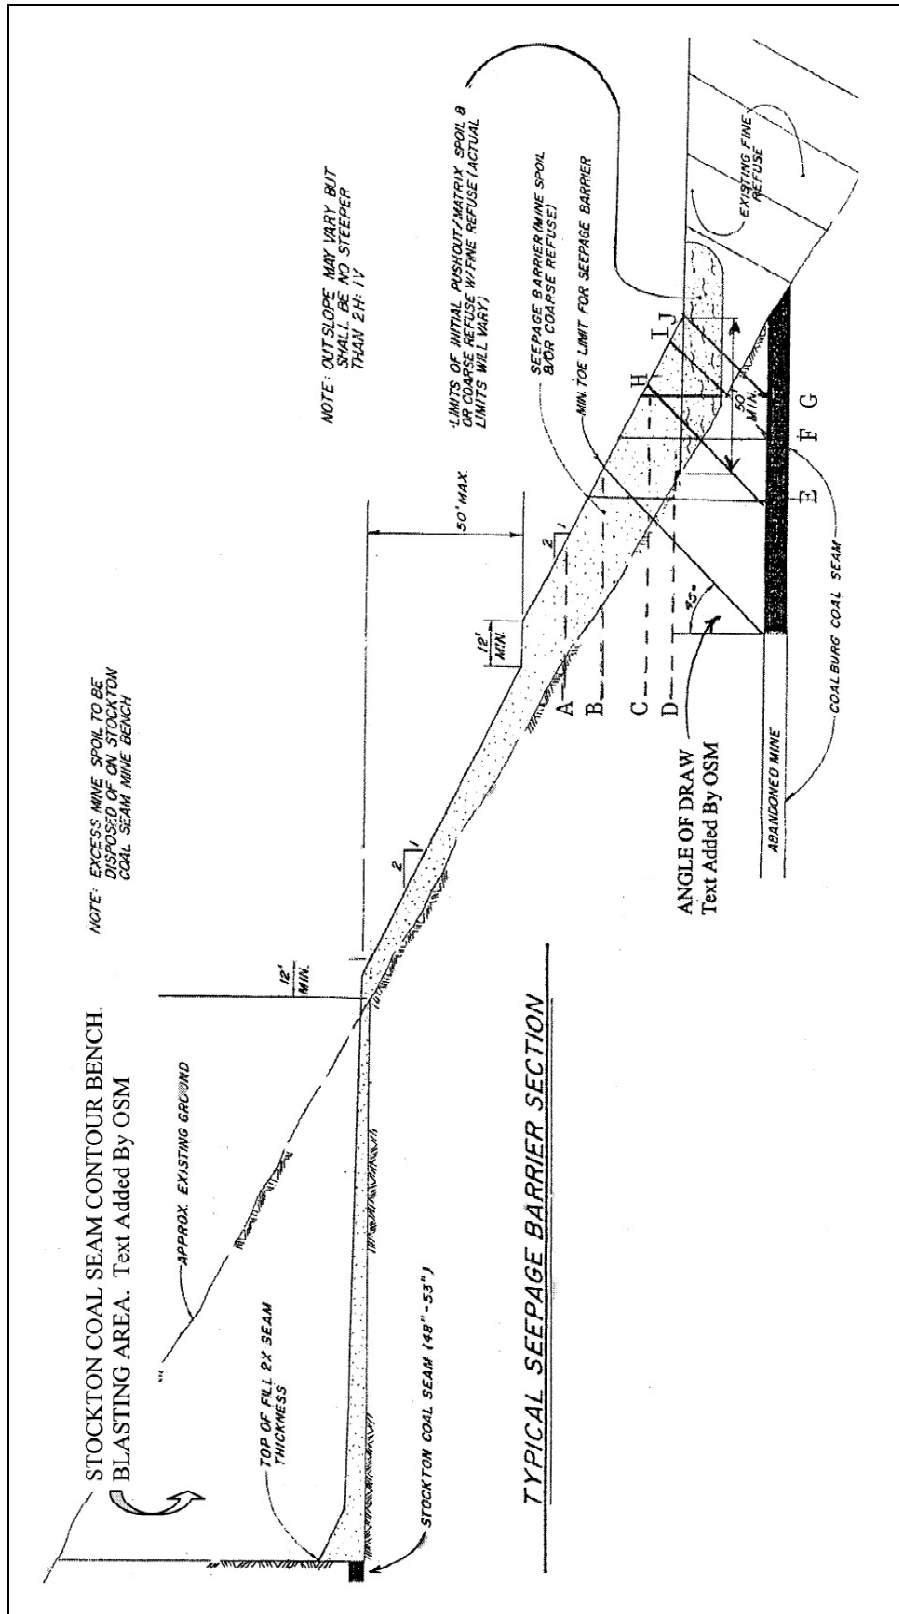
Figure 5. Cross-Section of Designed Seepage Barrier. Source: Sealing Plan, Details Sheet. Information added by OSM: 1) Mine roof caving height based on five times the mining height--line A for 12-foot mining height, line B for 10-foot mining height, line C for 7.5-foot mining height, and line D for 6-foot mining height; 2) Outcrop barrier width—vertical line E for 70-foot width, vertical line F for 50-foot width, and vertical line G for 35-foot width; 3) Lateral extent of subsidence based on a 45-degree angle of draw per MCCC —slanted line H based on a 70-foot wide outcrop barrier, slanted line I based on a 50-foot wide outcrop barrier, and slanted line J based on a 35-foot wide outcrop barrier.

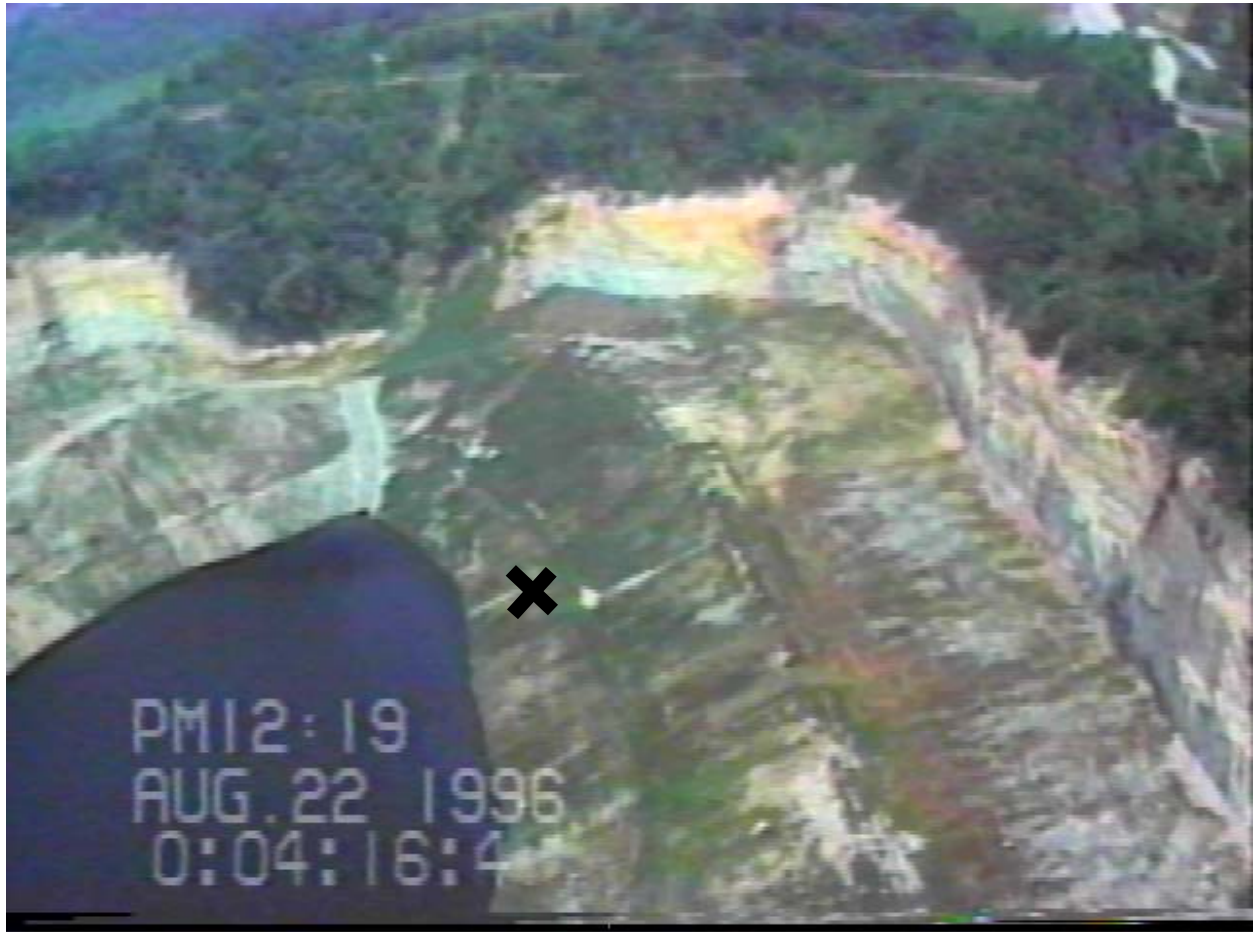
**Photo 6. Seepage Barrier by 2000 Breakthrough (After Construction) - August 22, 1996.**  
**Source: DSMRE aerial video. The X marks the approximate location of the 2000 breakthrough. Pool elevation 1,018 feet msl. Mine roof elevation 973 feet msl. Contour bench elevation 1,075 feet msl.**

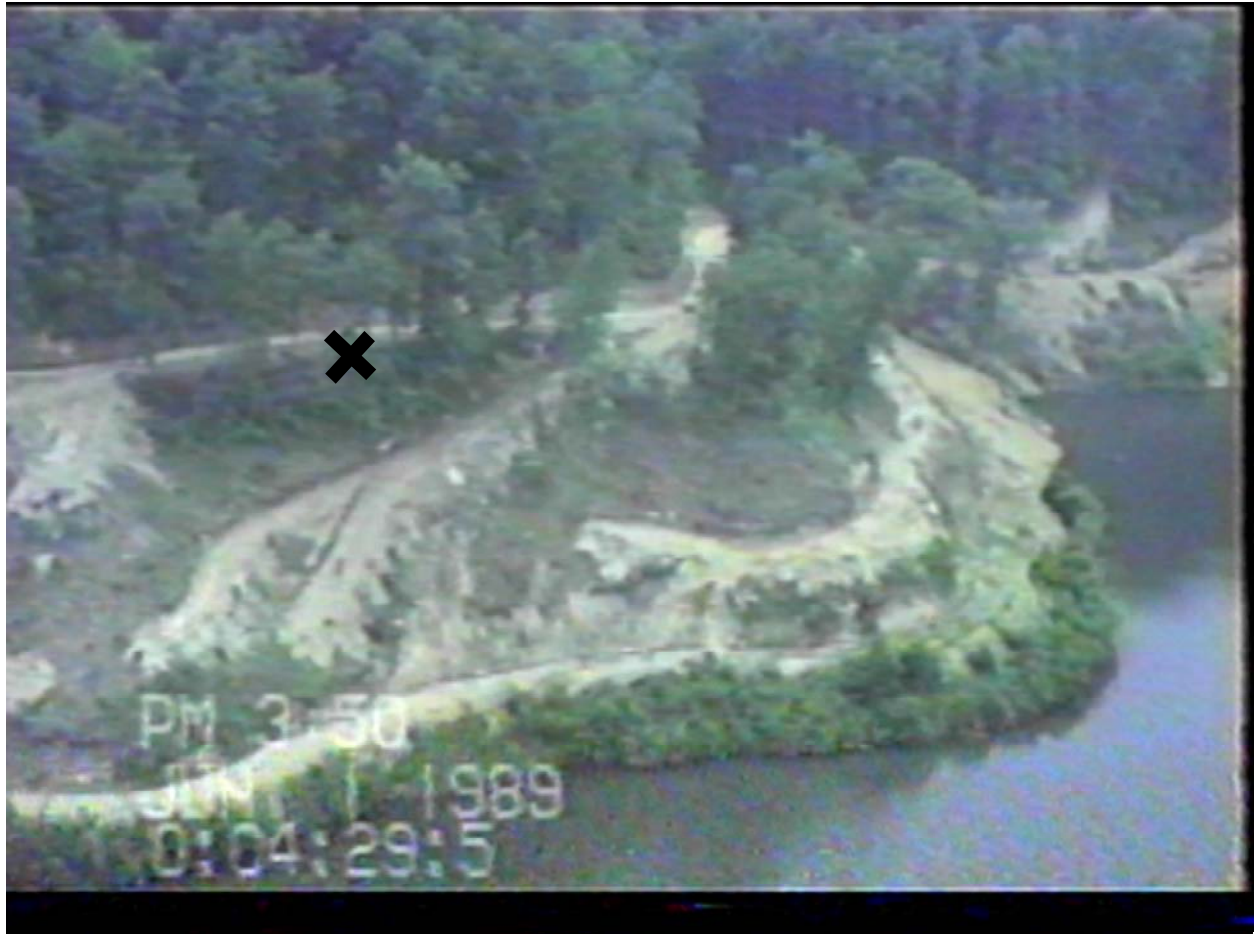
**Photo 7. Surface Conditions at 1994 Breakthrough - June 1, 1989. Source: DSMRE aerial video. The X marks the approximate location of the 1994 breakthrough. Pool elevation 958 feet msl. Mine roof elevation 964 feet msl.**

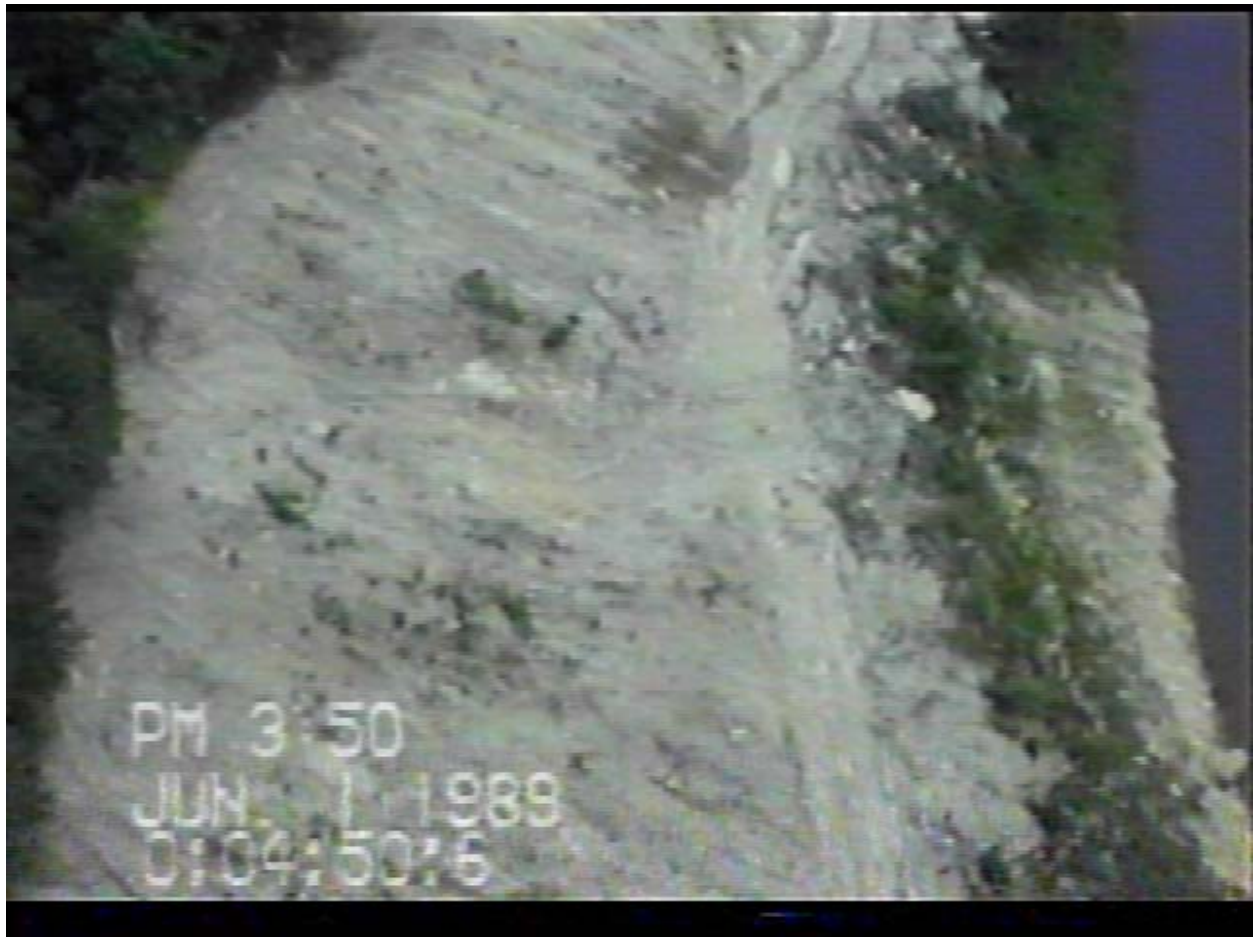
**Photo 8. Surface Conditions at 2000 Breakthrough – June 1, 1989. Source: DSMRE aerial video. Pool elevation 958 feet msl. Mine roof elevation 973 feet msl.**

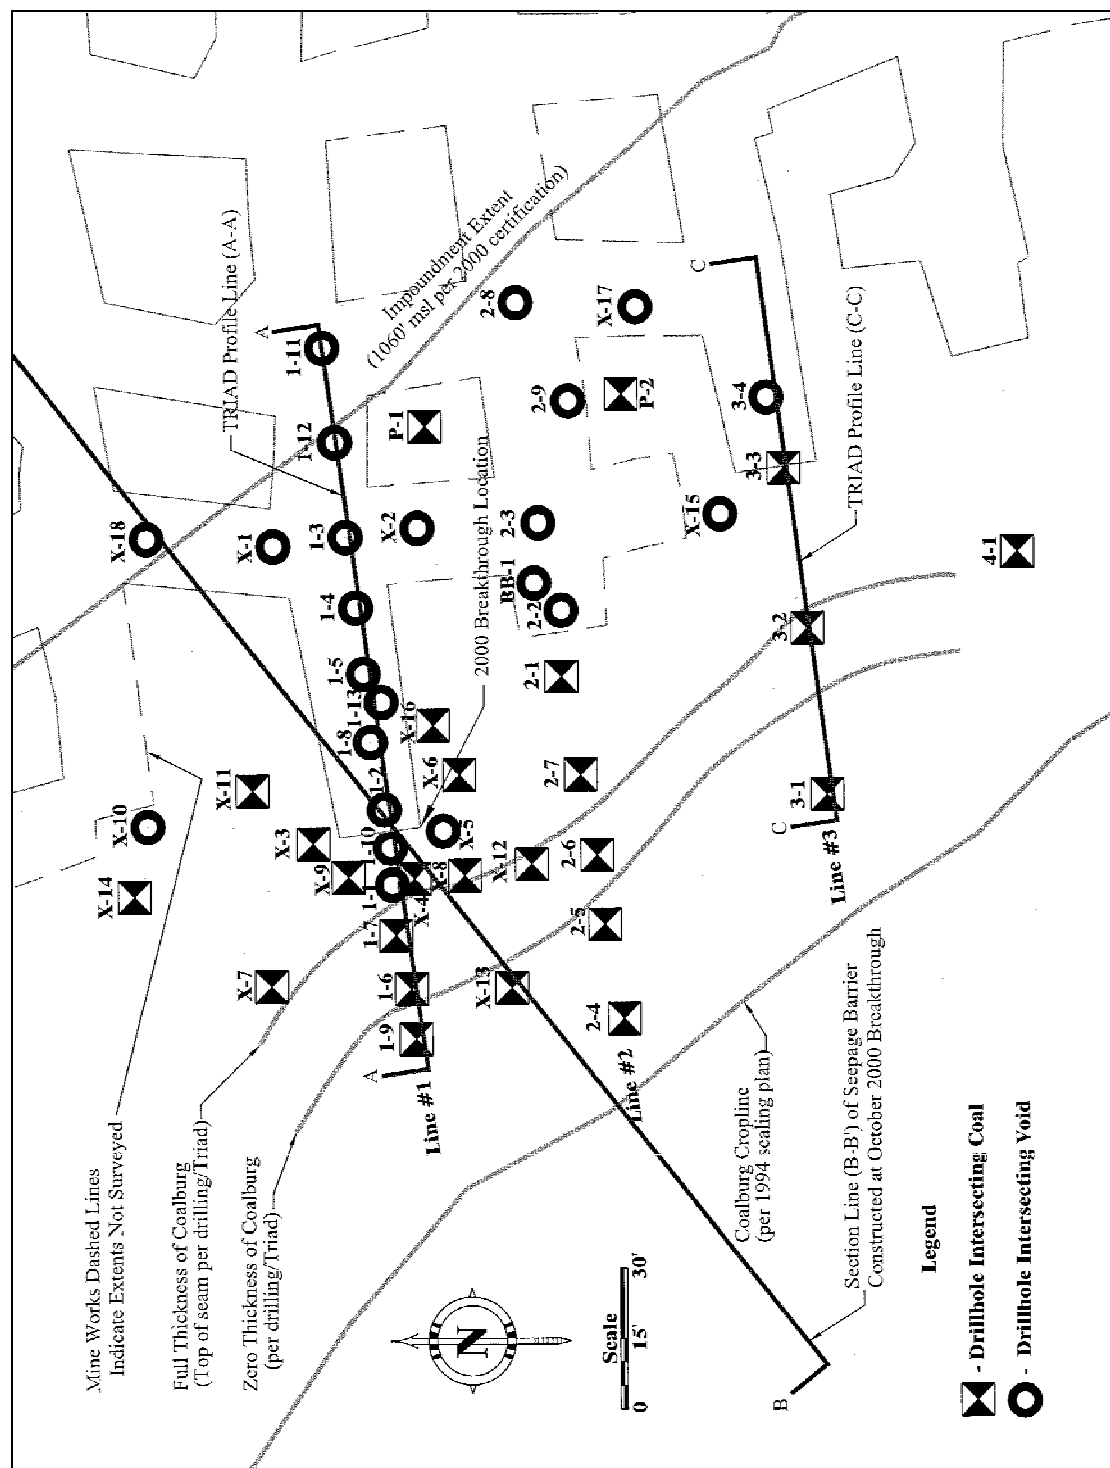
Figure 6. Drill Hole Location Map. Drawn by OSM using Triad drilling data. Note: The Triad drill logs did not indicate that voids were encountered by holes X-4 and X-8; however, these holes, along with X-5, are located in the breakthrough erosion channel.

The drilling, holes 1-1 and 1-10, identified a void beyond the mapped mine entry (mine limit) at the 2000 breakthrough. These drill holes were located along the centerline of the entry. This is in contrast to drill hole X-9, which did not identify a void near the left side of the entry. It is not known whether the “missing” coal was mined or eroded during the breakthrough. However, coal remaining at the base of the holes (1-1, X-4, X-5, X-8) suggests that the coal was eroded and not mined. Except for holes 3-4 and X-15, the Triad drilling indicates that MCCC mined the total thickness of coal.

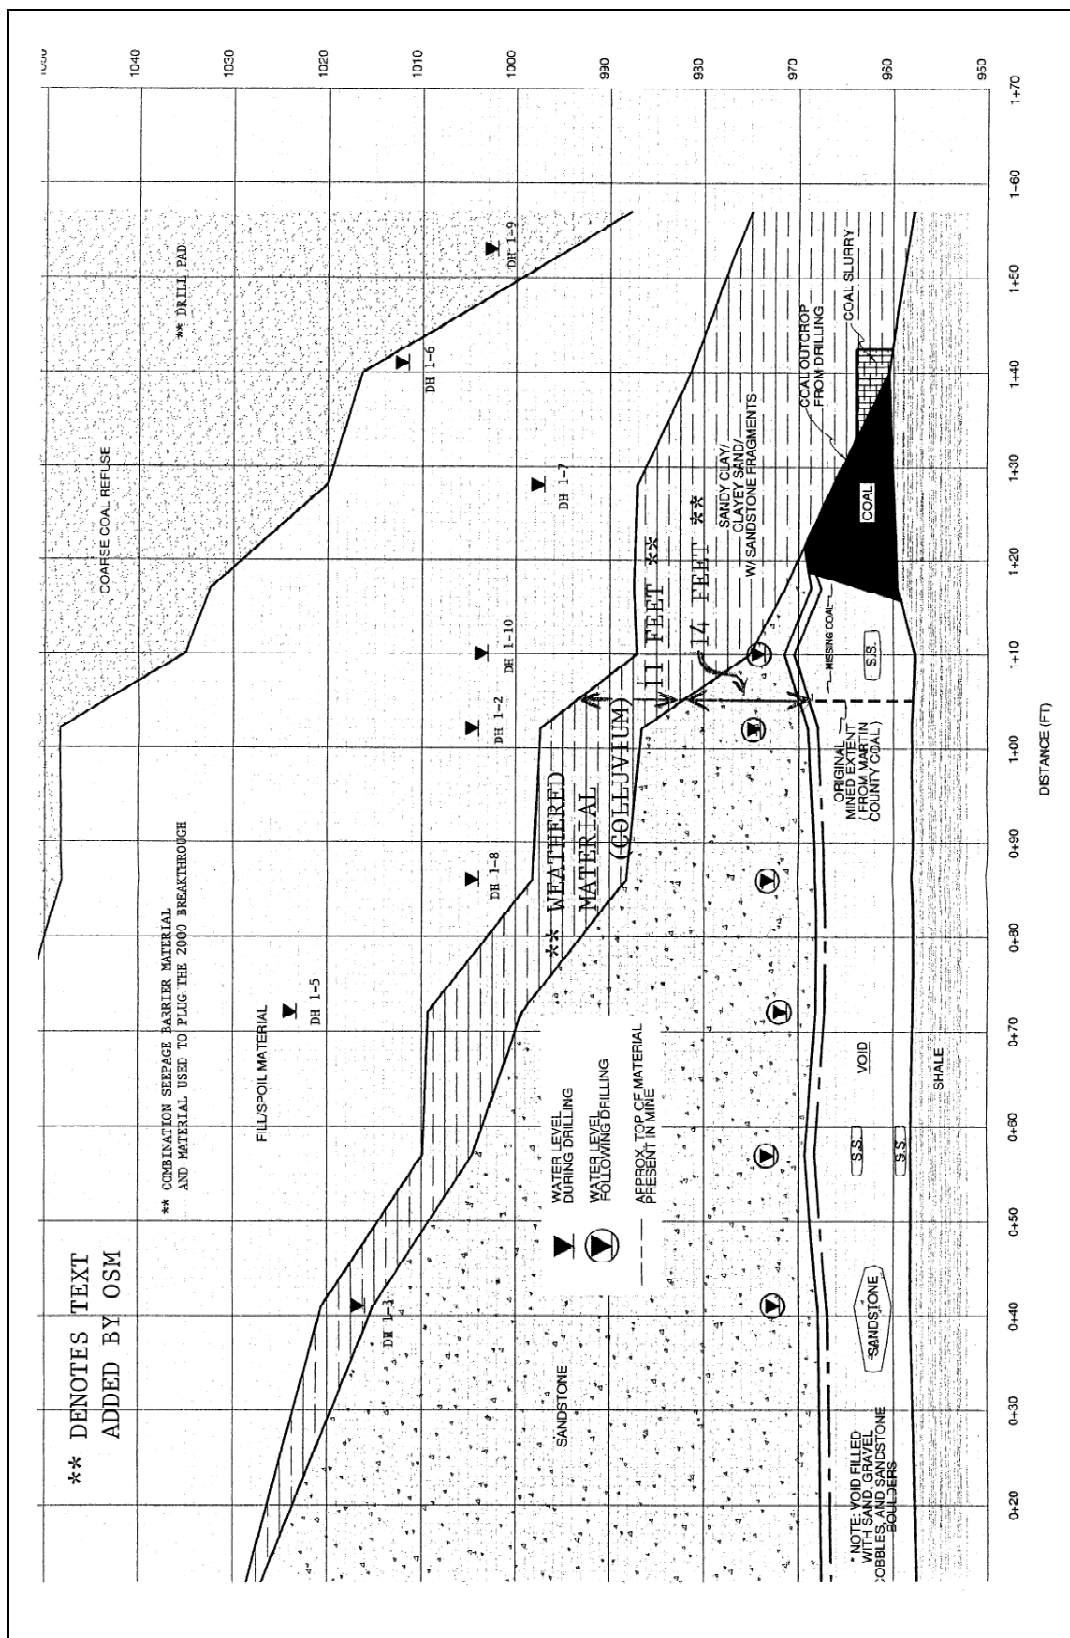
At the end of the 10- to 12-foot section of “missing coal” (Figure 7 [Page 55]), the overburden is composed of only about four feet of weathered sandstone and 15 feet of colluvium. This is in contrast to the sealing plan that indicates that the overburden was solid rock (Section 3.3.2.5). Further, the sealing plan’s cross-section and maps indicate that the horizontal distance between the mine limit at the 2000 breakthrough and the surface was 50 feet at the top of the coal seam and 70 feet at the bottom of the coal seam. However, the drilling near the breakthrough indicates that the Coalburg coal seam extended less than half the distance from the mine limit to the surface. The full thickness of the Coalburg coal seam exists for only about 15 feet beyond the mine limit as mapped and then it thins to zero feet thick at about 33 feet from the end of the mine (Figure 6 [Page 53]). The Triad drill logs did not identify coal in the remaining portion of the 70-foot wide outcrop barrier. This coal is presumed to be in a weathered condition, and it may have been transported downslope due to hillside creep.

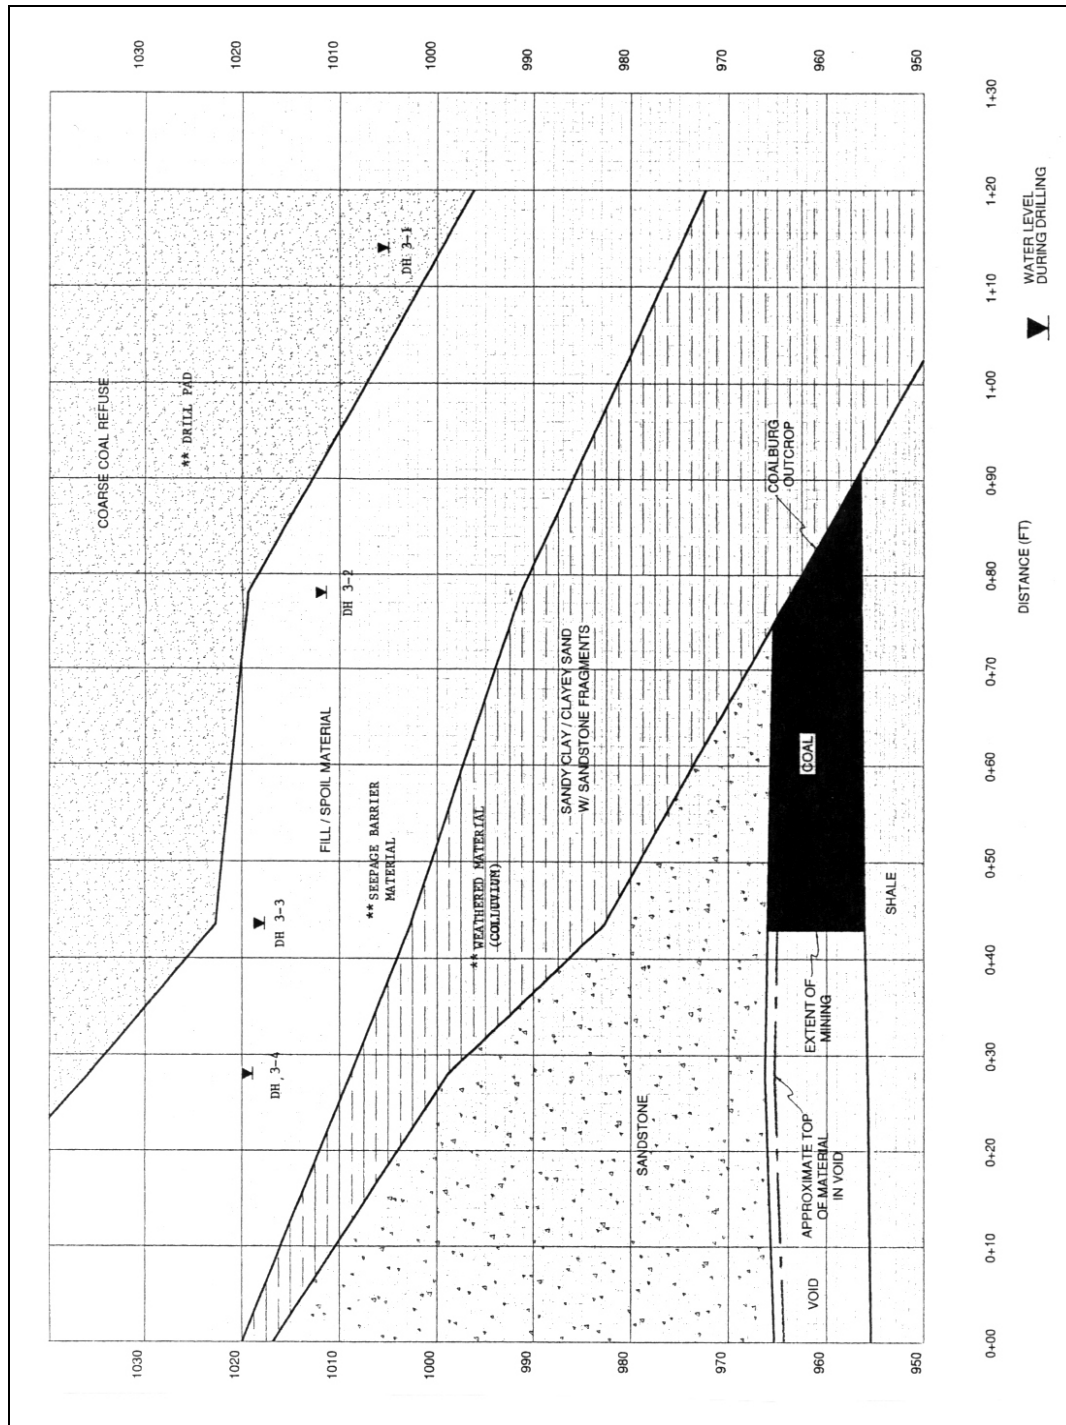
Figure 8. Triad Profile C-C. From Triad Report. Cross-Section at Line #3, Figure 6.  
 \*\* Denotes Text Added by OSM.

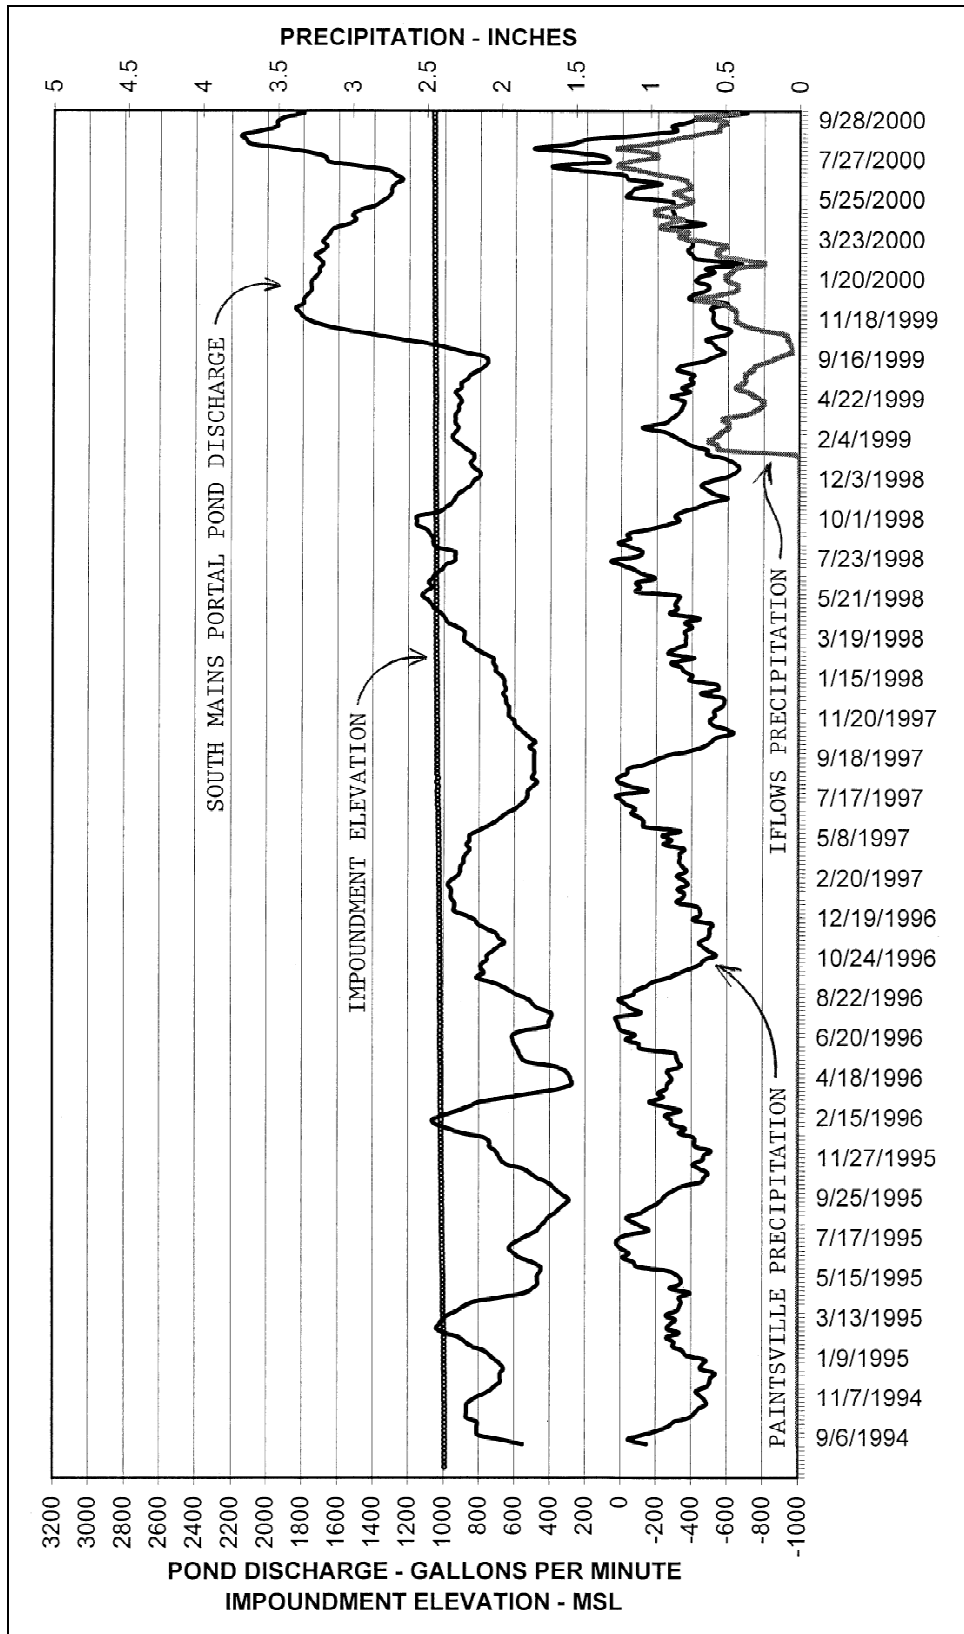
Figure 9. Impoundment Elevation, South Mains Portal Pond Discharge, and Precipitation. Impoundment elevation obtained from MCCC. Pond discharge calculated by OSM—for details see Appendix 10, Section 4. Precipitation obtained from National Weather Service, Paintsville, Kentucky and IFLAWS station number 3194. See Appendix 10, Figure 4 for data points. The discharge and precipitation lines are “trendlines” based on an eight point moving average.

- There was no clear, consistent trend between discharge rates and precipitation for the six ponds as contended by MCCC.
- There was not a relationship between precipitation and impoundment pool elevation.
