# Macondo

T H E G U L F O I L D I S A S T E R

Chief Counsel's Report | 2011

National Commission on the BP Deepwater Horizon Oil Spill and Offshore Drilling

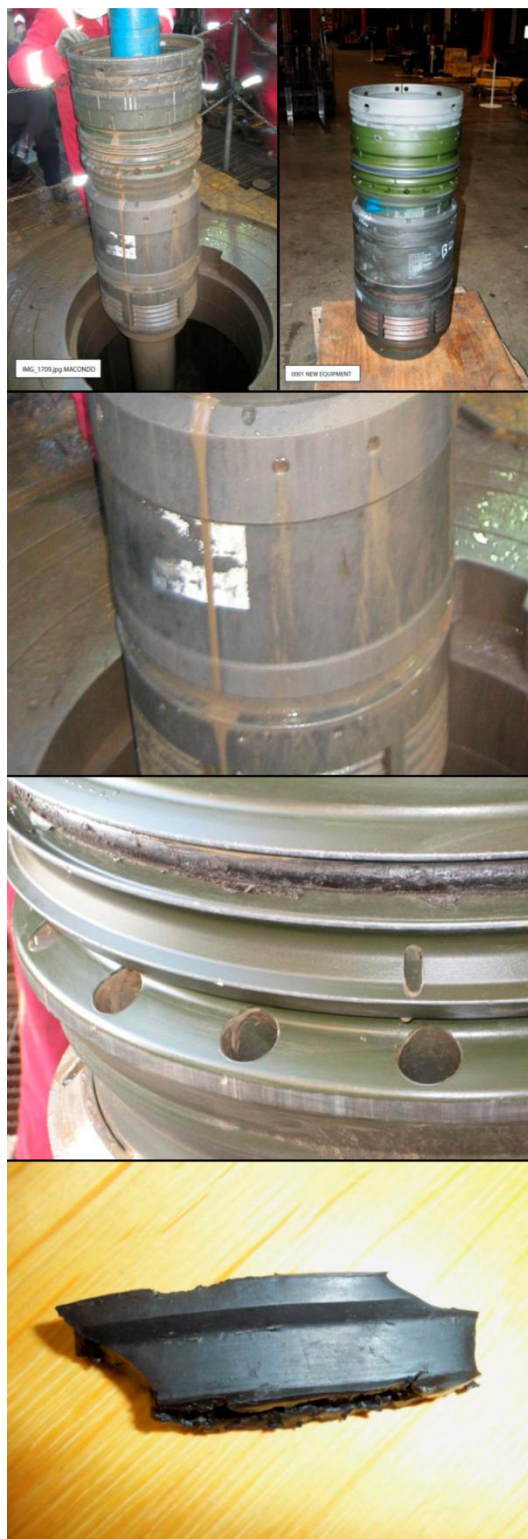
**Figure 4.1.4. Exterior of the Macondo production casing hanger and seal assembly.**

- Figure 4.1.4. Exterior of the Macondo production casing hanger and seal assembly. The outside surfaces of the Macondo casing hanger and seal assembly show no damage (left). They have no erosion-induced channels. Instead, they resemble the condition of brand-new equipment (right).

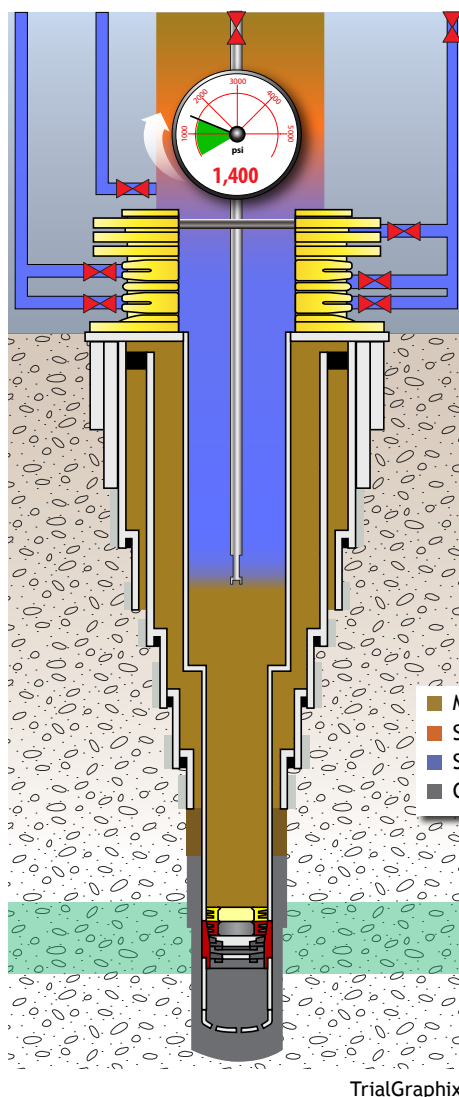
**Figure 4.6.7. First test failure.**

During the first negative pressure test, the crew repeatedly bled the drill pipe pressure down to 0 psi. However, more fluids bled than expected, and the drill pipe pressure repeatedly increased. After the last bleed, the drill pipe pressure rose from 0 to 1,400 psi, a clear failure.

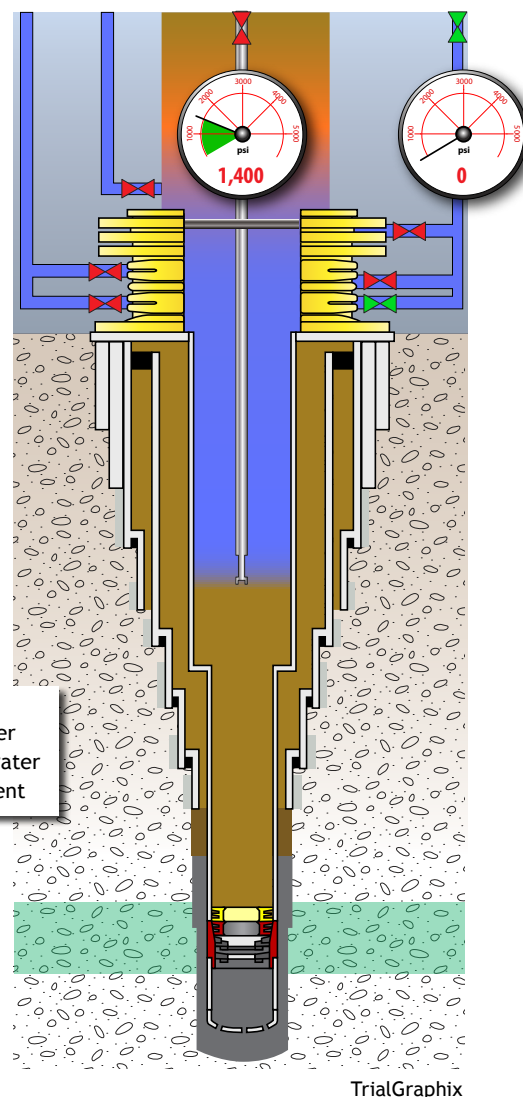
**Figure 4.6.8. Second test failure.**

During the second negative pressure test, the crew bled off the pressure in the kill line, rather than the drill pipe. The crew observed no excessive flow or pressure buildup on the kill line. The well site leaders and rig crew decided this was a successful test. But they had never accounted for the pressure on the drill pipe, which remained at 1,400 psi throughout the second test.

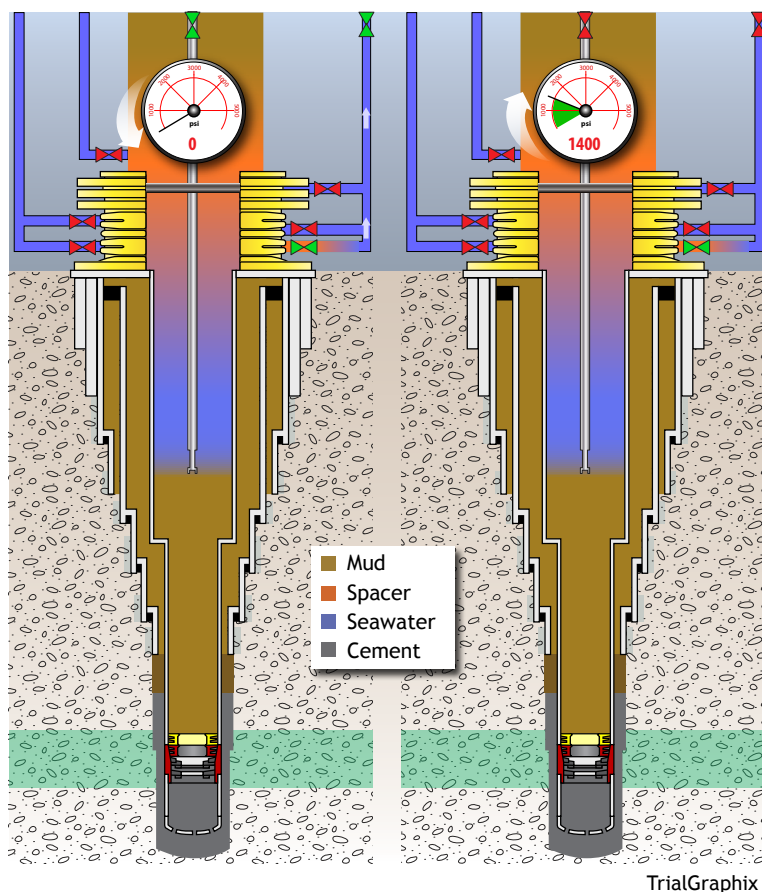
**Figure 4.6.16. 5:53 p.m.**

The rig crew bled drill pipe pressure down for a third time, this time through the kill line. Witnesses reported that three to 15 barrels were returned as the drill pipe reached 0 psi (left). When the drill pipe was shut, the drill pipe pressure rose to 1,400 psi. According to BP witnesses, the Transocean rig crew attributed this rise to a “bladder effect.” A 15-barrel return would have been excessive, and the rise of drill pipe pressure to 1,400 psi was a clear sign that the negative pressure test had failed (right).

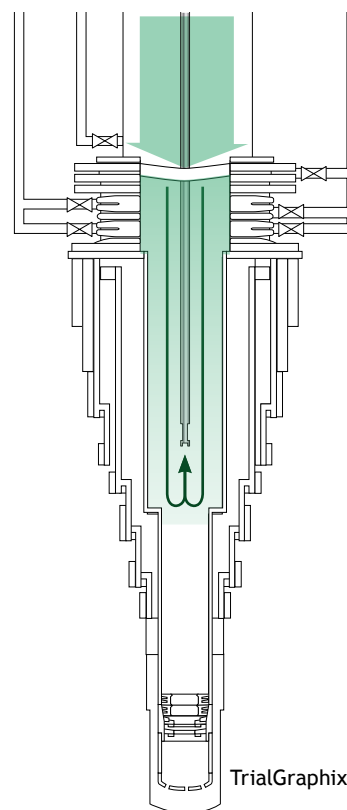
**Figure 4.6.17**

**Bladder Effect.** This figure represents the Chief Counsel's team's understanding of the "bladder effect" theory that supposedly explained the elevated pressure on the drill pipe. The "bladder effect" explanation contends that heavy fluids (mud and spacer) displaced to the riser were exerting force on the annular preventer from above, which in turn communicated pressure into the well. The Chief Counsel's team found no evidence to support this theory.

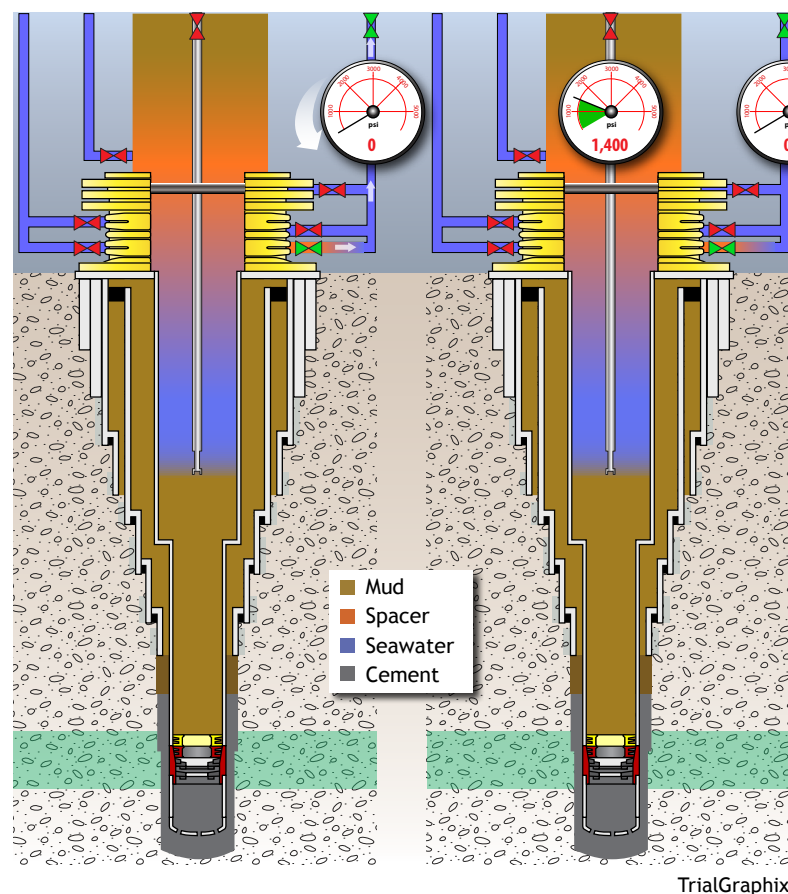
**Figure 4.6.18. 6:40 p.m.**

The rig crew conducted a negative pressure test on the kill line. The rig crew reduced the pressure on the kill line to 0 psi, bleeding an insignificant amount of water (left). No flow or pressure buildup was observed on the kill line, which on its own would have been a successful negative pressure test. However, the 1,400 psi on the drill pipe remained and was never properly accounted for (right).

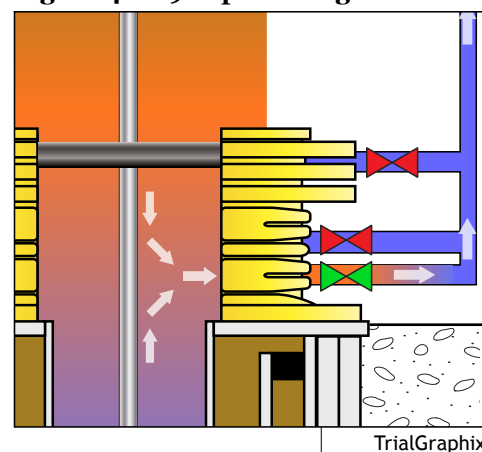
**Figure 4.6.19. Spacer migration.**

Leftover lost circulation material used as spacer for the negative pressure test could have migrated into the kill line during bleeds.
