National Transportation Safety Board

Railroad Accident Brief

Accident No: DCA-02-FR-013
Railroad: Norfolk Southern Railway
Train: Train 15T
Location: Farragut, Tennessee
Accident date and time: September 15, 2002, 11:20 a.m. eastern daylight time
Type of Accident: Derailment
Fatalities/Injuries: No fatalities or serious injuries
Property Damage: \$1.02 million

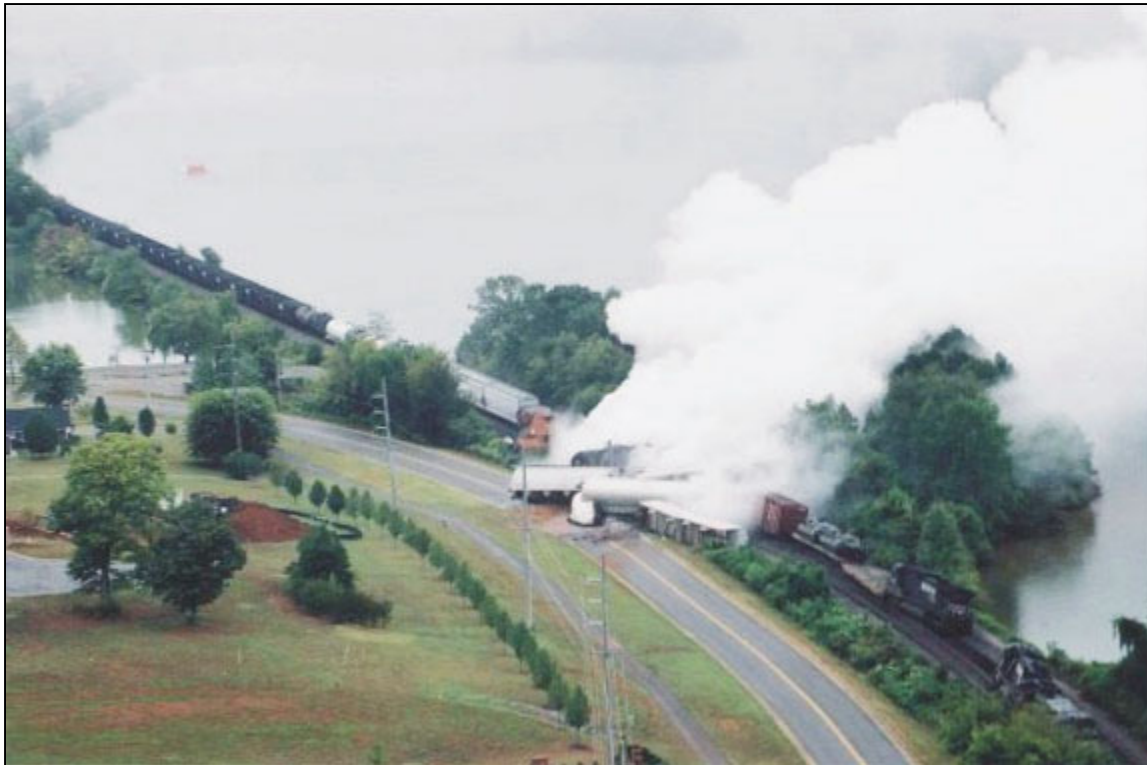
About 11:20 a.m. eastern daylight time on September 15, 2002, westbound Norfolk Southern Railway (NS) train No. 15T derailed in Farragut, Tennessee, while moving at 38 mph. The train was made up of 3 locomotives, 56 loads, and 86 empties; a total of 142 cars with a gross weight of 9,948 tons. Two locomotives and the first 25 cars derailed. A tank car containing sulfuric acid was punctured, releasing a cloud of toxic fumes that prompted local responders to evacuate about 2,600 people from a 4.4-square mile area around the site. The evacuation lasted for about 2 1/2 days. Several local residents were treated for minor respiratory difficulties. There was no fire. Damages were estimated to be \$1.02 million. (See figure 1.)

Figure 1. Looking east at the derailment of NS train 15T showing fuming sulfuric acid from ruptured tank car.

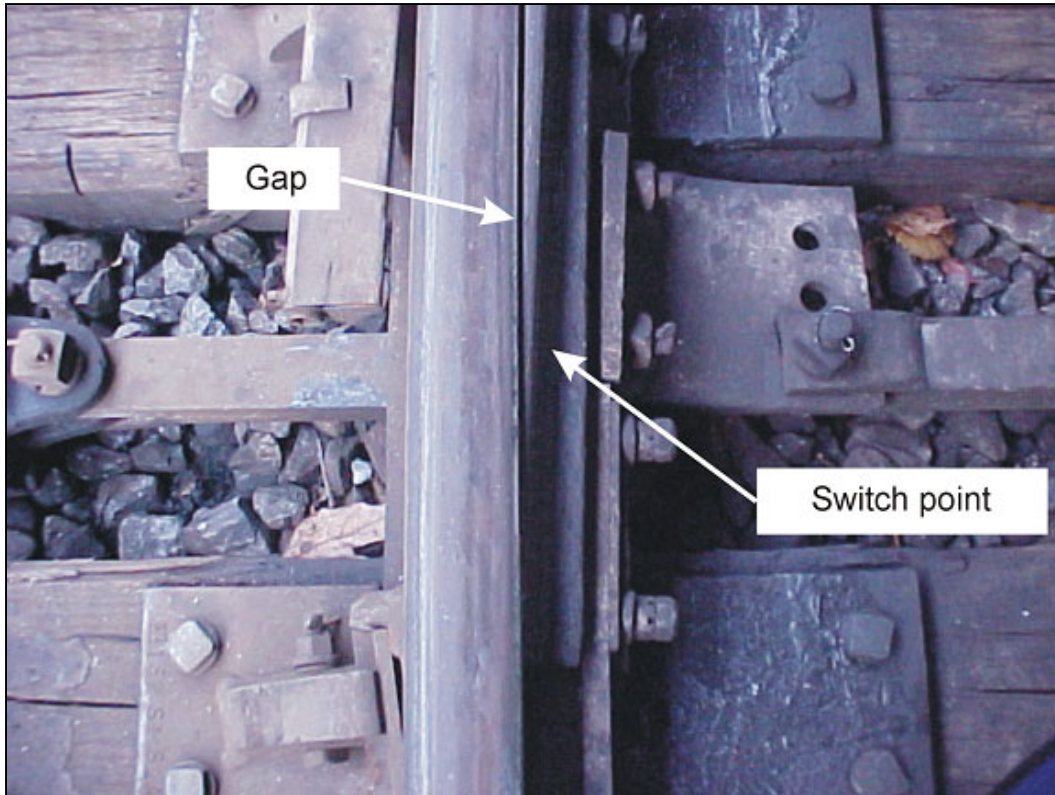
At the east end of the siding, the crew of train 703 stopped short of the spring switch so the conductor could look at the switch before proceeding. He found that the left switch point (when facing west) was not seated tightly against the stock rail but instead had a 1/4-inch gap.³ A spring switch can be thrown manually by moving a lever beside the track. After operating the spring switch through its motion several times, the conductor found that the left switch point still failed to close completely, leaving about a 1/8-inch gap between the switch point and the stock rail. (See Figures 2 and 3.)

³ Such a gap could cause the wheel flange of a westbound train to strike the end of the switch point, thereby damaging the switch or causing a derailment. The gap would also account for the *restricting* indication the crew had received from the automatic block signal.

Figure 2. Gapped switch point.

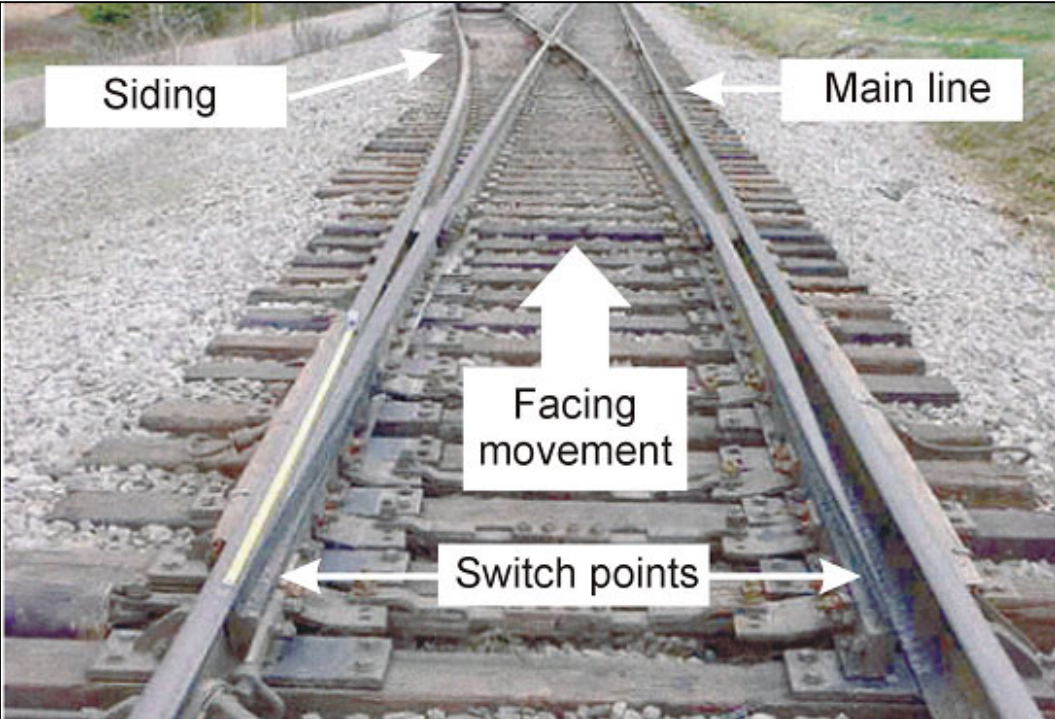
Figure 3. Spring switch similar to the East Boyd Siding switch where derailment occurred. Switch is aligned for main line movement.

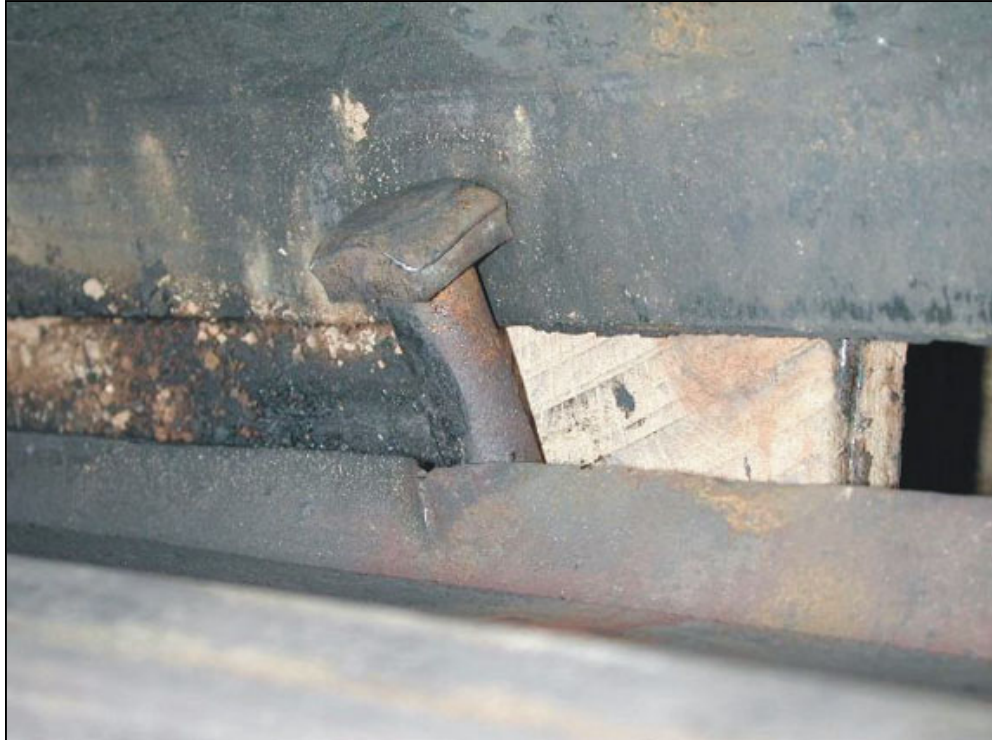
Postaccident inspection of the East Boyd spring switch revealed that a bolt was missing from the No. 4 throw rod. The missing bolt was 4 3/4 inches long and 3/4 inch in diameter. During the inspection, a 2 7/8-inch-long piece of the head section of what was believed to be the missing bolt was found approximately 80 inches back from the switch point, lodged between the base flanges of the left switch point rail and the left stock rail. (See figure 5.)

The head section of the switch throw rod bolt and the base of the stock rail and the base of the switch point showed marks and abrasions that were evidence of the bolt being lodged and thus obstructing the normal alignment of the two rails. At this location, the broken bolt section could interfere with the movement of the left switch point rail (when facing west) and cause a gap between the switch point and the stock rail. Although the switch points could be forced into alignment by a train making a trailing (eastbound) movement over the switch, the interference created by the lodged bolt made the points susceptible to gapping if they were disturbed, such as by a train making a facing (westbound) movement over the switch.

Because the bolt section was lodged at the base of the closed rails, it was not visible with the switch positioned as it was when the signal maintainer arrived. When the switch is operated and the rail sections separate, the switch point rail moves about 4 to 4 1/2 inches away from the stock rail. In this position, the heads of the throw rod bolts and the base of the rails are visible. The location of the missing bolt would also have been visible.

Figure 5. Postaccident reconstruction of broken bolt section as positioned before the derailment.

The National Transportation Safety Board determines that the probable cause of the September 15, 2002, derailment of Norfolk Southern train 15T was (1) the decision by the train dispatcher and signal maintainer to allow the train to pass over the spring switch at maximum authorized speed before the switch had been adequately inspected or clamped closed and (2) the lack of company procedures requiring that train dispatchers, after receiving a report of a problem involving a main track switch, immediately stop trains or implement an appropriate speed restriction in the affected area.

1. Require that train dispatchers, upon receiving reports of potentially hazardous conditions involving a main track segment or switch, stop train movements or immediately implement an appropriate speed restriction for the affected area and remove the restrictions only after the completion of those inspections and/or repairs that are essential for the safe movement of trains. (R-03-4)

2. Require that your train dispatchers, upon receiving reports of potentially hazardous conditions involving a main track switch, immediately stop train movements or implement an appropriate speed restriction for the affected area and remove the restrictions only after the completion of those inspections and/or repairs that are essential for the safe movement of trains. (R-03-5)
