# National Transportation Safety Board

## Aircraft Accident Brief

| Accident No.: | DCA00MA052 |
| Aircraft and Registration: | British Aerospace J-3101, N16EJ |

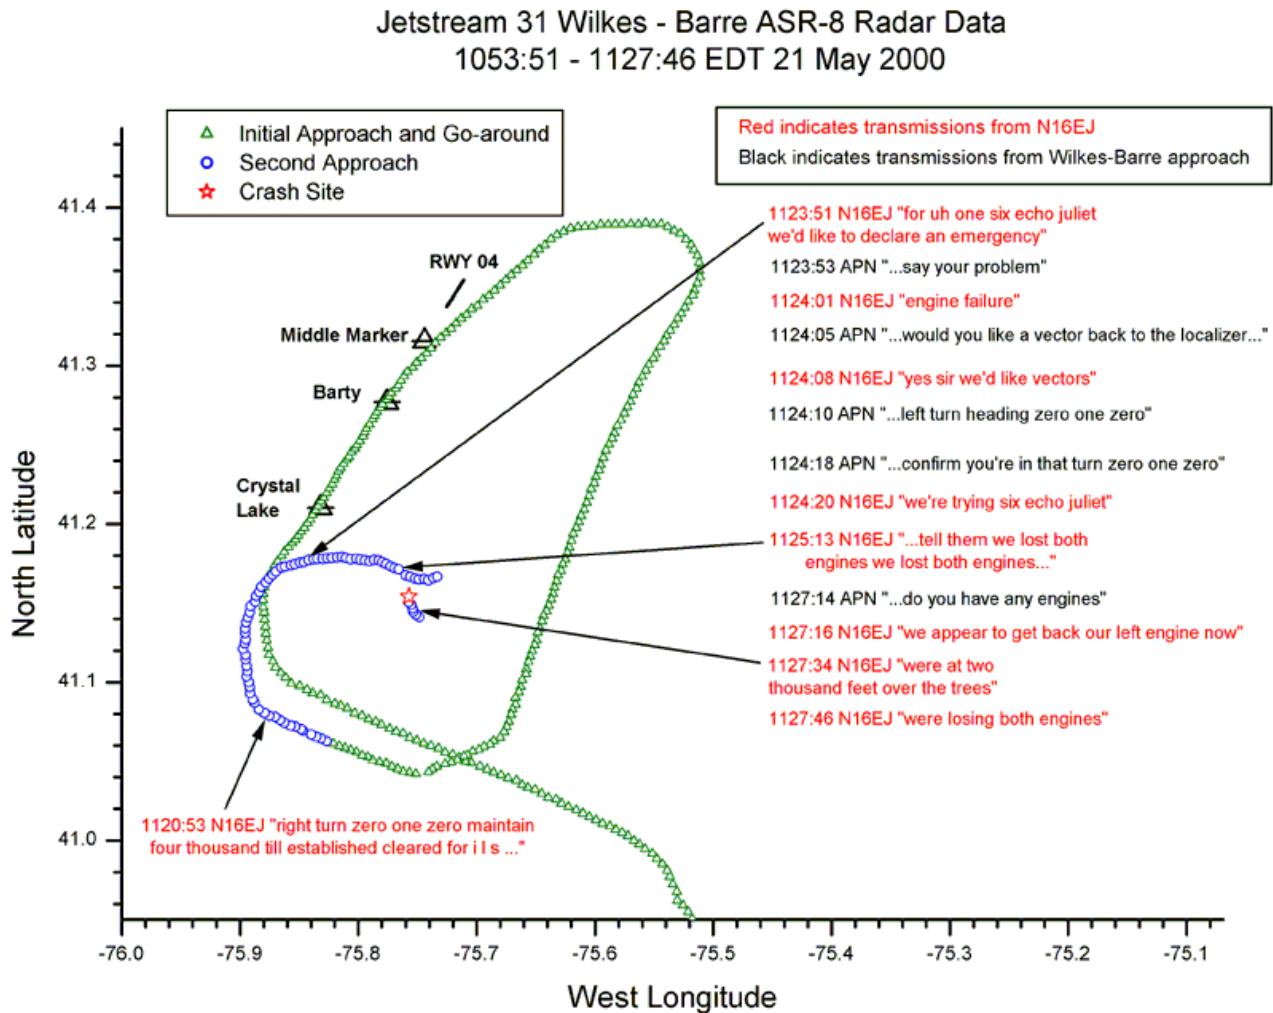
**Figure 4.** Plot of the accident airplane's initial and second approaches correlated with key ATC transmissions.

At 1127:16, when the pilots radioed that they had apparently regained power to the left engine, the airplane's heading would have been about 285°. The next radar return occurred at 1127:23. According to the performance calculations, the accident airplane would have had to execute a right turn while maintaining about 2,000 feet in a northwesterly direction to reach that radar return location. The final series of radar returns showed the airplane at 2,000 feet and an airspeed of 103 knots. The data indicated that the airplane continued to turn right at the same altitude and airspeed. The final radar return occurred at 1127:48, 2 seconds after the captain reported losing both engines. The crash site was about 0.22 nm north of the final radar return.
