Collision of Amtrak Passenger Train 371 and Norfolk
Southern Railway Company Freight Train 23M
Chicago, Illinois
November 30, 2007

Accident Report

NTSB/RAR-09/01
PB2009-916301

NTSB/RAR-09/01
PB2009-916301
Notation 7989A
Adopted March 31, 2009

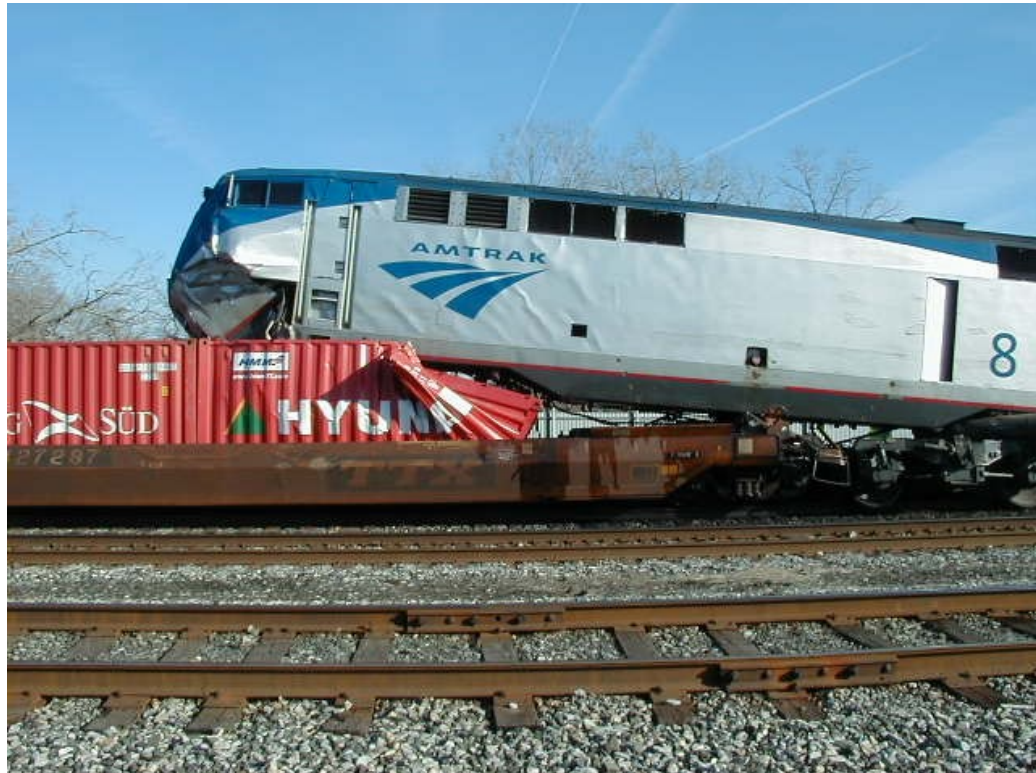
The Amtrak locomotive was the only derailed piece of equipment. The leading truck assembly⁶ ruptured the left front section of the fuel tank, and about 300 gallons of diesel fuel

spilled from the tank. Both front windows of the cab were dislodged during the collision. The rear window on the right side of the cab was shattered but still in its frame.

Figure 3. Amtrak locomotive resting on top of container on rear car of Norfolk Southern freight train.

Just inside the rear door to the cab from the engine room, the floor was lifted 7 inches and was arched upward in the cab. The engineer's seatback was about 5 1/2 inches from the roof of the cab, the center seatback was about 2 1/2 inches from the roof, and the left seatback was touching the roof. Normally, the seatbacks are 23 inches from the roof.

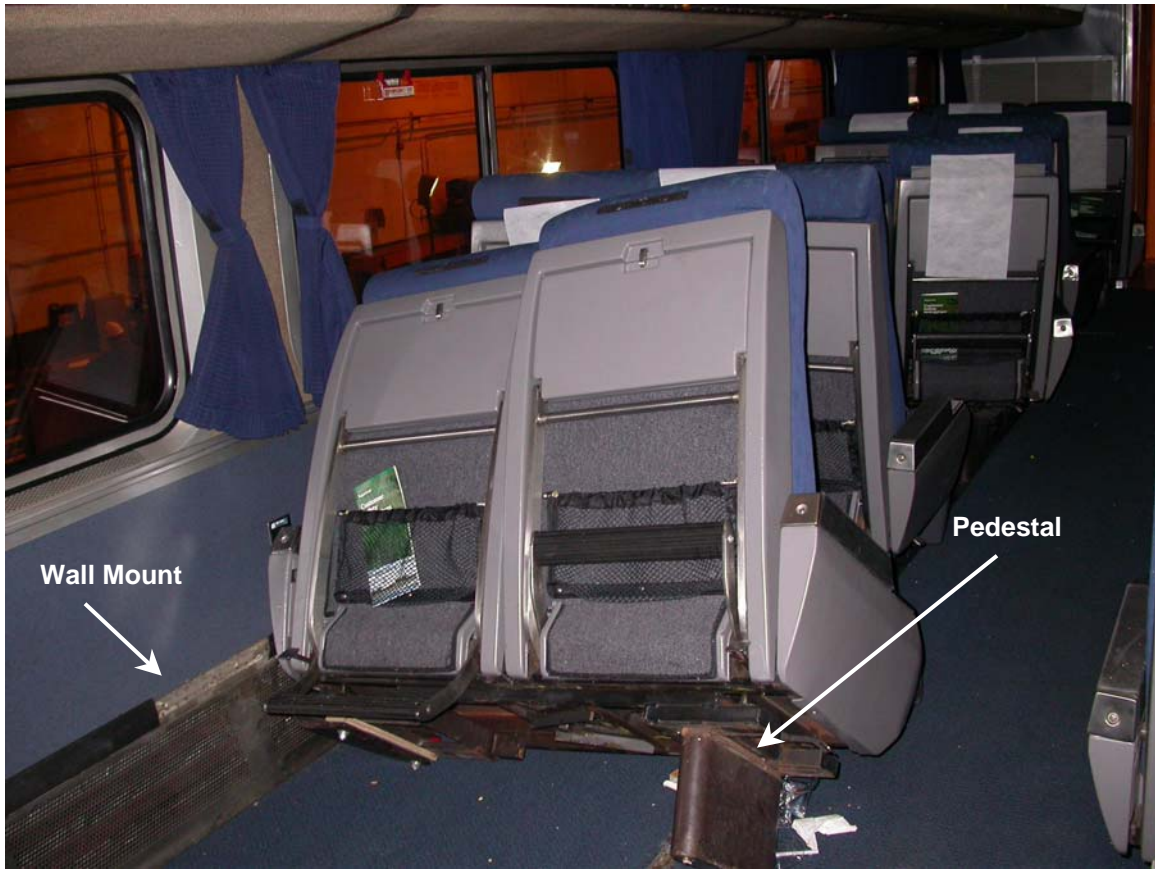
Figure 4. Seat pair 19-20.

The two fractured mount studs from seats 7-8 and the fractured mount stud from seats 19-20 from car 34054 were sent to the Safety Board's Materials Laboratory. The Materials Laboratory compared the accident mount studs that failed with an exemplar mount stud of the type that did not fail. The head profile of each mount stud was measured and the material was tested for hardness. Minor differences in head profiles and average hardness values were noted.

The fractures on two of the mount studs contained crack arrest marks that are typical of fatigue cracking emanating from the relief radius between the shank and head portion of the mount stud. The fractures on the head of the third mount stud had fine-grained features that are typical of overstress separation with no evidence of fatigue cracking. The exposed fracture faces showed metal flow that is consistent with the mount stud pulling up relative to the floor-mounting track. The upper side portion²¹ of the heads in areas that corresponded to a fatigue crack had fretting²² damage.

As a result of the collision, three seat pairs were detached from the guides on the floor of the car. The Safety Board’s Materials Laboratory examined the mount studs that attached the seat pedestals to the mounting guides on the floor. The head portions of two mount studs contained preexisting fatigue cracks that contributed to the detachment of each seat pedestal during the accident. The fatigue cracks were a stress riser that reduced the impact resistance of the mount studs.

The Safety Board concludes that some of the seat mount studs experienced fatigue cracking that resulted in seat pedestals detaching from the floor. Amtrak reviewed its existing inventory and found no seat mount studs of the type that fractured in this accident. All mount studs on the seats involved in this accident were replaced before the passenger cars were returned to service. During Amtrak’s ongoing overhaul program, replacement mount studs of the type that did not fracture are being installed in all seat pedestals on Superliner passenger cars. This replacement program will be completed within 4 years.
