Allision of Bahamas-Registered Tankship  
M/V *Kition* with Interstate Highway 10 Bridge Pier  
Baton Rouge, Louisiana  
February 10, 2007

NTSB/MAR-08/03  
PB2008-916403

# Marine Accident Report

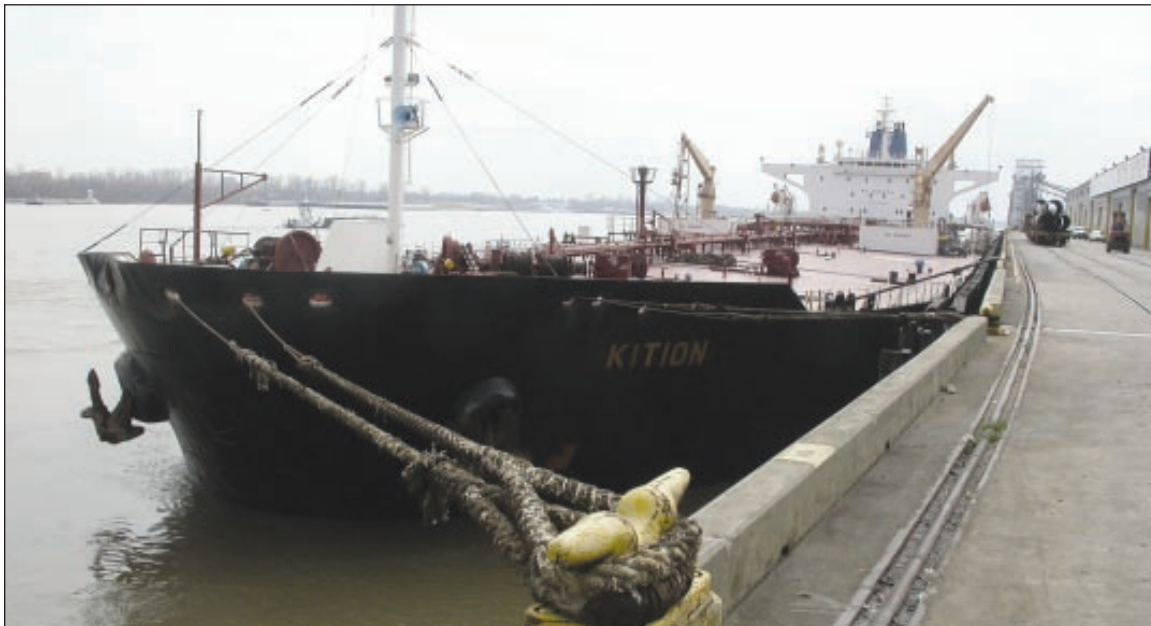
**Figure 1.** *Kition* docked downriver of the I-10 bridge after the accident. The vessel's draft (freshwater) on the day of the accident was 44 feet 7 inches.

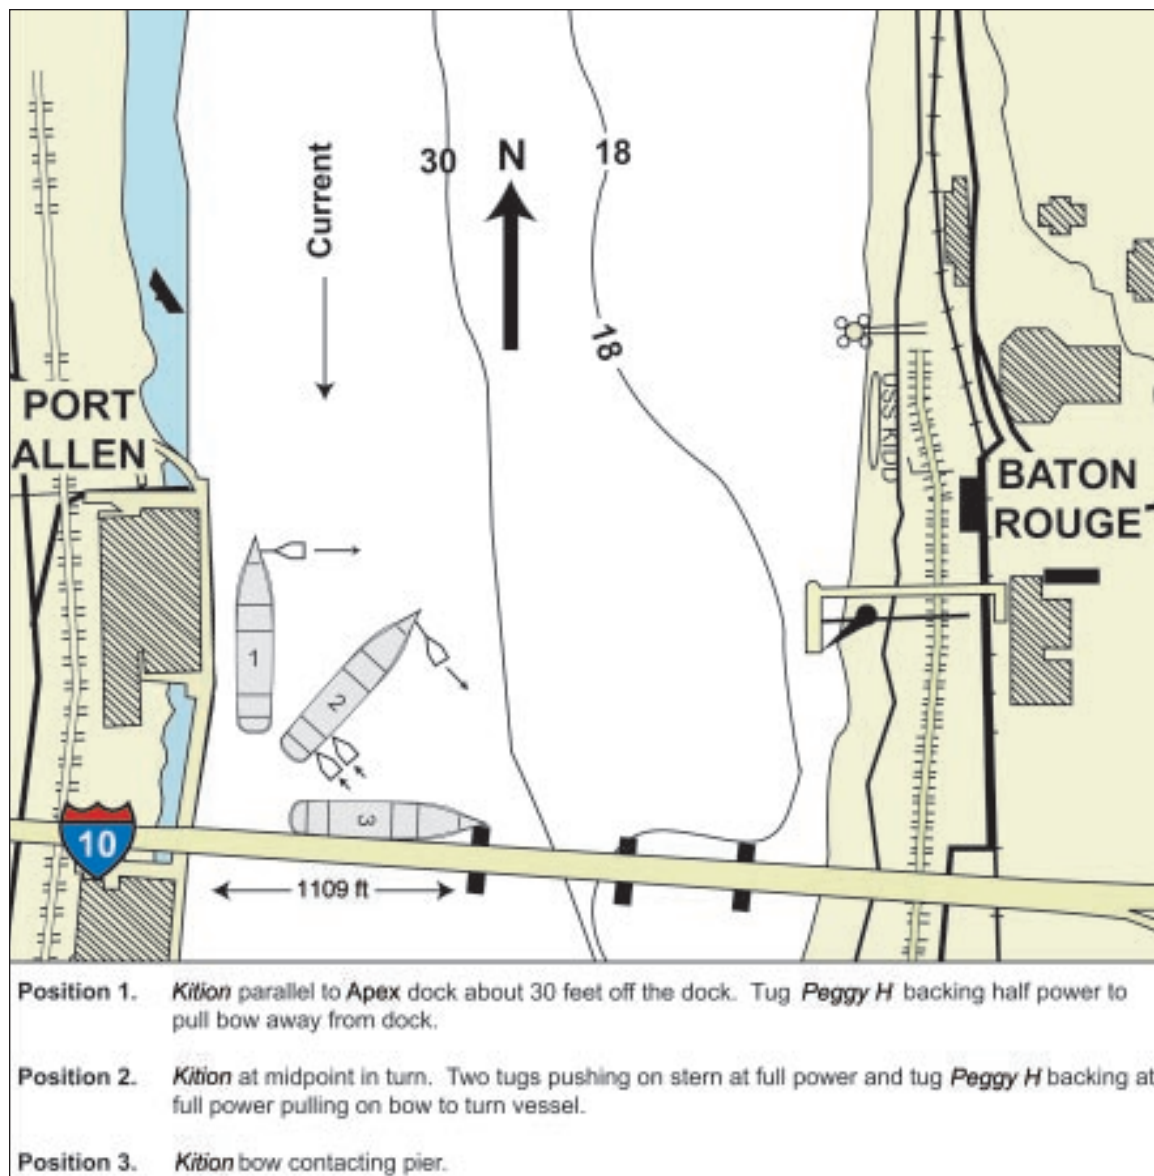
**Figure 2.** Diagram of *Kition* moving from the Apex No. 2 dock to its collision with the I-10 bridge pier.

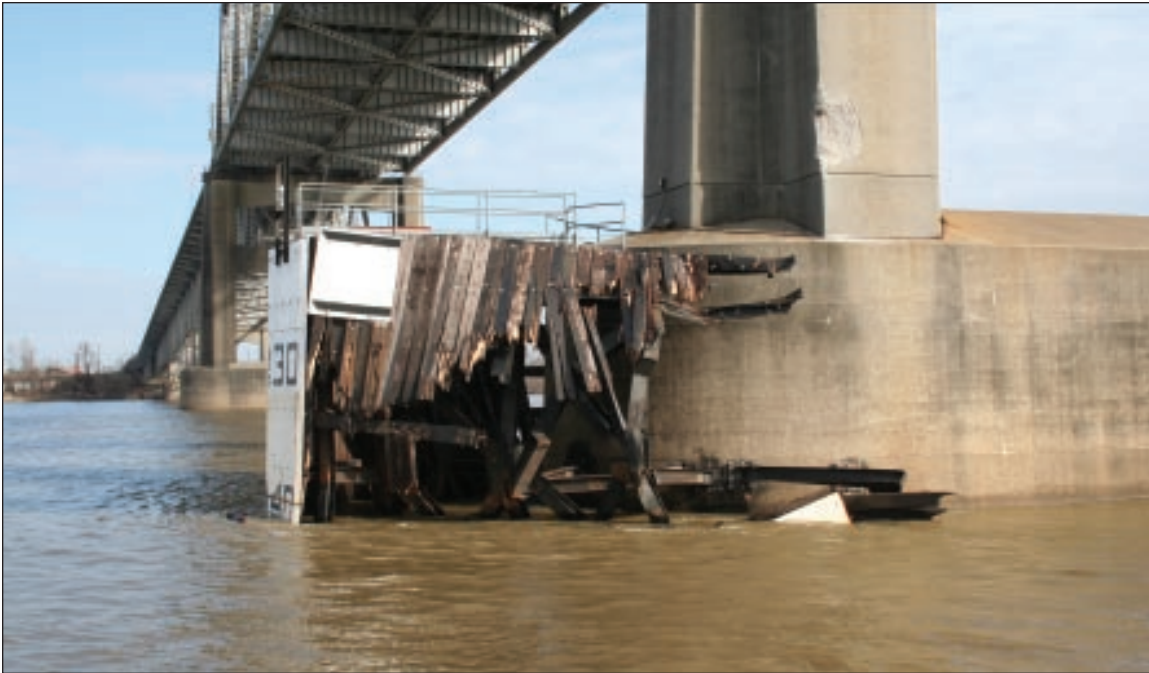
<sup>21</sup> The bridge was inspected by Louisiana Department of Transportation bridge inspectors and found to be safe for use. The estimated cost of reconstructing the fendering system was \$8 million.

**Figure 3.** Damage to the I-10 bridge fender system and pier.

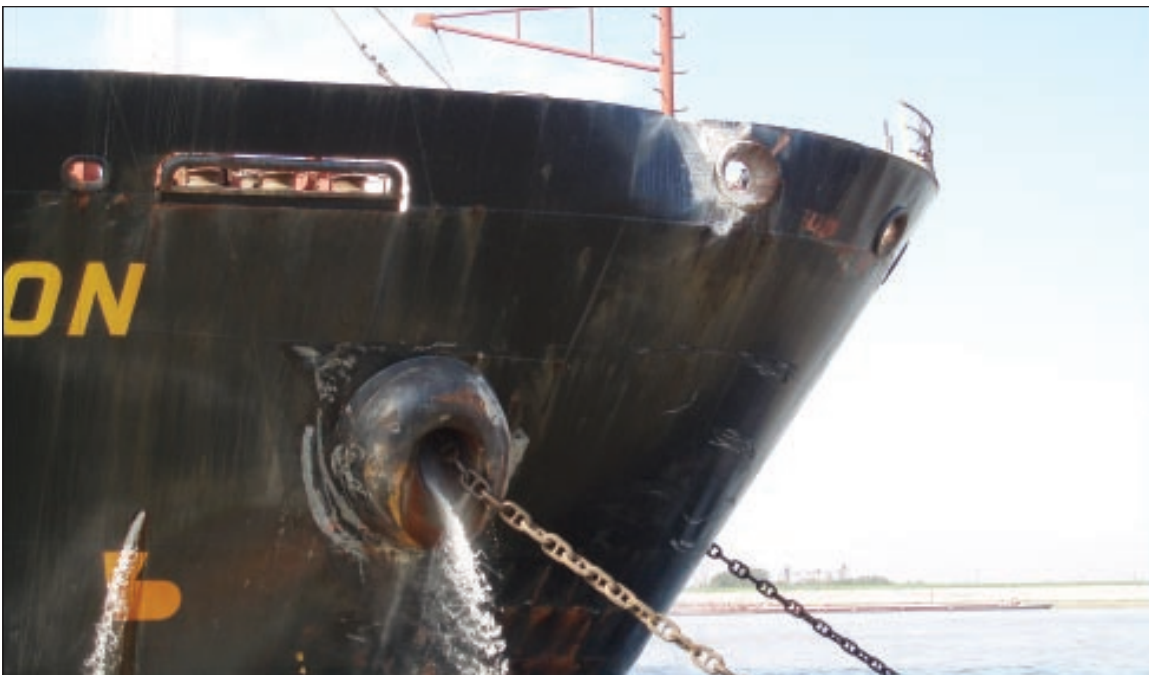
**Figure 4.** Damage to the bulwark on the *Kition's* starboard bow.

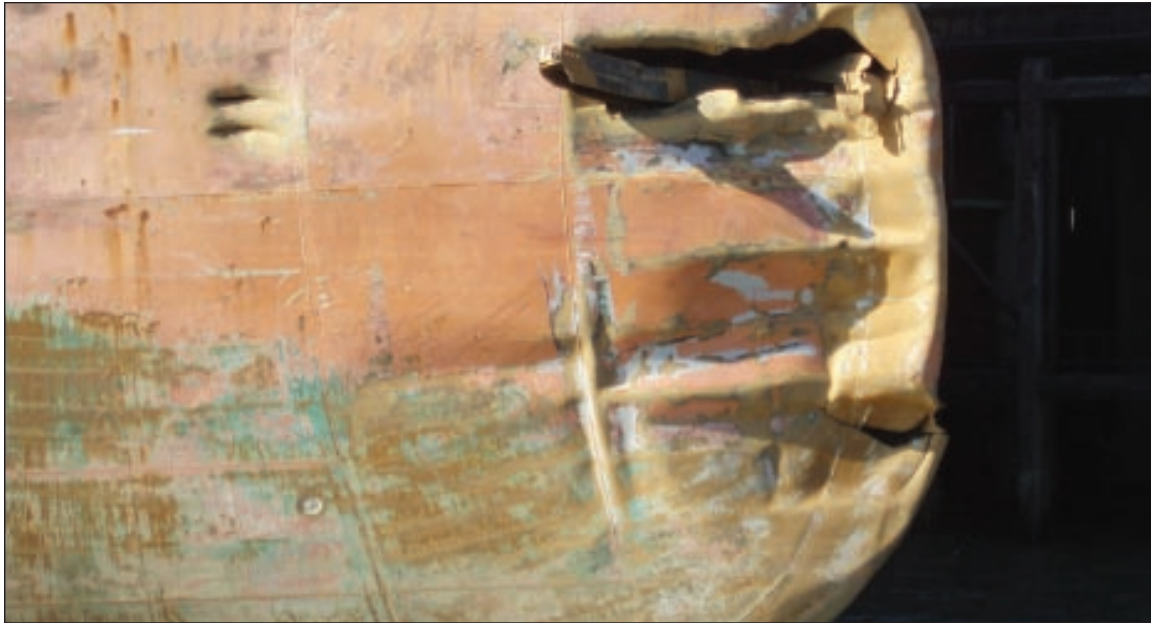
**Figure 5.** Holed forepeak tank and other damage to the *Kition*'s bulbous bow, shown after the bow was raised out of the water by removing cargo and ballasting the aft tanks.
