Pacific Gas and Electric Company  
Natural Gas Transmission Pipeline Rupture and Fire  
San Bruno, California  
September 9, 2010

NTSB/PAR-11/01  
PB2011-916501

# Pipeline Accident Report

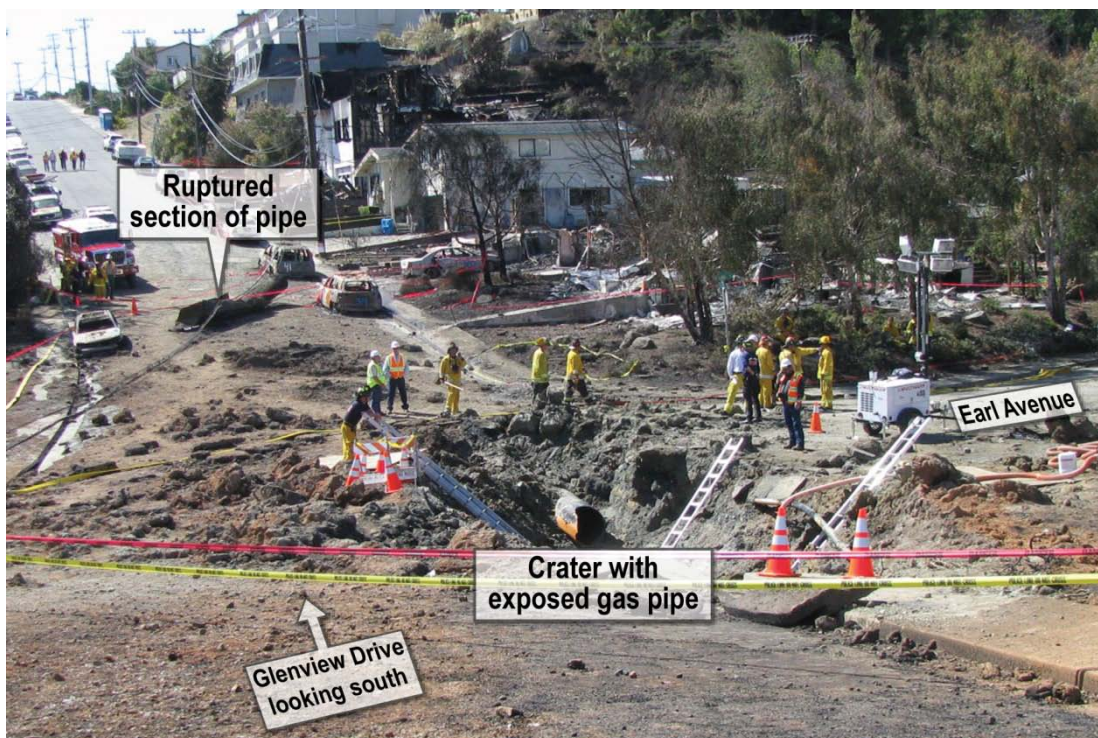
**Figure 2.** Picture of ejected pipe section.

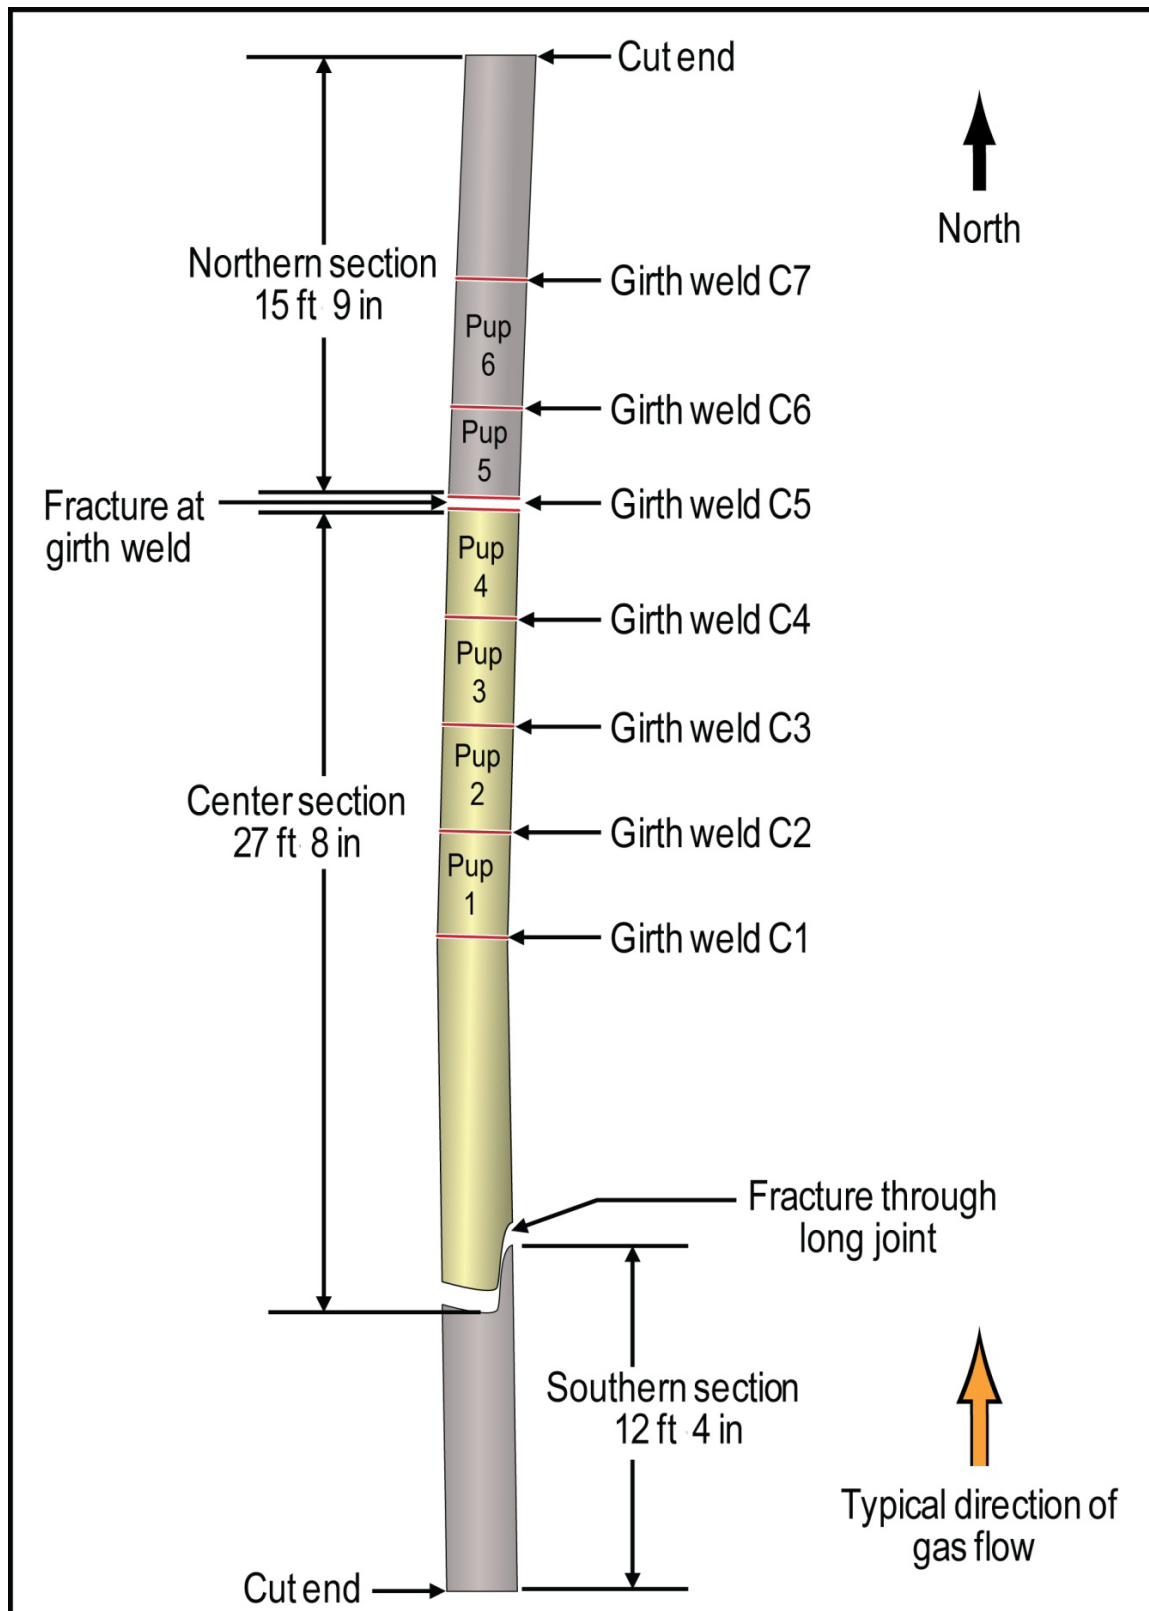
**Figure 18.** Schematic of accident pipe.

The length of pups 1–5 varied from 43.00–46.75 inches, and pup 6 measured 54.25 inches. All six pups were nominal 0.375-inch wall thickness pipe, as was the south long joint. However, the north long joint was nominal 0.312-inch wall thickness pipe. The pipe material codes on documents associated with the 1956 relocation project specified 0.375-inch wall thickness pipe. The circumference of each length of pipe was consistent with nominal 30-inch-diameter pipe.

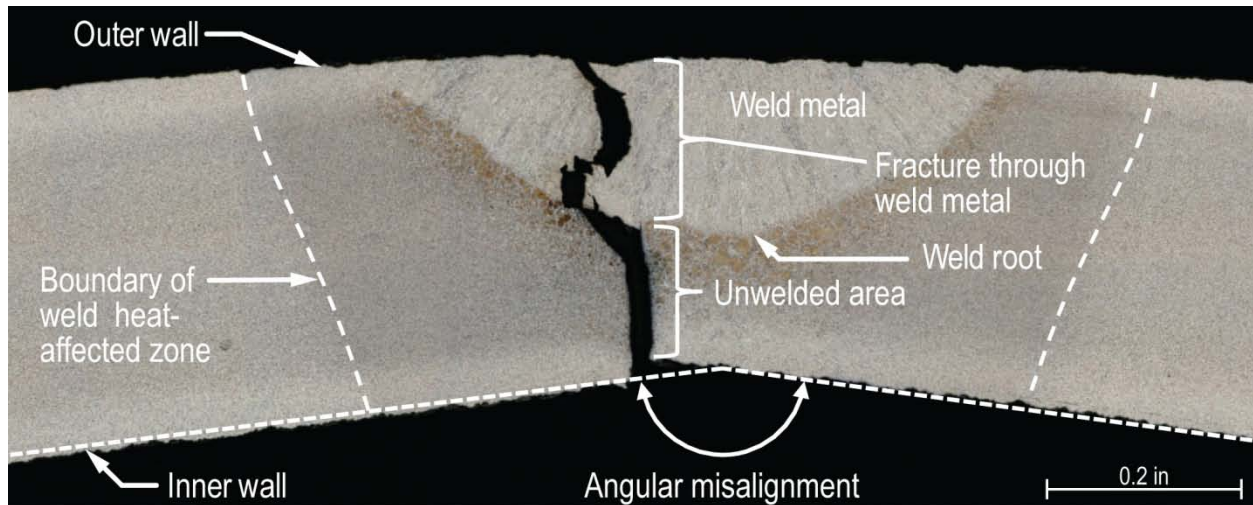
**Figure 19a.** Picture showing cross section of longitudinal seam in pup 1.

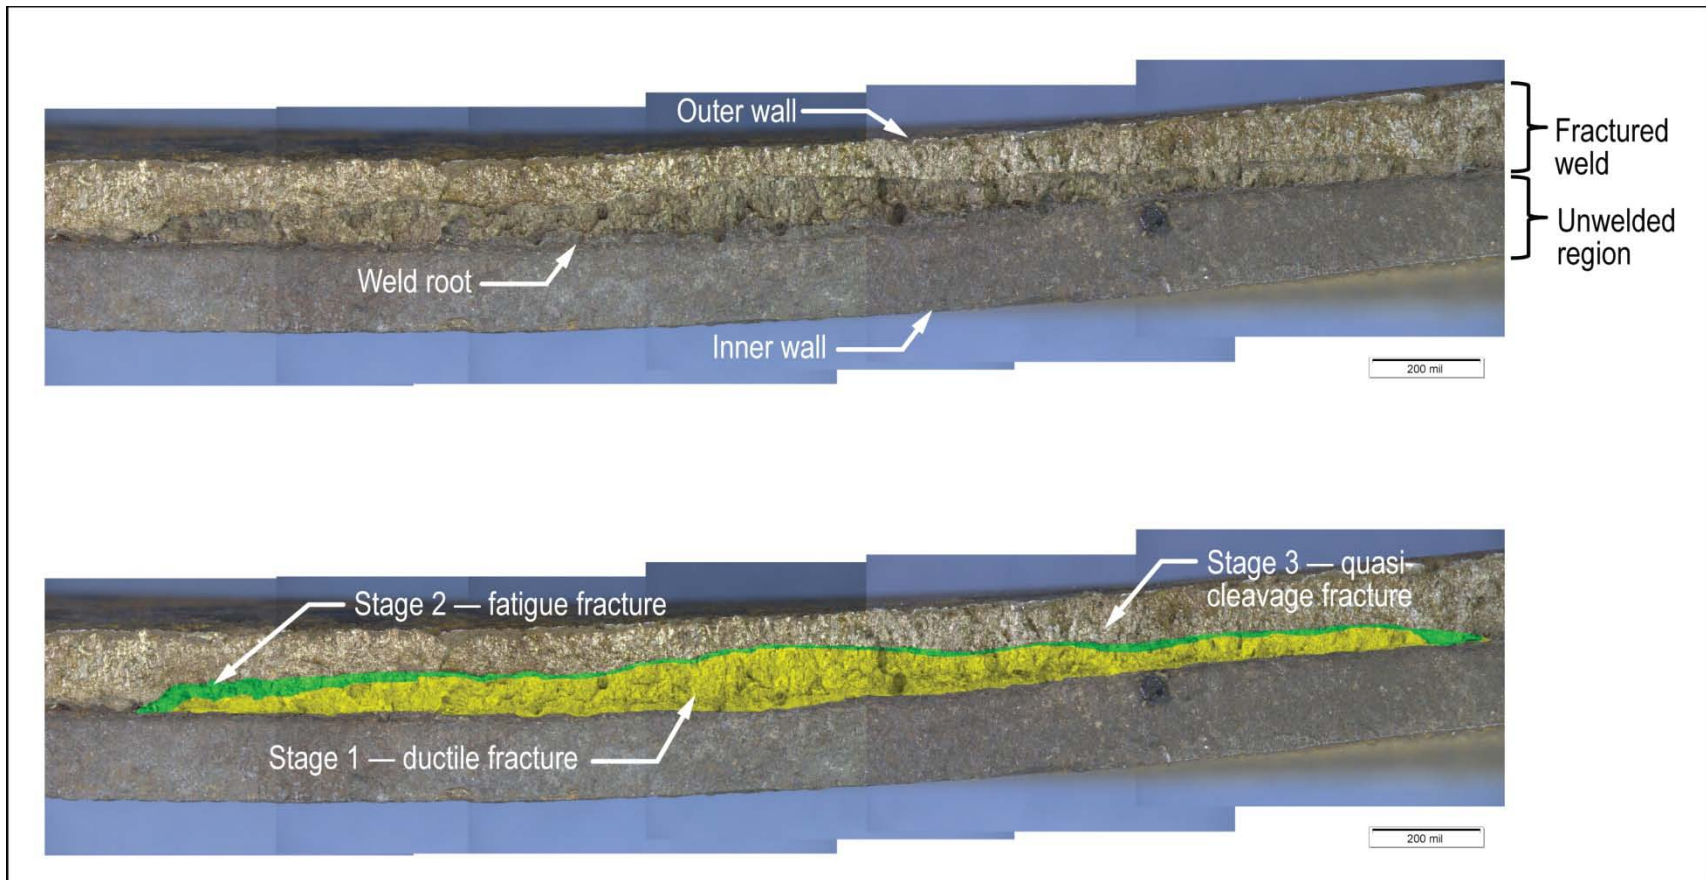
**Figure 21.** Pictures highlighting rupture initiation site in pup 1 longitudinal seam.

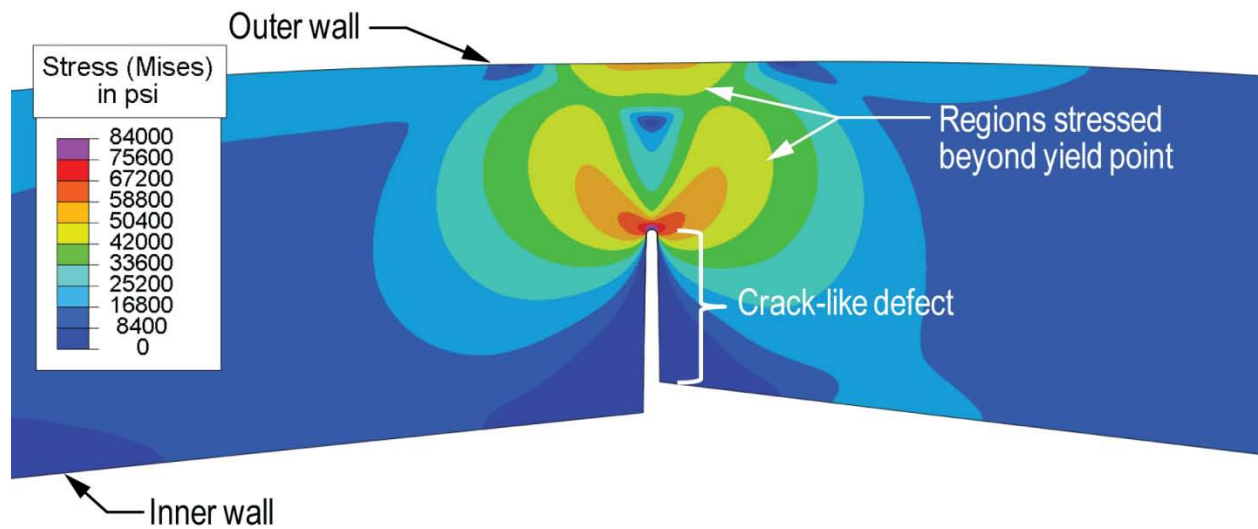
**Figure 22a.** Stress contours at an internal pressure of 375 psig for the finite element model of the weld geometry similar to pup 1. Contour values are the same as in figure 22b.
