# Framework for Improving Resilience of Bridge Design

Publication No. FHWA-IF-11-016  
January 2011

| 7. Author(s)<br>Brandon W. Chavel and John M. Yadlosky | | 8. Performing Organization Report No. | |

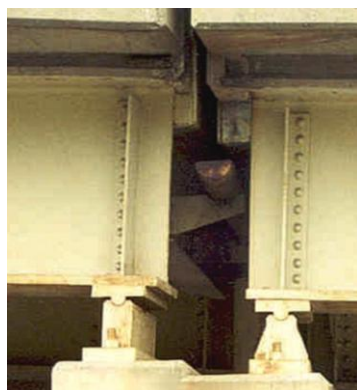
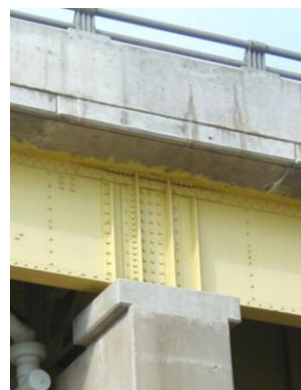
**Figure 2-3** Photos showing the before and after of the elimination of trough-type drainage details by making simple steel spans continuous during a rehabilitation project.

It is important to locate drainage scuppers and connecting elements in regions of the superstructure where, if they become clogged with debris, they will cause the least damage. It is also important that the down-spouting be accessible for inspection, maintenance, and repair, and has the necessary slopes and connections to prevent clogging. In addition, it may be advantageous to make the steel superstructure continuous and eliminate expansion joints, thus eliminating drainage details that cause problems. An example of where simple spans are made continuous, to eliminate poor drainage details is shown in Figure 2-3. Adequate drainage and the layout of the drainage elements will help to prevent girder corrosion.

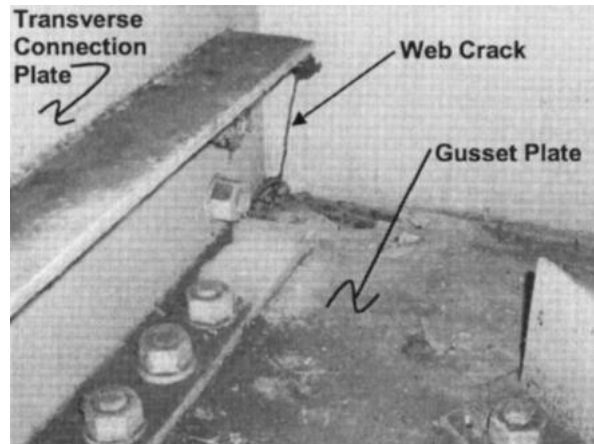
- In 2003, a fracture was found during a routine inspection on one of the main girders of the US 422 Bridge over the Schuylkill River in Pottstown, Pennsylvania. The bridge is a six-span two-girder steel structure, and employed a lateral bracing system near the bottom flange. The fracture, shown in Figure 2-4, was located in a positive moment region, and initiated at the intersecting welds connecting the web, lateral bracing gusset plate, and transverse connection plate approximately 3 in. above the bottom flange [17]. The fracture propagated upward in the web, above the gusset plate, and also propagated downward and completely severed the bottom flange.

**Figure 2-4** Photo of fractured girder of the US 422 Bridge showing a crack in the web emanating for intersecting welds (taken from [17])

The US 422 Bridge and Hoan Bridge fractures resulted from constraint-induced fracture, CIF [17]. Conner et al. [17] states that three conditions must be present for a detail to be vulnerable to CIF.

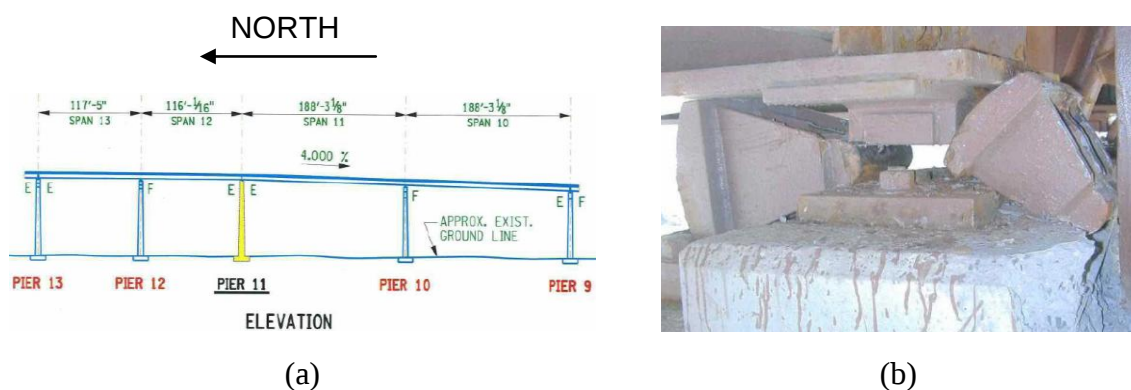
**Figure 2-5** *Dunn Memorial Bridge Interchange Rocker Bearing Failure: (a) Sketch of the bridge elevation from Pier 9 to Pier 13; (b) Photo of the failed rocker bearings at Pier 11 showing them tipped over (taken from [29]).*

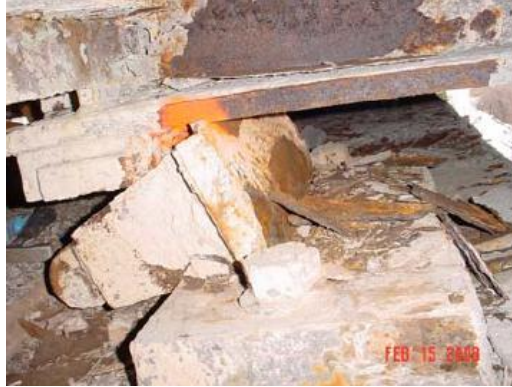
- A similar rocker bearing failure occurred in a steel plate girder approach span of the Birmingham Bridge in Pittsburgh, Pennsylvania, in February 2008. The rocker bearings at Pier 10S tipped over, dropping the steel girders and roadway approximately 8 inches. Based on the forensic investigation, the rocker bearings most likely tipped over at the pier due to a combination of events, including improper installation and a leaking expansion joint above the bearings that contributed to and accelerated the corrosion of the bearings. Collecting debris also allowed the ratcheting effect [30]. A photo of the tipped bearing at Pier 10S is shown in Figure 2-6.

**Figure 2-6** Photo of failed rocker bearing at Pier 10S of Birmingham Bridge Approach Span showing the rocker tipped over with girder sitting on top of failed bearing (taken from [30]).

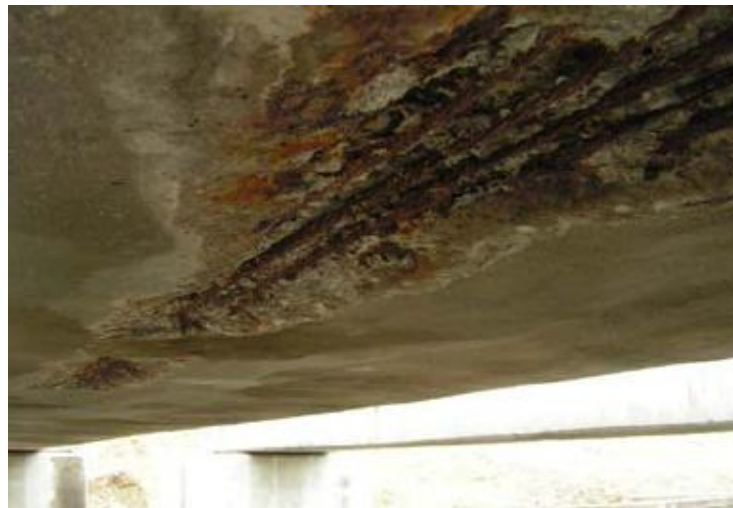
onto the bridge girders overhead. Salt-spray, and its effect on rate of corrosion, was one of the potential causes of the collapse of the exterior girder of the Lake View Bridge over I-70 in 2005 in Washington, Pennsylvania. Based on the pre-test inspections conducted, it appeared that the most exterior prestressing strand damage resulted from vehicle impacts damaging the concrete cover, followed by corrosion of the exposed strands [43]. A photo of the another beam in the structure, that did not collapse, showing the damaged girder and corroded strands is provided in Figure 3-3.

**Figure 3-3** Photo showing results of vehicle impact and subsequent corrosion damage to prestressing strands from a prestressed concrete box beam in Lake View Bridge over I-70 (taken from [43]).

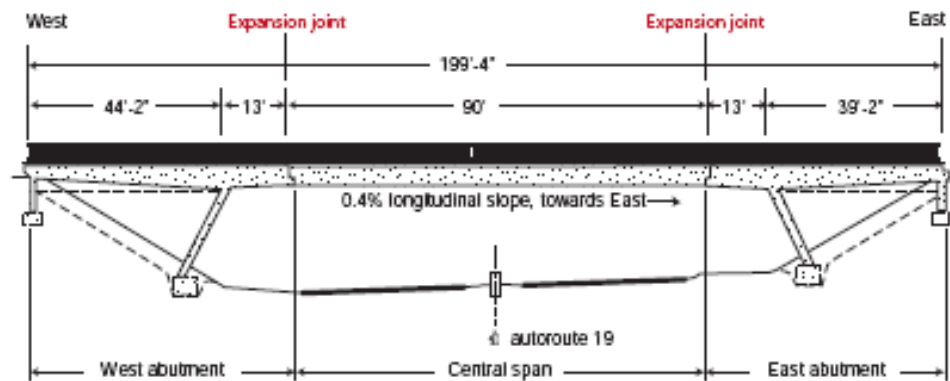
The collapse of the de la Concorde overpass shows that the bridge designer must fully consider the effects of reinforcement details in a concrete superstructure. An inquiry into the collapse of a portion of the overpass in Laval, Quebec, Canada, on September 30, 2006, found that improper detailing and installation of the steel reinforcement was a contributing factor to the bridge failure [52]. The simple single span of the bridge consisted of adjacent box girders, which rested on a beam seat. The beam seat was built into the thickened slab that cantilevered from the abutments at each end, as shown in Figure 3-4. The commission determined that in the as designed structure, the concentration of numerous reinforcement bars on the same plane in the upper part of the thickened cantilever slab created a plane of weakness where horizontal cracking could occur [52]. Top bars in the thickened slab were not sufficiently anchored. Additionally, the improper placement of several reinforcement bars during construction created a much larger zone of weakness extending into the thickened slab [52].

**Figure 3-4** Sketch showing the elevation of de la Concorde overpass; the simple central span of the bridge consisted of adjacent box girders, which rested on a beam seat that was built into the thickened slab that cantilevered from the abutments at each end (taken from [52]).

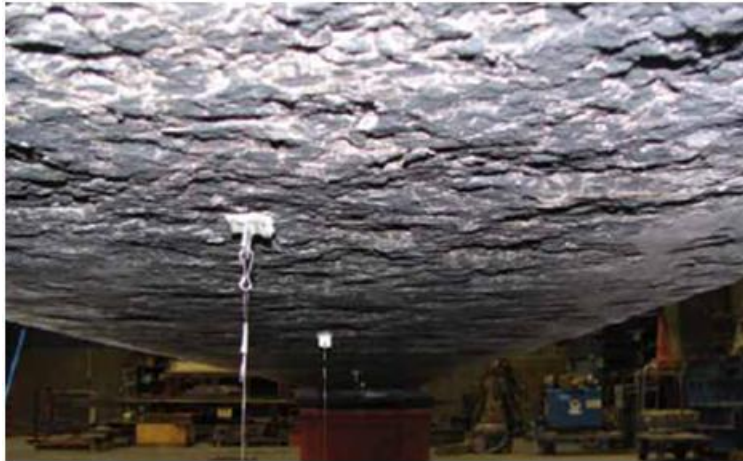
On July 12, 2005, a significant fire incident occurred near Ridgefield, Connecticut which caused significant damage to an adjacent box-beam bridge. The Connecticut DOT coordinated with the FHWA's Turner Fairbank Research Center to investigate the flexural capacity of the beams removed from the bridge after the fire. The results of the investigation showed that the beams still had sufficient flexural capacity but the long-term viability of the beams was questionable. The visual and petrographic examinations showed that the damage to the bottom flange concrete was sufficient to allow pathways through the concrete to the depth of the bottom prestressing strands [56]. This could potentially lead to the accelerated deterioration of the bottom row of strands due to water ingress and subsequent corrosion. A photo of the bottom face of one of the tested beams is provided in Figure 3-5.

**Figure 3-5** *Photo of the bottom face of a tested beam subjected to fire while in service showing that the concrete has deteriorated such that sufficient pathways through the concrete to the bottom layer of prestressing strands have developed (taken from [56]).*

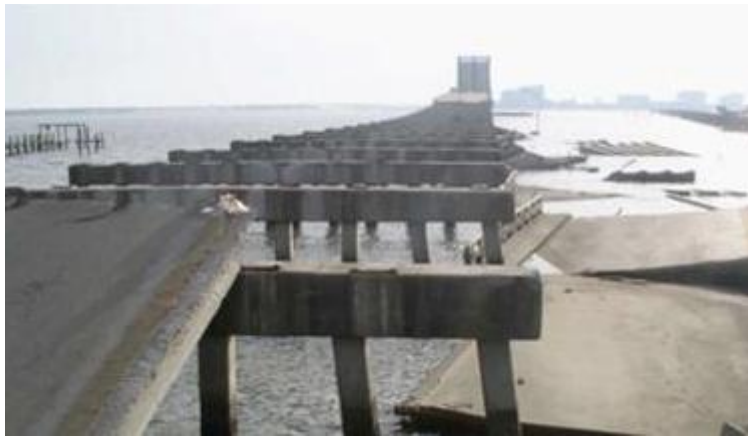
In August 2005, several concrete girder bridges were damaged or completely destroyed in Alabama, Louisiana, and Mississippi during Hurricane Katrina. Padgett et al. [57], used data from 44 damaged bridges to develop relationships between storm surge elevation, damage level, and repair costs. The authors point out that several traditional fixed spans displaced due to a combination of buoyant forces and pounding by waves. The US-90 Biloxi-Ocean Springs Bridge suffered severe damage due to a combination of storm surge and wind/wave induced loading [57]. The four-lane, 1.9 mile, multi-span concrete girder bridge had low-lying spans. The storm surge caused severe damage to the bearings, and most connections between the deck and the pier caps were destroyed, allowing free movement of the spans. In fact, several spans on the western half of the bridge became completely unseated and were submerged in the bay, as shown in Figure 3-6. In traditional hurricane prone areas, the designer should take measures to reduce the likelihood of failure caused by storm surge: the bridge could be designed to a higher elevation, provide details such as transverse shear keys to prevent lateral movement, or tie downs to prevent upward movement.

**Figure 3-6** *Photo showing the spans of the US-90 bridge completely unseated and submerged in the water due to storm surge induced loading (taken from [57]).*
