# Postearthquake Reconnaissance Report on Transportation Infrastructure Impact of the February 27, 2010, Offshore Maule Earthquake in Chile

PUBLICATION NO. FHWA-HRT-11-030

OCTOBER 2011

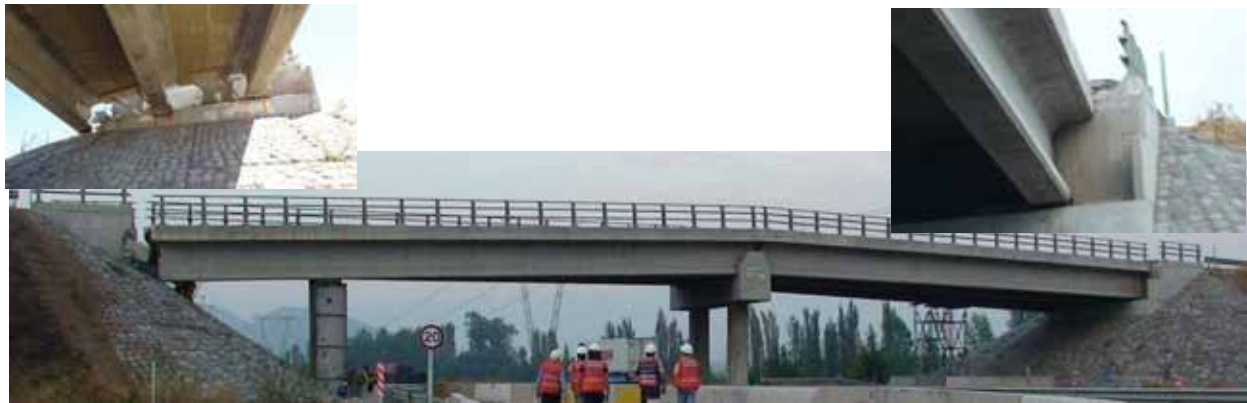
experienced a significant counterclockwise rotation during the earthquake. The exterior girders rotated off their abutment seats at both ends, resulting in a longitudinal crack between the exterior and interior girders in the deck slab.

**Figure 41. Photo. Las Mercedes bridge and girder unseating at abutments.**

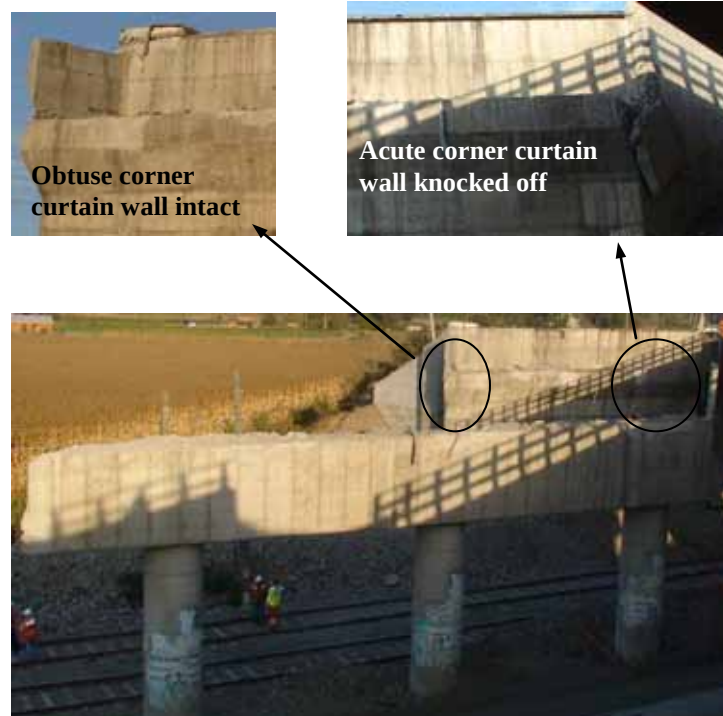
**Figure 105. Photo. Damage at south abutment of Route 5 overcrossing at Hospital.**

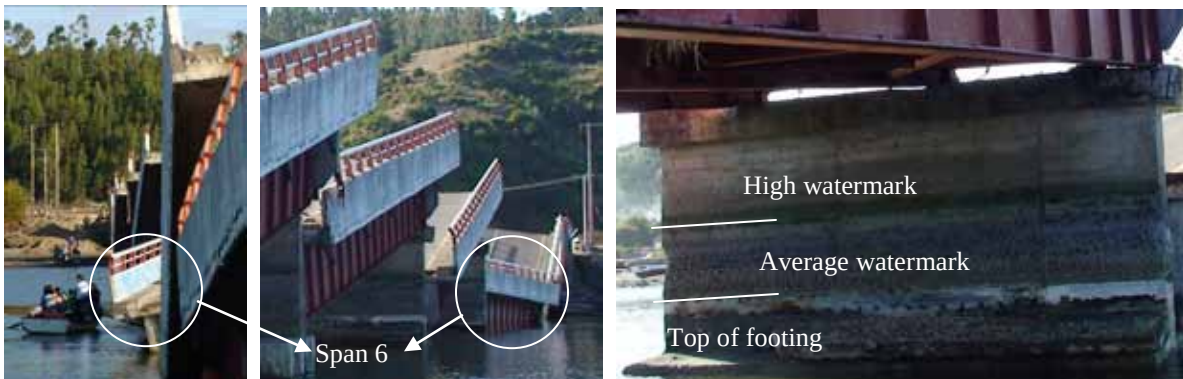
Local damage to the various piers and spans was inspected by boat. As shown in figure 114, span 6 lost support at its north end. Local residents confirmed that this span was like the others immediately after the main shock, but the north end collapsed during an aftershock during the first week, probably due to rigid body rotation of the wall pier. This difference in span 6 may be attributable to the fact that the span rotated from the north to the northeast, creating load concentration on the north support. Figure 117 shows watermarks on one of the wall piers. The concrete below the high watermark showed signs of deterioration, probably due to wet and dry cycles, particularly in the mid-height of the wet area at the average watermark.

**Figure 117. Photo. Span 6 of Tubul bridge, unseated at north end during an aftershock.**

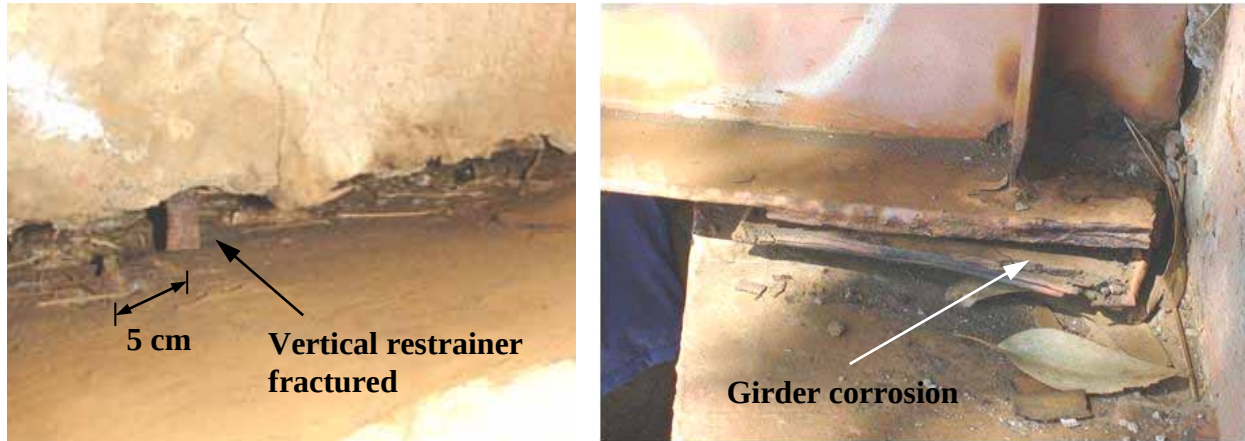
According to local residents, the tsunami was characterized by three waves starting approximately 10 min after the main shock. Since the clear height of the bridge from the water level is about 4.9 ft (1.5 m), the tsunami waves passed over the bridge, inducing large lateral forces on the girders. In addition, a visual inspection of the connecting elements at the south abutment revealed corrosion in the girders, cross braces, and vertical restrainers in the reinforced concrete diaphragms (see figure 147). Due to the corrosion, the capacity of the structural components of the south abutment was less than at the north abutment, making this abutment more likely to suffer damage.

**Figure 147. Photo. Damage on south abutment due to corrosion in Pichibudis bridge.**

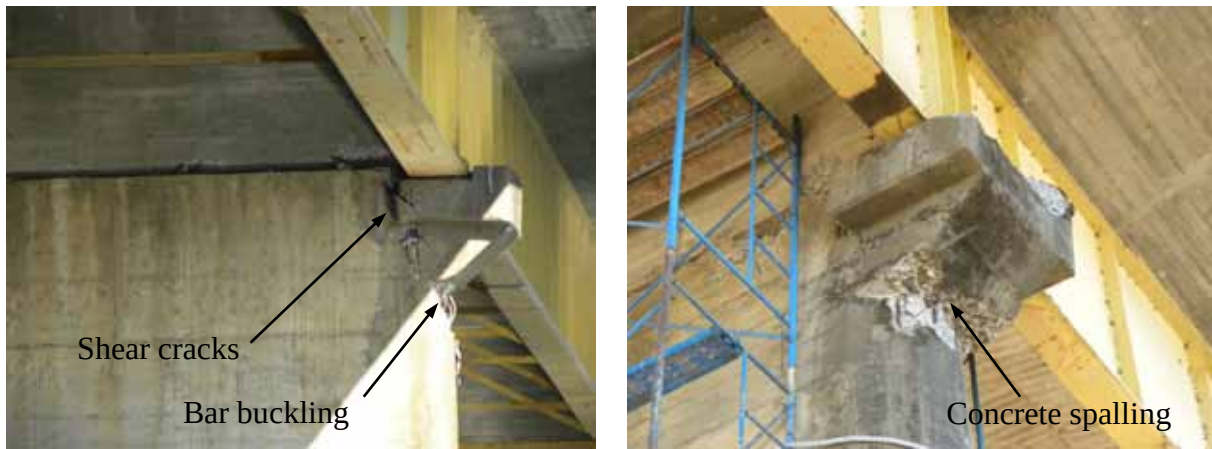
During the earthquake, the entire structure moved both longitudinally and transversely, with larger displacements occurring in the transverse direction. As a consequence, many of the concrete brackets suffered damage at their connections to the piers. The damage was characterized by shear cracks, concrete spalling, and bar buckling, as shown in figure 159. At the time of inspection, a temporary steel structure was under construction to retrofit the brackets and allow traffic on the bridge.

**Figure 159. Photo. Damage to girder supports of Itata River bridge.**

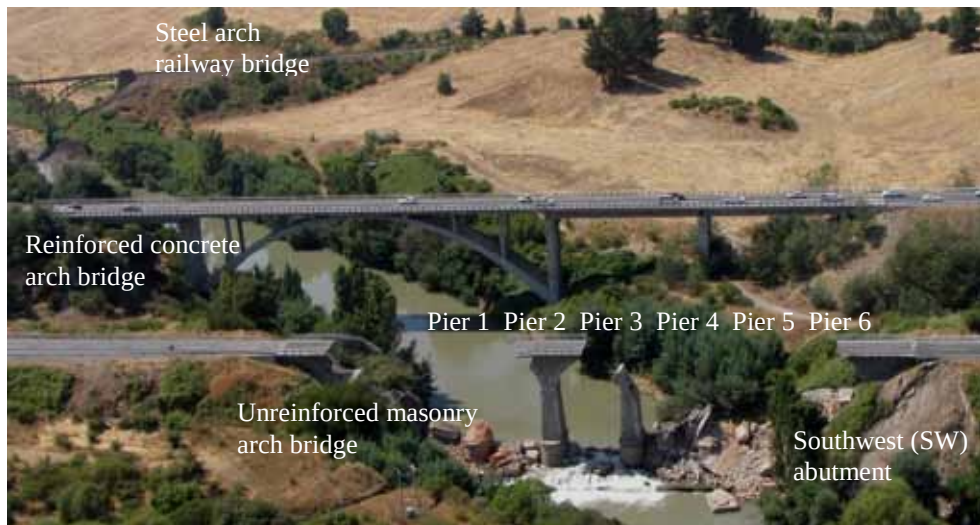
**Figure 165. Photo. Collapse of masonry arch bridge at Claro River.**

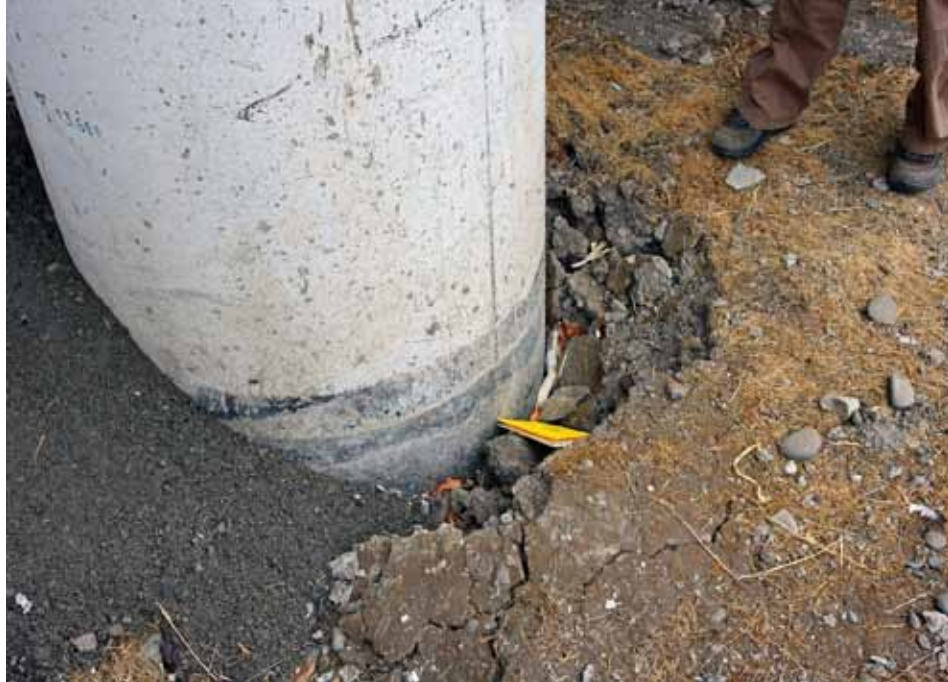
**Figure 186. Photo. Interior pier of Chada structure with 5.8- to 7.8-inch (150- to 200-mm) gap in soil transverse to bridge centerline.**

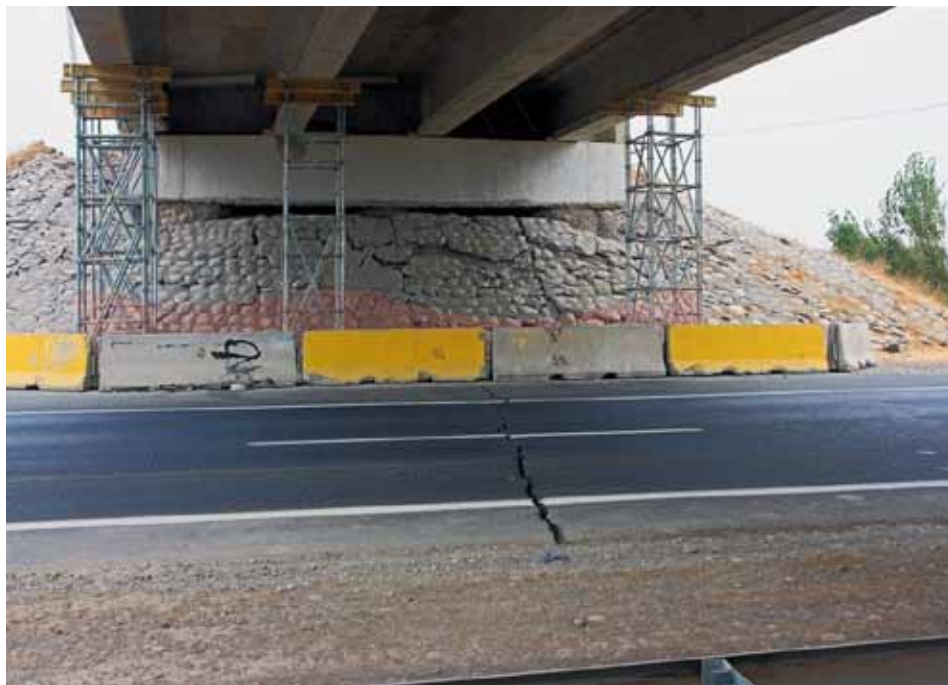
**Figure 187. Photo. East abutment of Chada structure showing large pavement crack directly below bridge centerline.**

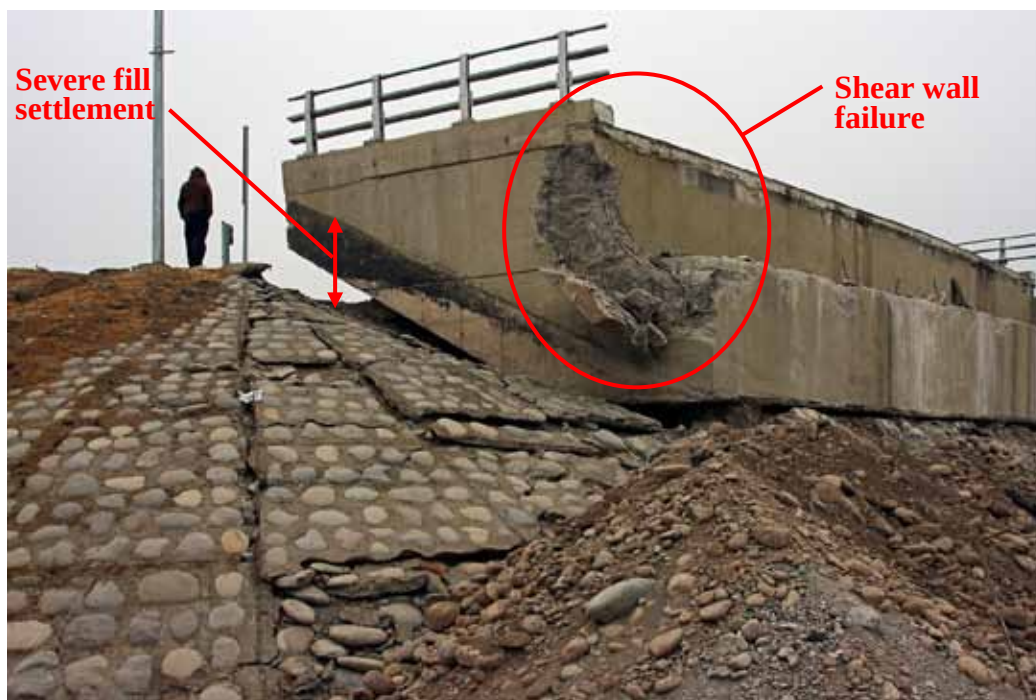
**Figure 189. Photo. Fill slumping observed at Romero bridge.**

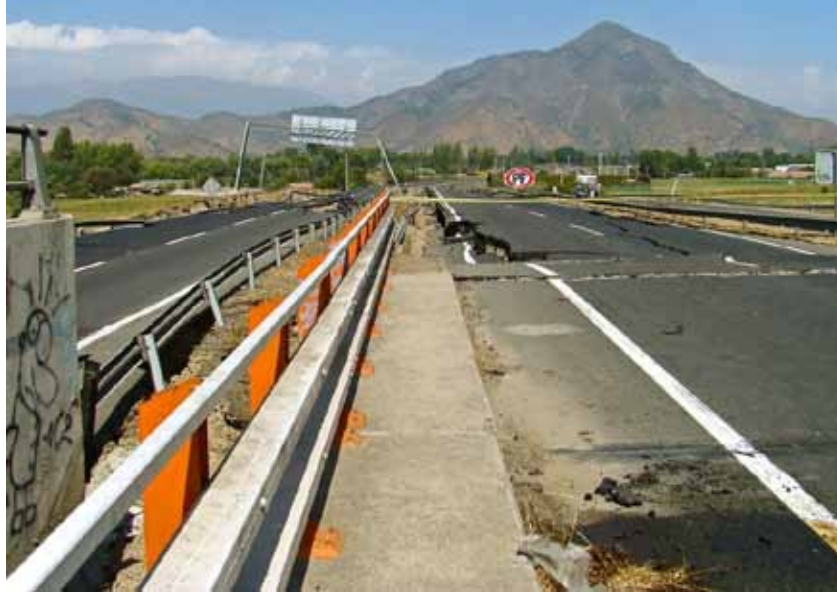
Significant roadway fill settlement and lateral movement also occurred at bridge site 10 (see figure 190). However, the difference between this site and sites 7 and 8 is that at site 10, it appears the soil beneath the roadway embankment failed, possibly in bearing, though the failure appears to be fairly shallow. Lateral movements of over 7 ft (2 m) appear to have occurred, considering the distortion in the sign bridge, and uplift of the soil surface beyond the toes of the approach fill also appears to have occurred (see figure 191). Lateral movement of the fill and soil below the fill at site 10 is rather complex and will require further investigation to determine what really happened. However, based on the available boring log, the upper soils consist of weak and likely sensitive clays (see appendix A). These clays are probably the source of the fill stability problems observed at this site. In any case, the bridge abutment at site 10 appeared to be unaffected by the observed approach fill movement, although the superstructure for one of the bridges at this site collapsed.

**Figure 190. Photo. View of roadway fill failure from abutment of Route 5 railway crossing at Hospital.**

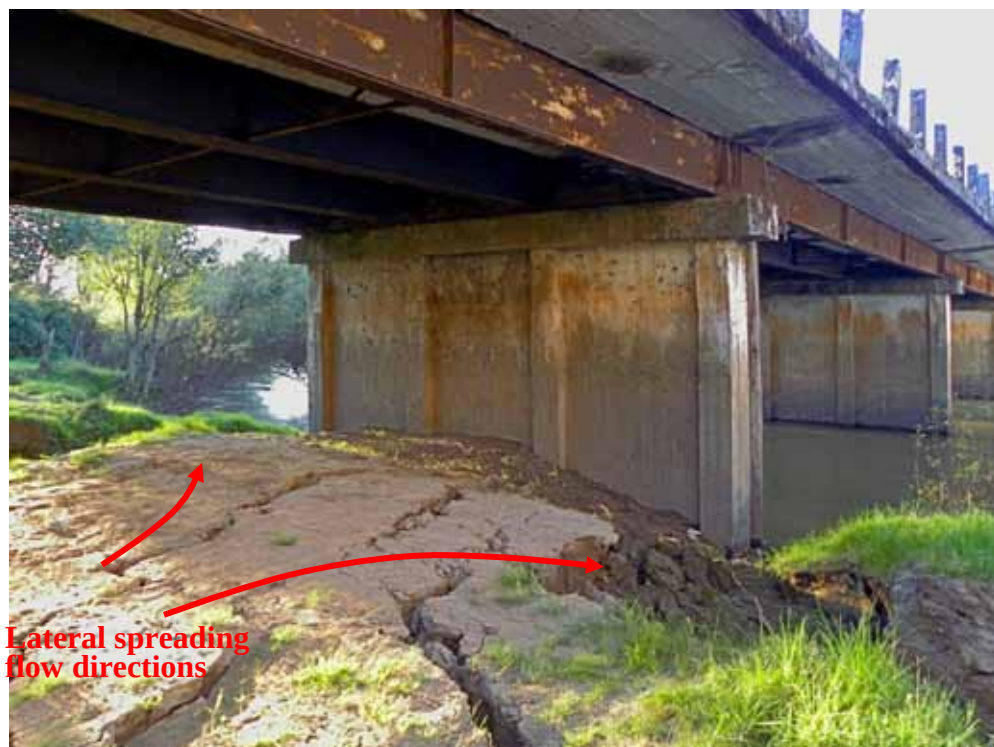
**Figure 194. Photo. Lateral spreading and ground failure at old Ramadillas bridge.**

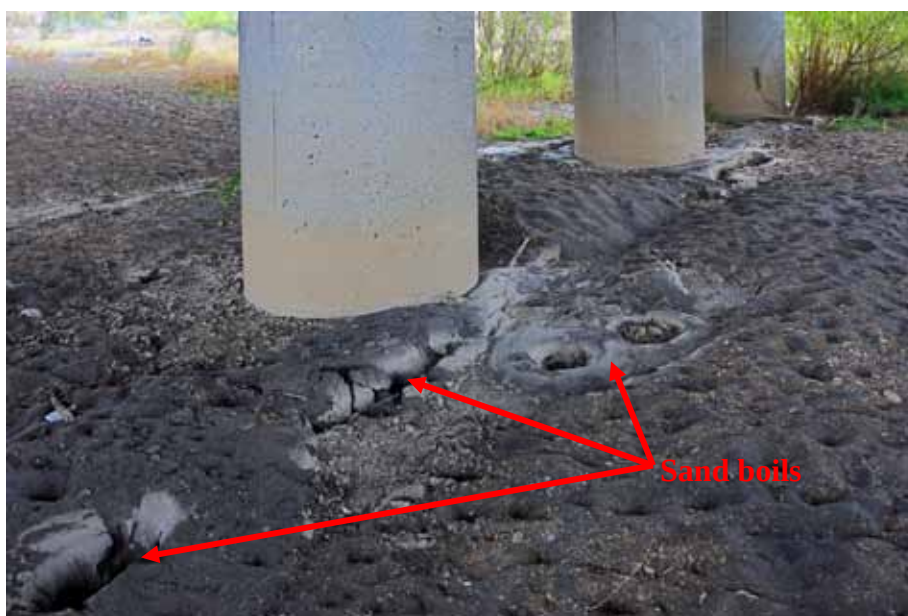
Figure 195 and figure 196 provide examples of sand boils and ejected sand from ground fissures due to liquefaction. In figure 195, the southwest end of the Llacolen bridge, the ground water depth is relatively shallow (less than 3 to 7 ft (1 to 2 m)). In figure 196, La Mochita bridge, the ejection of sand through ground fissures due to elevated pore pressures from liquefaction appeared to be more vigorous, considering the greater depth to the water table (approximately 13 to 16 ft (4 to 5 m)).

**Figure 195. Photo. Sand boils at southwest end of Llacolen bridge.**

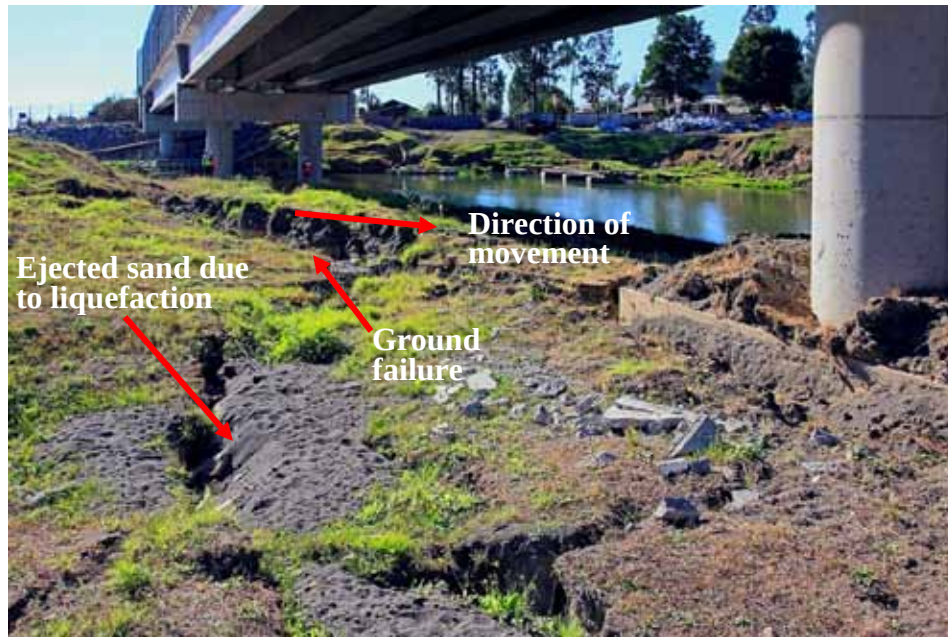
**Figure 196. Photo. Ejected sand due to liquefaction and ground failure at La Mochita bridge.**

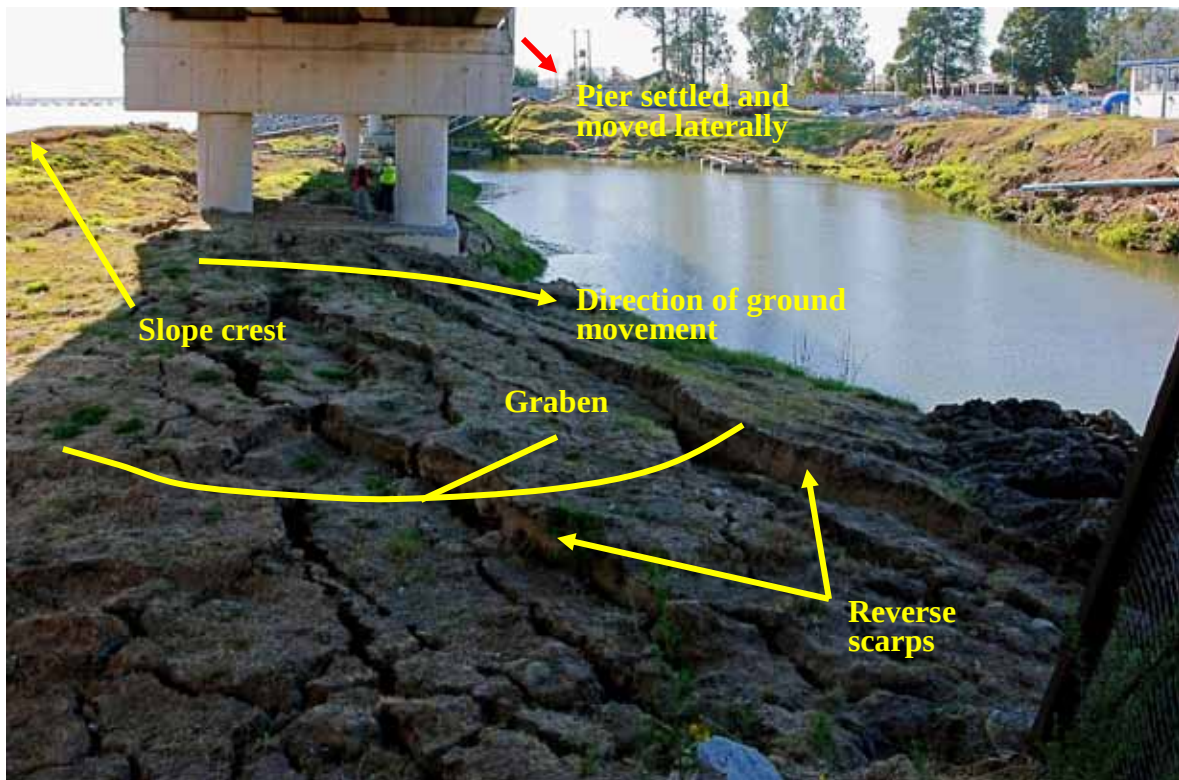
Figure 197 and figure 198 provide examples of more severe ground failure caused by liquefaction. In these cases, the ground water needed for liquefaction was 7 to 16 ft (2 to 5 m) below the ground surface, and the remaining soil above that layer was non-liquefied crust. Due to the weakness of the liquefied soil, a slope failure ensued. This type of failure can cause the greatest damage to bridges due to the significant volume of stronger, heavier soil moving laterally into the bridge foundations and vertically along the foundations. Because the non-liquefied crust is stronger than the liquefied soil, it is less able to flow around the foundations and is more likely to force the foundations to bear the full brunt of the lateral soil force.

**Figure 197. Photo. Severe ground failure at La Mochita bridge.**

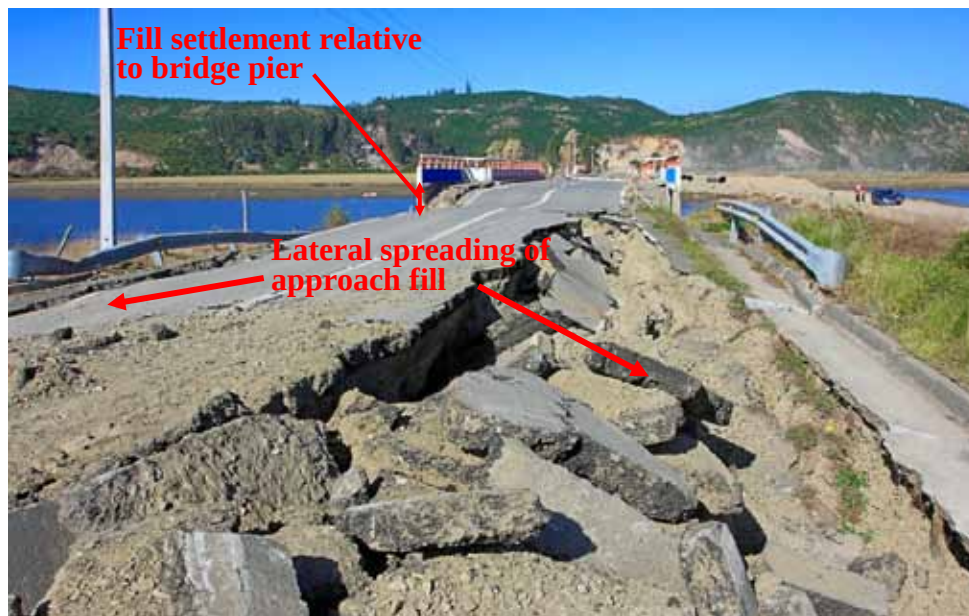
**Figure 198. Photo. Lateral spreading and ground failure at Raqui 2 bridge.**

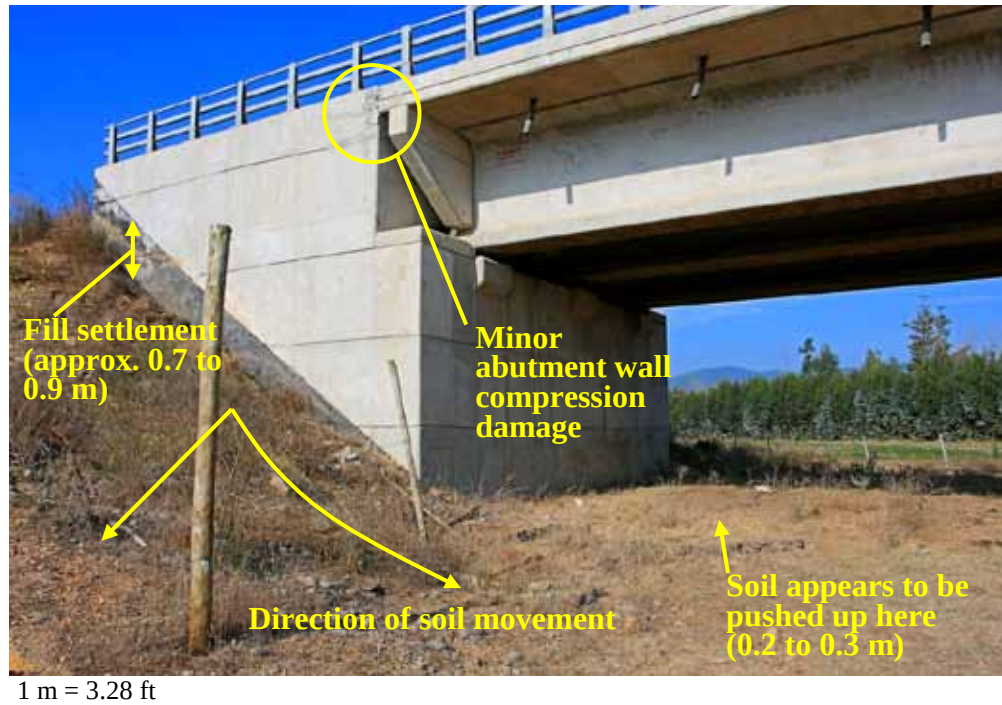
**Figure 202. Photo. Abutment fill settlement of northeast abutment of Mataquito bridge.**

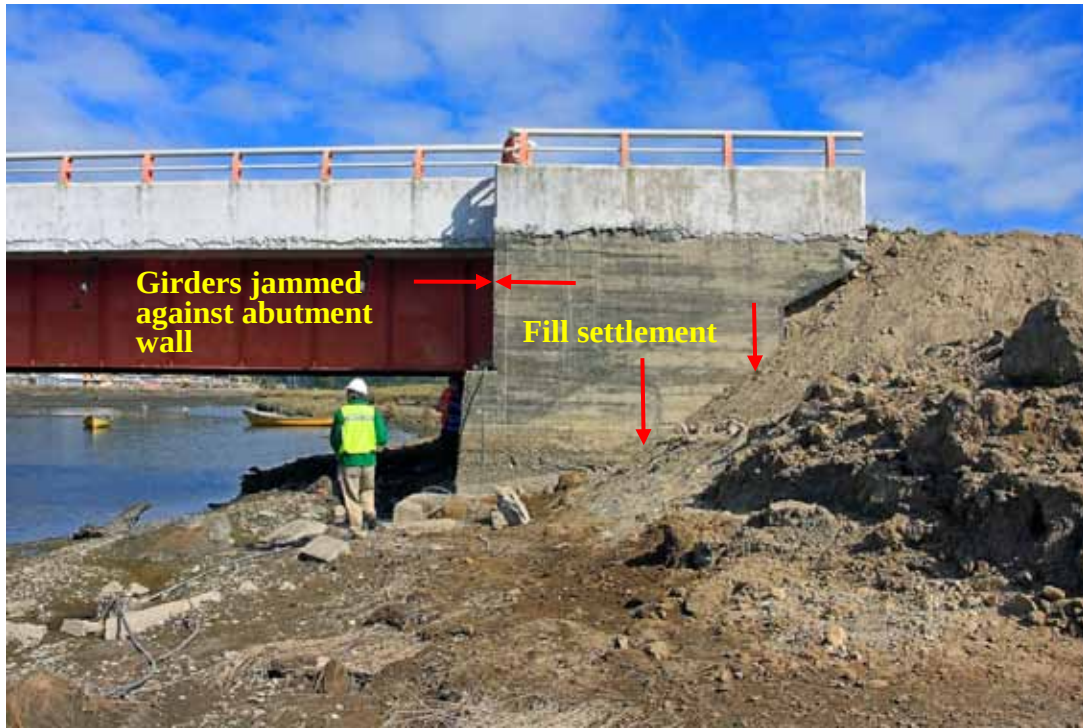
**Figure 205. Photo. Abutment fill settlement at northwest abutment of Raqui 1 bridge.**

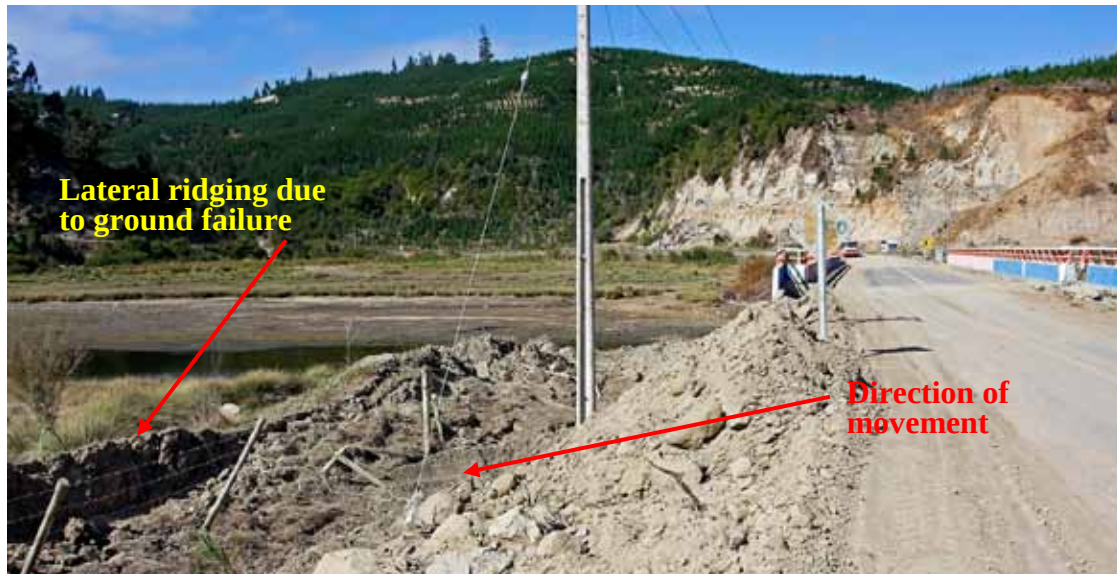
**Figure 208. Photo. Evidence of ground failure perpendicular to roadway centerline at northwest approach of Raqui 1 bridge.**

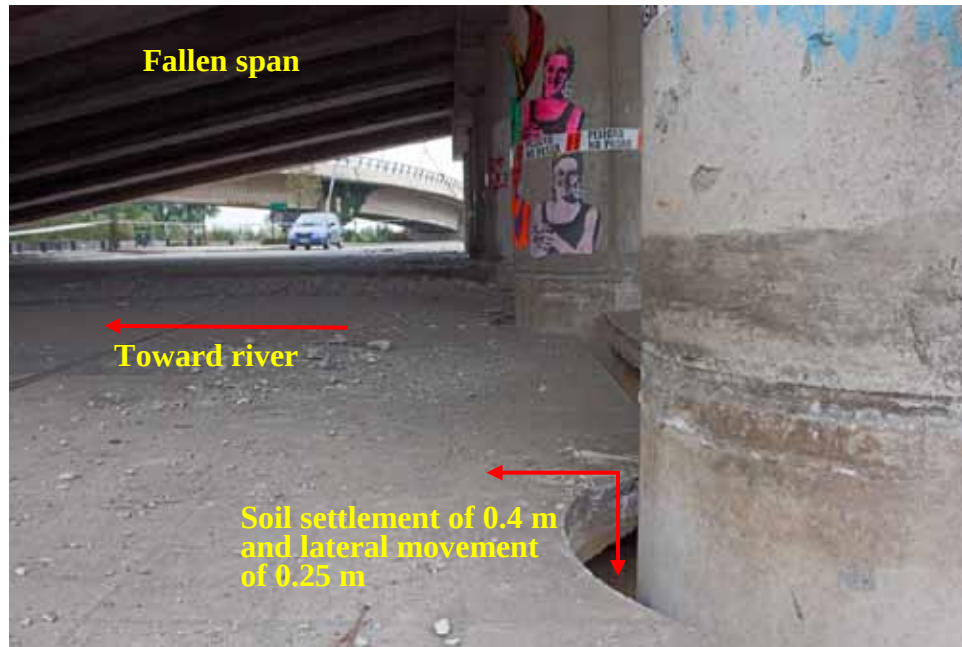
**Figure 213. Photo. Settlement and lateral ground movement of interior pier at northeast end of Llacolen bridge.**

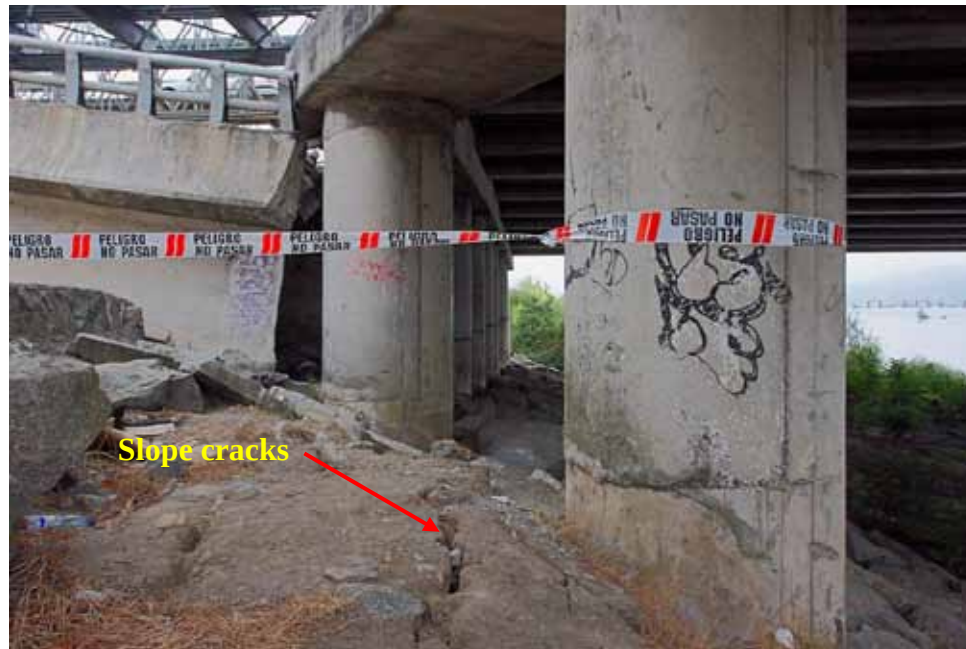
**Figure 214. Photo. Lateral ground and foundation movement at interior pier and fallen span at northeast end of Llacolen bridge.**

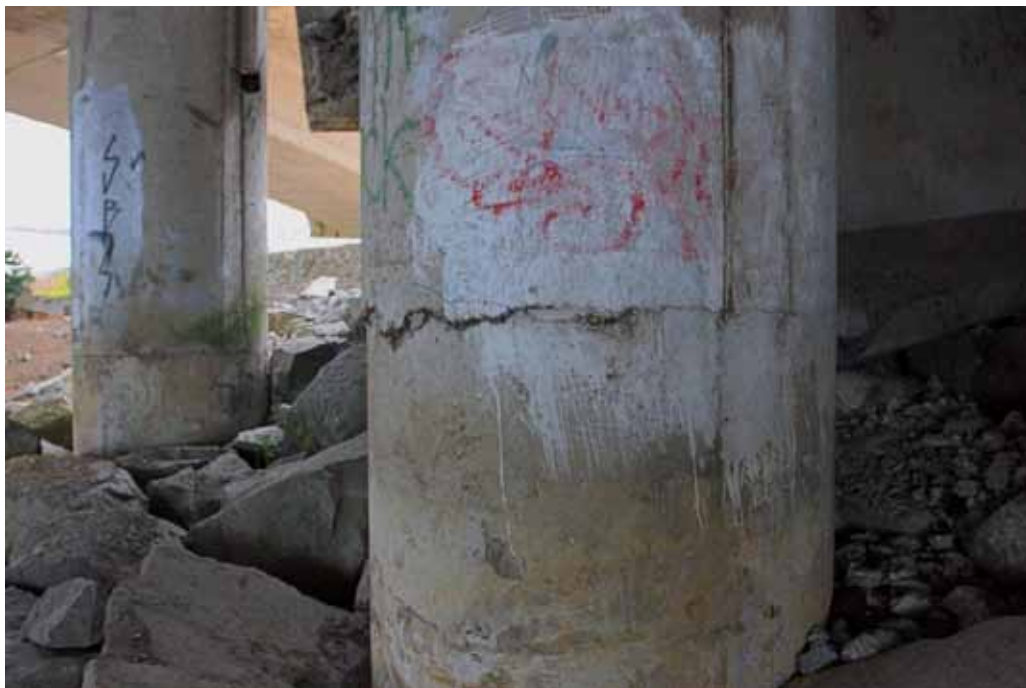
**Figure 215. Photo. Close-up of cracked column at northeast end of Llacolen bridge.**

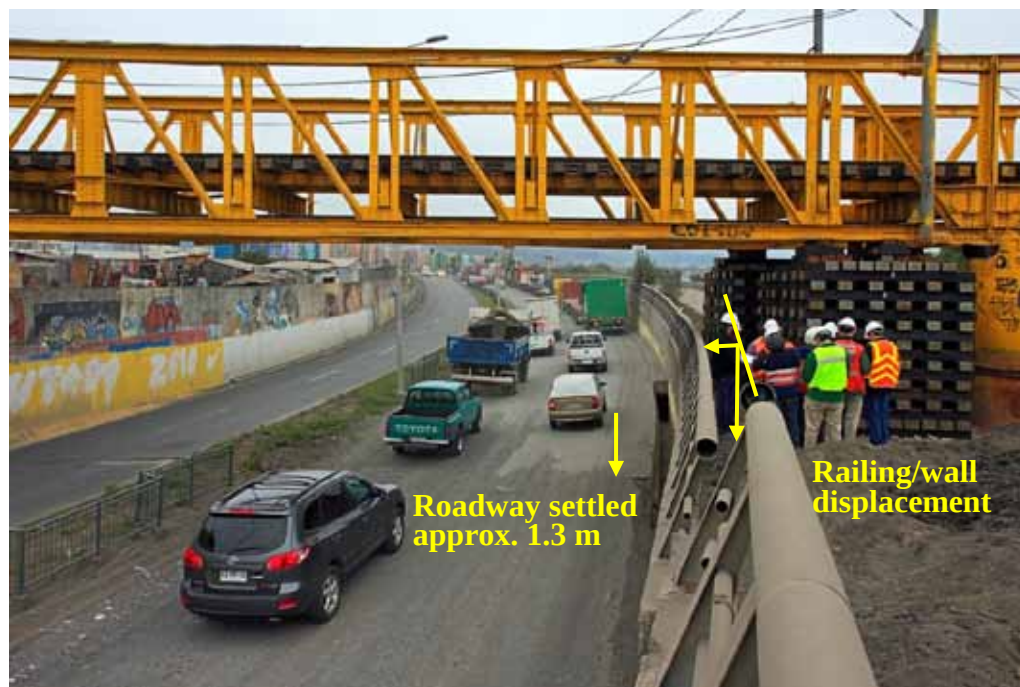
**Figure 216. Photo. Wall settlement due to slope movement and instability caused by liquefaction at northwest end of Chepe railroad bridge.**

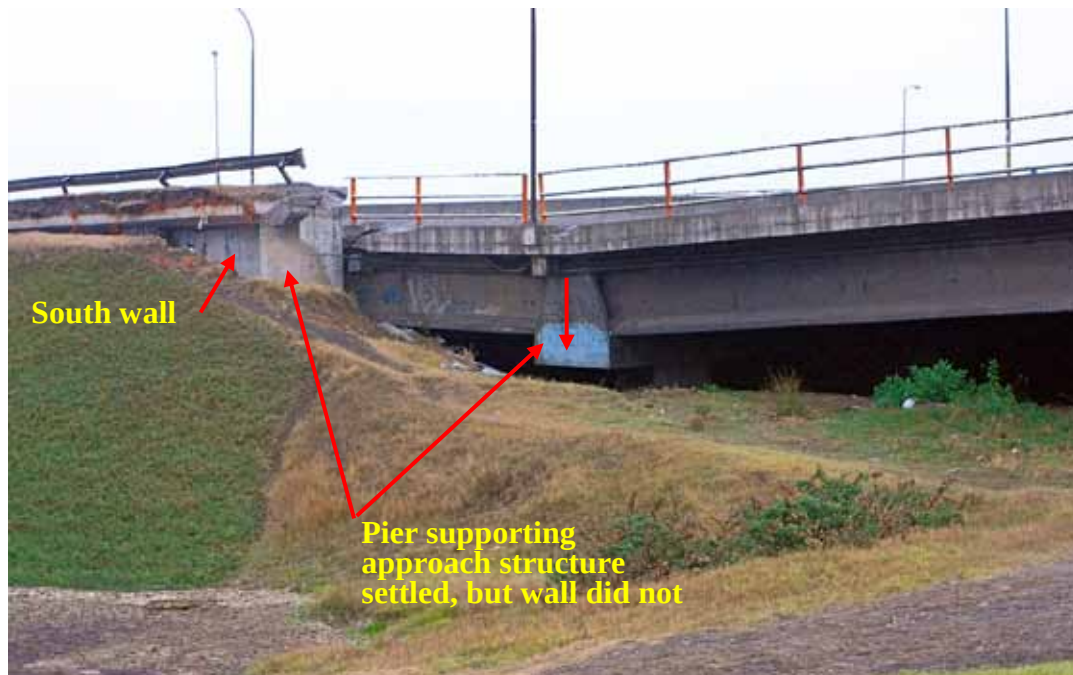
**Figure 217. Photo. Settlement of approach structure for Juan Pablo II bridge.**

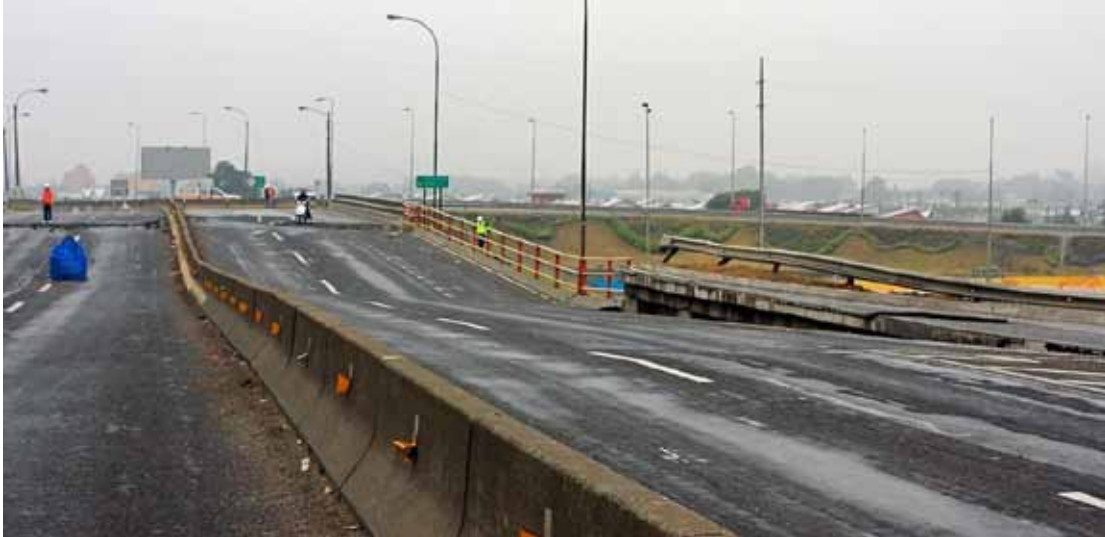
**Figure 219. Photo. Roadway settlement due to settlement of approach structure pier foundations for Juan Pablo II bridge.**

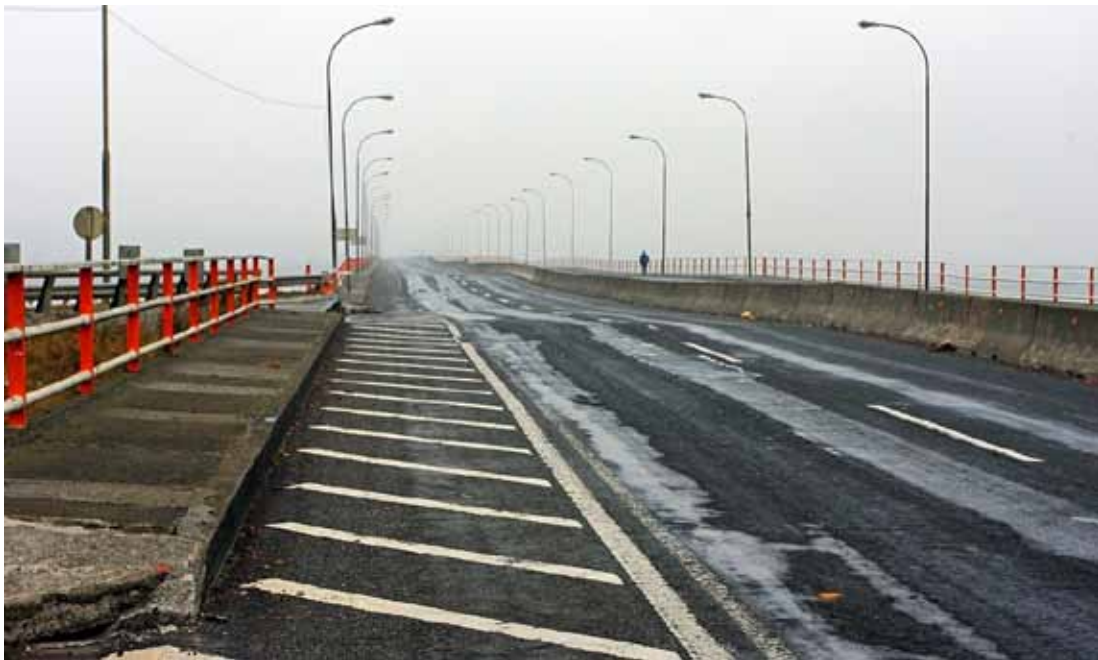
**Figure 220. Photo. Roadway settlement due to settlement of mainline pier foundations for Juan Pablo II Bridge.**

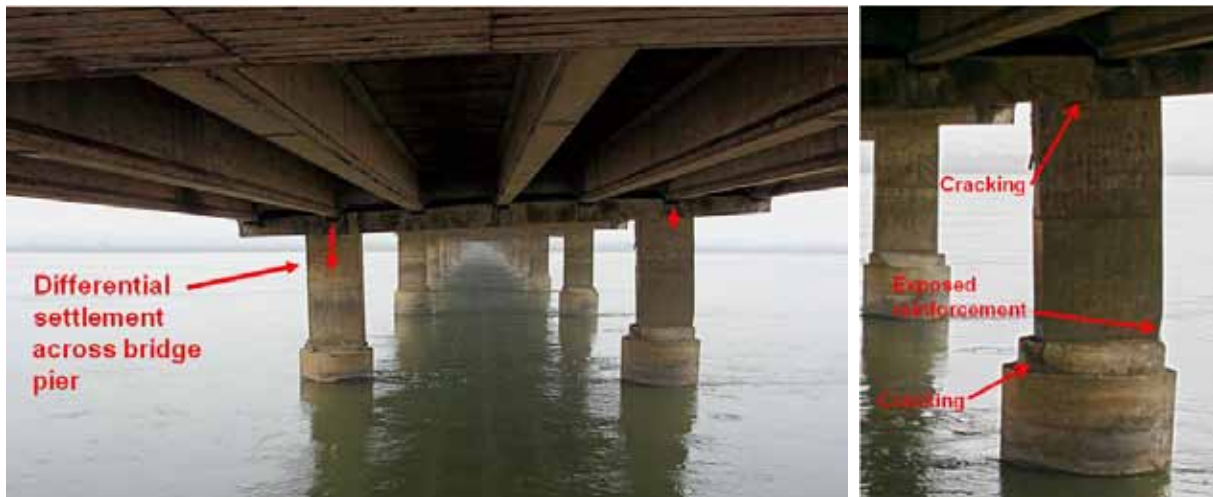
**Figure 221. Photo. Liquefaction-induced differential settlement of mainline pier foundations supporting Juan Pablo II bridge.**

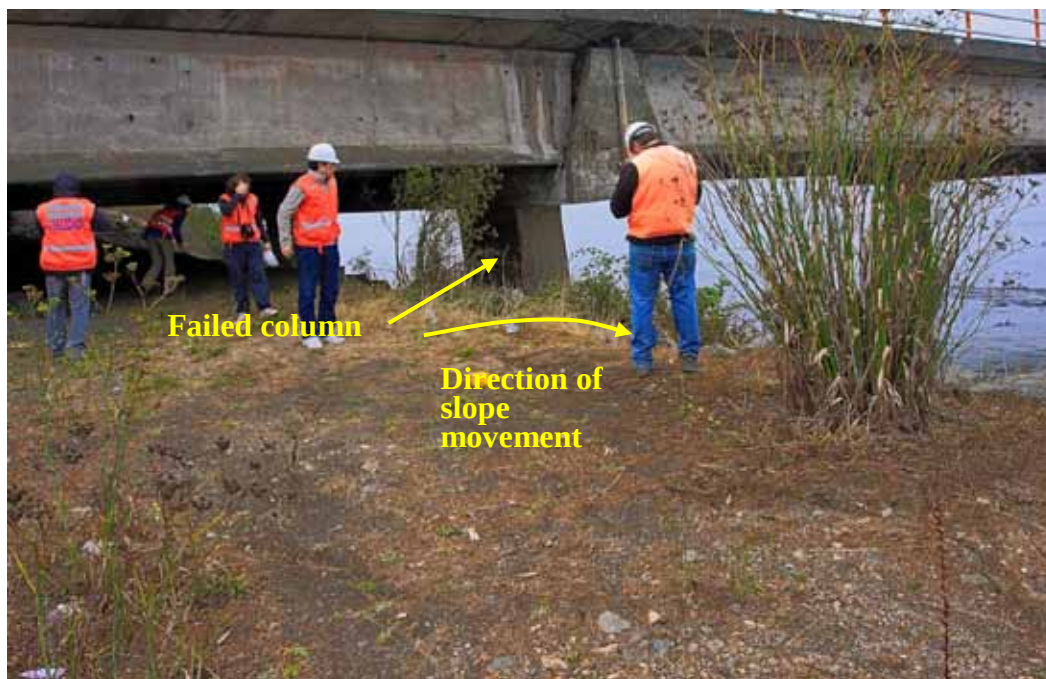
**Figure 222. Photo. Damage to pier columns for mainline Juan Pablo II bridge.**

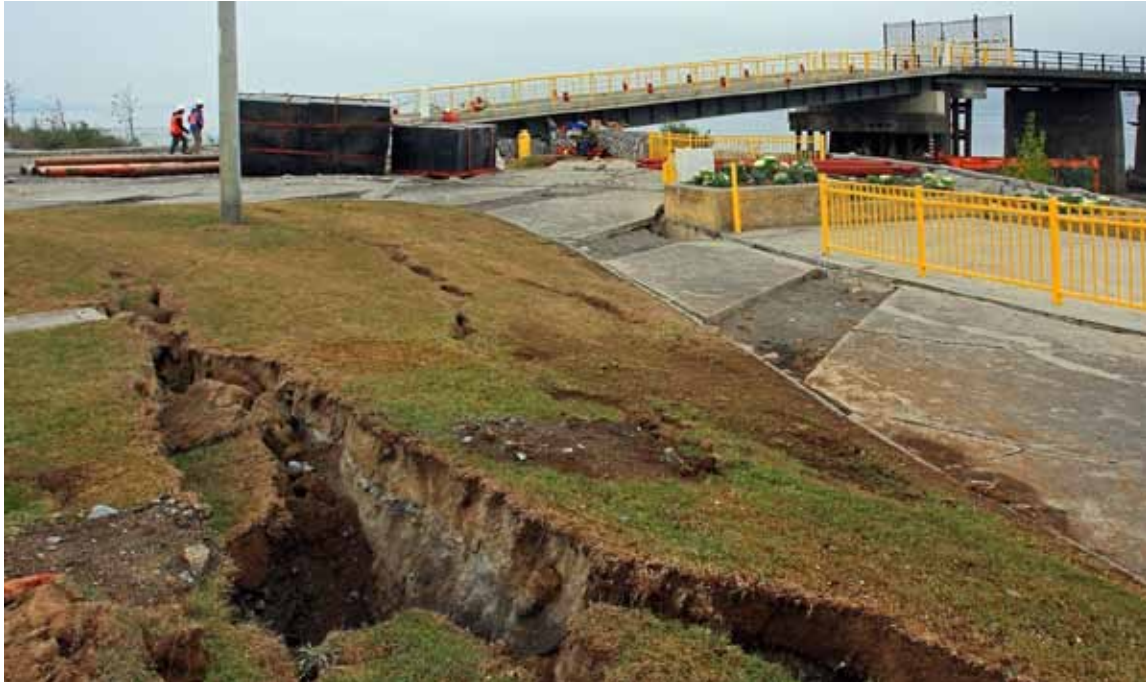
**Figure 225. Photo. Ground failure near northeast abutment of old Biobío River bridge.**

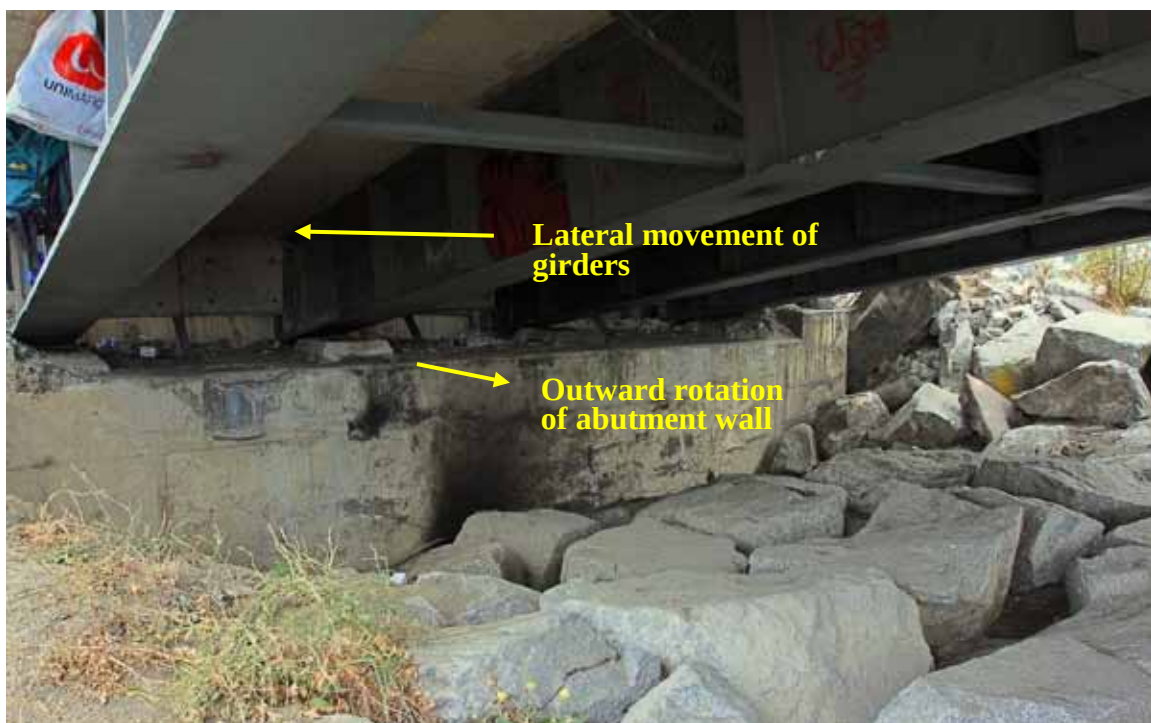
**Figure 226. Photo. Tilting of northeast abutment pier wall of old Biobío River bridge.**

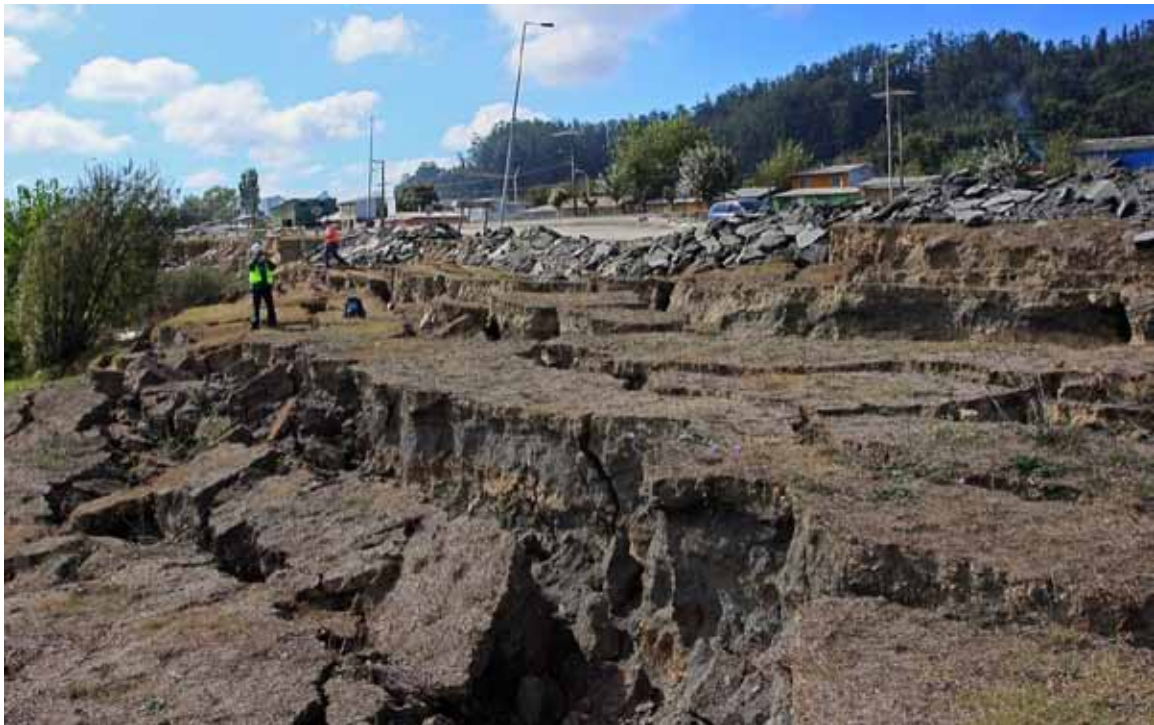
**Figure 227. Photo. Ground failure of north approach fill for La Mochita bridge.**

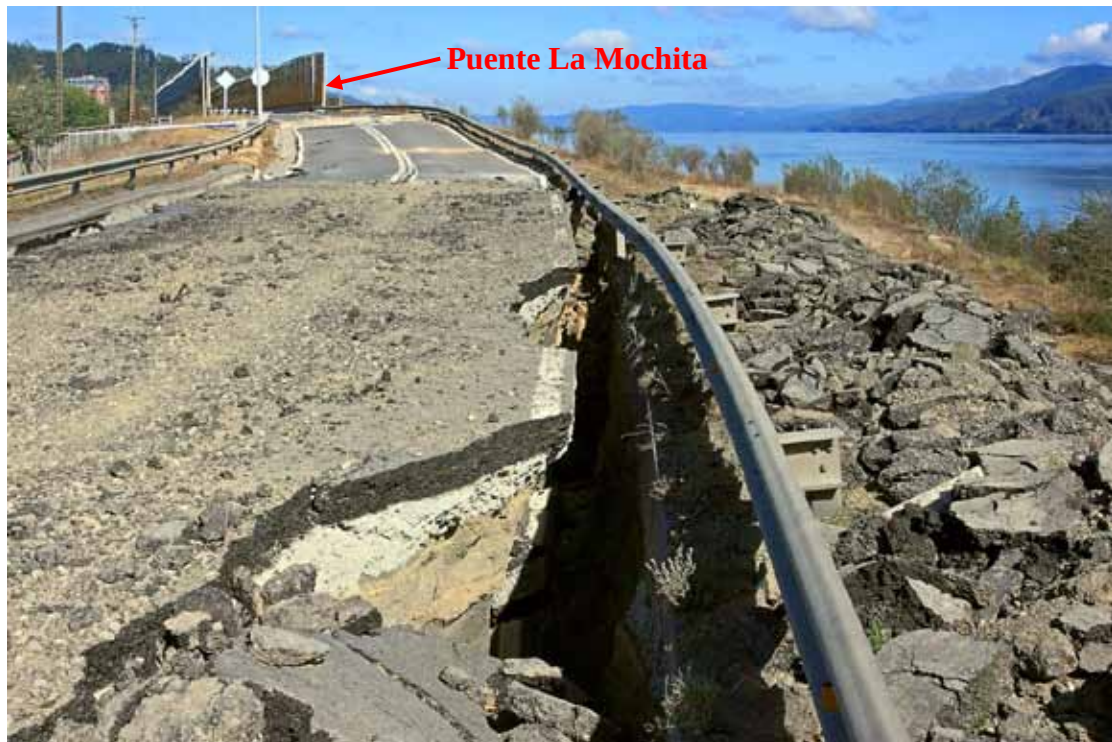
**Figure 228. Photo. La Mochita bridge north approach fill liquefaction-induced ground failure.**
