# Postearthquake Reconnaissance Report on Transportation Infrastructure Impact of the February 27, 2010, Offshore Maule Earthquake in Chile

PUBLICATION NO. FHWA-HRT-11-030

OCTOBER 2011

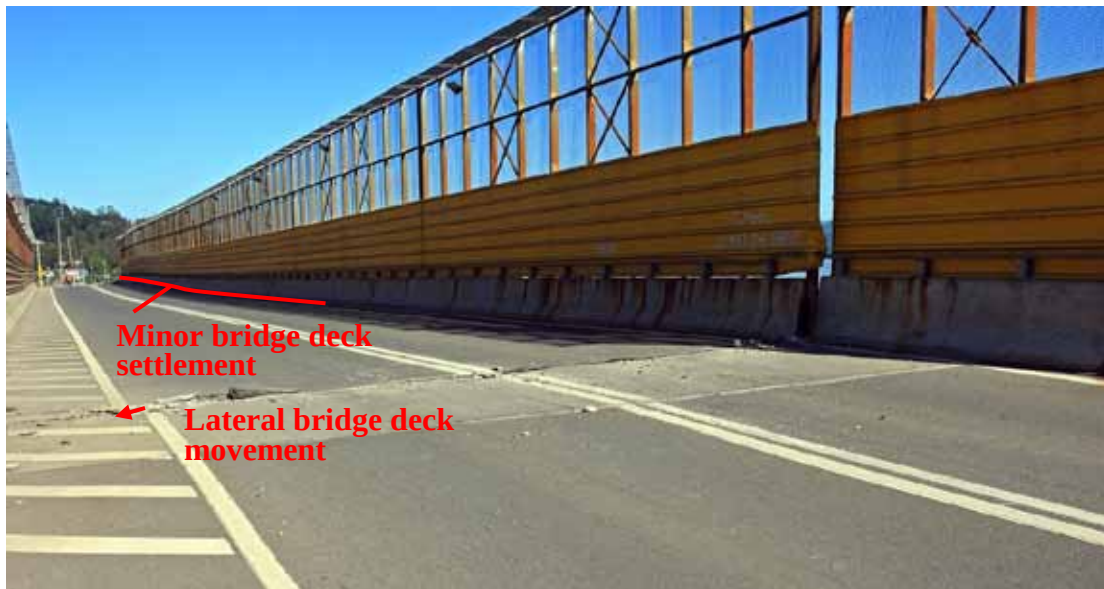
**Figure 230. Photo. La Mochita bridge deck and girder lateral movement.**

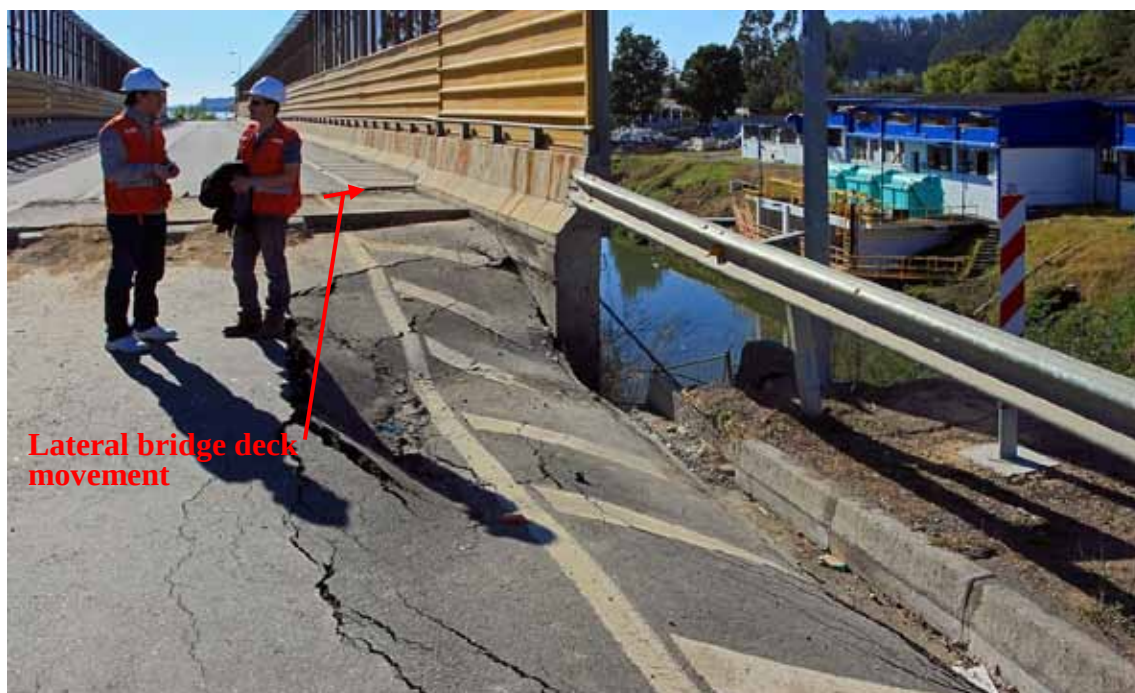
**Figure 231. Photo. La Mochita bridge deck and girder lateral movement and approach fill settlement.**

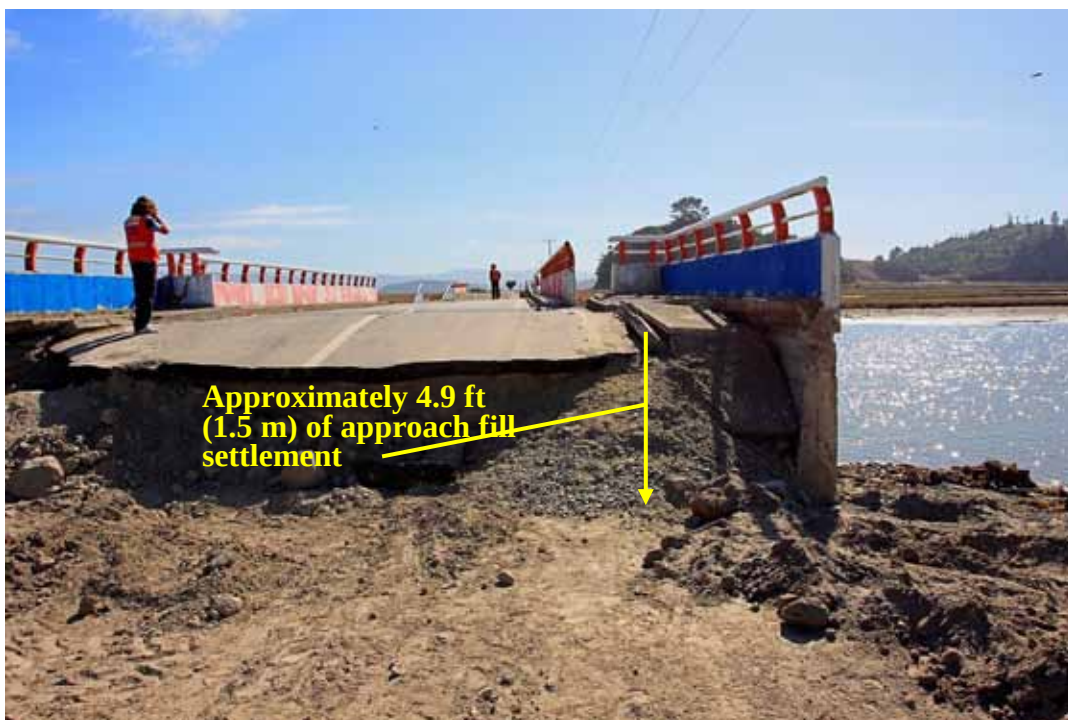
**Figure 233. Photo. Southeast approach fill damage at Raqui 2 bridge.**

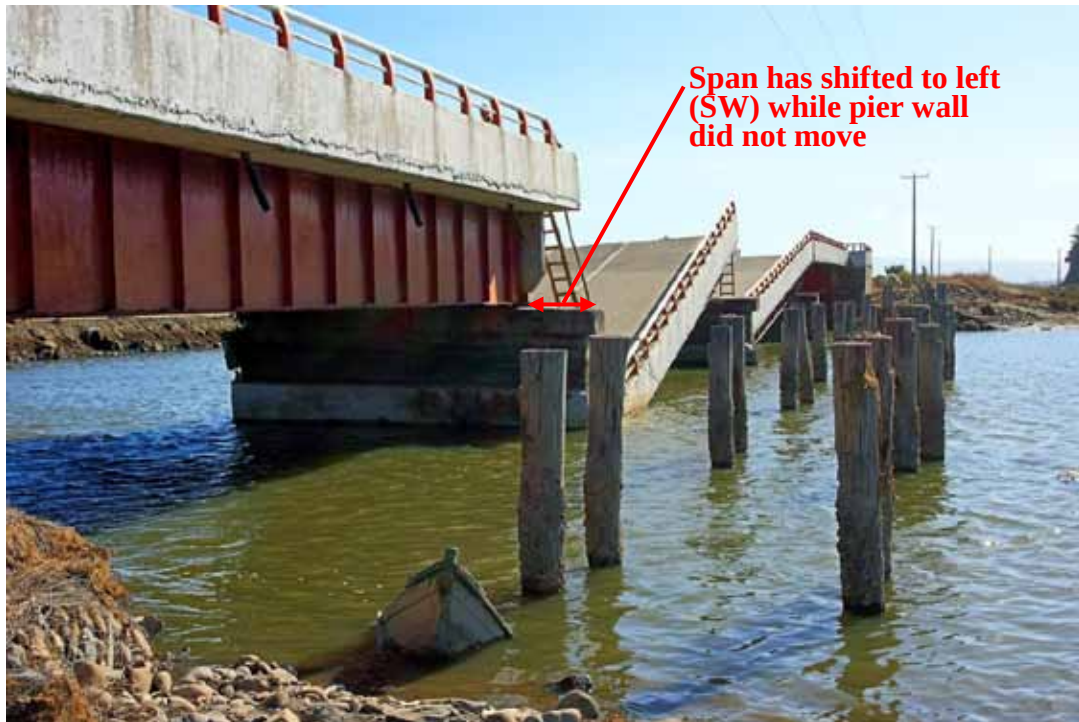
**Figure 234. Photo. Collapsed and shifted spans at Raqui 2 bridge as viewed from base of southeast abutment.**

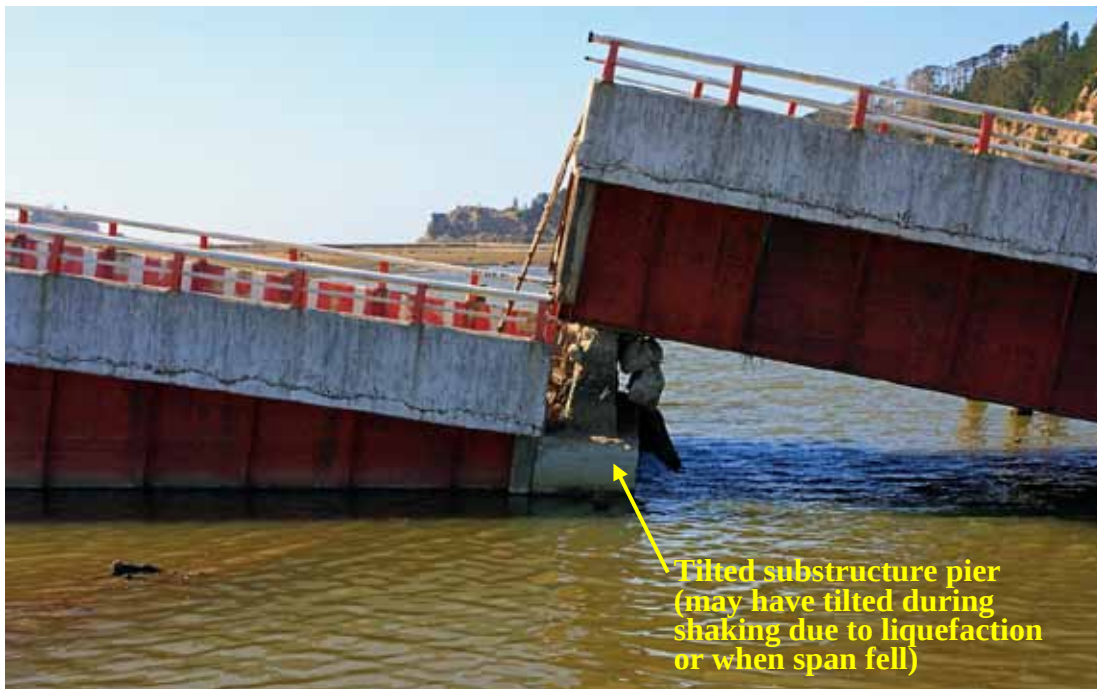
**Figure 235. Photo. Collapsed and shifted spans at Raqui 2 bridge due to liquefaction.**

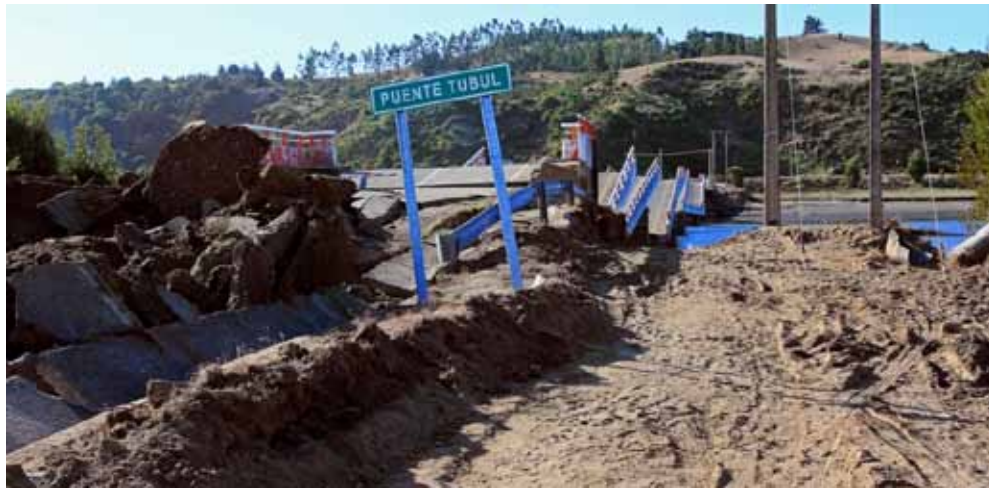
**Figure 236. Photo. South approach fill damage and collapsed spans at Tubul Bridge.**

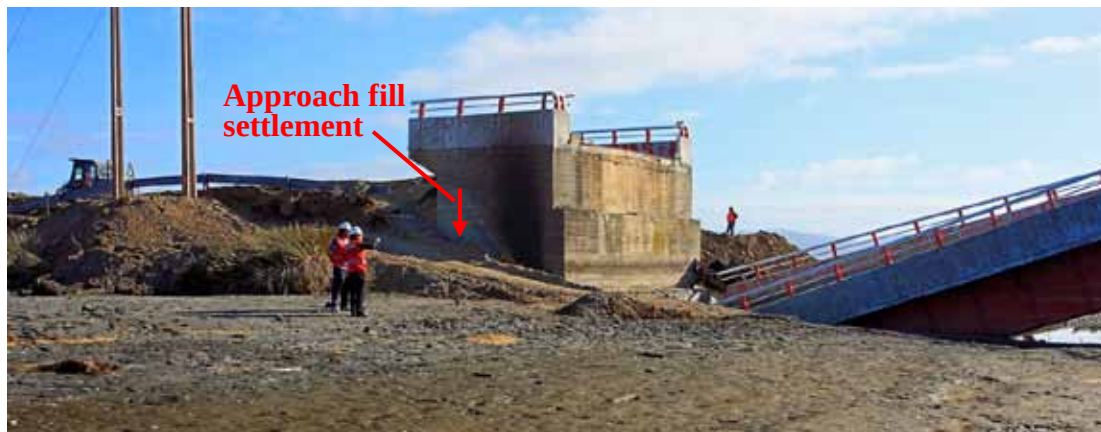
**Figure 237. Photo. Settlement of fill beside the south abutment of Tubul bridge.**

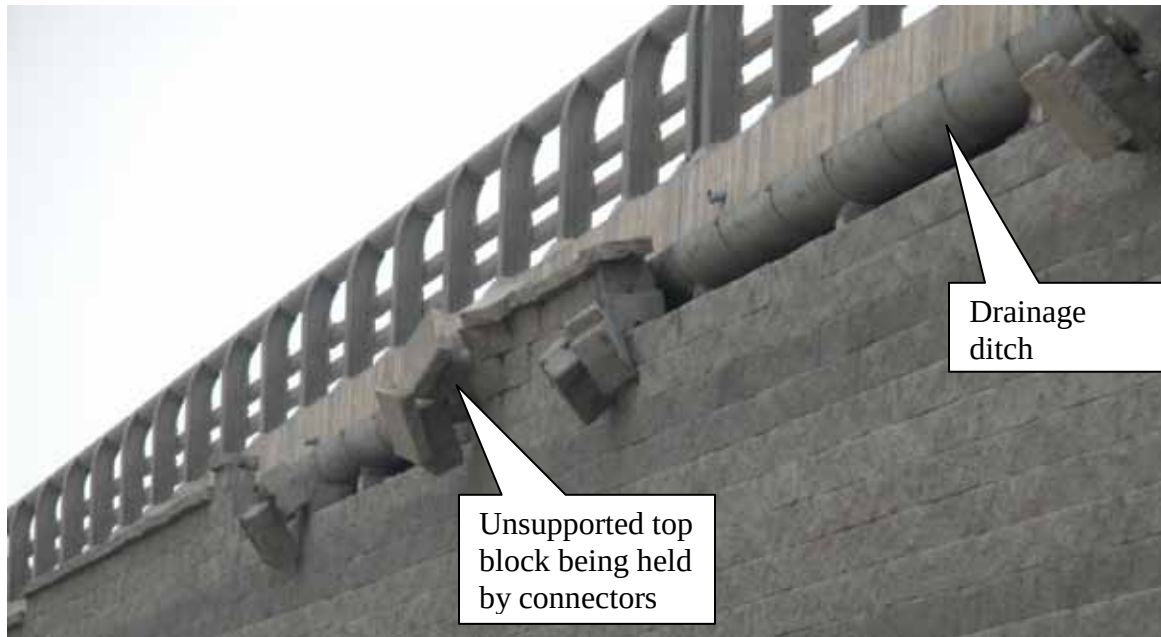
**Figure 261. Photo. Toppling of coping at Américo Vespucio/Independencia.**

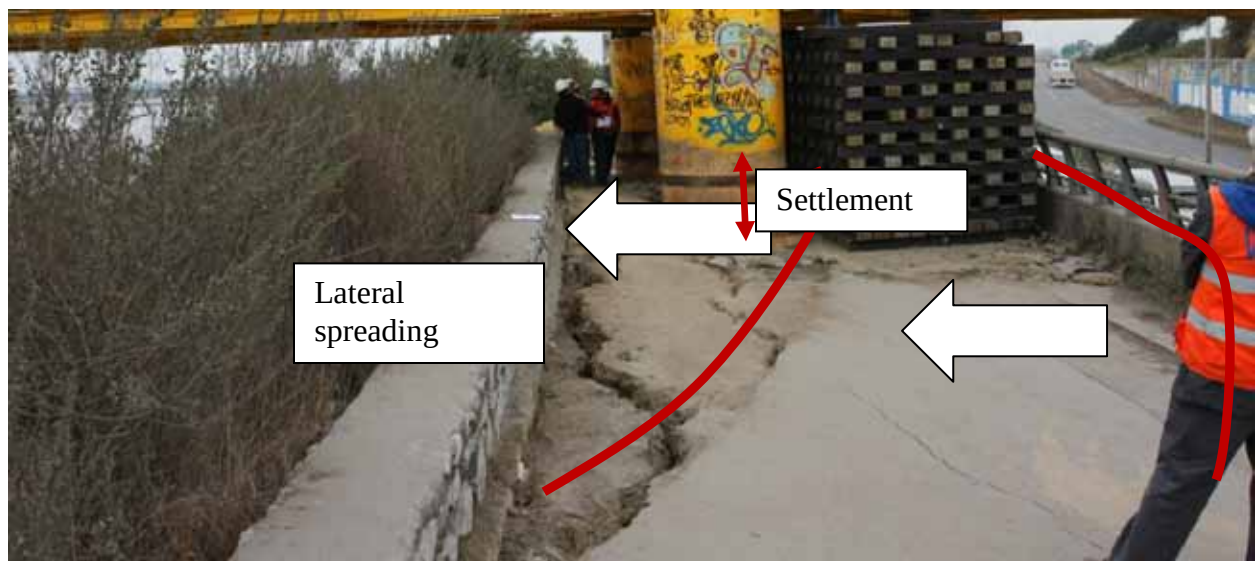
**Figure 263. Photo. Wall settlement and rotation due to lateral spreading and settlement.**

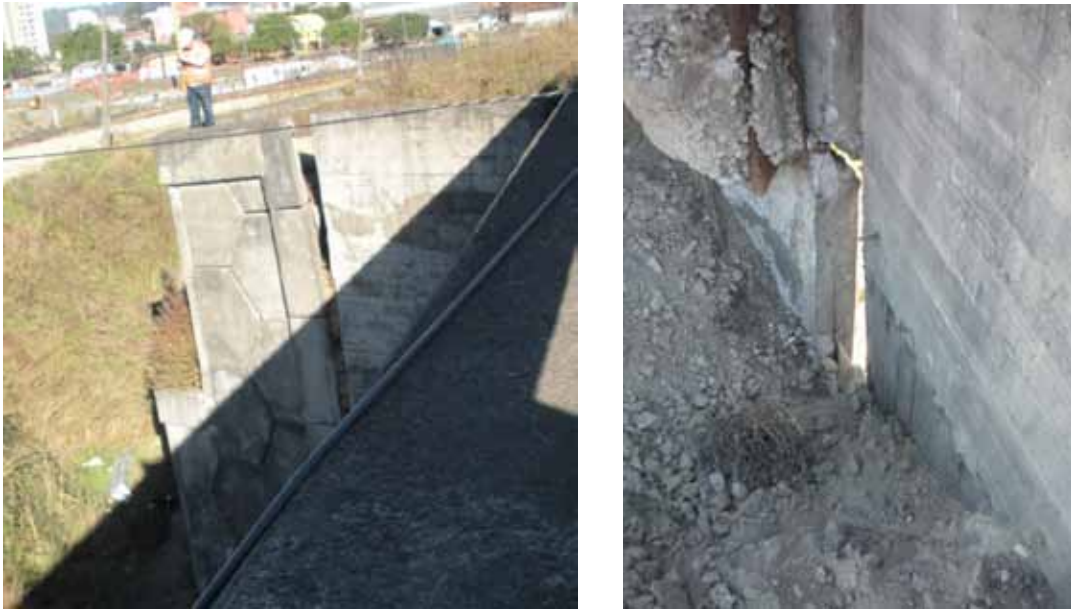
**Figure 267. Photo. Tiered wall corner tilting outward at wall site 28A.**

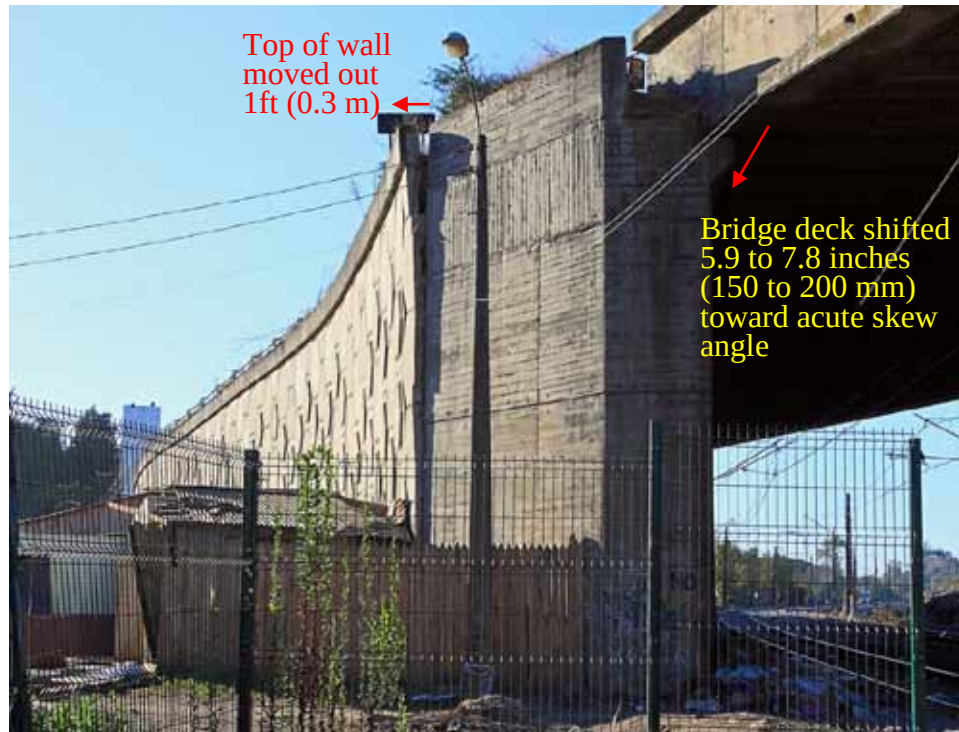
**Figure 268. Photo. Wall corner tilting outward at wall site 28B.**
