## Full-Scale Locomotive Dynamic Collision Testing and Correlations: Offset Collisions between a Locomotive and a Covered Hopper Car (Test 4)

| REPORT DOCUMENTATION PAGE | | | Form Approved<br>OMB No. 0704-0188 | |
|---|---|---|---|---|
| 4. TITLE AND SUBTITLE<br>Full-Scale Locomotive Dynamic Collision Testing and Correlations: Offset Collisions between a Locomotive and a Covered Hopper Car (Test 4) | | | 5. FUNDING NUMBERS | |
| 7. PERFORMING ORGANIZATION NAME(S) AND ADDRESS(ES)<br>Foster-Miller, Inc.<br>350 Second Avenue<br>Waltham, MA 02451-1196 | | | 8. PERFORMING ORGANIZATION<br>REPORT NUMBER<br>DFRA.040048 | |

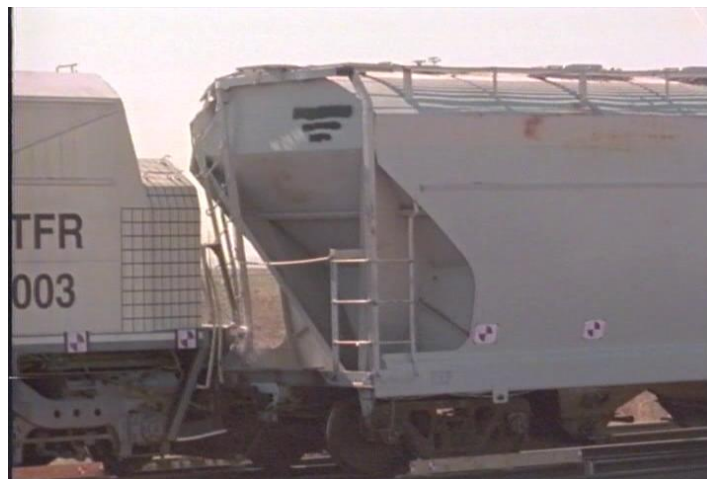
- The locomotive vertical end plate made contact with the covered hopper side sill and the horizontal end plate. The side sill was torn away from the horizontal end plate as the left corner of the horizontal end plate was bent downward, making contact with the covered hopper's front truck (Figure 11). The locomotive vertical end-plate sheared off vertically near the draft gear pocket and was bent back underneath the underframe when it came in contact with the front truck. The excessive deformation of the locomotive vertical end-plate caused the plow to completely break free of the end plate.

**Figure 11. Locomotive Vertical End Plate Contacts Front Truck**

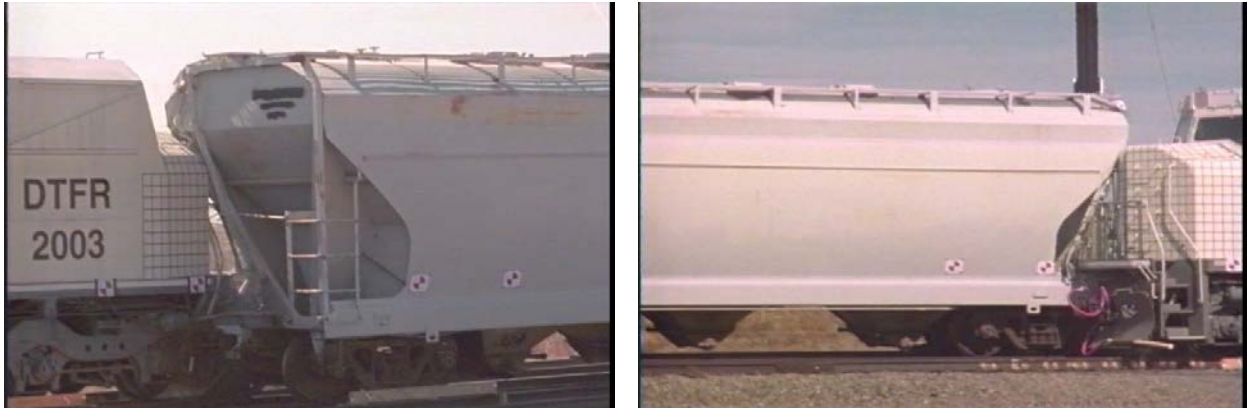
- As the end-plate interaction occurred, the locomotive nose made contact with the side and slanting front end of the covered hopper's body (Figure 12). The locomotive nose retained its shape and began to crash into the sloped end of the covered hopper body.

**Figure 12. Locomotive Nose Contacts Covered Hopper Body**

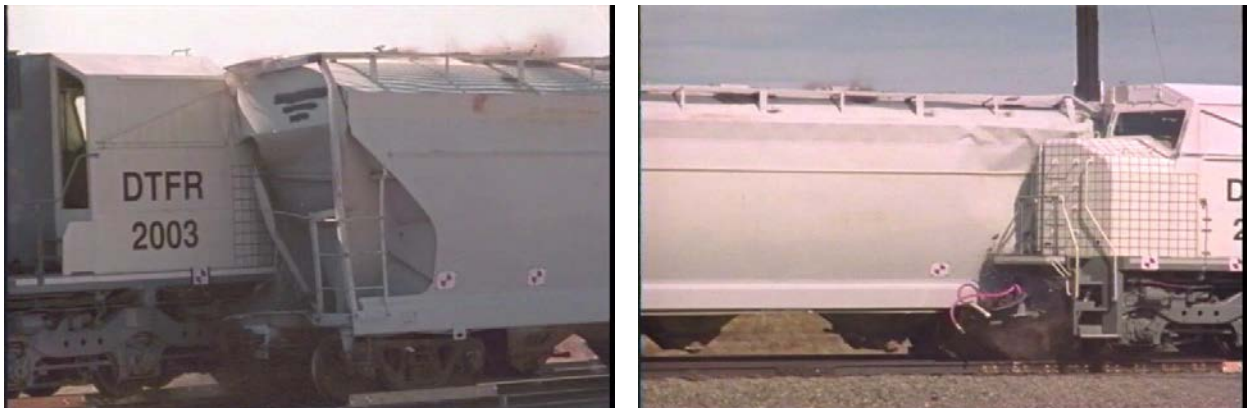
- The lateral forces at play shifted the locomotive and covered hopper away from one another before the locomotive nose could fully engage the hopper body. This lateral shift, however, caused the upper corner of the hopper body (just above the damaged sloped portion) to align with the locomotive's windshield corner post. The covered hopper corner buckled and tore away the corner post (Figure 13).

**Figure 13. Hopper Stiff Corner Contacts Windshield Corner Post**

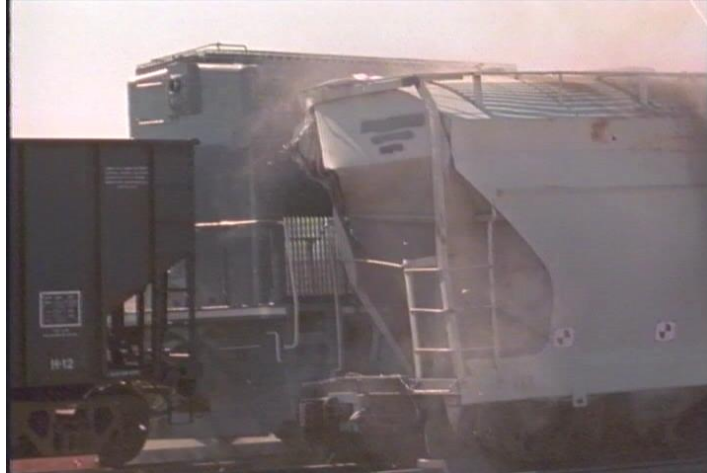
- The wheels of the locomotive's front truck now derailed, landing on the rail ties as the locomotive continued forward at an angle to its direction of travel. The right rear corner of the locomotive contacted the damaged covered hopper, bending the rear vertical end plate (Figure 14).

**Figure 14. Locomotive Right Rear Contacts Damaged Covered Hopper Car**

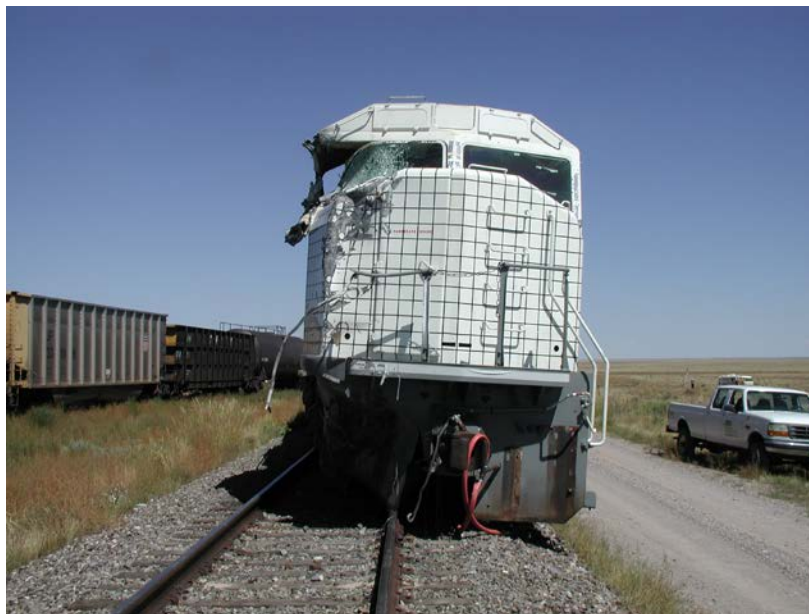
After the collision, the locomotive came to a stop with its lead truck resting on railroad ties and gravel, having tracked almost one full gauge width to the left after derailing in the collision with the covered hopper. The collision damaged the plow, the right-hand side of the vertical end plate and nose, and the right windshield corner post. Figure 15 shows the derailed, damaged locomotive after impact. Figure 16 provides closeup views of the damage to the windshield corner post, hood, and vertical end plate.

**Figure 15. Locomotive after Collision**

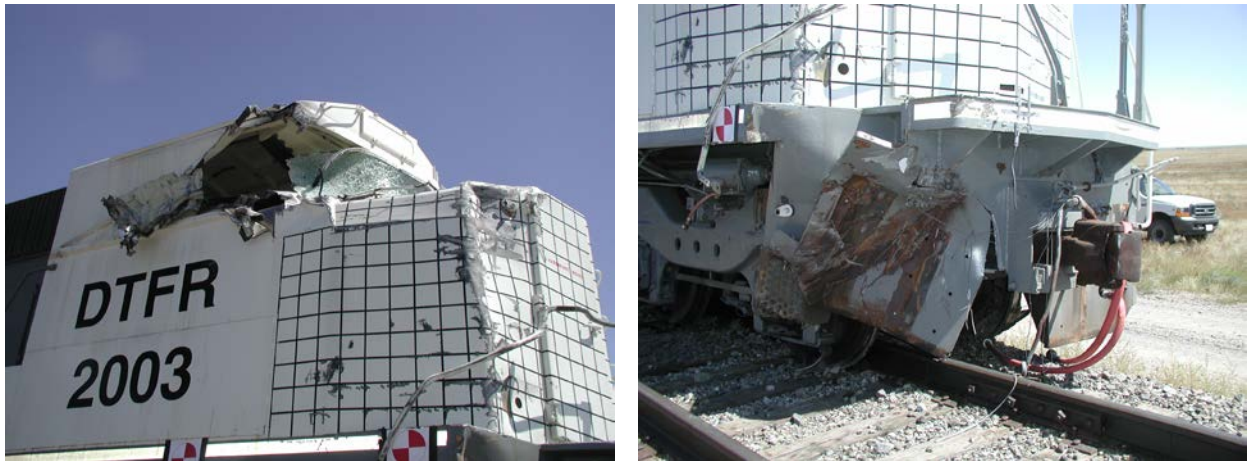
**Figure 16. Damage to Locomotive**

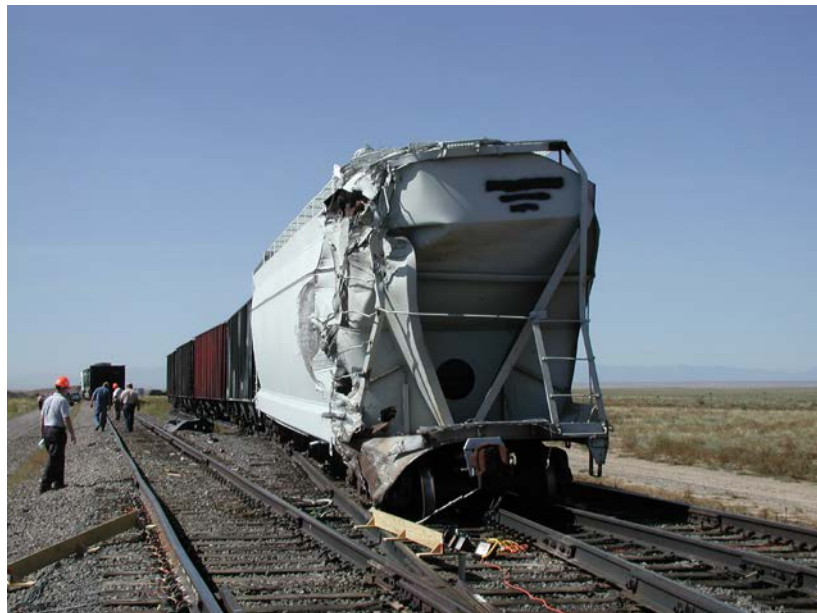
Longitudinal translation of the covered hopper car was limited by its being coupled to the remainder of the stationary consist. The collision slightly displaced the second and third stationary cars, which showed damage but did not derail. Figure 17 shows the derailed, damaged covered hopper car after the test. Figure 18 shows the close-up views of the damage of the side sill, horizontal end plate, bolster, and hopper body.

**Figure 17. Covered Hopper Car after Collision**

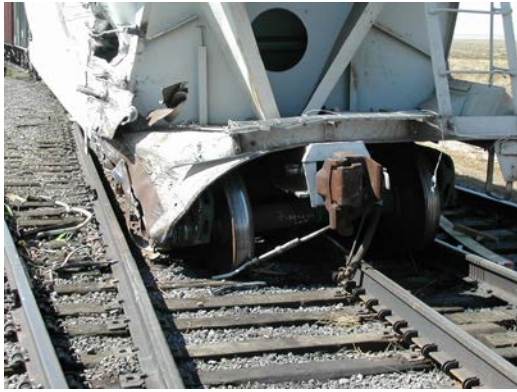
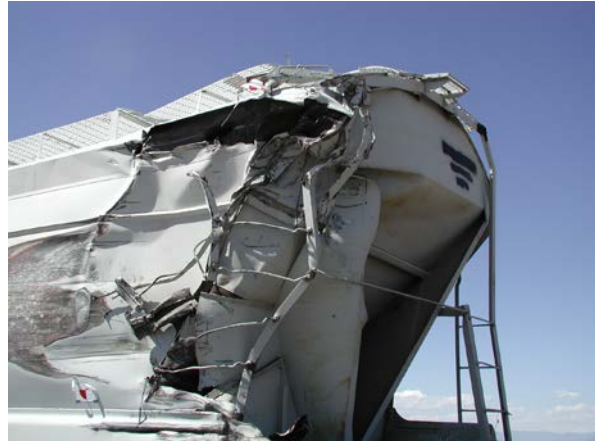
**Figure 18. Damage to Covered Hopper Car**

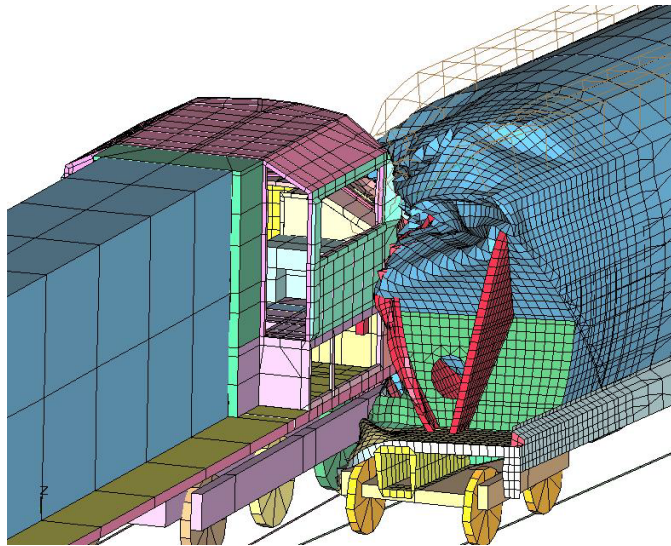
- As the end-plate interaction occurred, the locomotive hood made contact with the sloped end of the covered hopper's body. The locomotive hood was significantly damaged with

plastic deformation at the side of the right collision post. Figure 27 shows that the hopper body side and roof were significantly damaged, exposing the ballast inside the hopper body.

**Figure 27. Covered Hopper Car Body Damage**

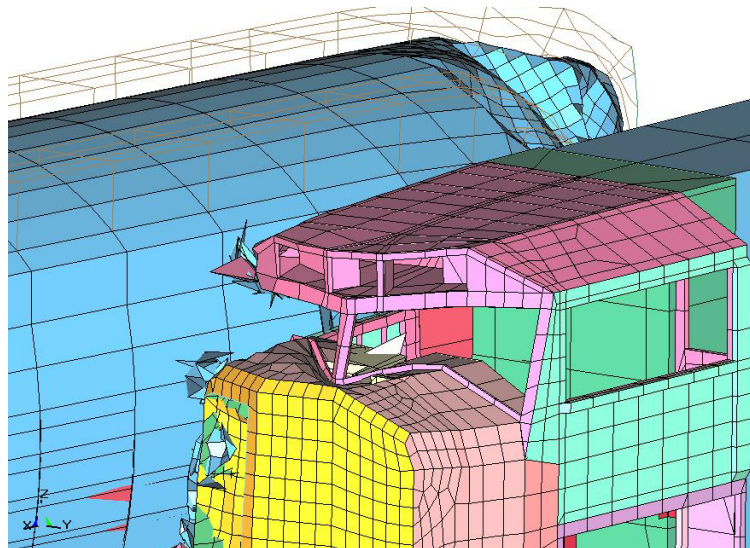
- The lateral forces shifted the locomotive and covered hopper away from one another. This interaction of the locomotive hood and roof with the hopper body moved the covered hopper toward the locomotive. Figure 28 shows that the tangle of hopper body materials tore the locomotive windshield corner post and deformed the side of the locomotive cab.

**Figure 28. Locomotive Windshield Corner Just after Post Removal**

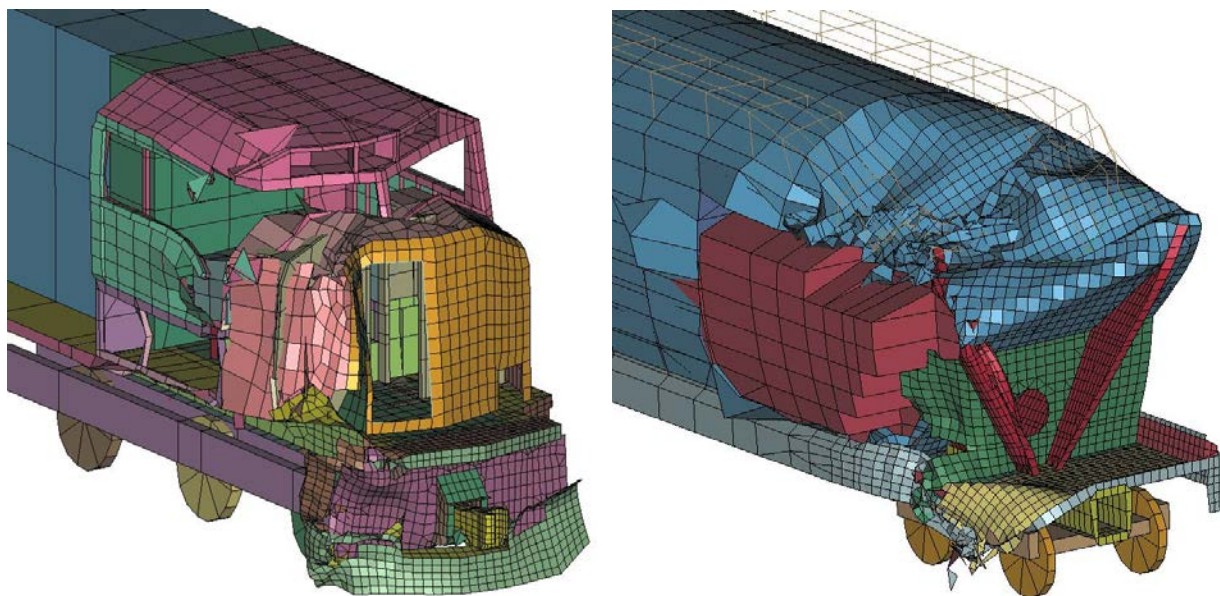
Figure 29 shows the damage to the locomotive and hopper car from the simulated collision.

**Figure 29. Locomotive and Covered Hopper Car Damage from Simulation**

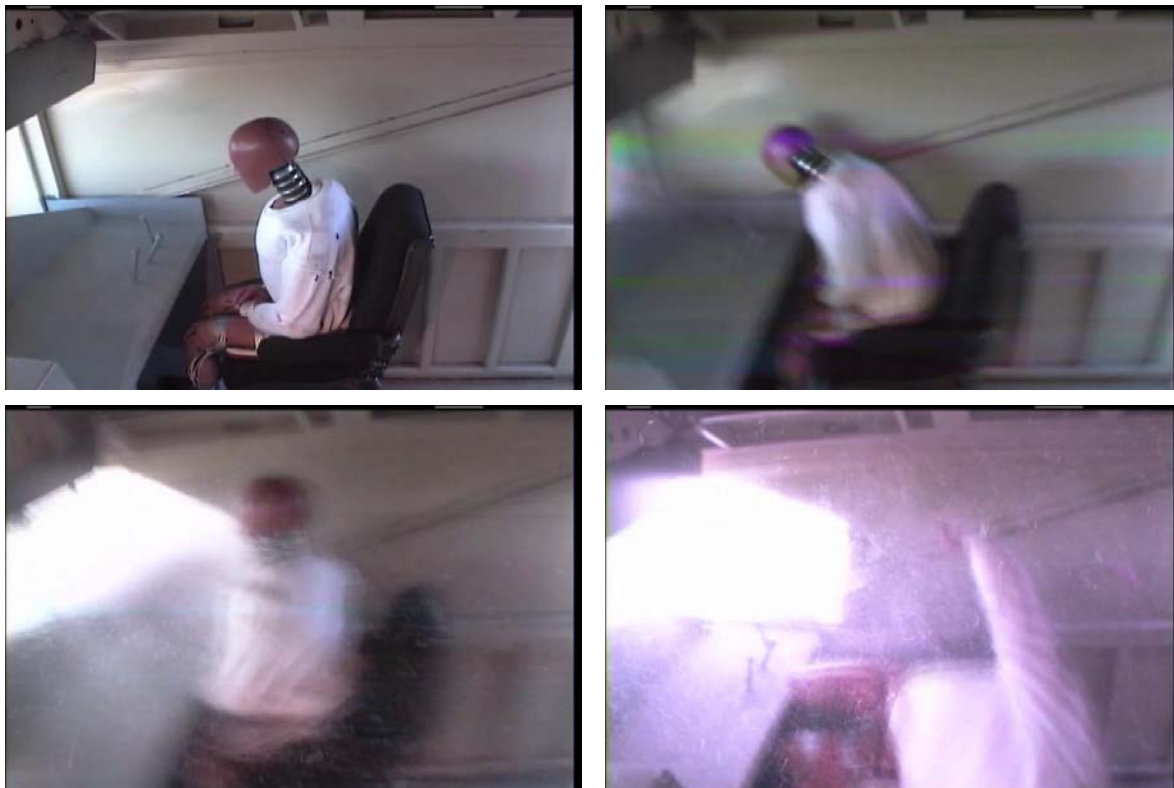
**Figure 38. ATD Impact with Corner Post Sequence**

- Significant damage to the corner post area occurred in this test. The intrusion of the cab is a potential for primary injuries to crew.
