U.S. CHEMICAL SAFETY AND HAZARD INVESTIGATION BOARD

# **INVESTIGATION REPORT**

## **EXPLOSIVES MANUFACTURING INCIDENT**

### **SIERRA CHEMICAL COMPANY**

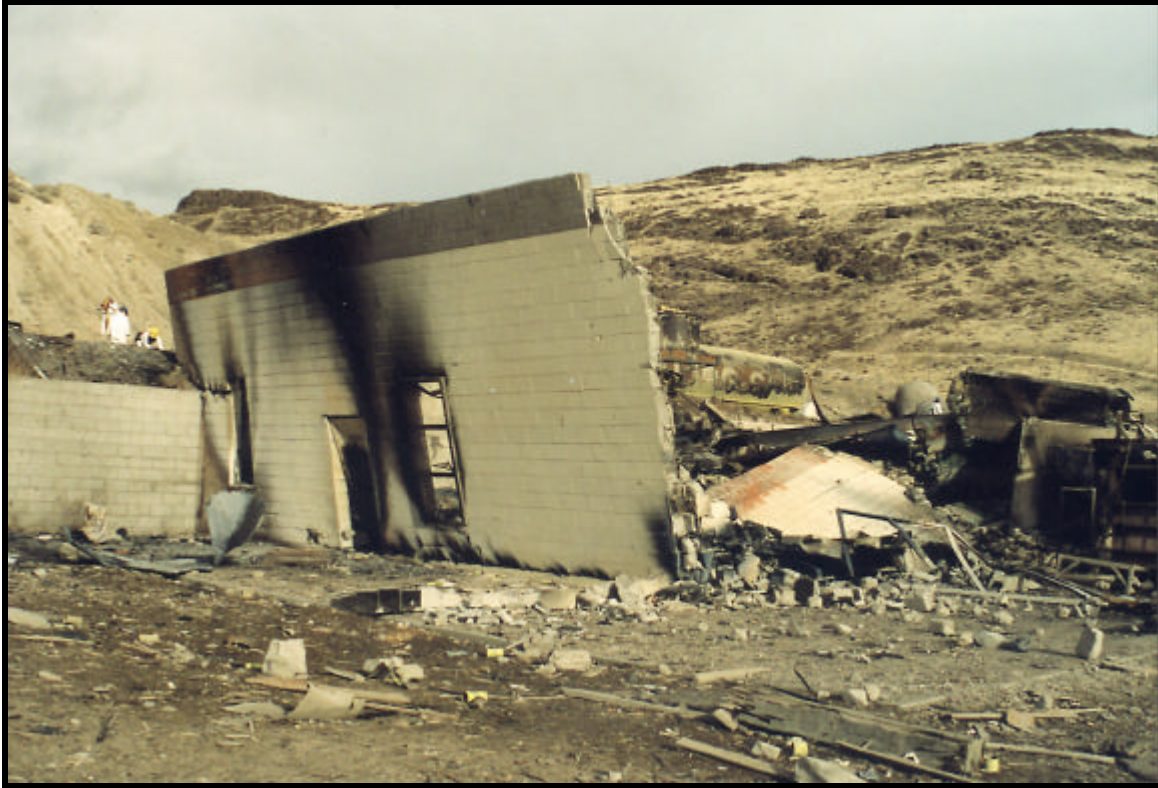
**Figure 7. Booster Room 1 After Explosion**

The blast effects of the explosions leveled the site and threw structural materials, manufacturing equipment, raw materials from the booster and flux operations, and other fragmentation up to 1,000 yards away. Figure 7 shows Booster Room 1 and Figure 8 shows Booster Room 2 following the explosions. The legs and cross bracing from an empty tank, which previously stood at the corner of the change room, were imbedded in a motor home located 900 feet from the production building. The doors of one of the large magazines and a portable magazine located west of the production facility were sprung open by the negative pressure pulse; however, large quantities of explosive materials that were stored inside did not detonate. Many undetonated boosters had been scattered throughout the site by the explosion. Other hazards at this time included fires, toxic chemicals, and potential detonation of the explosives in Booster Room 1 as the fire progressed.

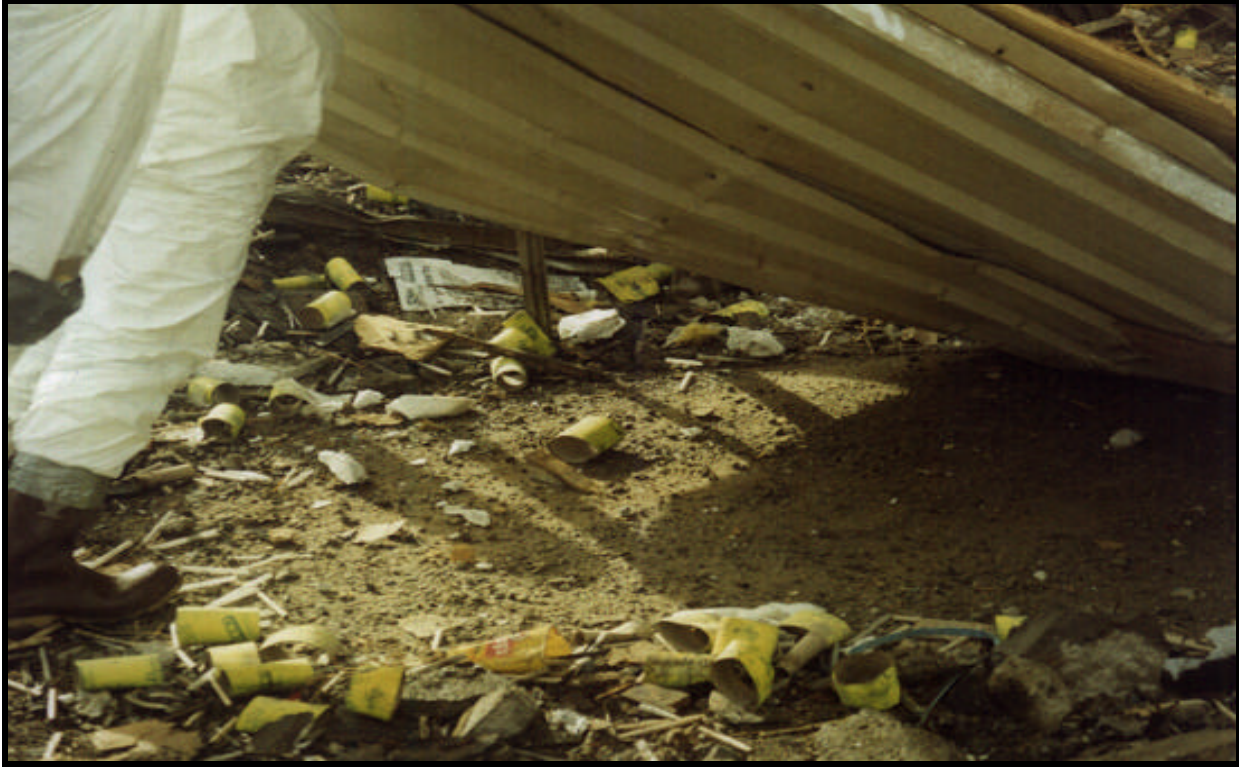
**Figure 9. Lifting the Sliding Door**

Layering of debris further demonstrated the sequence of the explosions. The concrete roof of the Boiler Building fell on top of pieces of its walls. (The Boiler Building is labeled "Main Electrical Panel and Boiler" in Figure 3.) These were in turn located on top of a corner and pinned down a seven- by ten-foot sheet-metal sliding door from the east side of Booster Room 1. A small tank, previously located outside the Boiler Building, also came to rest on this door. When the sliding door was finally lifted (see Figure 9), no debris was under it, even though it was surrounded by debris from the concrete Boiler Building. This layering, like archeological strata, indicated that the blast from Booster Room 2, which knocked down the wall between the warehouse and Booster Room 1, blew out the sliding door to the raised platform in Mixing Room 1. The second blast from the PETN building destroyed the Boiler Building and its concrete roof fell down on top of pieces of the wall.

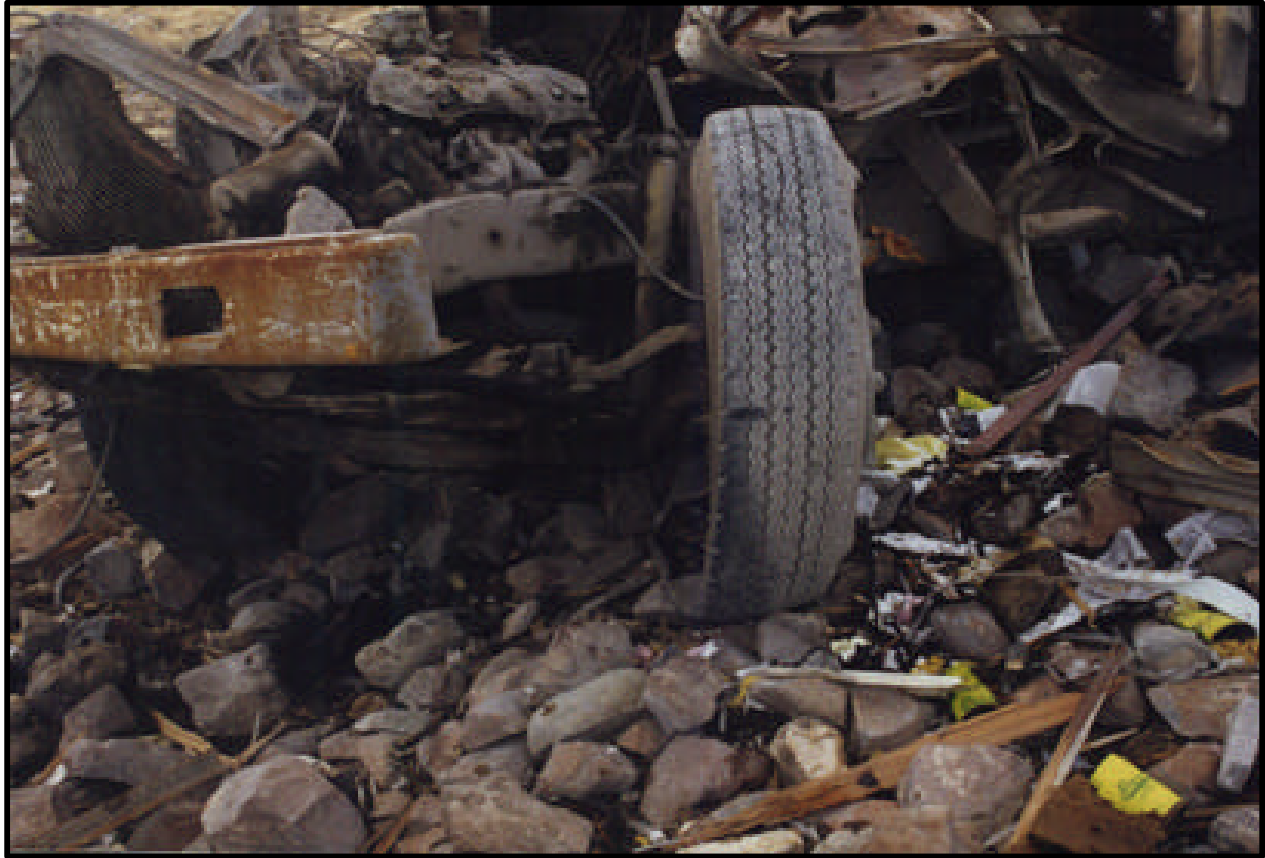
**Figure 11. Flatbed Truck Showing Riprap Against Tire**

A flatbed truck, which had been parked facing east on the terrace, south of the tanks outside of the change room/office, came to rest after the explosions facing southeast, with the cab diagonally hanging over the edge of the riprapped slope between terraces. The driver side of the engine and cab of the truck showed multiple fragment penetrations. A mixing pot fragment was found lodged on the driver's side of the truck. The passenger side of the truck showed blast damage that lifted the front of the cab off of the chassis. A pile of riprap was found on the uphill side of the driver-side front tire, with a path cleared in the riprap on the other side of the tire (see Figure 11). There was less riprap material on the uphill side of the passenger-side front tire. A steel cargo rack, which had been welded to the front of the truck bed behind the driver, was found hanging from the bed on the driver side on top of other blast debris from the vicinity of Booster Room 2.

The investigation team determined that the front of the truck was struck by the blast from Booster Room 2, and the blast propelled the truck partially over the slope, with the undercarriage resting on the brow of the slope. The axis of the truck was nearly perpendicular to the brow of the slope. The blast from the PETN building then struck the passenger side of the truck, which rotated the front of the truck back uphill about six feet, with upward damage to the cab. The second blast also tore the cargo rack from the front of the truck bed and deposited it on the uphill side of the truck on top of debris from Booster Room 2, including part of the stand from pot 4. This second blast lifted the passenger side of the vehicle, which resulted in more riprap being pushed uphill by the driver-side tire. Because the last movement of the truck was uphill, away from the PETN building, observations of the final truck position and condition supports the conclusion that the first explosion occurred in Booster Room 2.

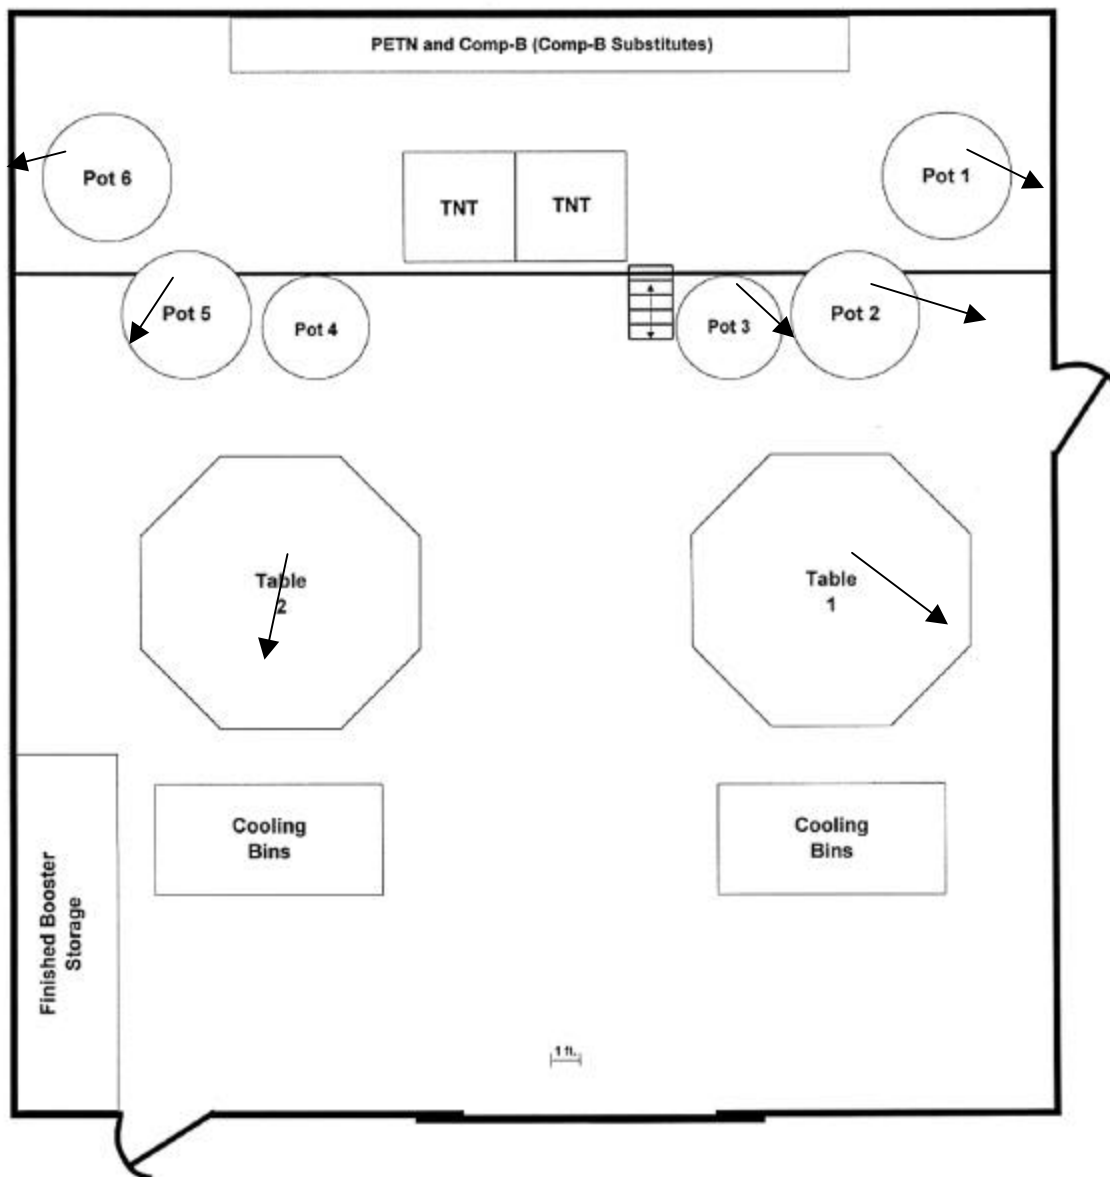
The investigation team found a number of identifiable components from Booster Room 2, including table bases and several mixing-pot shafts. Figure 12 shows the original location of these items in the room and the direction (indicated by an arrow) that each traveled following the explosion. The presence of pot fragments and components in virtually all directions indicates that mixing pot 5 exploded before the staged explosives on the platform did. Figure 12 also shows that the blast was concentrated in the areas where these explosives were staged.

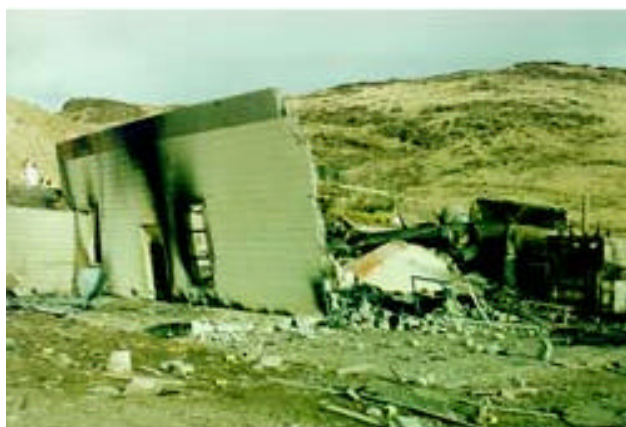
View of booster room 1 following the explosion, with west wall still standing. The five workers in this room survived.
