U.S. CHEMICAL SAFETY AND HAZARD INVESTIGATION BOARD

## OIL REFINERY FIRE AND EXPLOSION

No. 2004-08-I-NM  
October 2005

GIANT INDUSTRIES' CINIZA OIL REFINERY

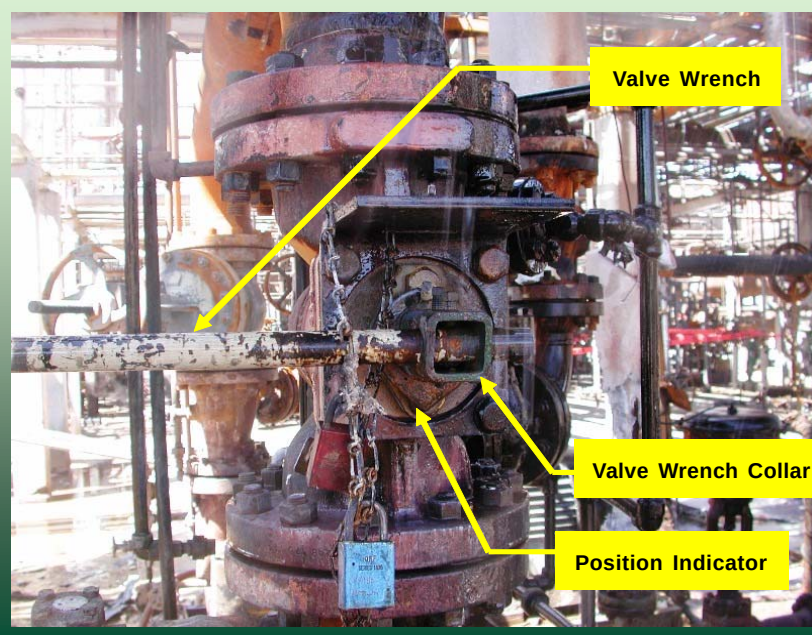
**Figure 1.**

the closed position with the wrench perpendicular to the flow of product. Interviews with several operators revealed that some operators used the valve wrench's position relative to the flow to determine whether the valve was open or closed, while others referred to the position indicator on the valve stem. The valve was actually open.

The pump needed to be disassembled and the rear pump housing assembly and impeller moved to the shop for repair. Before leaving the area to obtain materials needed to remove the pump, the mechanic noticed that the valve position indicator on the suction valve body showed that the valve was open (See Figure 1). He did not relate this information to his co-workers.

Suction Valve and Position Indicator as Found After Incident

Any valve position indication used by employees to determine the open/closed position of valves should communicate accurate information to employees. Valve modification should receive MOC analysis to determine whether new hazards or risks have been introduced.

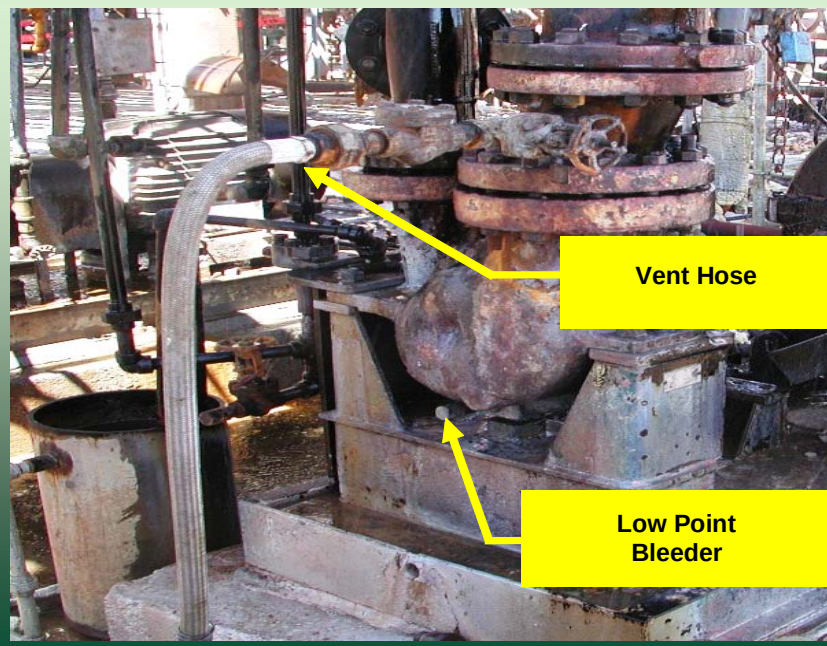
**Figure 2**

Depressurizing Hose

The operator then disconnected the pump's vent hose to verify that no pressure was in the pump case. The low point drain plug was not used because it was not equipped with a valve to isolate it from the line used for depressuring the pump. (See Figure 2) Giant lockout/tagout procedures outlining operator responsibilities state:

After uncoupling the hose at the connection to the flare line, a stream of alkylate flowed from the pump housing through the hose and subsided after a few seconds. The operator and the maintenance mechanics believed the pump had been de-pressured and was ready for removal. Actually, the vent line was plugged, and the pump was not de-pressured.

Lockout/tagout programs should require effective verification that equipment has been isolated, depressurized and drained.

locked out, the facility lacked procedures to verify that the pump had been isolated, depressurized and drained. Equipment being prepared for maintenance should be drained of all liquid at a low point drain.

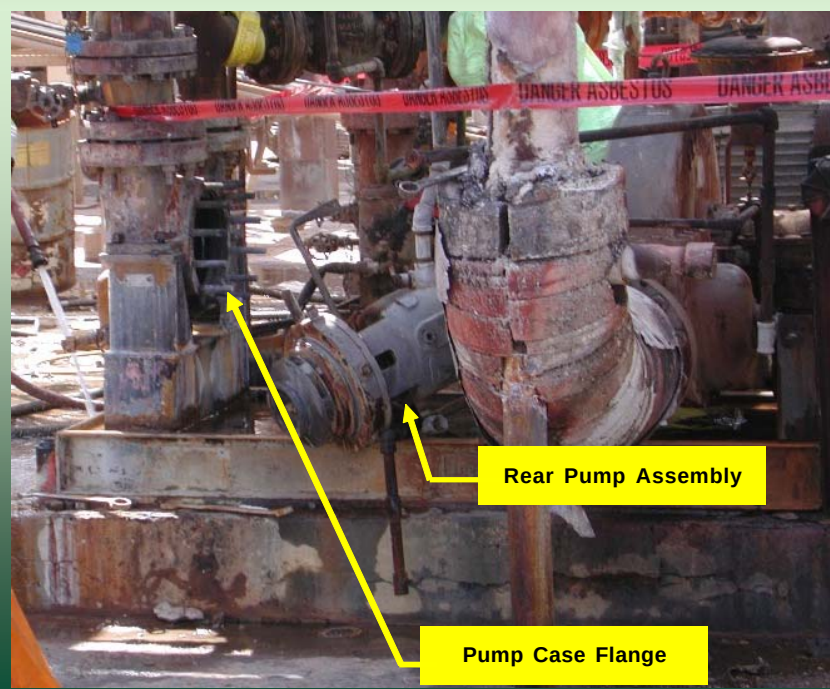
**Figure 3.**

Damage to Area of Pump

The pump shaft coupling and the flange connecting the pump to the pump case were unbolted. (See Figure 3) As the pump case flange was separated, alkylate was suddenly released at about 150 pounds per square inch gauge (psig) and 350 degrees Fahrenheit. The release produced a loud roaring sound that could be heard throughout the refinery.

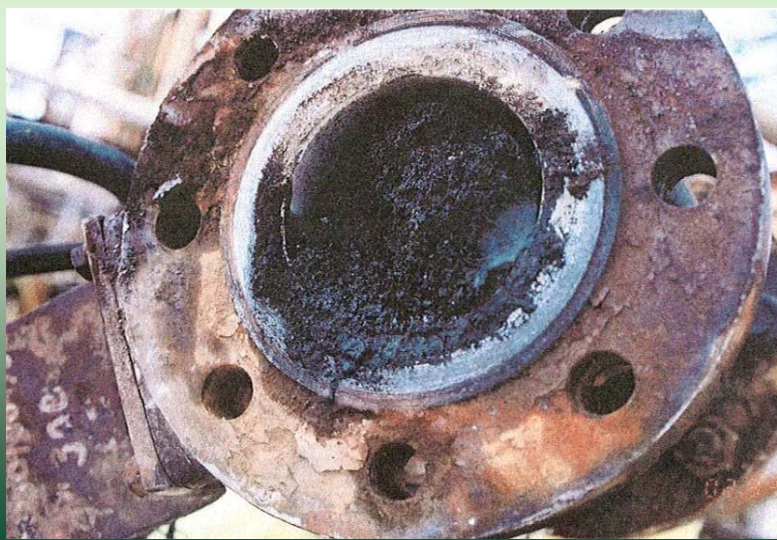
**Figure 4**

Giant's mechanical integrity program did not effectively prevent these repeated failures of the pump seals. After the incident occurred, plugging material was found in the pump discharge line, the depressurizing line, pump housing, and the impeller. (See Figure 4). Giant's approach to these frequent pump seal problems was an example of breakdown maintenance. In other words, pump failures were addressed when the equipment finally broke down, instead of identifying causes of breakdowns and preventing them before they occurred again.

cleanup activities. Some of this soft, water-laden scale comes off when the unit is running. The rest creates a site for extremely fast and extensive corrosion, resulting in a large amount of scale being added into the process. Scale may accumulate and settle at low points and orifices in equipment such as spare pumps.

Plugging Material Found in Discharge Valve

Mechanical integrity programs should prevent breakdown maintenance. Identifying operating conditions that could be contributing to equipment failure is a critical component of mechanical integrity.

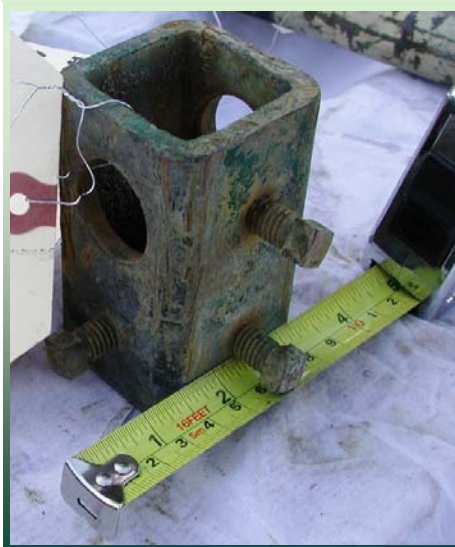
**Figure 5**

Examination of the 6-inch,  $\frac{1}{4}$  turn, plug valve after the incident determined that it was originally designed to be opened and closed by a gear-operated actuator. The gear-driver had been removed and was replaced by a valve wrench. The wrench was a two-foot-long bar inserted into a collar. Because it had a square shape, the collar could be easily removed and repositioned on the valve stem in different directions. (See Figure 5)

Spare Pump Valve Wrench Collar

In some instances, set screws would be loosened, and the wrench would be removed and placed on the pump base to provide better clearance for personnel walking nearby. When the valve was to be opened or closed, the wrench would be replaced on the valve stem. In the Ciniza oil refinery incident, the valve wrench collar was installed in the wrong position.

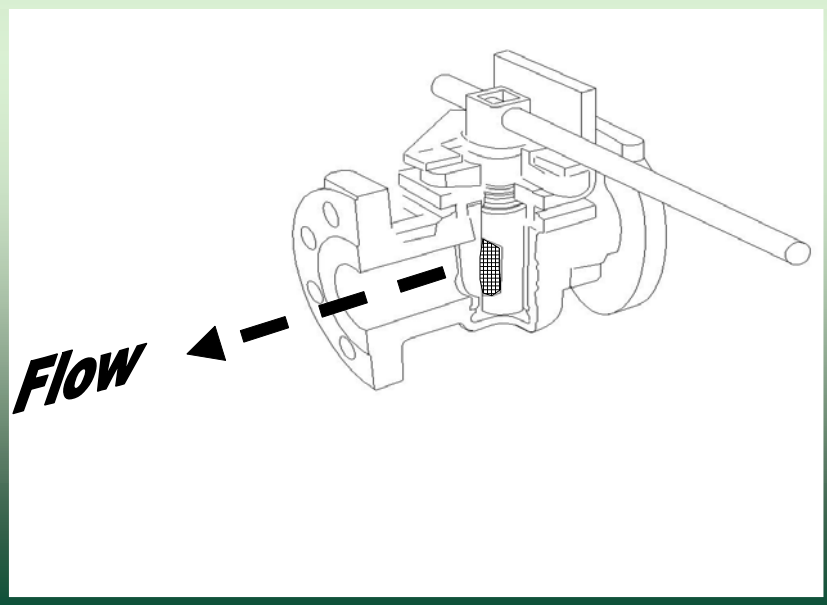
**Figure 6**

Plug Valve in the Open Position

Figure 6 is a drawing of the plug valve in the open position with the wrench in the perpendicular or perceived “closed” position.

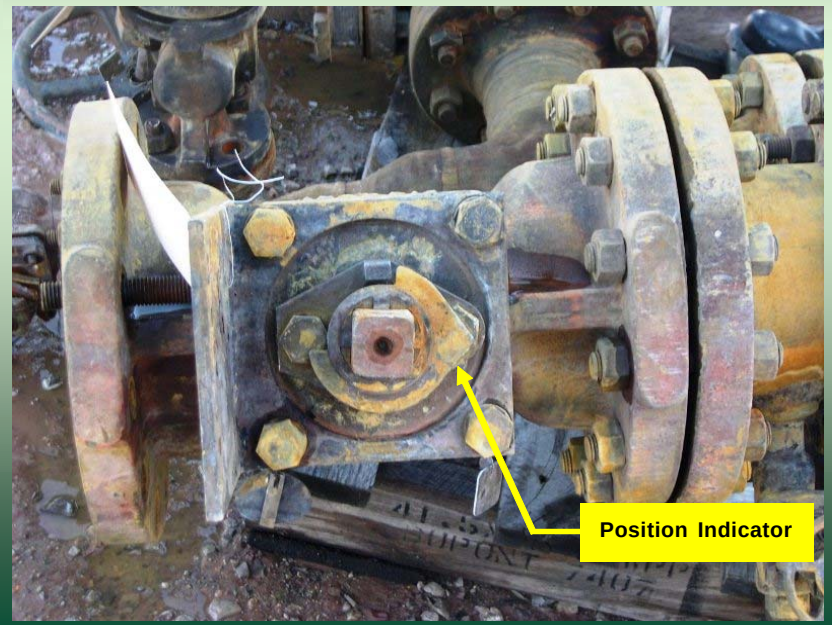
**Figure 7**

Technically, the wrench was not intended to indicate valve position because the valve was equipped with the position indicator, which was located on the valve stem. (See Figure 7) In practice, however, some plant employees used the wrench to determine valve position, partly because the wrench was much more visible than the actual valve position indicator.

Suction Valve & Position Indicator
