U.S. CHEMICAL SAFETY AND HAZARD INVESTIGATION BOARD

INVESTIGATION REPORT

Pesticide Chemical Runaway Reaction Pressure Vessel Explosion

Report No. 2008-08-I-WV
January 2011

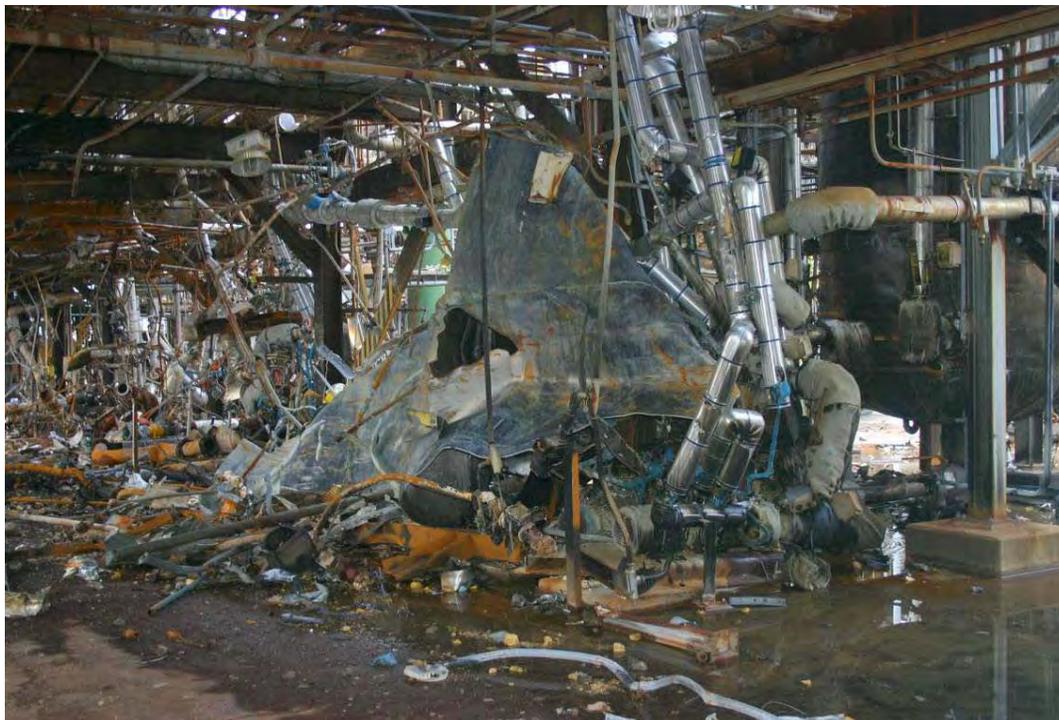
Debris was thrown in all directions, some hundreds of feet. The 5,700-pound residue treater ripped out piping, electrical conduit, and a structural steel support column as it split apart and careened northeast into the Methomyl-Larvin production unit structure (Figure 1). The blast overpressure moderately damaged the unit control building and other nearby structures. Flying debris struck the protective steel shield blanket surrounding a 6,700-gallon methyl isocyanate (MIC) “day tank” located about 70 feet southwest of the residue treater (Figure 2), but did not damage the day tank. The steel blanket also protected the MIC day tank from the radiant heat generated by the nearby fires that burned for more than 4 hours.

Figure 1. Residue treater came to rest inside the Methomyl-Larvin unit

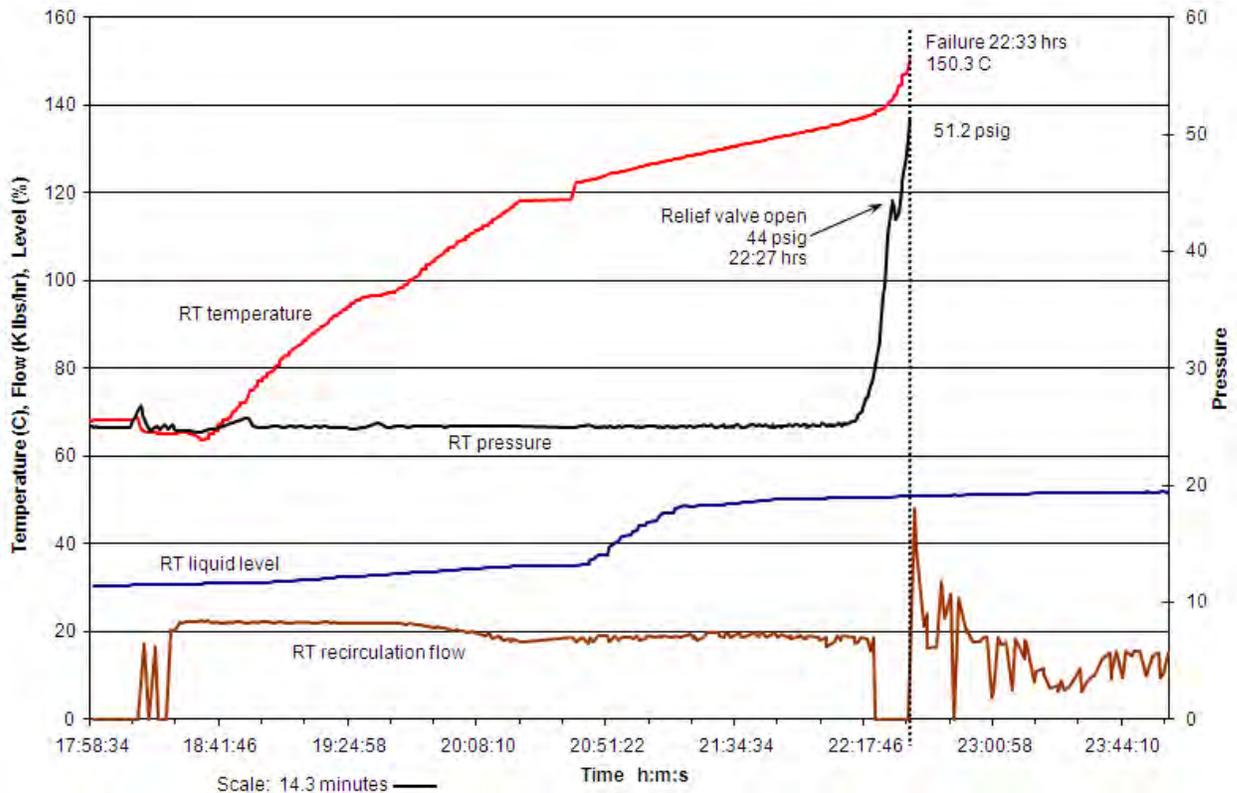
ranged between 60 and 65 °C (140-149 °F), still significantly below 135 °C (275 °F), the critical decomposition temperature. The pressure remained constant at 22 psig. At 6:38 p.m., the temperature began steadily rising about 0.6 degrees per minute (Figure 11). At 10:21 p.m., the level was 51 percent when the recirculation flow suddenly dropped to zero.²⁹ In less than 3 minutes, the temperature was at 141 °C (286 °F), rapidly approaching 155 °C (311 °F), the safe operating limit, and climbing at the rate of more than two degrees per minute.

Figure 11. Residue treater process variables before the explosion. Failure occurred at 22:33, as shown at vertical dotted line

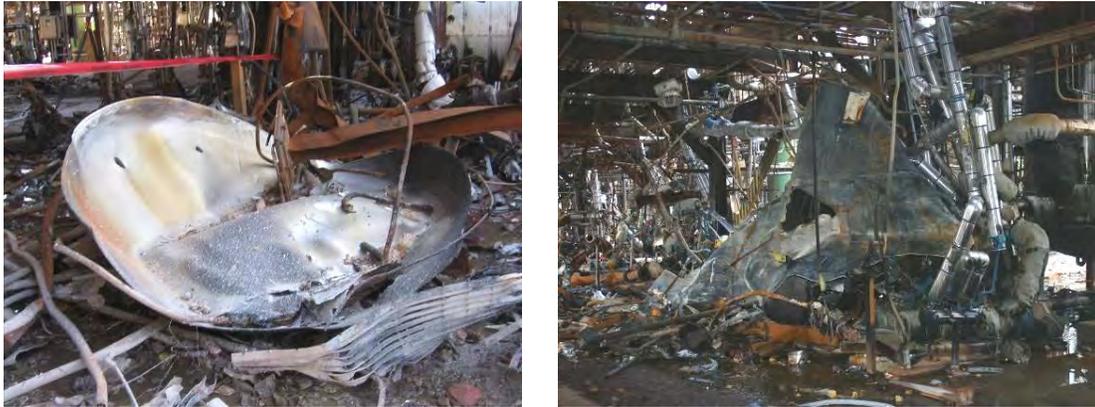
treater foundation. The explosion destroyed nearby pumps, heat exchangers, and electrical switchgear. The fire was fueled primarily by the solvent inside the residue treater and other flammable liquids that spilled from the ruptured piping systems.

Figure 12. Residue treater bottom head (left); vessel shell and top head (right)

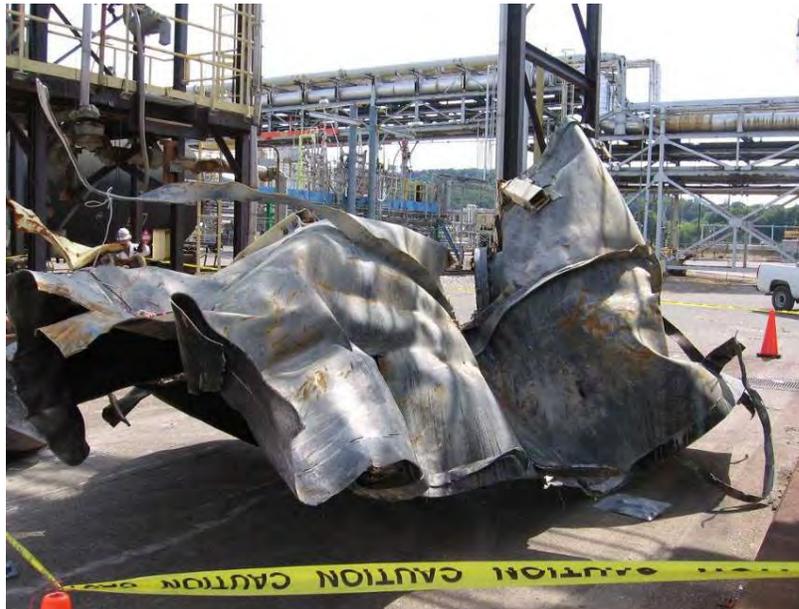
Figure 13. Residue treater shell and top head recovered from inside the Methomyl-Larvin unit

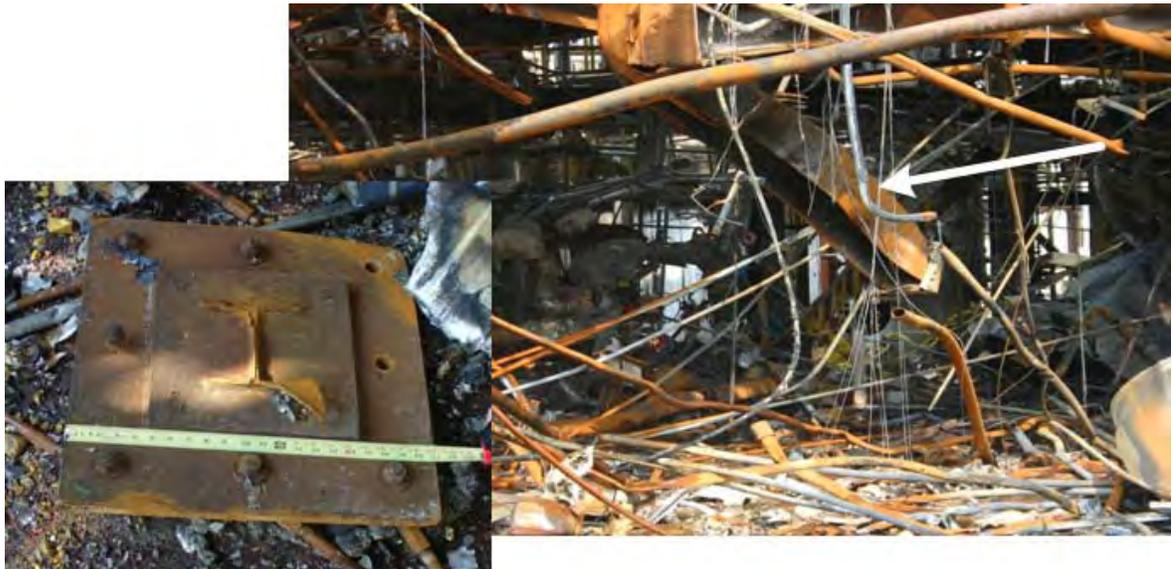
The residue treater struck a large support column on the four-story process unit structure and sheared it off the baseplate on the concrete foundation (Figure 14). Small debris, including conduit, valves, small diameter pipe segments, and insulation, was thrown in all directions, some of which struck, but did not penetrate the MIC day tank blast blanket. The blast blanket also functioned as a heat shield to protect the tank and attached piping from the intense solvent-fueled fire.

Figure 14. Structural column (arrow) ripped from the steel baseplate (left)

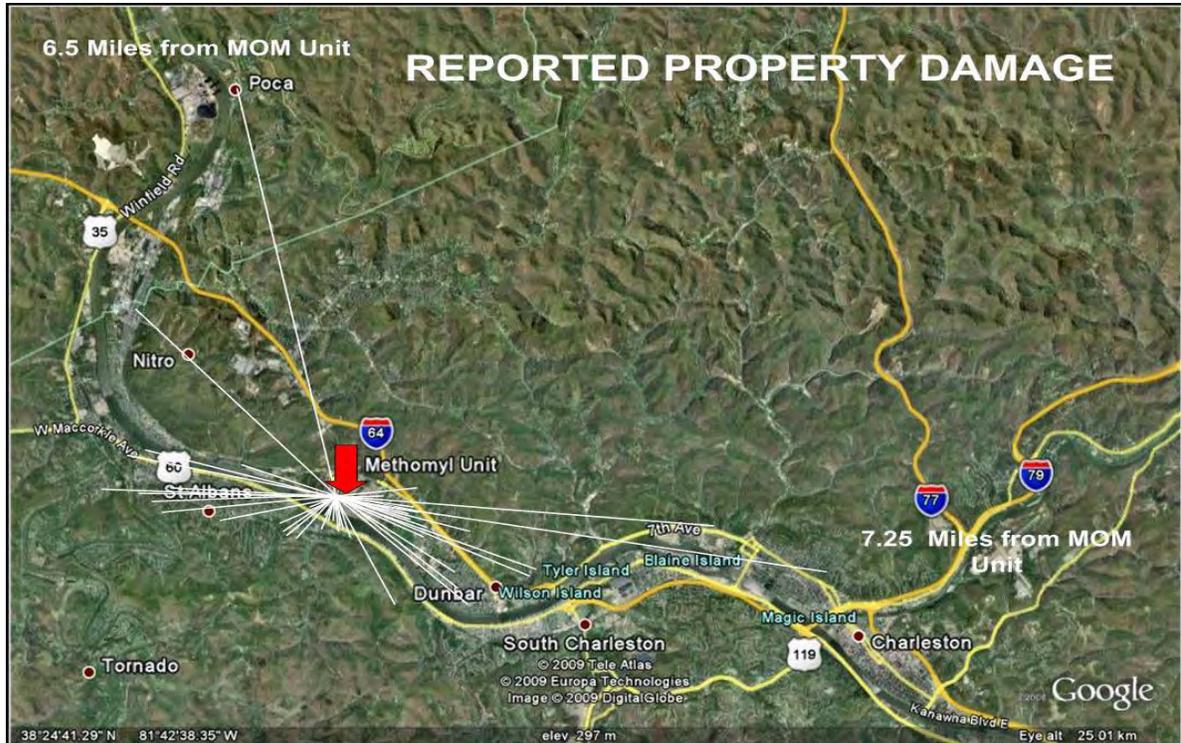
The overpressure produced by the rupturing residue treater damaged properties in the surrounding community. Mobile homes, houses, businesses, and vehicles sustained primarily window breakage and minor structural damage. The majority of the property damage reports were within 1.5 miles of the explosion epicenter; however, some damage was reported as far away as 7 miles (Figure 15). Bayer received 57 property damage claims from residences and businesses totaling about \$37,000.

Figure 15. Aerial view of locations of reported offsite property damage

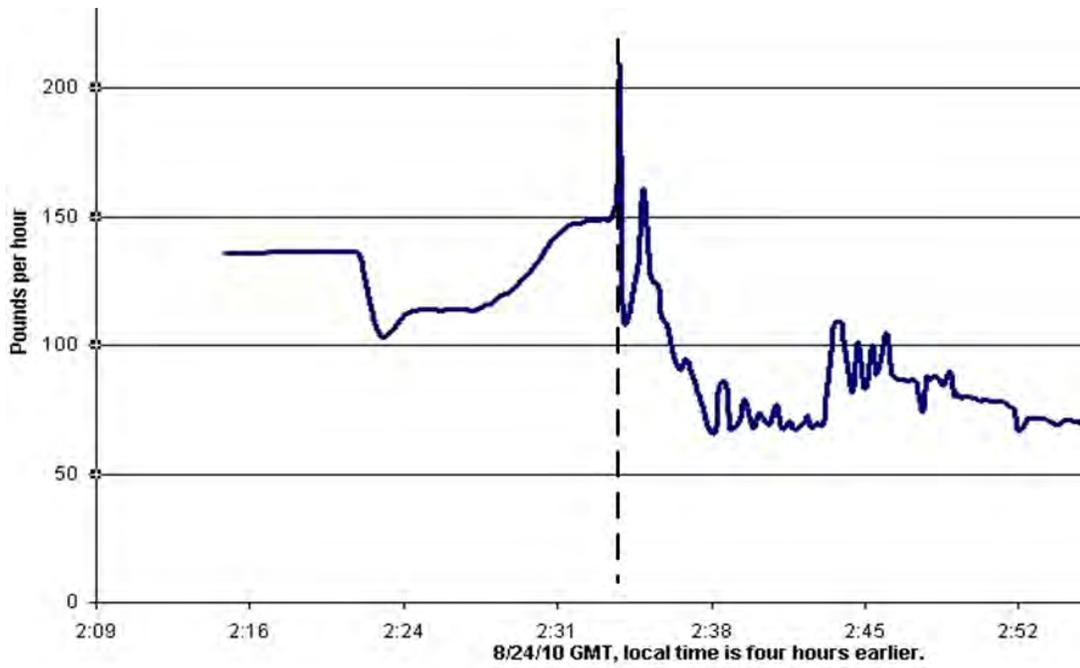
Figure 19. Indicated steam flow through the residue treater heater. Vertical dashed line shows point of vessel failure. Actual flow was zero because valve was closed

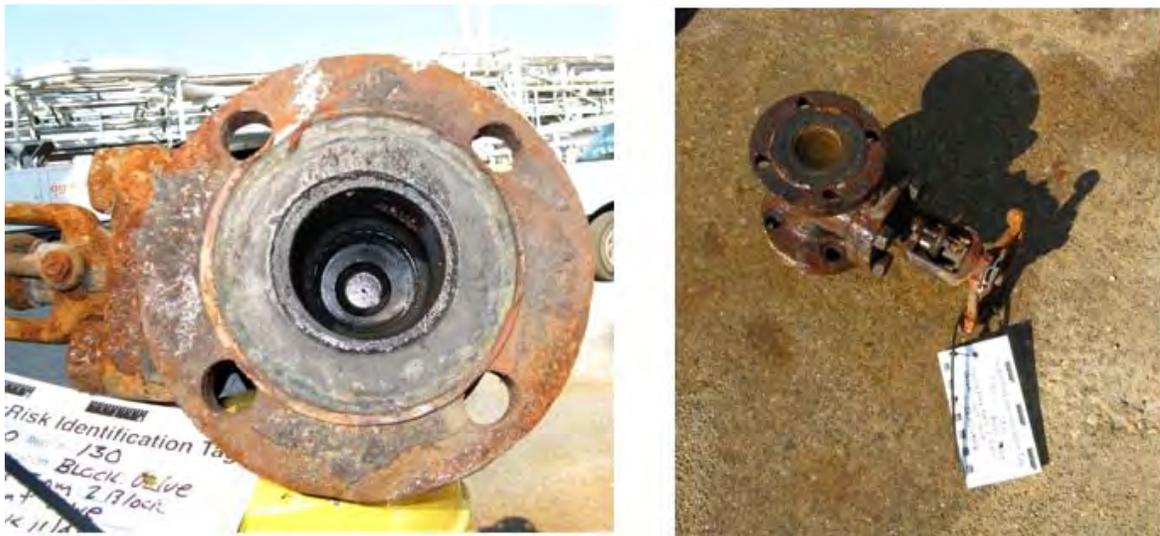
⁴⁰ The valve was removed from the pipe and visually examined. Water placed in the valve body did not leak past the seat in any measurable amount.

Figure 20. Closed steam block valve recovered from residue treater heater steam supply valve

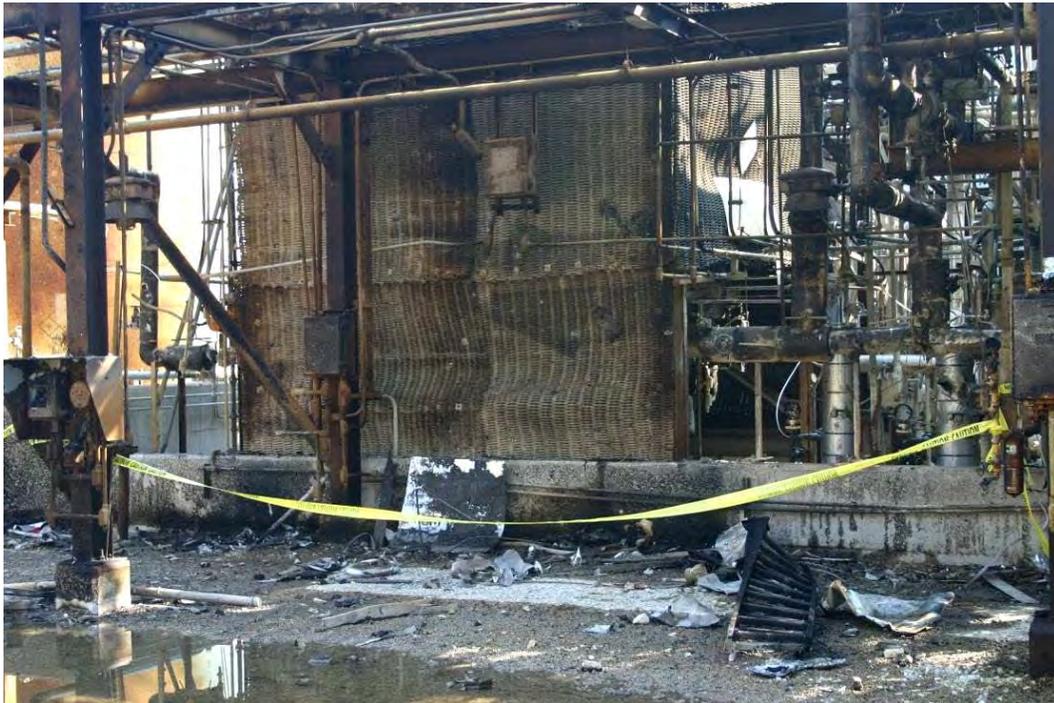
The day tank contained approximately 13,700 pounds of MIC on the night of the residue treater explosion and fire. Neither the empty cross-plant transfer line nor the carbofuran unit transfer system, which was operating at the time of the incident, was damaged. Debris from the explosion struck the blast blanket surrounding the day tank (Figure C-1), and the blast blanket was exposed to radiant heat from the fires. However, the MIC day tank was not damaged.

Figure C-1. MIC tank blast shield post-incident

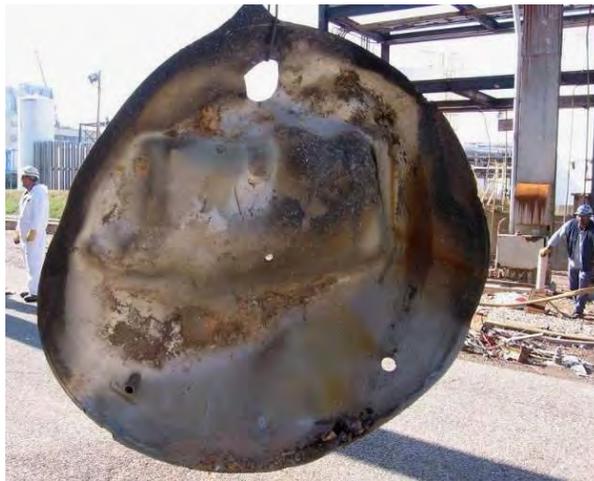
The shell and one head careened into the methomyl unit when the residue treater violently exploded. The other 800-pound head (Figure C-3) sheared off and came to rest near the installed location of the residue treater. A small piece of the vessel cylindrical shell separated and lodged between a catwalk and the shell of a distillation column (Figure C-4) some 15 to 20 feet from the residue treater installed location.

Figure C-3. 800-pound residue treater bottom head

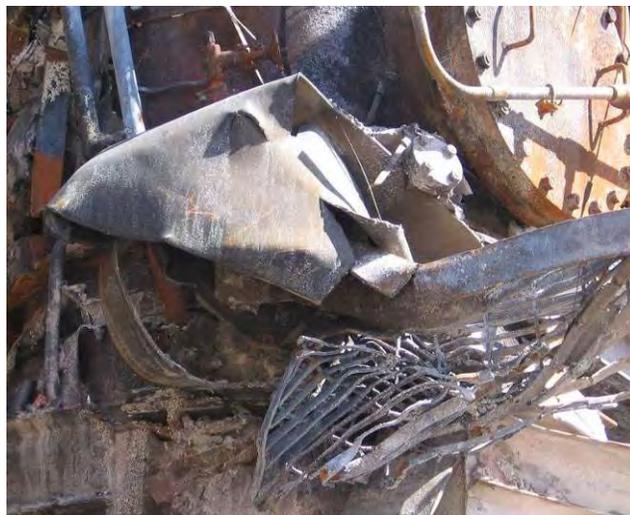
Figure C-4. Residue treater shell fragment lodged in catwalk of adjacent distillation column

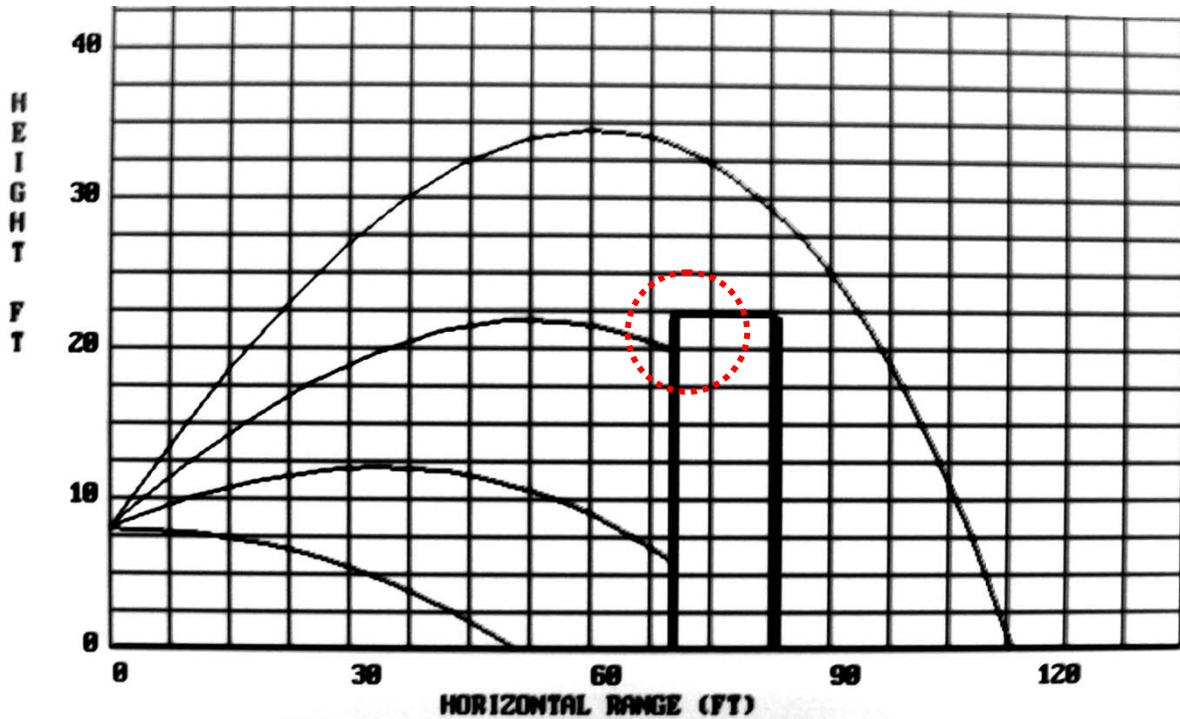
If a large, high velocity fragment strikes the shield structure at the elevation where the MIC tank piping passes through the grating with enough energy to deflect the structure more than about 4 inches horizontally, the piping could be damaged. The model predicts that the residue treater main fragment will strike the structure at this elevation (circled area on Figure C-5) when the departure trajectory angle from the explosion epicenter is about 30 degrees above horizontal. The fragment energy at impact is 137,000 foot-pounds.

Figure C-5. TRAJ plot with fragment impact with the blast shield structure (vertical line at 75 feet range). The curves represent fragment departure angles of 0, 15, 30, and 45 degrees.
