U.S. CHEMICAL SAFETY AND HAZARD INVESTIGATION BOARD

Pesticide Chemical Runaway Reaction Pressure Vessel Explosion

BAYER CROPSCIENCE, LP

Report No. 2008-08-I-WV
January 2011

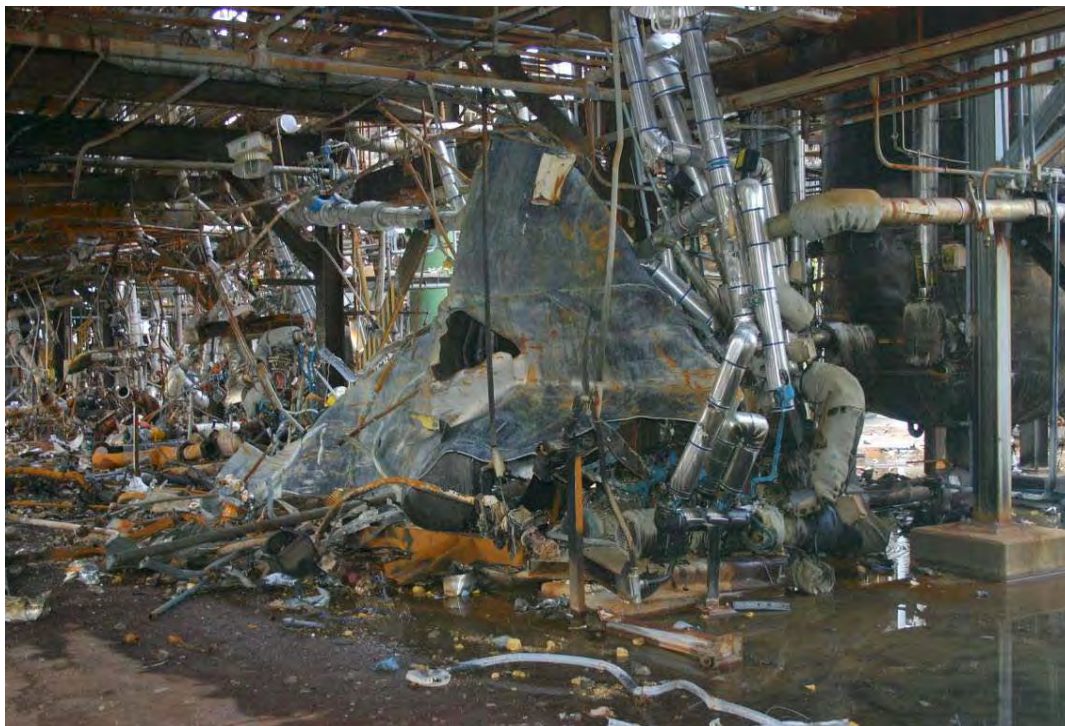
Debris was thrown in all directions, some hundreds of feet. The 5,700-pound residue treater ripped out piping, electrical conduit, and a structural steel support column as it split apart and careened northeast into the Methomyl-Larvin production unit structure (Figure 1). The blast overpressure moderately damaged the unit control building and other nearby structures. Flying debris struck the protective steel shield blanket surrounding a 6,700-gallon methyl isocyanate (MIC) “day tank” located about 70 feet southwest of the residue treater (Figure 2), but did not damage the day tank. The steel blanket also protected the MIC day tank from the radiant heat generated by the nearby fires that burned for more than 4 hours.

Figure 1. Residue treater came to rest inside the Methomyl-Larvin unit

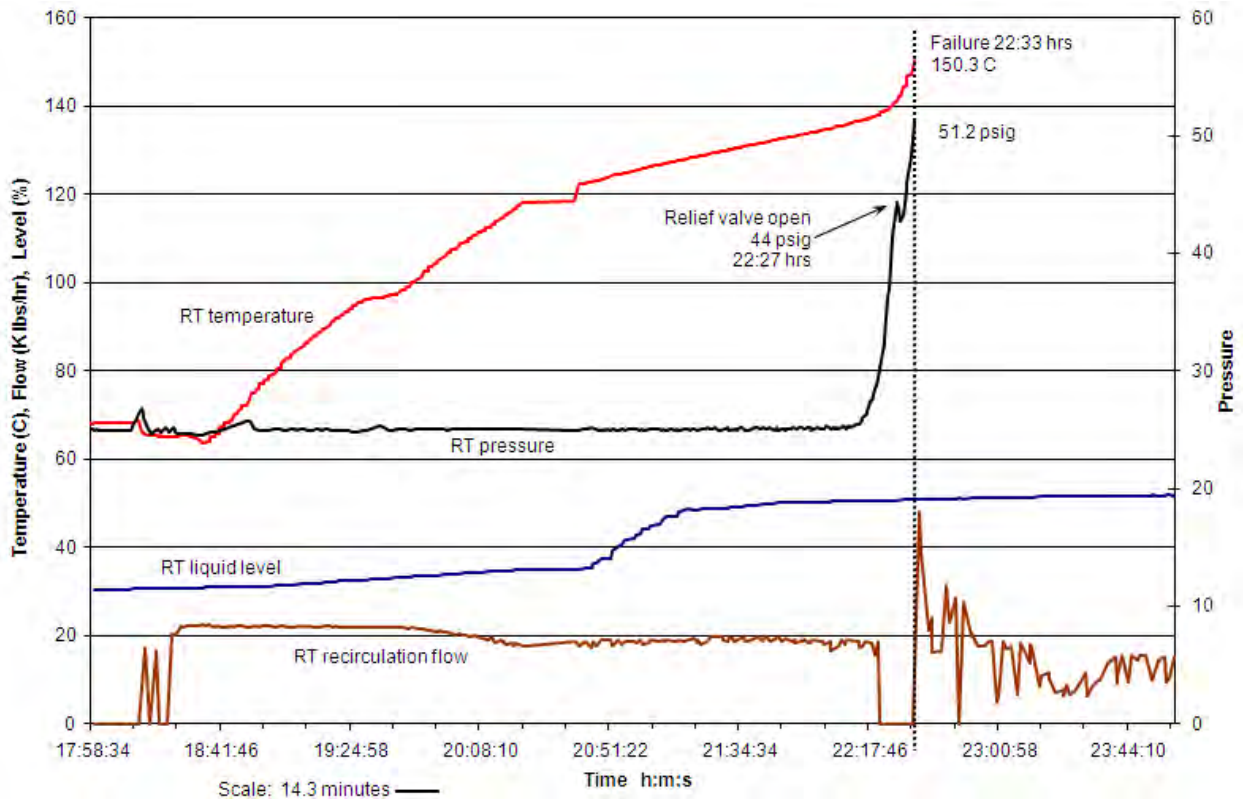
ranged between 60 and 65 °C (140-149 °F), still significantly below 135 °C (275 °F), the critical decomposition temperature. The pressure remained constant at 22 psig. At 6:38 p.m., the temperature began steadily rising about 0.6 degrees per minute (Figure 11). At 10:21 p.m., the level was 51 percent when the recirculation flow suddenly dropped to zero.²⁹ In less than 3 minutes, the temperature was at 141 °C (286 °F), rapidly approaching 155 °C (311 °F), the safe operating limit, and climbing at the rate of more than two degrees per minute.

Figure 11. Residue treater process variables before the explosion. Failure occurred at 22:33, as shown at vertical dotted line

²⁹ A Bayer review after the incident determined that the split-range temperature control was incorrectly programmed in the DCS. In the process of changing from heating to cooling, the residue treater recirculation flow valves to both the heater and cooler closed, blocking all recirculation flow. However, the CSB concluded that this was not causal to the runaway reaction and vessel rupture.

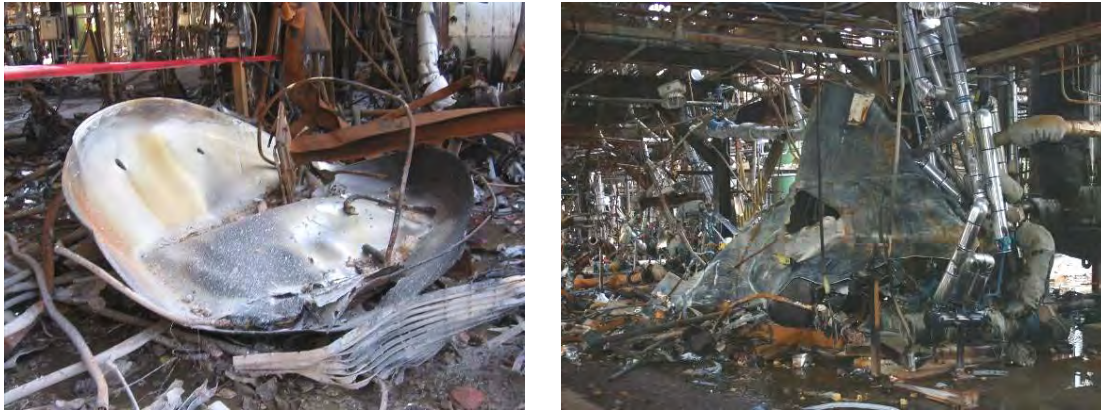
treater foundation. The explosion destroyed nearby pumps, heat exchangers, and electrical switchgear. The fire was fueled primarily by the solvent inside the residue treater and other flammable liquids that spilled from the ruptured piping systems.

Figure 12. Residue treater bottom head (left); vessel shell and top head (right)

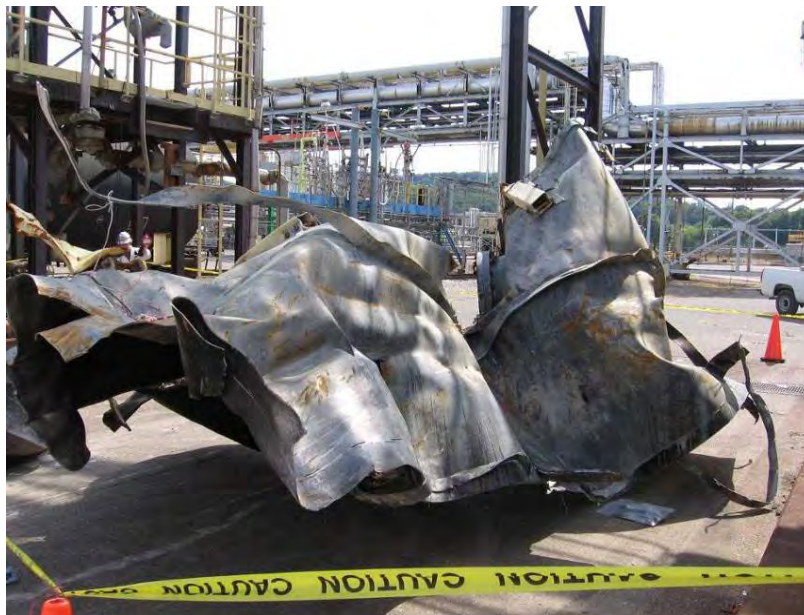
Figure 13. Residue treater shell and top head recovered from inside the Methomyl-Larvin unit

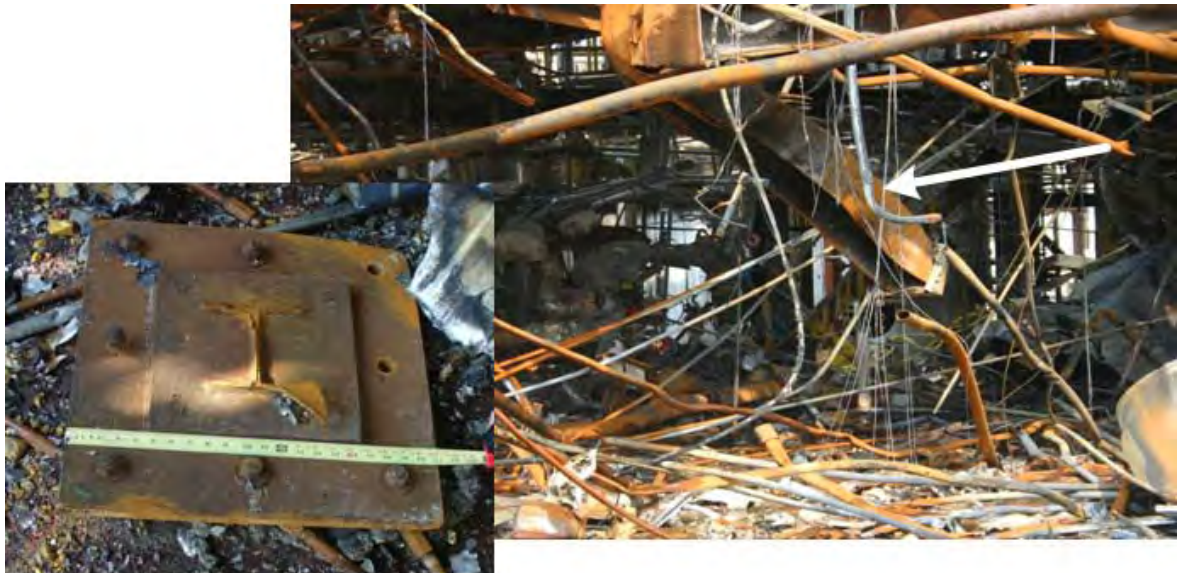
The residue treater struck a large support column on the four-story process unit structure and sheared it off the baseplate on the concrete foundation (Figure 14). Small debris, including conduit, valves, small diameter pipe segments, and insulation, was thrown in all directions, some of which struck, but did not penetrate the MIC day tank blast blanket. The blast blanket also functioned as a heat shield to protect the tank and attached piping from the intense solvent-fueled fire.

Figure 14. Structural column (arrow) ripped from the steel baseplate (left)

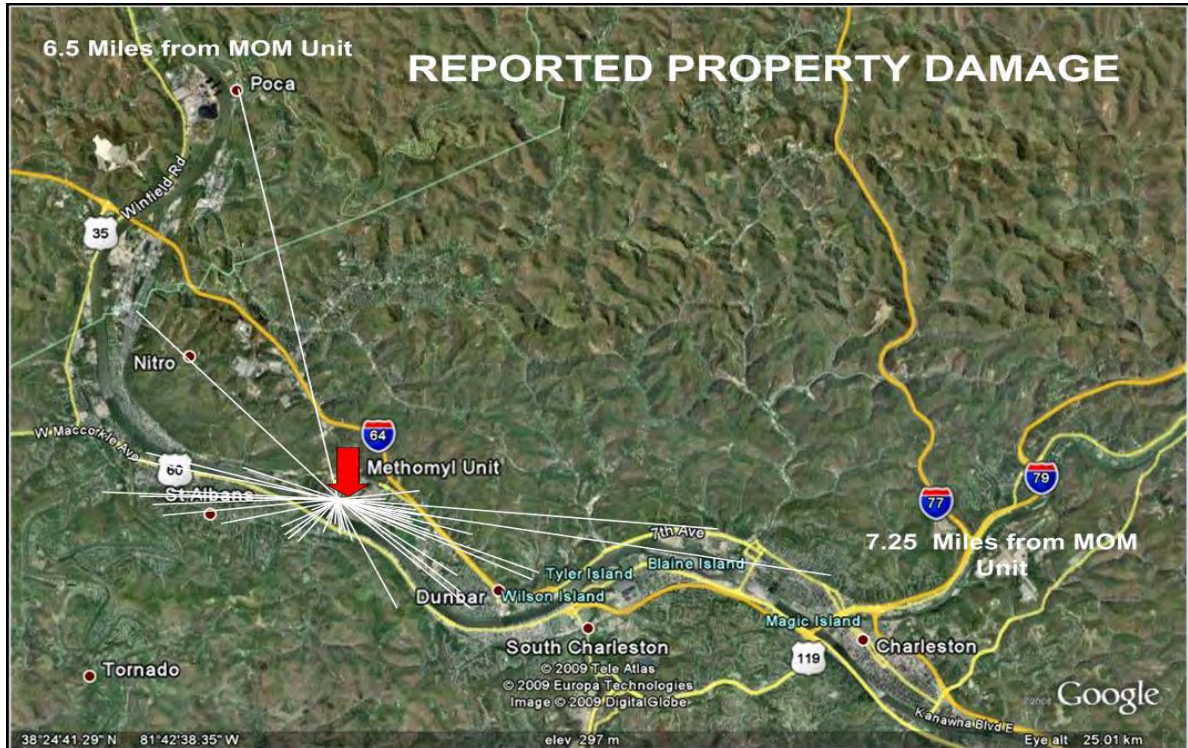
The overpressure produced by the rupturing residue treater damaged properties in the surrounding community. Mobile homes, houses, businesses, and vehicles sustained primarily window breakage and minor structural damage. The majority of the property damage reports were within 1.5 miles of the explosion epicenter; however, some damage was reported as far away as 7 miles (Figure 15). Bayer received 57 property damage claims from residences and businesses totaling about \$37,000.

Figure 15. Aerial view of locations of reported offsite property damage

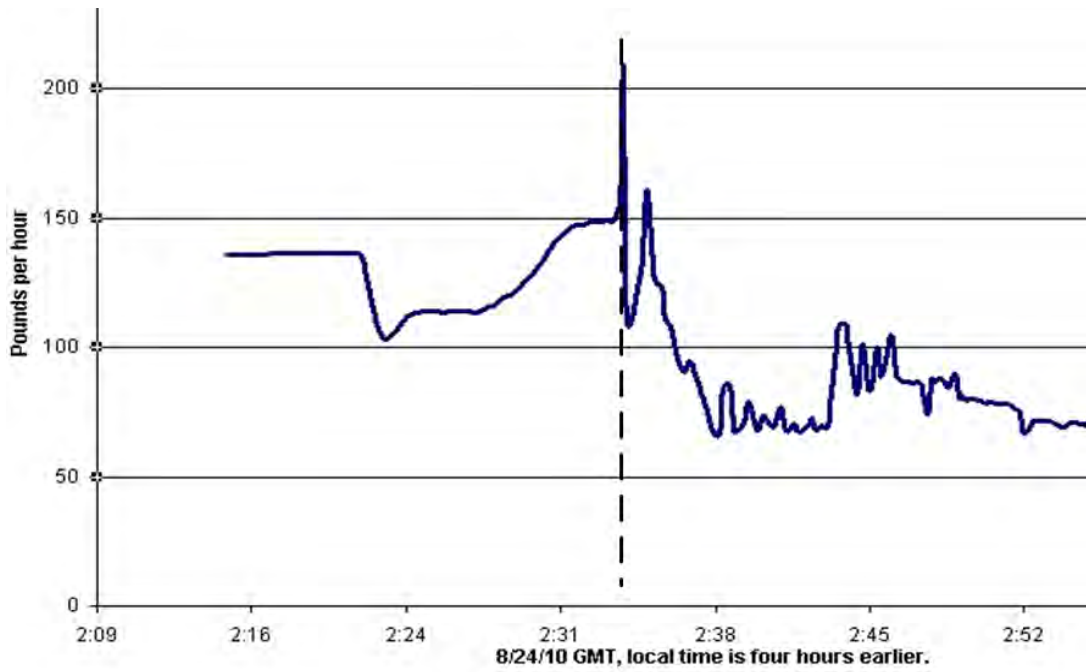
Figure 19. Indicated steam flow through the residue treater heater. Vertical dashed line shows point of vessel failure. Actual flow was zero because valve was closed

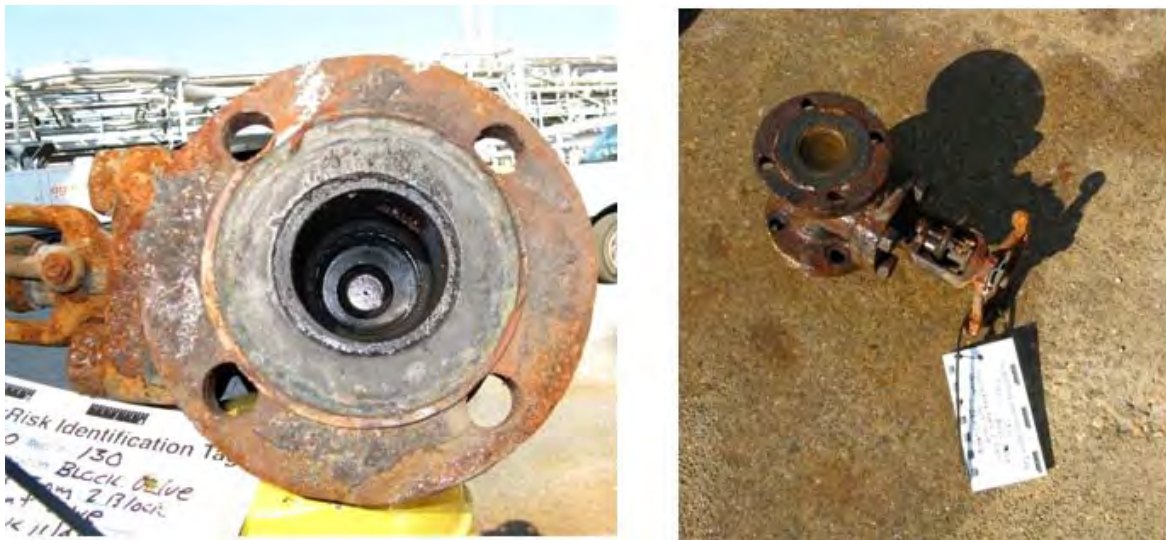
⁴⁰ The valve was removed from the pipe and visually examined. Water placed in the valve body did not leak past the seat in any measurable amount.

Figure 20. Closed steam block valve recovered from residue treater heater steam supply valve

It was determined that the automatic temperature control system closed both the heater and cooler flow control valves (see Figure 10) at the same time when the recirculation temperature control transitioned from heating to cooling. Bayer examined the temperature controller and its investigation team concluded that

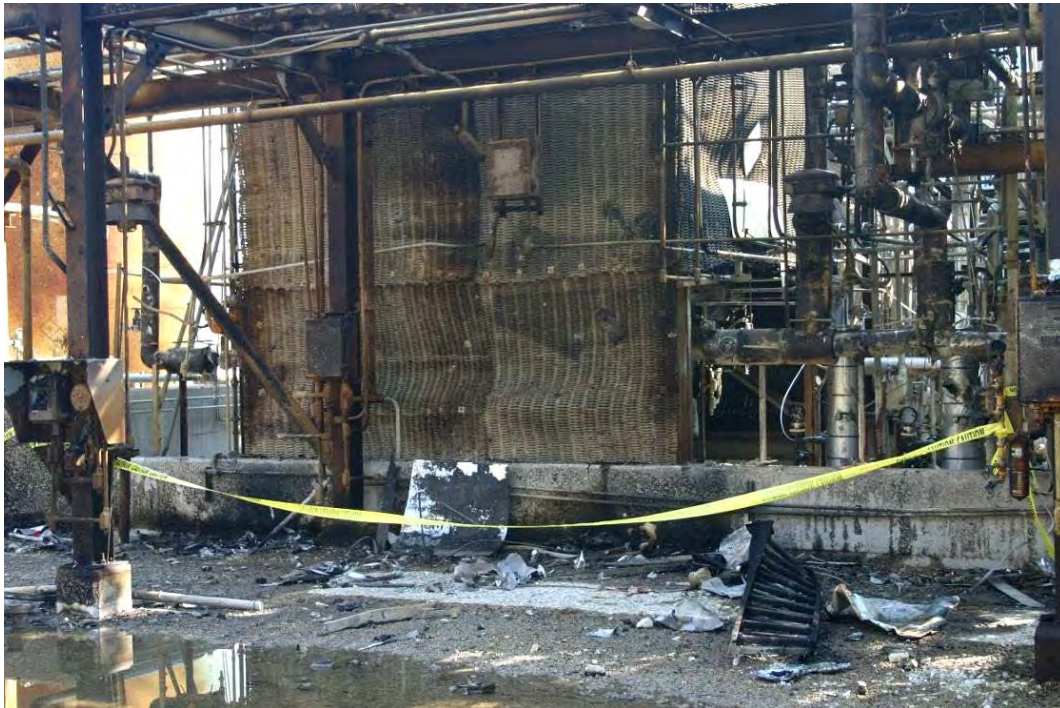
The day tank contained approximately 13,700 pounds of MIC on the night of the residue treater explosion and fire. Neither the empty cross-plant transfer line nor the carbofuran unit transfer system, which was operating at the time of the incident, was damaged. Debris from the explosion struck the blast blanket surrounding the day tank (Figure C-1), and the blast blanket was exposed to radiant heat from the fires. However, the MIC day tank was not damaged.

Figure C-1. MIC tank blast shield post-incident

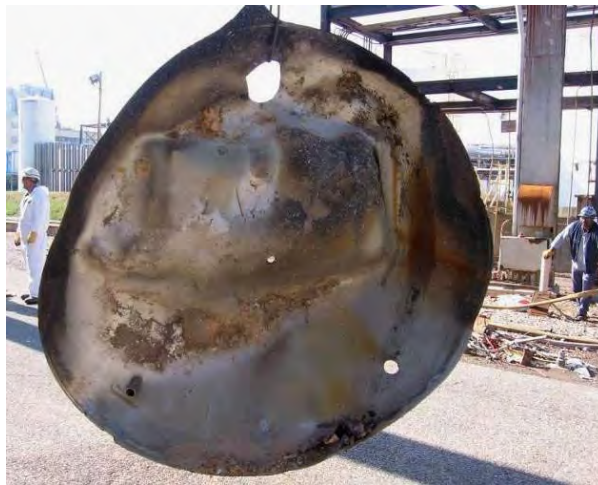
The shell and one head careened into the methomyl unit when the residue treater violently exploded. The other 800-pound head (Figure C-3) sheared off and came to rest near the installed location of the residue treater. A small piece of the vessel cylindrical shell separated and lodged between a catwalk and the shell of a distillation column (Figure C-4) some 15 to 20 feet from the residue treater installed location.

Figure C-3. 800-pound residue treater bottom head

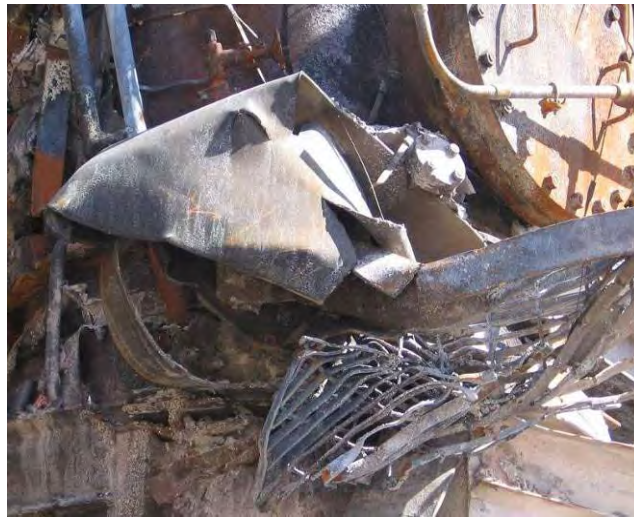
Figure C-4. Residue treater shell fragment lodged in catwalk of adjacent distillation column

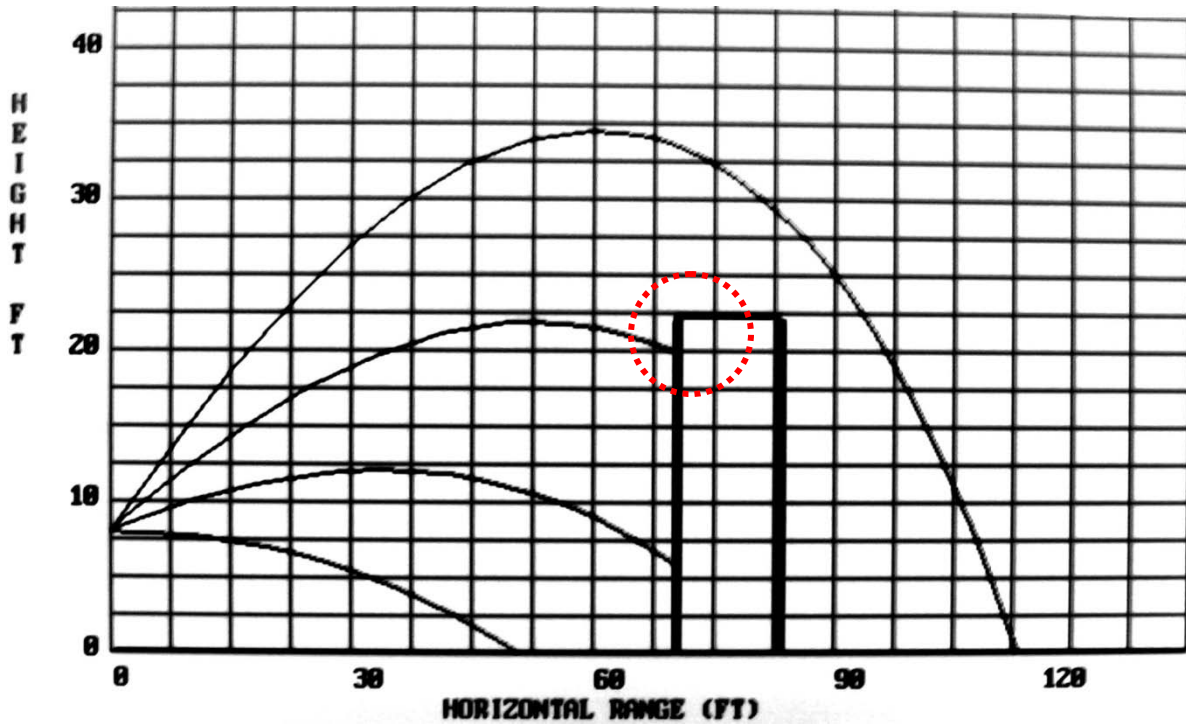
If a large, high velocity fragment strikes the shield structure at the elevation where the MIC tank piping passes through the grating with enough energy to deflect the structure more than about 4 inches horizontally, the piping could be damaged. The model predicts that the residue treater main fragment will strike the structure at this elevation (circled area on Figure C-5) when the departure trajectory angle from the explosion epicenter is about 30 degrees above horizontal. The fragment energy at impact is 137,000 foot-pounds.

Figure C-5. TRAJ plot with fragment impact with the blast shield structure (vertical line at 75 feet range). The curves represent fragment departure angles of 0, 15, 30, and 45 degrees.
